**NATIONAL TRANSPORTATION SAFETY BOARD**

**SURVIVAL FACTORS**

**Specialist's Factual Report**

**ERA16LA195**

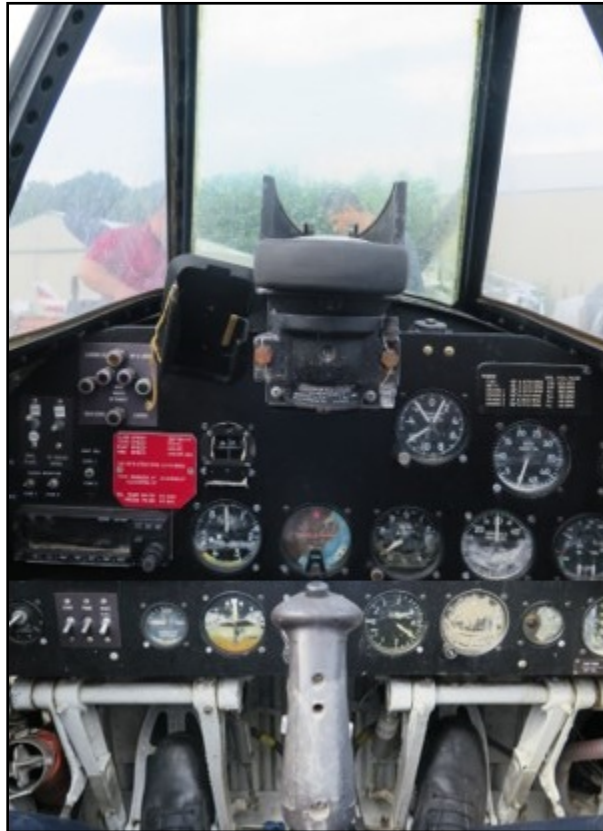
**Photograph 2 – Cockpit control stick and instrument panel.**

The airplane control stick and cockpit instrument panel (photograph 2) of the P-47D was visually inspected for damage. The inspection showed no evidence of damage to the airplane control stick and cockpit instrument panel.

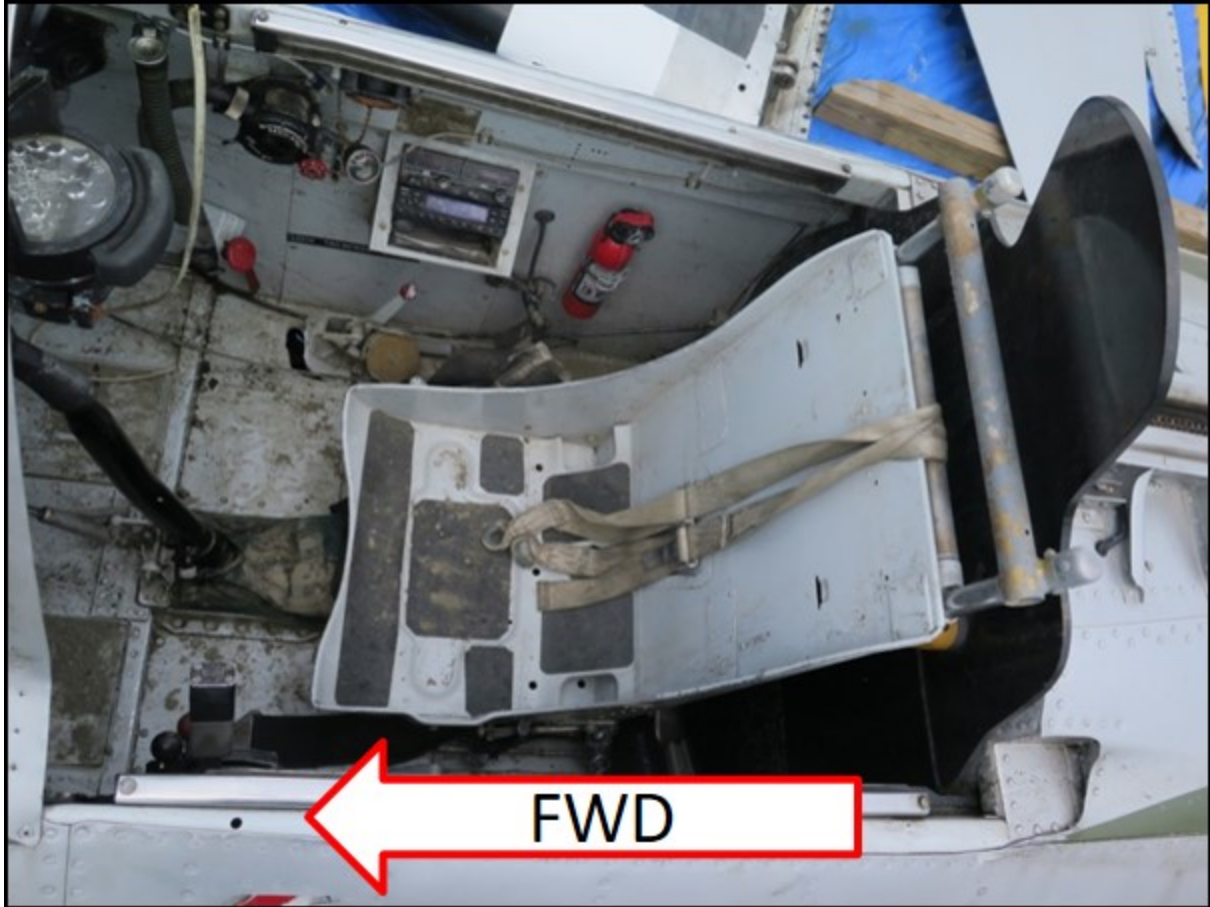
**Photograph 3 – Pilot seat.**

The pilot seat (photograph 3) was permanently attached in the cockpit. The seat bottom was attached to the cockpit floor while the seat back was attached to the aft bulkhead. The seat did not adjust forward or backward, but was vertically adjustable by pulling the adjustment handle located at the right seat corner. No part number was visible on the seat or frame. The seat was examined and able to be adjusted in its full range of motion. The pilot's parachute was used as a cushion.

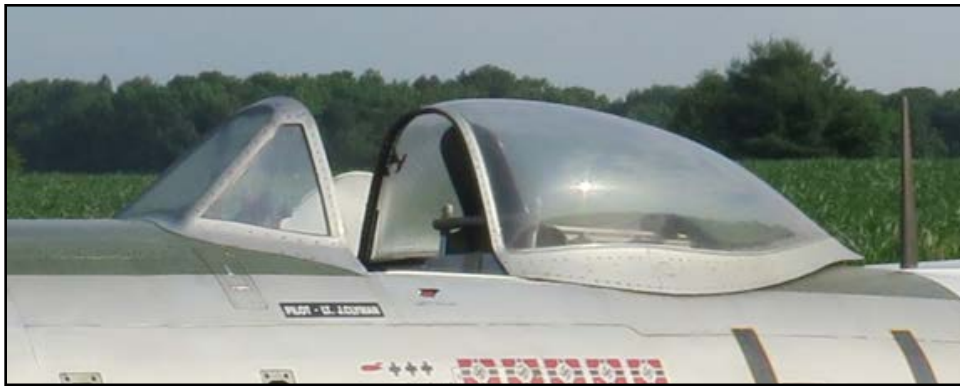
**Photograph 6 – Cockpit Canopy.**

The cockpit canopy was found in the fully open position (photograph 6).

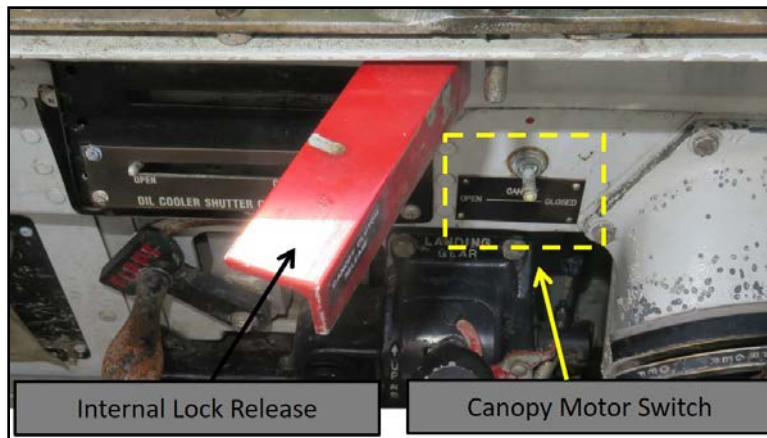
**Photograph 7 – Internal canopy release mechanism.**

An examination of the internal and external lock release mechanism was performed. Both lock release mechanisms disengaged the motor and allowed the canopy to move freely on its rails. Due to flammable fluids in the area and no power source, the automatic motor switches were not tested.

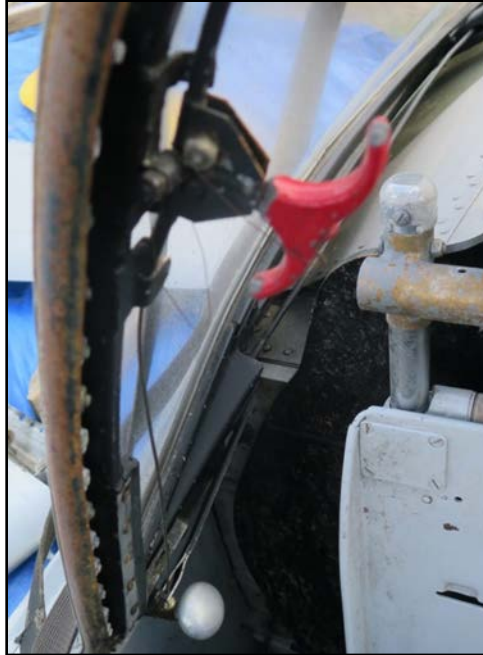
**Photograph 9 – Jettison handle.**

The canopy was designed to jettison from the airplane. To accomplish this the pilot would pull the red jettison handle (photograph 9) mounted on the front right frame of the canopy. This action allows the locking pins to be pulled from the jettison fittings which hold the canopy to the roller assemblies. All three fittings are then free and the canopy may be jettisoned in flight or removed while the airplane is on the ground. The jettison system was tested by pulling the t-handle, which released the canopy from the rails. The canopy was then removed from the airplane, demonstrating the system worked as designed. (photograph 10).

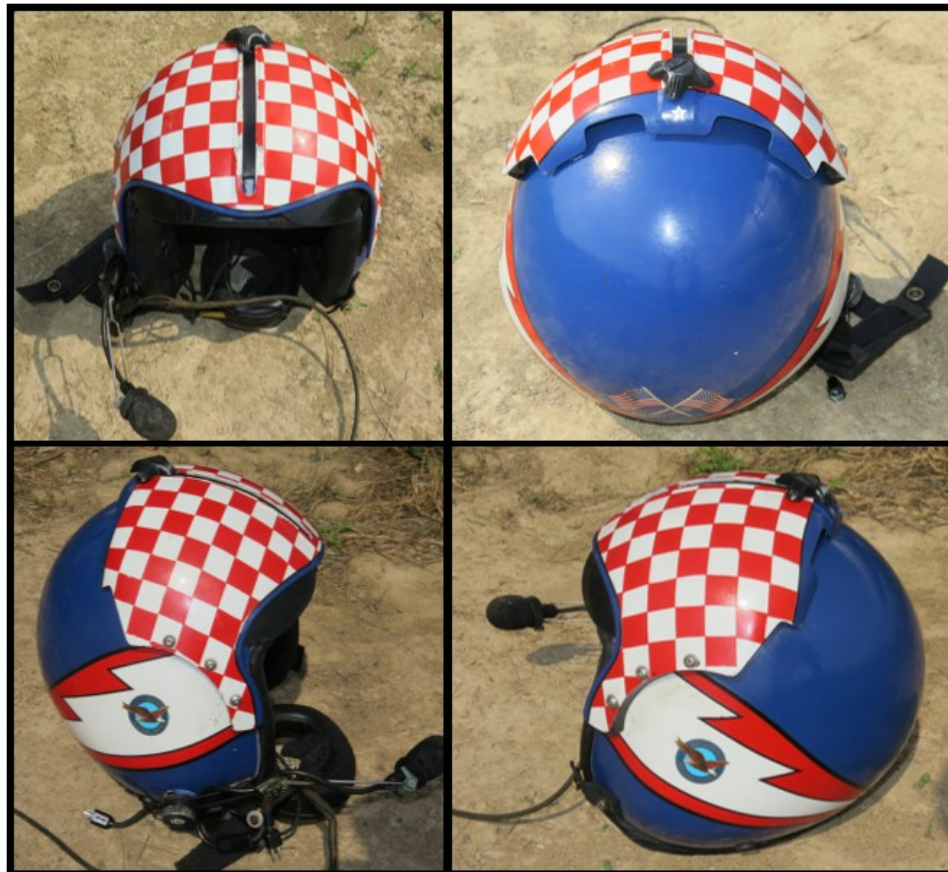
**Photograph 11 – Flight helmet.**

The flight helmet (photograph 11) was recovered from the accident airplane. The helmet shell showed no signs of impact damage and all manual functions of the helmet operated normally. The electronics components of the helmet were not tested. The helmet did not display a make or model number.
