# NATIONAL TRANSPORTATION SAFETY BOARD

## MATERIALS LABORATORY FACTUAL REPORT

Report No. 16-093

Place : Toughkenamon, Pennsylvania  
Date : June 1, 2016  
Vehicle : Aeronca 7AC N83547  
NTSB No. : ERA16LA200  
Investigator : Todd Gunther

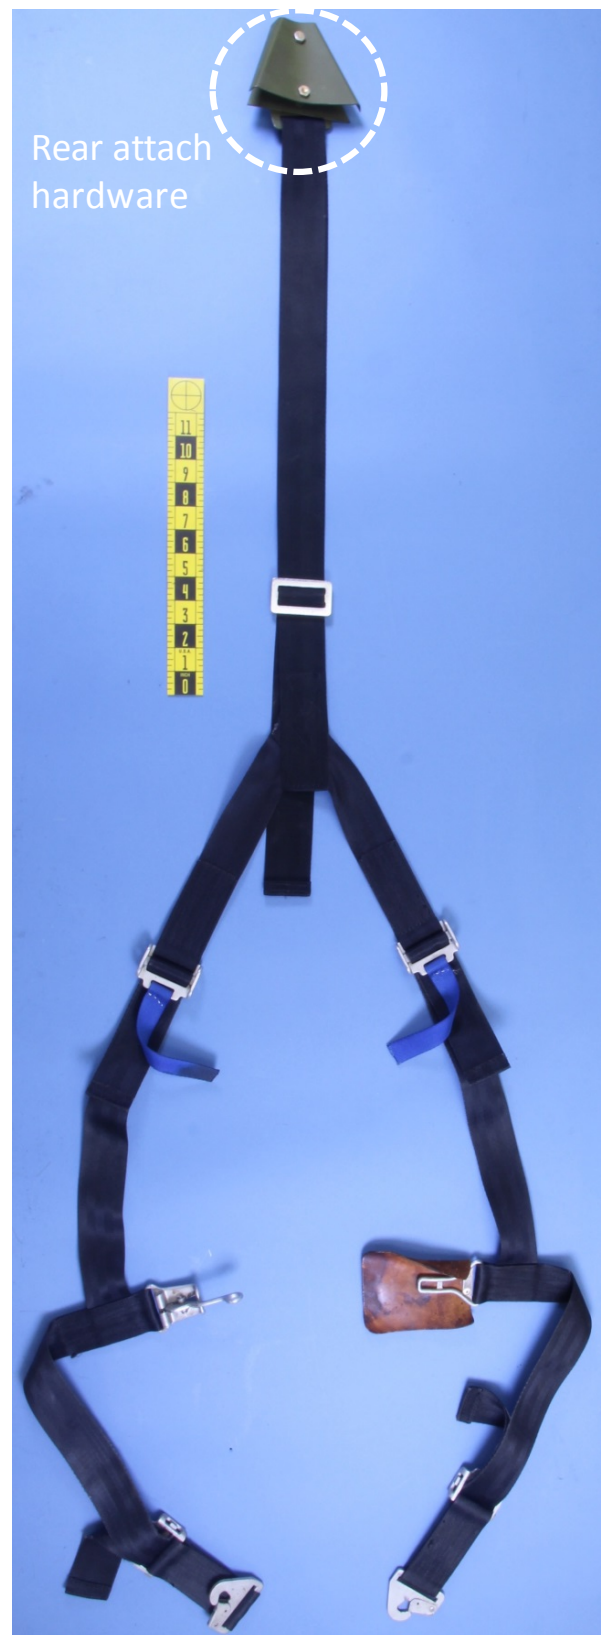
Figure 1 shows the submitted rear-seat shoulder-harness and rear attach-hardware assembly. The purpose of the laboratory investigation is to document the accident damage to the attach hardware as identified in Figure 1. For reference, Figure 2 shows post-accident images of the structural tubing arrangement behind the rear seat of the accident airplane (Figure 2a) and the post-accident position of the rear attach hardware on those structural tubes (Figure 2b).

Figure 1 As-received rear-seat shoulder-harness and rear attach-hardware assembly.

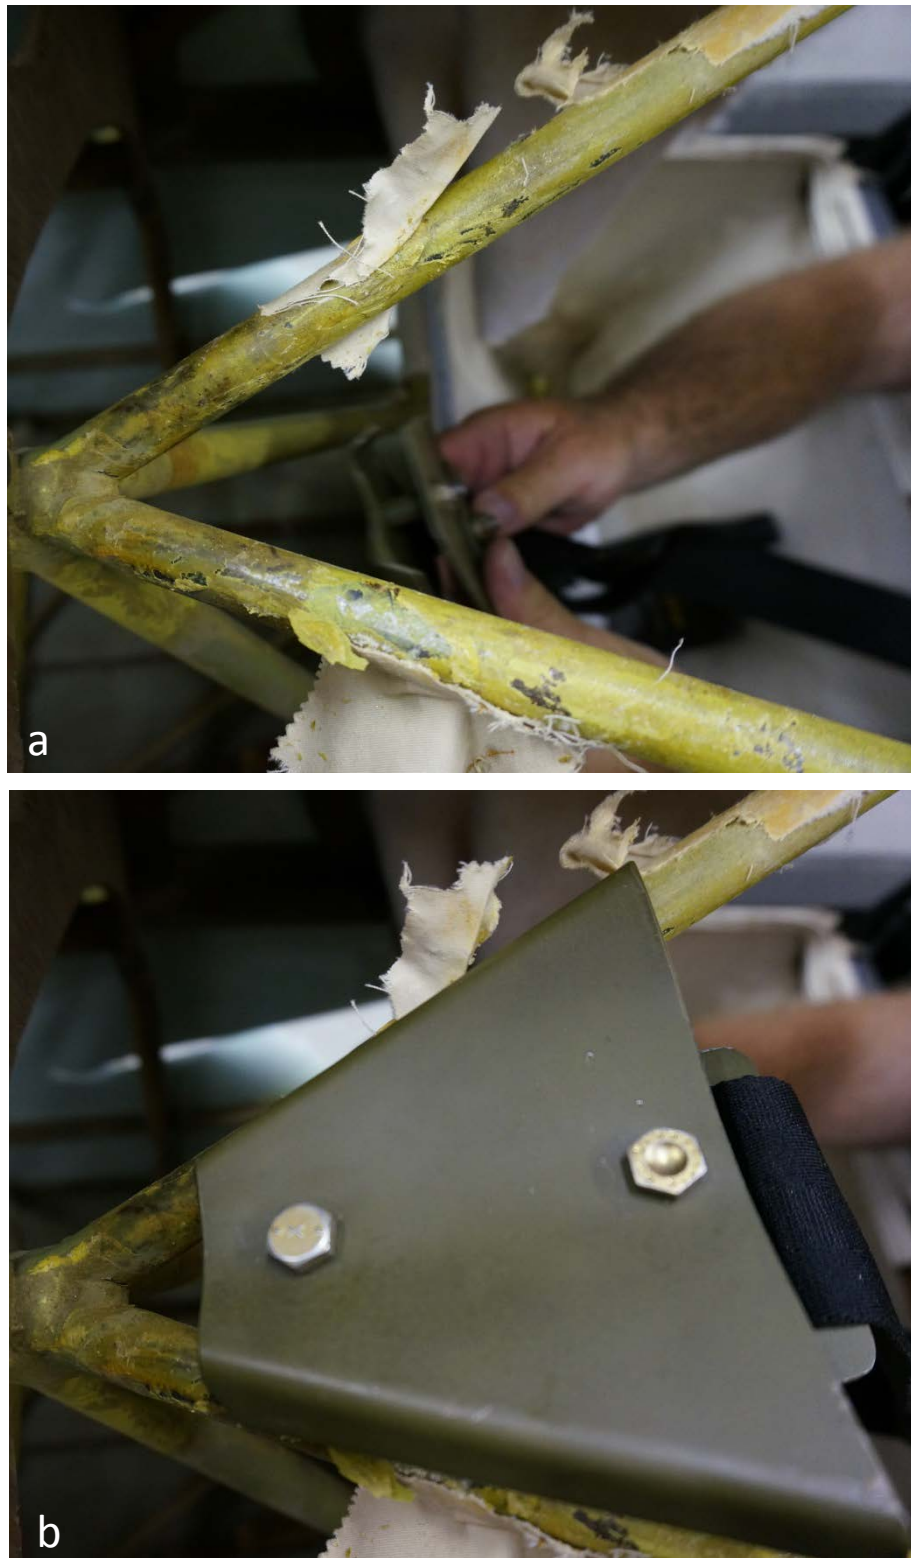
Figure 2 Post-accident images of the structural tubing arrangement behind the rear seat of the accident airplane (View a) and the position of the rear attach hardware on those structural tubes (View b).

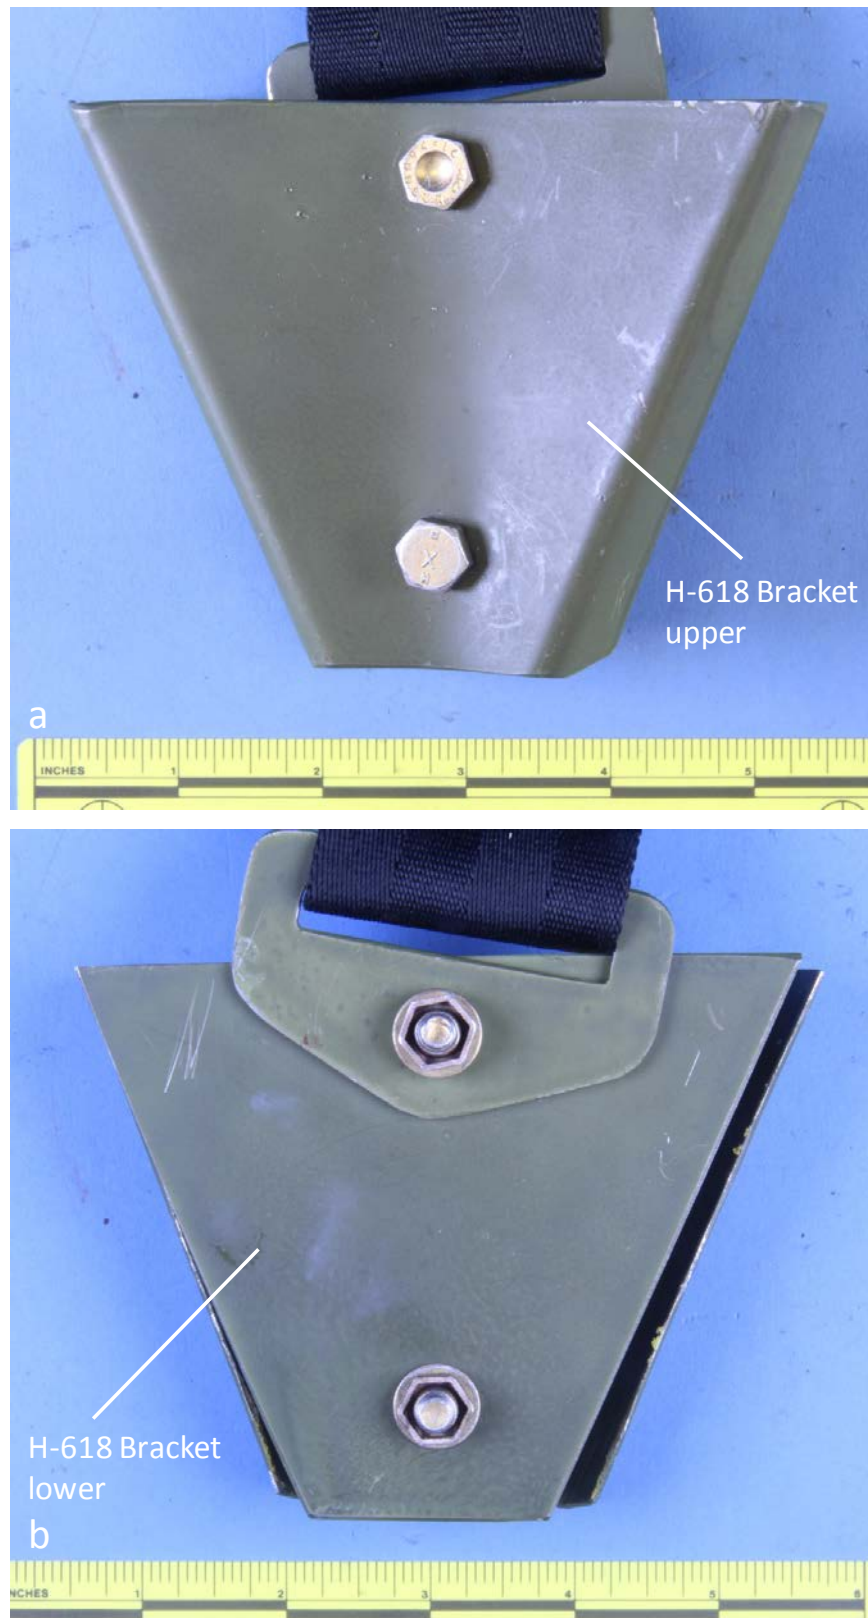
Closer views of the rear attach-hardware are shown in Figures 3 and 4. As observed in Figures 3a and 4, the upper attach bracket exhibits permanent bending deformation of the flat (planar) portion of the bracket from its original shape (e.g. double cantilever bending). The degree of bending from planarity is shown in Figure 4a (each half of the upper bracket is bent approximately 12°). The bending deformation is consistent with the installed bracket assembly being mechanically pulled or slid over the aircraft structural tubes (see Figure 2).

Figure 3 Images of the upper and lower brackets of the as-received rear attach hardware assembly.

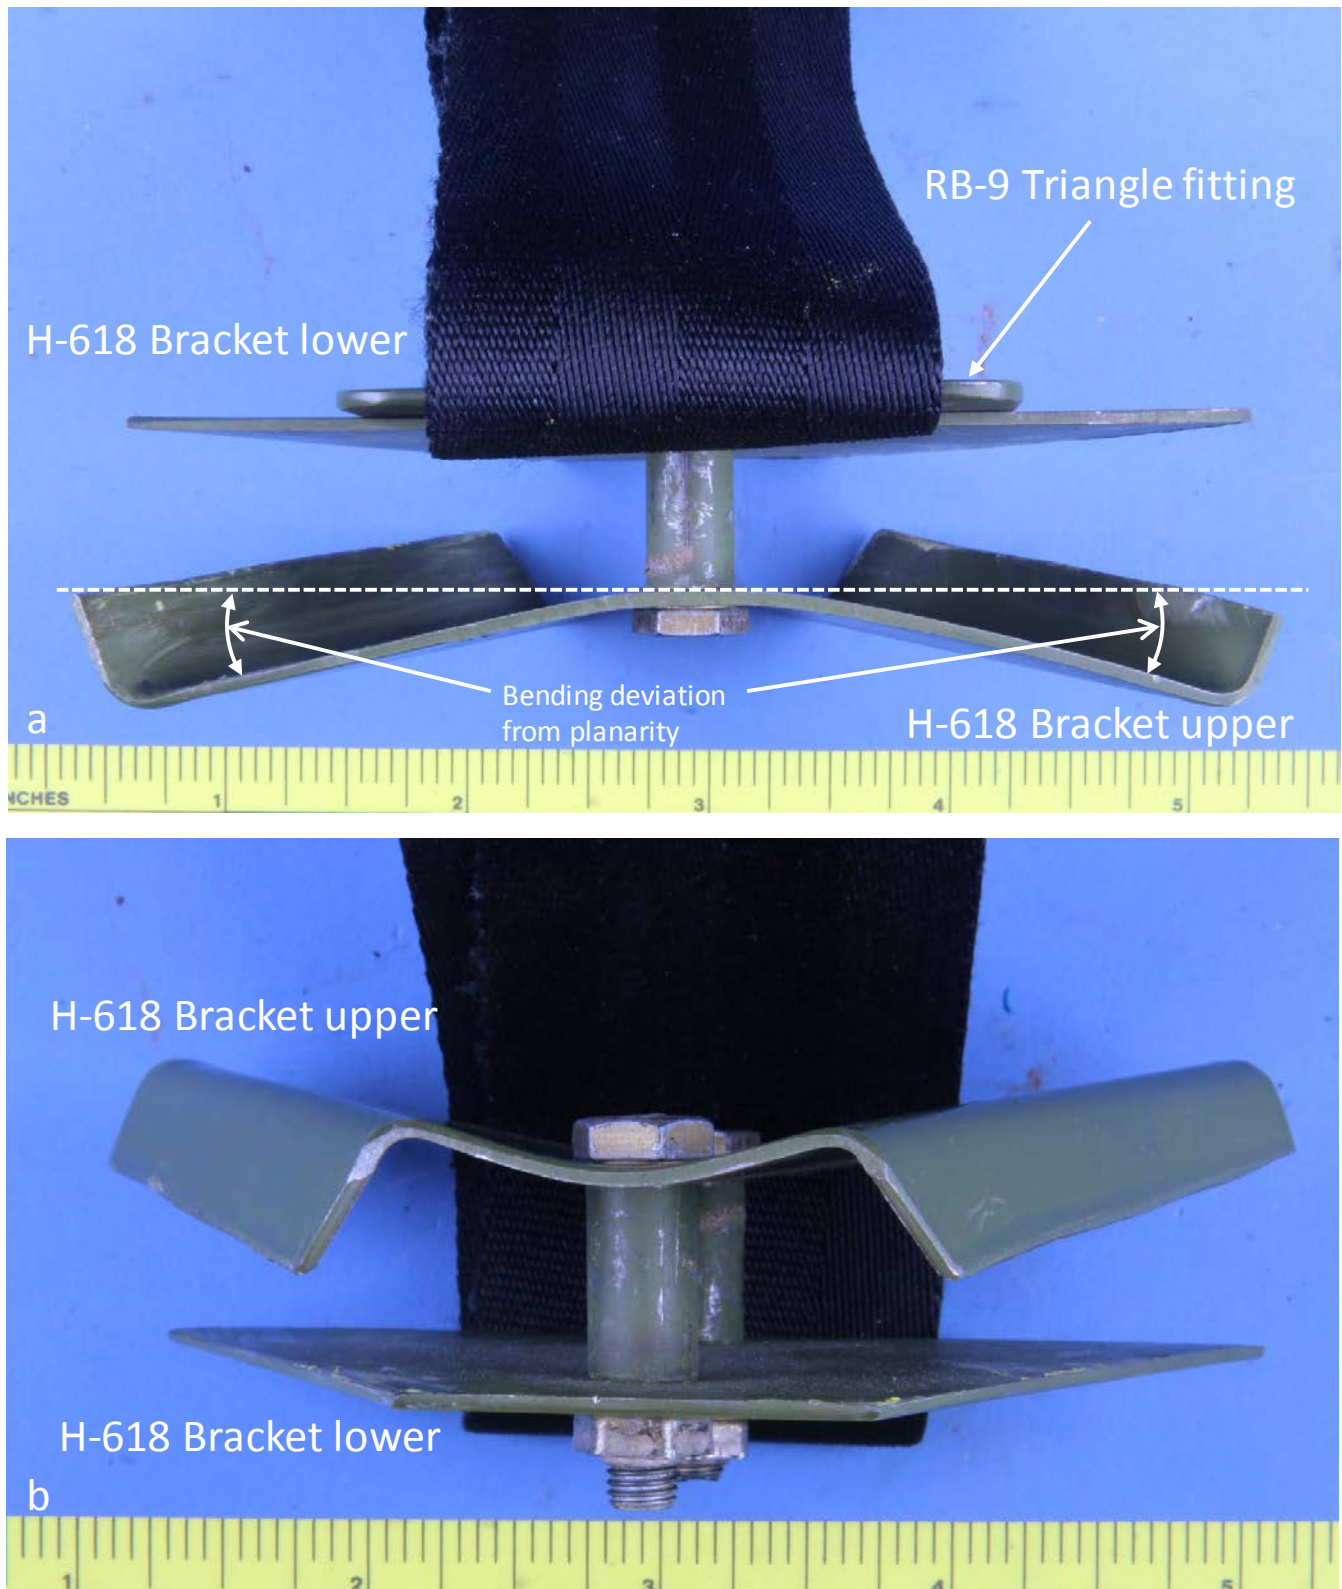
Figure 4 Edge views of the rear attach hardware assembly showing permanent bending deformation in the upper bracket.

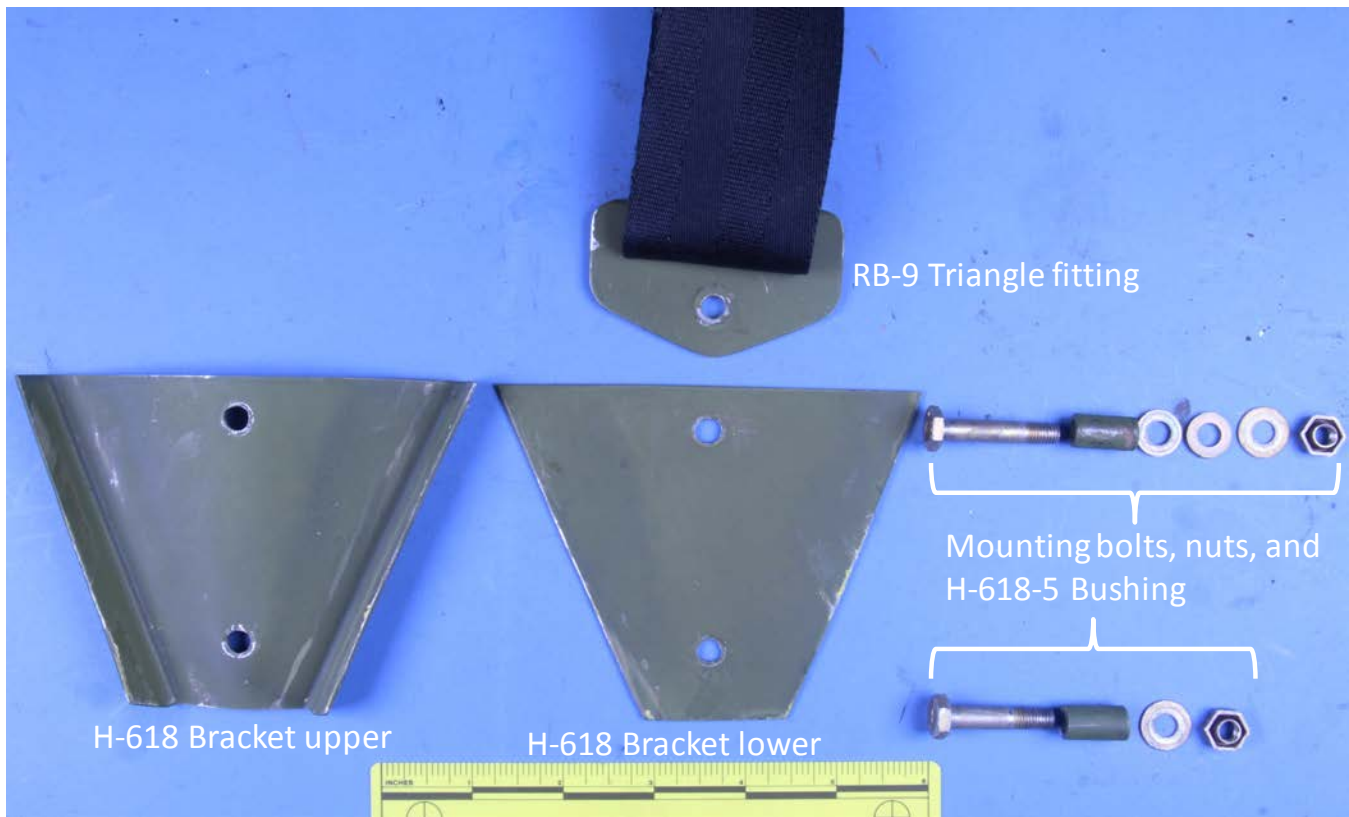
Figure 5 shows the internal surfaces of the disassembled rear attach hardware. Yellow paint transfer is noted along the edges of the upper and lower brackets as indicated in Figure 6. The paint transfer is consistent with the installed bracket assembly being mechanically pulled or slid over the aircraft structural tubes. The associated rear-attach fastening-hardware is also shown in Figure 5. The specification calls for AN365-624 elastic stop nuts for the fastening hardware, rather the submitted evidence included stamped lock-nuts. The specification requires a single AN960-616 washer to be installed under each nut, rather the bolt at the wide end of the attach

hardware had two AN960-616 washers and a unknown washer. The bolt at the narrow end of the attach hardware had an unknown washer.

Figure 5 View of the inner surfaces of the disassembled rear attach hardware.

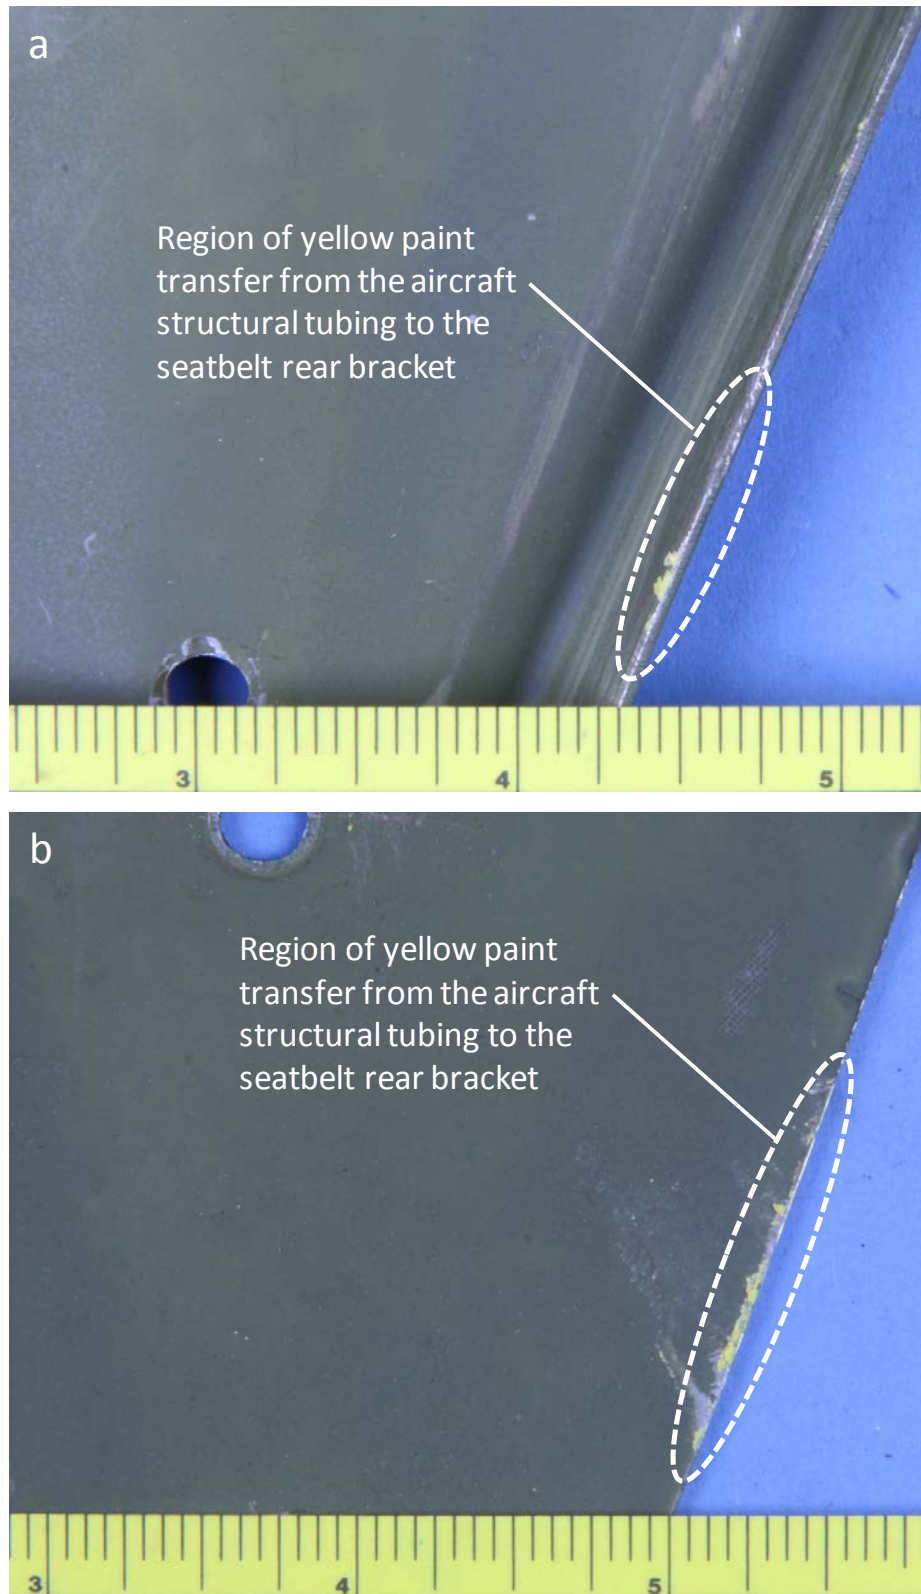
Figure 6 Areas of paint transfer from an airplane structural tube to the upper (View a) and lower (View b) brackets.
