# N429BB– Aircraft Accident- May 30, 2016

**NOTE:** The information in these notes is preliminary, may contain opinion, is subject to change, and may contain errors.

**Aircraft:** N429BB - 2012, Storch FI-156, S/N: CS 09008

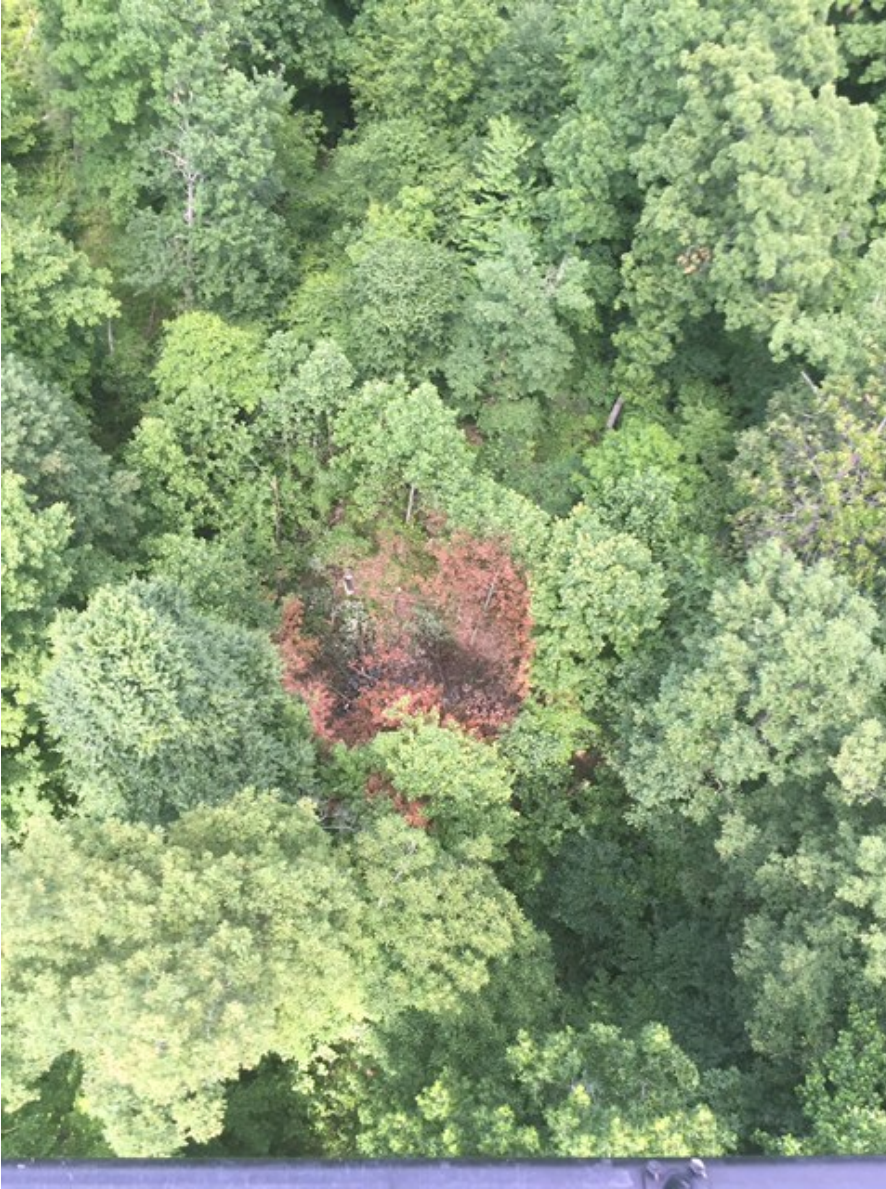
N429BB, VFR flight, impacted a heavily forested area on a heading of approx. north to northeast, at a high angle (approx. 75 degrees) at a high velocity, with a post crash fire. **Flight History:** See NTSB Preliminary Report.

A ground search was conducted from the impact site to the point of first indication of tree impact and beyond to observe the area for investigative clues. The ground foliage was dense and time consuming to search, with no results. Tree top damage was not detected outside of the impact area. Tree damage at the impact site included trees with diameters of 6 to 8 inches.

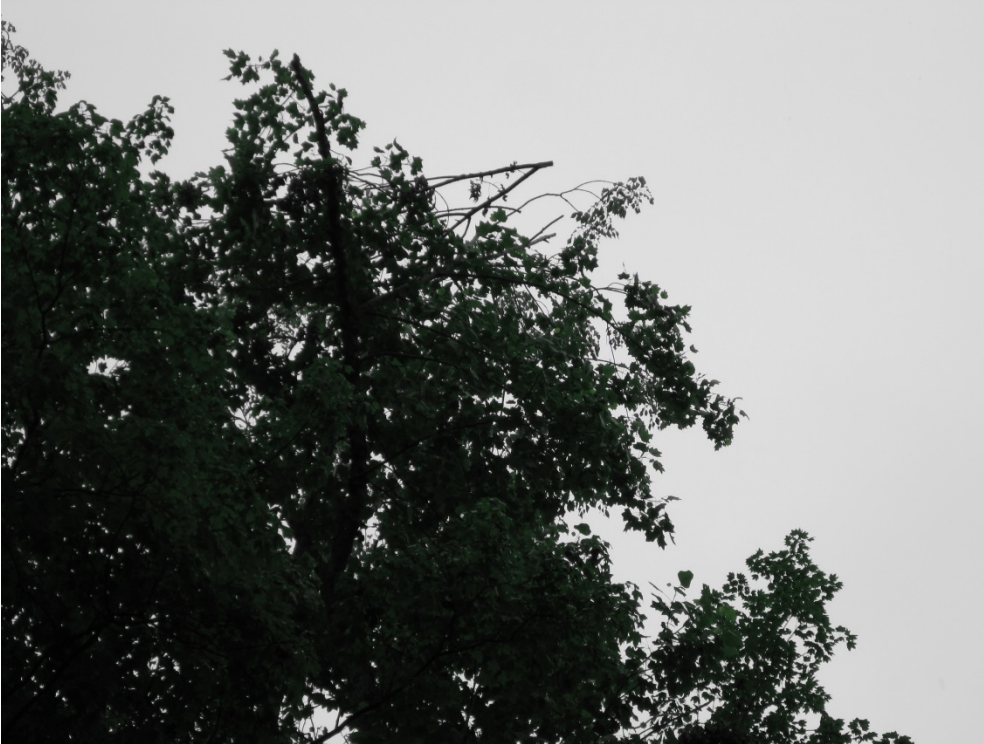
The aircraft was resting in an upright position, with the engine detached, laying to the left of the firewall approx. 3 to 4 foot.

The engine was subject to a high intensity fire that melted materials such as aluminum with a low melting point, which melted intakes, fuel pump and various components of the engine assembly (see the engine examination). The wood propeller was consumed by fire, leaving approx. 10% of the hub area to examine. The propeller mounting hardware was present and secured.

The cockpit was also exposed to multiple impacts and heat from the post crash fire. Most aluminum of the cockpit area was melted/burned to the extent of switch plates, instrument panel, doors, etc were not present to examine (high temp metal was present). Switches that were present were not contained in the switch plate and switch position could not be verified. Engine controls were pulled from the cockpit area during the crash when the engine separated, thus verification of control positions was not possible. Flight and Engine instruments, consisting of an engine monitor and GPS were damaged by multiple impact and fire and no investigative information was available.

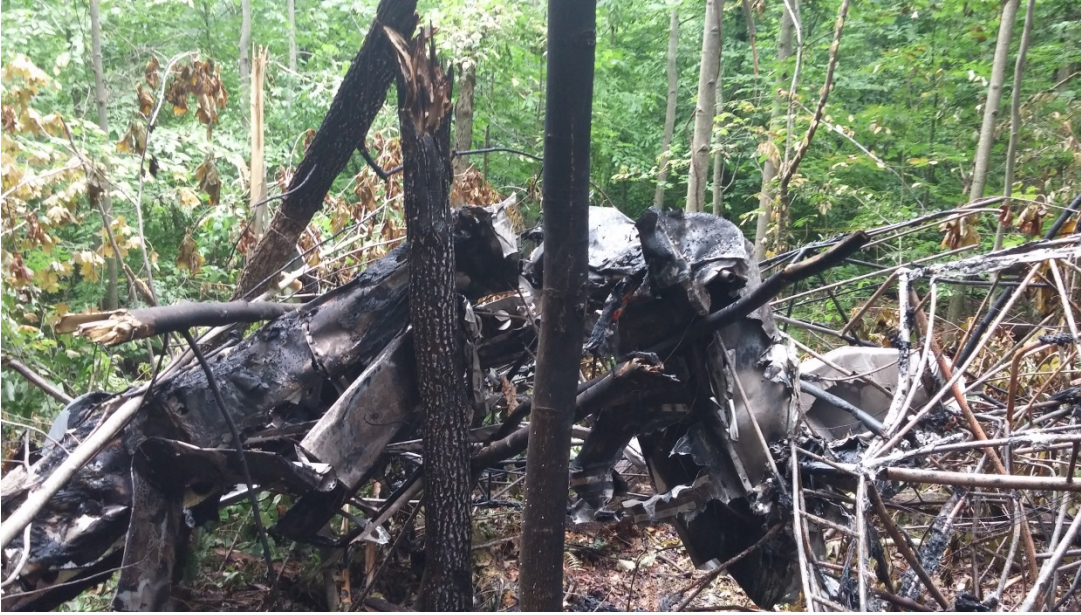
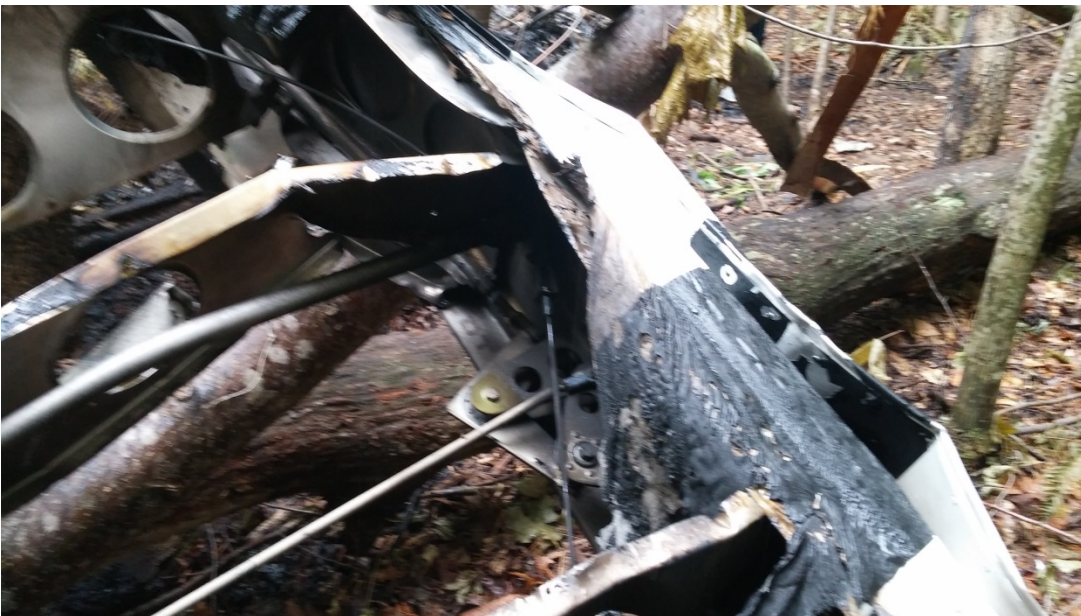
The left wing fiberglass tip and left MLG were detached and laying in front of the aircraft at a 45 degree angle approx. 20 foot from the wreckage.

The right wing was attached but severely damaged by impact and consumed partially by fire in the area of the fuel tanks, indicating a substantial amount of fuel was aboard at impact. The left wing was detached due to impact and consumed partially by fire also. All attaching hardware for slat and flaperons was present. Control continuity for ailerons/flaperons verified up to the cockpit, but not including the control stick. Flaperons were retracted.

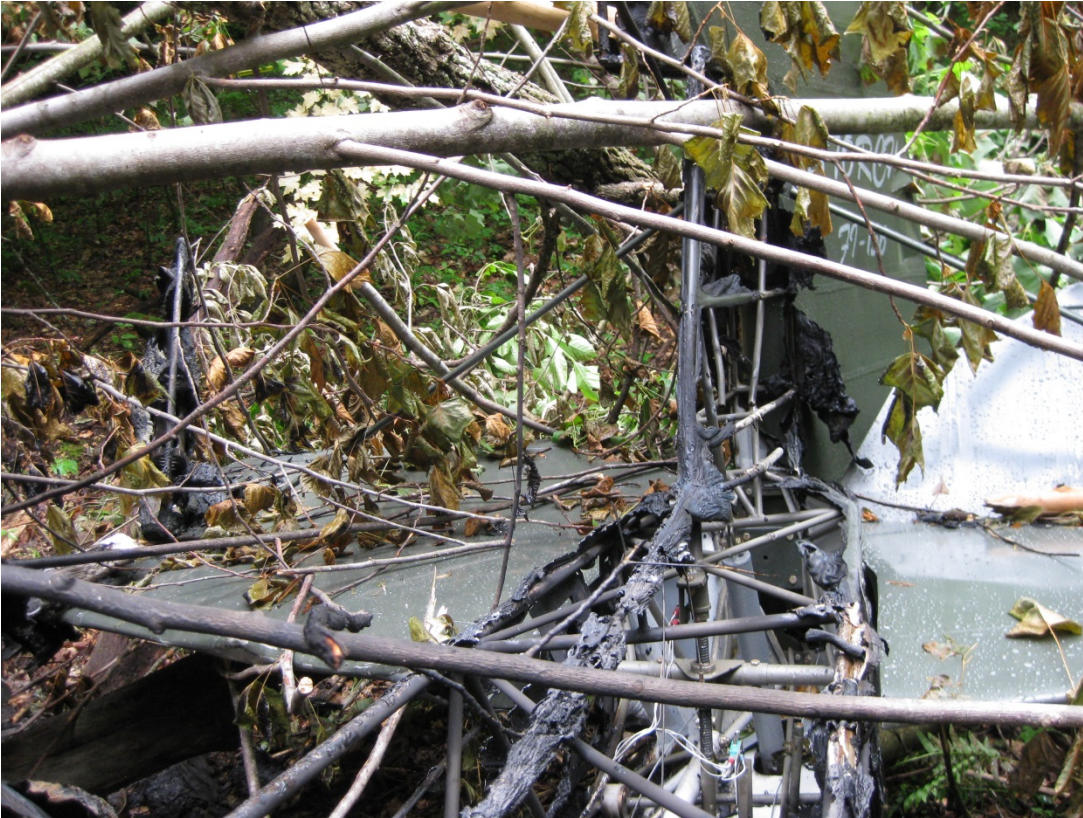
The empennage was intact with minimal damage as compared to the wings/cockpit. The rudder and elevator were attached and movement verified at hinges. Control cables failed due to stress overload, indicating continuity to the cockpit at time of impact. Pitch trim (elevator) was mid travel, indicating the aircraft was trimmed for level flight at approx. cruise conditions.
