| | | <h1 style="text-align: center;">MATERIALS EVALUATION<br/>REPORT</h1> <p style="text-align: center;">Materials Engineering Department</p> | | | |
| <b>TITLE</b><br><b>METALLURGICAL INVESTIGATION OF A<br/>COMPRESSOR DIFFUSER, P/N 23064637,<br/>INSTALLED IN AN M250 C47B ENGINE, S/N<br/>CAE847731</b> | | <b>SIGN</b><br><i>Signature on File</i> | | | |

Report Request ID: 11681  
 Traceability ID Number: Not Applicable  
 Part Name: Compressor Diffuser Assembly  
 Part Number: 23064637  
 Part Serial Number: GY27720R  
 Processes: Not Applicable  
 Part Time: Unknown  
 Engine Model: M250-C47B  
 Engine Serial Number: CAE847731  
 FPA Number: Not Applicable  
 Supplier: Not Applicable  
 Supplier Location / Vendor Code: Not Applicable  
 Evaluations: Failure Analysis

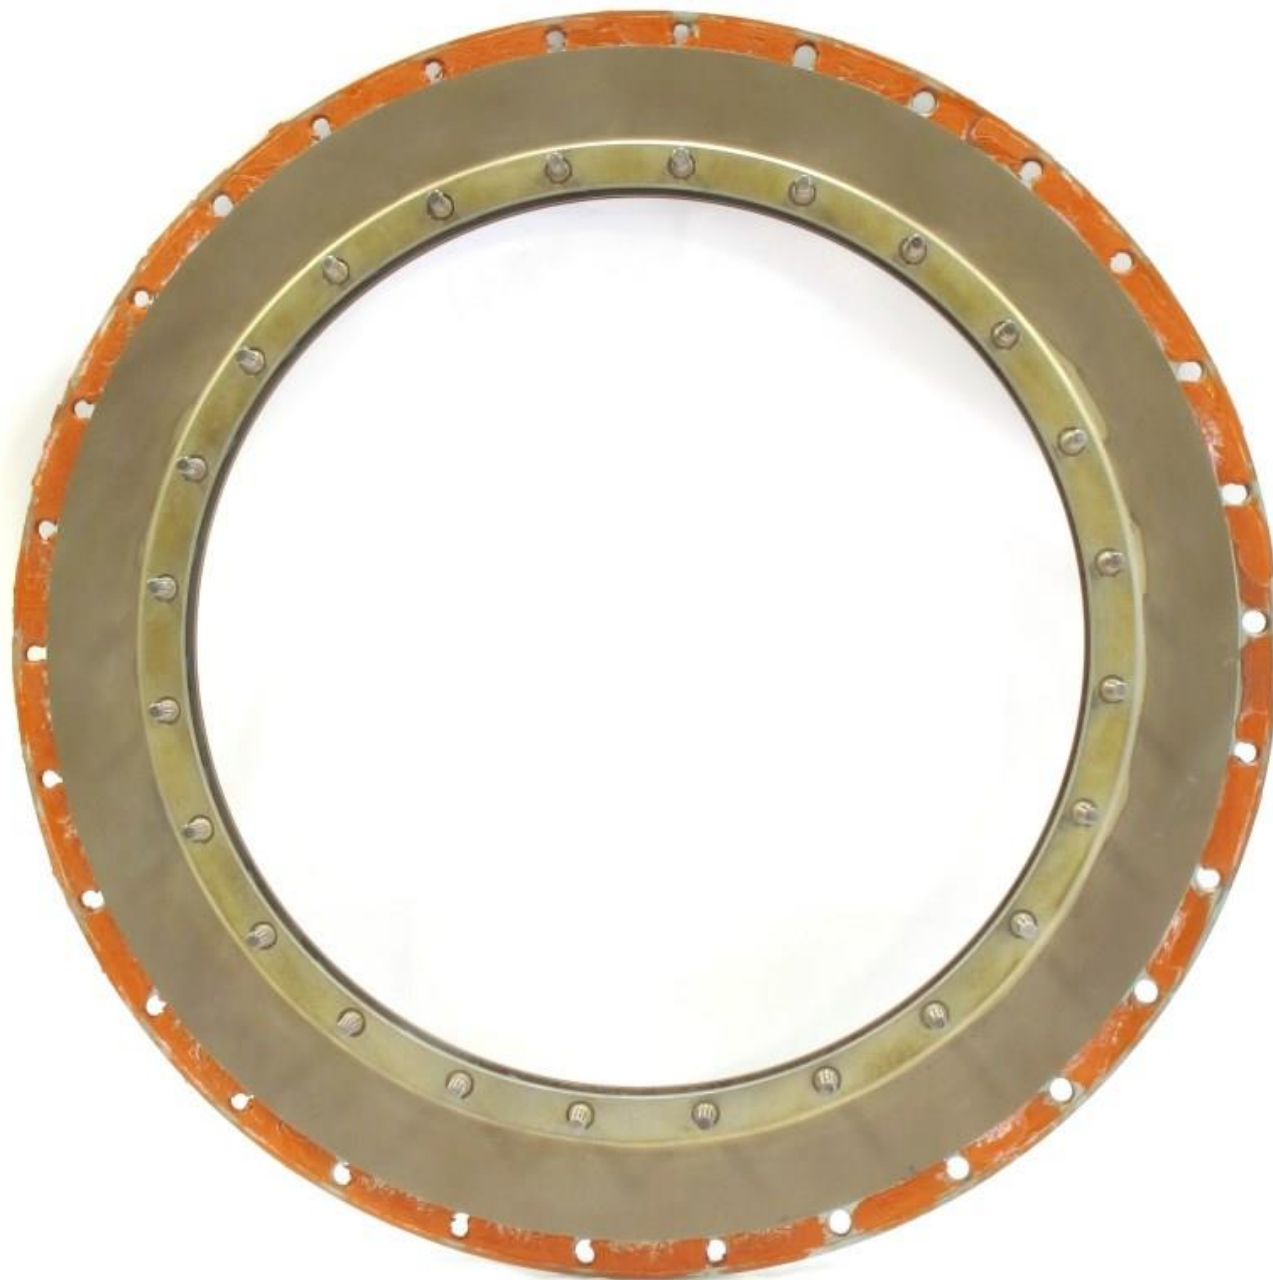
**Figure 1. Forward side of the compressor diffuser in the as-received condition.**

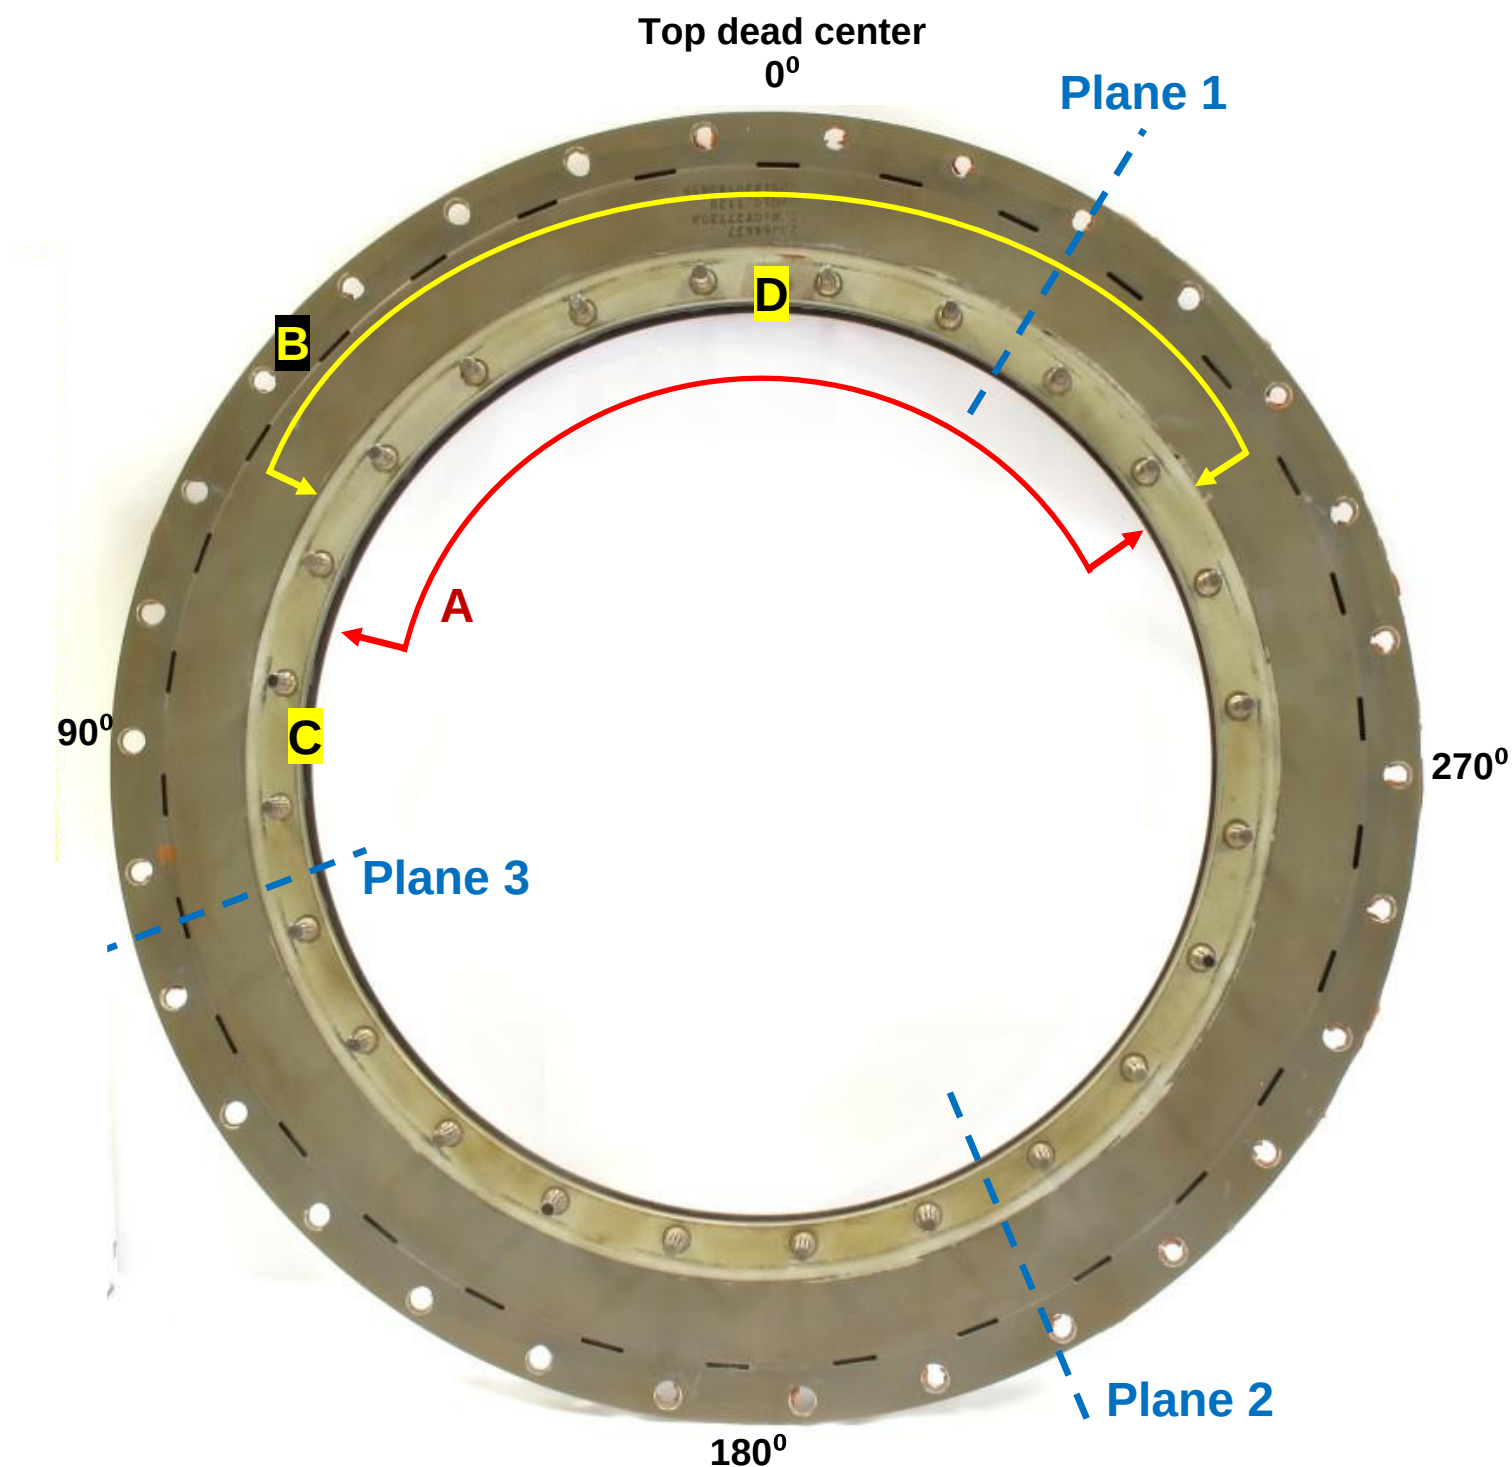
A portion of the aft plate was also separated from the remainder of the diffuser on the aft face at the 0° position approximately 0.65 inch outboard of the inner diameter, as shown in Figure 8. The separation on the aft plate extended around approximately 33% of the circumference, starting counter-clockwise from the 300° position to the 60° position (see region B in Figure 2). This portion (hereafter known as the aft ring plate) was a detail distinct from the remaining aft plate and encompassed the entire circumference of the inboard rim. The aft ring plate was a part of the assembly, but did not meet the configuration of the engineering drawing, which specified the aft plate as a single detail.

**Figure 2.** Aft side of the compressor diffuser in the as-received condition. Region A marks the circumferential extent of the separation at the inboard aft braze joint between the airfoil plate and the aft plate (see Figure 4), and region B marks the circumferential extent of separation on the aft face of the aft plate (see Figure 8). The braze coverage at locations C and D are shown in more detail in Figure 9. Blue dotted lines mark planes 1 through 3 selected for metallographic evaluation (see Figure 11 through Figure 19).

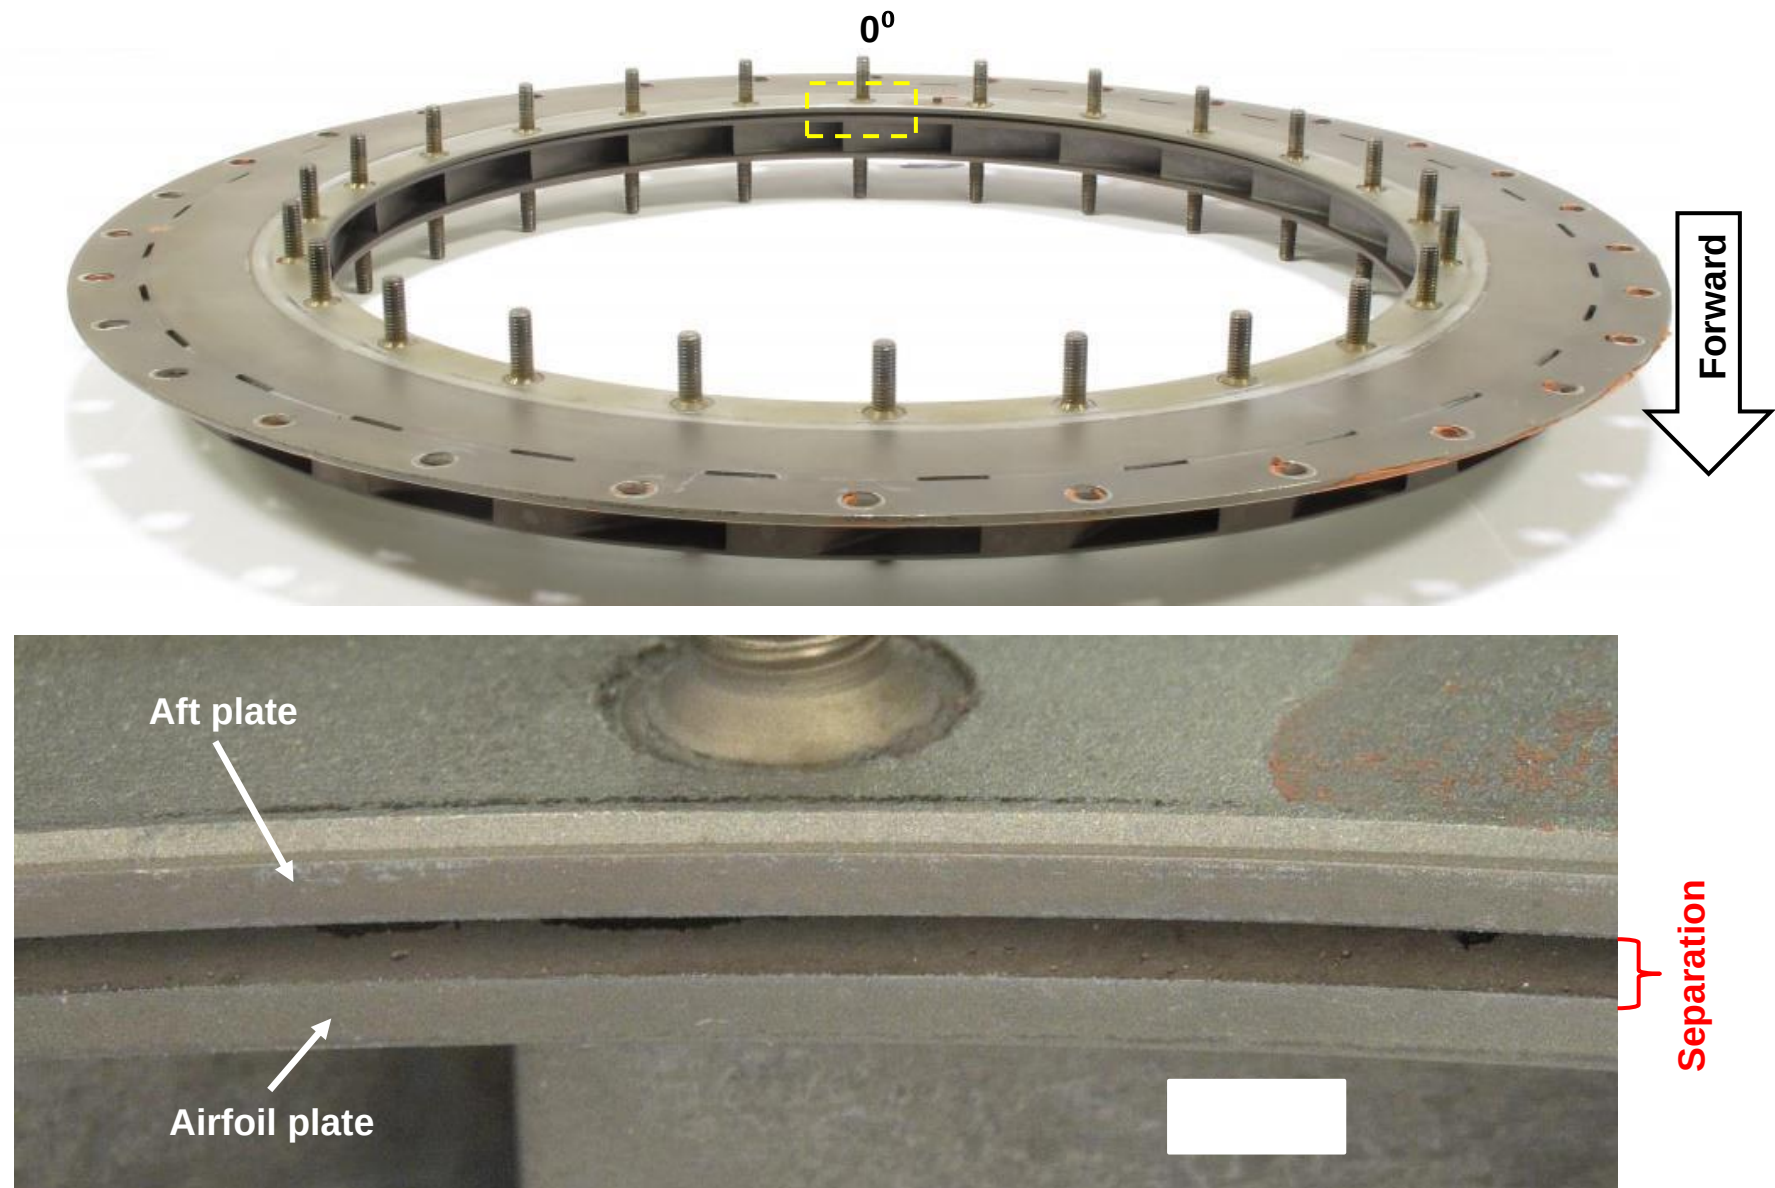
Figure 4. Radial views of the aft side of the compressor diffuser. The bottom image shows a detailed view of the inboard rim at the 0° position, which exhibited separation at the inboard aft braze joint between the airfoil plate and the aft plate.

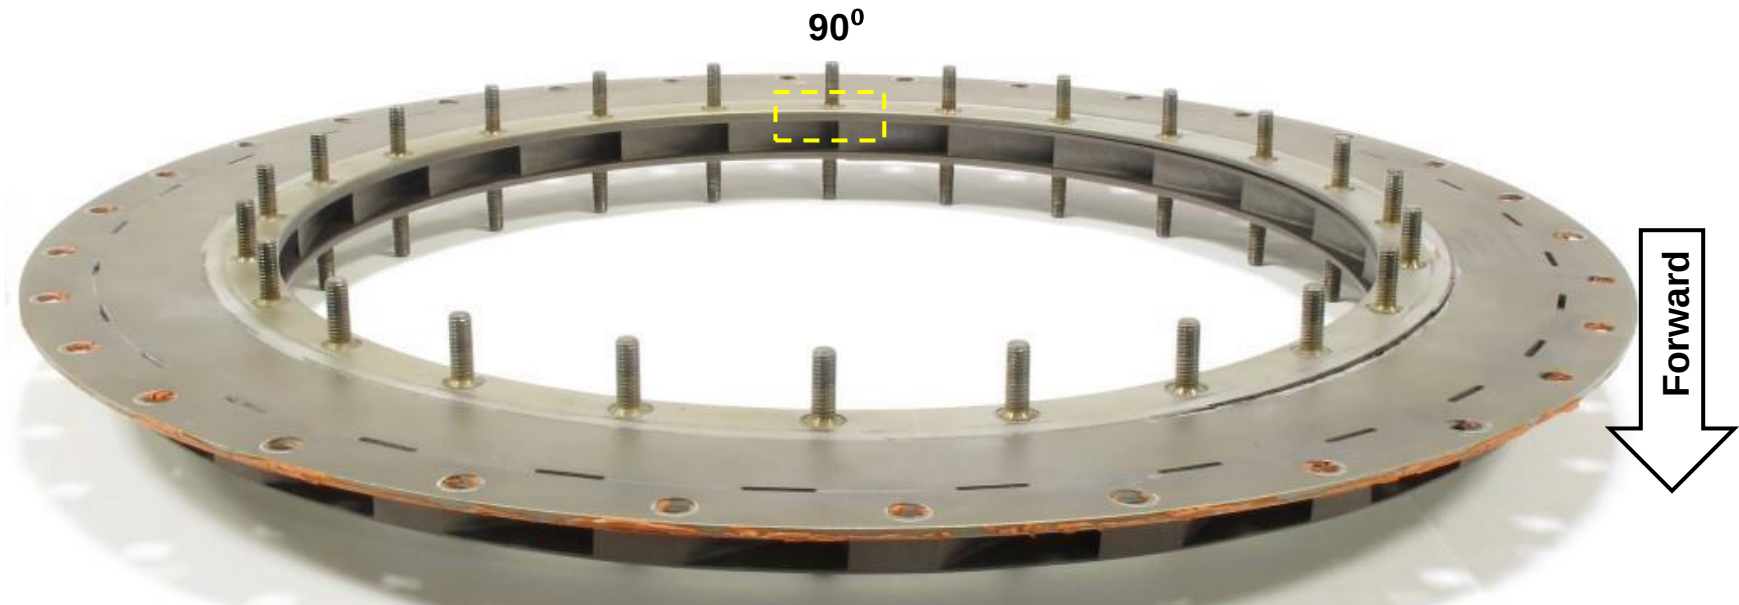
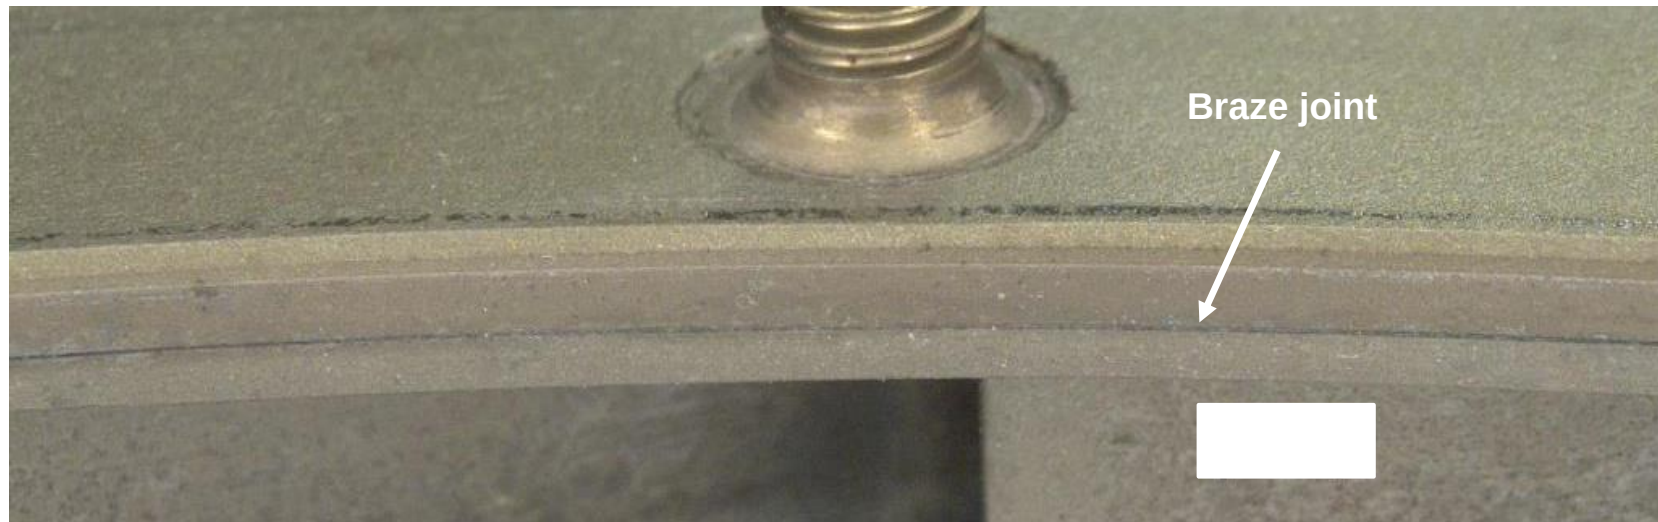
Figure 5. Radial views of the aft side of the compressor diffuser. The views are rotated approximately 90° from Figure 4. The bottom image shows a detailed view of the inboard rim at the 90° position, which exhibited no evidence of voids or debonding at the inboard aft braze joint.

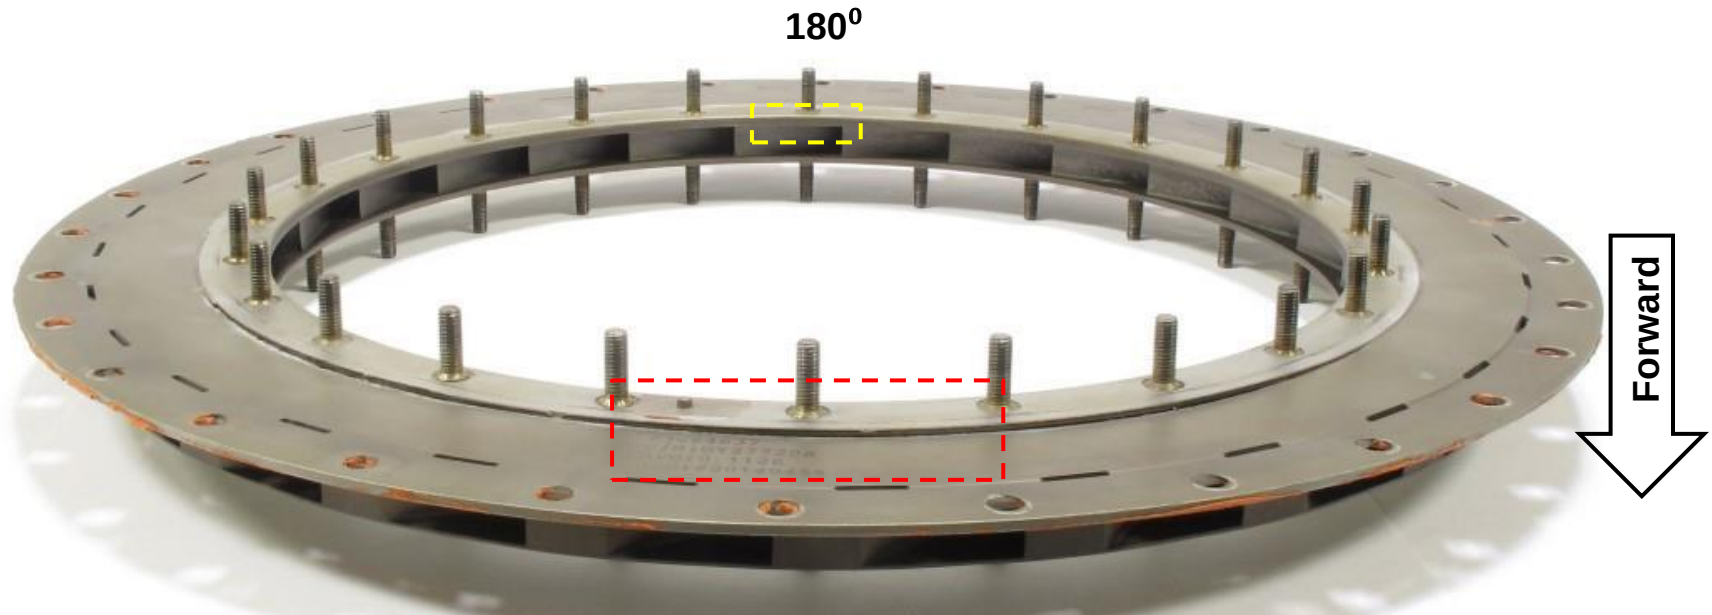
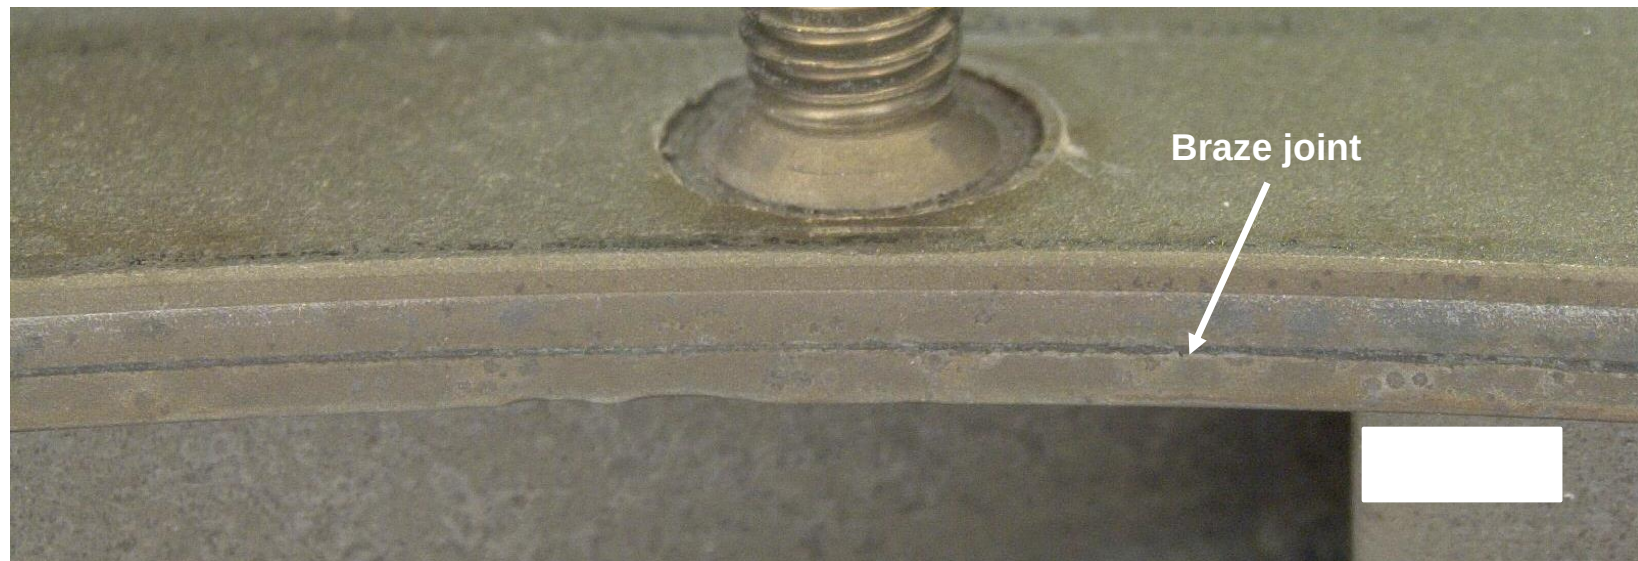
**Figure 6.** Radial views of the aft side of the compressor diffuser. The views are rotated approximately 90° from Figure 5. The bottom image (yellow boxed area) shows a detailed view of the inboard rim at the 180° position, which exhibited no evidence of voids or debonding at the inboard aft braze joint. The red boxed area is shown in more detail in Figure 8.

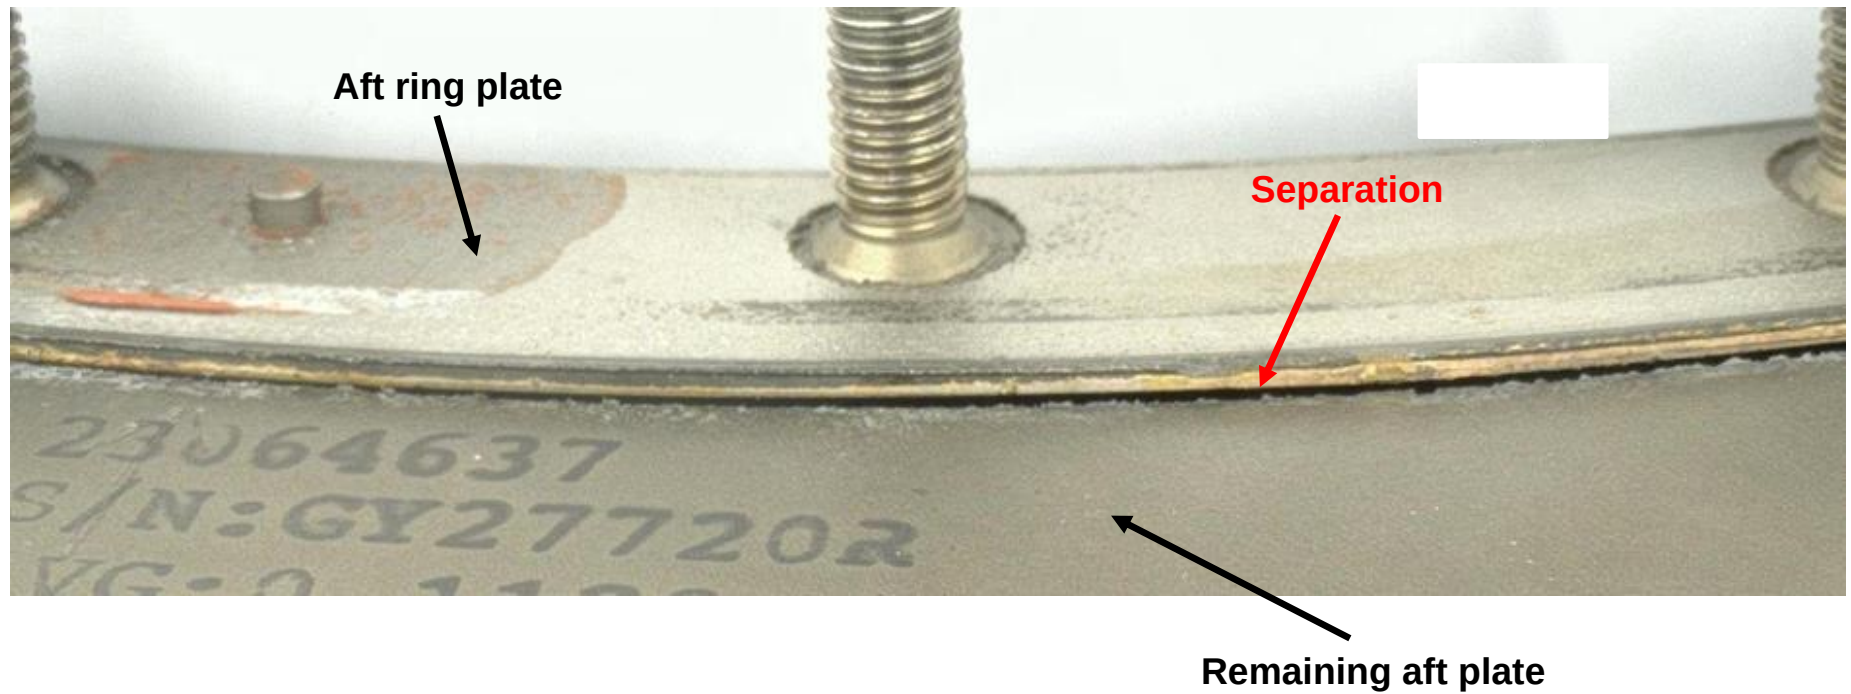
- 2.2 The separated portion of the aft plate was a detail distinct from the remaining aft plate and was not consistent with the configuration of the component definition, which specified the aft plate as a single detail.

**Figure 8.** A detailed view of the aft face of the inboard rim at the 0° position, which exhibited separation between the aft ring plate and the remaining aft plate.

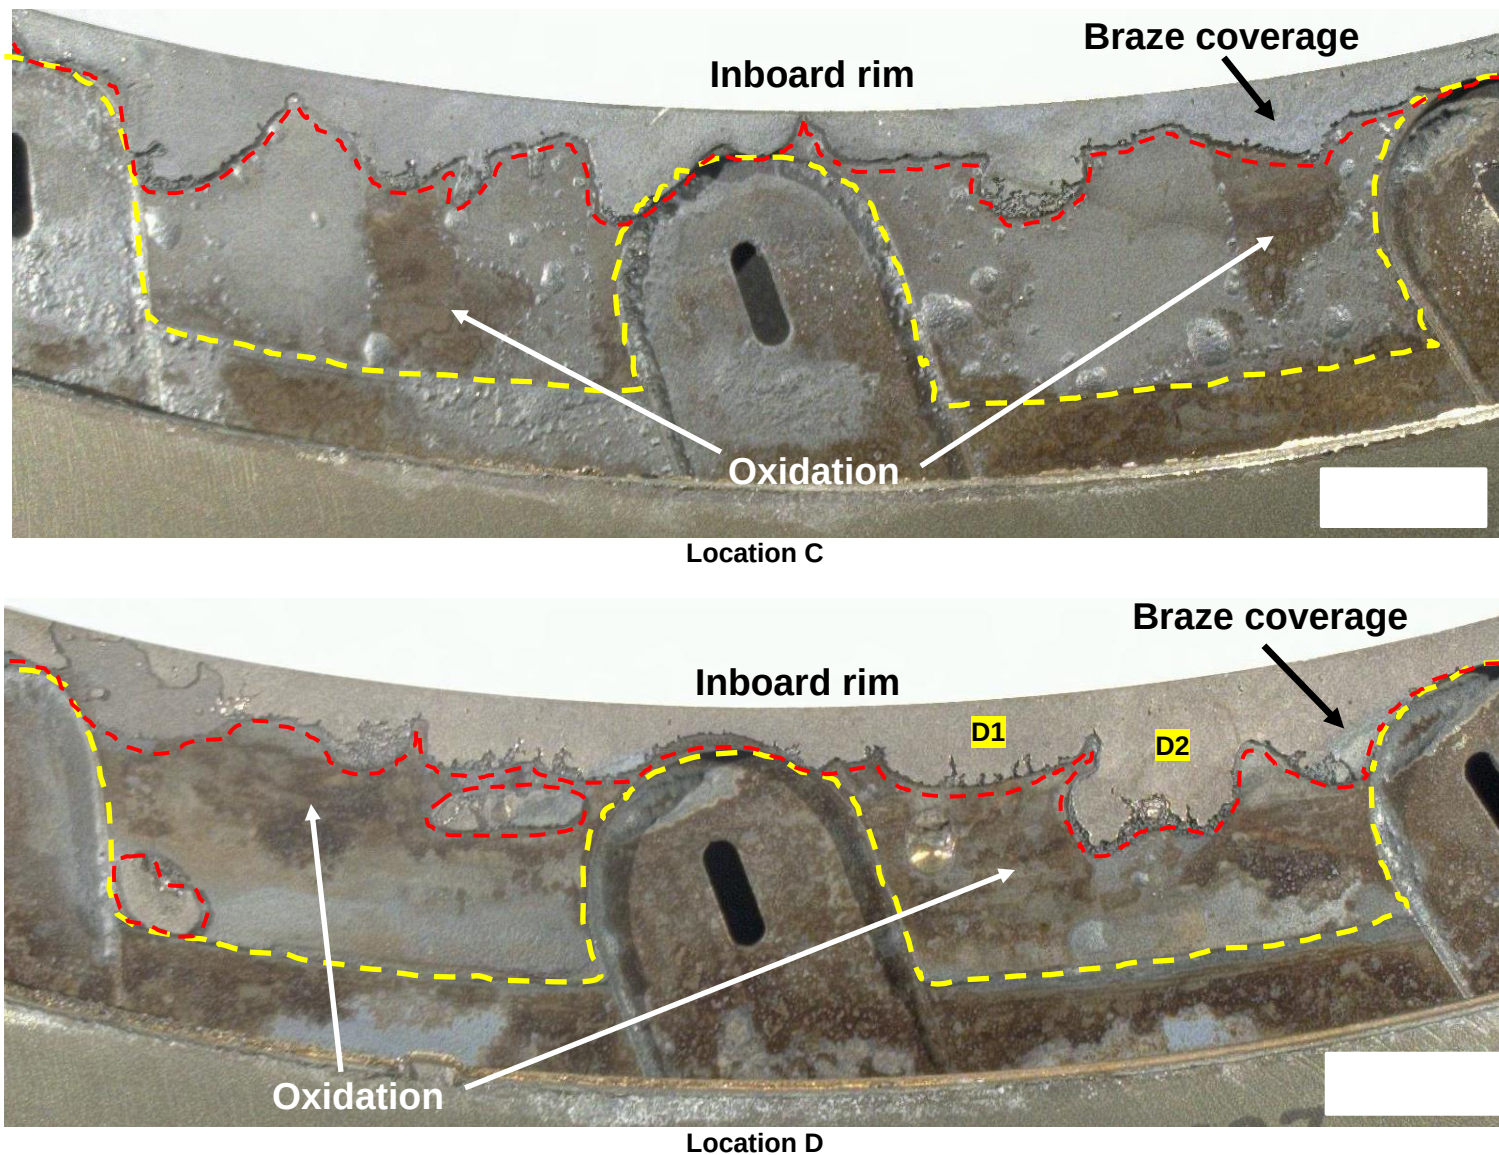
The compressor diffuser was sectioned radially at planes 1 and 3, as shown in Figure 2. The aft ring plate hung loose from the diffuser segment at plane 1, but was still joined to the segment near plane 3. The aft ring plate was pulled from the segment near plane 3, and the braze coverage at the inboard aft joint was visually inspected between the circumferential locations at planes 1 and 3. Figure 9 shows representative images of braze coverage on the airfoil plate at the inboard aft joint.

The areas of braze coverage were calculated using image analysis software. The braze coverage did not meet the component definition requirement, and the braze land of the airfoil plate also exhibited oxidation.

**Figure 9.** Detailed views of the airfoil plate at the inboard aft joint (see locations C and D in Figure 2) after removal of the the aft ring plate. Braze coverage did not meet the component definition requirement, and the braze land exhibited oxidation. The red dotted lines mark the area of the braze coverage, and the yellow dotted lines mark the inner extremity of the braze land. Locations D1 and D2 are shown in more detail in Figure 10.

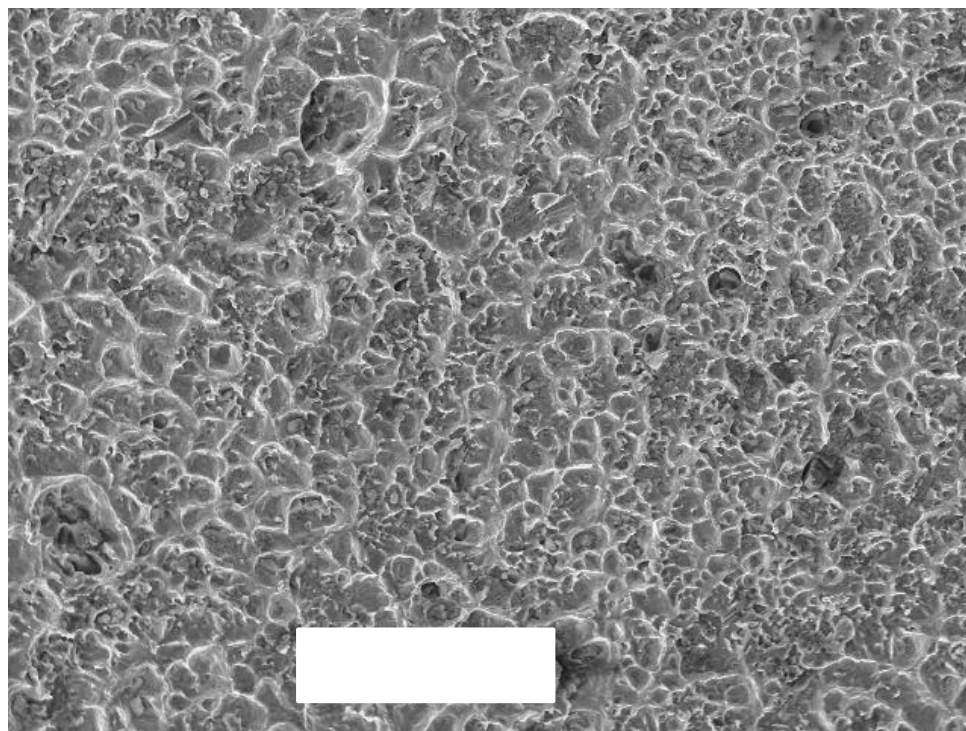
**Location D1**

The braze surface on the airfoil plate at the aft inboard joint exhibited ductile dimples consistent with tensile overload. Figure 10 shows representative SEM images of the ductile dimples on the braze surface on the airfoil plate at the inboard aft joint.

**Figure 10. Secondary electron SEM images showing the braze surface on the airfoil plate at the inboard aft joint (see locations D1 and D2 in Figure 9), which displayed ductile dimples consistent with tensile overload.**

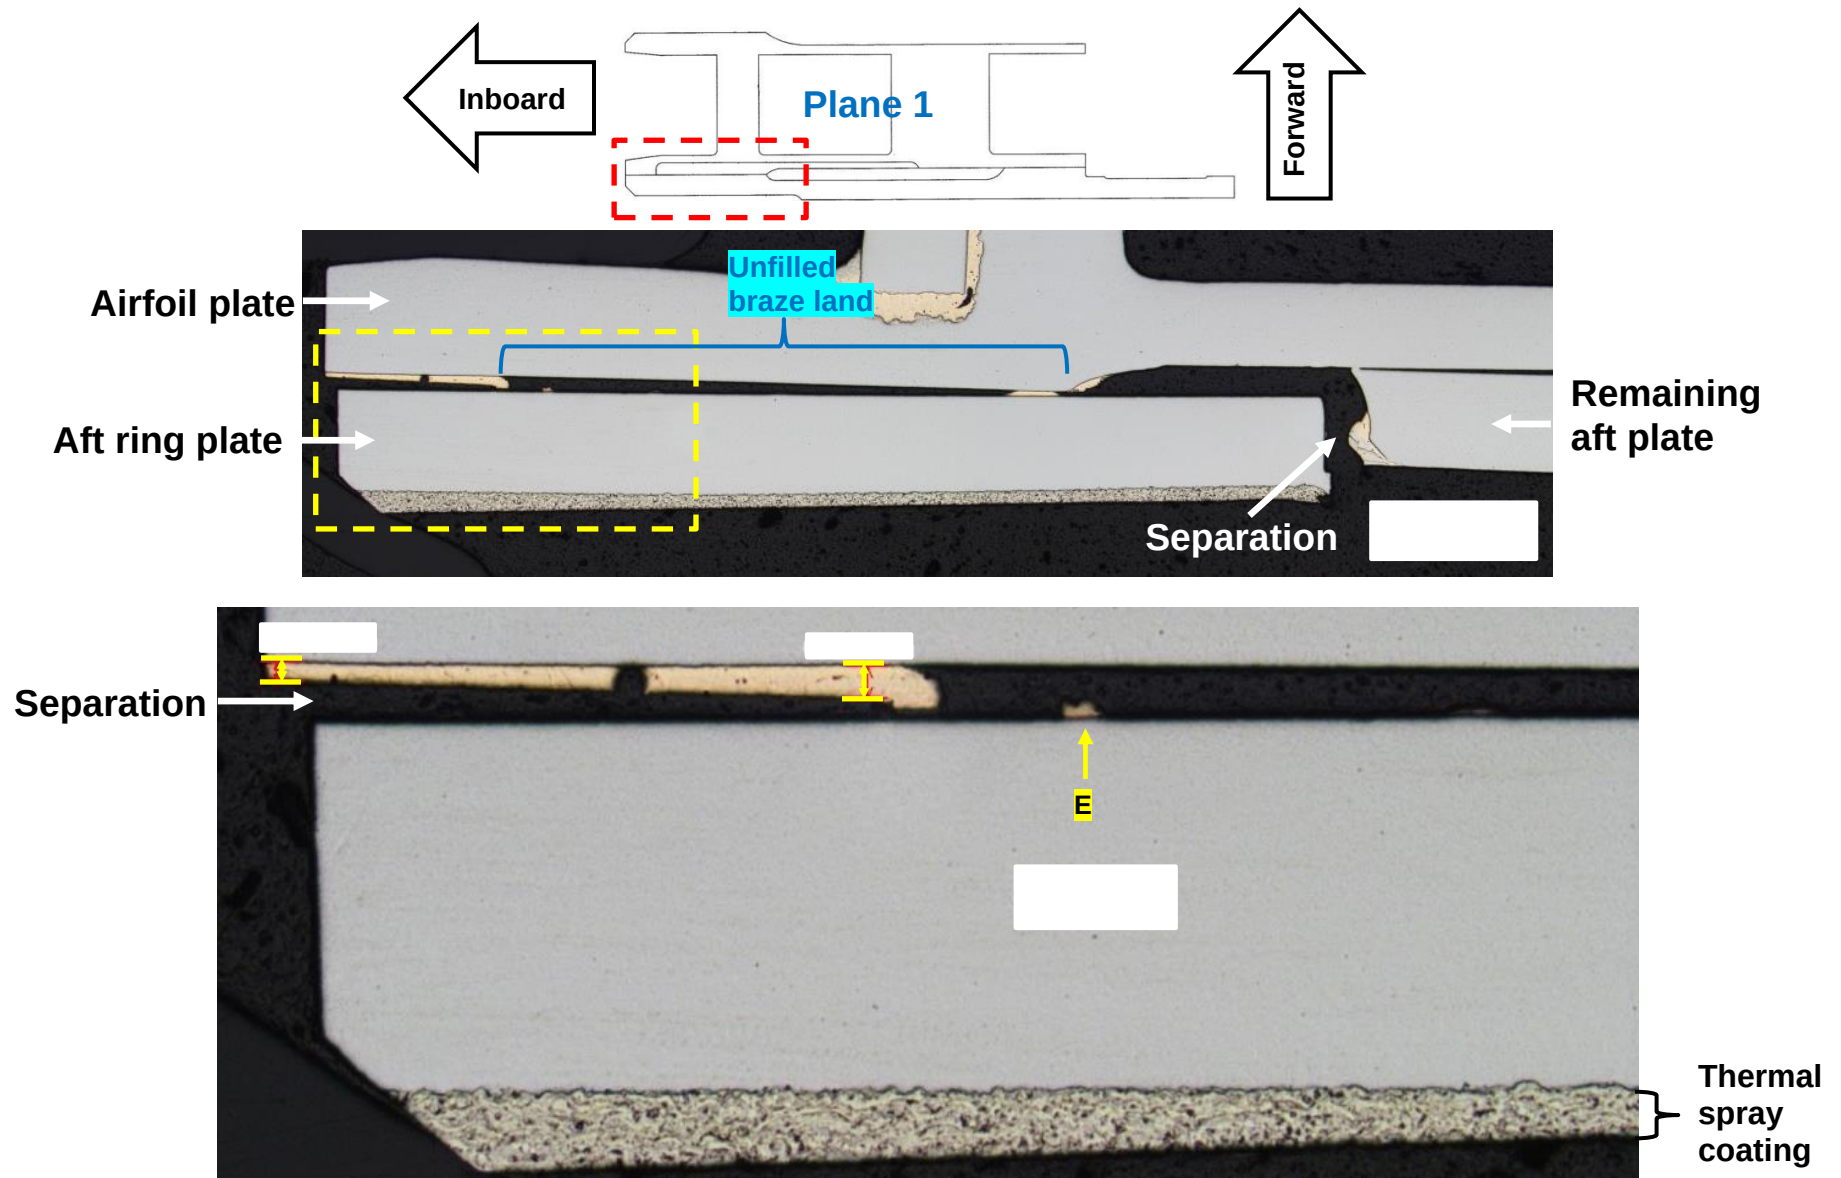
Metallographic evaluation was performed on the cross-sections of the compressor diffuser (planes 1 through 3). Figure 11 shows the metallographic cross-section through the inboard aft joint at a circumferential location where the aft ring plate appeared separated from the airfoil plate (see plane 1 in Figure 2). The braze gap could not be measured due to the separation of the aft ring plate from the assembly, but the thickness of braze alloy that adhered to the airfoil plate did not meet the component definition requirement. Braze alloy coverage on the braze land also did not meet the component definition requirement. The aft ring plate surface in the unfilled portion of the braze gap also displayed oxidation (see Figure 12). The aft face of the aft ring plate exhibited thermal spray coating, which is not specified by the component definition. Figure 13 shows the metallographic cross-section through the outboard aft joint. The braze gap was completely filled, but its thickness did not meet the component definition requirement. The forward face of the aft plate exhibited thermal spray coating near the outboard aft joint, but no coating is specified by the component definition.

Figure 11. Photographs showing the metallographic cross-section through the inboard aft joint (see plane 1 in Figure 2). The braze alloy did not cover the entire braze land. The braze gap could not be measured since the aft ring plate was separated from the assembly, but the thickness of braze alloy that adhered to the airfoil plate did not meet the component definition requirement. Location E is shown in more detailed in Figure 12. Unetched.

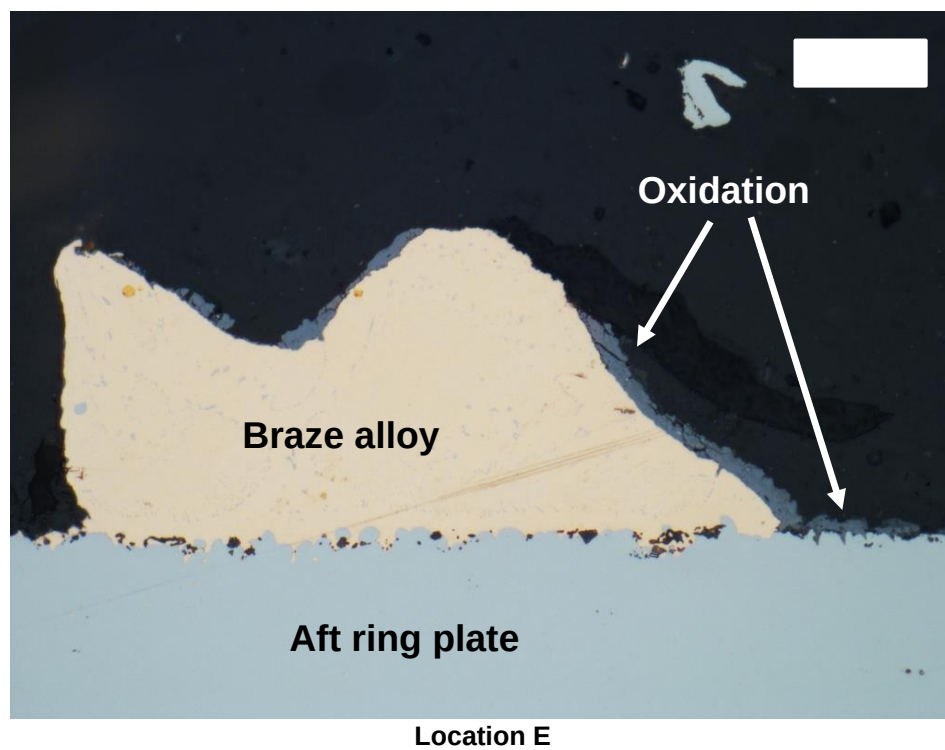
**Figure 12.** A representative metallographic cross-section through the aft ring plate in the unfilled portion of the the inboard aft joint (see location E in Figure 11), which exhibited oxidation. Unetched

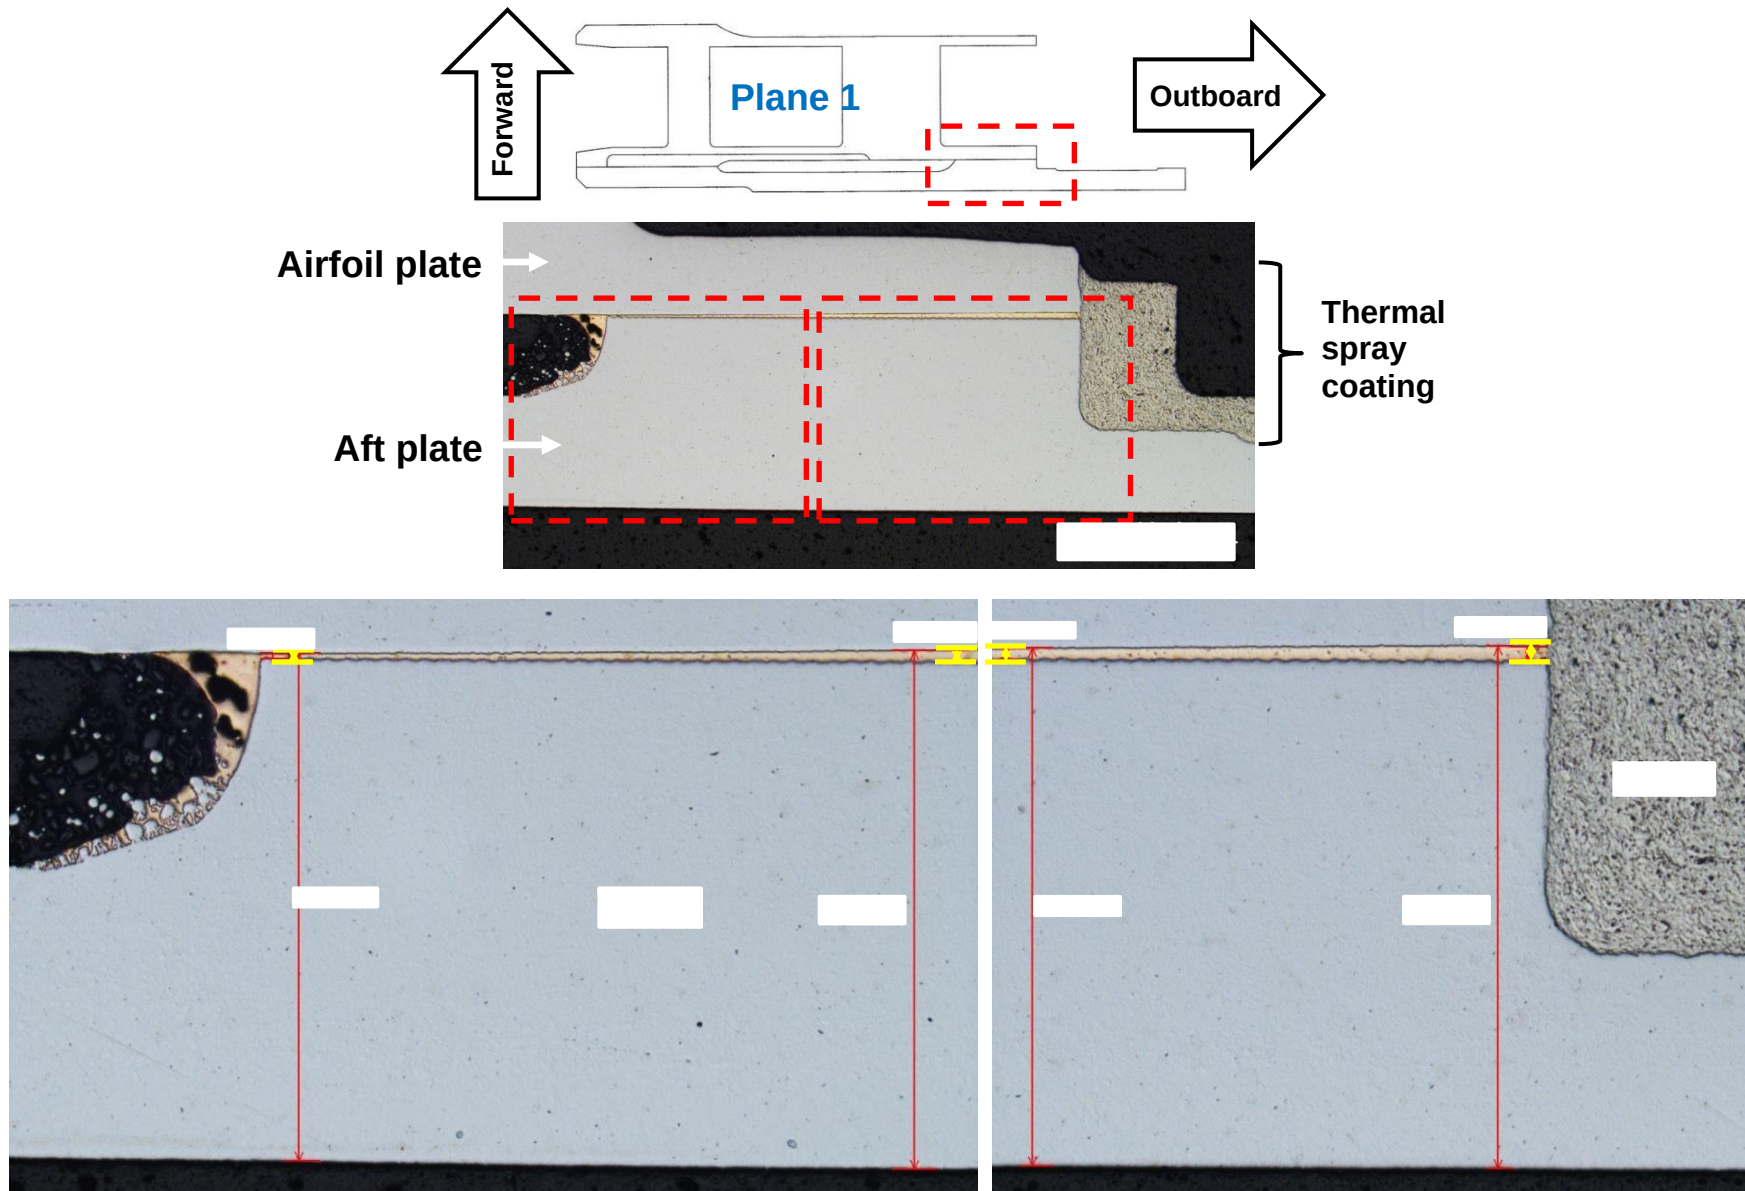
**Figure 13. Photographs showing the metallographic cross-section through the outboard aft joint (see plane 1 in Figure 2). The braze gap was completely filled, but its thickness did not meet the component definition requirement. Unetched**

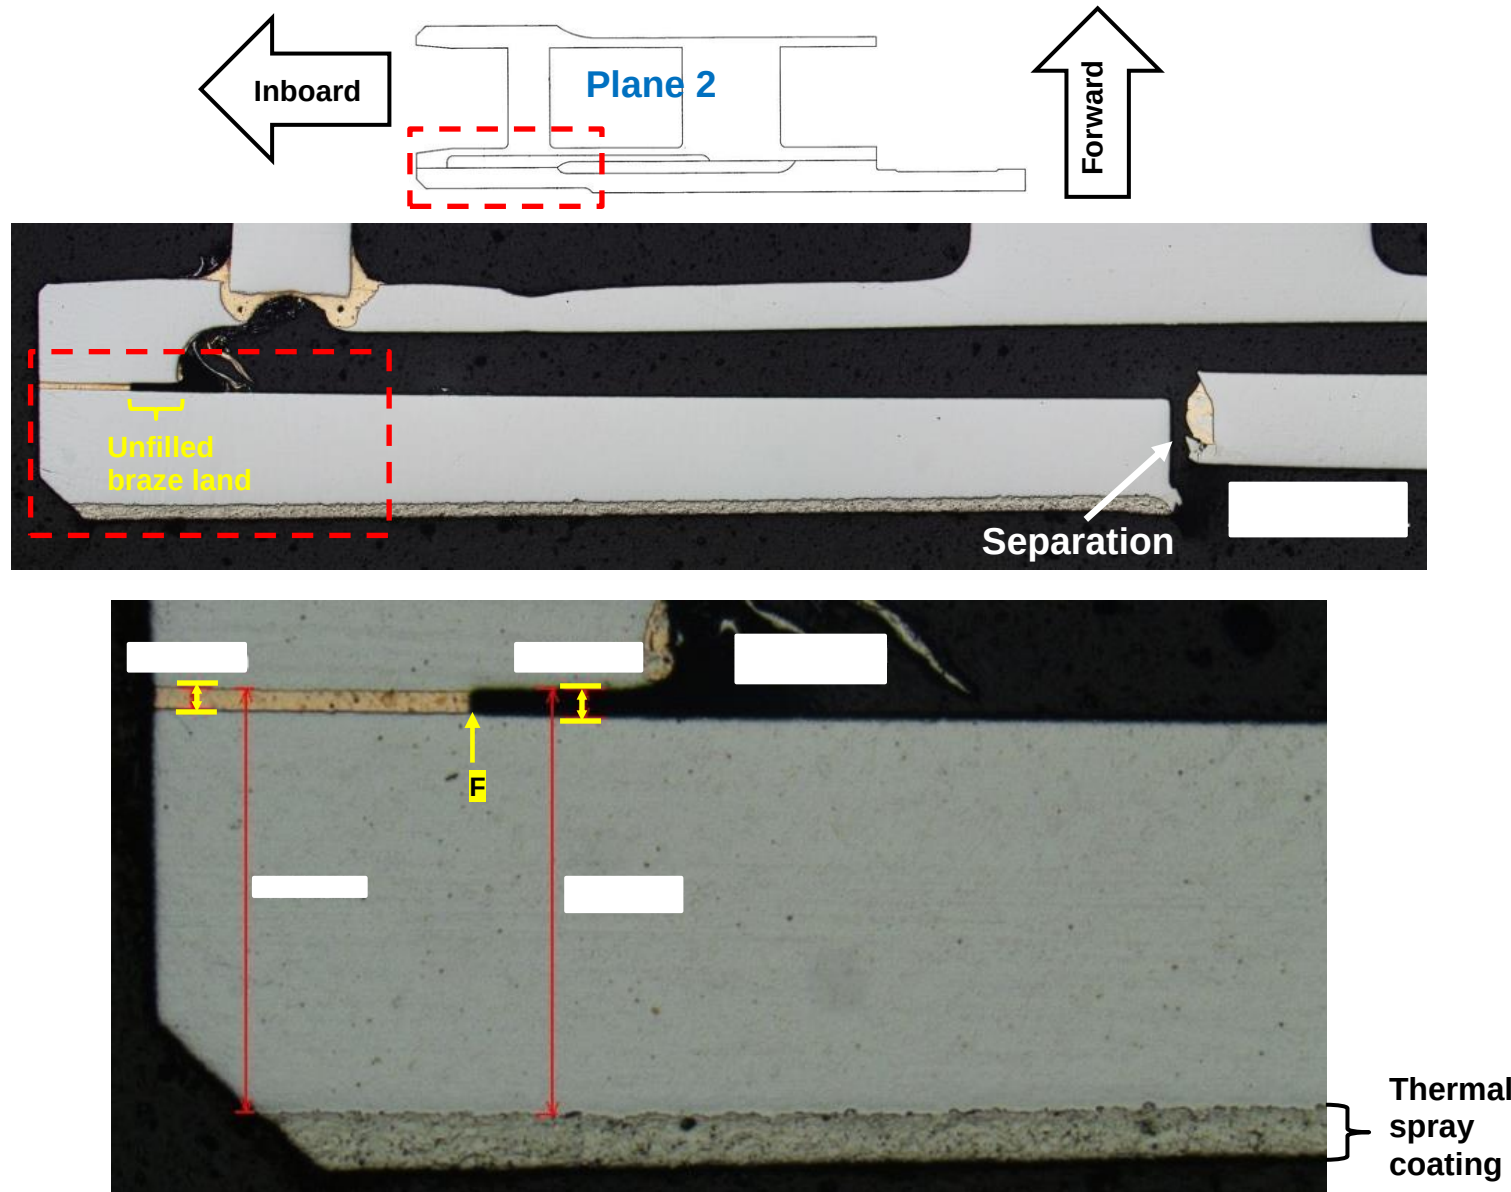
Figure 14 shows the metallographic cross-section through the inboard aft joint at a circumferential location where the braze joint appeared completely bonded (see plane 2 in Figure 2). Braze alloy coverage on the braze land met the component definition requirement, but the braze gap did not meet the component definition requirement. The surface of the bridged braze alloy exposed to the unfilled portion of the braze gap also displayed oxidation (see Figure 15). The aft face of the aft ring plate exhibited thermal spray coating, which is not specified by the component definition. Figure 16 shows the metallographic cross-section through the outboard aft joint. The braze gap was completely filled, and its thickness met the component definition requirement. The forward face of the aft plate exhibited thermal spray coating near the outboard aft joint, but no coating is specified by the component definition.

Figure 14. Photographs showing the metallographic cross-section through the inboard aft joint (see plane 2 in Figure 2). Braze alloy bridged the braze gap, but did not cover the entire braze land. The braze gap did not meet the gap requirement specified by the component definition. Location F is shown in more detailed in Figure 15. Unetched
