| | | <h1 style="text-align: center;">MATERIALS EVALUATION<br/>REPORT</h1> <p style="text-align: center;">Materials Engineering Department</p> | | | |
| <b>TITLE</b><br><b>METALLURGICAL INVESTIGATION OF A<br/>COMPRESSOR DIFFUSER, P/N 23064637,<br/>INSTALLED IN AN M250 C47B ENGINE, S/N<br/>CAE847731</b> | | <b>SIGN</b><br><i>Signature on File</i> | | | |

Report Request ID: 11681  
 Traceability ID Number: Not Applicable  
 Part Name: Compressor Diffuser Assembly  
 Part Number: 23064637  
 Part Serial Number: GY27720R  
 Processes: Not Applicable  
 Part Time: Unknown  
 Engine Model: M250-C47B  
 Engine Serial Number: CAE847731  
 FPA Number: Not Applicable  
 Supplier: Not Applicable  
 Supplier Location / Vendor Code: Not Applicable  
 Evaluations: Failure Analysis

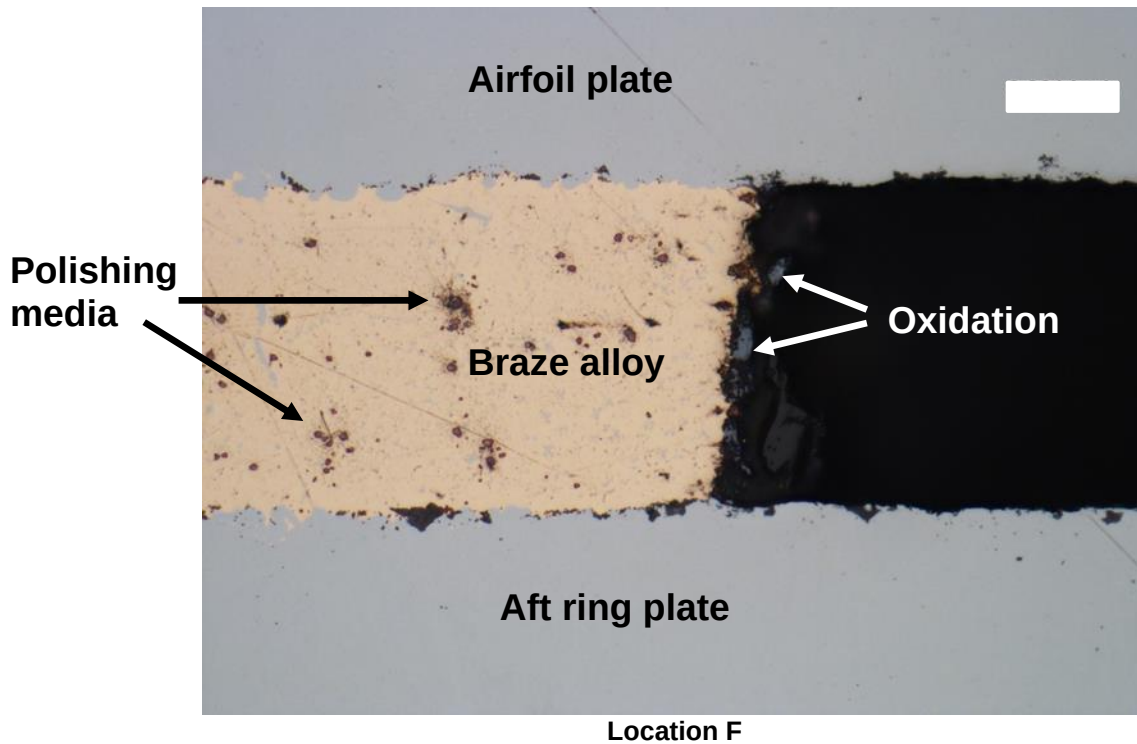
**Figure 15.** Detailed view of the metallographic cross-section through the inboard aft joint (see location F in Figure 14). The surface of the bridged braze alloy exposed to the unfilled portion of the braze gap exhibited oxidation. Unetched

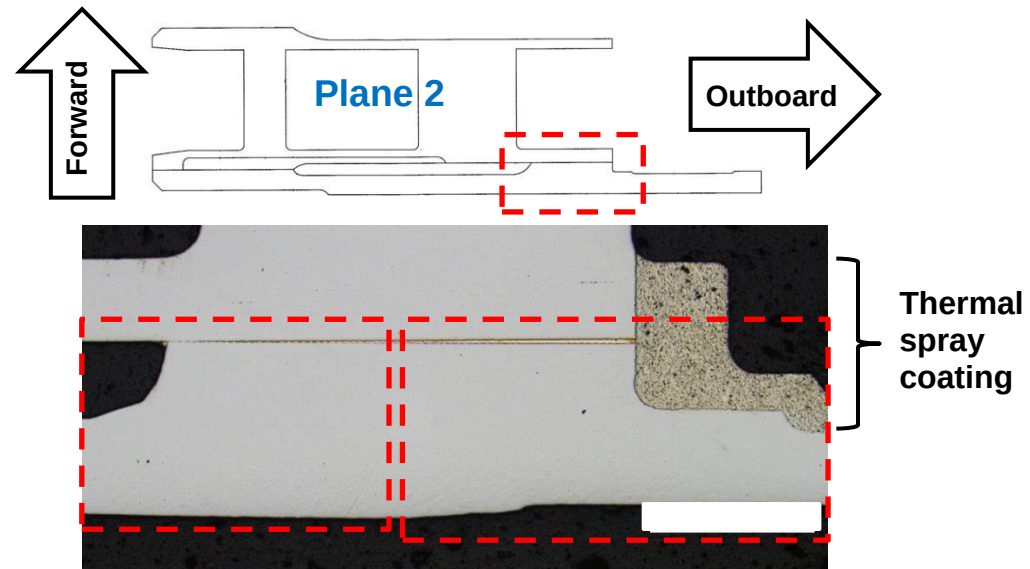
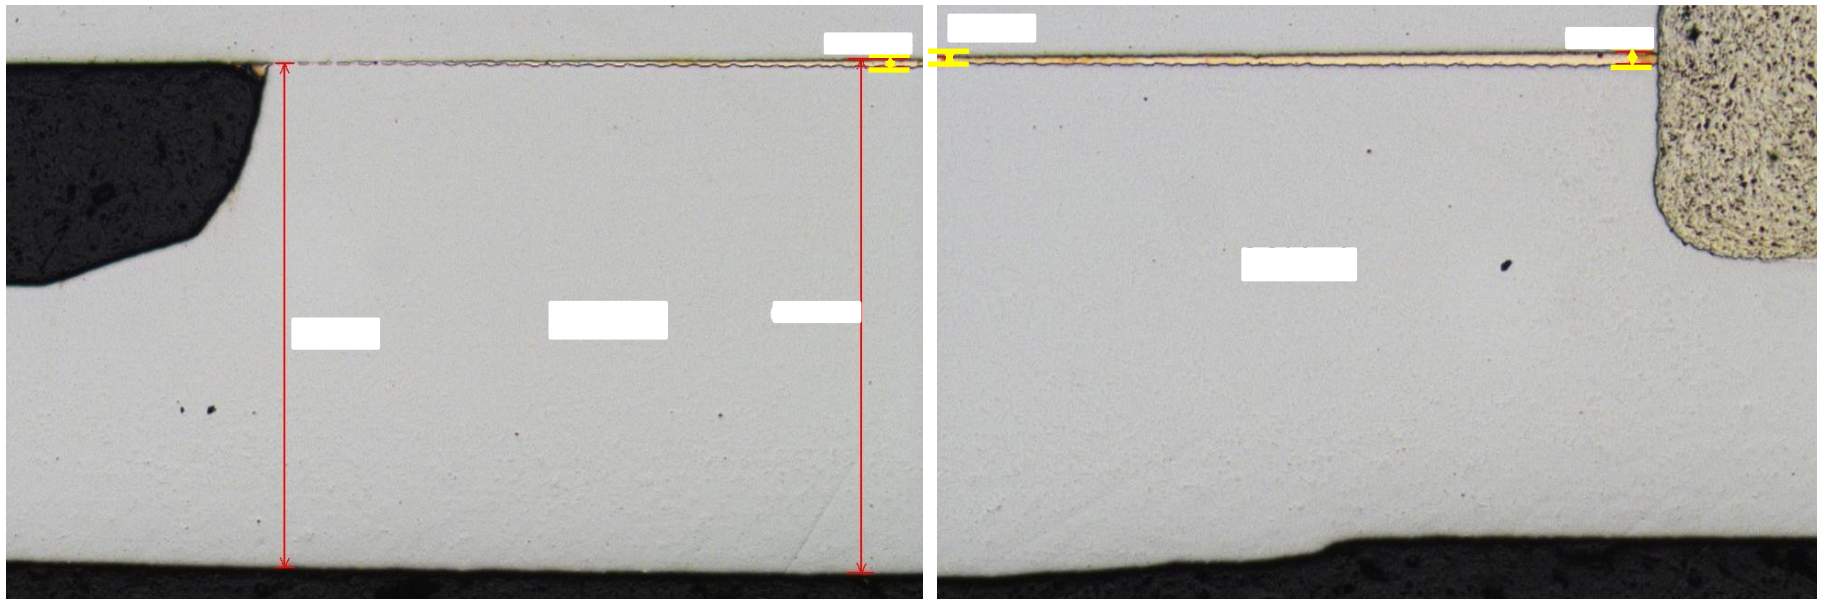
Figure 16. Photographs showing the metallographic cross-section through the outboard aft joint (see plane 2 in Figure 2). The braze gap was completely filled, and its thickness met the component definition requirement. Unetched

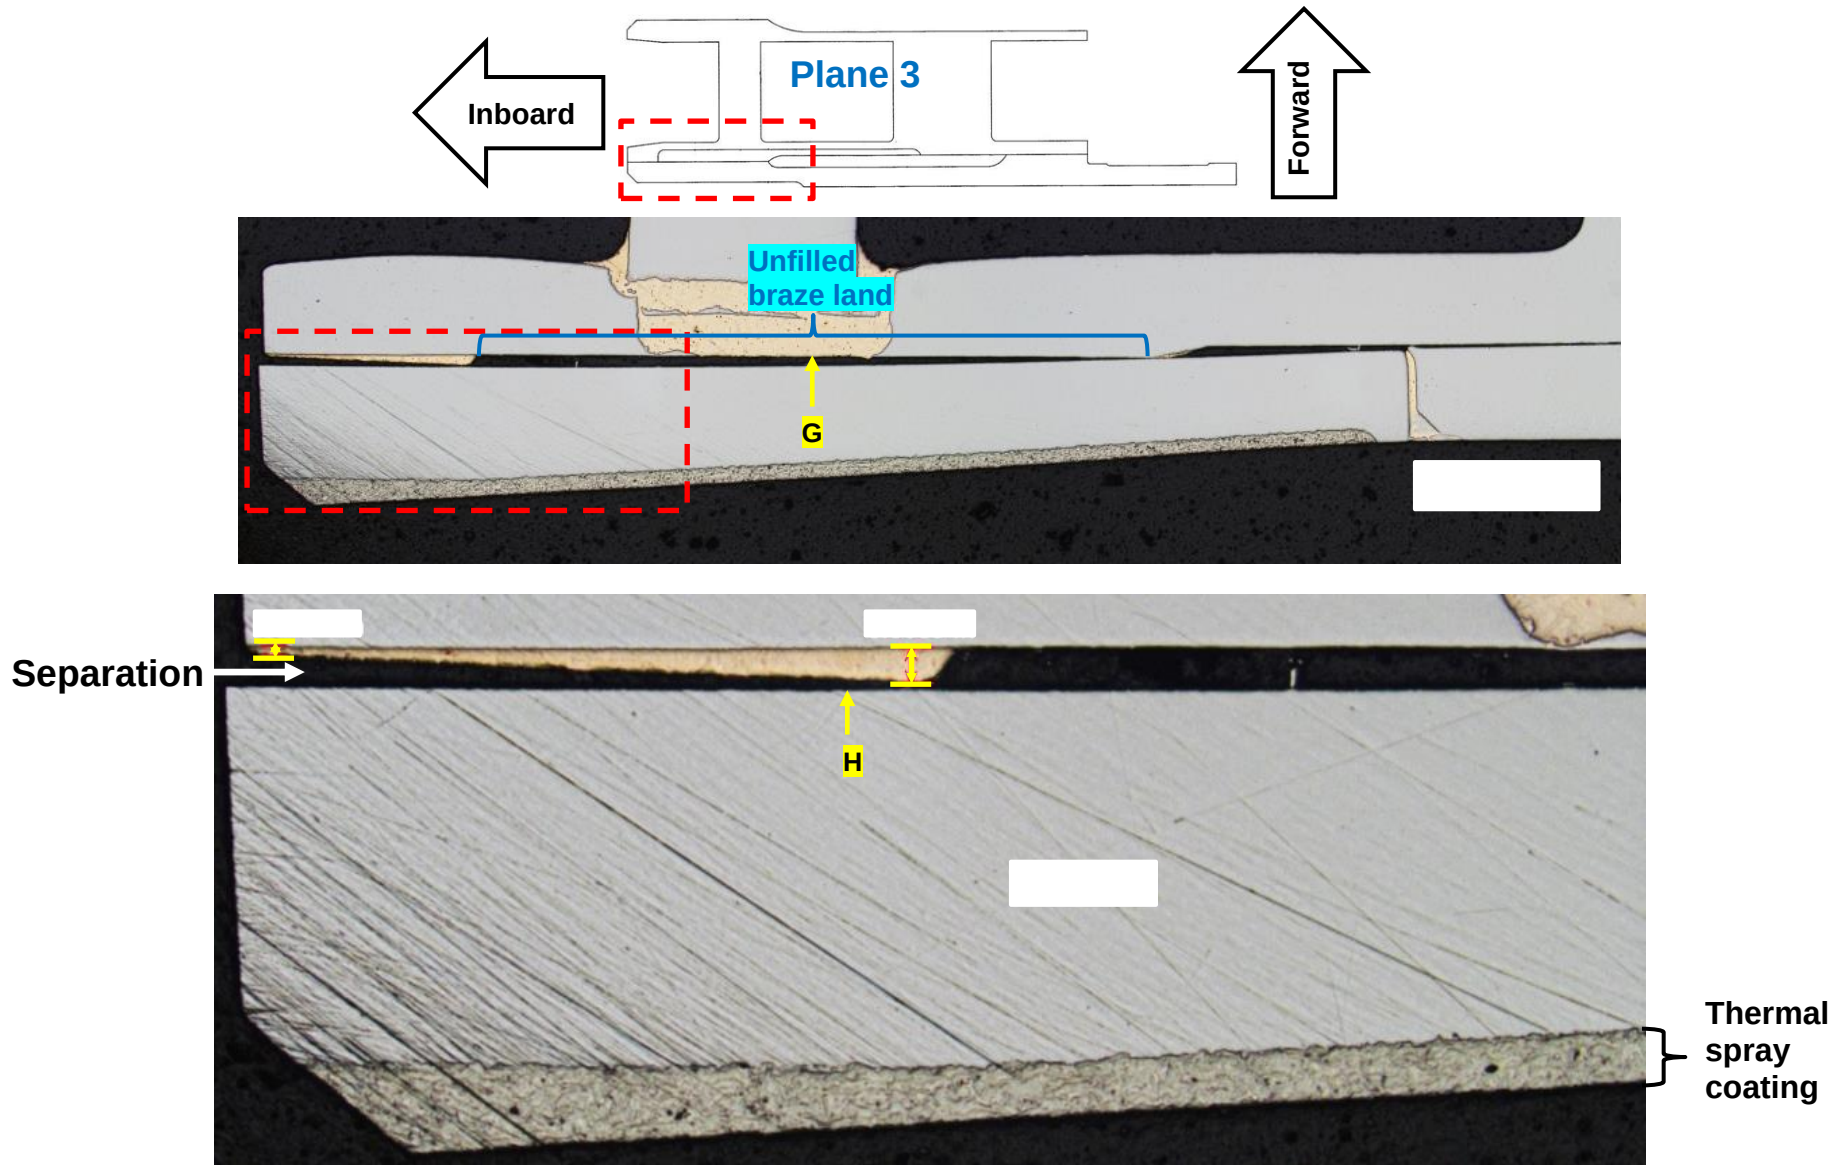
Figure 17 shows the metallographic cross-section through the inboard aft joint at a circumferential location bordering the region where the aft ring plate appeared separated from the airfoil plate (see plane 3 in Figure 2). The braze gap could not be measured due to the separation of the aft ring plate from the assembly, but the thickness of braze alloy did not meet the component definition requirement. Separation of the braze gap was potentially due to sample preparation. Braze alloy coverage on the braze land did not meet the component definition requirement. Surfaces in the unfilled portion of the braze gap, as well as surfaces where the aft ring plate separated from the braze alloy, displayed oxidation (see Figure 18). The aft face of the aft ring plate exhibited thermal spray coating, which is not specified by the component definition. Figure 19 shows the metallographic cross-section through the outboard aft joint. The braze gap was completely filled, but its thickness did not meet the component definition requirement. The forward face of the aft plate exhibited thermal spray coating near the outboard aft joint, but no coating is specified by the component definition.

Figure 17. Photographs showing the metallographic cross-section through the inboard aft joint (see plane 3 in Figure 2). The braze alloy did not cover the entire braze land. The braze gap could not be measured since the aft ring plate was separated from the assembly, but the the thickness of braze alloy did not meet the component definition requirement. Locations G and H are shown in more detailed in Figure 18. Unetched

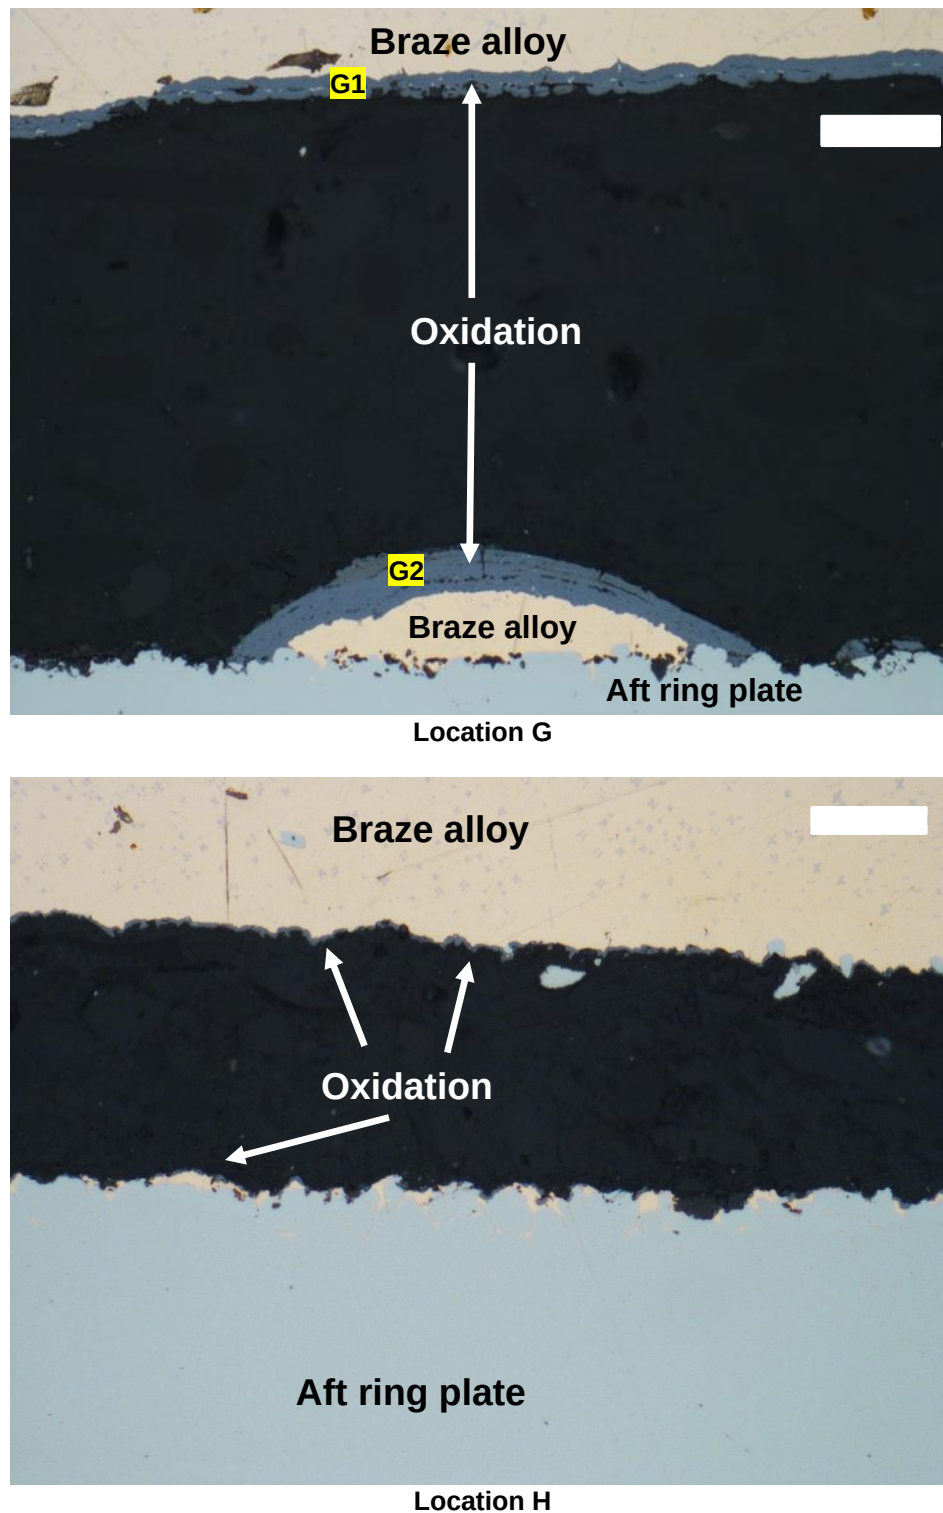
Semi-quantitative energy dispersive spectroscopy (EDS) analysis determined the darkened layer on the exposed surfaces of the braze material (see locations G1 and G2 in Figure 18) was consistent with corrosion.

**Figure 18.** Detailed views of the metallographic cross-section through the inboard aft joint (see locations G and H in Figure 17). The top image shows braze alloy in the unfilled portion of the braze gap, which exhibited oxidation. The bottom image shows surfaces where the aft ring plate separated from the braze alloy, which also displayed light oxidation. Unetched

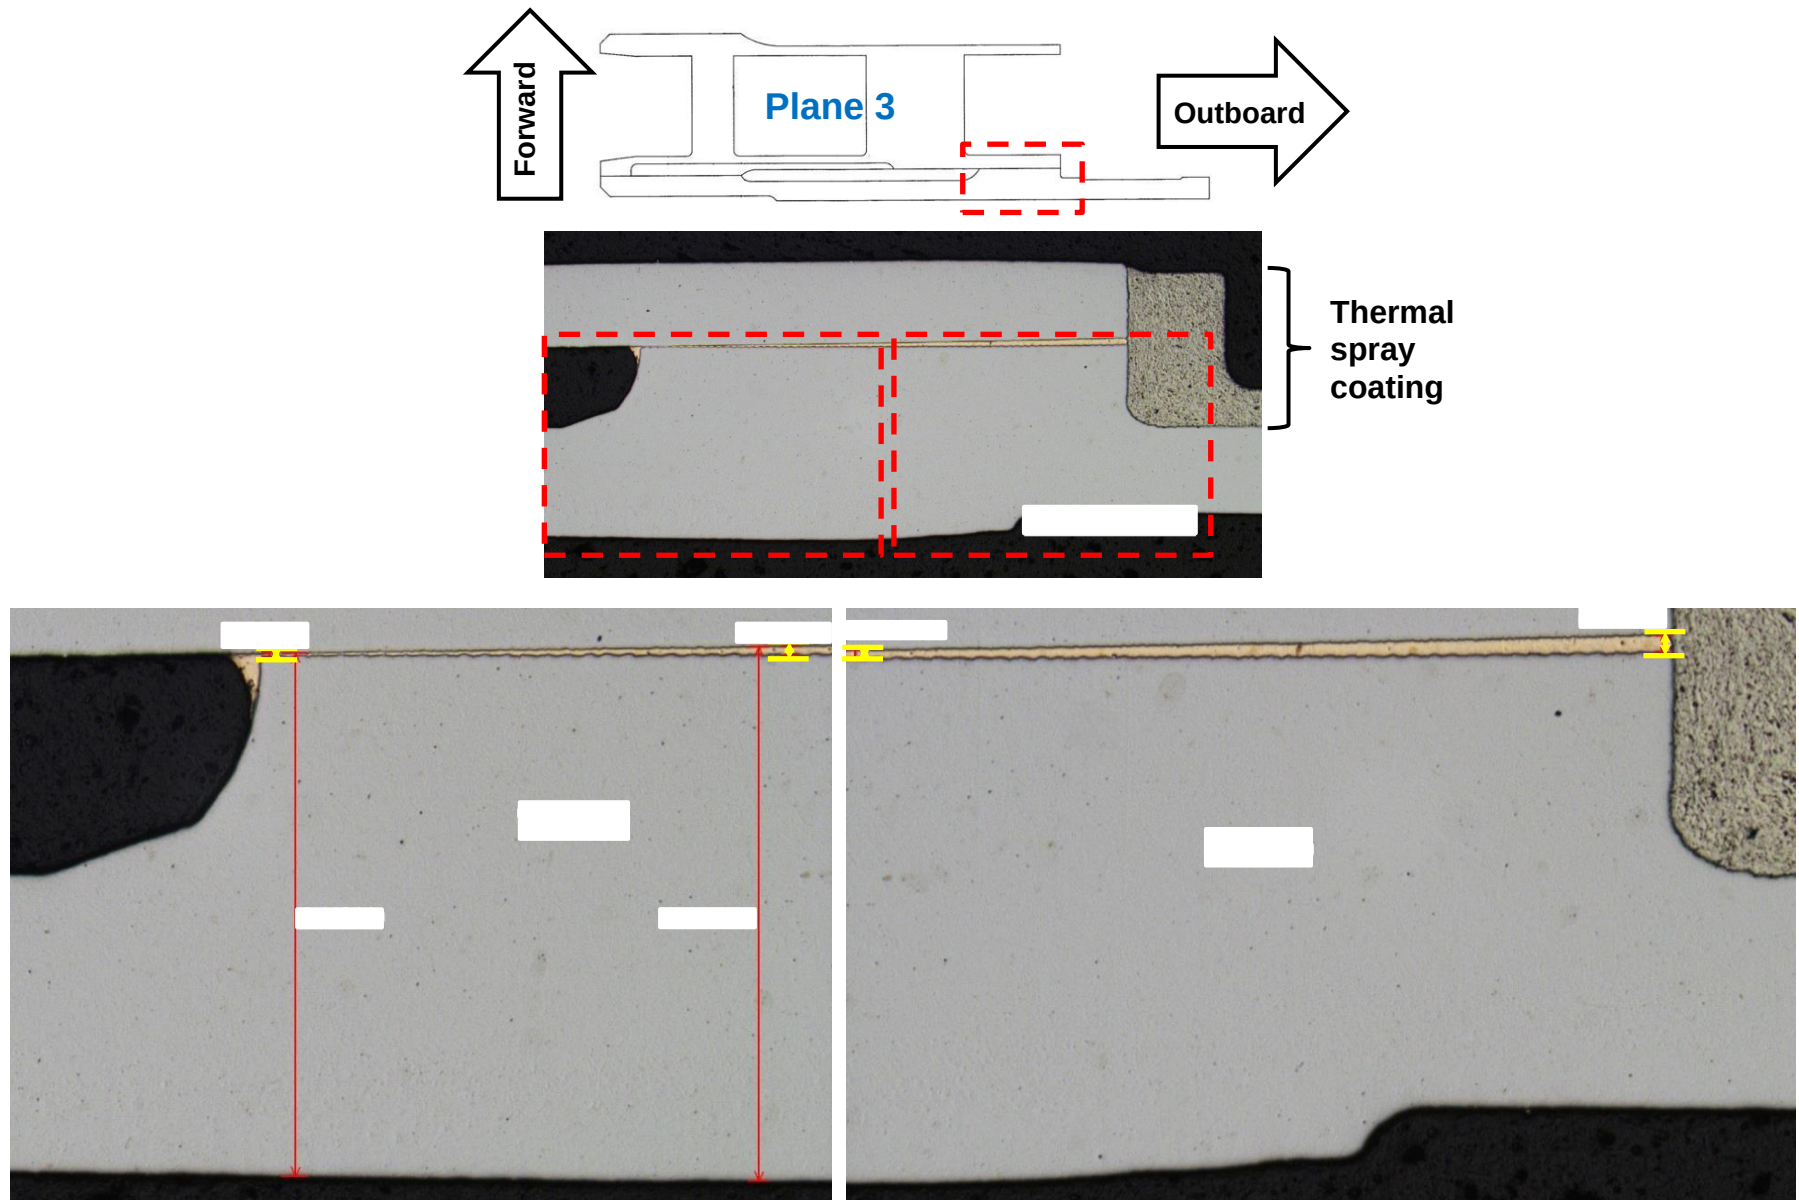
Figure 19. Photographs showing the metallographic cross-section through the outboard aft joint (see plane 3 in Figure 2). The braze gap was completely filled, but its thickness did not meet the component definition requirement. Unetched
