## **NATIONAL TRANSPORTATION SAFETY BOARD**

# **STRUCTURES**

## **Group Chairman's Factual Report**

**ERA16LA209**

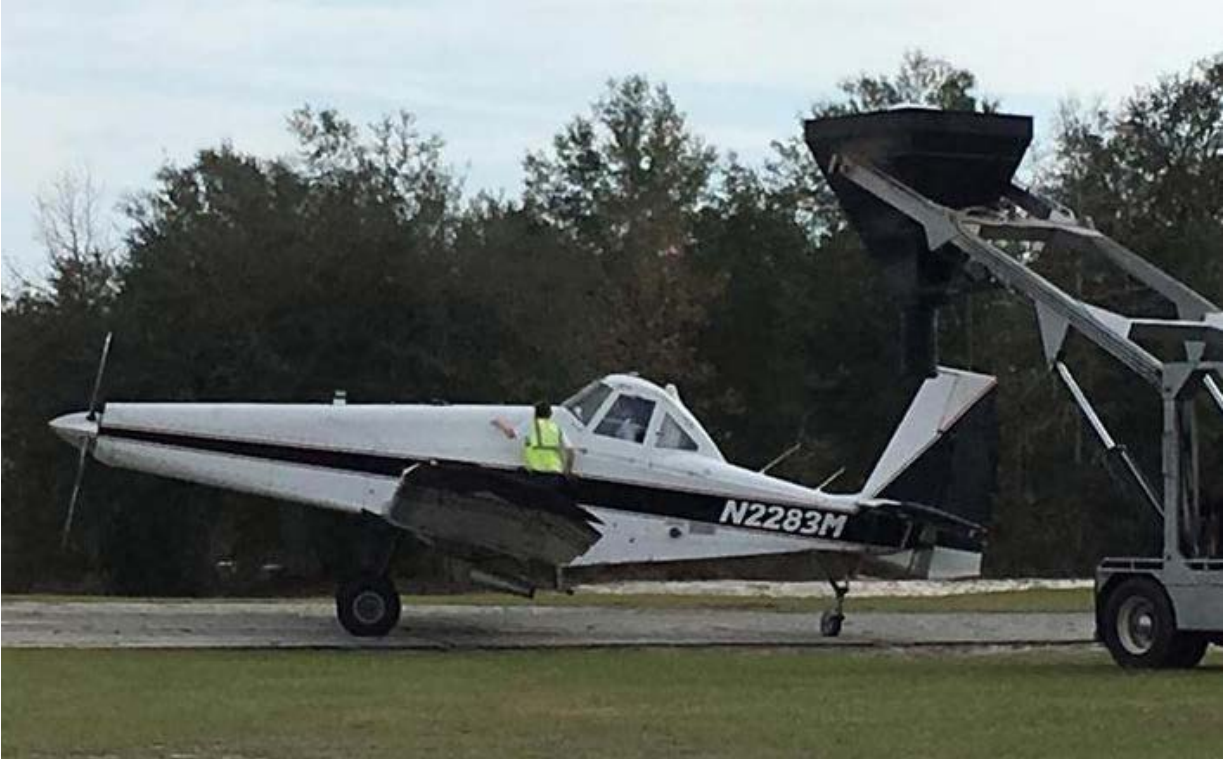
**Figure 2 – Mielec M-18A, N2283M, accident airplane**

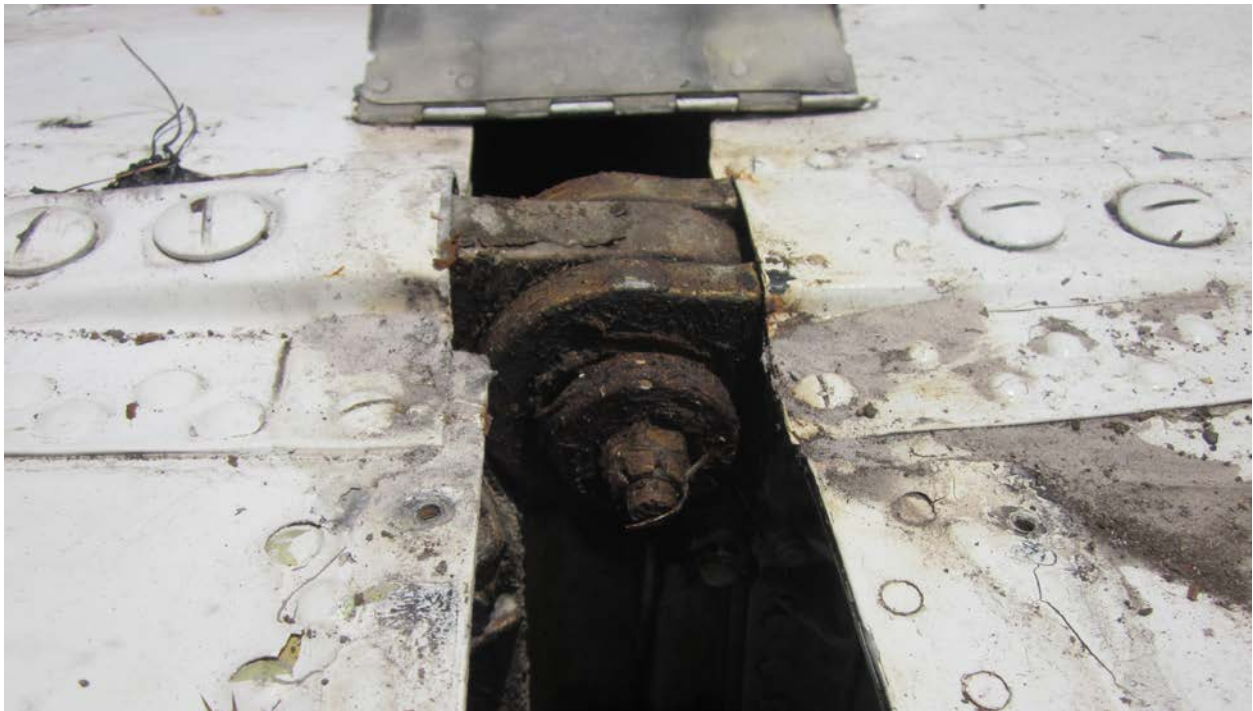
**Figure 3 – Left wing forward spar upper attach point, N2283M**

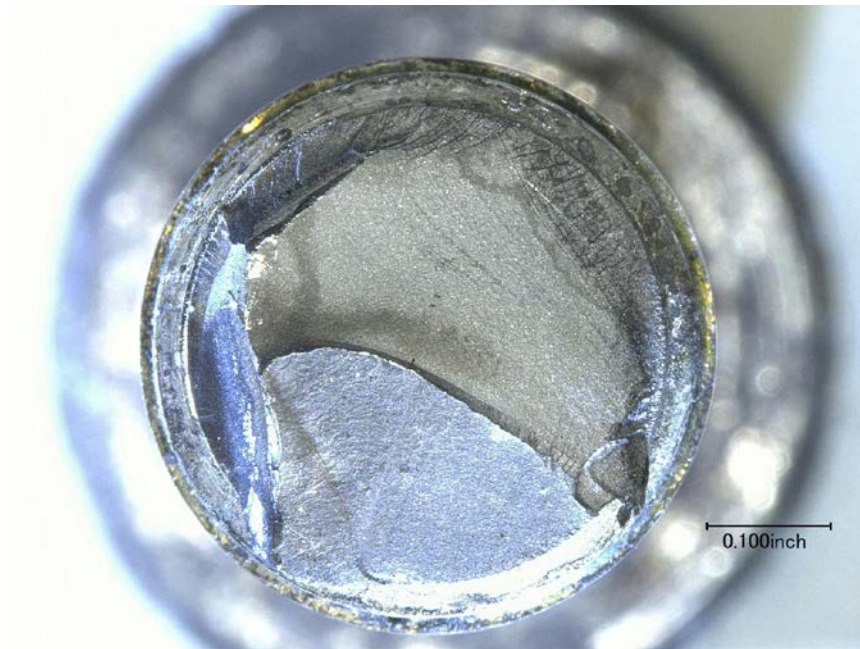
Figure 5 – Fractured wing fitting attach bolt
