# NATIONAL TRANSPORTATION SAFETY BOARD

MATERIALS LABORATORY FACTUAL REPORT

Report No. 17-024

Place : Brunswick, North Carolina  
Date : June 10, 2016  
Vehicle : WSK PZL MIELEC M-18A Agriculture Airplane, N2283M  
NTSB No. : ERA16LA209  
Investigator : Daniel Boggs ASI-ERA

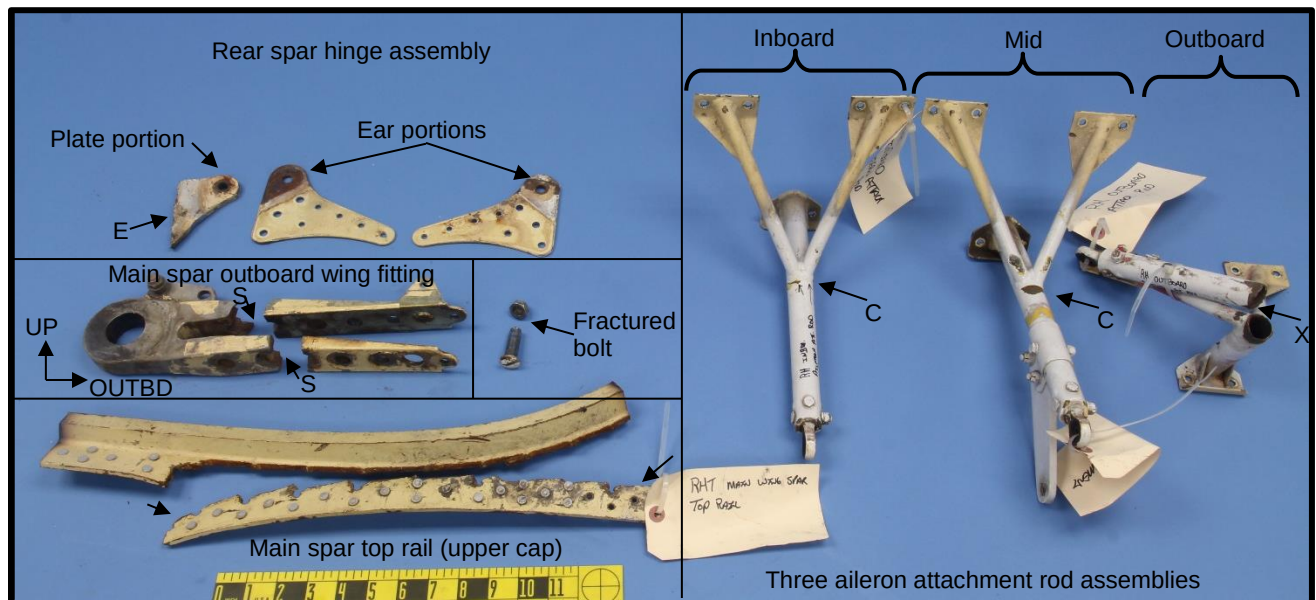
Figure 1 shows a photograph of the as-received pieces from the right wing.

The main spar top rail (upper cap) fractured along a row of rivets, in the area between unmarked arrows in figure 1. The fracture face contained no evidence of a fatigue crack.

Figure 1. As-received photograph of the main spar outboard wing fitting that fractured at the upper and lower arms; one bolt that fractured at the threaded portion; three aileron attachment rod assemblies (one is fractured at the rod portion in area indicated by arrow "X", and the other two contained a crack in same respective locations indicated by arrows "C"); main spar top rail (upper cap) that fractured along a row of rivets; rear spar hinge assembly. All pieces are from the right wing.

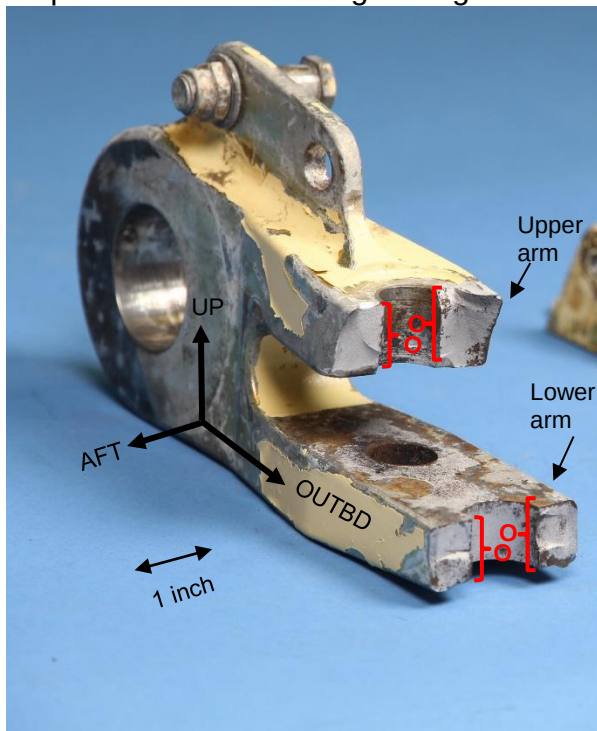
The main spar outboard wing fitting contained two arms. The fitting fractured at the two arms, in the areas indicated by arrows "S" in figure 1. Each arm contained six bolt holes. The fracture in the upper arm intersected the first hole at the inboard end. The fracture in the lower arm intersected the second hole from the inboard end. Bench binocular microscope of the fractured arms revealed the lower fracture faces contained fatigue cracks that emanated from the bore of the hole on diametrically opposite sides of each hole, in the areas indicated by brackets "O" in figure 2. Figure 3 shows a photograph of the lower fracture face. The fatigue crack in the lower face of the fracture emanated from multiple origins along the entire length of the bolt hole, areas indicated by brackets "O" in figure 3. Fatigue propagation on each side of the hole was through approximately 90% of the wall and terminated in the areas indicated by dashed lines in figure 3.

Figure 2. Photograph of the as-received main spar outboard wing fitting that fractured at the upper and lower arms in the area indicated by arrows "S" in figure 1, showing the inboard face of the fracture.

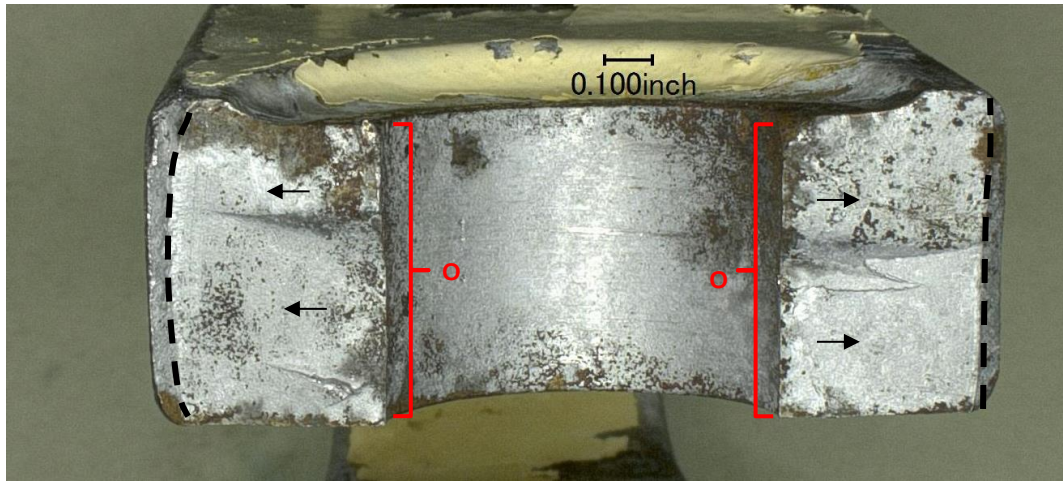
Figure 3. Photograph of the main spar outboard wing fitting showing the lower arm outboard face of the fracture. Fatigue cracking emanated from the bore of the hole in the areas indicated by bracket "O".

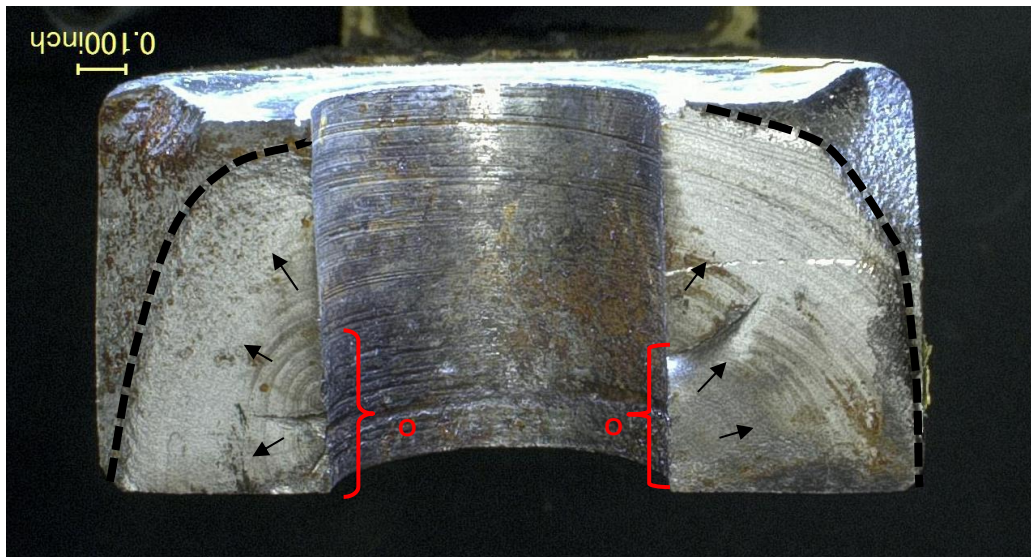
Figure 4 shows a photograph of the upper fracture face. The upper fracture face contained similar fatigue cracks with the exception that the fatigue origin areas emanated from the lower corner of the hole (see figure 4). The fatigue crack in the upper fracture face exhibited better defined fatigue fracture features, than those on the lower fracture face. According to the engineering drawing number D.22.200.36.1 for the fitting, the fitting is specified to be made from "30HGSA" low alloy high strength steel, heat treated to a tensile strength between 110 and 130 Kg/mm<sup>2</sup>. This converts to between 156,456 and

Figure 4. Photograph of the main spar outboard wing fitting showing the upper arm outboard face of the fracture. Fatigue cracking emanated from the lower corner of the hole in the areas indicated by bracket "O".

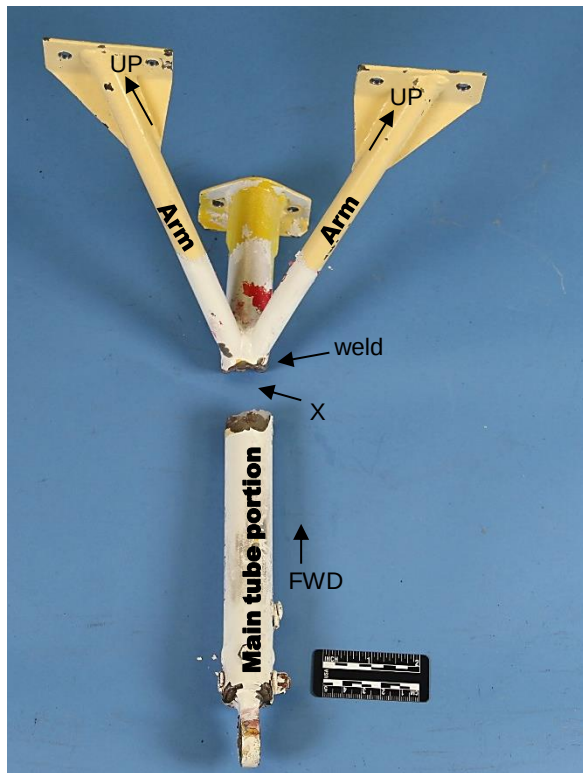
The right wing contained an inboard, middle (mid), and an outboard aileron attachment rod assembly. The outboard attachment rod contained a circumferential fracture in the main tube portion. The assembly contains two arm portions that were welded to the main tube portion. The fracture intersected the welds at the base of the two arms, indicated by arrows "X" in figures 1 and 5. The fracture intersected the aft edges of the welds (intersection between the weld and main tube portion). Bench binocular microscope examination of the forward face of the main tube fracture revealed a fatigue cracks emanated from the outer surface of the main tube, at the aft edges of the welds, in the areas indicated by bracket "O" in figure 6. Fatigue propagation was through approximately 50% of the wall and terminated in the areas indicated by a dashed line in figure 6. The fatigue crack extended around approximately 30% of the tube circumference.

Figure 5. Photograph of the aileron attachment rod assembly that fractured in the tube portion in the area indicated by arrow "X" in figure 1.

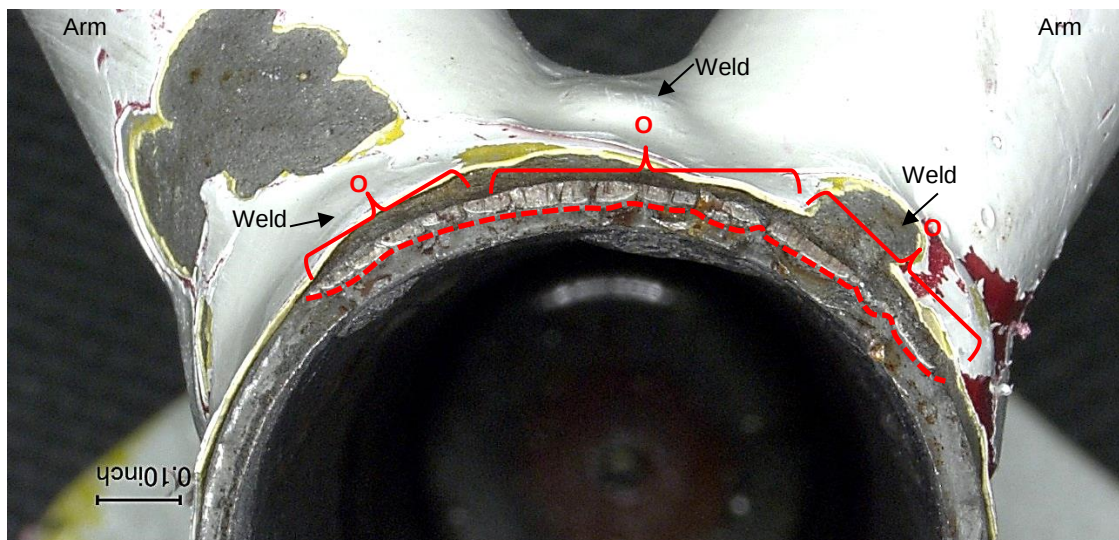
Figure 6. Forward face of the fractured aileron attachment rod assembly showing fatigue cracks that emanated from the outer surface in the areas indicated by brackets "O".

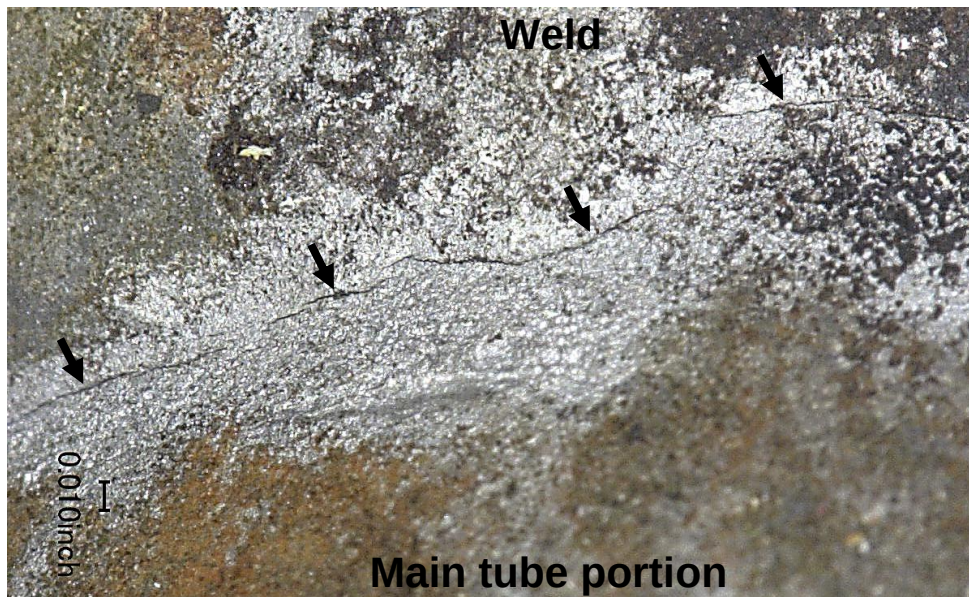
The inboard and mid aileron attachment rod assemblies were intact. Both assemblies contained cracks in the white paint layer and in the same respective locations as the fatigue cracks in the outboard assembly. The paint was removed with a commercial paint stripper from the weld areas of the intact assemblies. Bench binocular microscope examination of both intact assemblies after paint stripping revealed presence of intermittent cracks on the outer surface of the welds in the same respective location as the fracture on the outboard assembly. Figure 7 shows a close-up photograph of several intermittent cracks at the aft edges of the weld, after the paint was removed from the inboard rod assembly. A saw cut was made through the main tube portion of the two intact assemblies in the areas approximately 0.2 inch aft of the crack locations. Examination of the inner face of the main tube portion for both intact assemblies revealed the intermittent cracks did not extend through the wall.

Figure 7. Close-up photograph of the aileron attachment rod assembly showing intermittent cracks in the area along the aft edge of the weld in the areas indicated by arrows.
