# NATIONAL TRANSPORTATION SAFETY BOARD

## MATERIALS LABORATORY FACTUAL REPORT

Report No. 16-081

Place : Chatham, Massachusetts  
Date : June 17, 2016  
Vehicle : Robinson R44, N141TM  
NTSB No. : ERA16LA216  
Investigator : Robert Gretz, AS-ERA

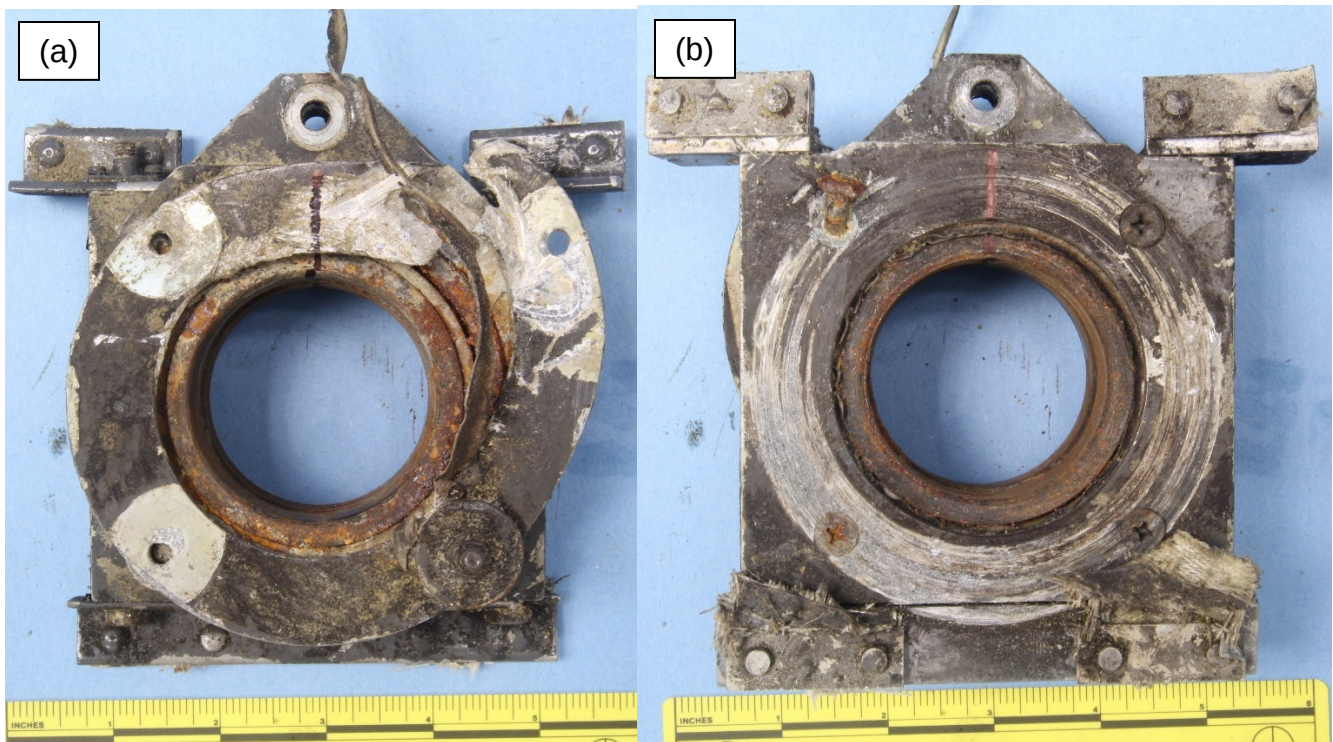
Figure 1 shows the shaft bearing assembly, as received. Three of the nuts from the through bolts on the forward side had been sheared off, consistent with damage incurred during ground impact. All four bolt heads, which were tapered, were still present in the countersunk holes on the aft side.

Figure 1 – The R44 shaft bearing assembly, as received, viewed from (a) the forward side and (b) the aft side.

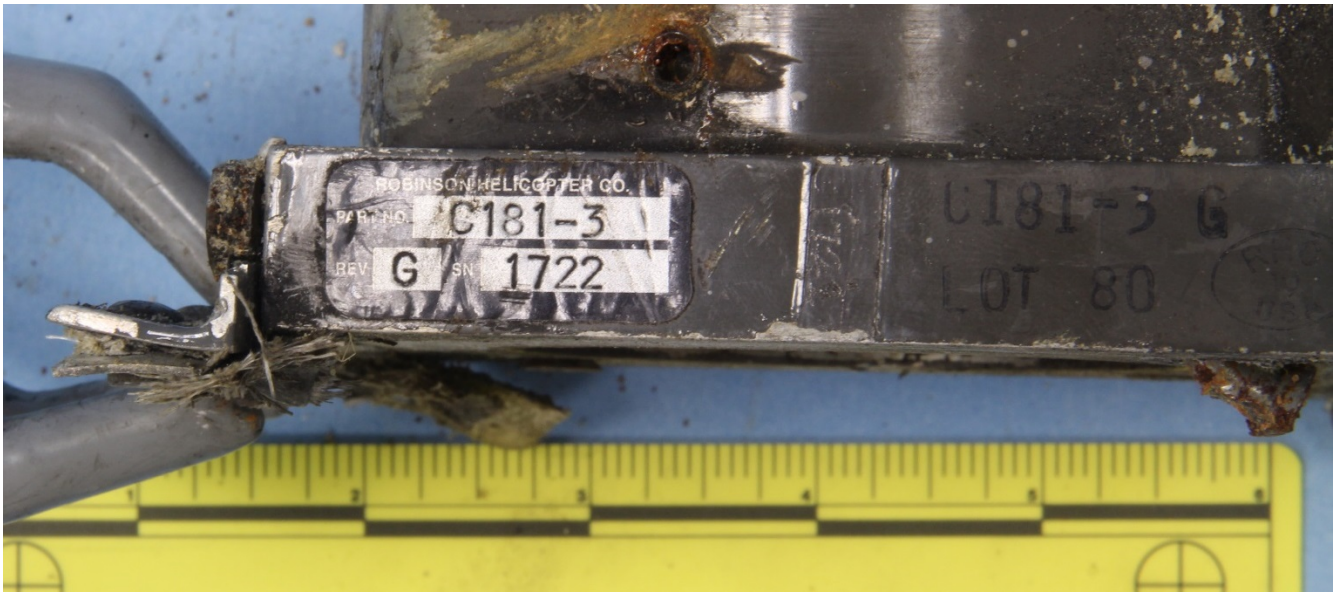
The markings on the lower flange are illustrated in Figure 2. The markings indicated the part number was "C181-3" from "Rev G" with a serial number "1722". The part was stated to be from Lot 80. The interior of the bearing inner race, which had been in contact with the shaft, is shown in Figure 3. This surface showed circumferential wear and gouging, consistent with rotational contact with the adjacent shaft under little or no lubrication.

Figure 2 – The markings on the flange of the bearing assembly, as received.

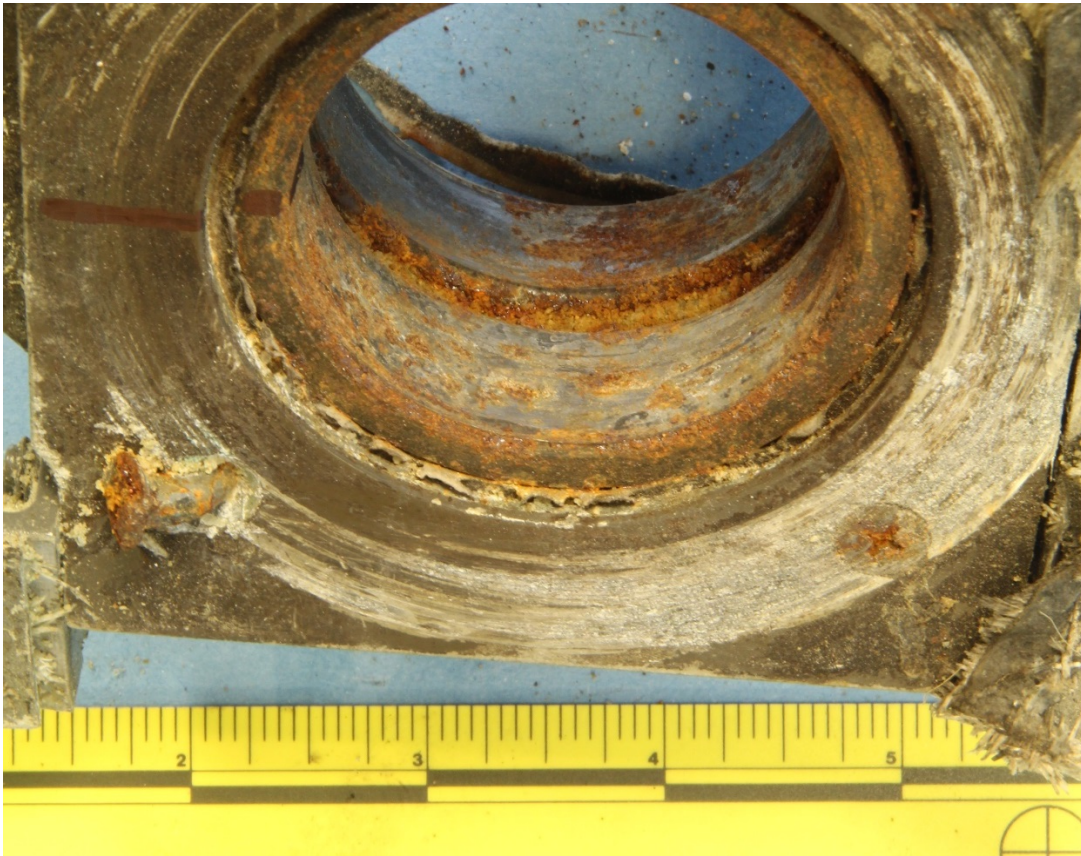
Figure 3 – The interior of the inner race of the aft side of the bearing. The 12 o'clock position was marked on the left side.

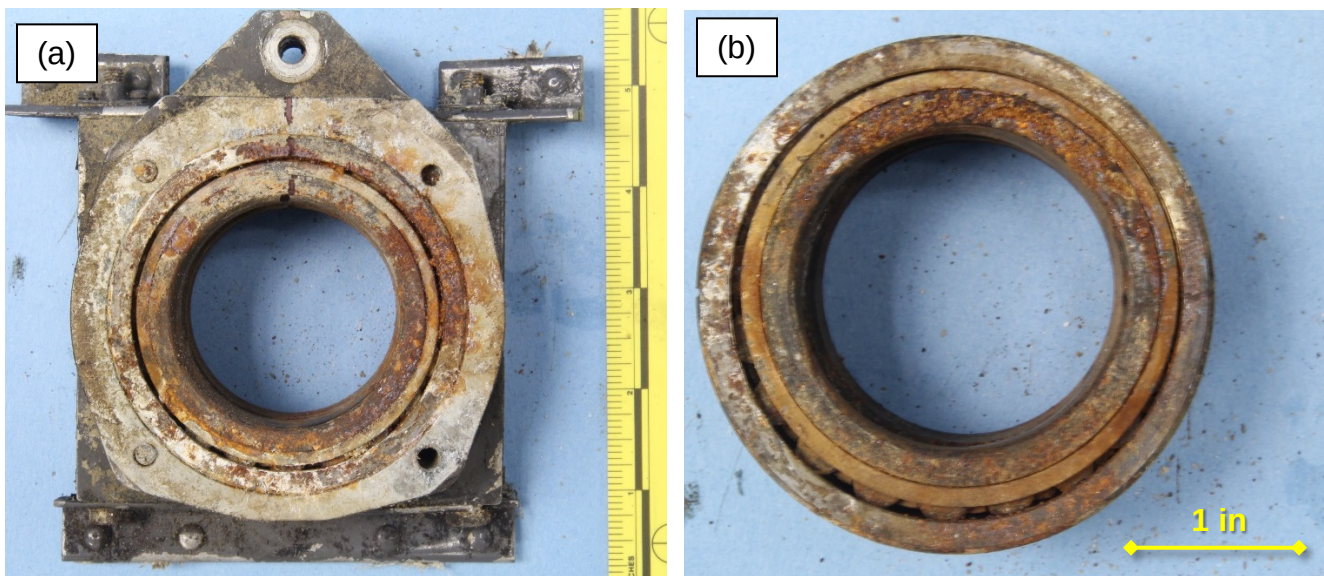
The bearing assembly was disassembled by first removing the through bolts and cross bolts. After removing the attached forward and aft housing flanges, the bearing components would still not rotate or move (see Figure 4a). The housing was sectioned at 90° to separate it from the bearing. During removal, the outer retainer fell away. However, none of the other bearing components could be actuated due to the extensive corrosion. The bearing was a compound double roller bearing (see Figure 4b). Figure 5 shows all of the bearing components disassembled, set out from forward to aft sides. The components consisted of the two inner races, attached to bearing cages with rollers, two outer races, and three spaces: one each forward and aft, and another between the two roller bearings. Each bearing contained 20 cylindrical rollers.

Figure 4 – The bearing assembly, as viewed from the forward side, during disassembly: (a) shows the bearing assembly after removal of the forward housing, and (b) shows the double bearing after removal of the surrounding housing.

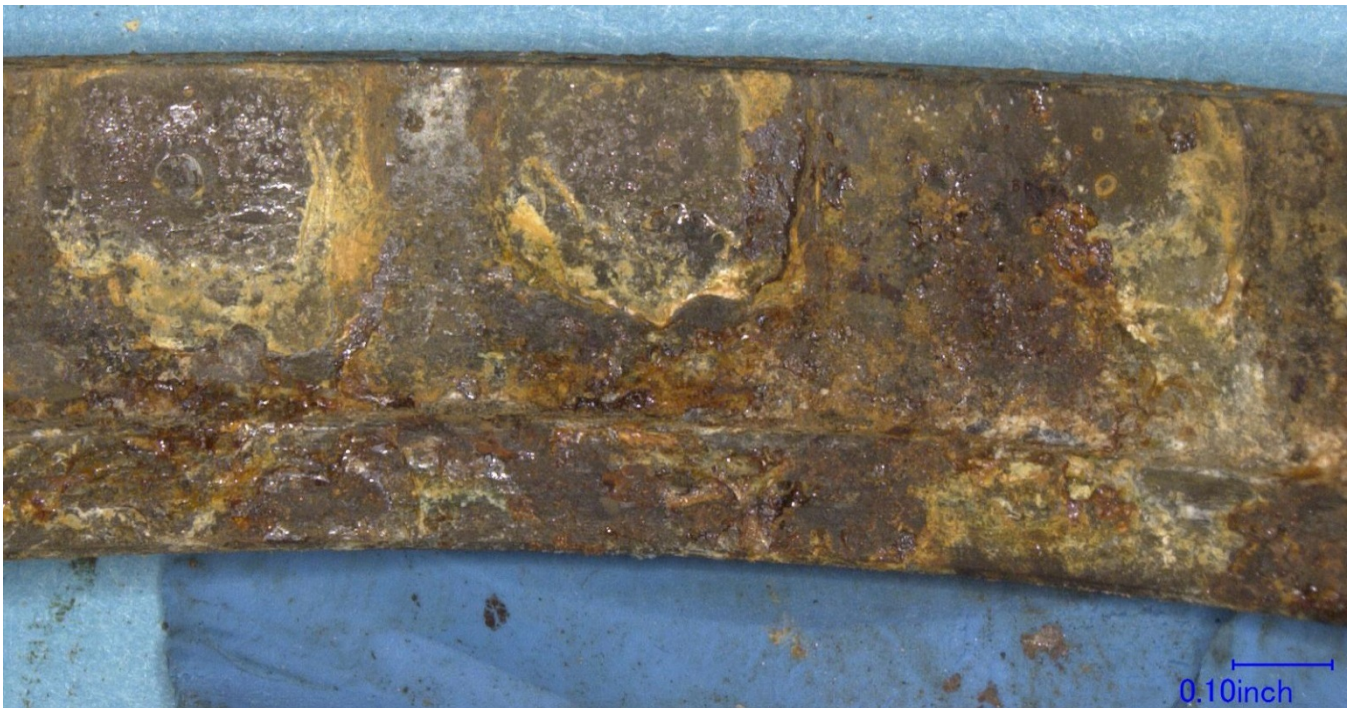
The aft bearing was examined first. After removal of the outer race, the rollers and cage were able to rotate freely about the inner race. Examination of the inner surface of the outer race revealed roller-shaped oxidation deposits, as illustrated in Figure 6. Once the oxidation was removed, there were no other witness marks observed on the outer race consistent with other damage. With the exception of oxidation, no other issues were noted on the components of the aft bearing.

Figure 6 – Inner surface of the aft bearing outer race, as received. The depressions were consistent with the positions of the rollers while oxidation occurred.

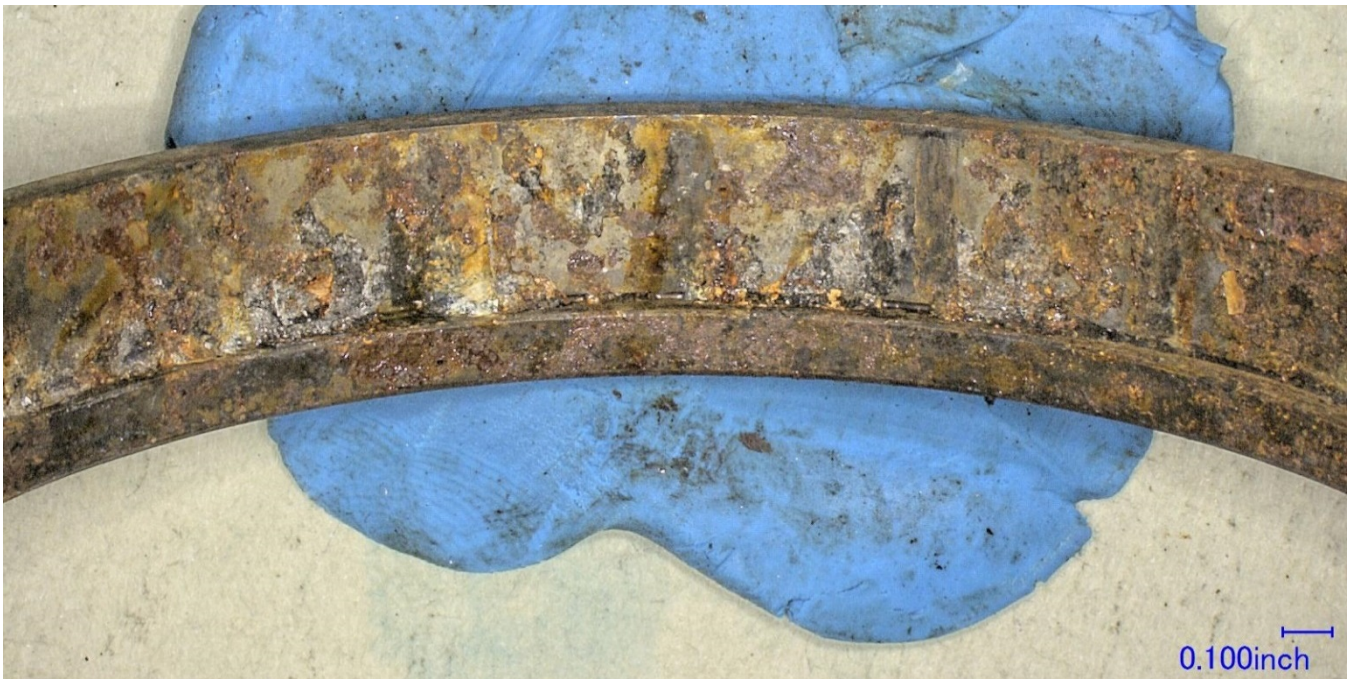
Examination of the forward bearing revealed more damage to the components compared to their counterparts on the aft bearing. Figure 7 illustrates the inner surface of the outer race after cleaning, revealing regularly spaced linear depressions. These witness marks were consistent with true brinelling on the surface from the adjacent rollers. The depressions were present under the surface oxidation, consistent with their positions before being exposed to water (Figure 8). The outer race exhibited an outer diameter of 0.314 inch, a minimum inner diameter of 2.738 inches (due to the flange), and a broader inner diameter of 2.869 inches.

Figure 7 – The inner surface of the forward bearing outer race, after cleaning with acetone. The linear depressions were consistent with true brinelling of the race surface.

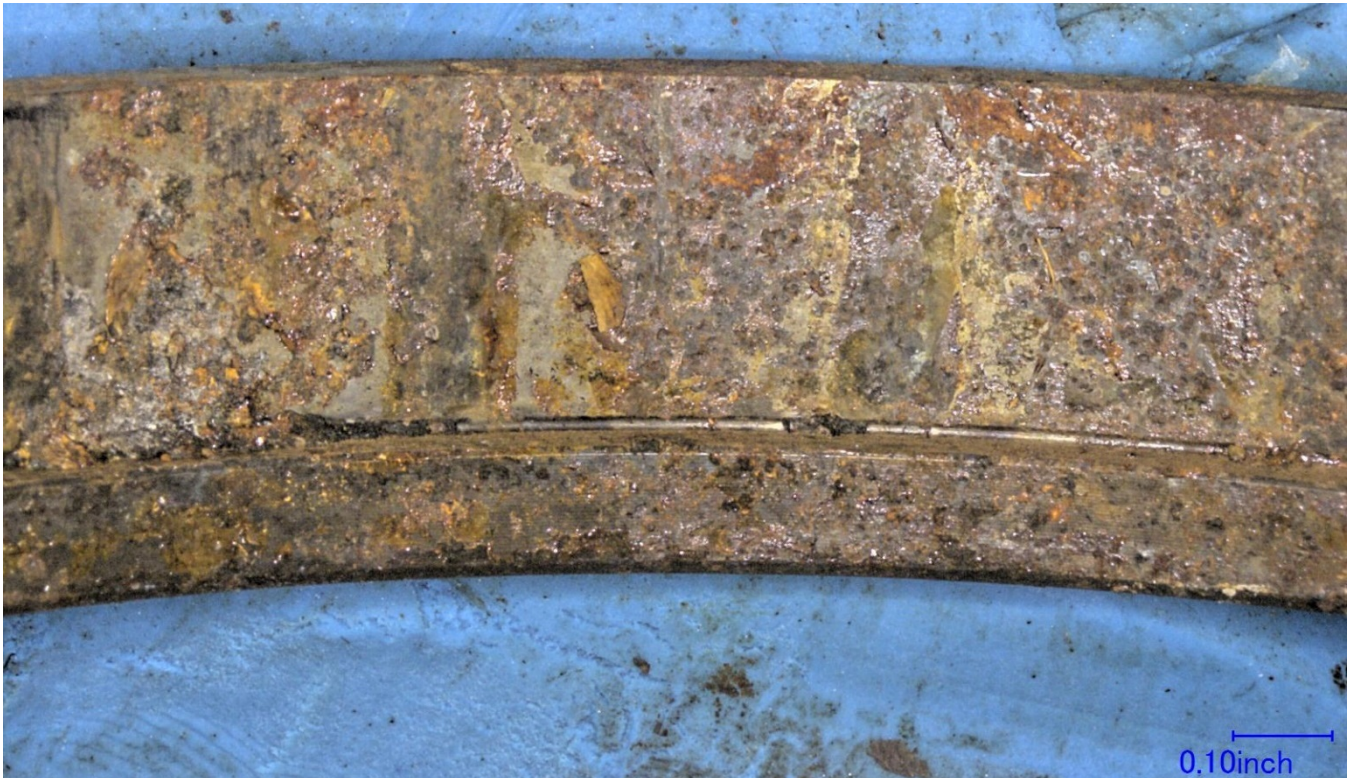
Figure 8 – A closer view of the brinelling depressions on the inner surface of the forward bearing race.

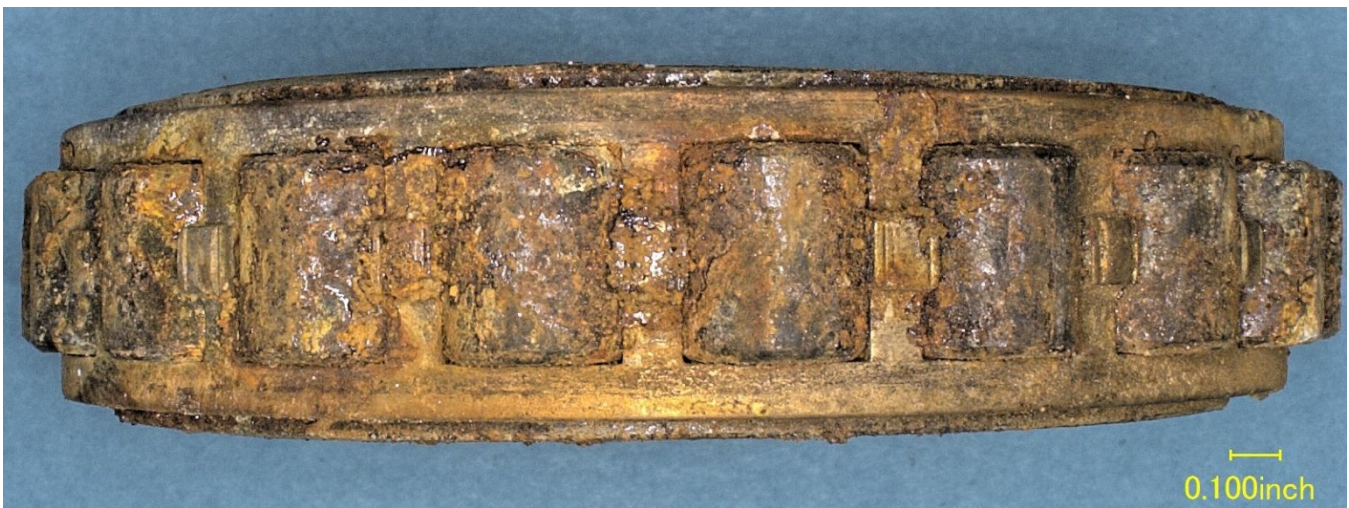
The roller, cage, and inner race assembly are shown in Figure 9. Like the aft bearing, this assembly exhibited heavy oxidation on all the surface components. Unlike the aft bearing, the rollers on the forward bearing could not be moved. It was only after physical sectioning of the cage and inner race that these components were examined.

Figure 9 – A view of the forward bearing rollers, cage and inner race, viewed from outside, after cleaning with acetone.

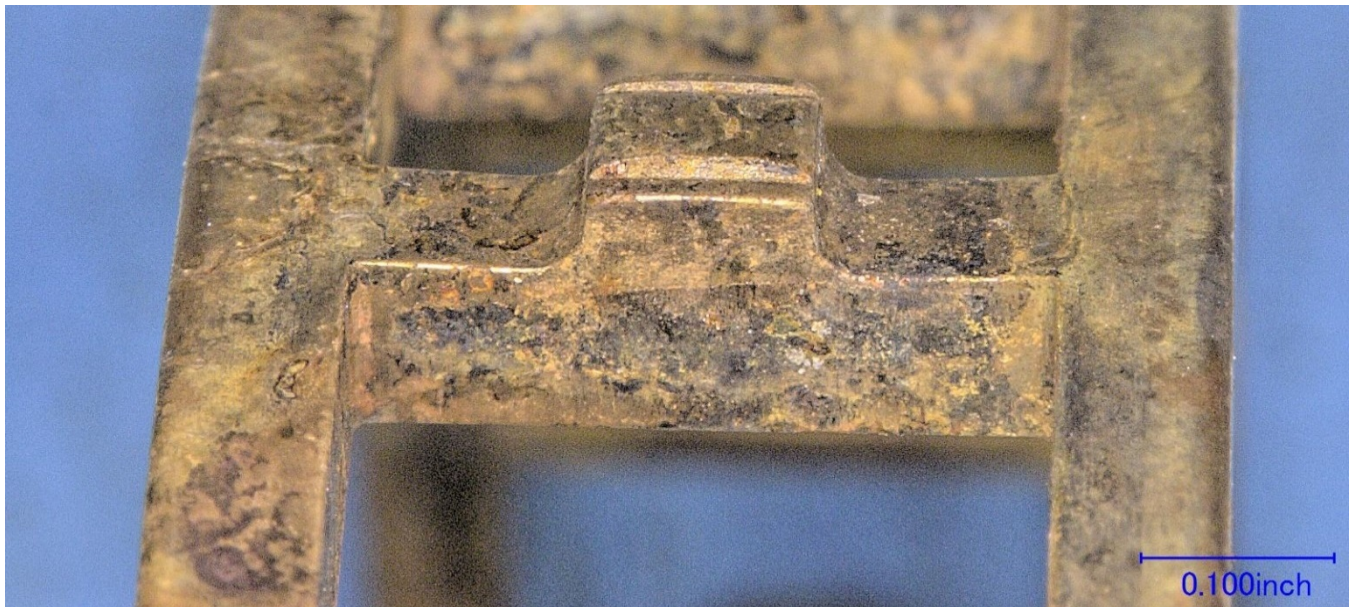
The cage exhibited a golden-colored appearance and relatively little oxidation, consistent with a copper-based alloy. Figure 10 shows typical sides inside the bearing cage pockets. The pockets exhibited wear marks consistent with contact from the rollers, but showed no indications of gouging, or depressions consistent with excessive wear or sliding. The outer diameter of the cage was measured as 2.64 inches, and the pocket width varied between 0.318 inch and 0.322 inch.

Figure 10 – A view of the pocket sides of the cage from the forward bearing, after full disassembly and cleaning. Mild wear marks could be observed on the side.

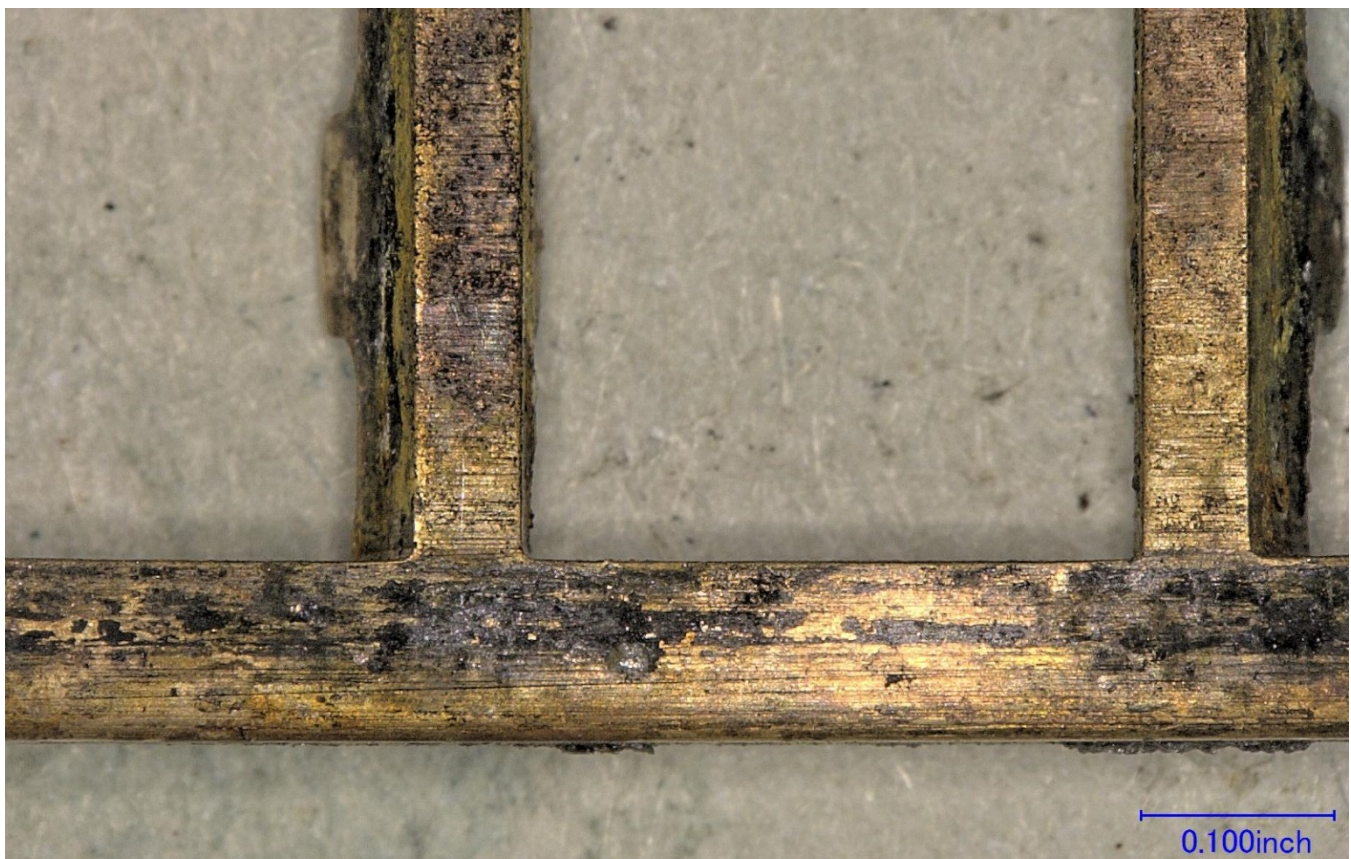
However, examination of the inner surface of the cage found circumferential wear marks consistent with sliding against the inner race (see Figure 11). Dark char deposits were also present on this surface, consistent with exposure of the lubricant or adjacent components to relatively high temperature.

Figure 11 – The inner surface of the forward bearing cage, showing circumferential sliding wear, consistent with contact with the inner race.

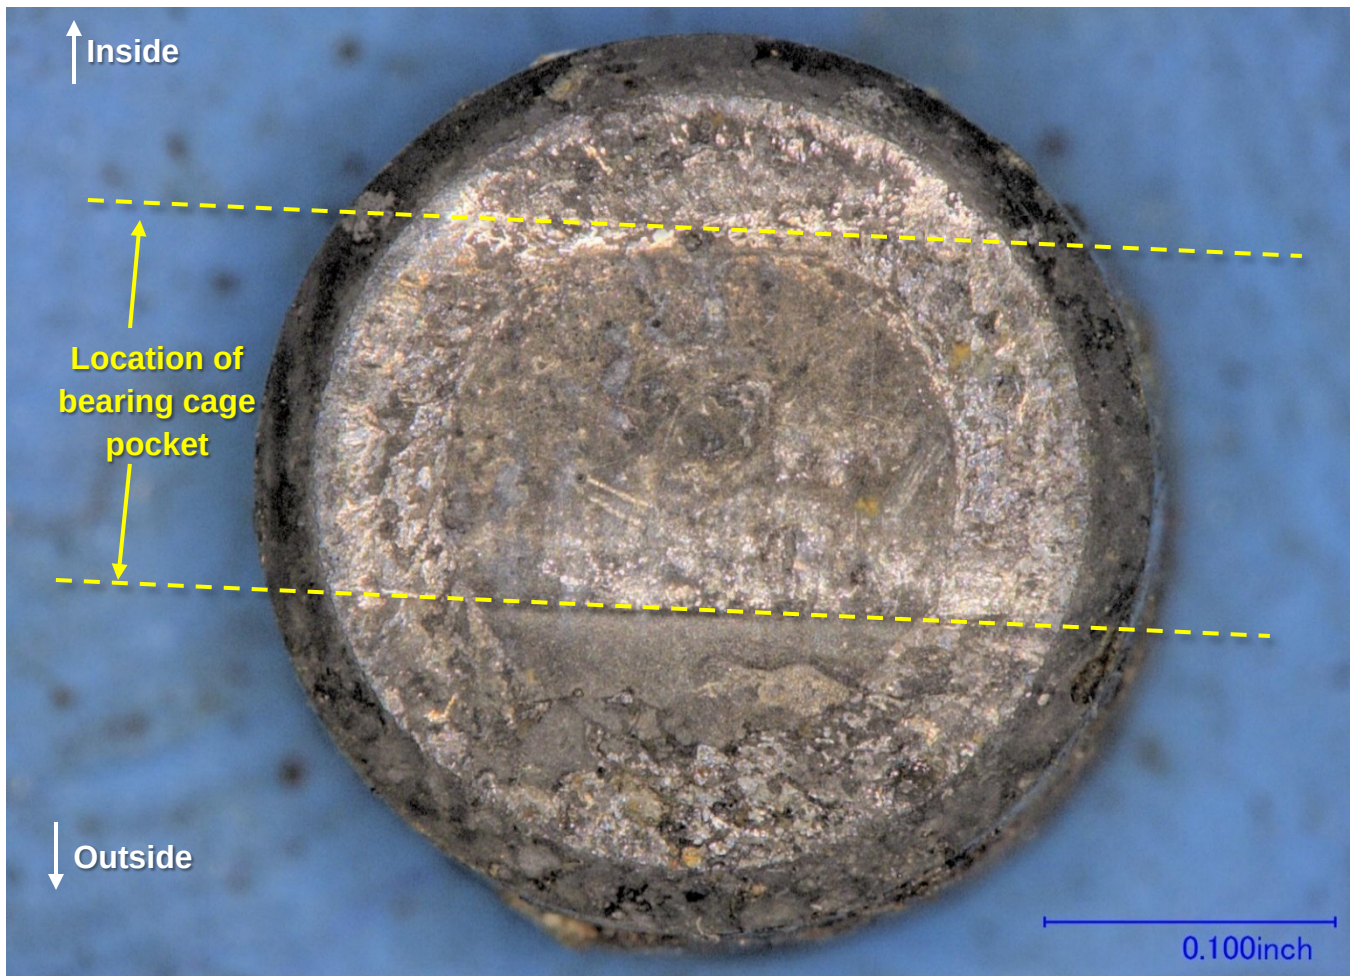
Examination of the rollers found that most of them exhibited witness marks consistent with their final resting location in the pockets of the bearing cage (see Figure

12). There were some indications of ring-shaped wear on the outside of the roller (or “bullseyeing”) on the axial surfaces of the rollers, but it was not excessive enough that discernible depressions were observed. On the inner cylindrical surface, some circumferential sliding marks were observed, consistent with contact on the inner race outer surface. The minimum inner diameter of this part was 1.665 inches, and the maximum outer diameter was 2.420 inches.

Figure 12 – A side view of one of the rollers from the forward bearing, after disassembly and cleaning. Horizontal wear marks were consistent with the location of the bearing cage and wear with the inner race channel.

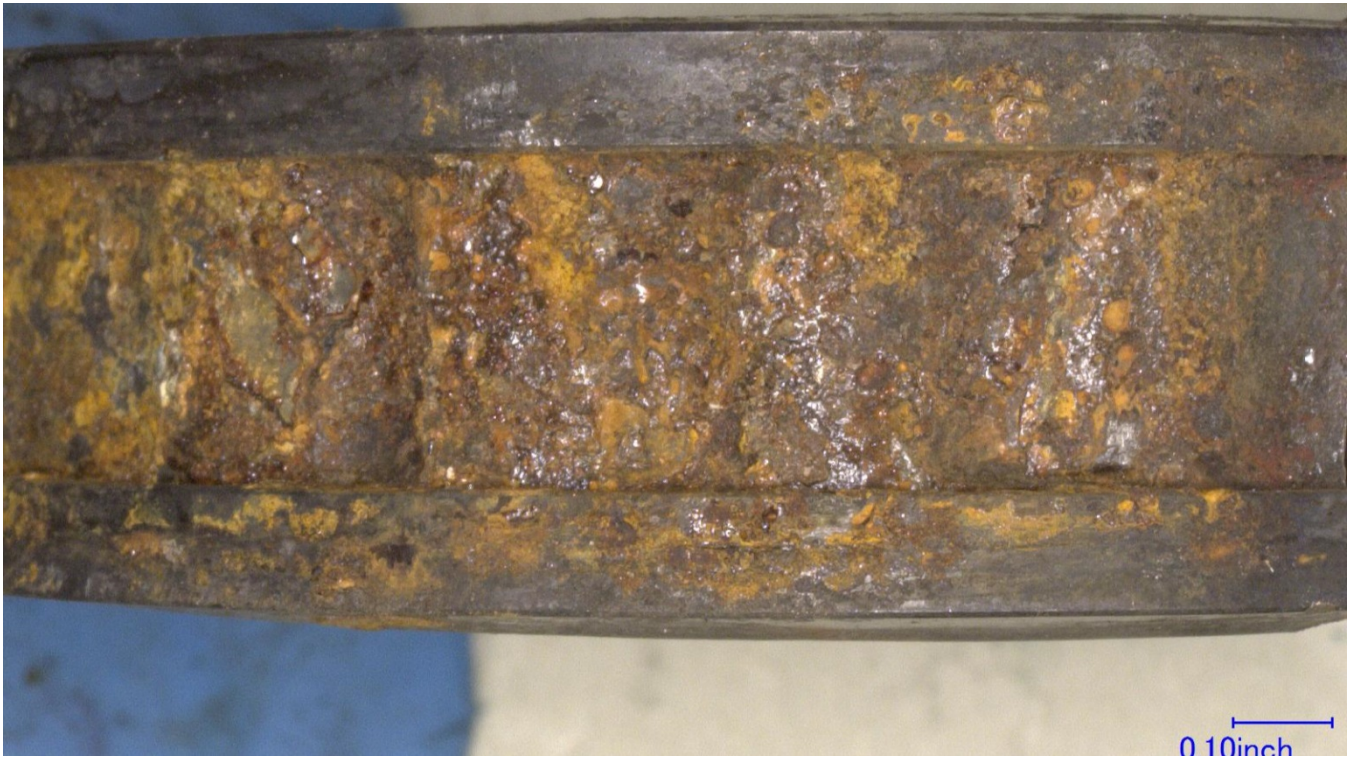
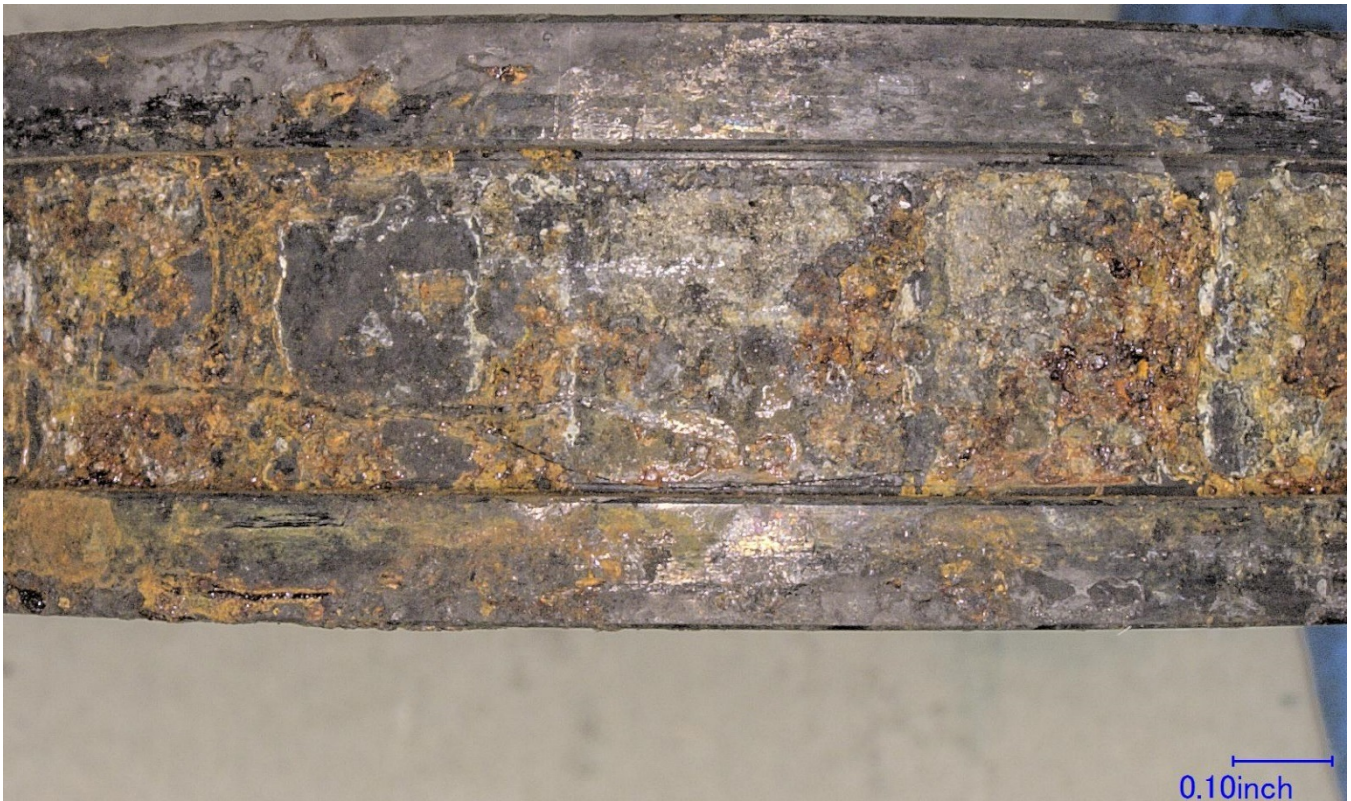
The outer face of the inner surface is shown in Figure 13 and Figure 14. The roller groove on the outer surface exhibited oxidation enough to cover much of the underlying detail. Upon removal of the oxide, discernible depressions consistent with deformation from the adjacent rollers was observed. On the crests of these depressions, sliding wear marks were observed (see Figure 15). These marks were consistent with sliding against the adjacent rollers.

Figure 13 – The outer face of the inner race of forward bearing, showing dents and depressions consistent with the rollers, and deformation of the aft surface flange.

Figure 14 – The inner race of the forward bearing, after cleaning, showing deformation of the aft flange and roller depressions.

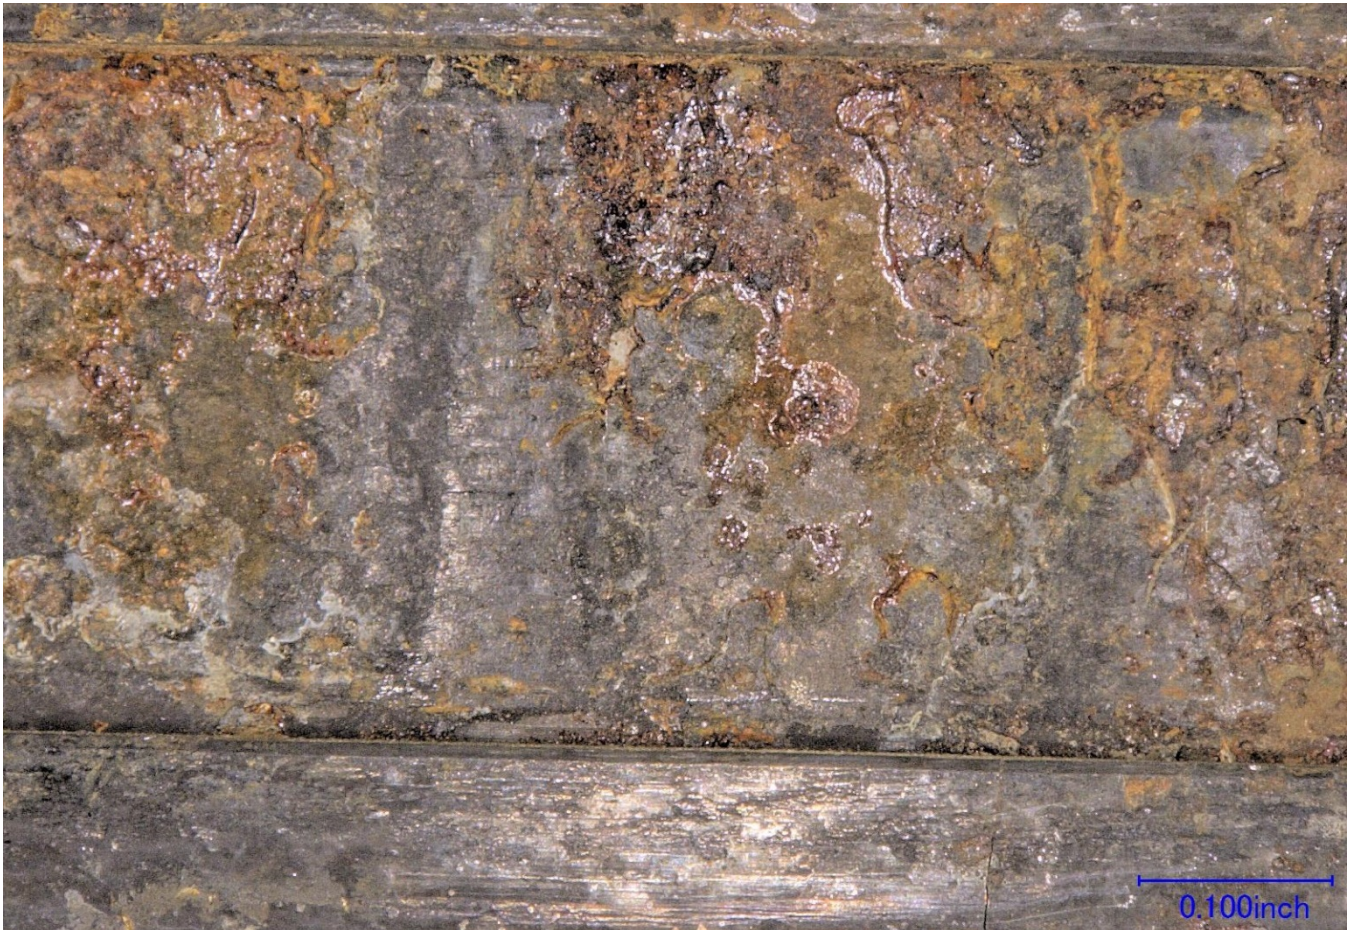
Figure 15 – Closer view of the inner race channel from Figure 14, showing sliding wear marks with a roller.

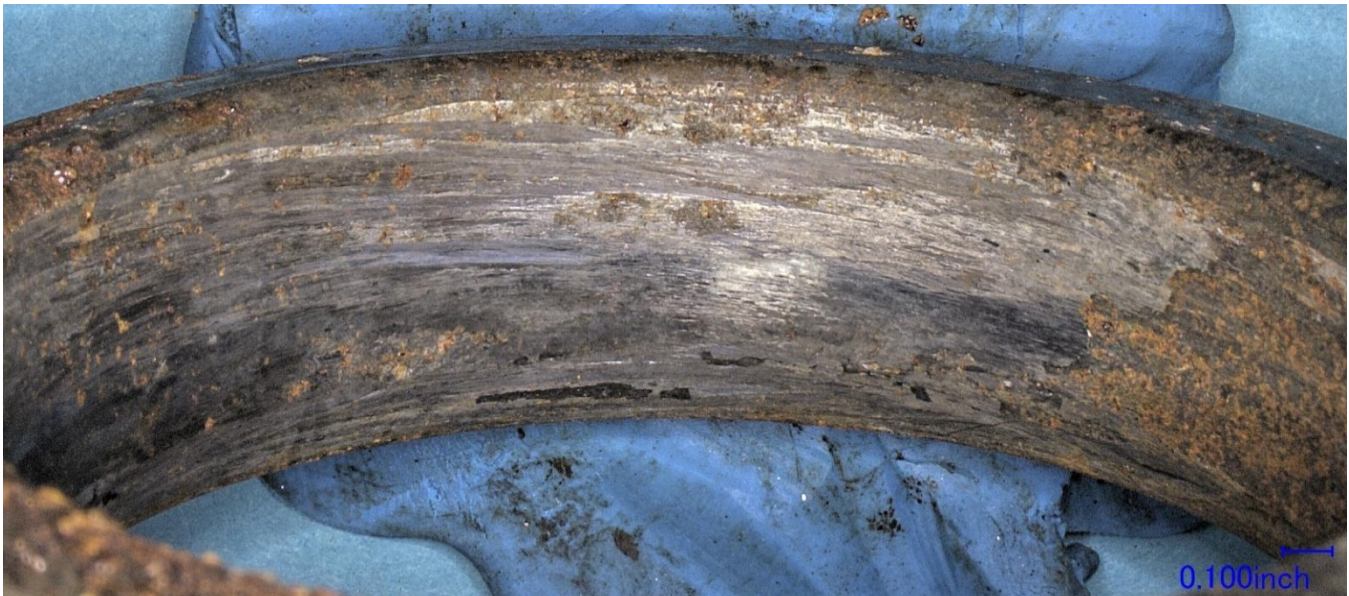
In addition, the flanges on the forward and aft sides of the roller groove on the outer surface exhibited deformation. The direction of the flange deformation was consistent with being bent inward towards the rollers. The inner surface of the inner race exhibited severe circumferential wear, including loss of material and gouging marks (Figure 16). These marks were consistent with rotational sliding along the shaft with little to no lubrication, at elevated temperatures.

Figure 16 – The inner surface of the forward bearing inner race, showing circumferential wear and gouging.

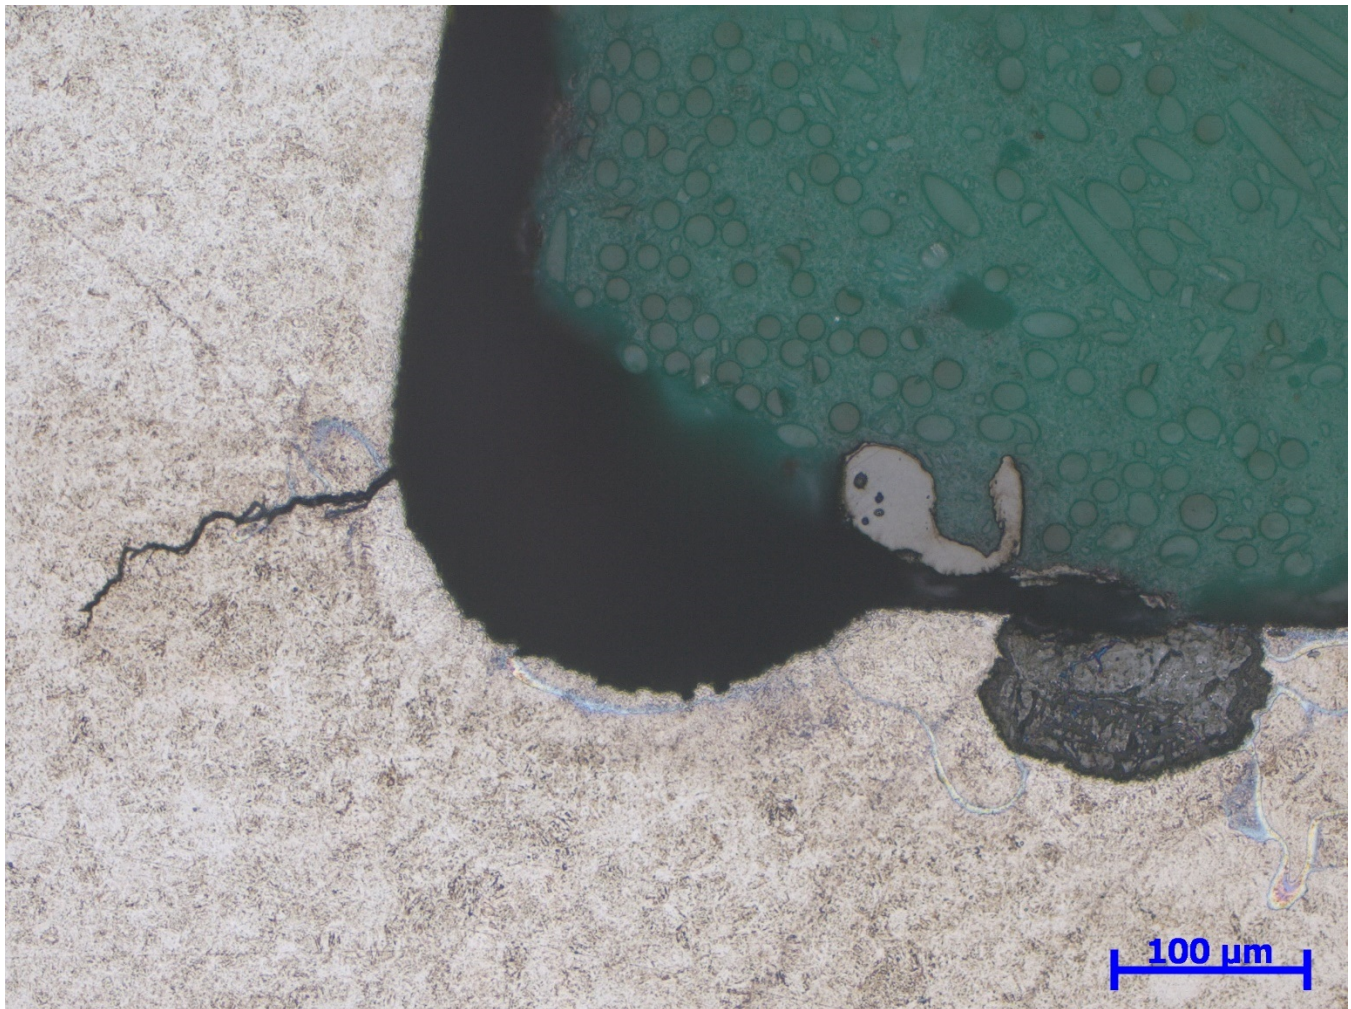
Figure 17 shows a portion of a corner of the inner race outer surface. The corner had been machine rounded. Of note in this area was a crack that propagated into the inner race from groove corner. In addition, a dark-colored corrosion pit was found near the corner. In general, much of the inner race contact surfaces exhibited sub-surface corrosion products (as exemplified by the darker portion in Figure 18).

Figure 17 – Bright-field (BF) optical metallograph of the forward bearing inner race outer surface channel, showing corrosion pitting and a corner crack (~200X, etched 2% Nital).

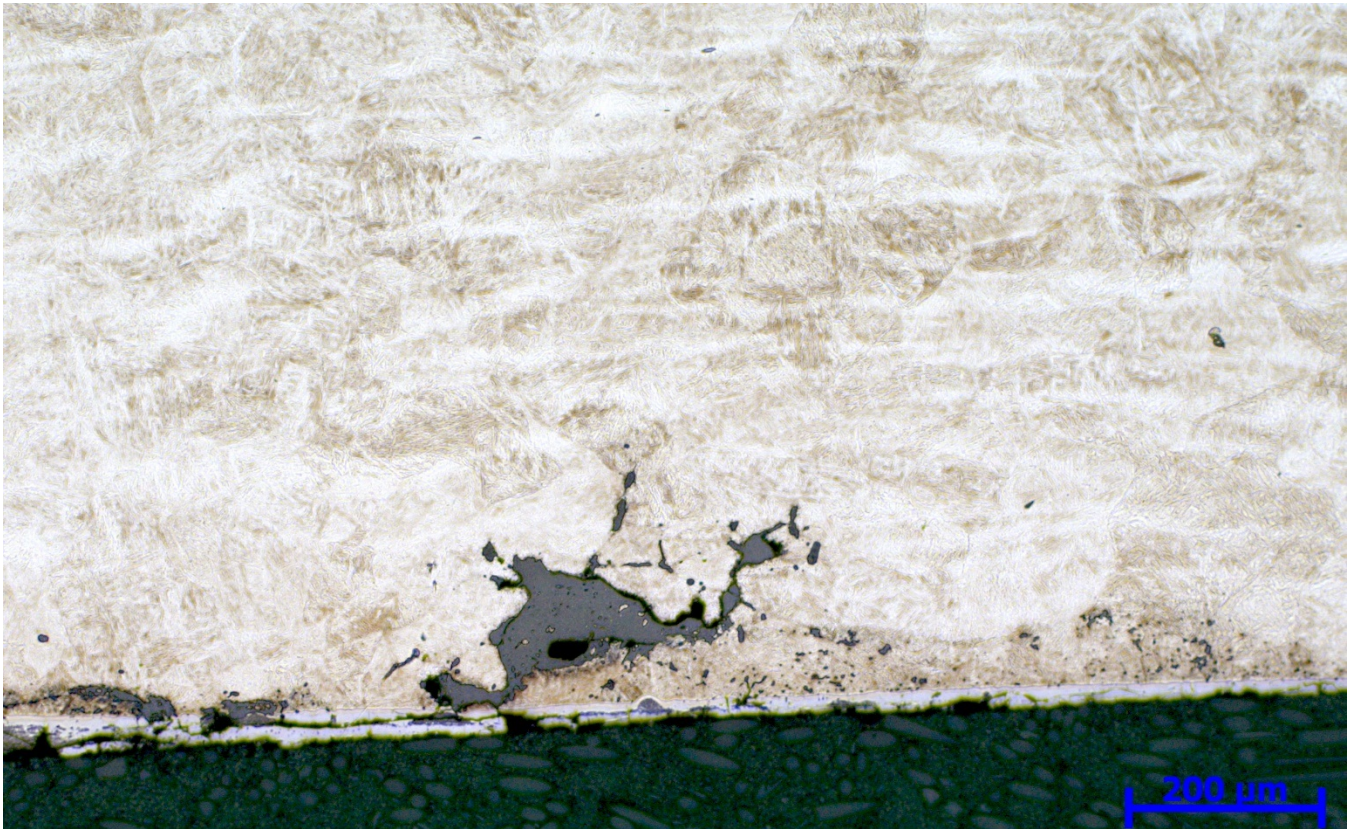
Figure 18 – BF optical metallograph of the forward bearing inner race inner surface, showing microstructure contrast and subsurface oxidation (~100X, etched 2% Nital).

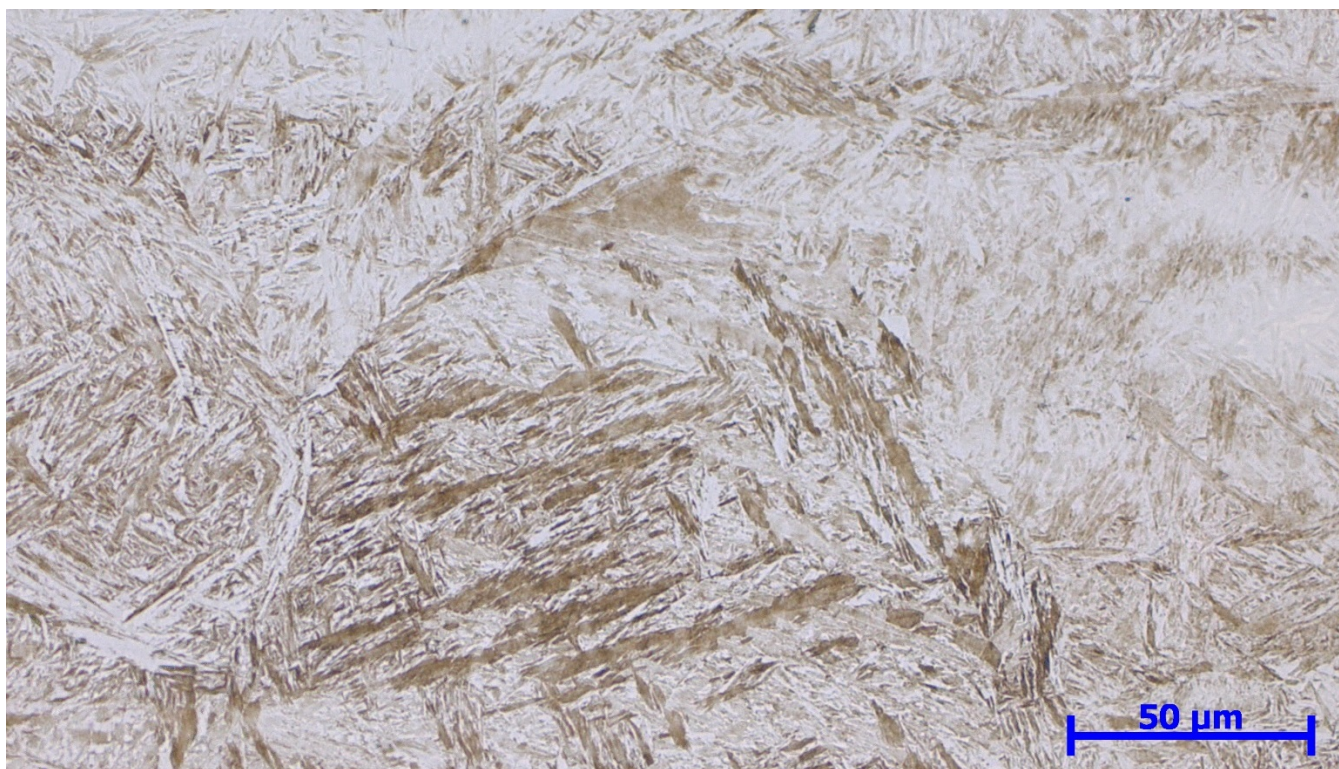
In contrast, the microstructure of inner surface of the inner race contained coarse plates of tempered martensite (dark) and retained austenite (white), with no indications of carbides (see Figure 20). This microstructure was consistent with one from the same material having heated to higher temperatures (and/or for longer times) than that seen in Figure 19.<sup>3</sup>

Figure 20 – BF optical metallograph of the forward bearing inner race, showing a typical area of microstructure near from the inner surface exhibiting martensite laths and prior austenite grain boundaries (~500X, etched 2% Nital).

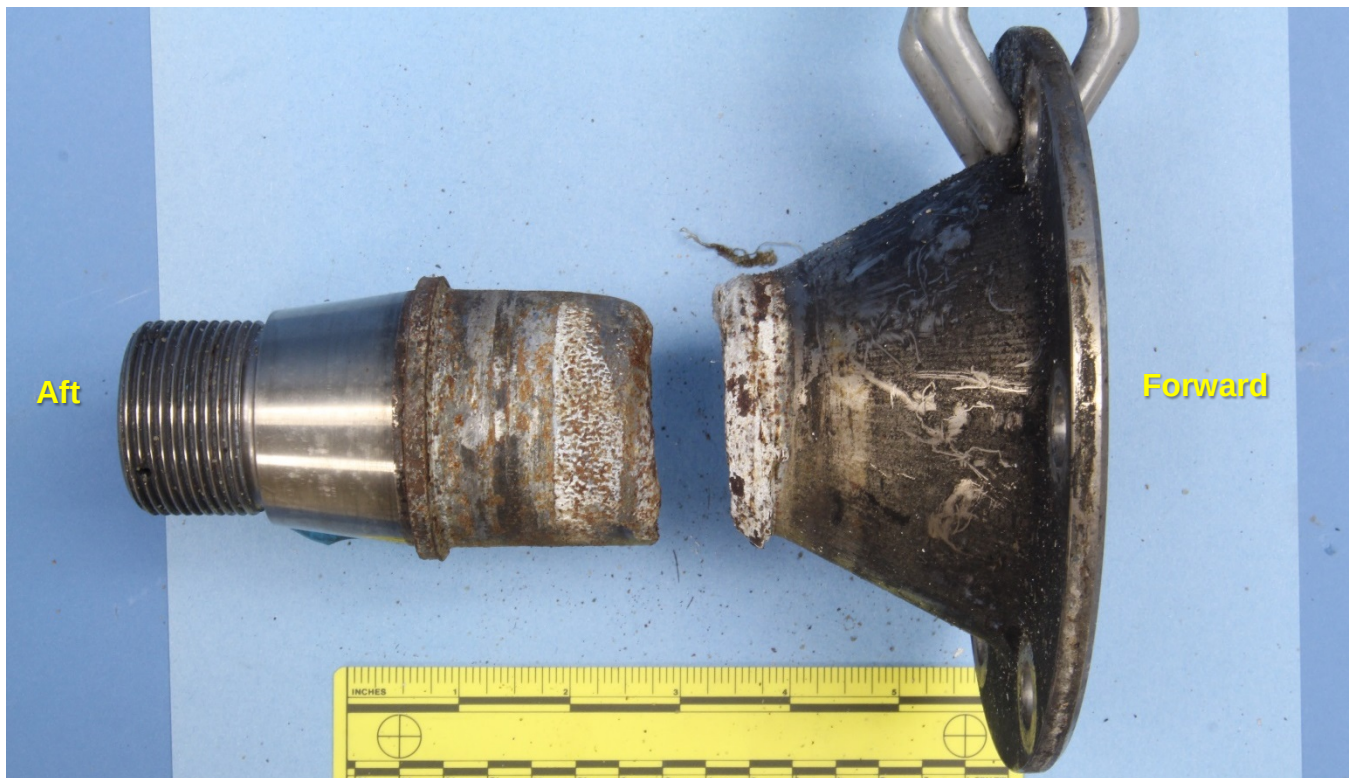
Figure 24 illustrates the two fractured halves of the shaft that sits inside the bearing assembly, as received. The shaft exhibited circumferential wear, as well as white and dark ashing, consistent with exposure to elevated temperature. The material adjacent the fracture on both mating faces exhibited material thinning and deformation (see Figure 25).

Figure 24 – The R44 shaft, showing the fracture location along the shaft taper, where the bearing assembly was positioned.

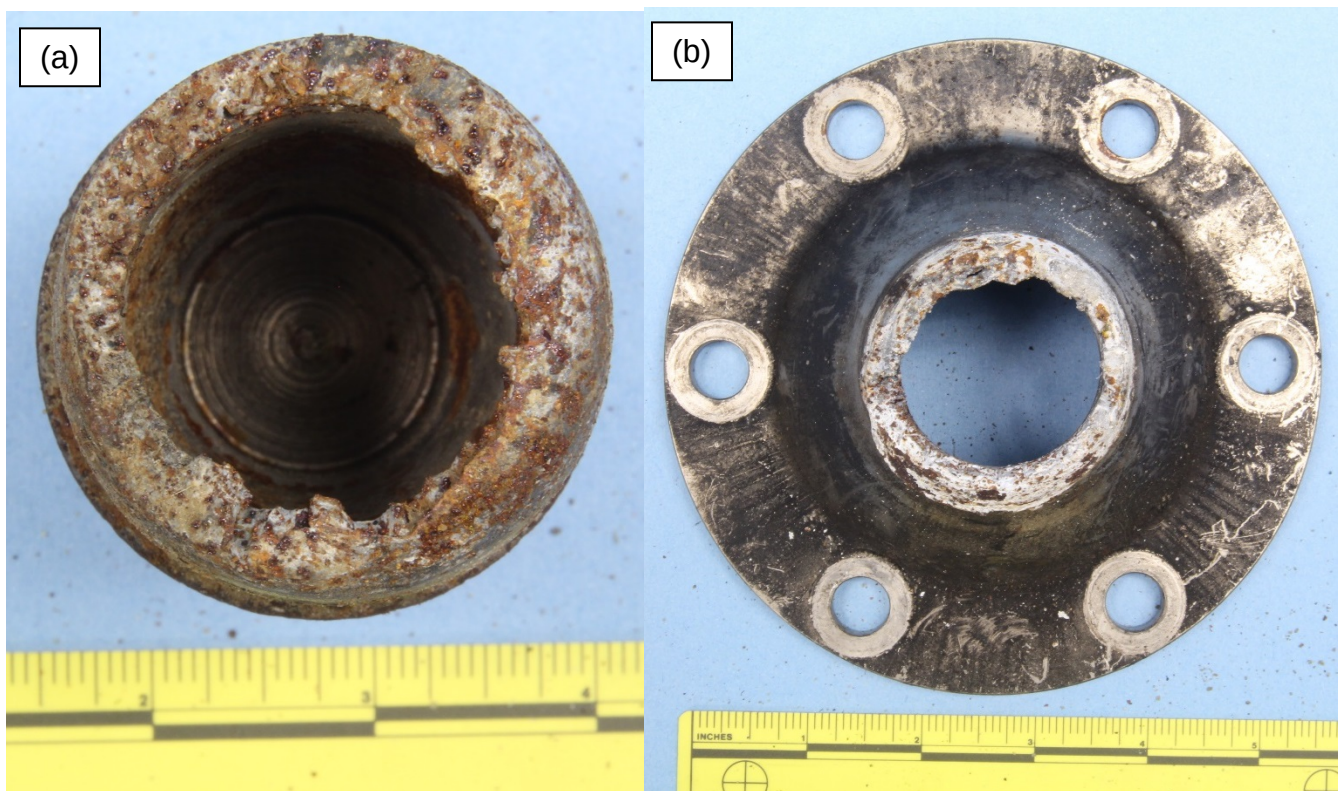
Figure 25 – The fracture surfaces of the bearing shaft, from (a) the aft side and (b) the forward side.
