# NATIONAL TRANSPORTATION SAFETY BOARD

## MATERIALS LABORATORY FACTUAL REPORT

Report No. 16-081

Place : Chatham, Massachusetts  
Date : June 17, 2016  
Vehicle : Robinson R44, N141TM  
NTSB No. : ERA16LA216  
Investigator : Robert Gretz, AS-ERA

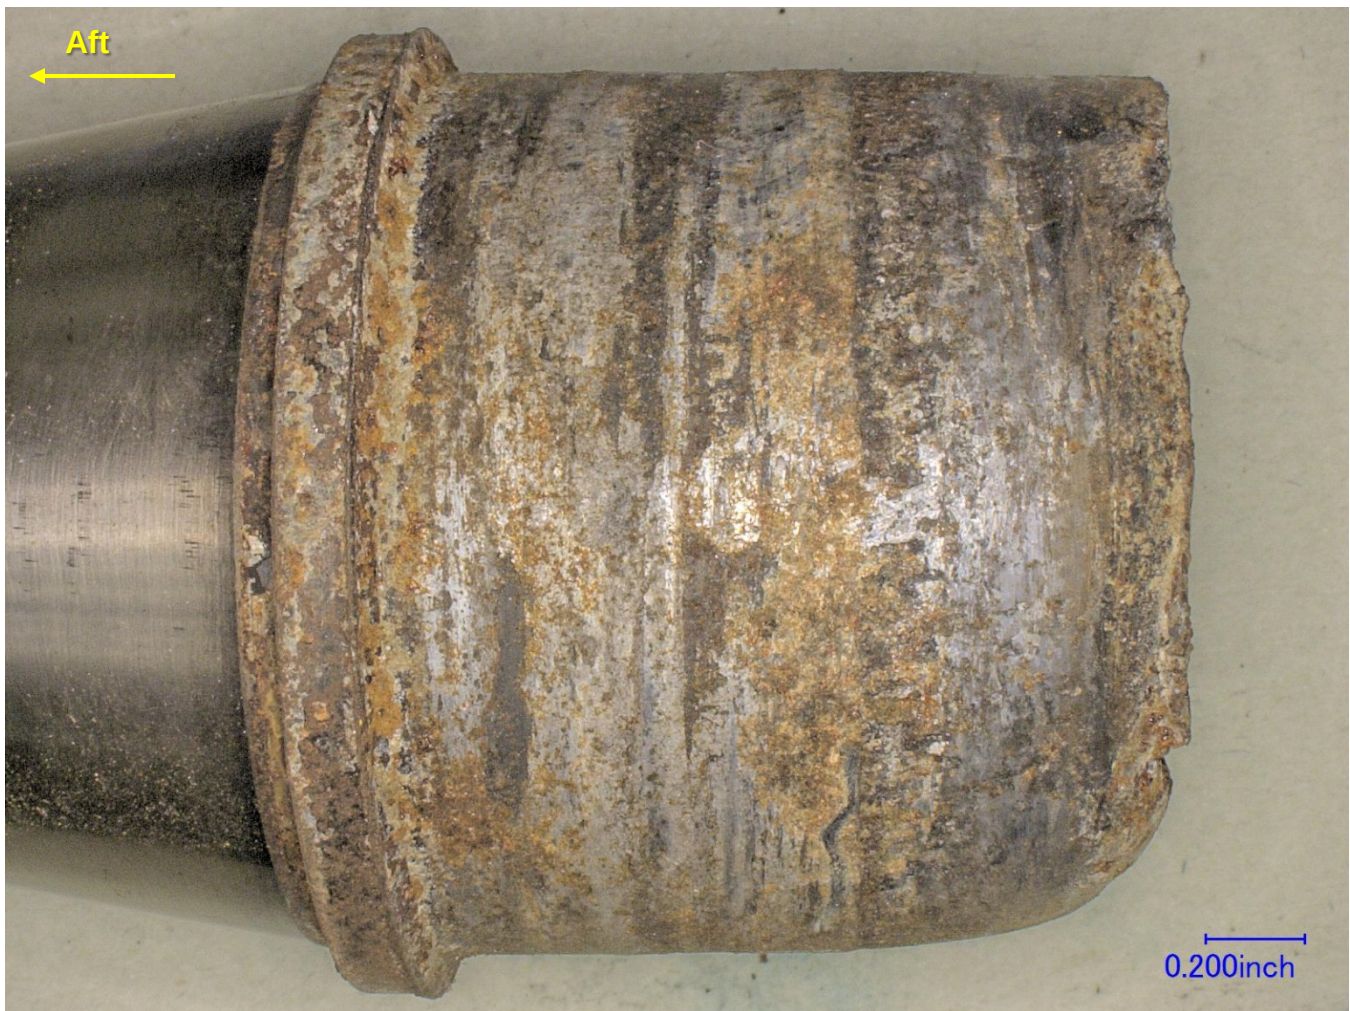
A closer view of the aft shaft fragment shows the location of the circumferential wear (Figure 26). Most of the shaft damage, concentrated towards the location of the fracture, was located where the forward bearing had been positioned. The forward bearing had exhibited the most damage.

Figure 26 – Closer view of the aft side of the shaft, showing circumferential wear marks and deformation at the fracture.

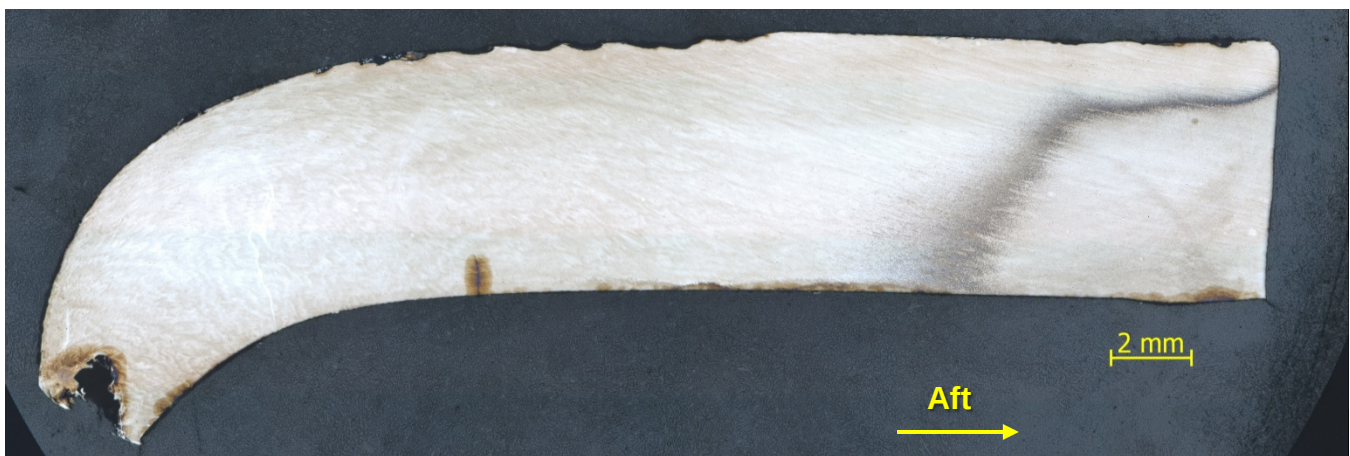
Figure 27 shows a montage optical metallograph of a cross section of the aft shaft through the fracture. Towards the fracture location, the material exhibited signs of deformation, necking, and inward bending. The outer surface exhibited missing material and “bumpiness,” consistent with gouging and material spallation. Figure 28 shows the microstructure of the aft shaft fragment adjacent the fracture surface. The microstructure exhibited plastic deformation at the surface and the presence of white-etching localized

shear bands below the surface. This pattern was consistent with severe plastic deformation and frictional heating from impact abrasion.<sup>6</sup>

Figure 27 – BF optical metallograph cross section of the fracture surface of the aft shaft section (reversed from Figure 26). The fracture was located on the left (~500X, etched 2% Nital).

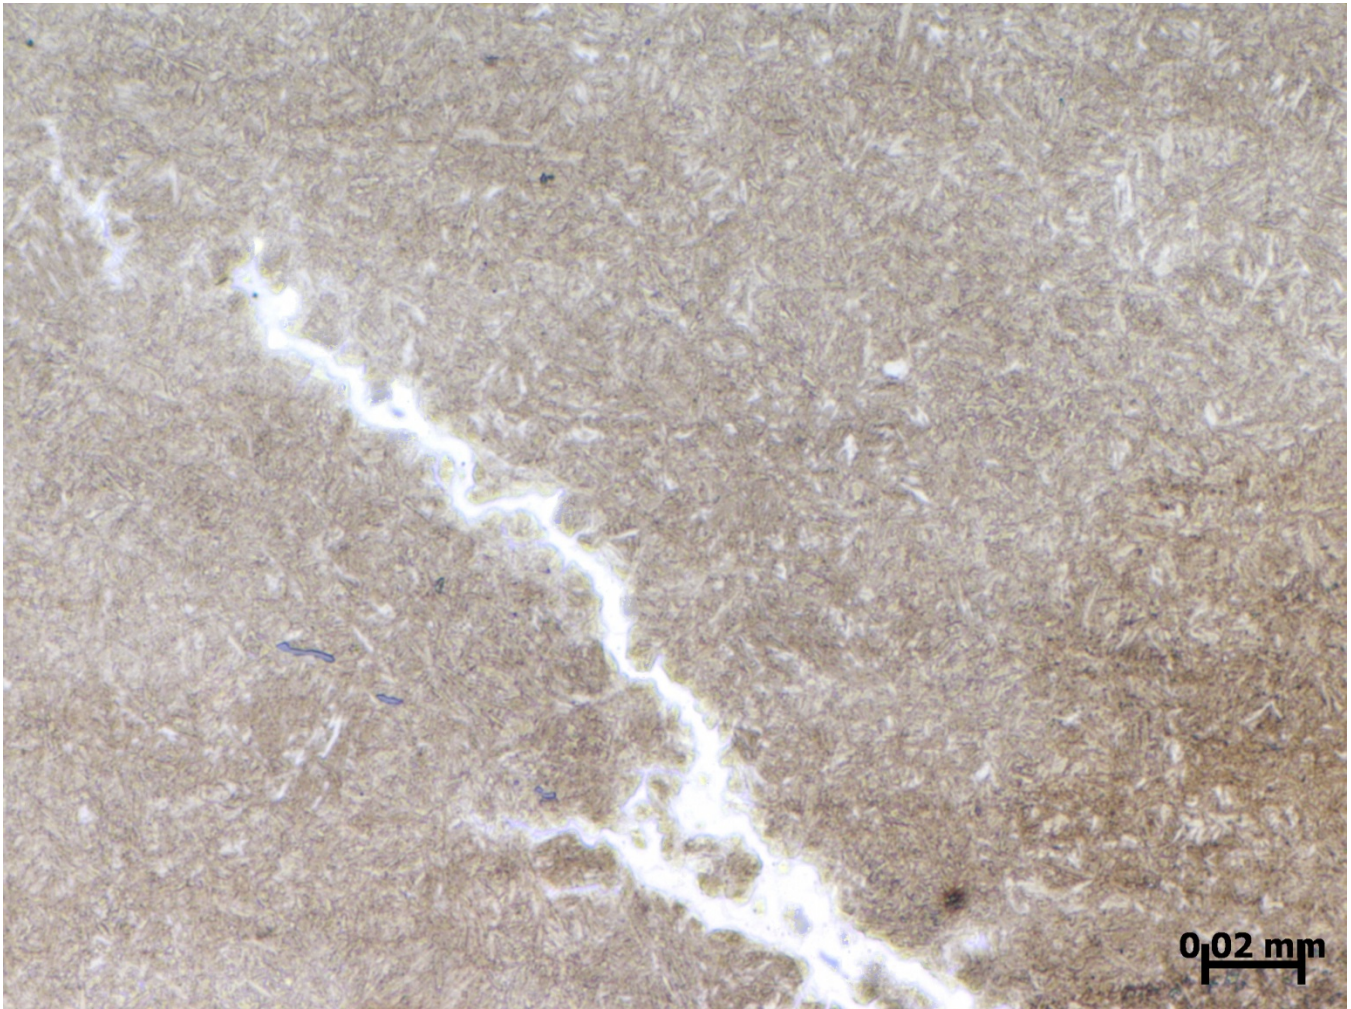
Figure 28 – BF optical metallograph showing a subsurface white layer near the fracture surface tip (~500X, etched 2% Nital).
