**ERA16LA217**

**Beechcraft P35 – N112MB**

**NTSB ENGINE EXAMINATION REPORT**

**February 6-7, 2017**

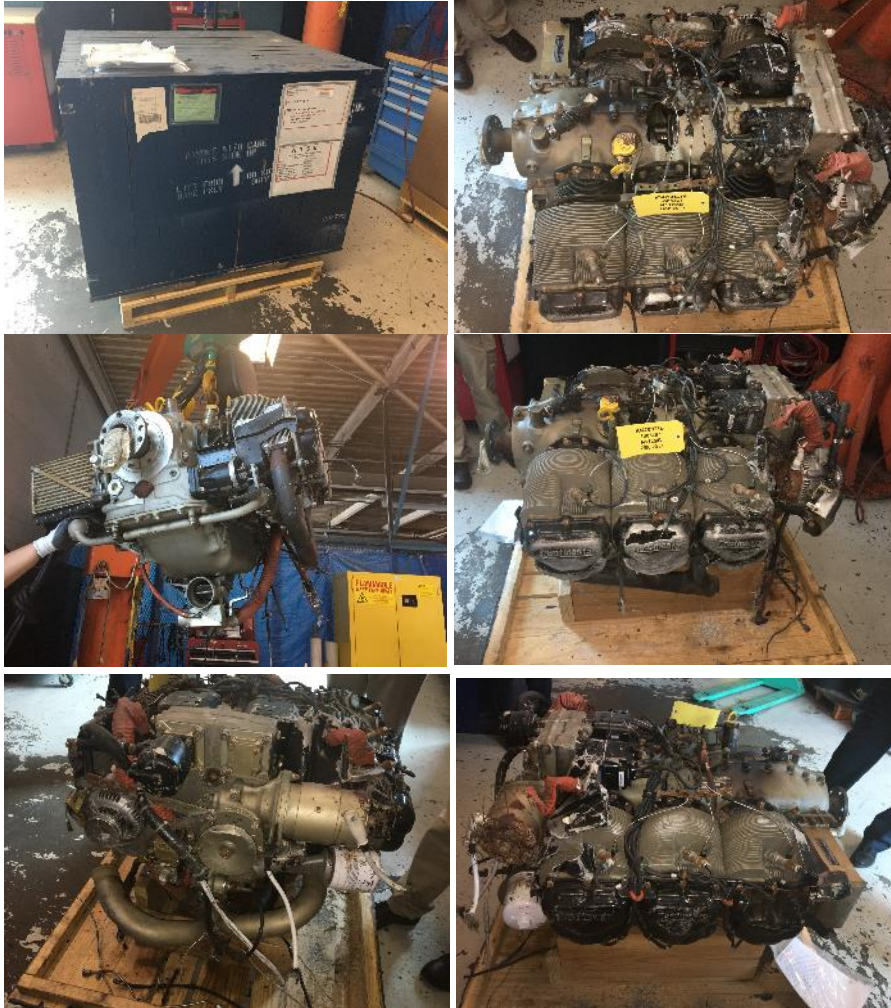
The engine was received crated and sealed. After removal of the crate, the engine was examined and the following discrepancies were noted:

- There was a hole in the top of the crankcase.
- The Nos. 2, 4, and rocker box covers had a hole in them.
- The engine exhibited corrosion.
- A gasket on the oil filter adapter was protruding and torn.

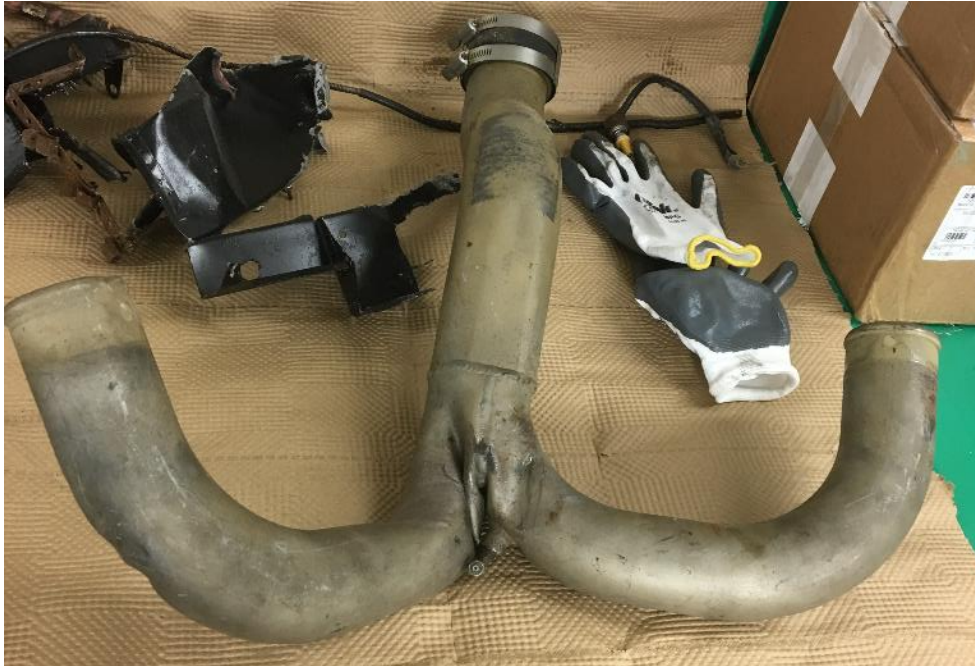
Picture 2. View of Induction System

The air induction tubes remained attached to the engine. The intake manifold assembly remained intact and was bent on the left side.

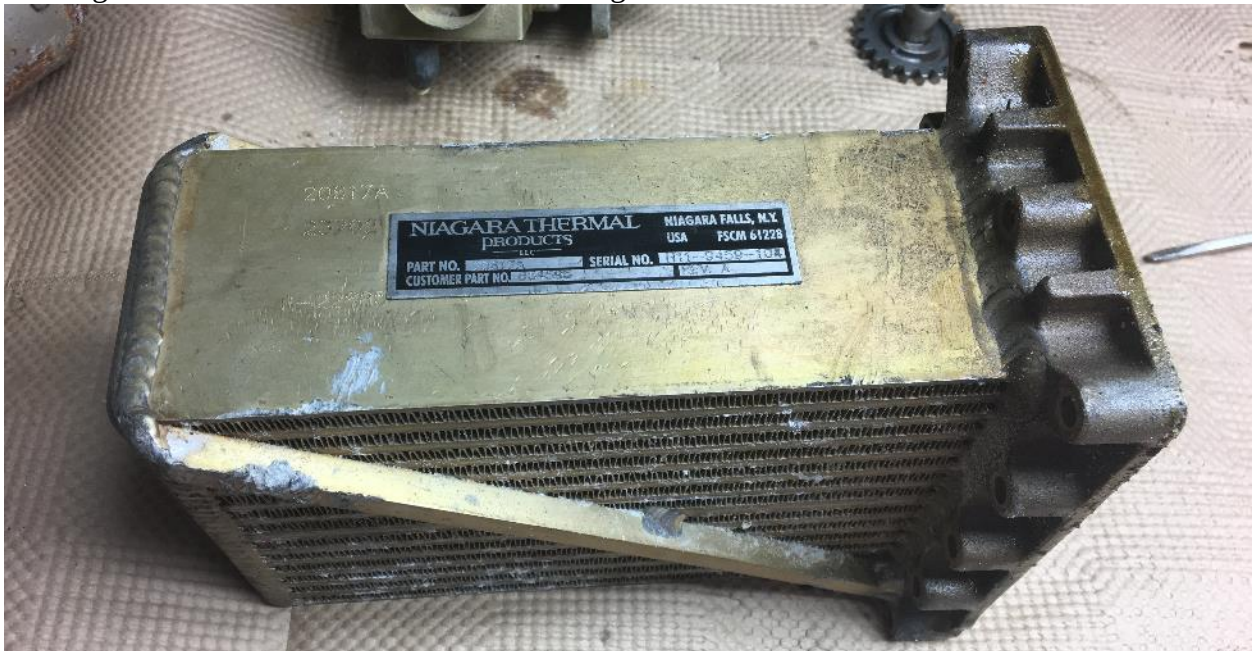
Picture 3. View of Oil Cooler

The engine oil cooler was removed from the engine and examined with no anomalies noted.

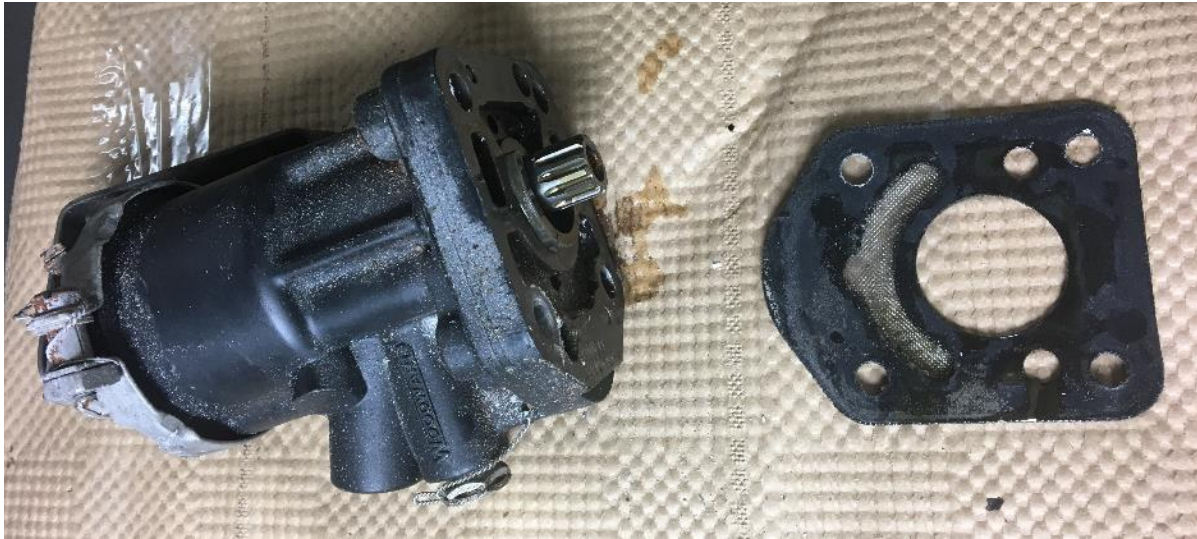
The propeller governor was removed from the engine and did not rotate. The oil screen on the governor was removed and corrosion was noted in the screen.

Picture 4. View of Propeller Governor with Oil Screen Removed.

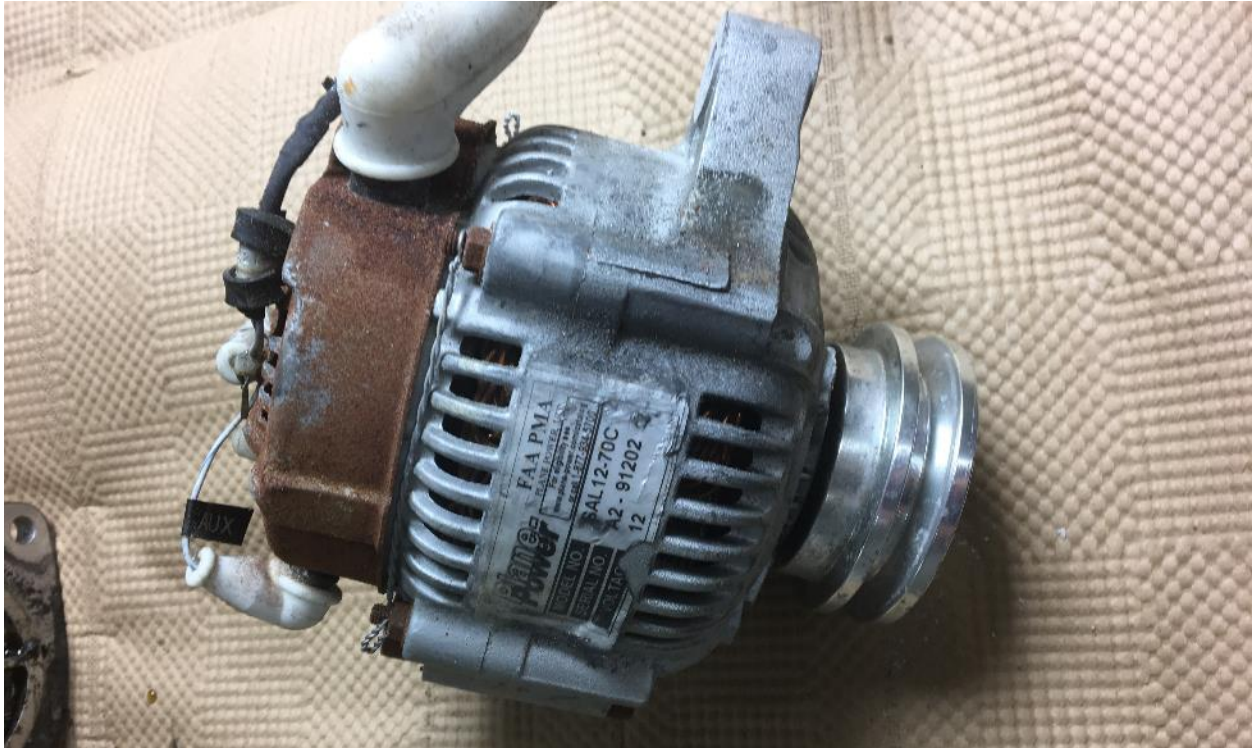
Picture 5. View of Alternator

The alternator was removed from the engine.

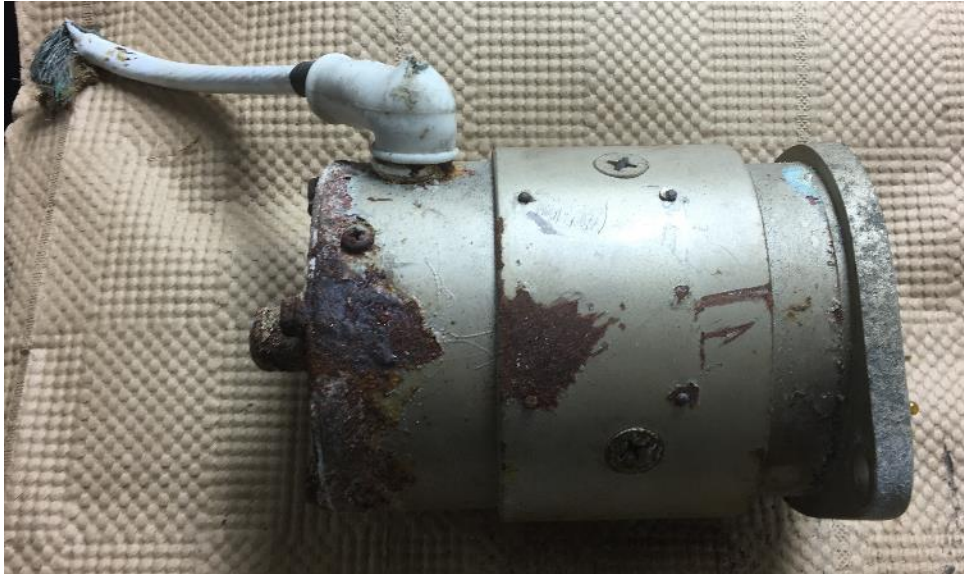
Picture 6. View of Starter

The starter was removed from the engine. The starter drive adaptor was removed and metal fragments were noted on the drive shaft.

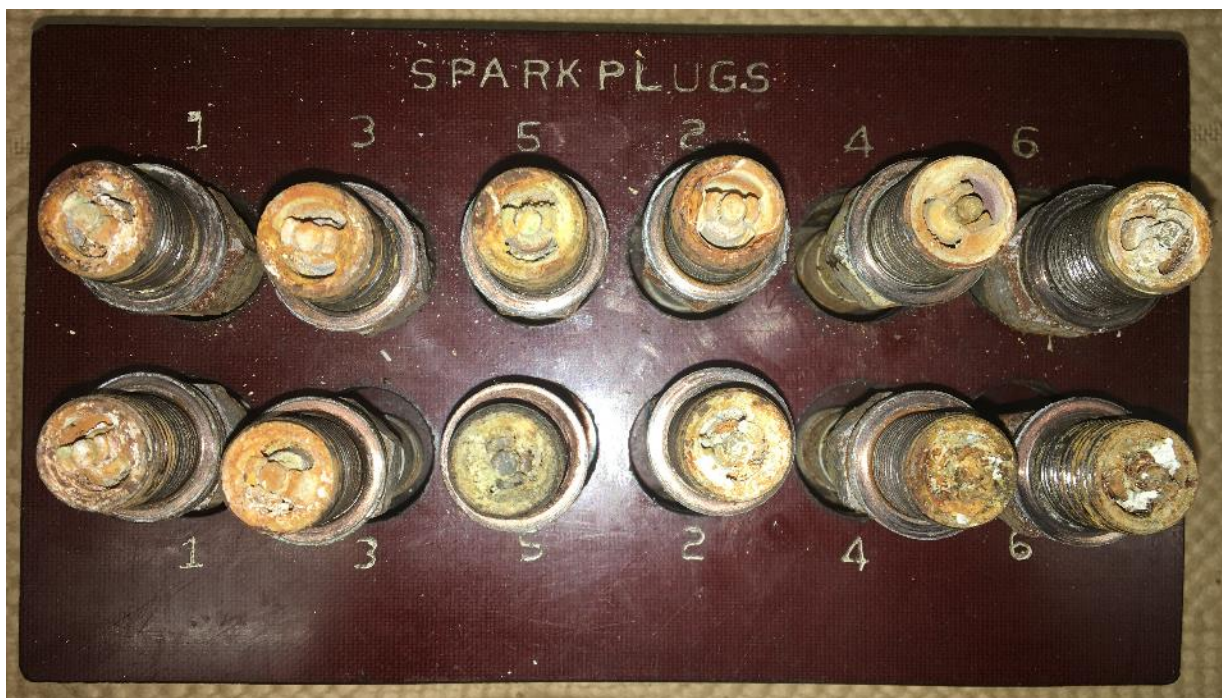
Picture 7. All Top and Bottom Spark Plugs

All spark plugs were removed from the engine. The spark plugs were massive electrode type plugs. All spark plugs exhibited corrosion, consistent with saltwater emersion.

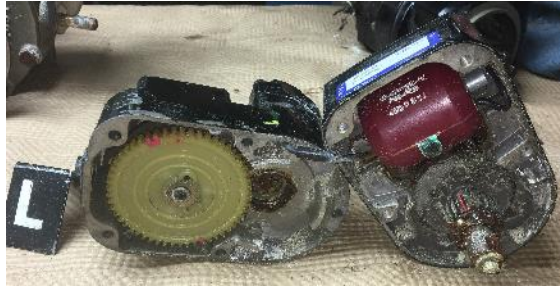
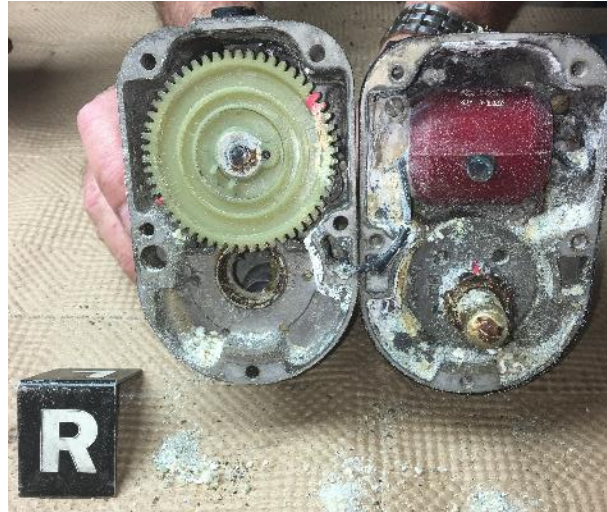
Picture 8. View of both disassembled magnetos

The magnetos remained attached to the engine and were removed. They did not rotate by hand. They were disassembled and corrosion was noted inside both magnetos, which was consistent with salt water emersion.

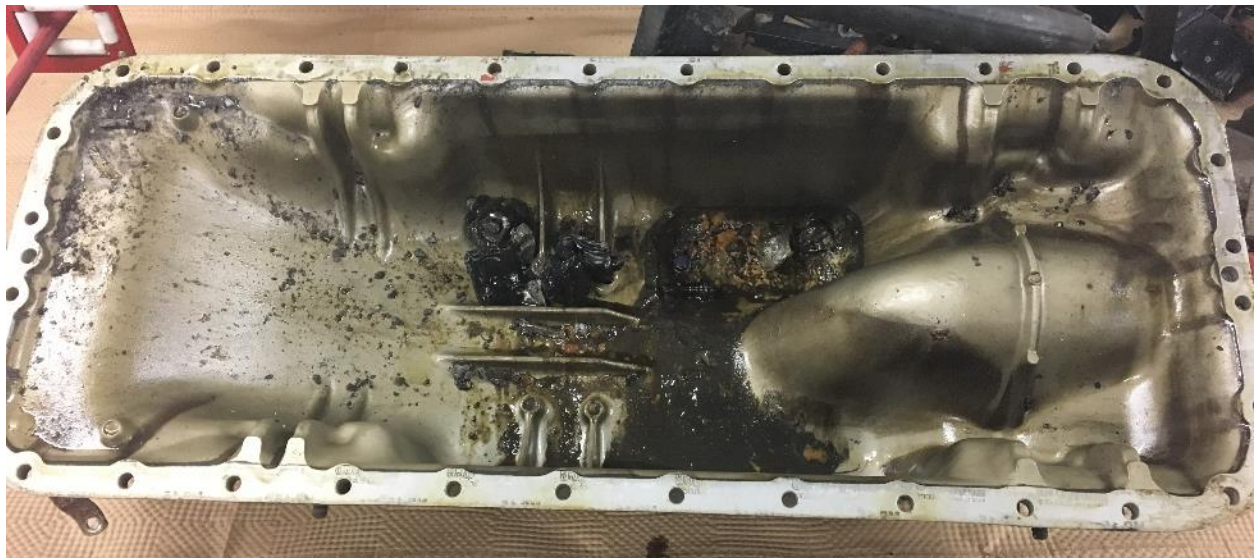
The engine oil sump was removed from the engine. Sections of the No. 4 connecting rod were located in the oil sump along with bearing material. In addition, an unmeasured amount of oil and metal particles were noted inside the oil sump.

Picture 9. View of Oil Sump and Metallic Particles

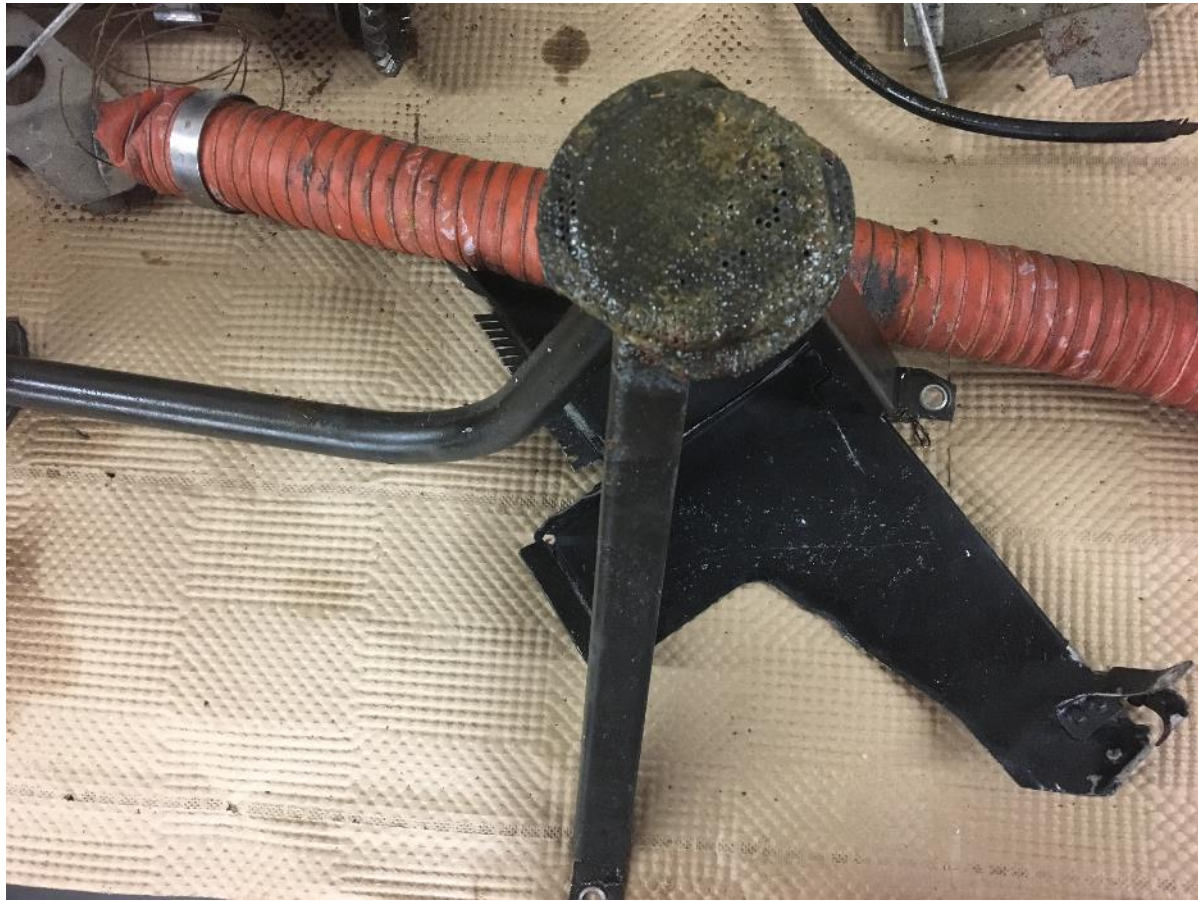
Picture 10. View of oil suction screen.

The oil suction screen was examined and debris consistent with salt water emersion was noted.

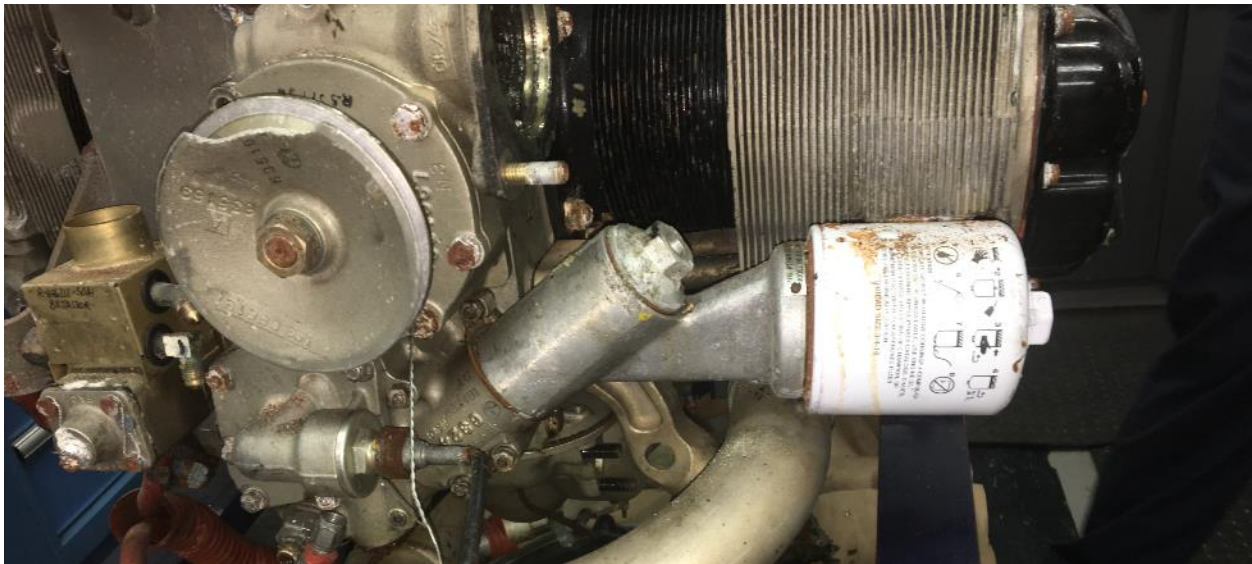
Picture 11. Oil filter installed on oil filter adaptor.

The oil filter remained attached to the engine through an oil filter adapter. When the oil filter was removed, the break away torque was 163 in lbs. The loosening torque was less than 160 in lbs. The torque wrench would not measure anything below 160 in lbs. Furthermore, the fiber gasket was torn and partially extruded from the adapter. The oil filter adapter was removed and the fiber gasket was removed. The fiber gasket was torn in one location and the crush deformation not symmetrical around the gasket. The oil filter was disassembled and metal particles were noted in the filter. The maintenance log indicated that the most recent oil change occurred about 10 hours prior to the accident.

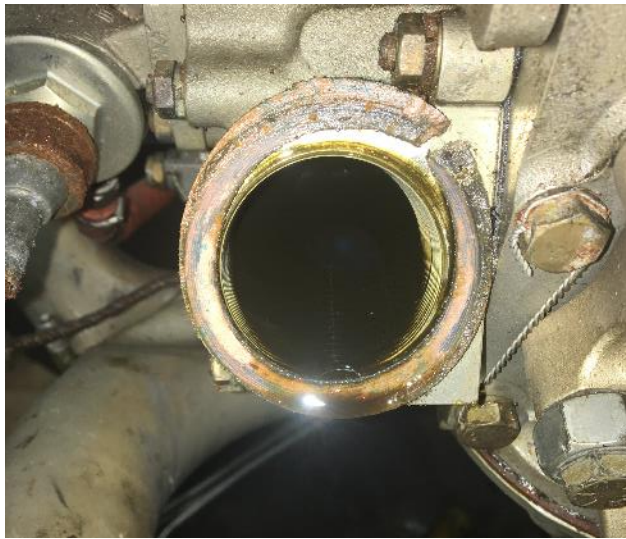
Picture 12. View of Torn Gasket as found on engine.

The examination revealed that the oil gasket was torn and extruded from the oil filter adaptor.

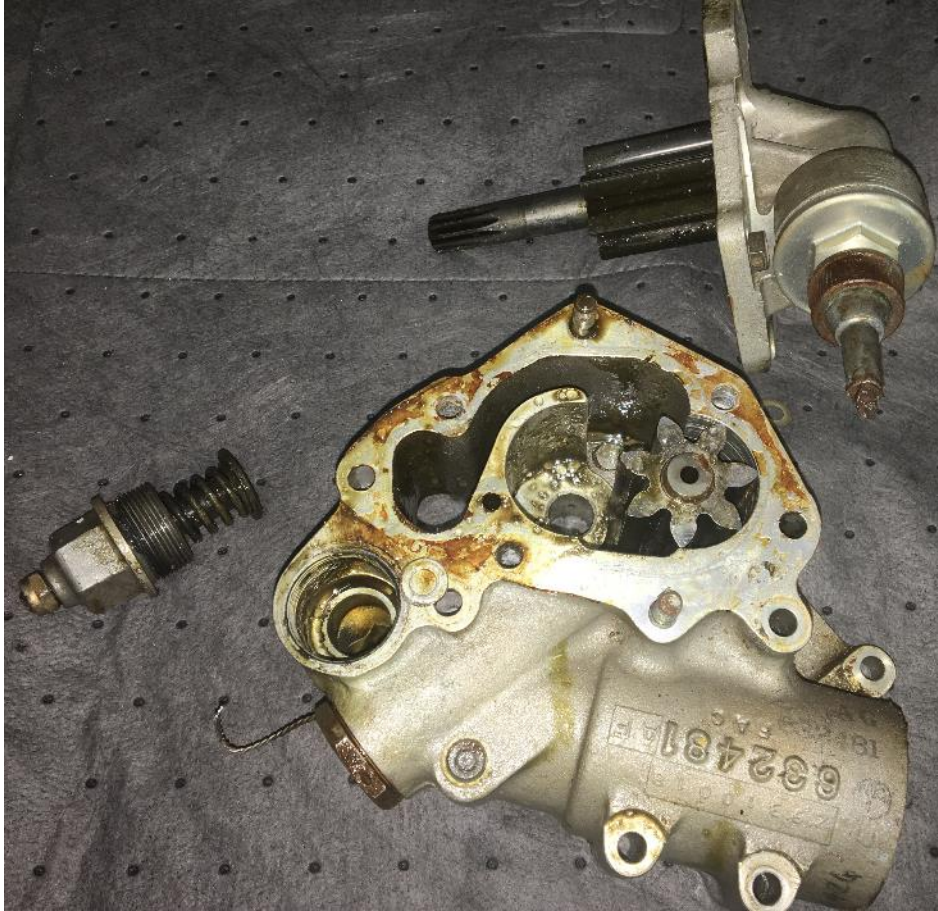
The oil pump was removed from the engine and it was disassembled. The pump rotated when turned by hand. The pump body had scoring consistent with hard particle passage through the pump.

Picture 15. View of oil pump with interior scoring.

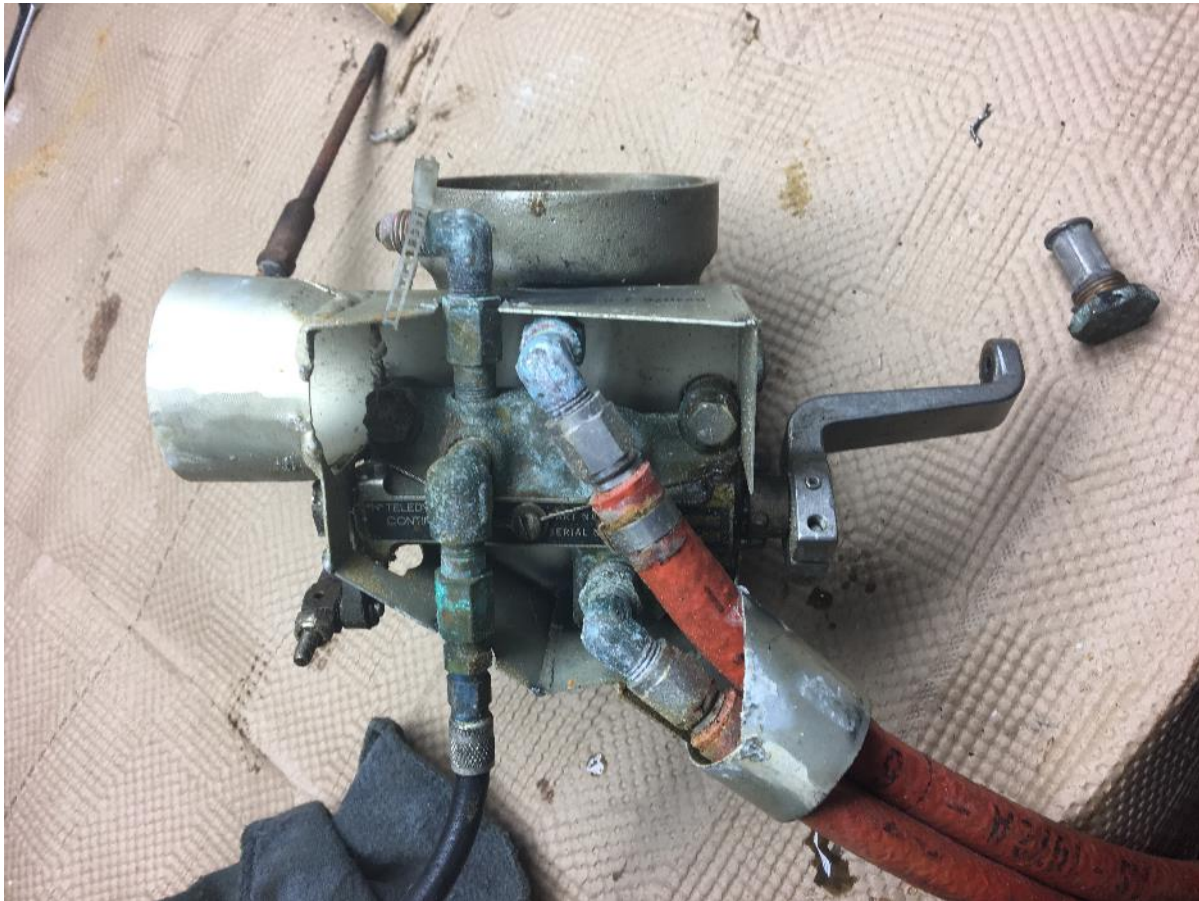
Picture 16. View of Throttle and Metering Assembly

The throttle and metering assembly was removed from the engine. The fuel screen was removed and no debris was noted.

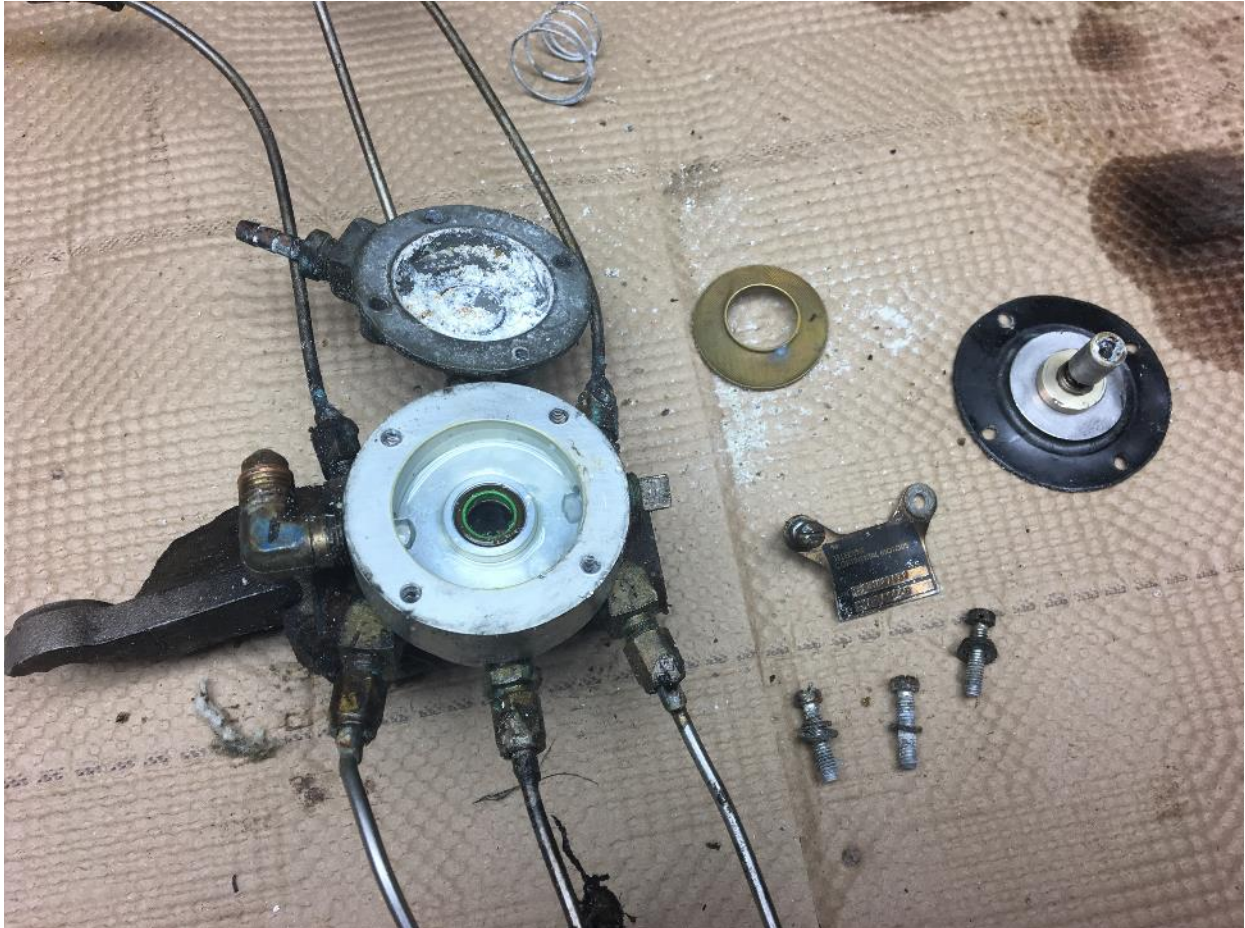
The fuel manifold valve was removed from the engine. It was disassembled and fuel was noted in the manifold and corrosion was noted, which was consistent with salt water emersion. In addition, the screen was free of debris.

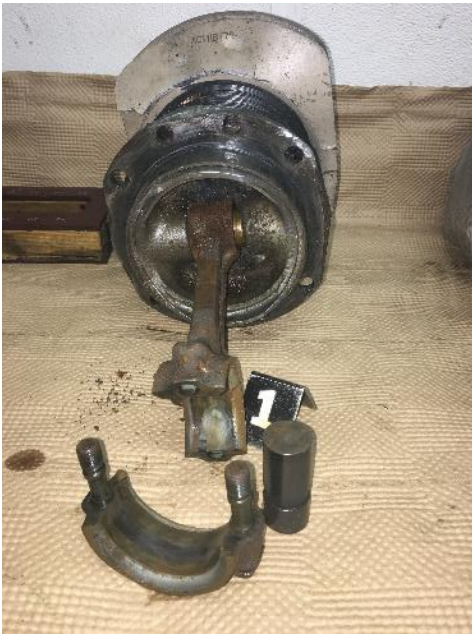
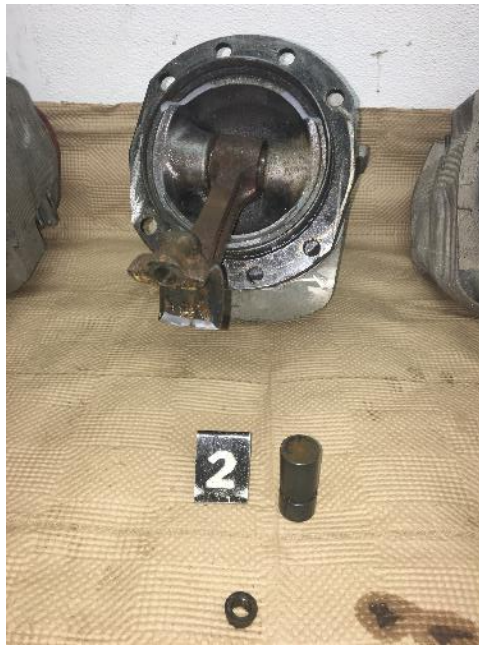
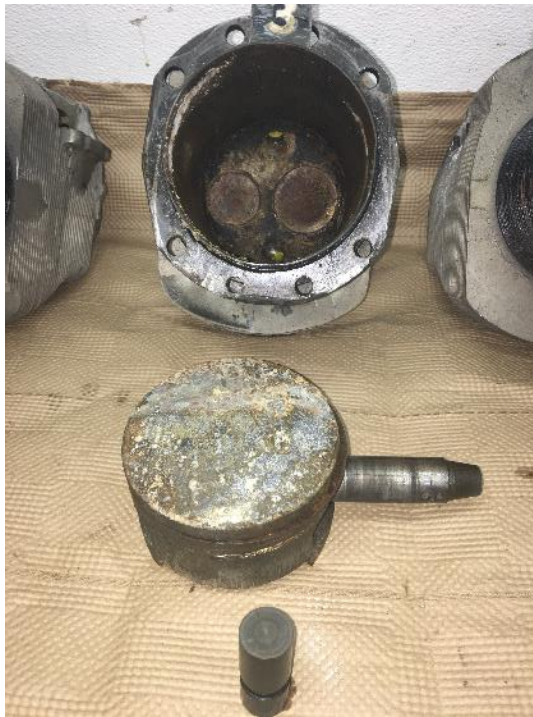
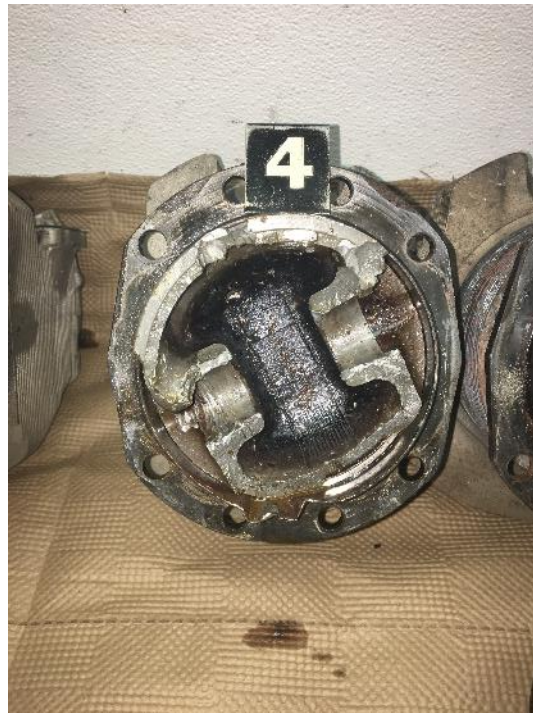
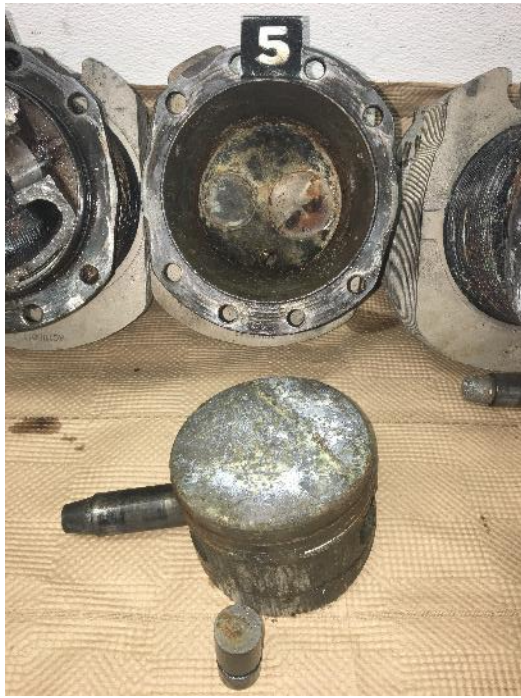
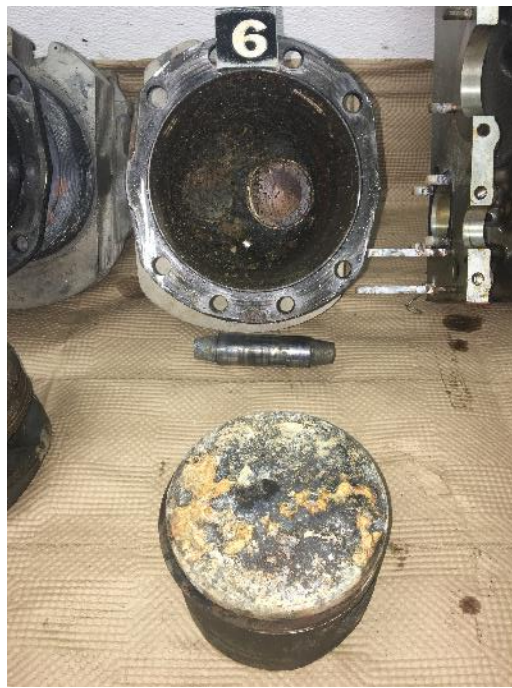
The rocker box covers were removed to examine the valve train system. Cylinders remained attached to the engine and were removed to facilitate examination. The cylinders and valves remained intact. The No.4 piston exhibited impact damage.

The Nos. 1, 2, and 4 pistons were lodged in the cylinders and unable to be removed.

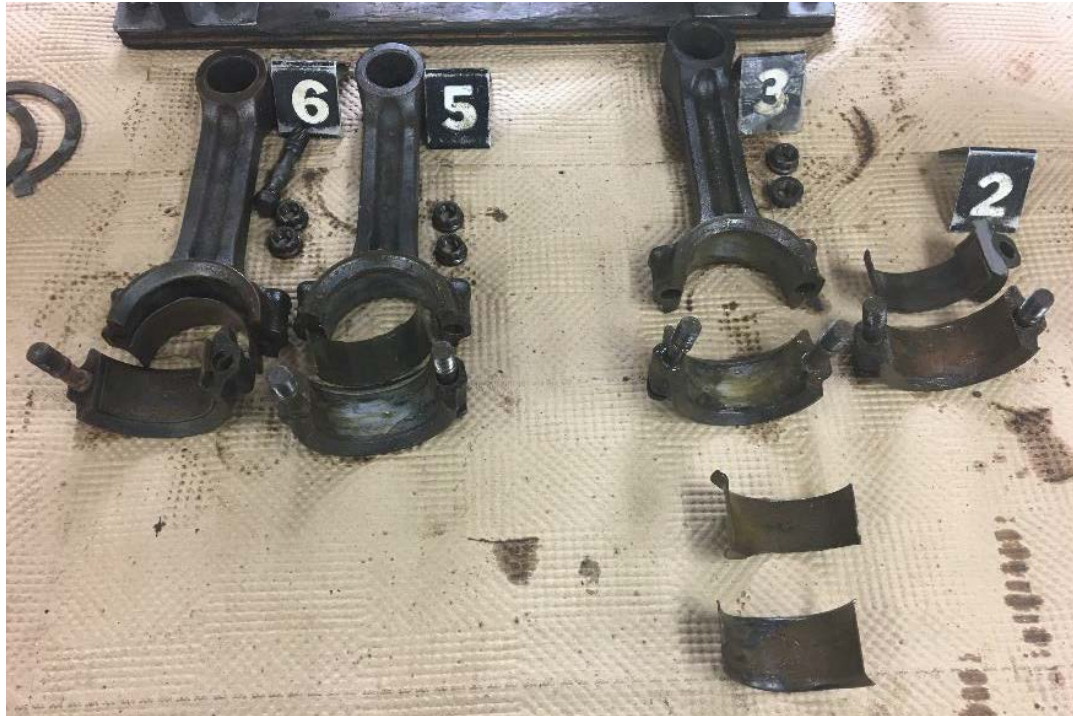
Picture 17. View of Connecting Rods

The connecting rods were removed from the crankshaft and examined with no anomalies noted on the Nos. 1, 3, 5, and 6. The Nos. 2 and 4 connecting rods were fractured from the crankshaft. The Nos. 1 and 2 connecting rods remained attached to the pistons. Parts of the No. 4 connecting rod were located throughout the engine, however not all parts were located.

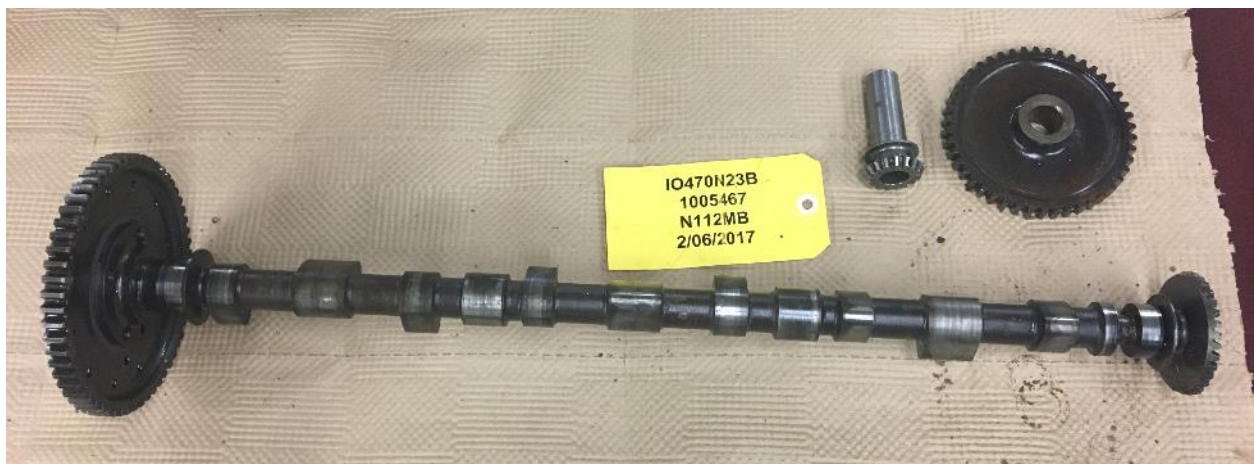
Picture 18. View of Camshaft.

The camshaft remained intact and was removed from the engine. No anomalies were noted on the camshaft.

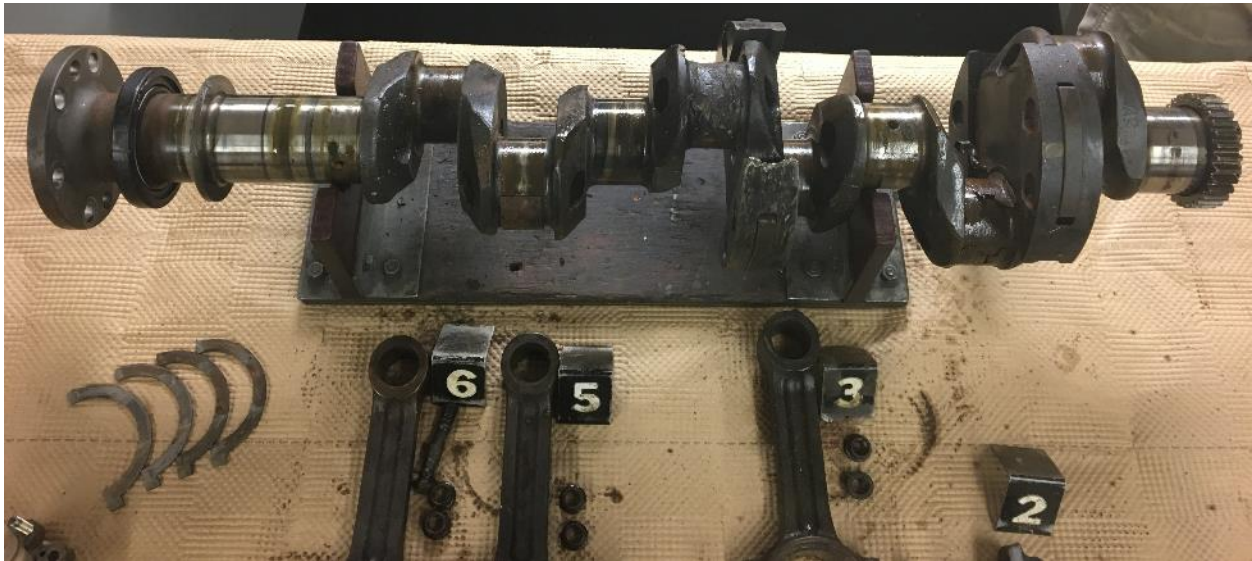
Picture 19. View of Crankshaft.

The propeller mounting flange remained intact and the mounting holes were not elongated (propeller had remained attached but removed for engine shipment). The four counterweights remained attached to the crankshaft and moved freely by hand. All of the connecting rod journals exhibited thermal damage and lubrication distress.

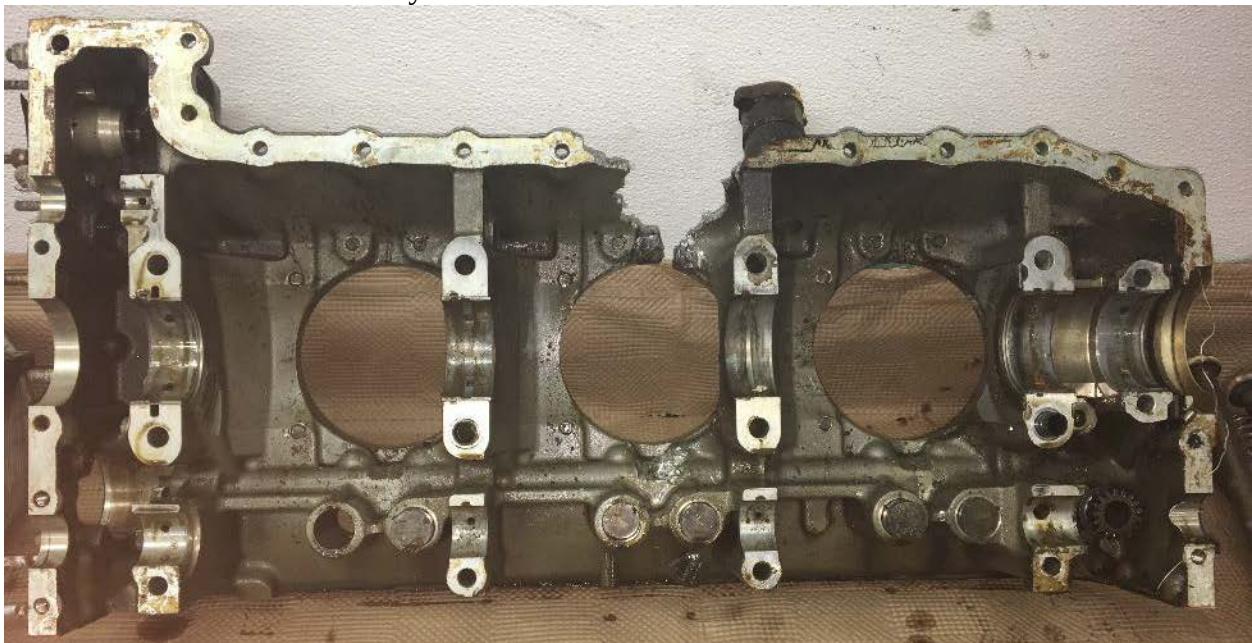
Picture 20. Nos. 2, 4, 6 Side of Crankcase

The engine case halves were separated to examine the internal components. The oil passages were free of debris. The No. 3 main bearing exhibited lubrication distress, but there was no bearing shift or bearing fretting noted on any of the bearings. Damage was noted on the inside of the case near the Nos. 3 and 4 cylinders.
