**Factual Report – Attachment 1**

**Illustrations**

**AIR TRAFFIC CONTROL**

ERA16LA225

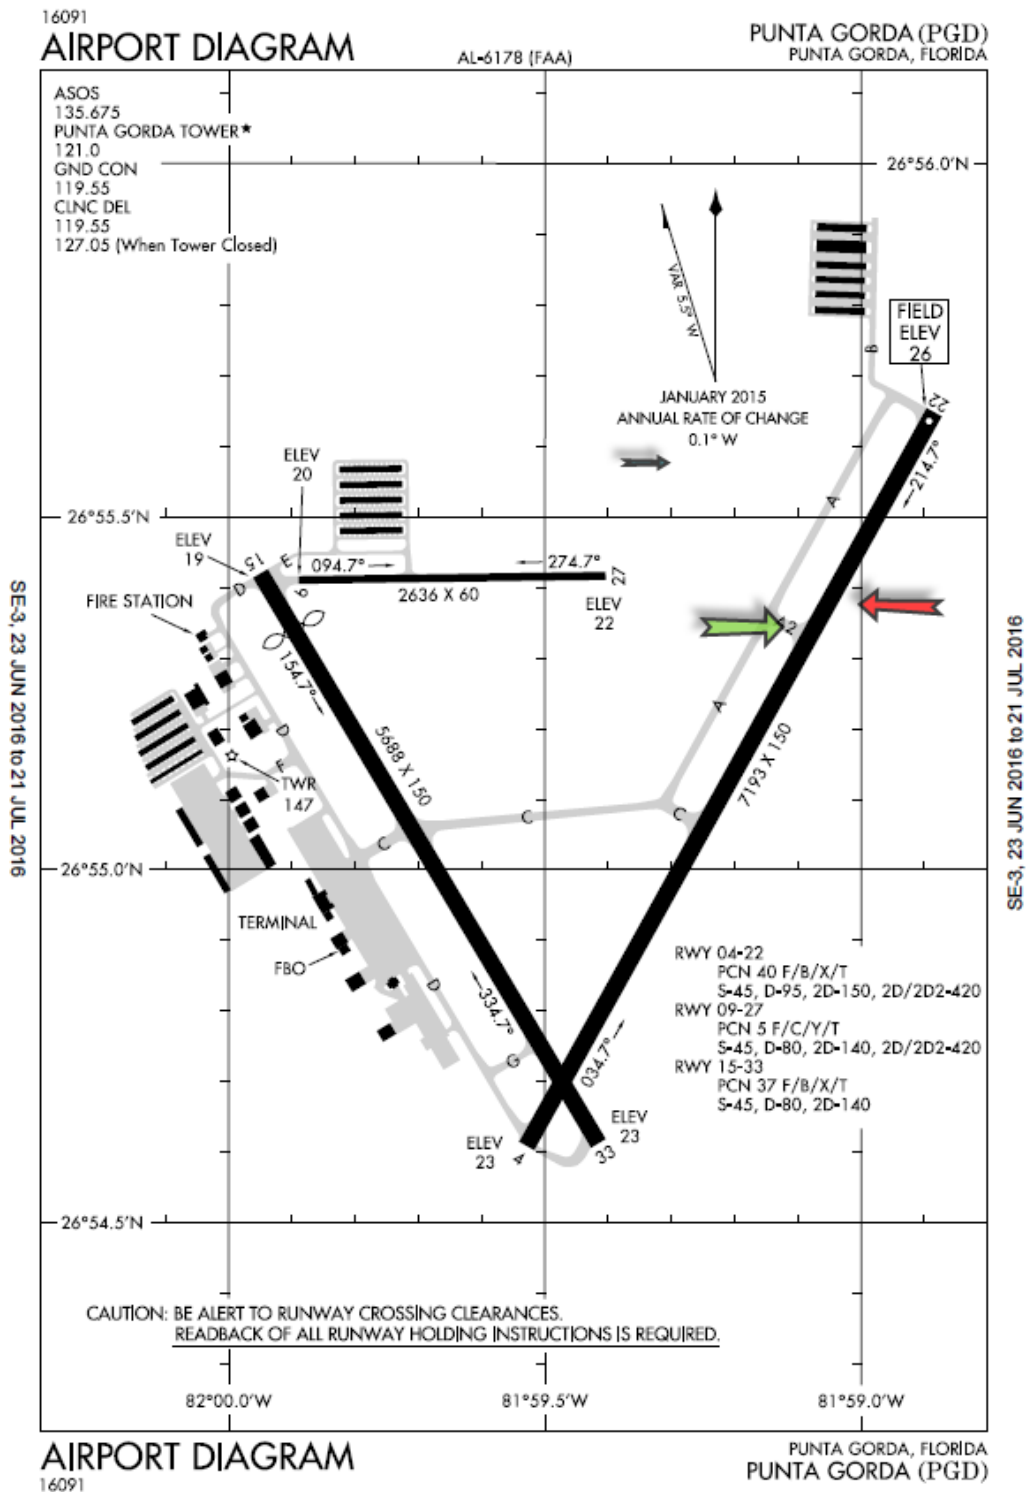
Figure 1 – Punta Gorda Airport Diagram with a green arrow representing the approximate location of AAY Maintenance 869 and the red arrow representing the approximate location that N8161X departed runway 22.

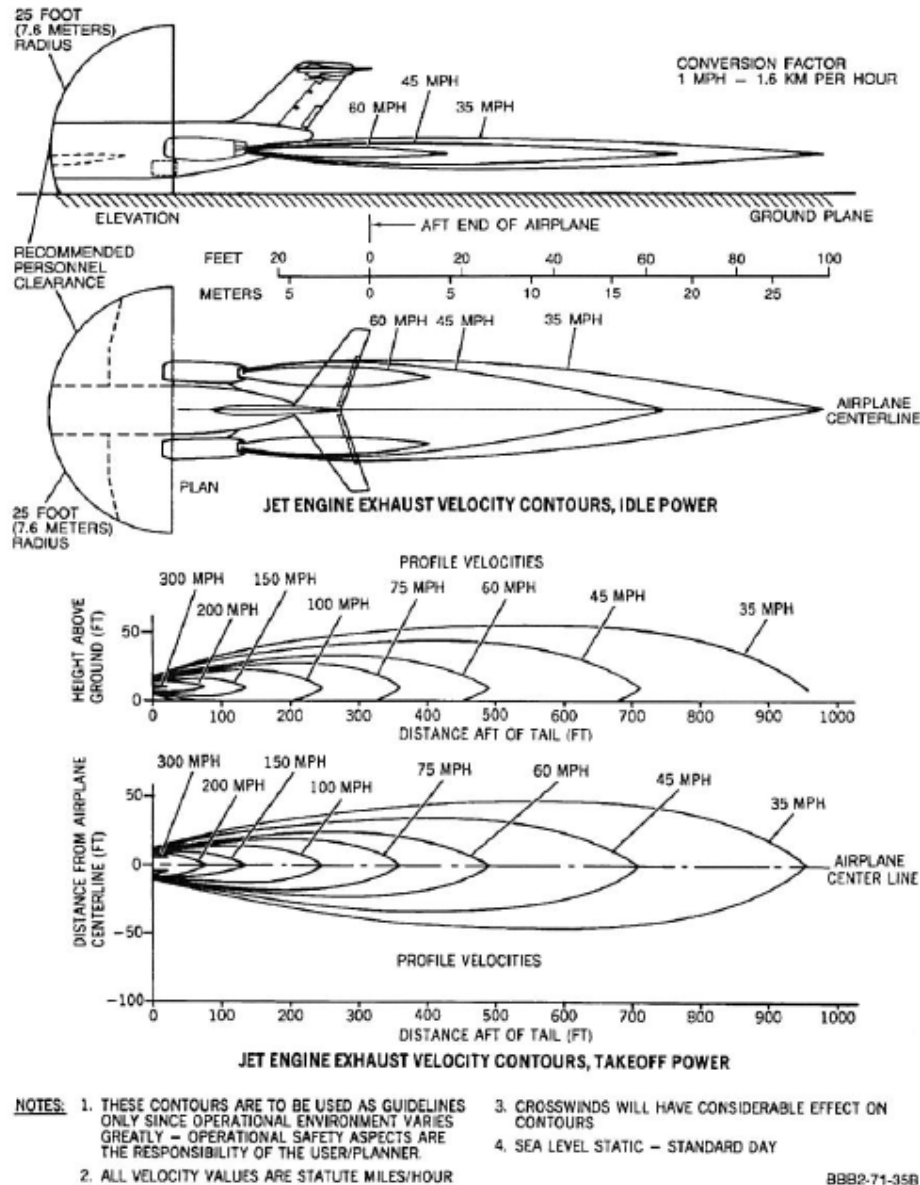
Figure 501. Engine Restricted Areas -- JT8D-209 Engine  
Sheet 1 of 1  
WJE 415-427, 429, 861-866, 868, 869, 871, 872, 891

Figure 4 – MD80 Series Aircraft Jet Exhaust Velocity Contours

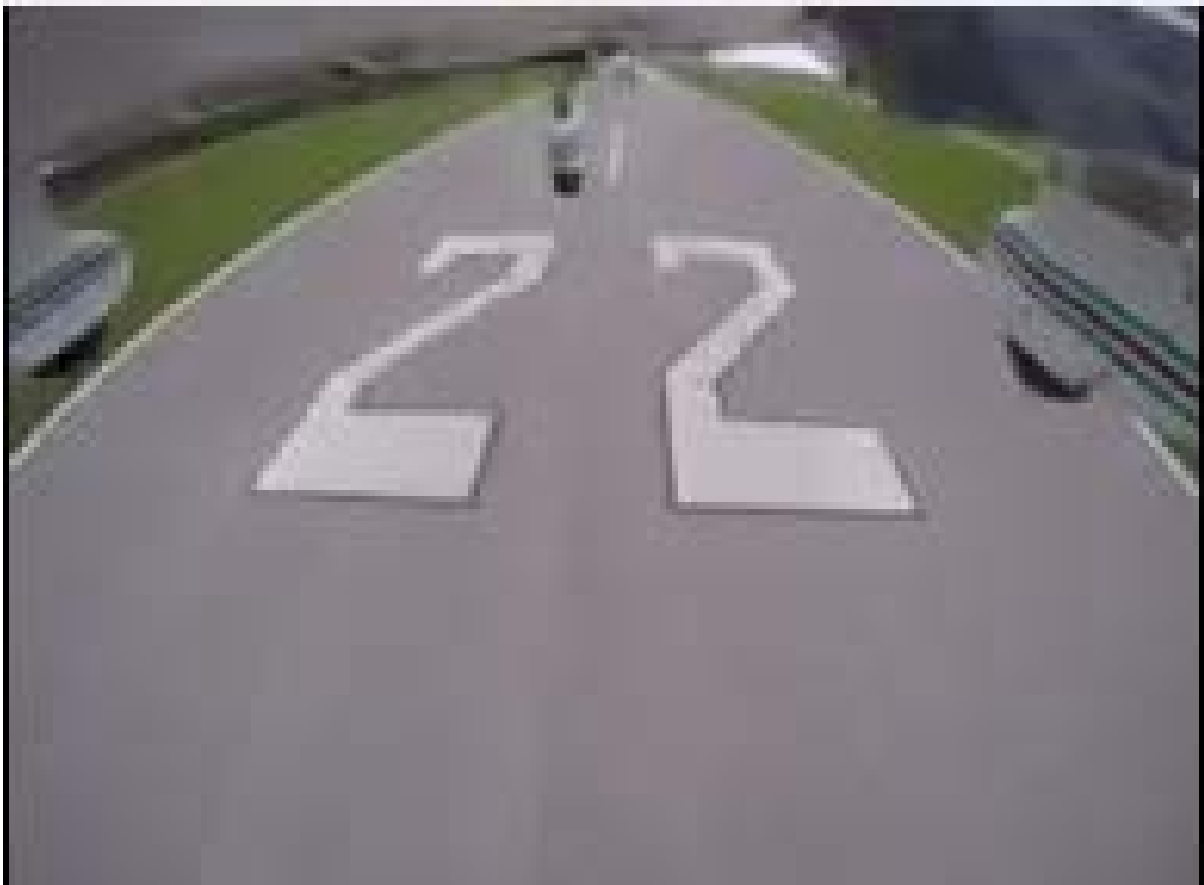
Figure 5 – N8161X belly mounted camera capture over the approach end of runway 22 at PGD on June 17, 2016

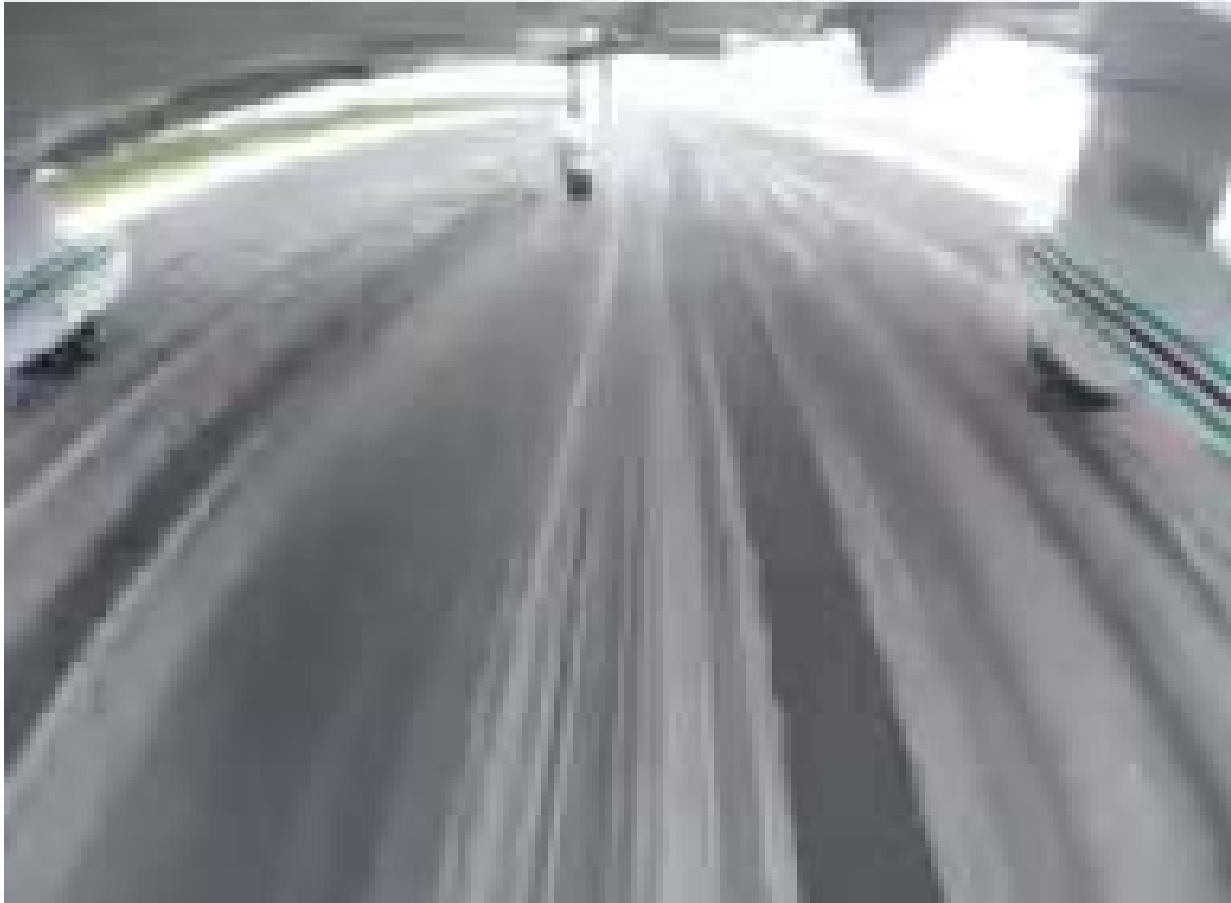
Figure 6- N8161X on landing rollout runway 22 at PGD

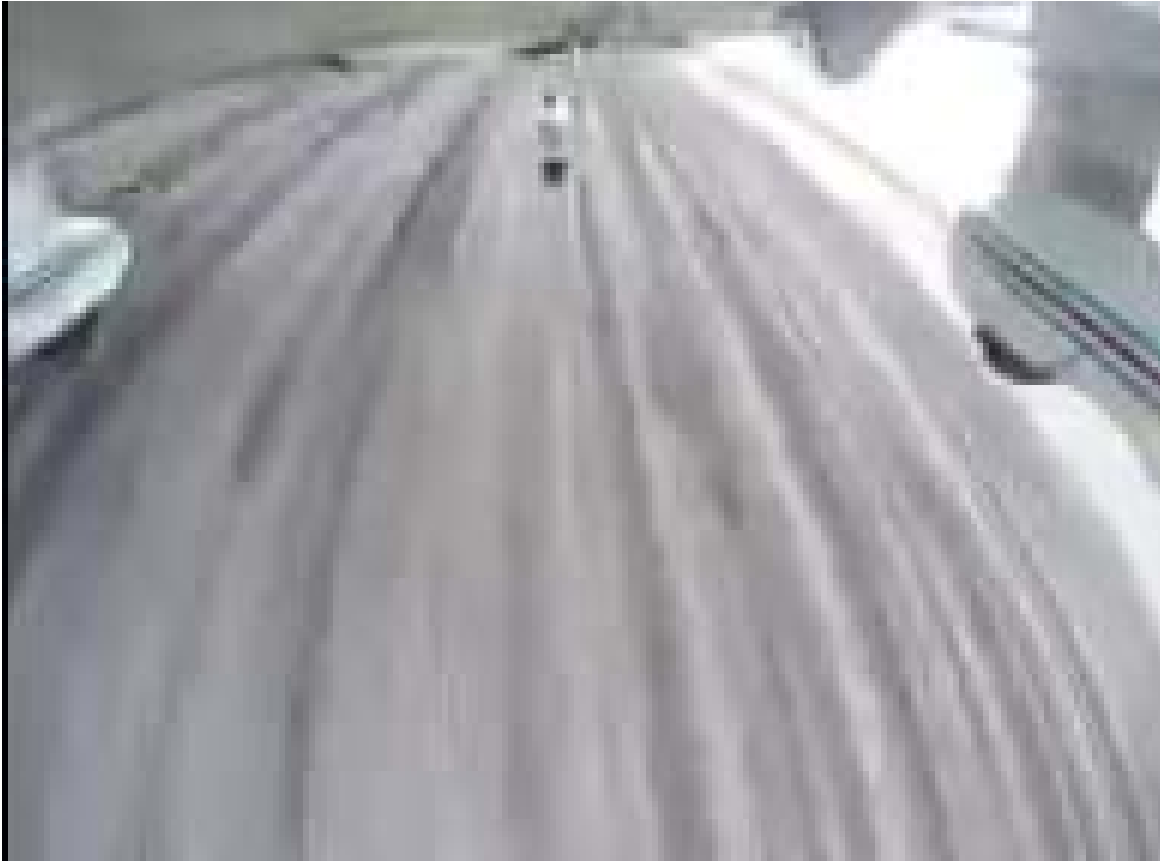
Figure 7 – N8161X right wing lifting and right main landing gear off the runway just prior to the runway excursion.

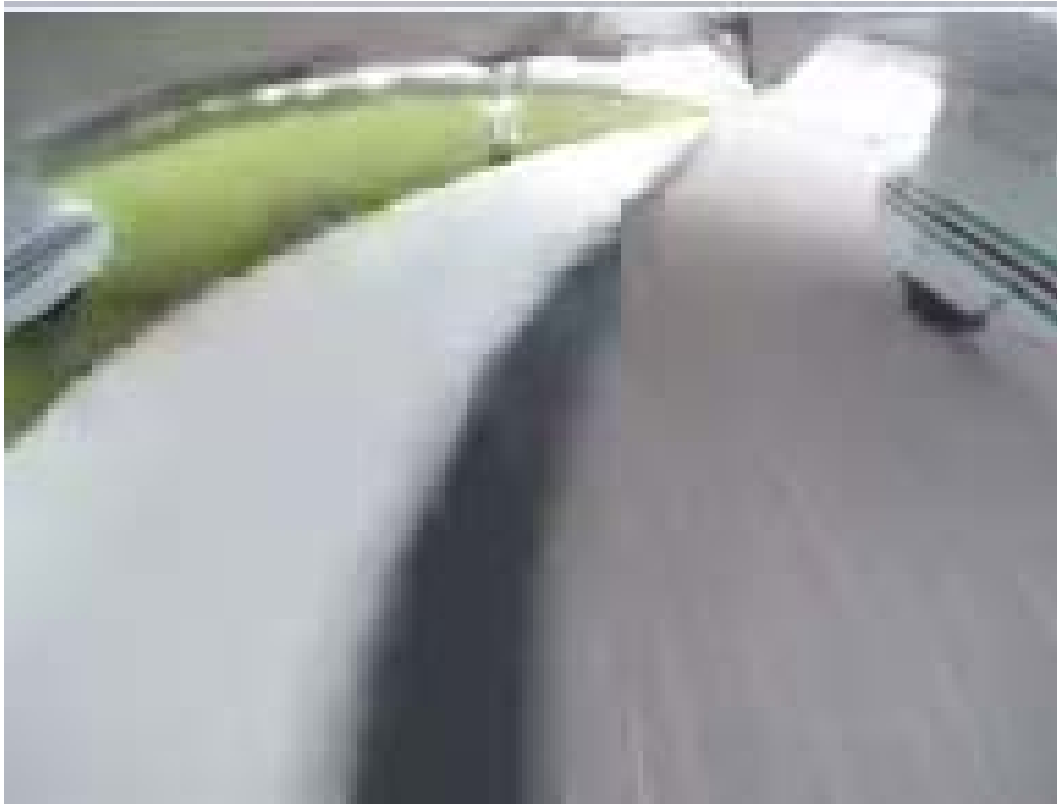
Figure 8 - N8161X departing the left side of runway 22 at PGD.
