## April 4, 2017 Evaluation of NTSB Fuel Pump

Re: Evaluation of FUEL Pump sent by NTSB, with help of the manufacturer, Aero Accessories, Inc. at their facility on April 4, 2017.

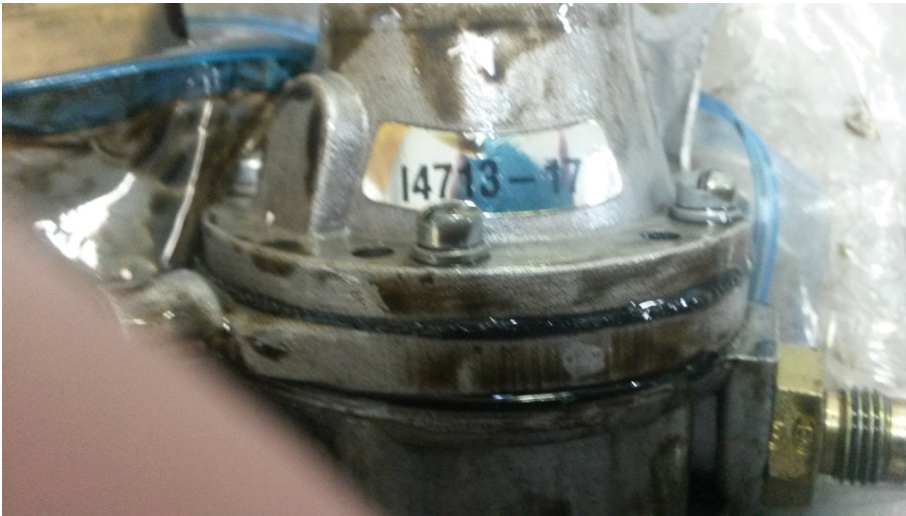
1. The Shipping box was opened and the fuel pump carefully removed once at the manufacturer's facility..

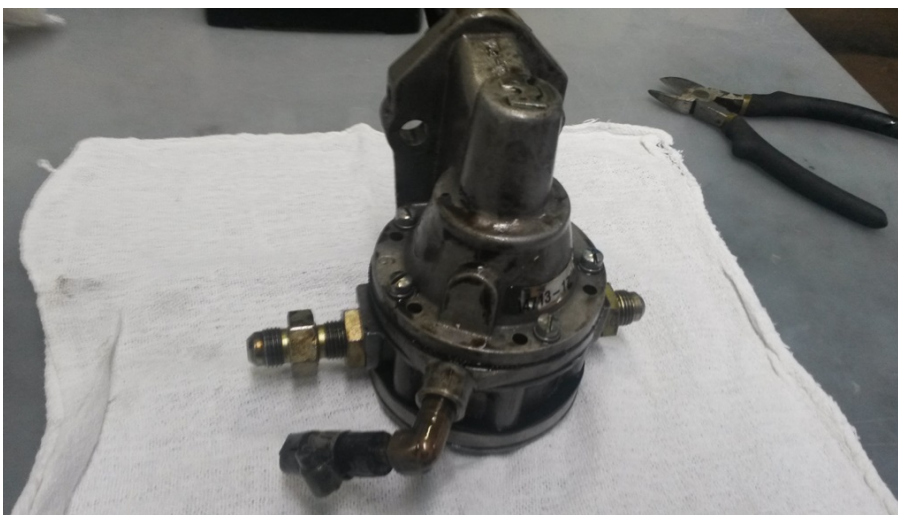
2. . After initial visual assessment, the majority of oil was carefully removed for closer inspection and formal evaluation.

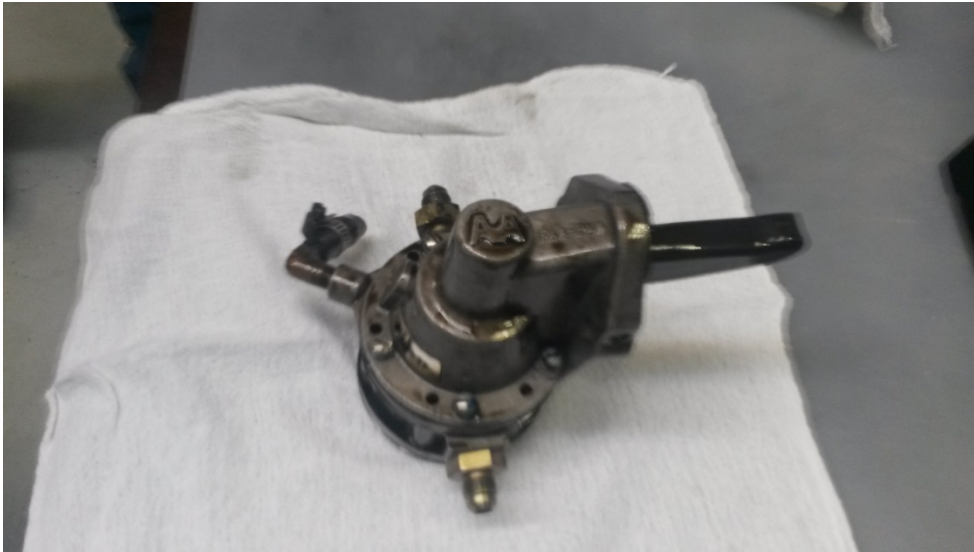
3. Once primary external cleaning and visual inspection was performed, inspection of the external fittings was made, then fittings carefully removed to be fitted for the test flow bench operational checks.

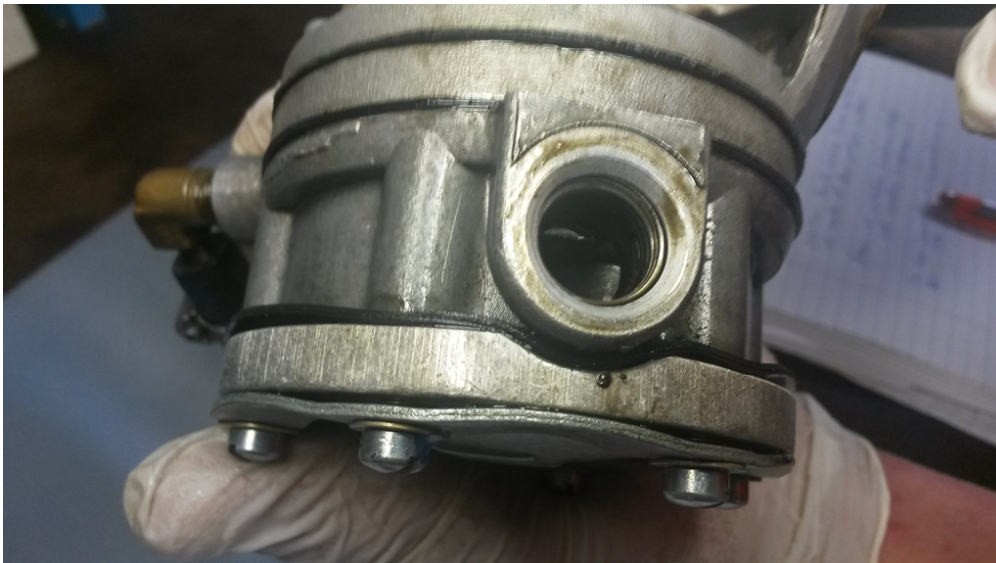
4. The internal threaded areas where fittings were removed were inspected for any contaminants or damage. Some physical damage appeared to exist at lower cover of pump.

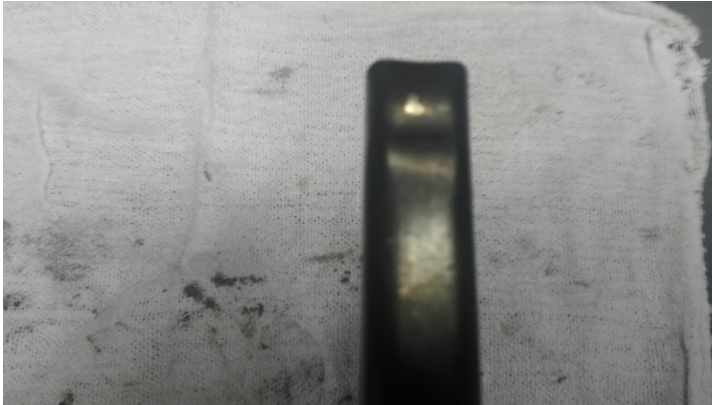
5. Prior to installing the pump on the test bench a visual check was made of the actuator arm, at the point of contact where the pushrod in the engine accessory case area transfers mechanical action to the pump. The contact point indicates whether the

alignment is proper or if mechanical issues may exist in this area. In the photo below it appears to have been making proper contact within acceptable tolerances to transfer the mechanical loads to the fuel pump for proper operation.

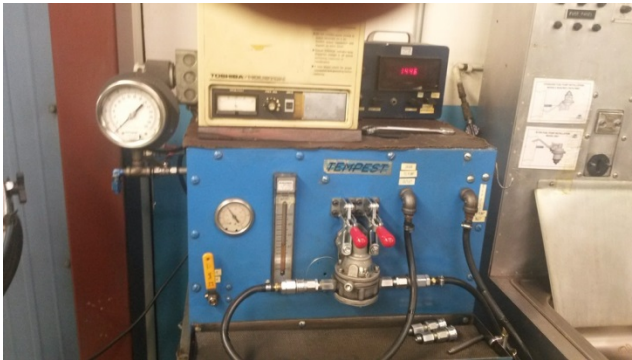
6. The attempt to operate it on the flow bench testing equipment; resulted in zero pressure and zero flow, indicating there was a mechanical type failure internally in the pump mechanism.

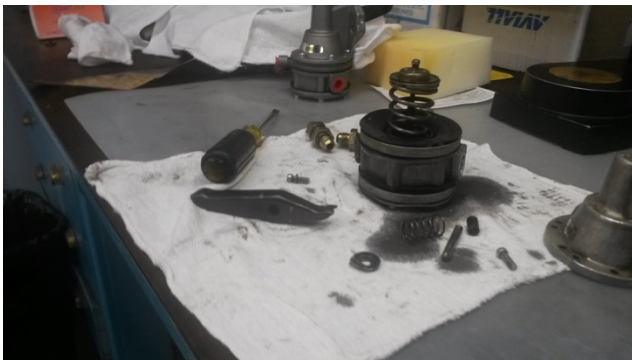
7. At this point I contacted Heidi by phone at the NTSB to ask if it were ok to disassemble the pump for further internal evaluation. Once permission was granted, the pump was disassembled for further detailed inspection.

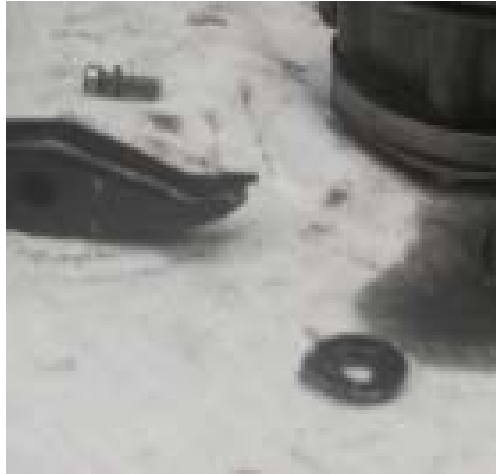
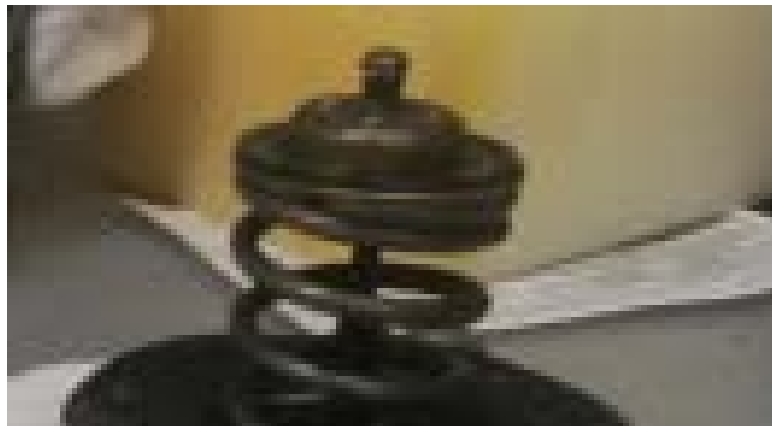
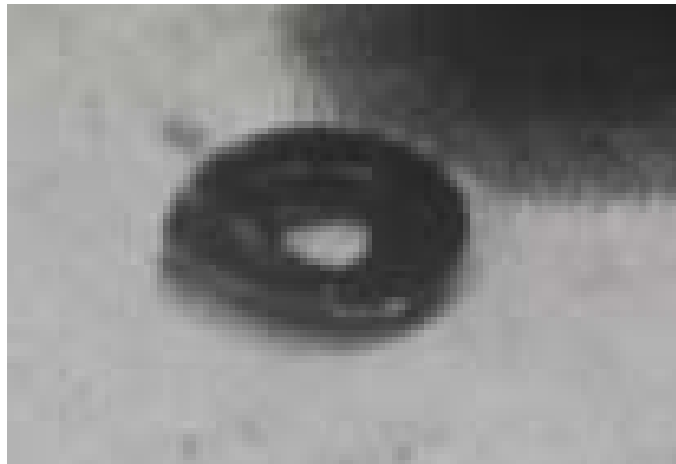
8. By zooming in on the actuator arm and parts which connect the arm to the diaphragm pump actuator rod assembly; anomalies were identified as having failed to perform their proper pump functions.

9. The stamped ring is intended to be attached to the top of the diaphragm actuator rod of the fuel pump along with a washer and a fiber type spacer or washer. In this instance the stamped ring indicated physical damage of unknown origin and as a result of physical damage, the washer and fiber elements in this stackup were separated and the mechanical actuator linkages from the engine accessory section were unable to physically activate the pump.
10. Closer inspection of the stamped ring under a microscope did not reveal a specific source of the physical deformation or failure. As a result of this deformation where the actuator meets the diaphragm lift stem; the pump was unable to actuate the diaphragm elements: This resulted in the failure to produce flow, pressure or volume as designed.

While I could not determine the cause in the sequence which led to the part damage; the damage was to the stamped "lift cup" which rides on the lift stem and is supposed to be joined with a steel washer and a fabric washer with this group held in place on the stem by a controlled deformation of the stem by heat and pressure.

From my experience, this is very unusual.

As the steel washer and the fabric washer were missing, and no fragments noted in the pump; do you know if the crankcase was carefully cleaned? Could these be found in the crankcase? May provide better clues.

With the inability to locate any similar failures, no systemic problems were found. I am thinking about a possible Safety Recommendation which could produce an SAIB, but am reviewing the processes which would be required to detect, and identify if such an anomaly were present; from which to write a viable inspection process. If you have ideas on this concept, let me know.
