# NATIONAL TRANSPORTATION SAFETY BOARD

## MATERIALS LABORATORY FACTUAL REPORT

Report No. 17-080

Place : Dayton, Tennessee  
Date : June 20, 2016  
Vehicle : Rockwell International 112A, N  
NTSB No. : ERA16LA226  
Investigator : Heidi Kemner, AS-ERA

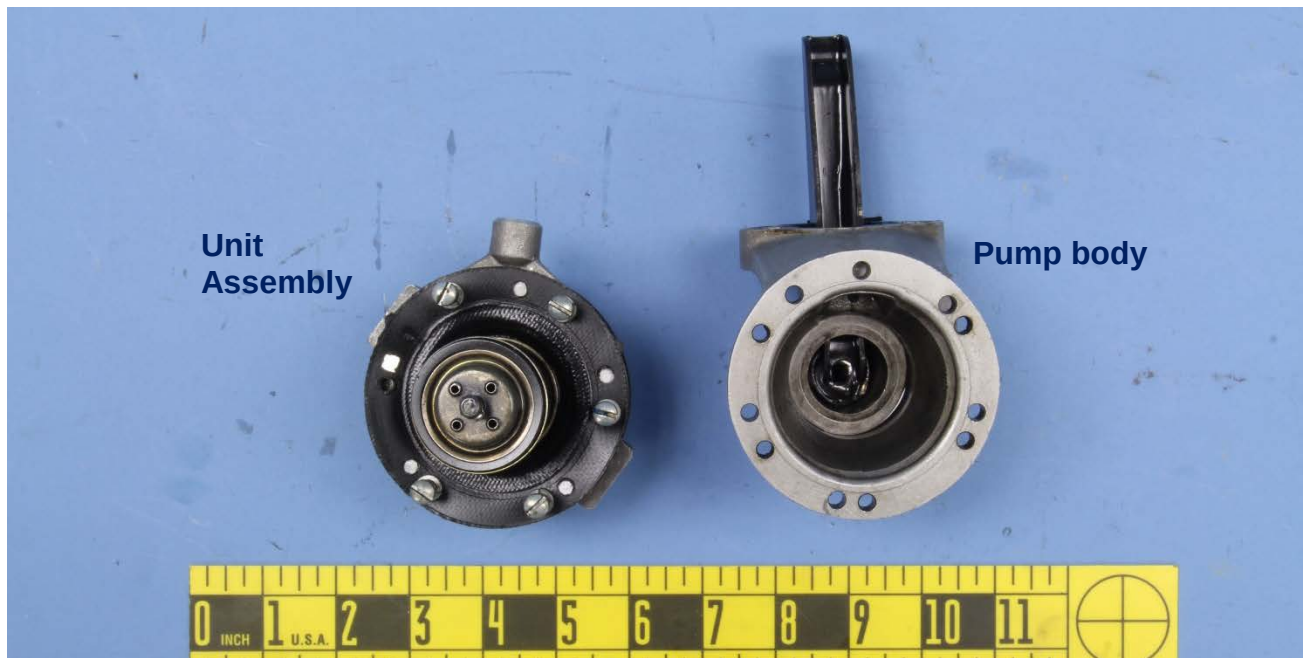
Figure 1 shows the fuel pump components, as received. The pump body had been separated from the unit assembly and the fittings had been removed prior to receipt. There were no noted features or witness marks on the removed fittings or on the outer body surfaces of the pump components. Of note was a fractured remnant attached to the diaphragm spindle, shown in Figure 2. This remnant matched a circular fracture on the diaphragm retainer still present adjacent to the pushrod arm inside the pump body, shown in Figure 3.

Figure 1 – The components of the fuel pump (less the fittings), as received. The removed fittings are not shown.

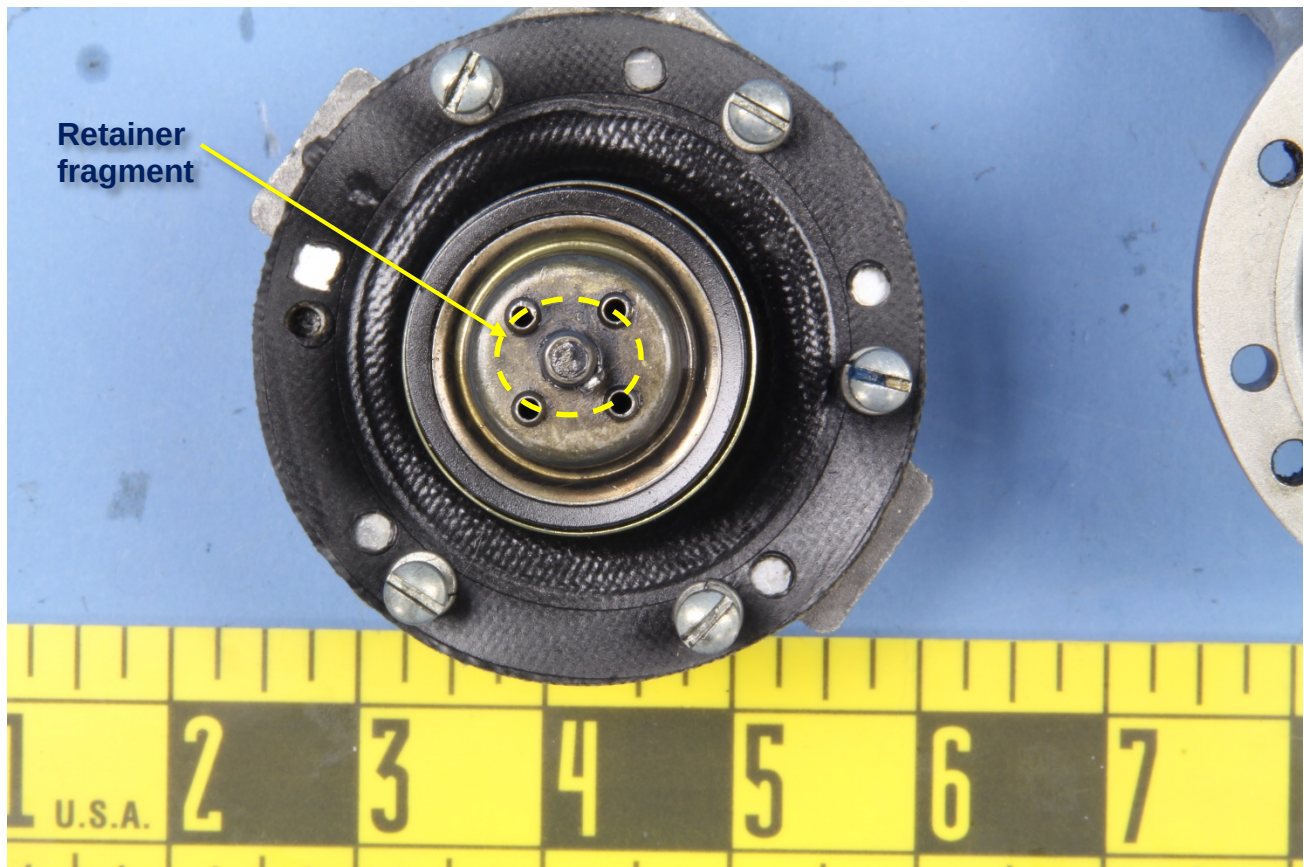
Figure 2 – Closer view of the interior of the unit assembly, as received.

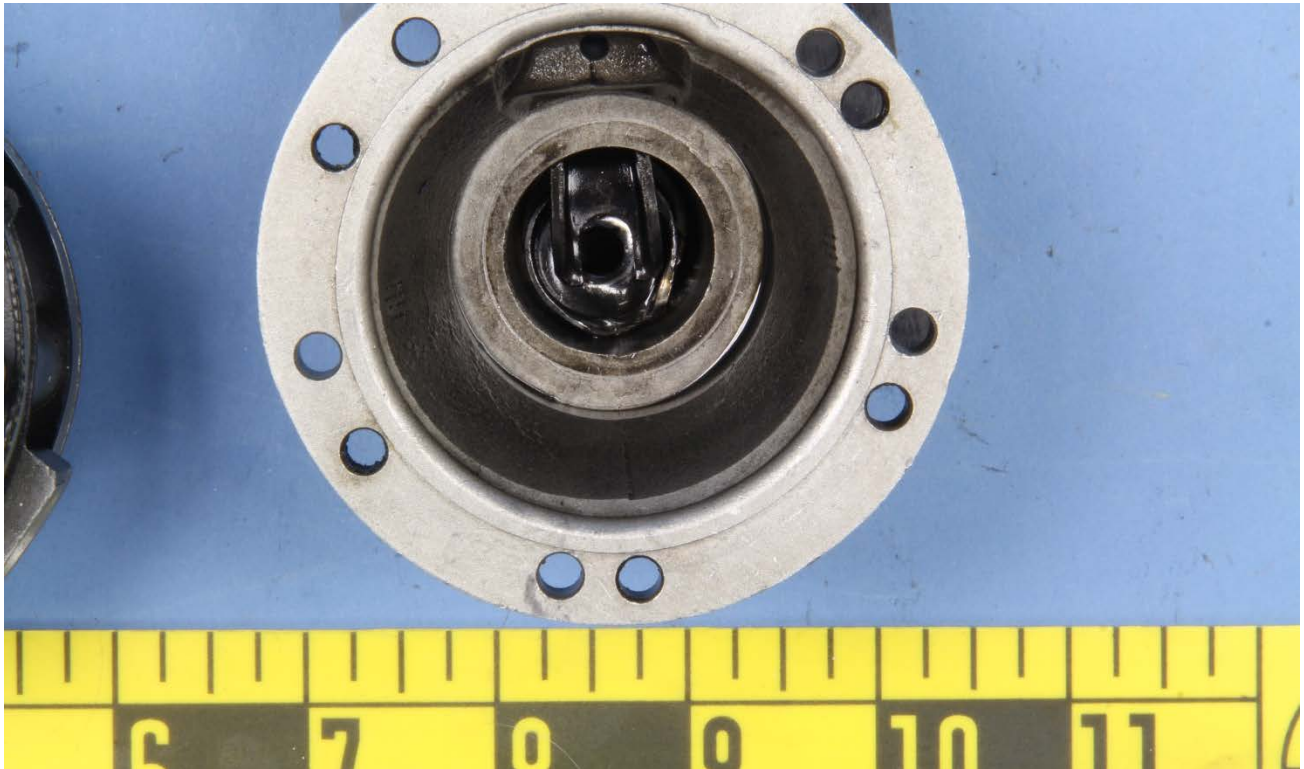
Figure 3 – A view of interior of the pump body, as received.

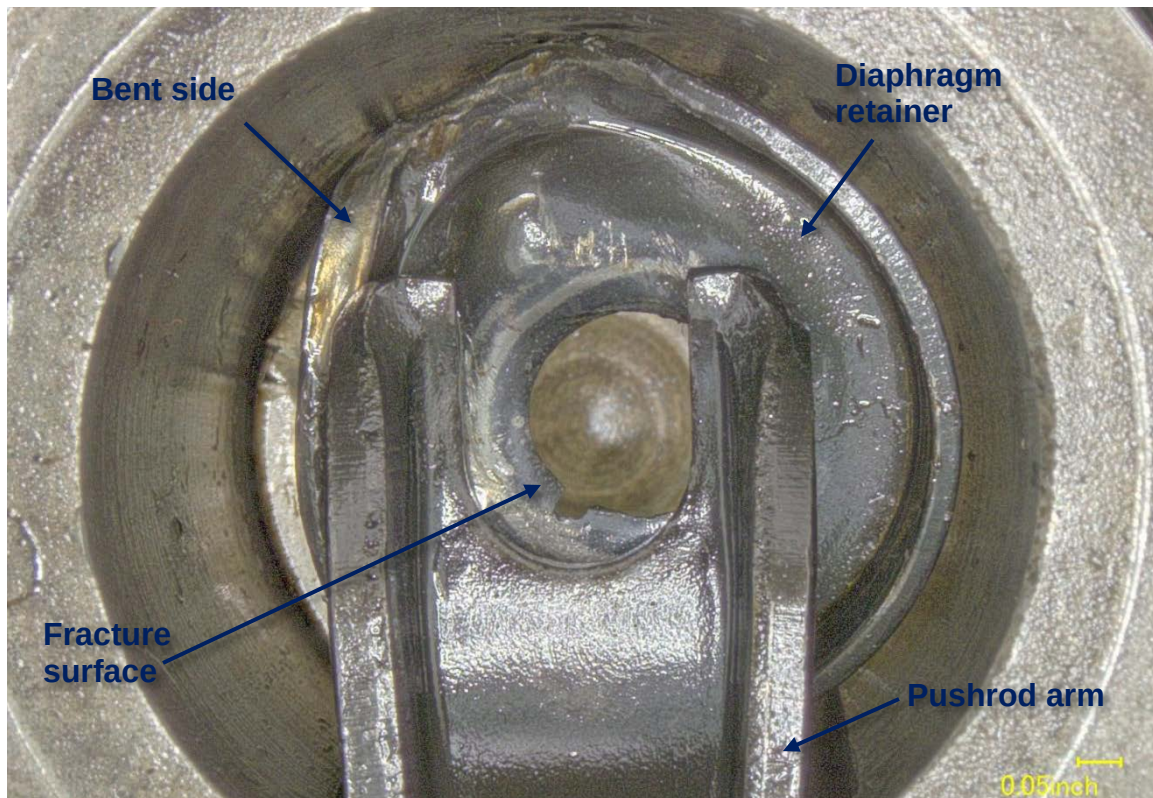
The retainer inside the pump body is highlighted in Figure 4, and its fracture surface is illustrated in Figure 5. The left side of the retainer in Figure 4 was bent (upward towards the reader) facing towards the unit assembly. The fracture was generally circular in orientation, matching that of the remnant on the spindle. The general morphology of the fracture was slanted, with indications of localized plastic deformation adjacent the fracture surface. Witness marks were present on this side of the retainer, consistent with rubbing or fretting against the pushrod arm.

Figure 4 – Closer view of the interior of the pump body, showing a damaged diaphragm retainer.

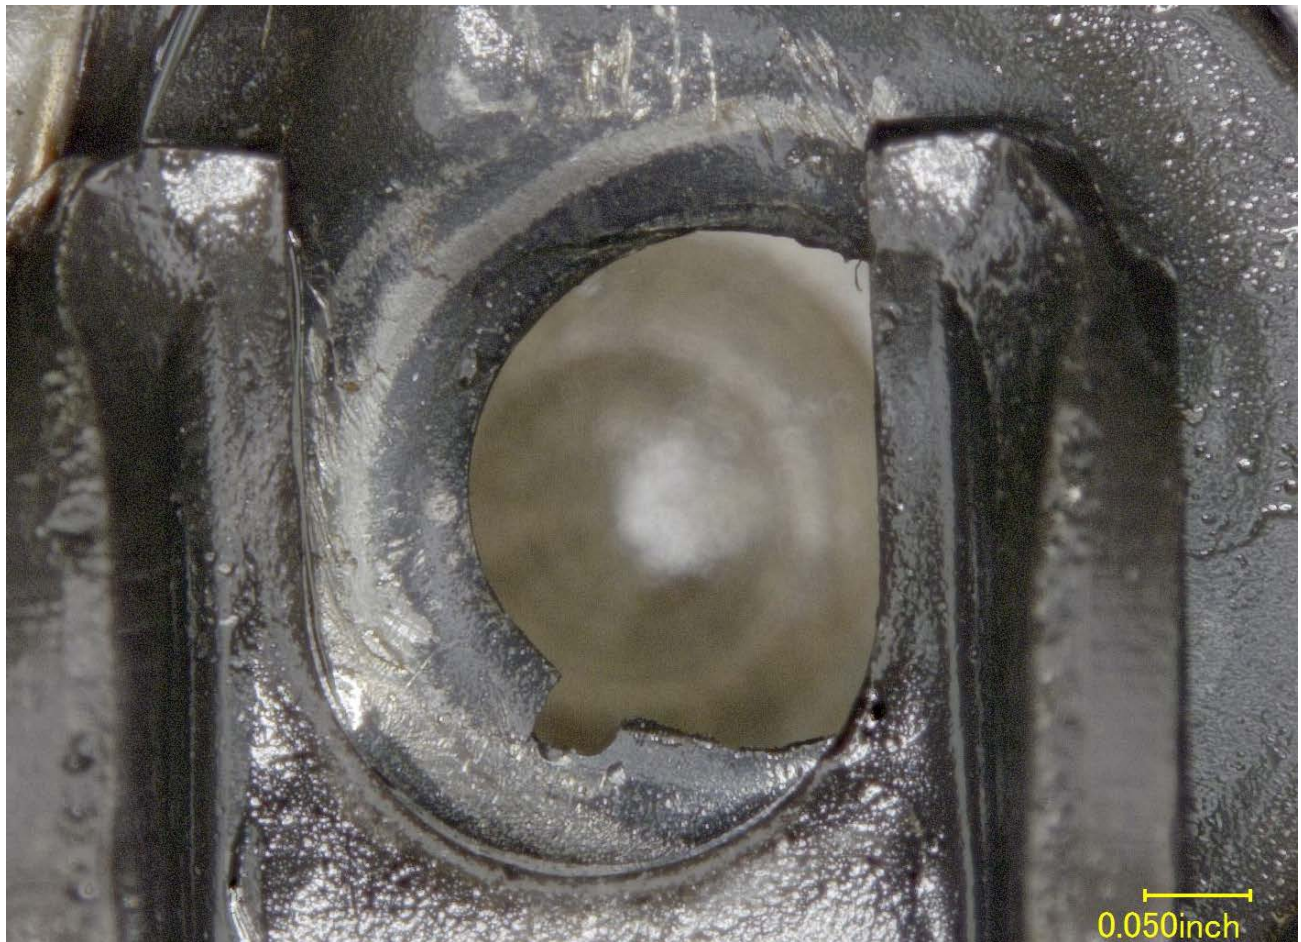
Figure 5 – Closer view of the diaphragm retainer from Figure 4, showing a slanted circular fracture.

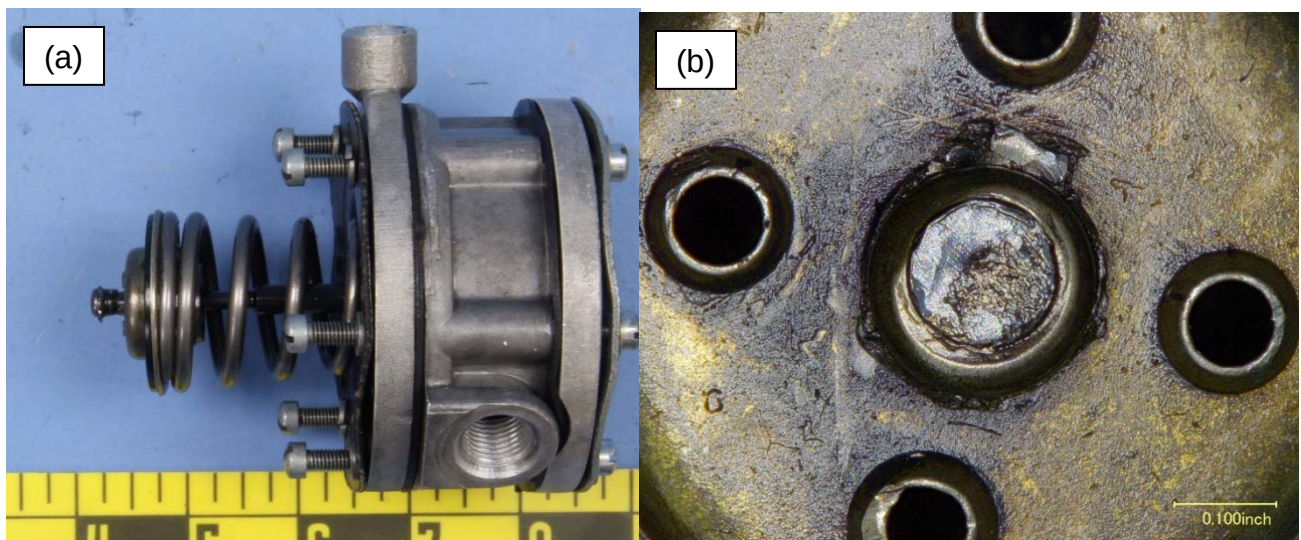
The retainer remnant on the diaphragm spindle is shown in Figure 6. The top of the flared end of the spindle exhibited rub and impact marks, as shown in Figure 6b. No other indications of damage to the spindle were observed.

Figure 6 – The unit assembly from (a) the side and (b) the top, showing a retainer remnant.

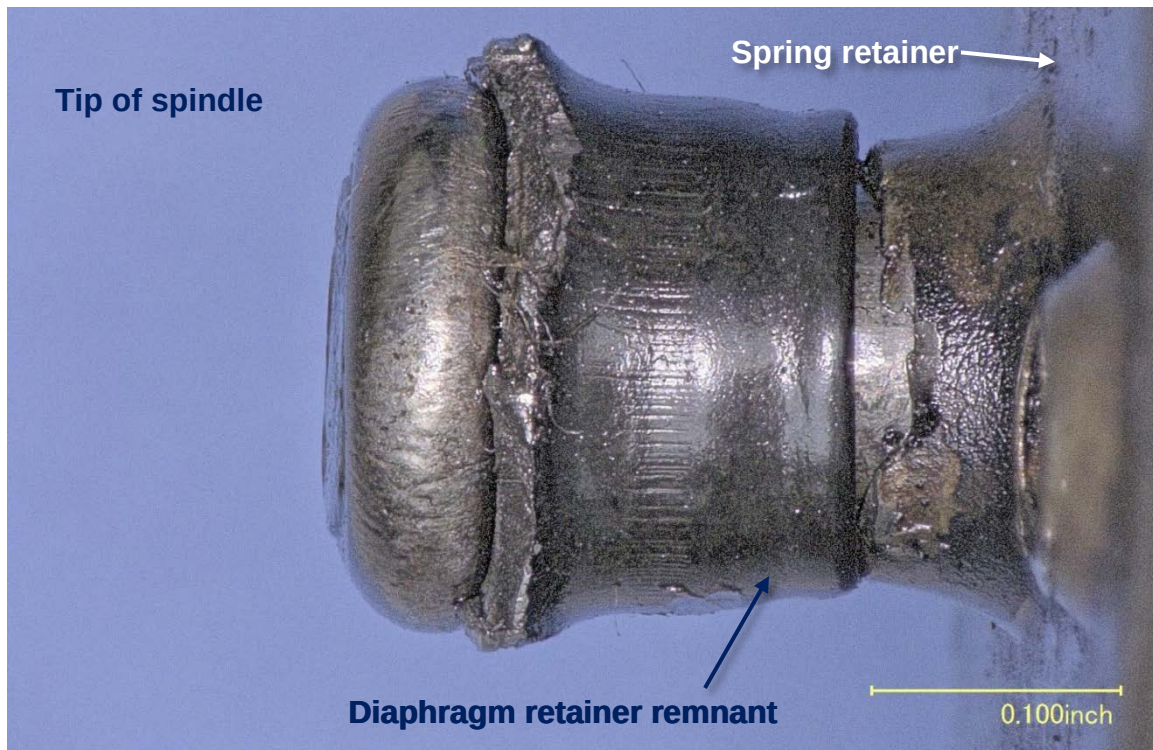
The retainer remnant is highlighted in Figures 7 and 8, as received. This remnant exhibited a circumferential fracture surface, consistent with the mating surface of the retainer in the pump body. The fracture surface of the remnant was generally slanted in orientation. One side of the remnant fracture jetted out, consistent with a tearing motion on that side (Figure 8). The bottom side of the remnant was found pushed inward towards the spindle and the spring retainer.

Figure 7 – A closer view of the diaphragm retainer remnant in shown in Figure 6a.

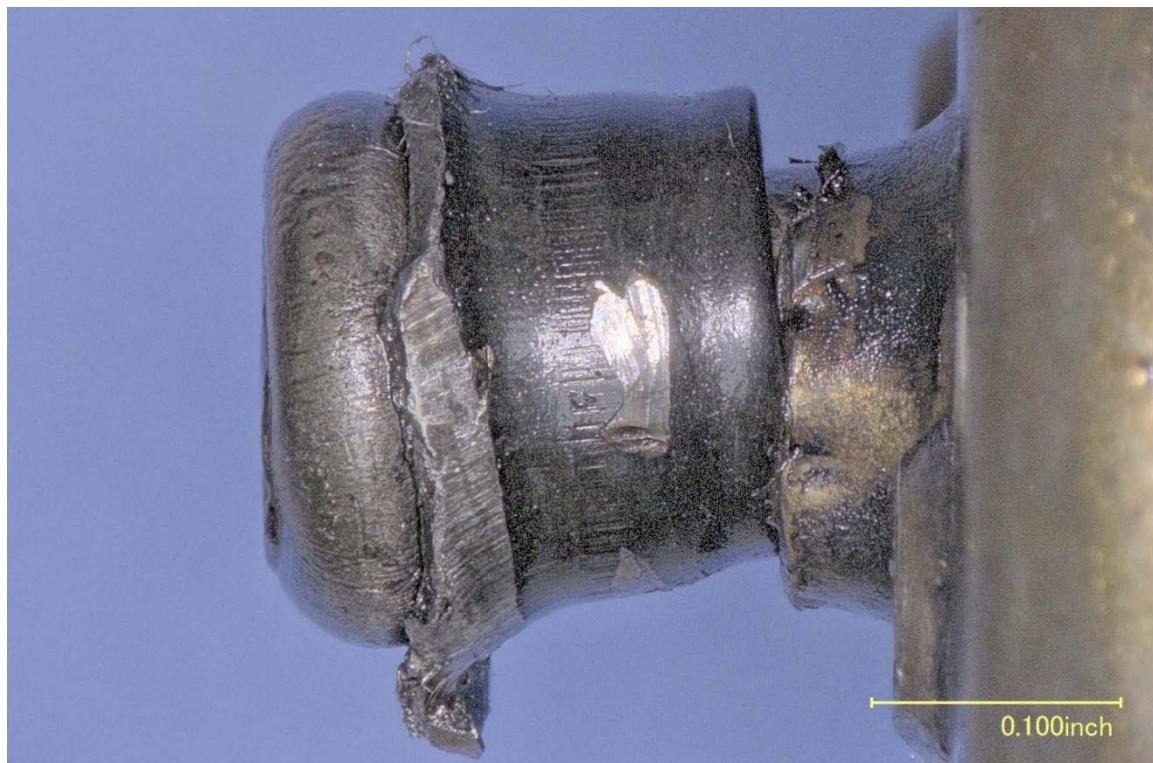
Figure 8 – The retainer remnant viewed from the side, rotated 90° from Figure 7.

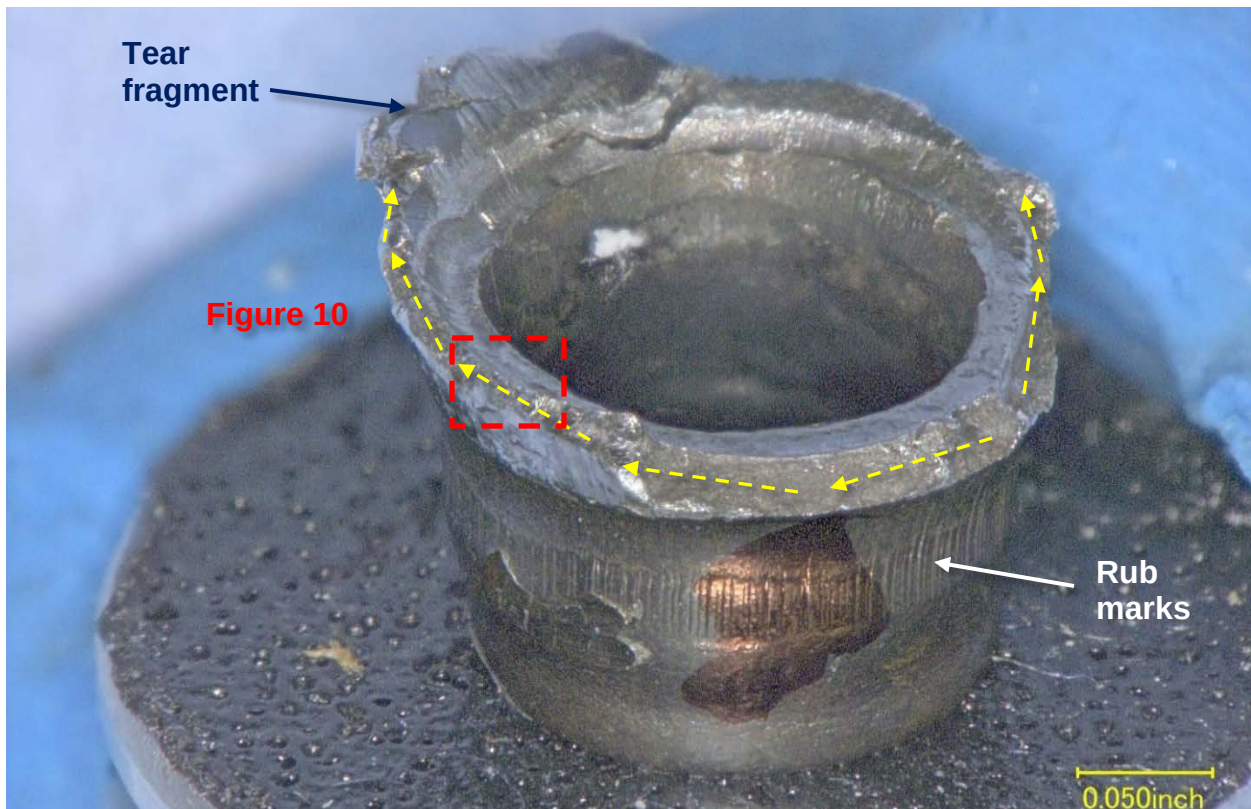
Figure 9 shows the remnant after removal from the spindle and cleaning. The remnant was positioned in Figure 9 at an angled orientation. The fracture surface exhibited features such as river patterns and chevron marks. These features were consistent with a fracture having occurred on one side of the retainer, and then advancing around either side of the retainer cavity. The portion of the retainer remnant 180° from the start of the fracture was the last to fracture, and it exhibited features consistent with plastic deformation from being torn away. The dashed arrows in Figure 9 illustrate the direction of fracture of the retainer.

In addition, the area below the fracture on the retainer remnant exhibited a circumferential region of longitudinal wear or rub marks (see Figure 9). The location of these marks was consistent with the location of the pushrod arm clevis.

Figure 9 – The retainer remnant, after removal and cleaning. The arrows show the fracture direction(s). The red dashed box is shown in Figure 10.

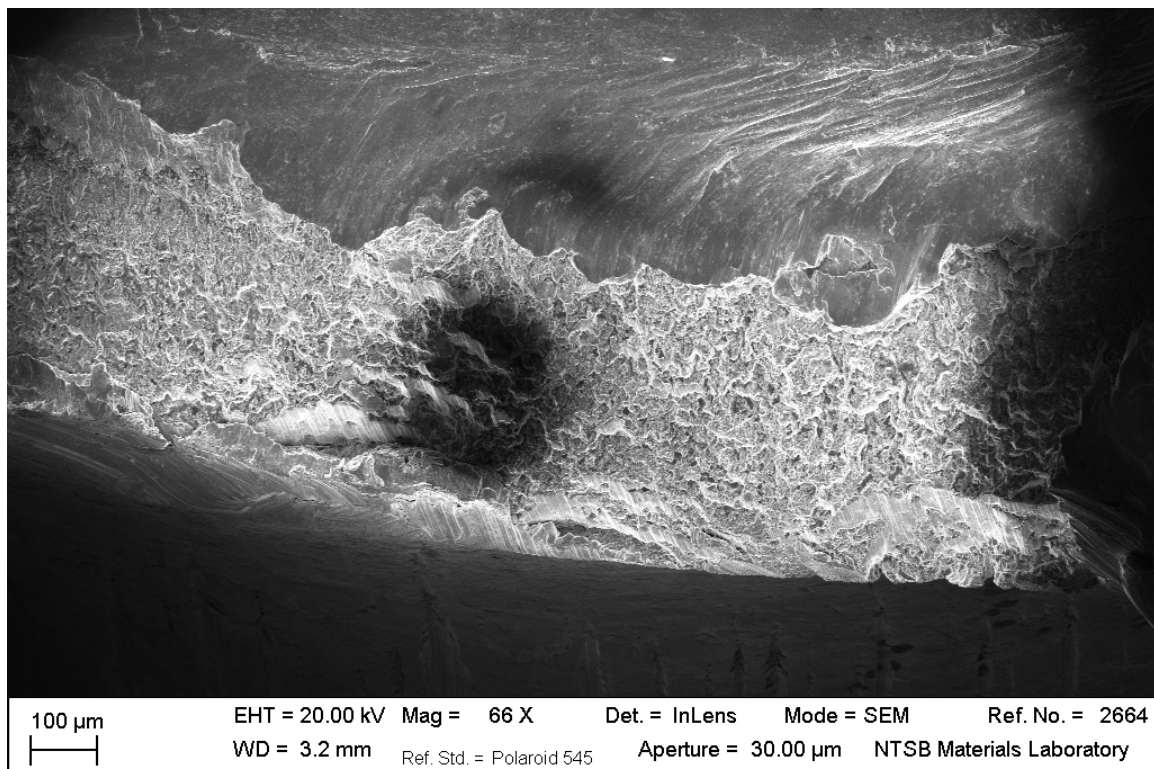
The remnant was inspected using a scanning electron microscope (SEM). The fracture surface exhibited either slanted fracture faces or a local necking/tapering adjacent to the fracture surface, as shown in Figure 10. Much of the fracture surface was damaged or obliterated by smearing, consistent with post fracture contact with adjacent components. The areas not damaged exhibited dimple rupture, as exemplified in Figure 11. No indications of other failure modes were observed on the fracture surfaces.

Figure 10 – Secondary electron (SE) micrograph of the remnant fracture surface.

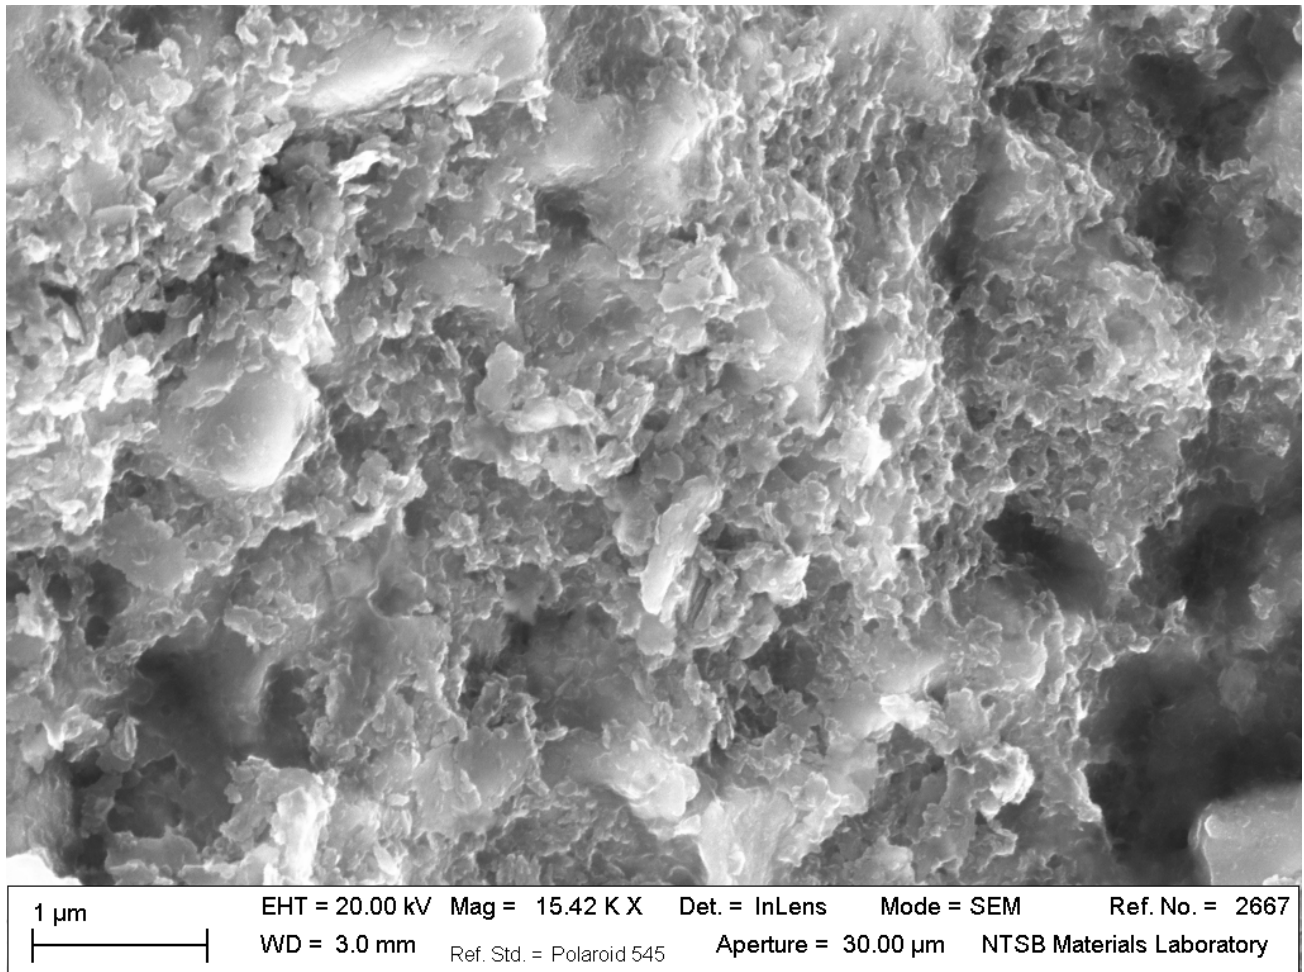
Figure 11 – SE micrograph of the fracture surface in , showing oxidized featured consistent with dimple rupture.
