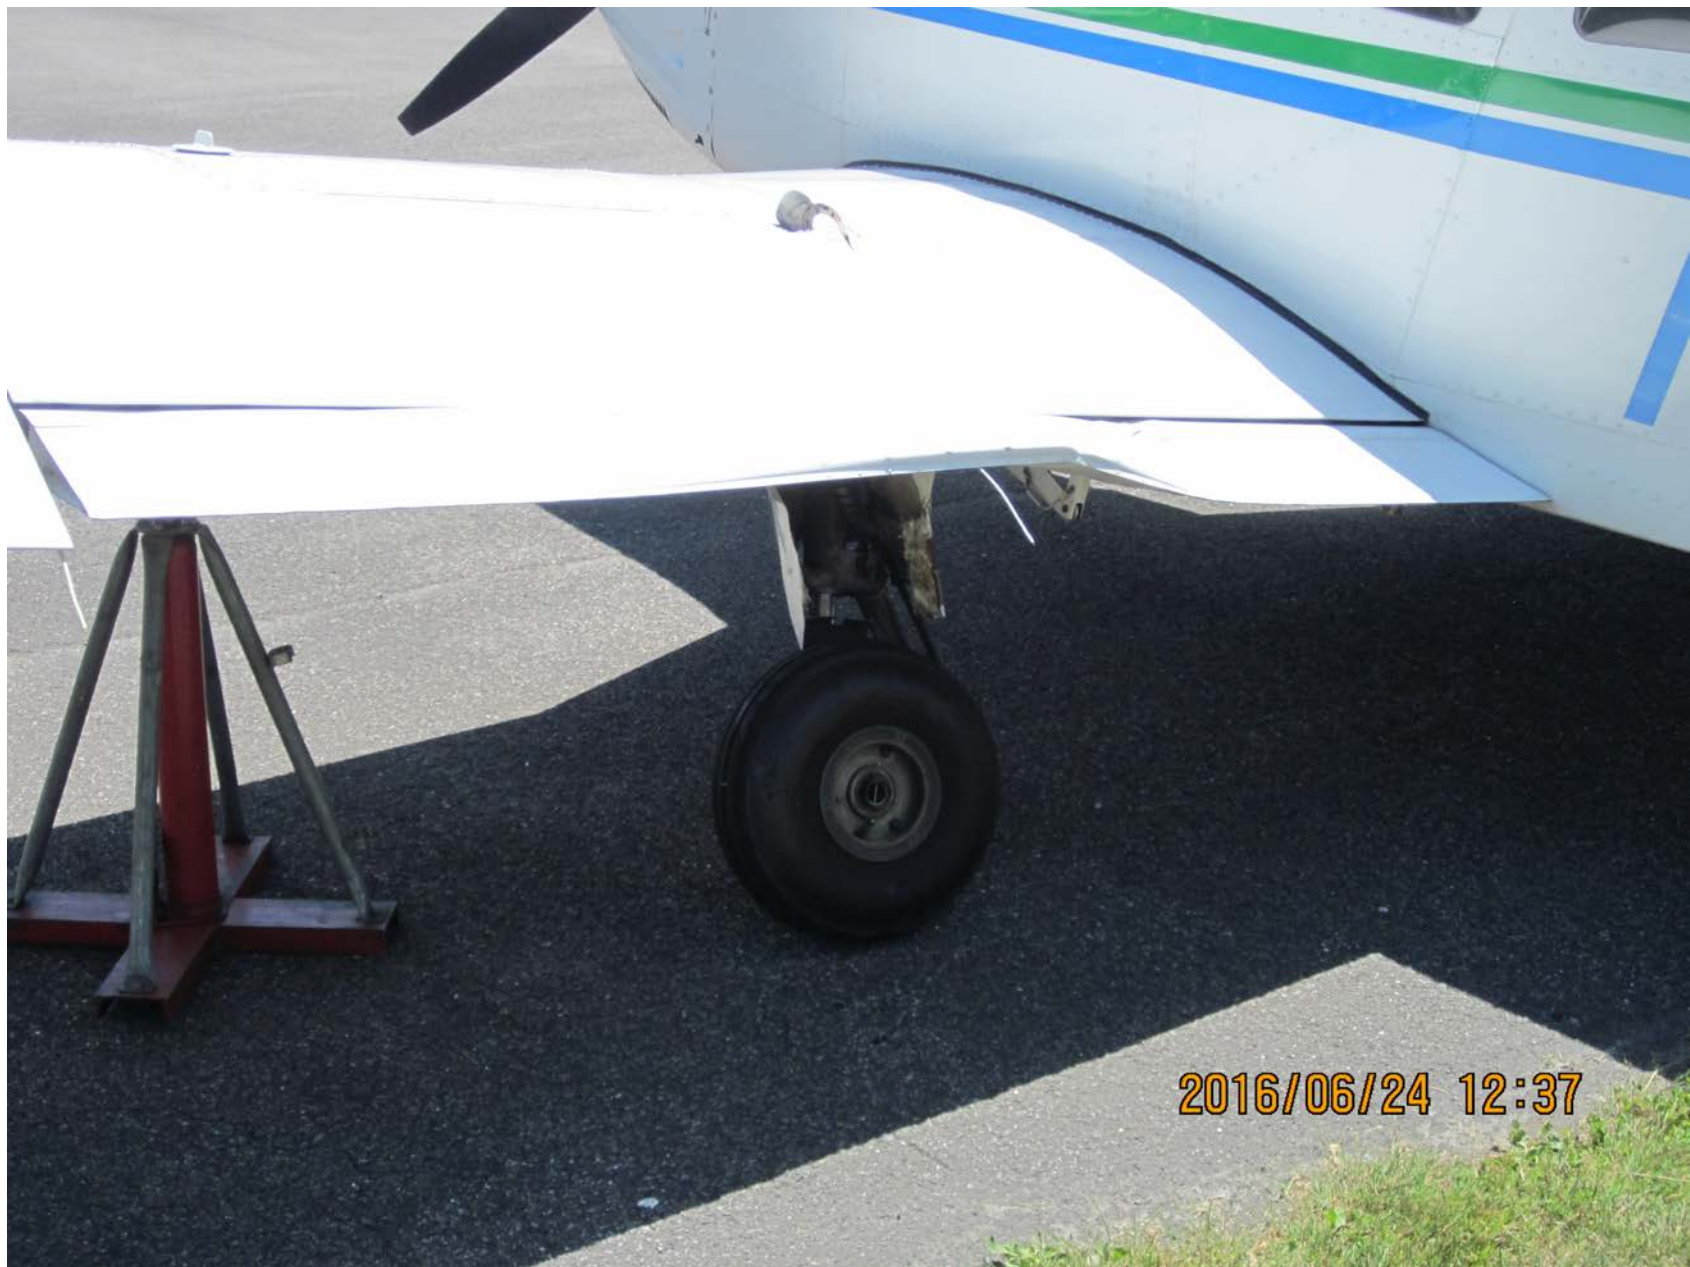
**Photo 1 – FAA photo- Left landing gear strut protruding from top of left wing**

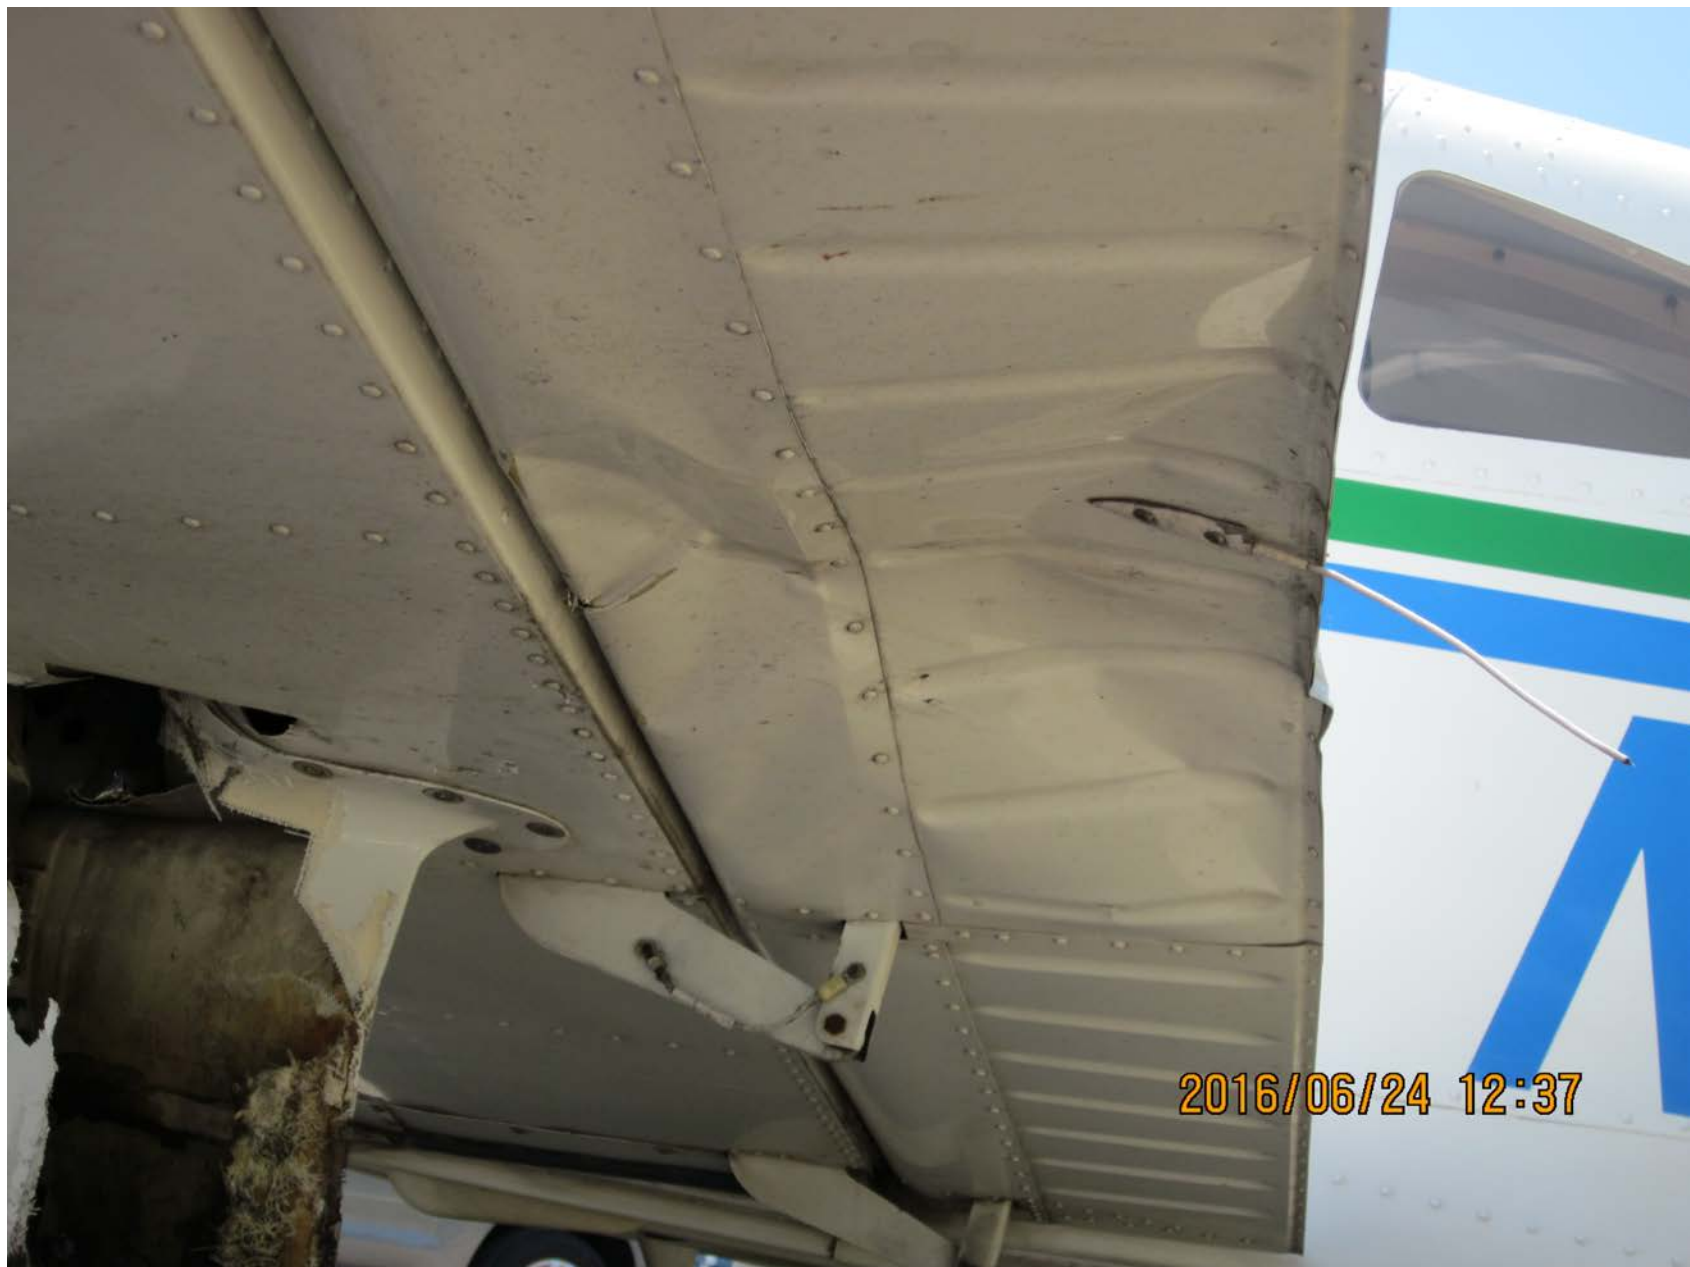
**Photo 2 – FAA photo- View of under wing showing left flap damage**

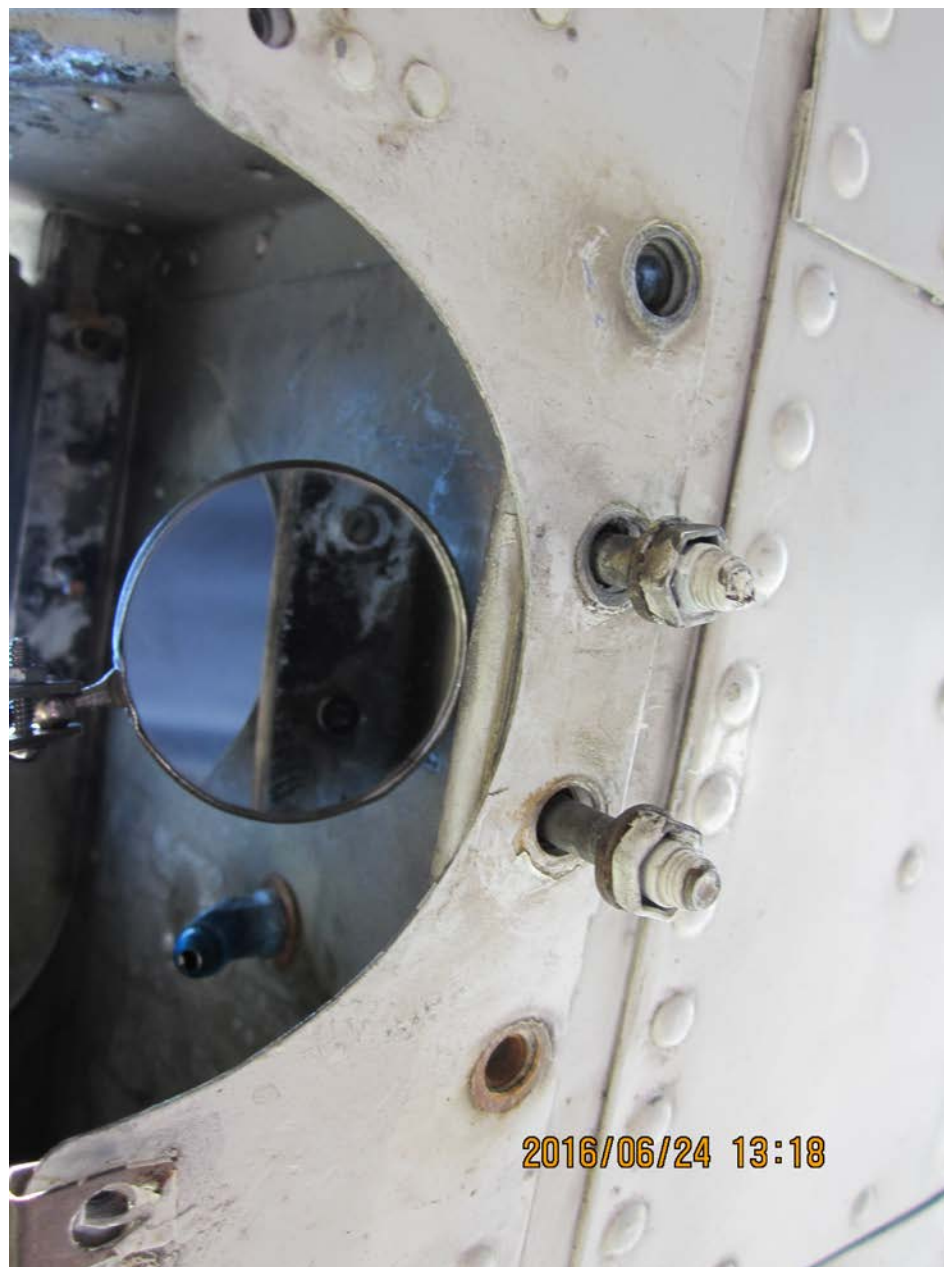
**Photo 3 – FAA photo-View of spar damage**

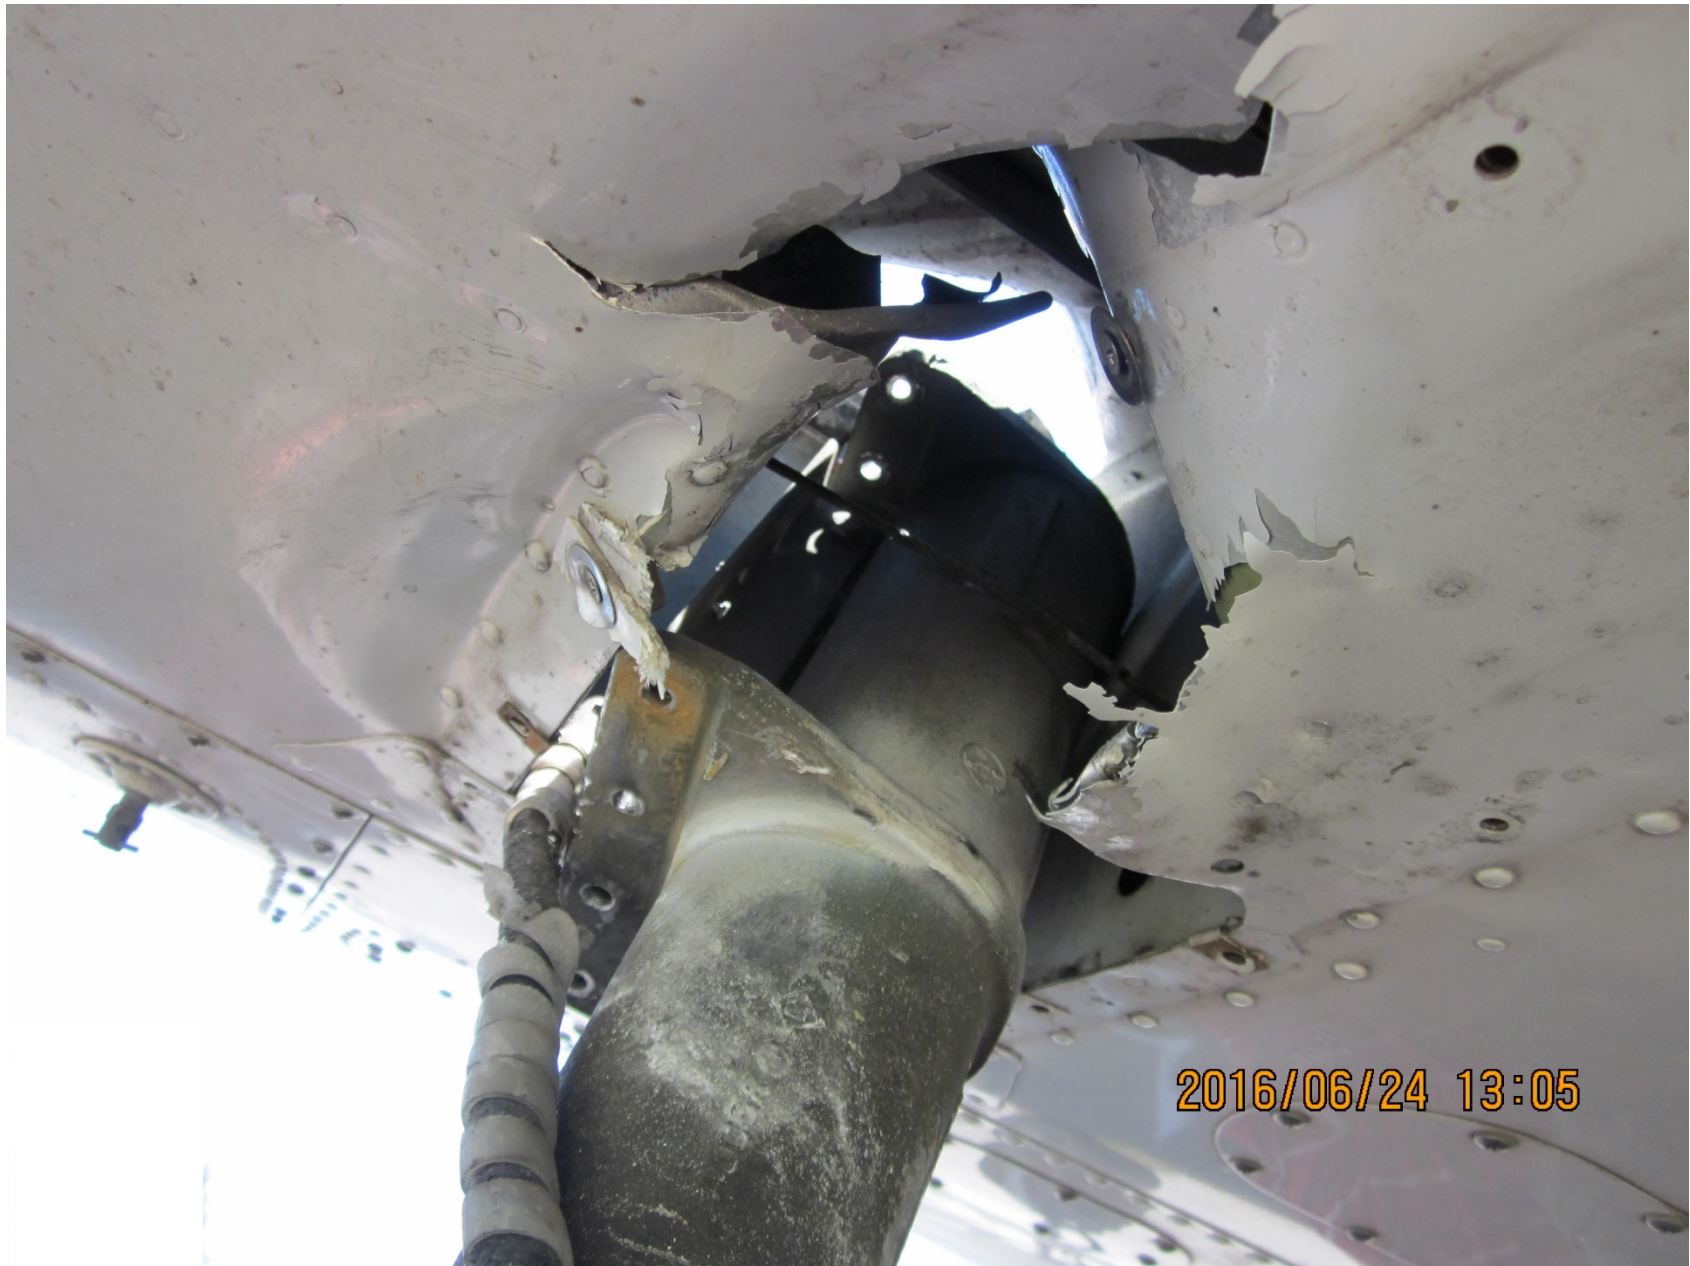
**Photo 4 – FAA photo-view of strut separated in wing**
