## **INVESTIGATION REPORT**

| <b><u>ACCIDENT INFORMATION</u></b> | | | |
|---|---|---|---|
| <b>Date of accident:</b> | 07/09/2016 | <b>NTSB file number:</b> | ERA16LA247 |
| <b>Aircraft Make:</b> | Adventurea | <b>Aircraft registration:</b> | N932MC |
| <b>Engine Type:</b> | Rotax 912 ULS | <b>Engine TTSN</b> | Unknown |

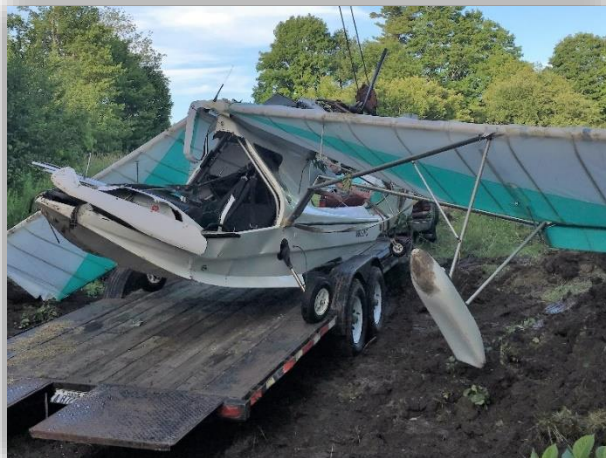
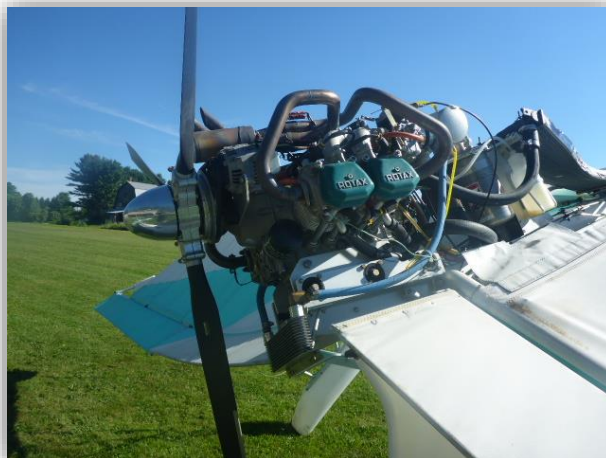
The aircraft sustained severe frontal impact damage. The Rotax 912 ULS, S/N 5648772 was still attached to the engine mount and airframe.

All three propeller blades were still attached to the hub and were undamaged. The engine and its components were in good physical condition with no impact damage. There was no coolant in the coolant system as the coolant radiator was breached from recovery or impact damage.

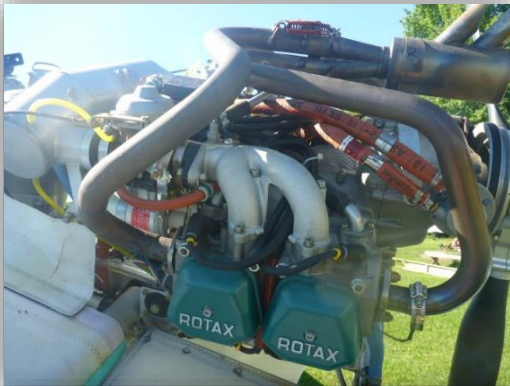
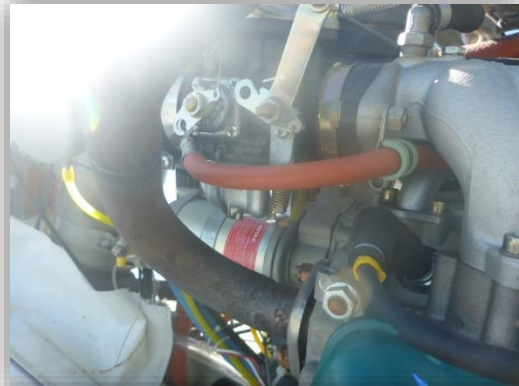
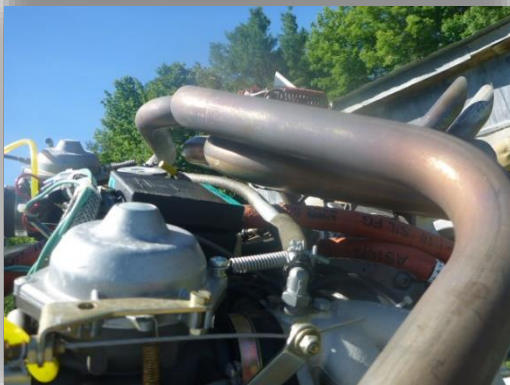
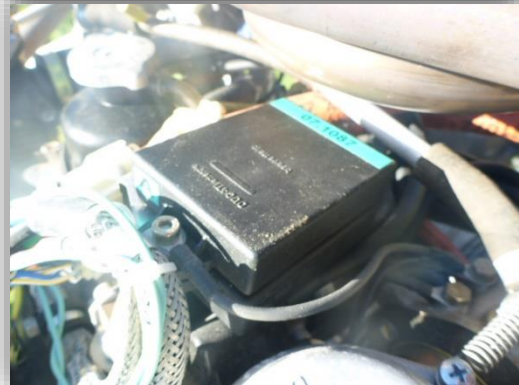
The exhaust system was examined for condition, modifications and conformity. The exhaust system was an aftermarket non-Rotax exhaust that was mounted above the engine in close proximity to temperature sensitive electronic components and fuel lines. No heat shielding was installed to protect these heat sensitive components from radiant heat that the exhaust would produce.

Fuel lines with no firesleeve or heat protection in close proximity to exhaust system. The Rotax installation manual states "To avoid vapour lock keep the temperature of the fuel lines, float chamber and related devices below 113 F (45C). The electronic ignition modules were also found in close proximity to the exhaust system with no heat protection. The electronic ignition modules have a max ambient temperatures of 176 F (89 C). The exhaust system can reach temperatures of 1616 F ( 880 C)

One possibility for the loss of engine power is vapor lock as the aircrafts fuel system did not incorporate a fuel return line or protect the aircrafts fuel system from the high temperatures of the exhaust system.

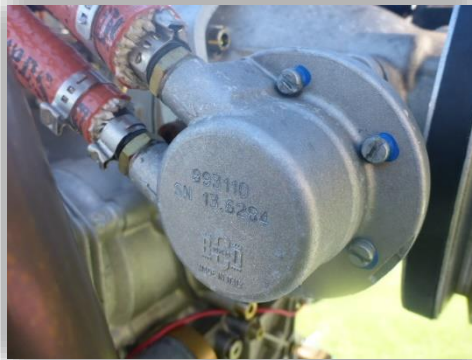
The fuel system was examined for condition, modifications and conformity. No fuel return line was installed on this aircraft as per the Rotax installation manual requirements. The Rotax installation manual states the following: **“NOTICE. The installation of a fuel return line is mandatory”**. **“The return line prevents malfunctions caused by the formation of vapor lock”**.

**Fuel Pump:** No anomalies were found with the diaphragm fuel pump.

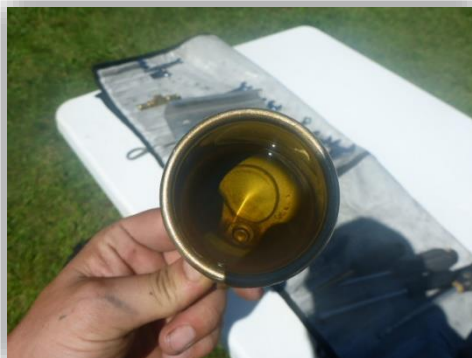
**Gascolator:** The gascolator bowl was removed and examined. The gascolator was approximately half full of fuel with no contamination found. No anomalies were found with the gascolator and its contents.

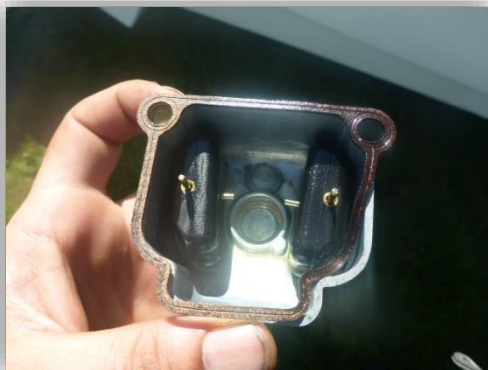
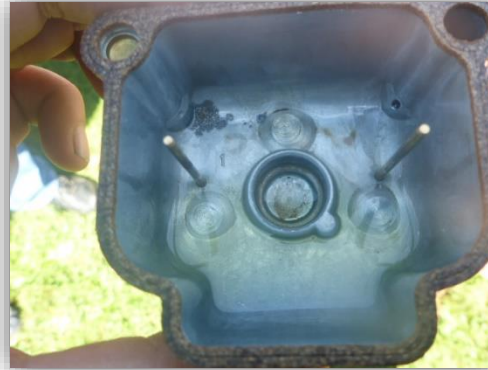
**1/3 Carburetor:** The 1/3 Carburetor float bowl was removed and examined for fuel contamination. Corrosion was found within the 1/3 float bowl underneath the float. No fuel was contained inside.

Corrosion found within both the 1/3 and 2/4 Carburetor float bowls was the only anomalies found with the 1/3 and 2/4 carburetors.

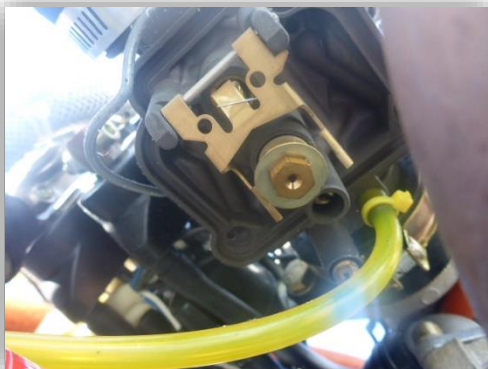
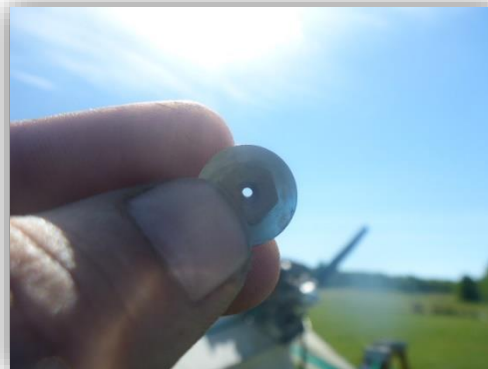
The main jet was removed and examined for any obstructions and proper size. No obstructions were seen and it was the stock 155 size main jet.

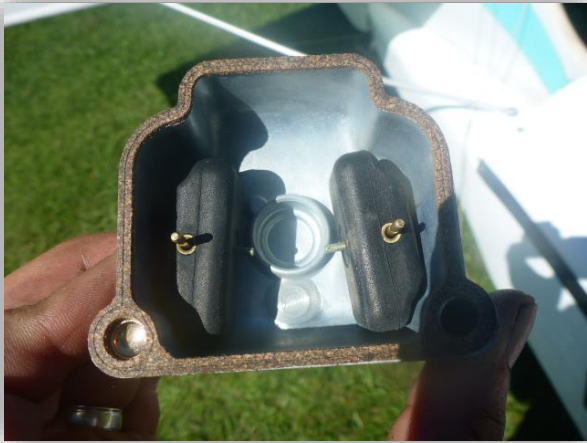
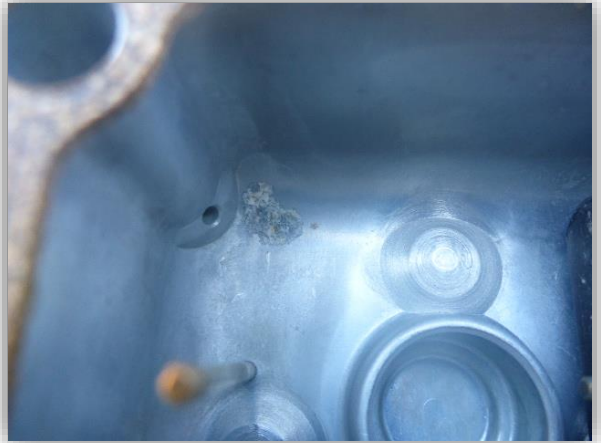
Corrosion was found within the 2/4 float bowl underneath the float. No fuel was contained inside.

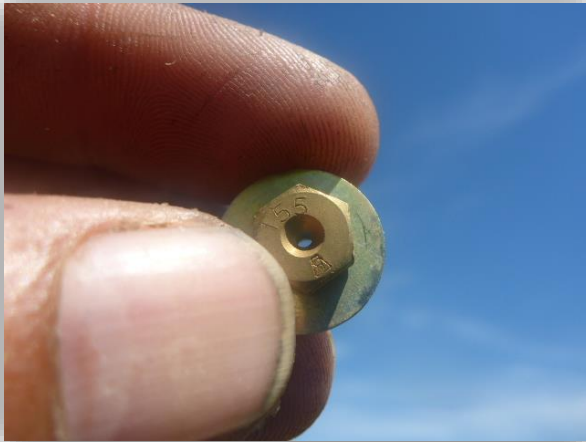
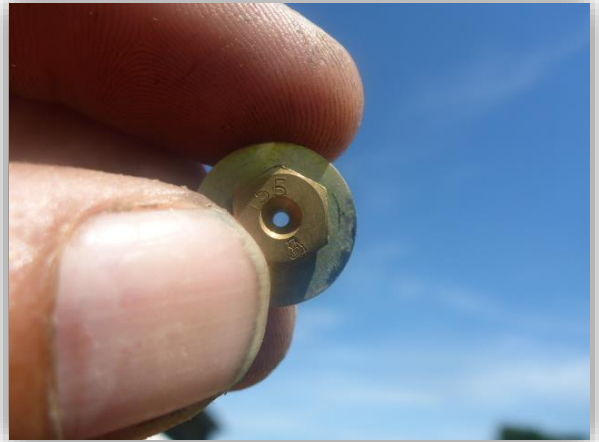
The main jet was removed and examined for any obstructions and proper size. No obstructions were seen and it was the stock 155 size main jet.

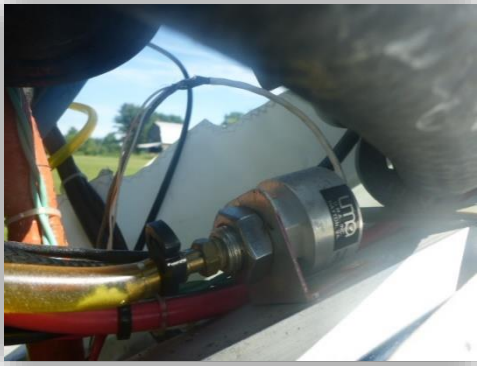
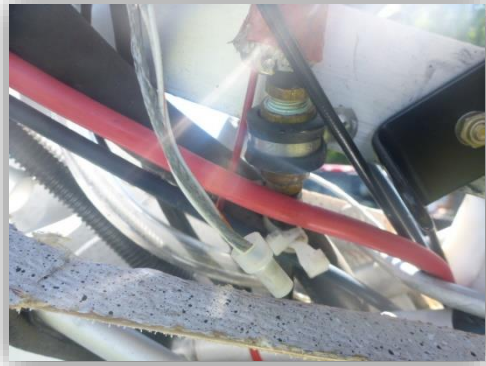
**Fuel Pressure Indication:** A fuel pressure indicator was installed but was not connected electrically. This aircraft had no other means of measuring fuel pressure.

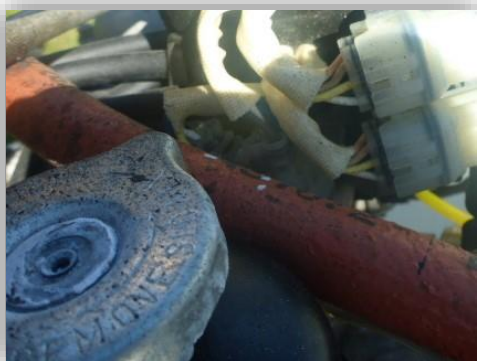
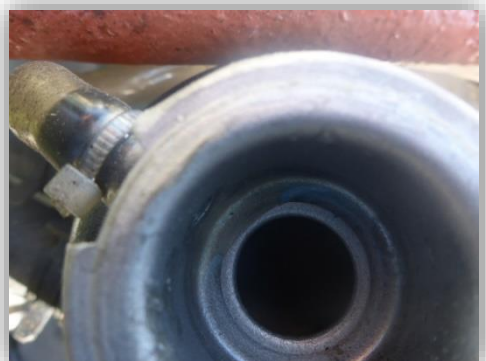
**Expansion tank:** The expansion tank cap was removed to examine the contents within. No coolant remained within the expansion tank due to a breach in the system from impact or wreckage recovery. No anomalies were found with the coolant expansion tank.

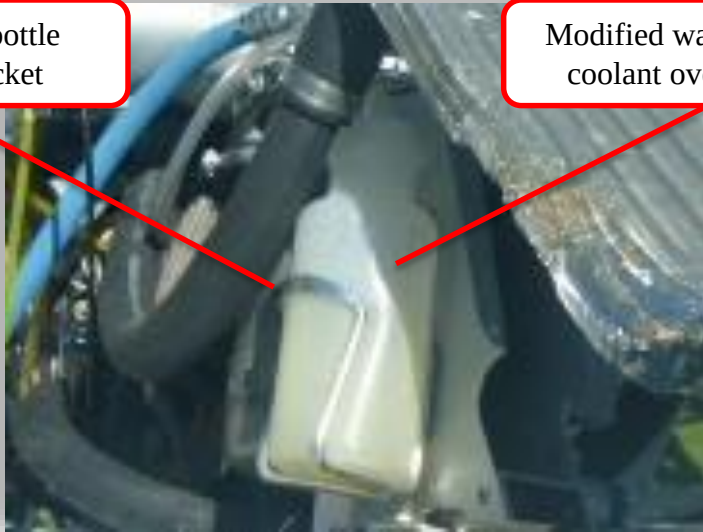
**Overflow bottle:** The coolant overflow bottle was a modified water bottle with a bicycle water bottle mounting bracket. No coolant was seen inside the tank due to the system being breached. Other than the overflow tank was a modified water bottle, no anomalies were found with the overflow tank.

Bicycle water bottle mounting bracket

Modified water bottle for coolant overflow tank

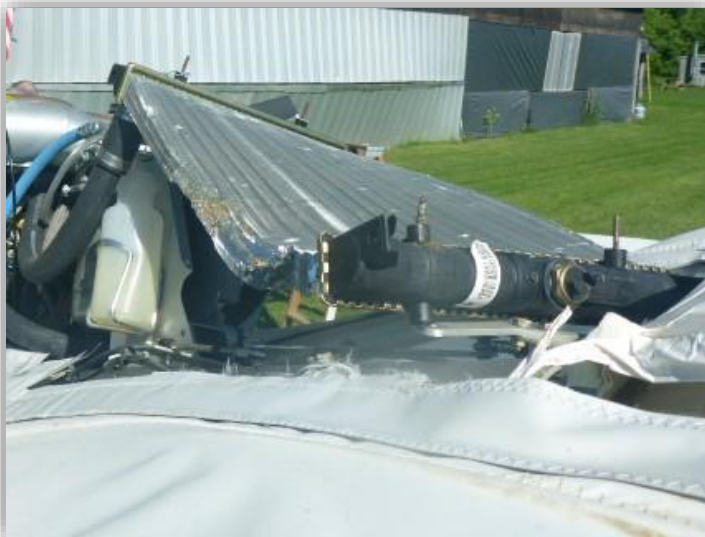
**Radiator:** The radiator was substantially damaged from impact or aircraft recovery. There was no coolant contained within the coolant radiator due to the system being breached. No anomalies were found with the coolant radiator.

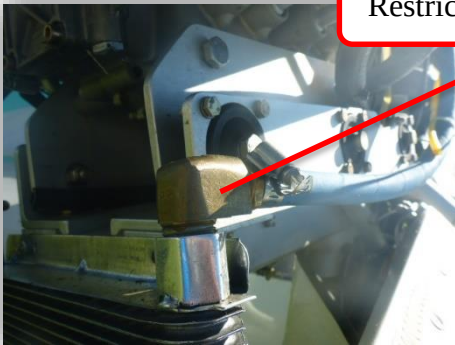
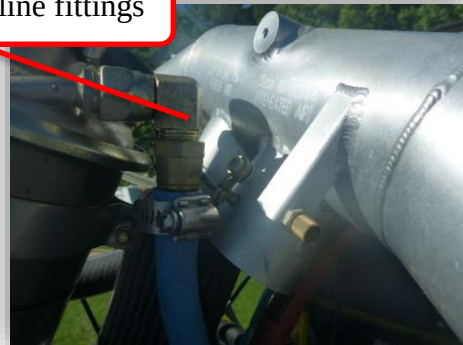
**Oil lines:** The oil lines were examined for condition and proper type. The oil lines were the proper type but two of the oil line fittings from the oil cooler and the oil tank were restrictive and could cause cavitation within the oil system resulting in improper lubrication of the engine and its internal components/

Restrictive oil line fittings

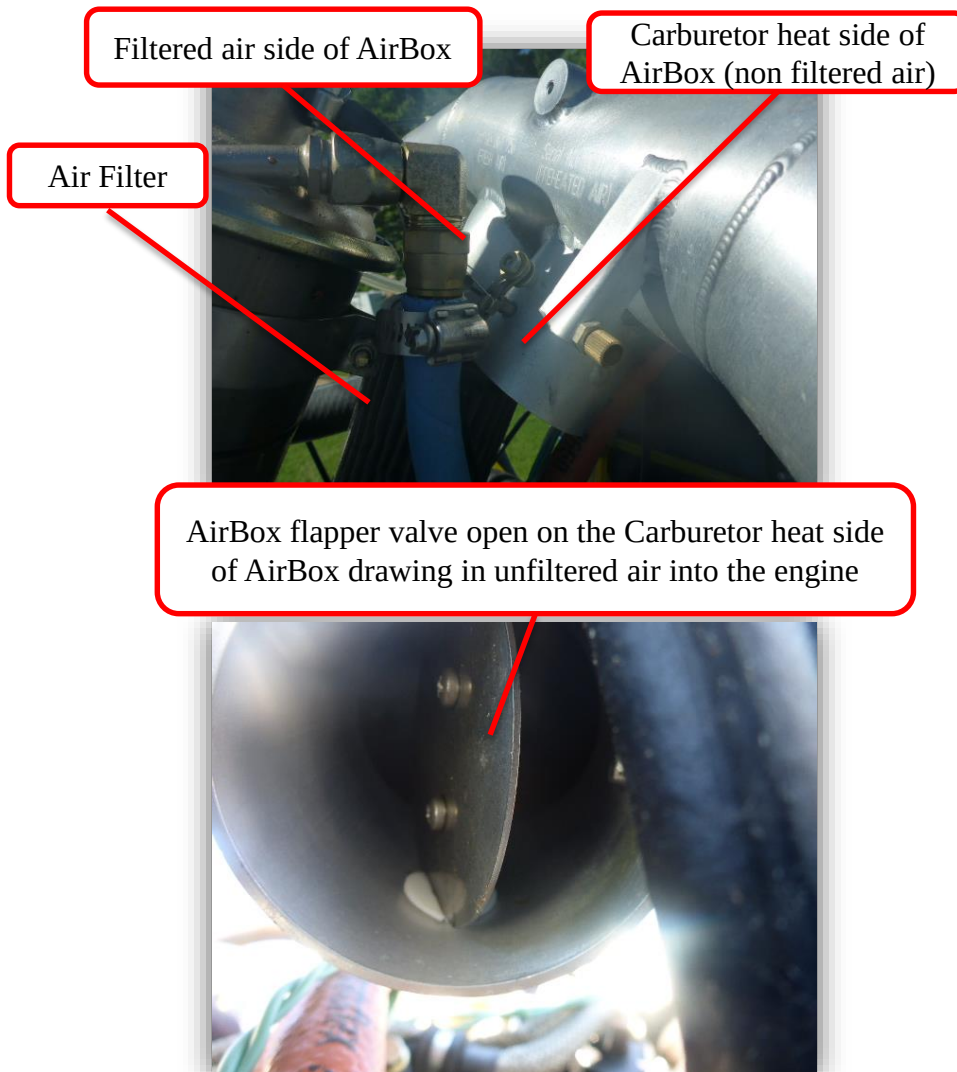
**AirBox:** The engine was equipped with the optional Rotax AirBox. The AirBox was examined for condition, modifications and anomalies. The control linkage to switch from filtered air to carburetor heat was not connected and the lever was positioned so induction air was being pulled from the carburetor heat side of the AirBox (non filtered air).

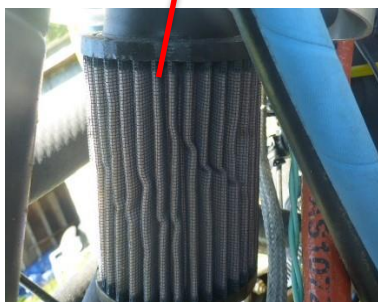
**Air Filter:** The air filter was examined for condition and proper type. The air filter was a K&N brand and the filter pleats were grey with no protecting oil. The filter oil acts as a tacking agent designed to grab fine particles of dirt so it does not enter the engine.

Grey “non oiled” filter pleats on accident aircraft air filter

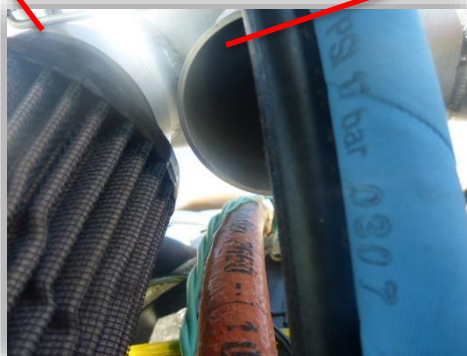
**Carburetor Heat:** The carburetor heat system was examined for condition and conformity. The engine was equipped with the proper Rotax AirBox that would allow the owner to use a carburetor heat system in the form of a heat muff. The carburetor heat system was not operational as the aircraft was not fully equipped with the additional components required.

Filtered air section of AirBox

Carburetor heat section of AirBox
