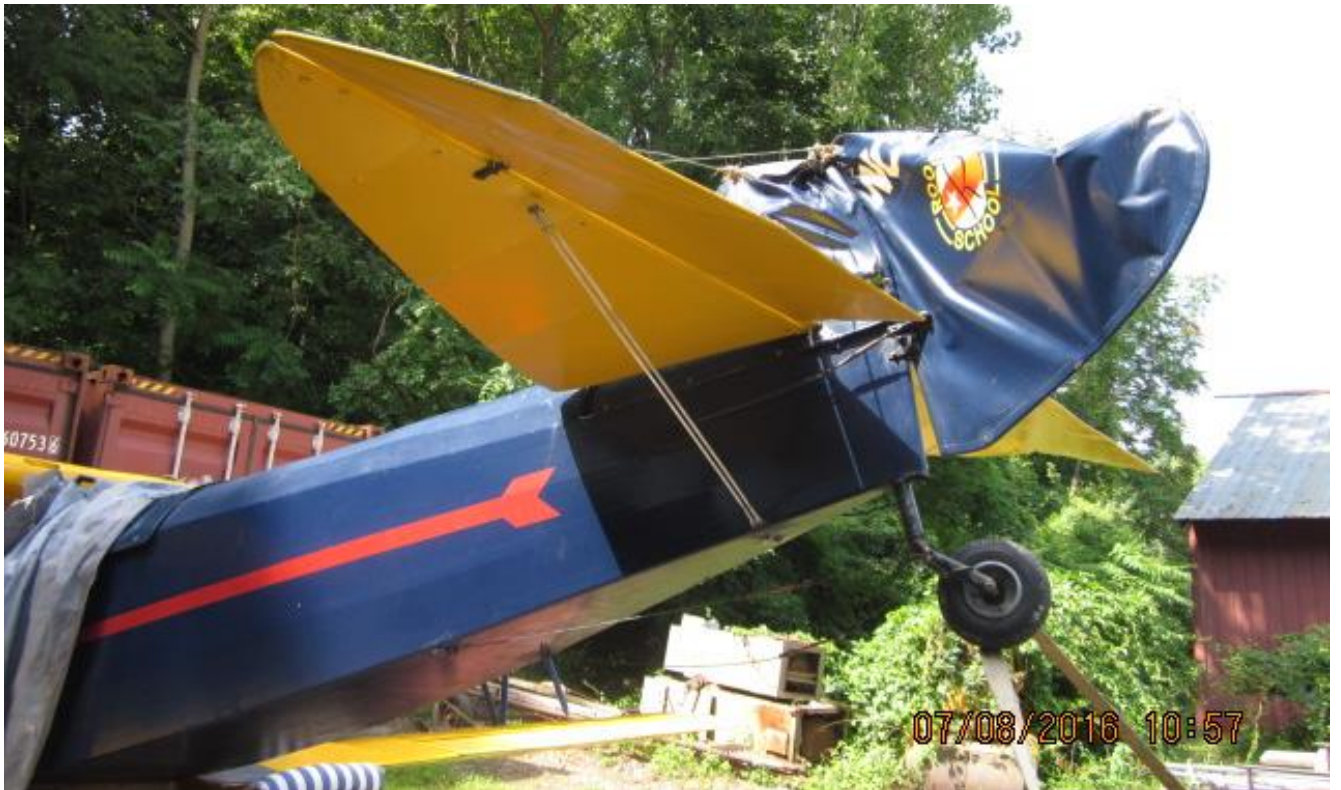
Figure 2: Damage to the vertical stabilizer
