# NATIONAL TRANSPORTATION SAFETY BOARD

MATERIALS LABORATORY FACTUAL REPORT

Report No. 16-104

Place : Somerville, TN  
Date : July 14, 2016  
Vehicle : Pitts S-1, N4714H  
NTSB No. : ERA16LA260  
Investigator : Bob Gretz

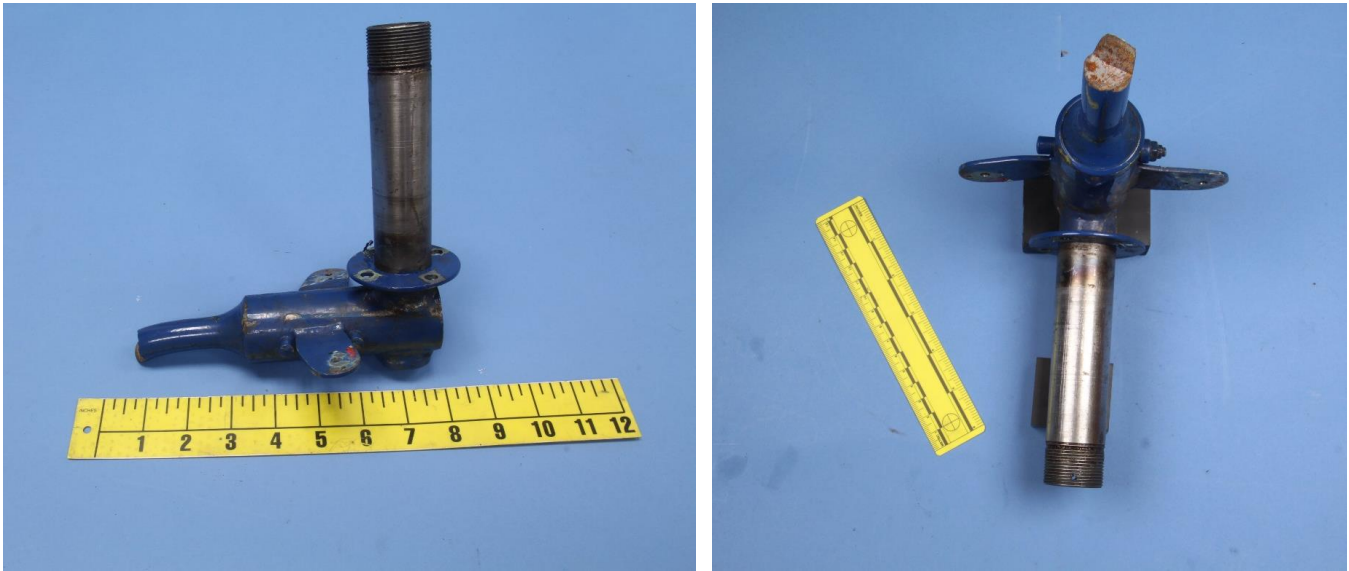
A portion of a landing gear strut (figure 1).

Figure 1: Two views of the landing gear strut as received.

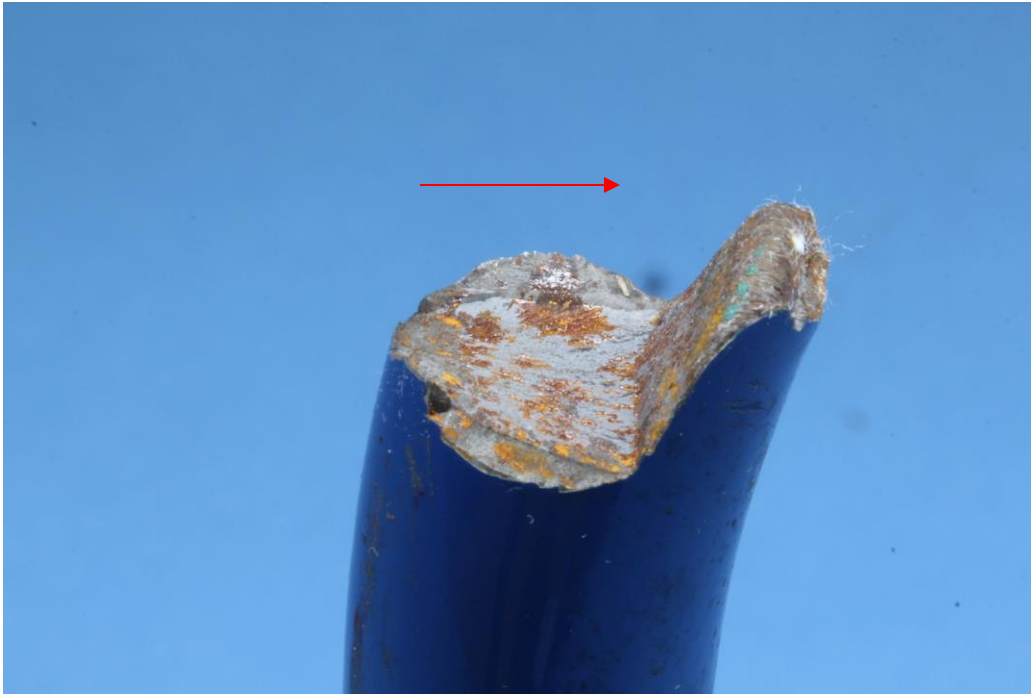
The fracture on the landing gear strut occurred in a solid cylindrical portion of the strut. The cylindrical portion of the strut exhibited plastic deformation in the direction consistent with the fracture direction (figure 2). The fracture surface exhibited a small thumbnail like fatigue region (approximately 0.017 inch deep) followed by an overstress region (figures 3, 4). Hardness measurements were made on a section of material cut approximately 1 inch below the fracture. The average hardness measured was 45.9 on the Rockwell C scale.

Figure 2: Side view of fracture surface and deformation. Red arrow shows direction of force.

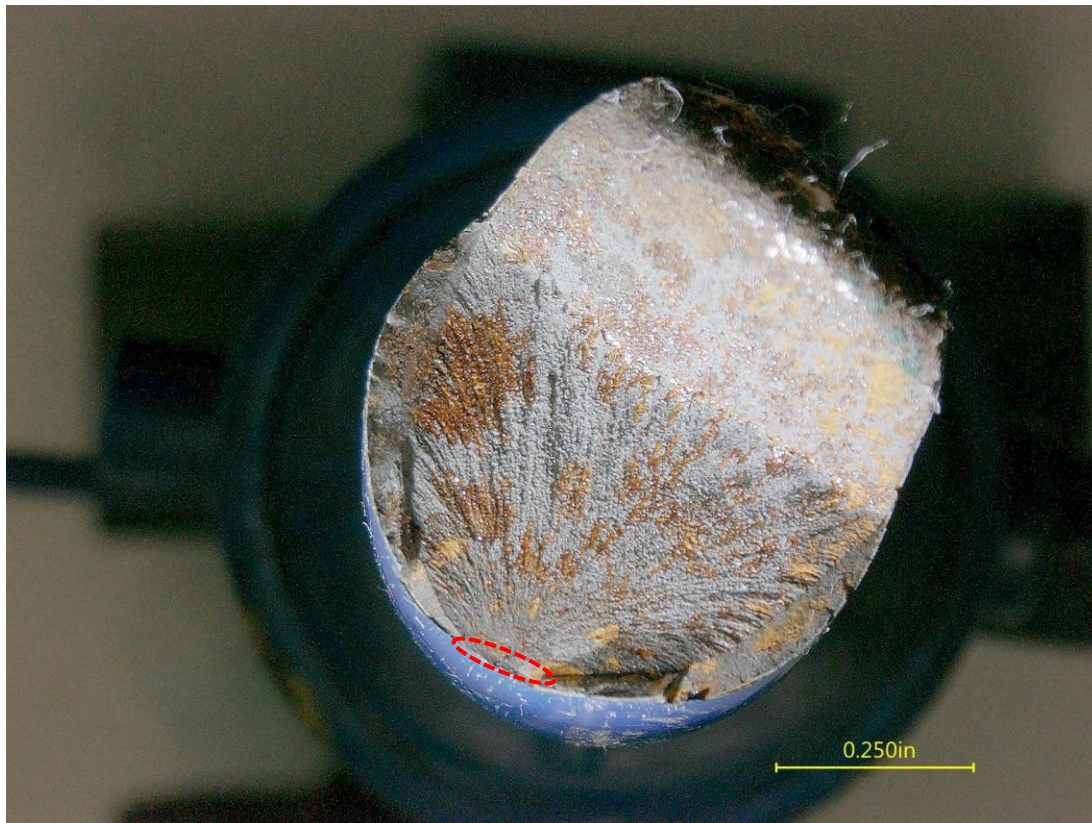
Figure 3: Overview of fracture surface with origin area circled.

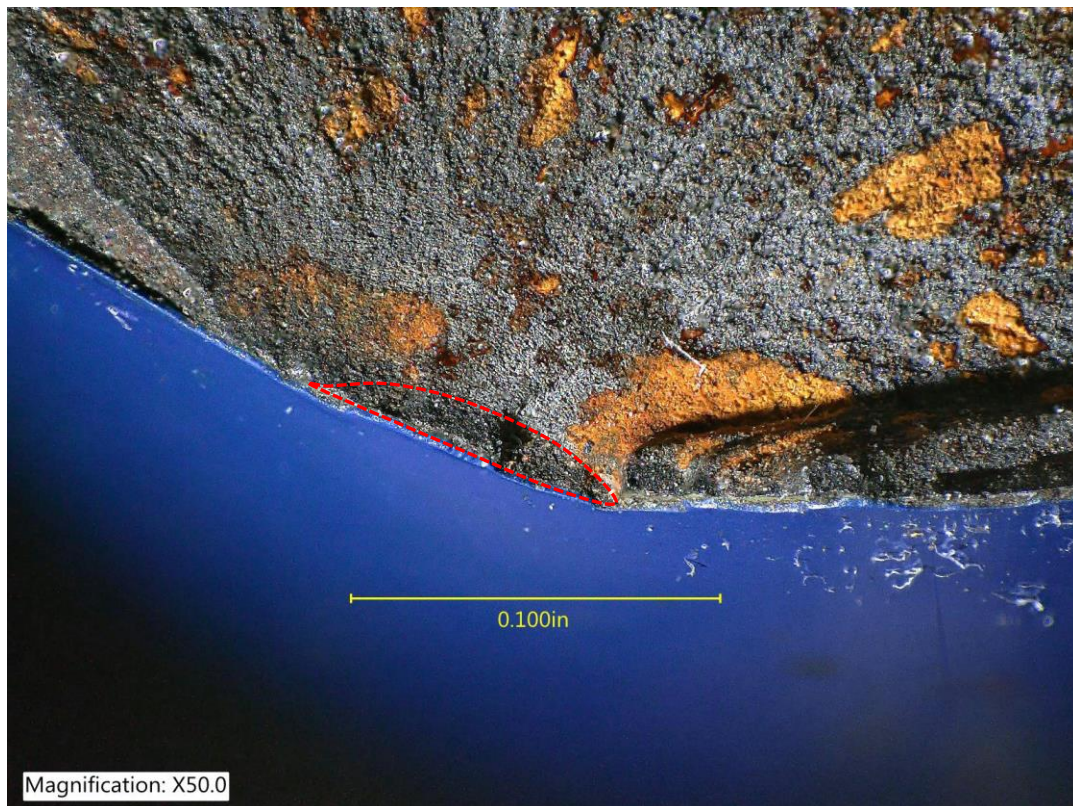
Figure 4: Fatigue fracture region outlined in red.
