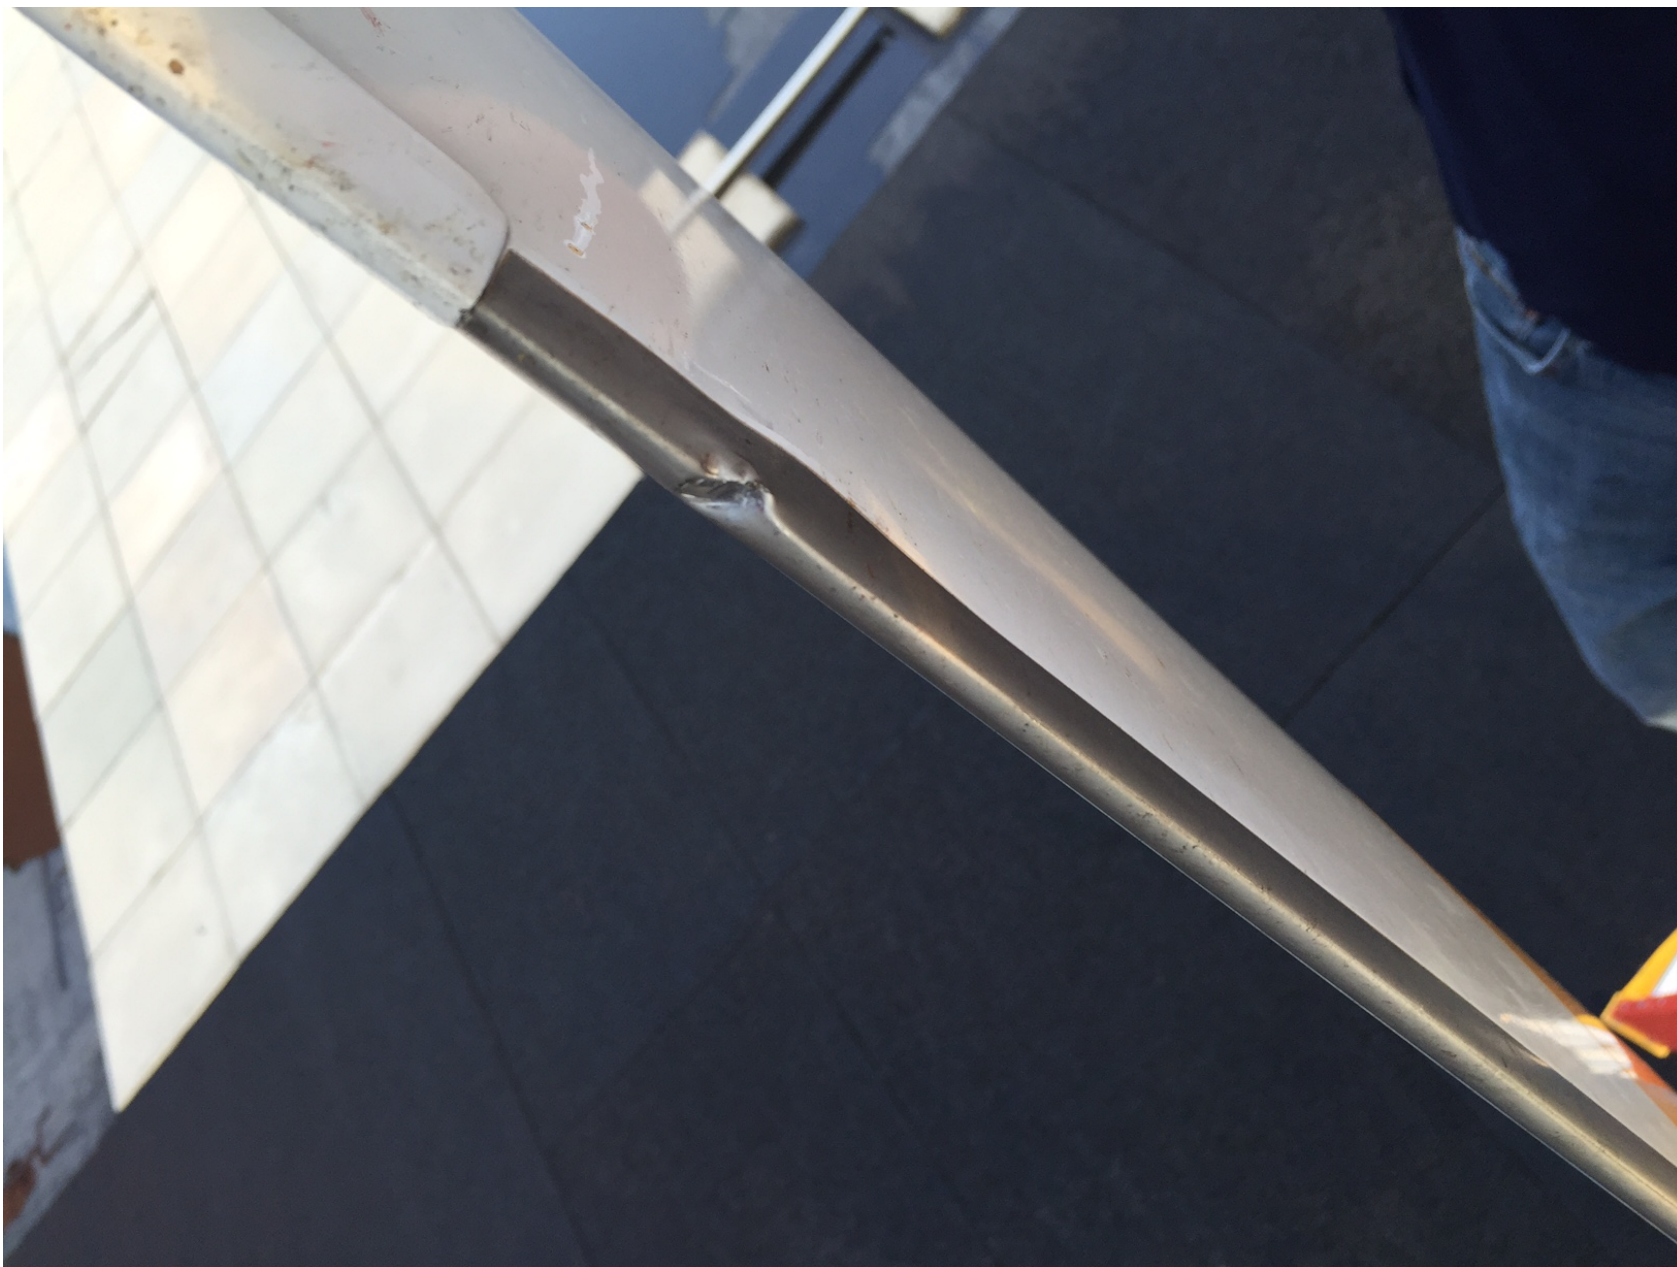
**Photo 1 – Tailrotor Blade Damage (Photo Courtesy of FAA)**

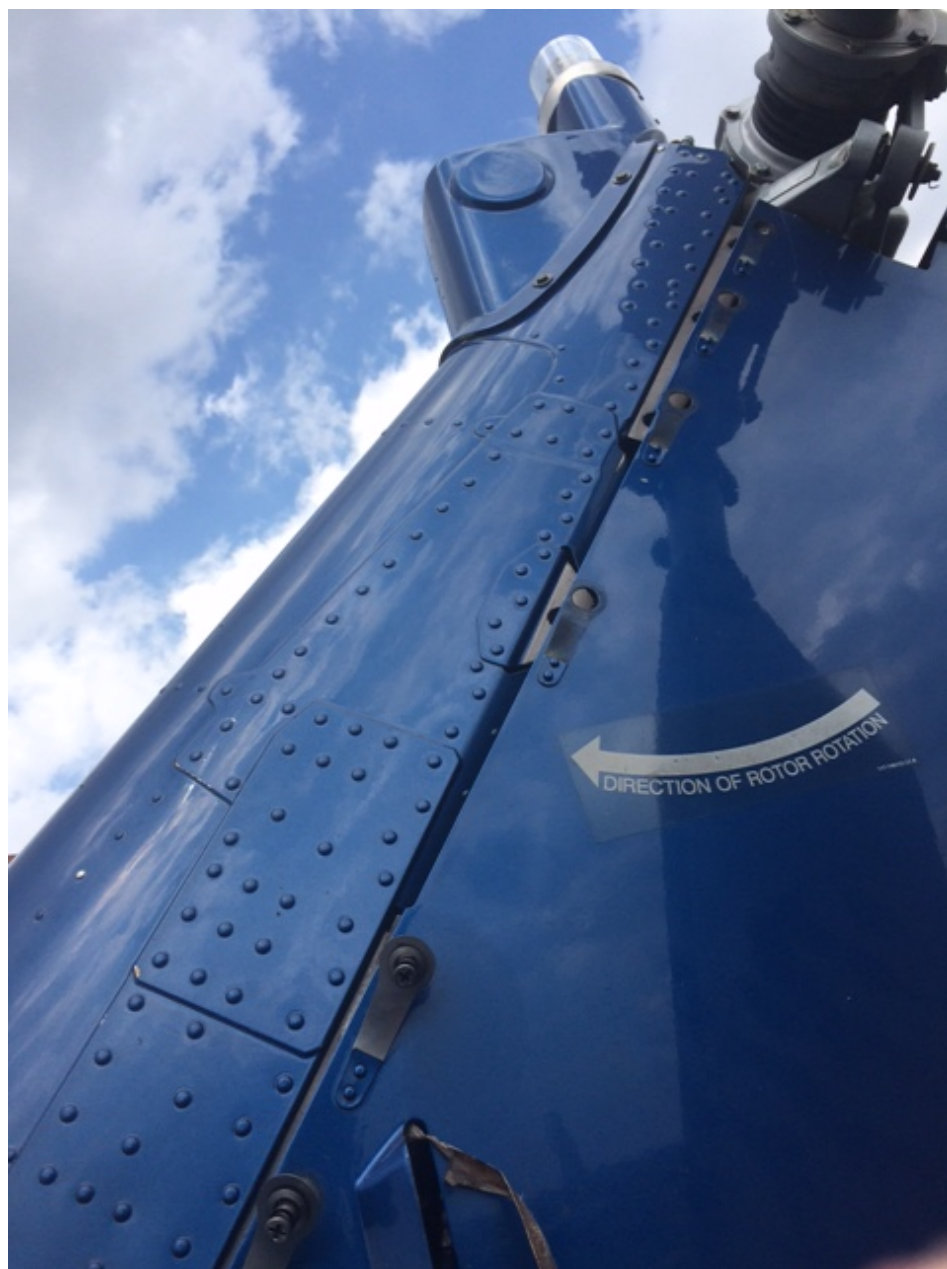
**Photo 2 – Aft Vertical Cowling (Photo Courtesy of FAA)**

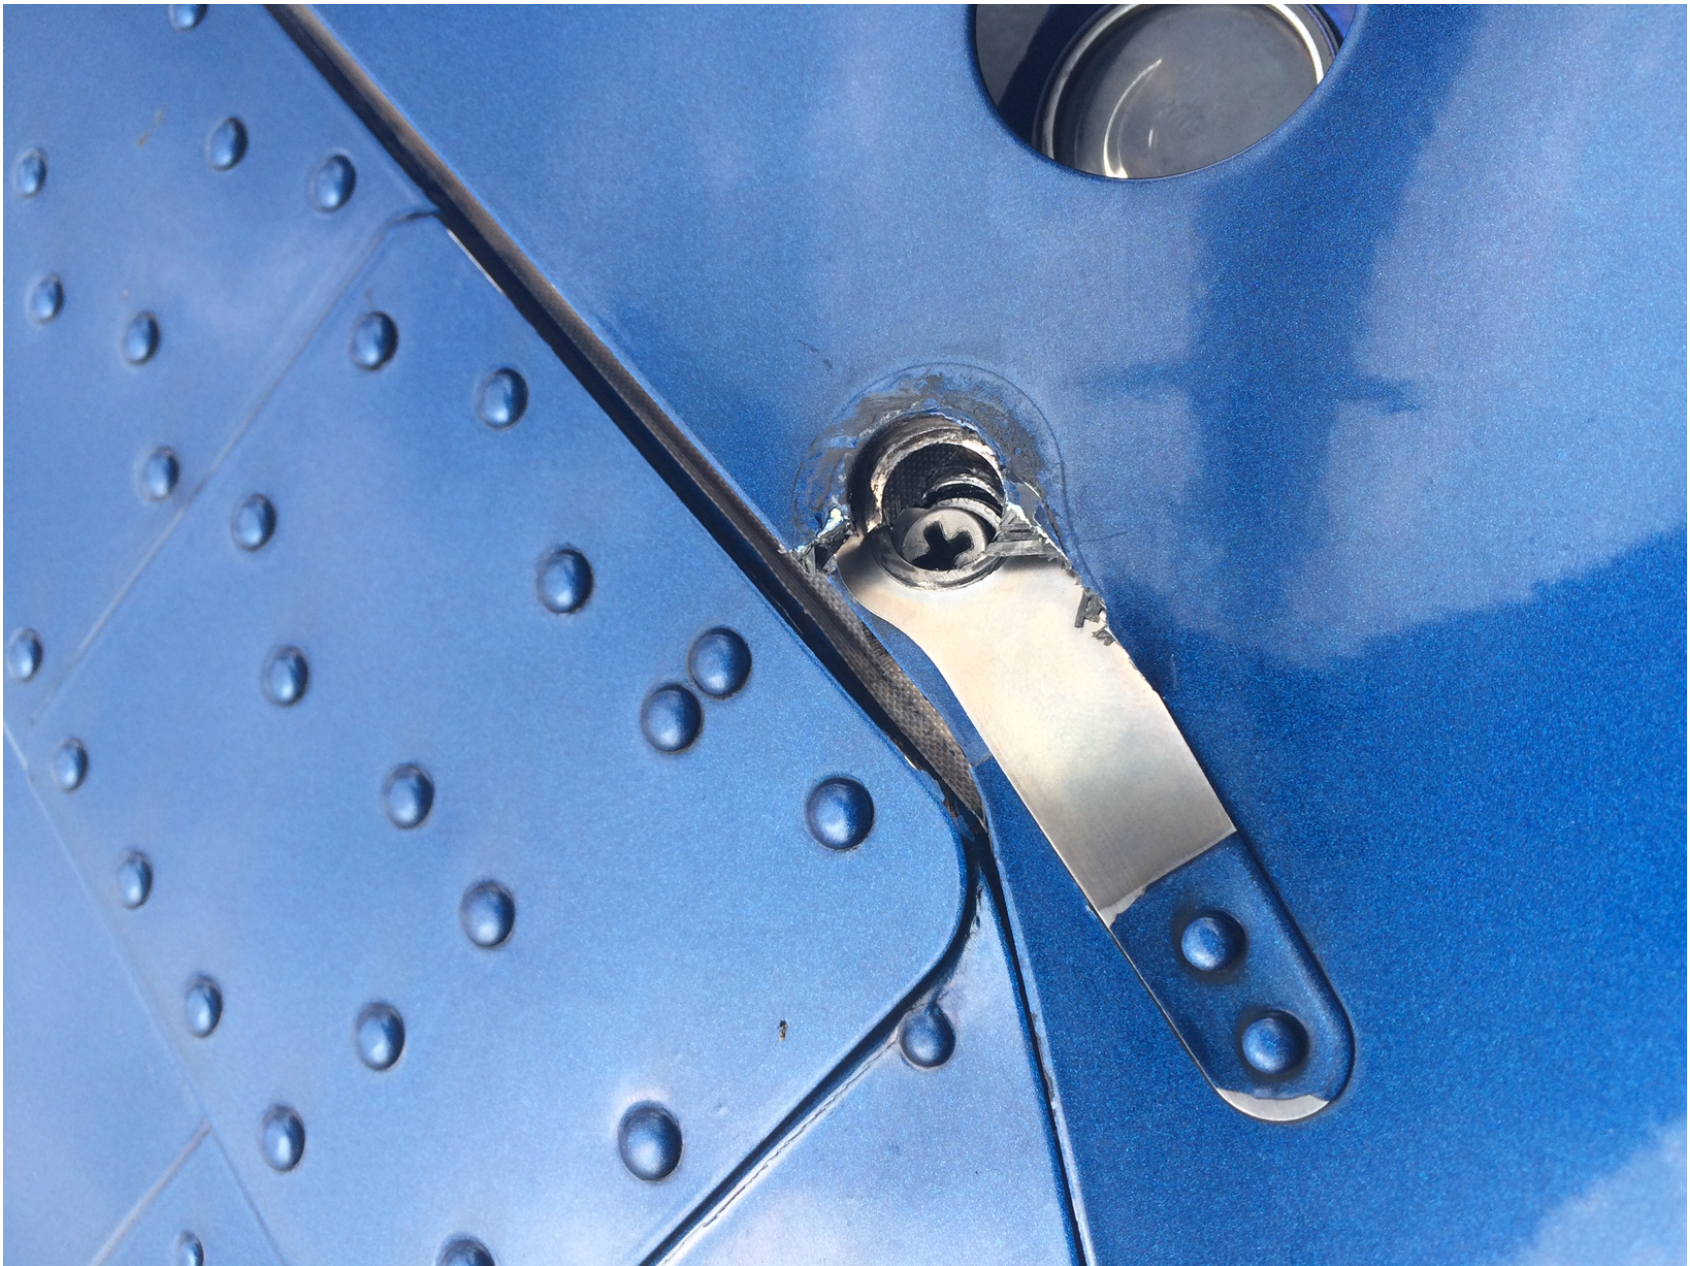
**Photo 3 – Fastener (Photo Courtesy of FAA)**
