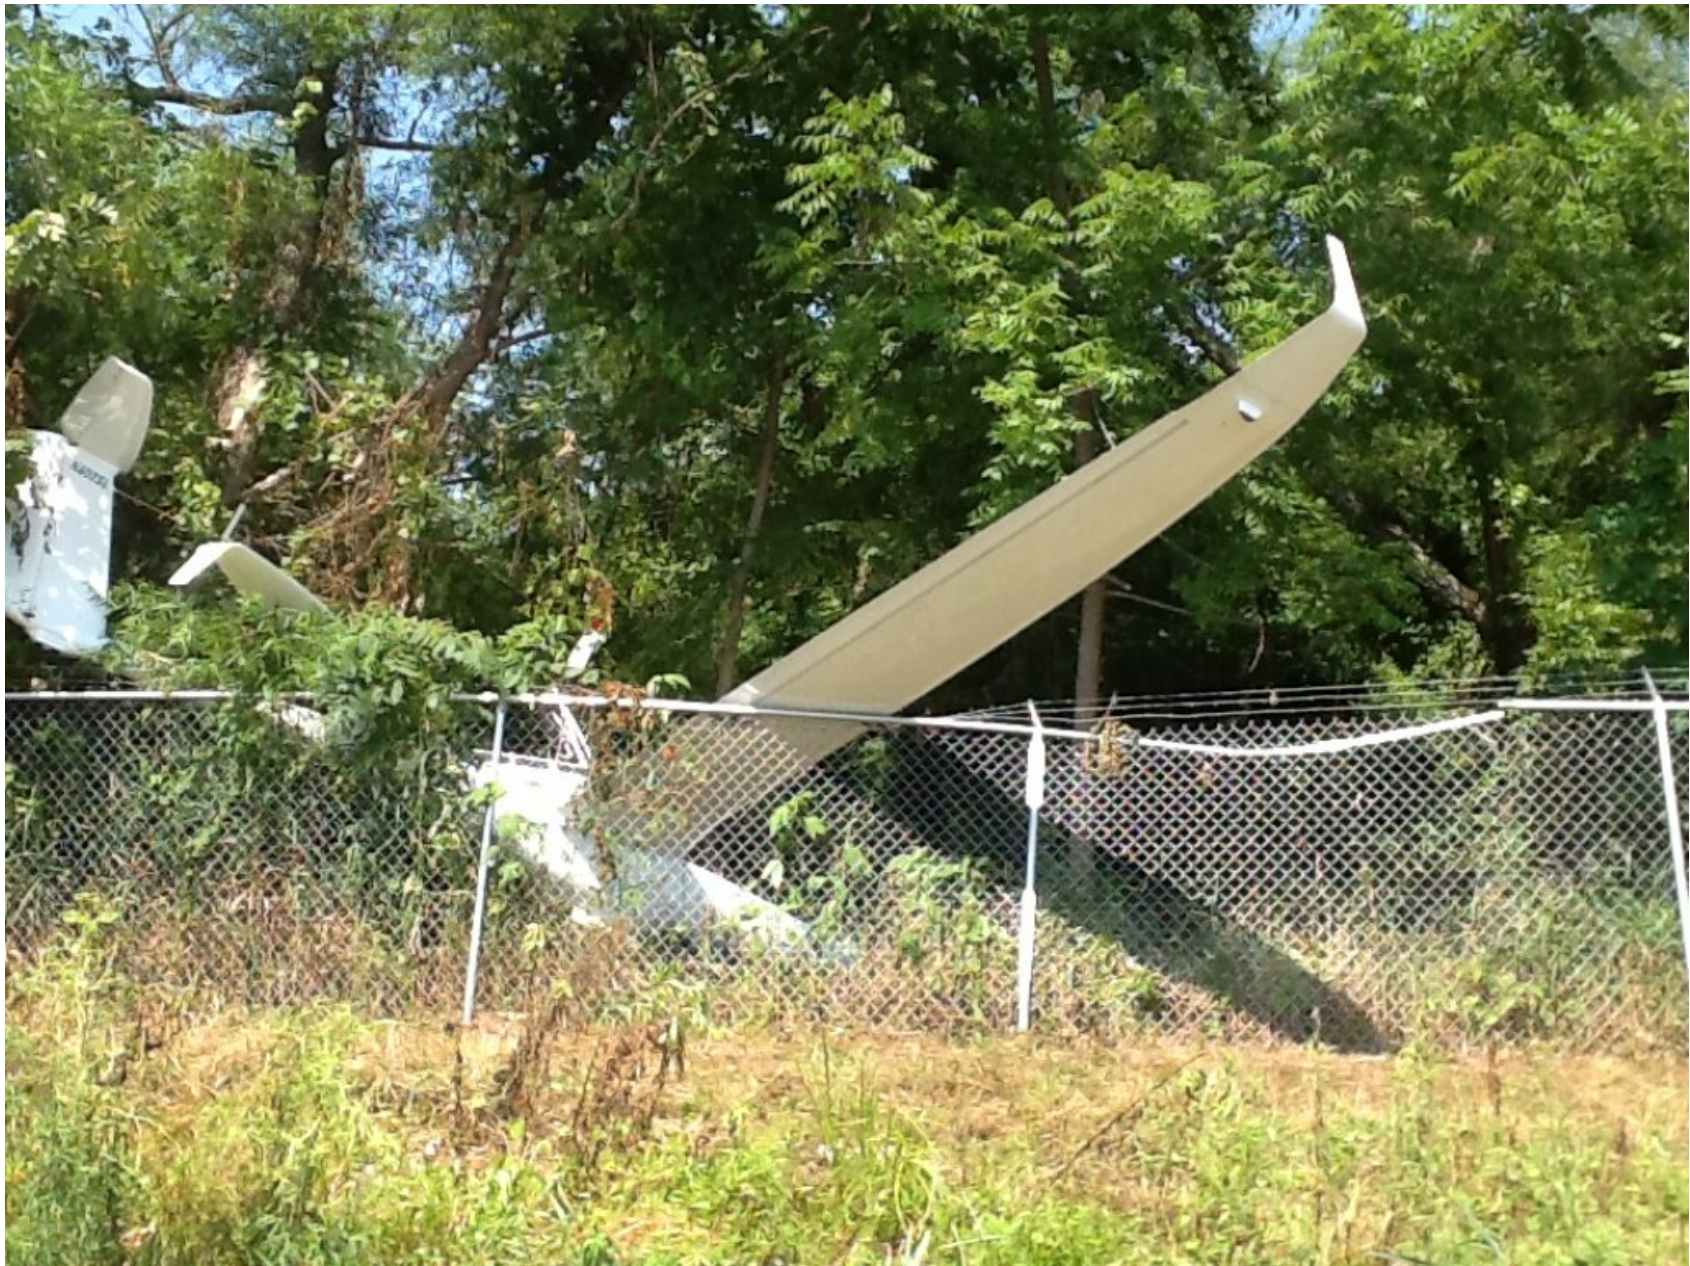
**Photo 1 – Photograph Provided by Recovery Personnel. View of the Aircraft at the Accident Site.**

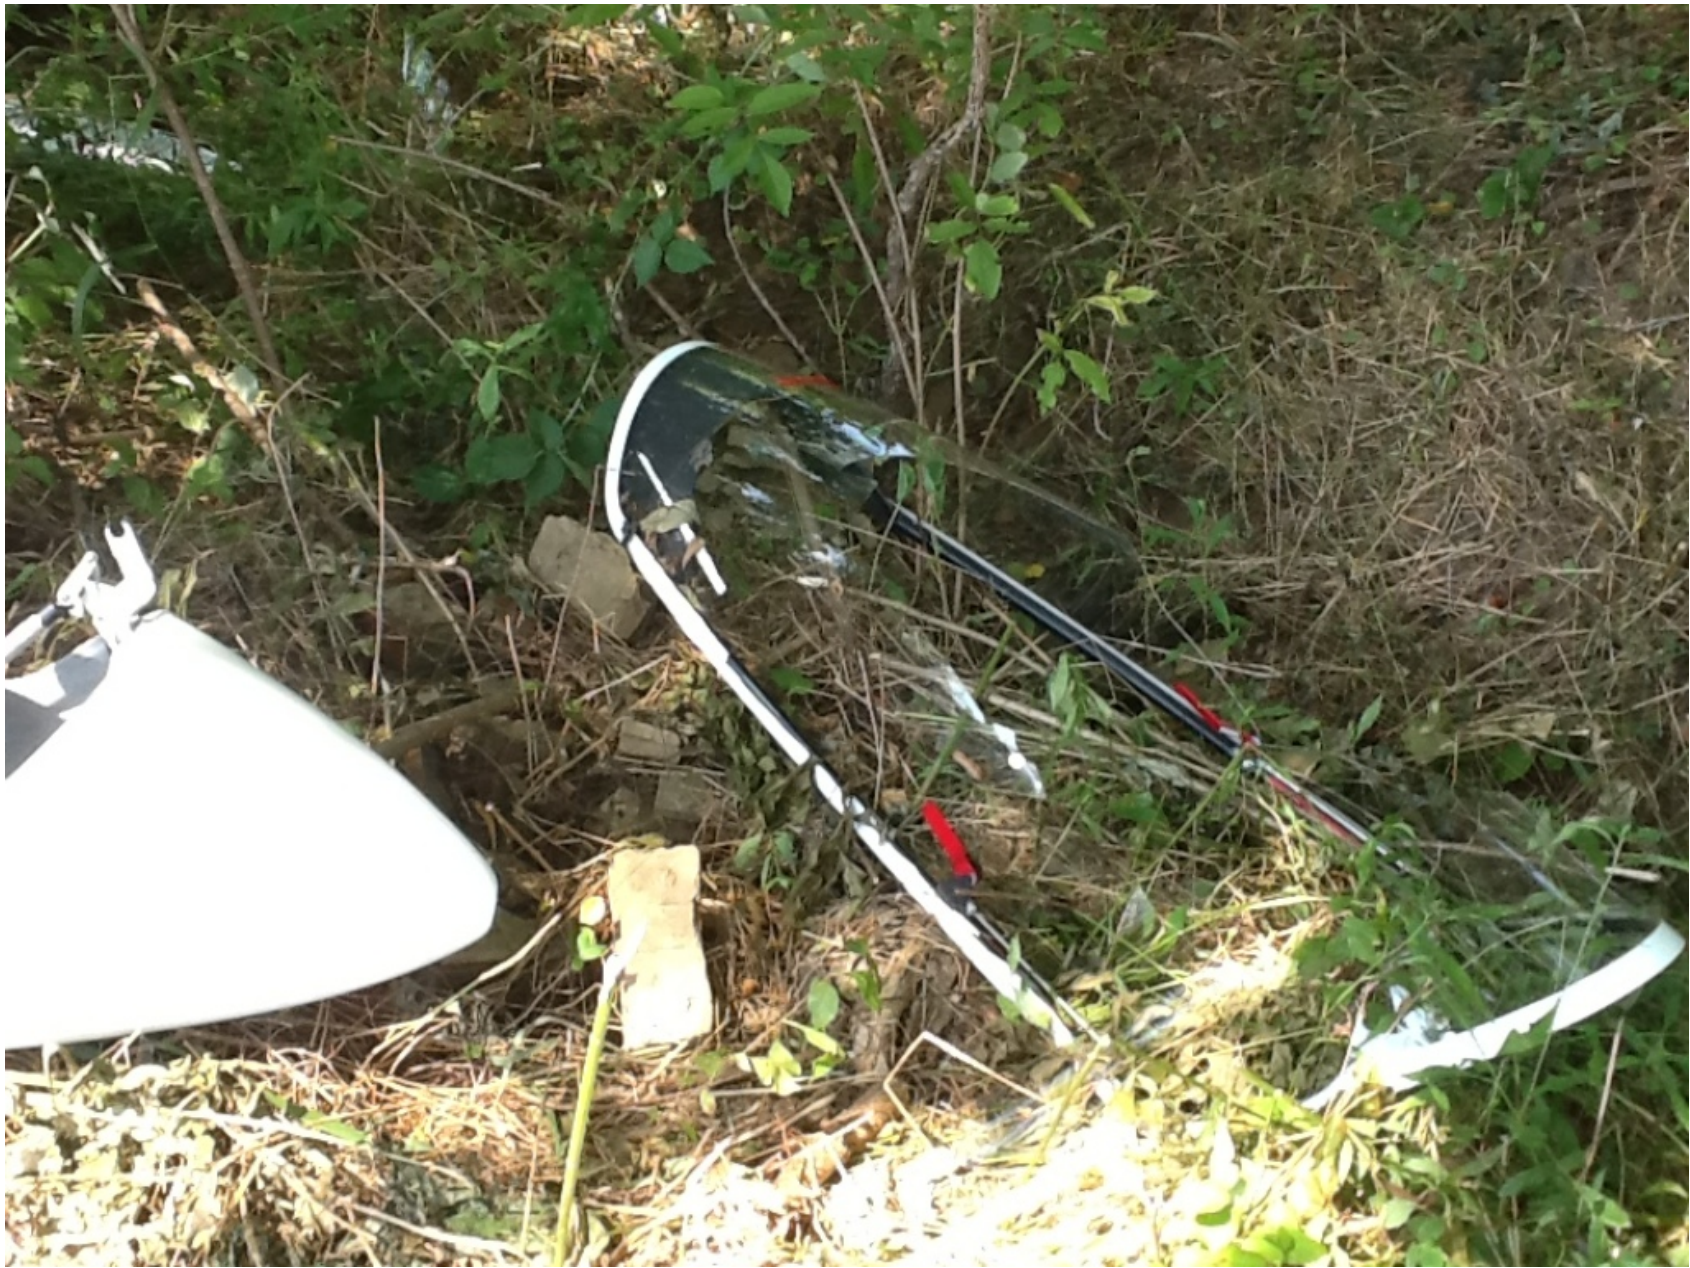
**Photo 2 - Photograph Provided by Recovery Personnel. View of the Canopy at the Accident Site**

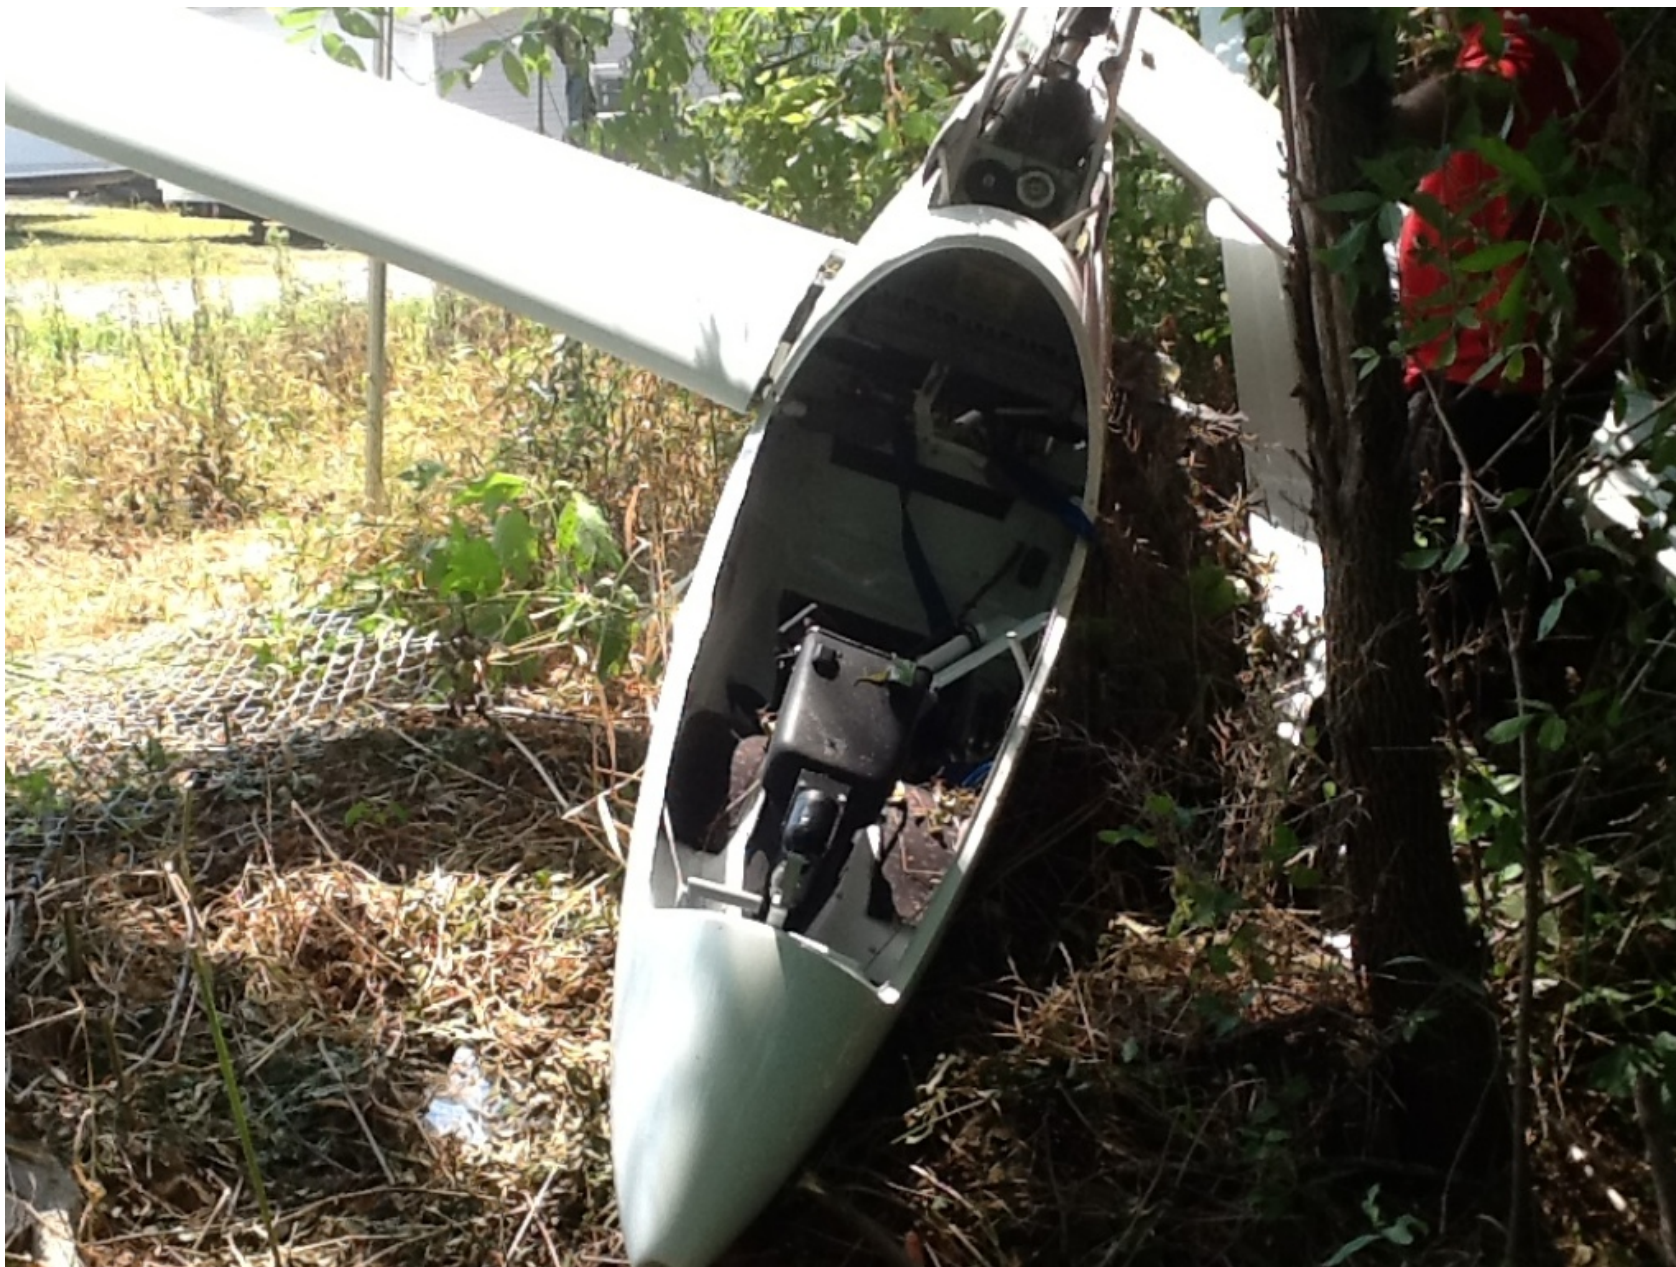
**Photo 3 - Photograph Provided by Recovery Personnel. View of the Cockpit Showing the Detached Canopy**

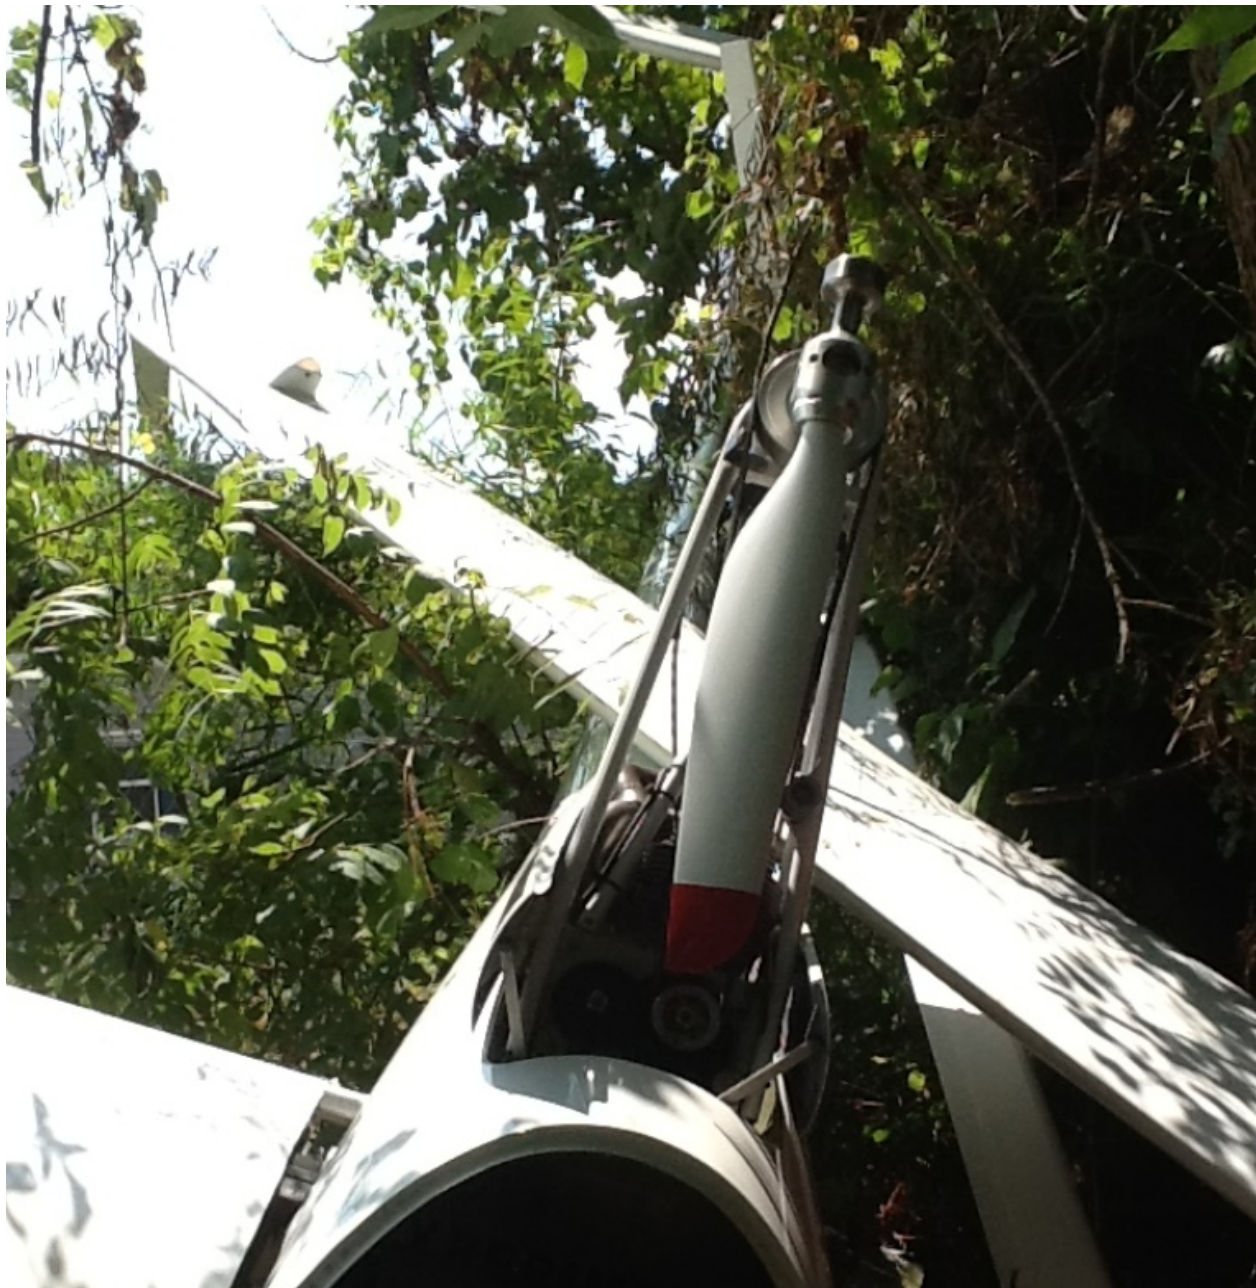
**Photo 4 - Photograph Provided by Recovery Personnel. View of the Extended Engine and Propeller**

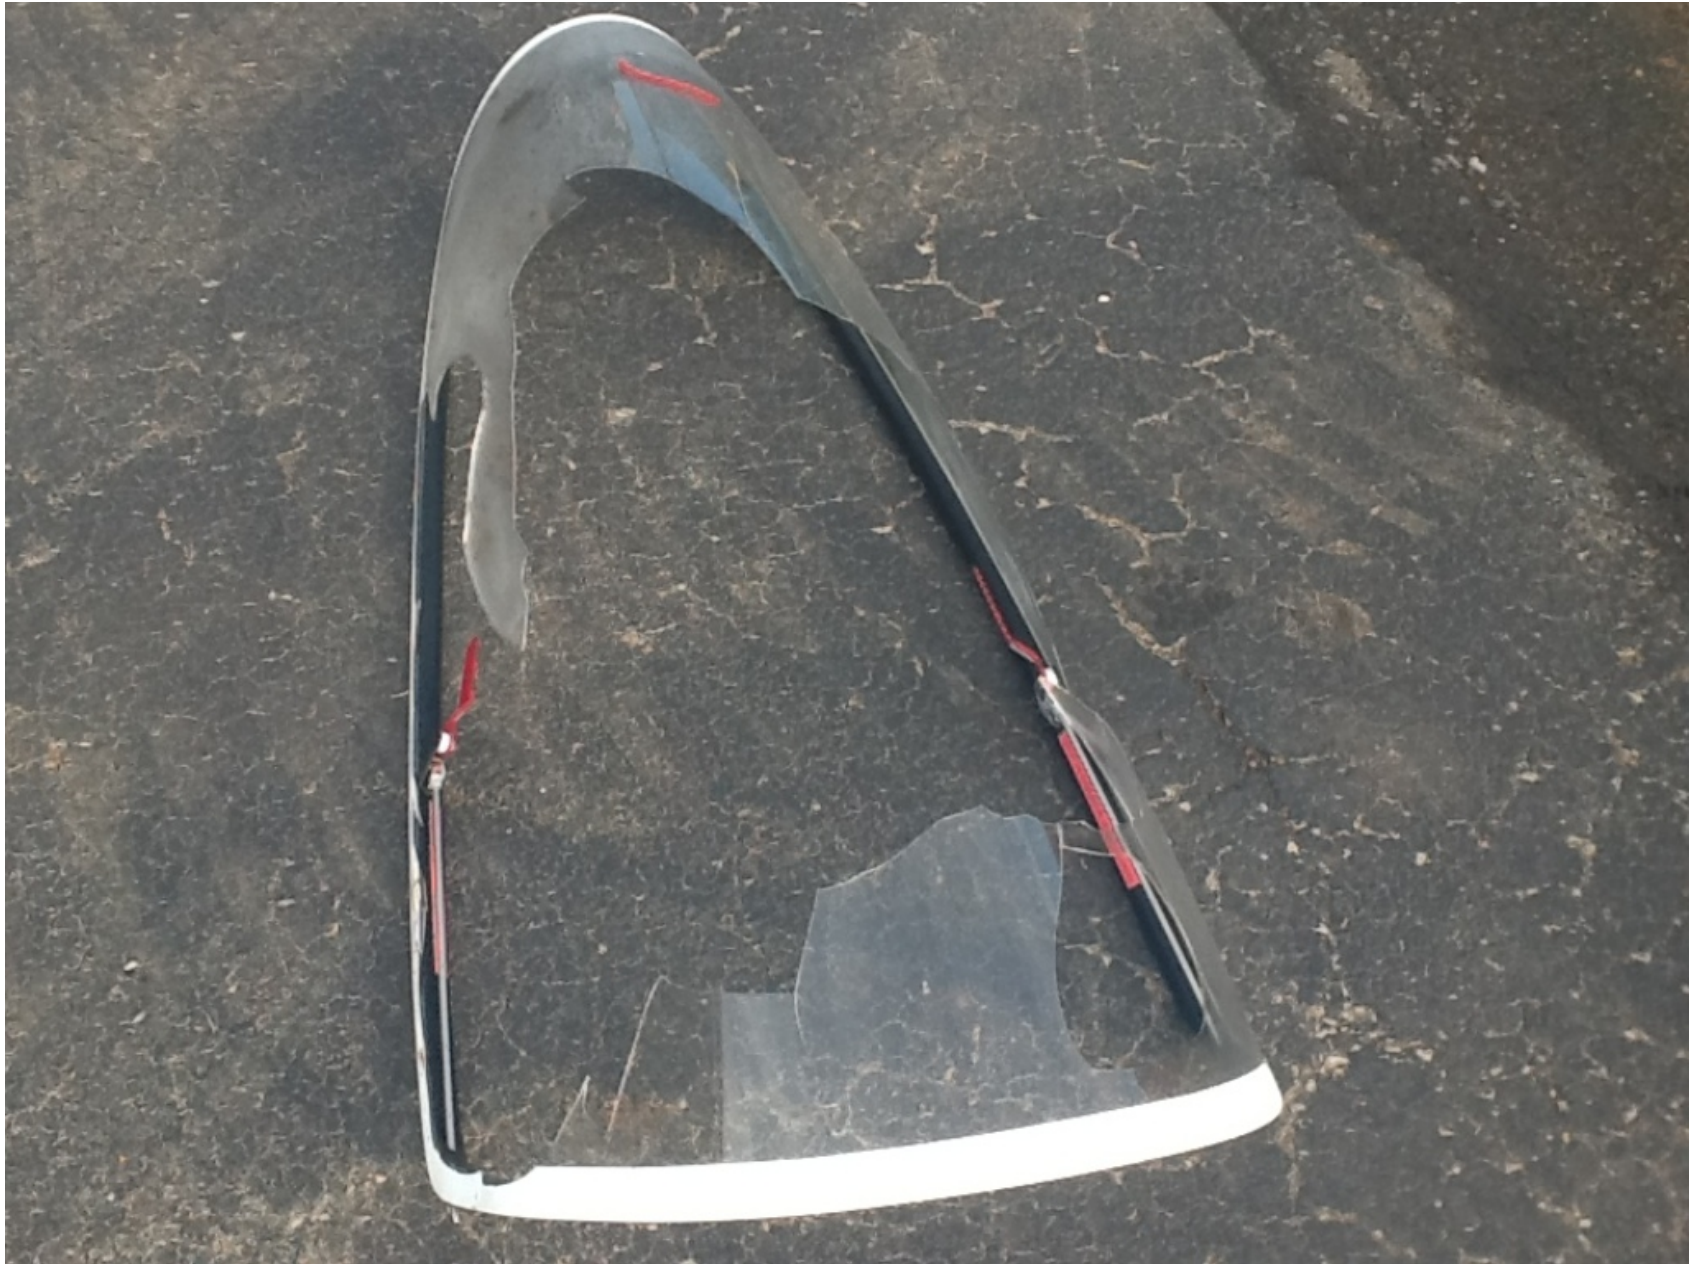
**Photo 5 - Photograph Provided by Recovery Personnel. View of the Canopy. Note the Position of the Left and Right Canopy Latches**

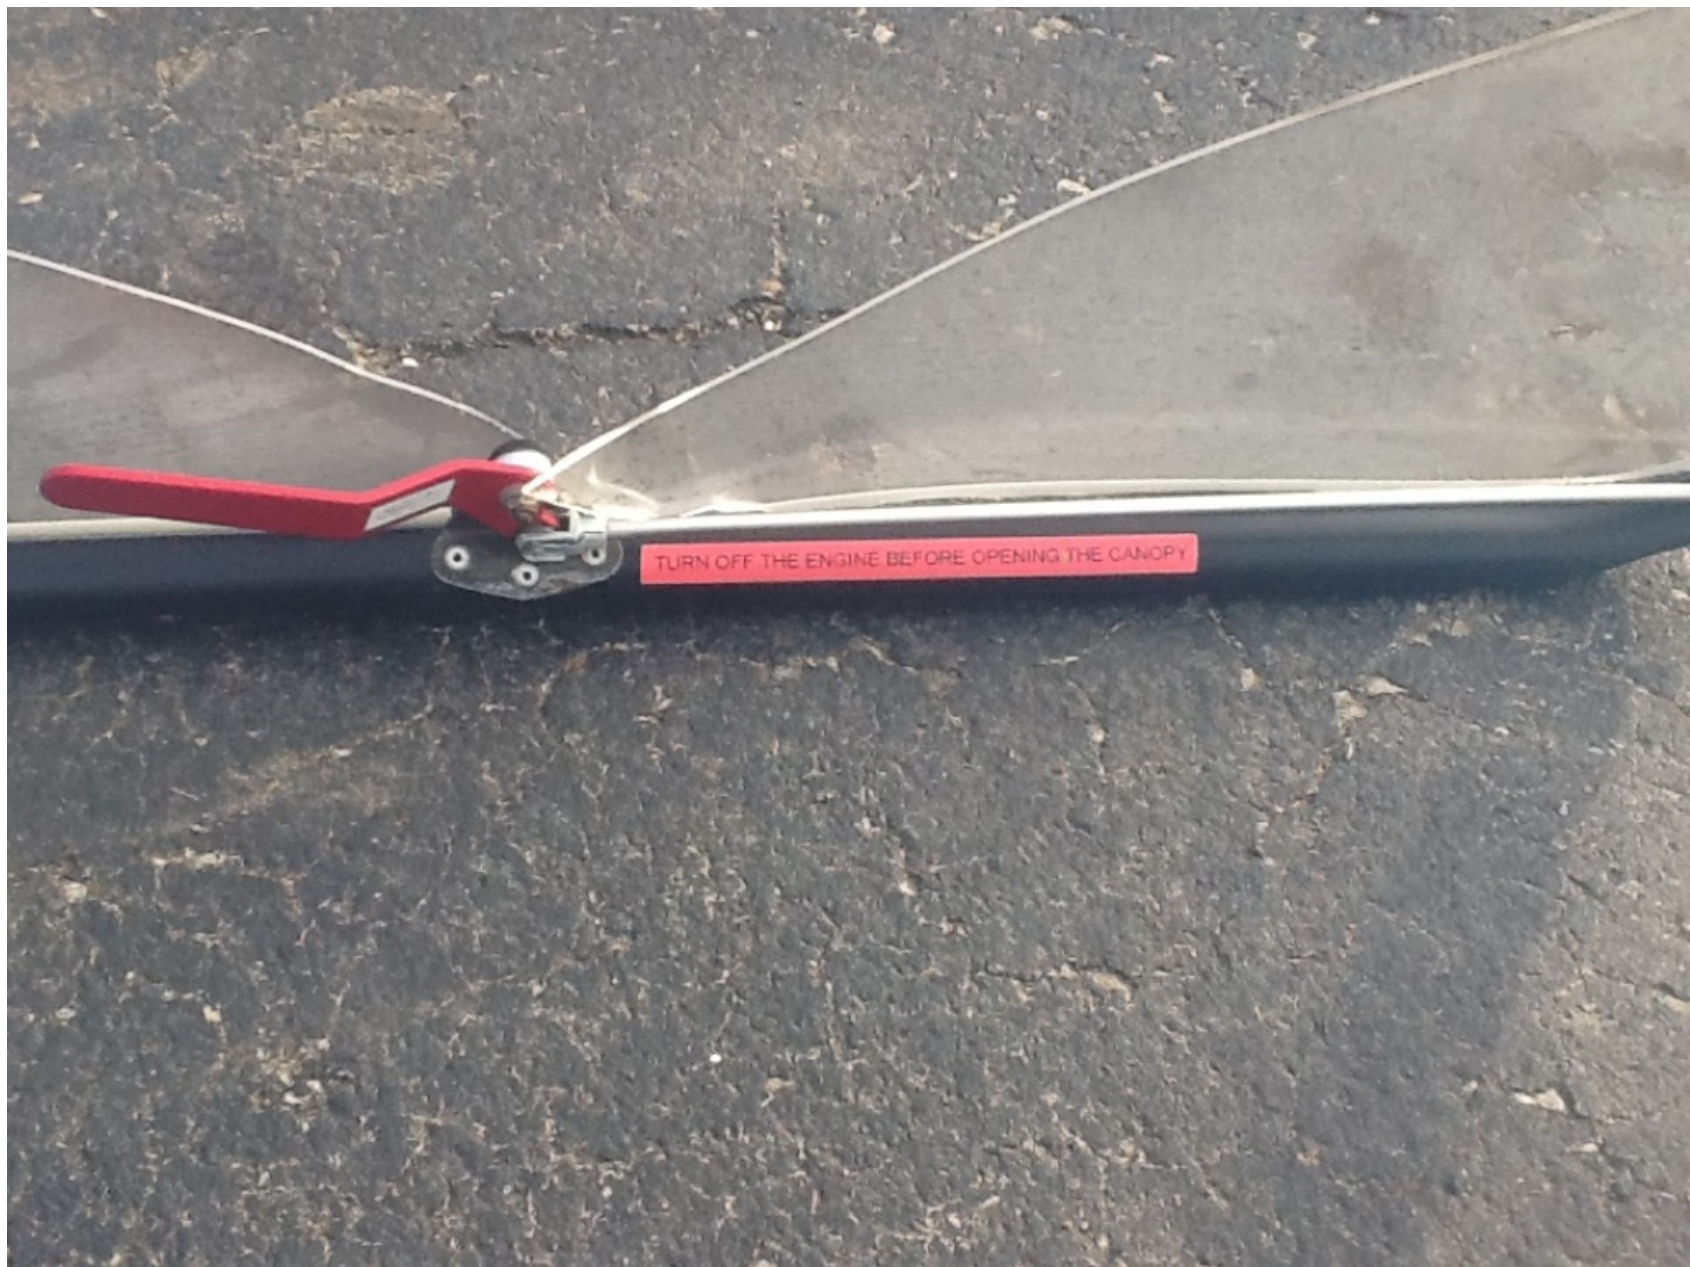
**Photo 6 - Photograph Provided by Recovery Personnel. View of the Right Canopy Latch Handle**

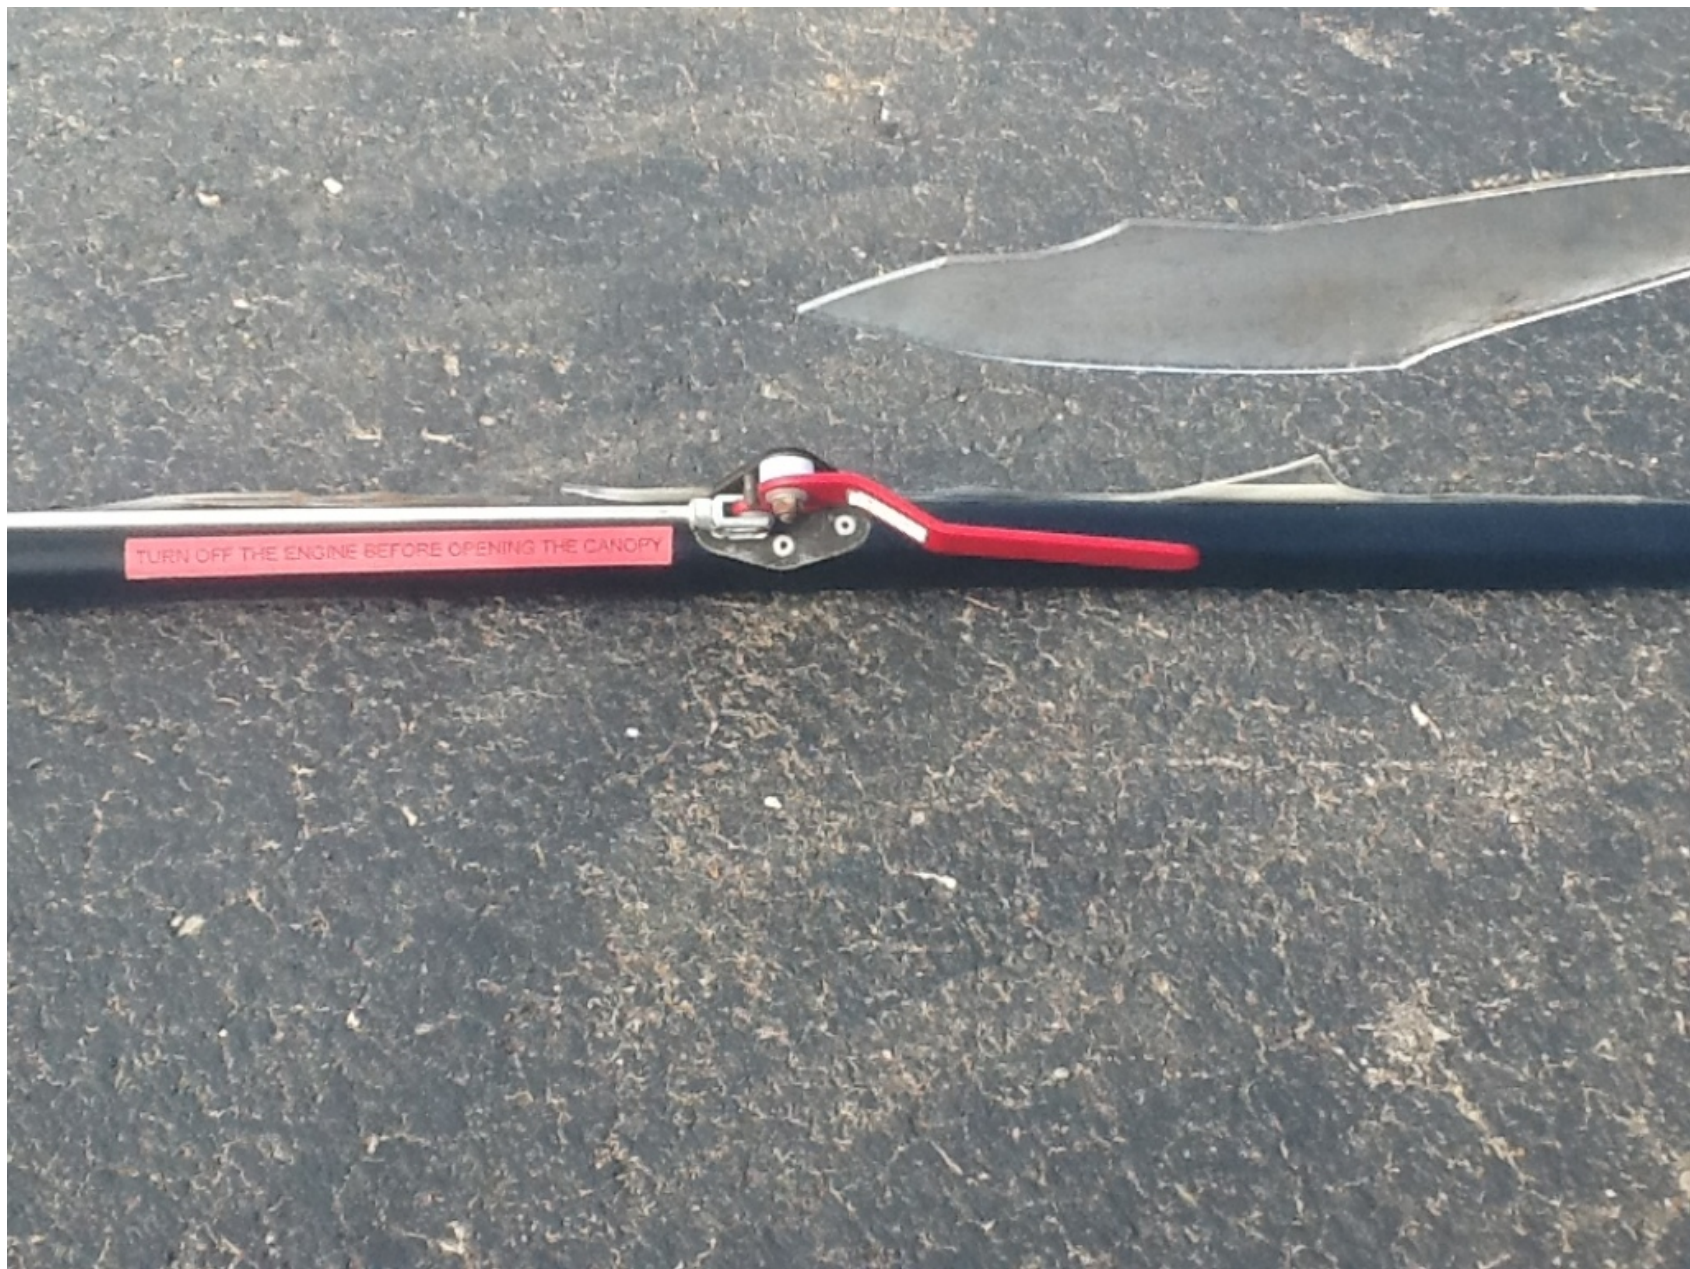
**Photo 7 - Photograph Provided by Recovery Personnel. View of the Left Canopy Latch Handle**

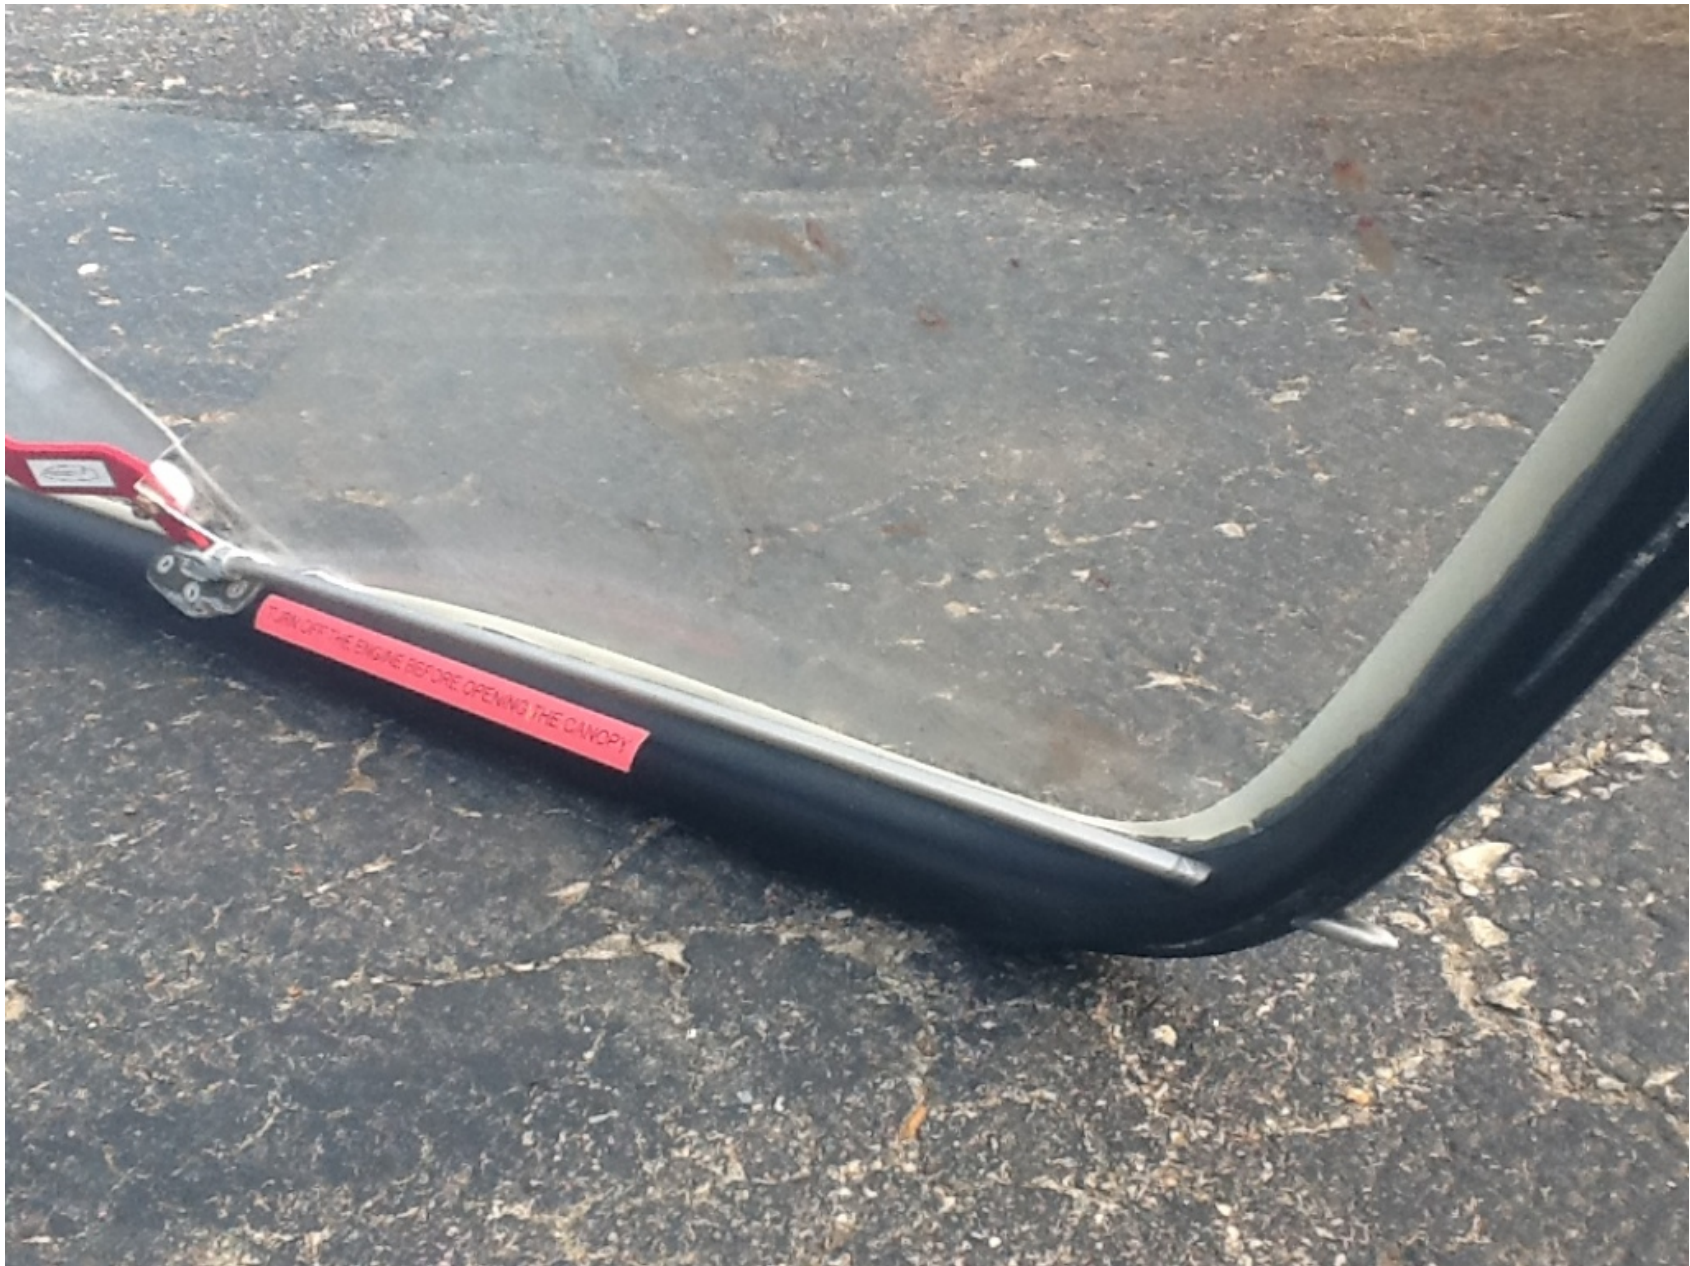
**Photo 8 - Photograph Provided by Recovery Personnel. View of the Right Canopy Latch Assembly Depicting the Pin Extending Beyond the Canopy Frame**

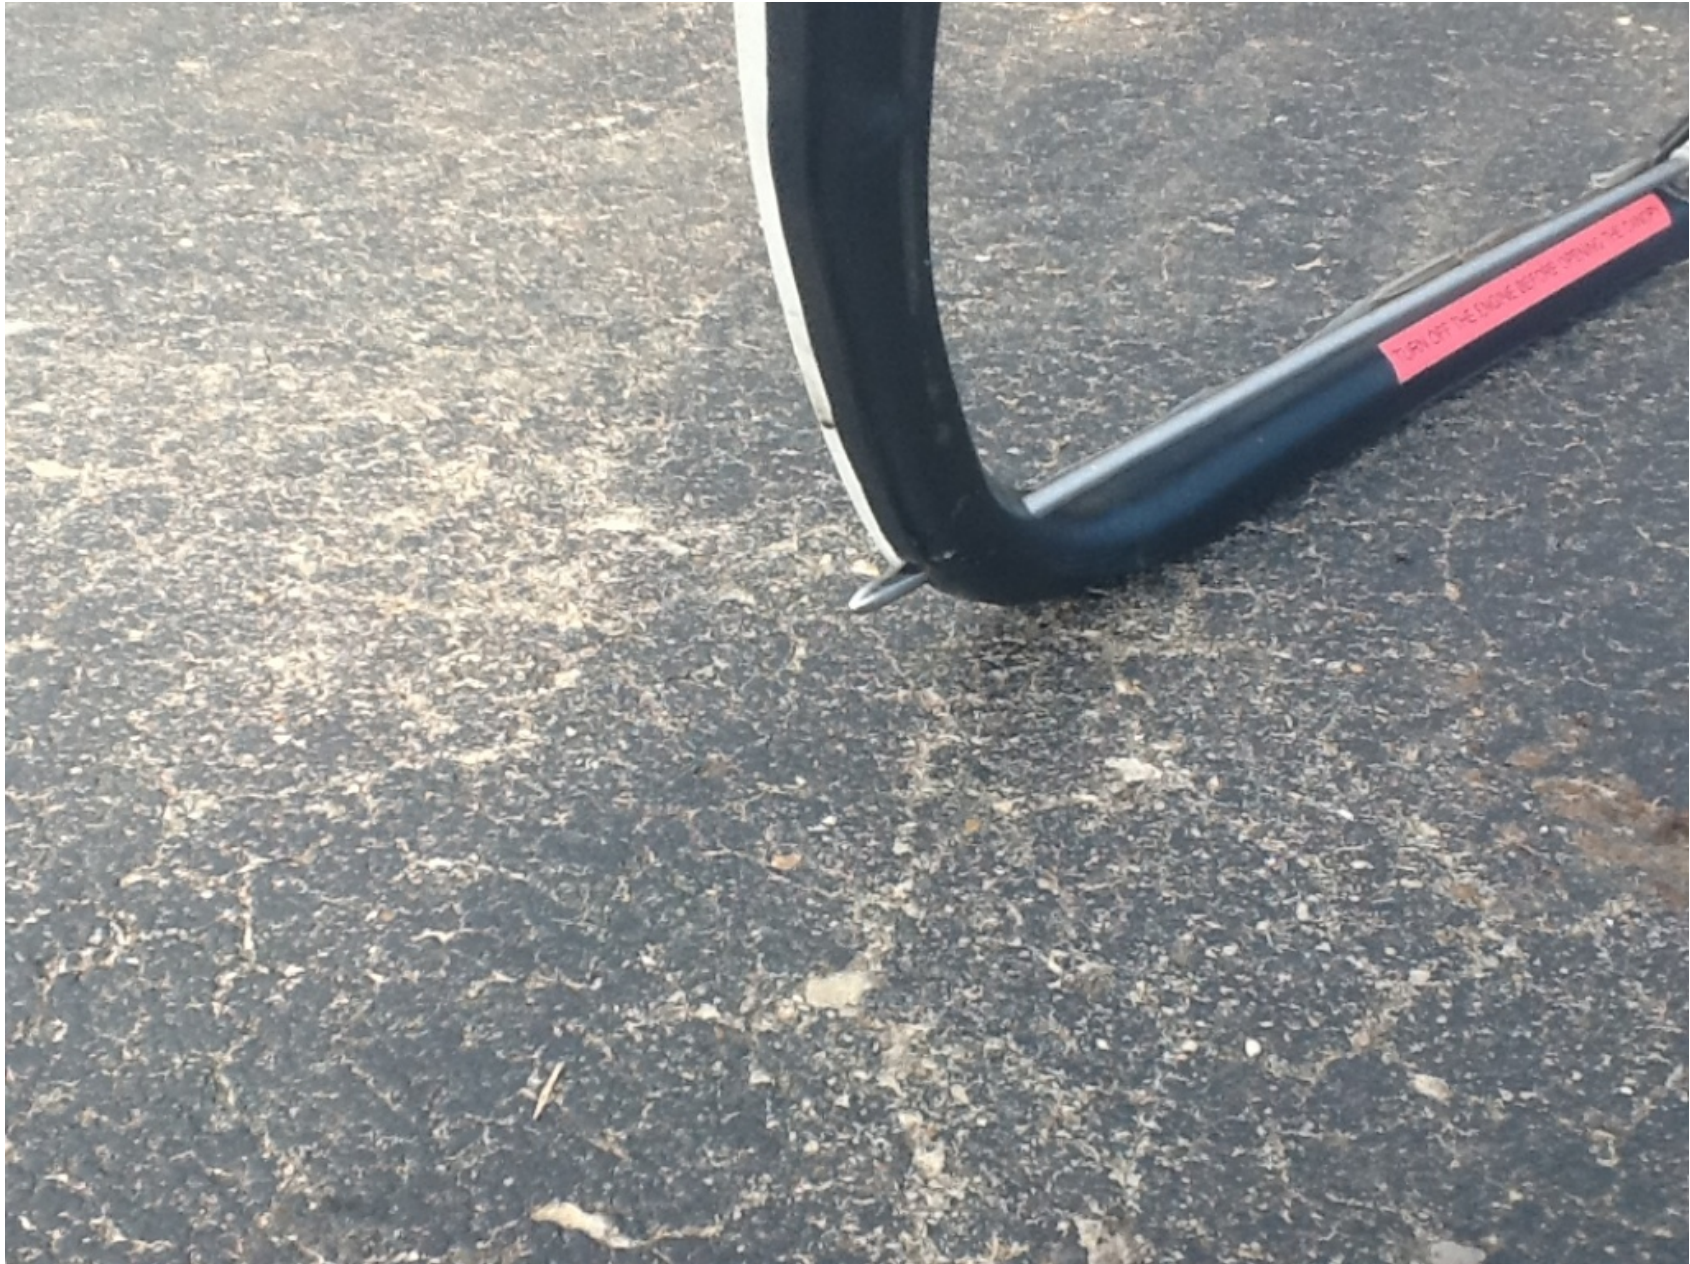
**Photo 9 - Photograph Provided by Recovery Personnel. View of the Left Canopy Latch Assembly Depicting the Pin Extending Beyond the Canopy Frame**

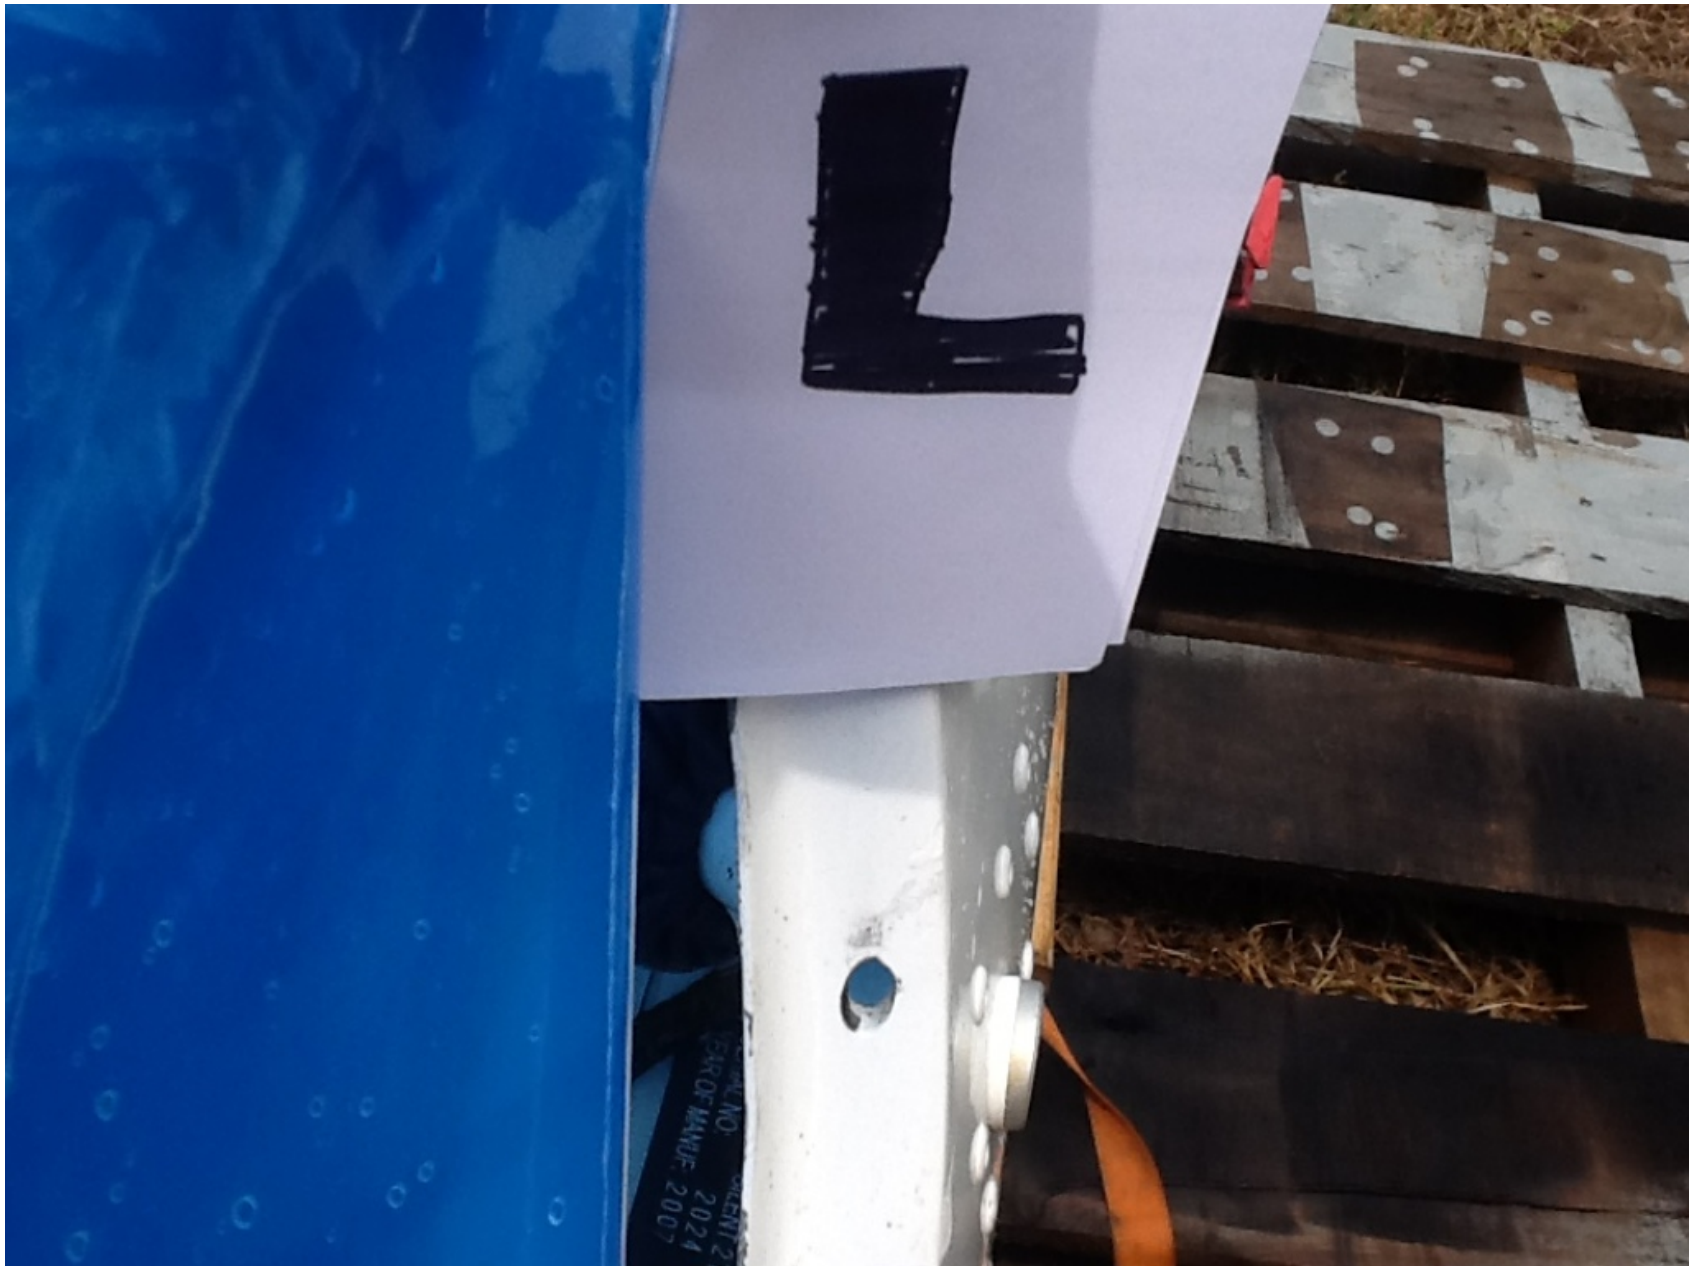
**Photo 10 - Photograph Provided by Recovery Personnel. View of the Left Canopy Latch Pin Receiver**

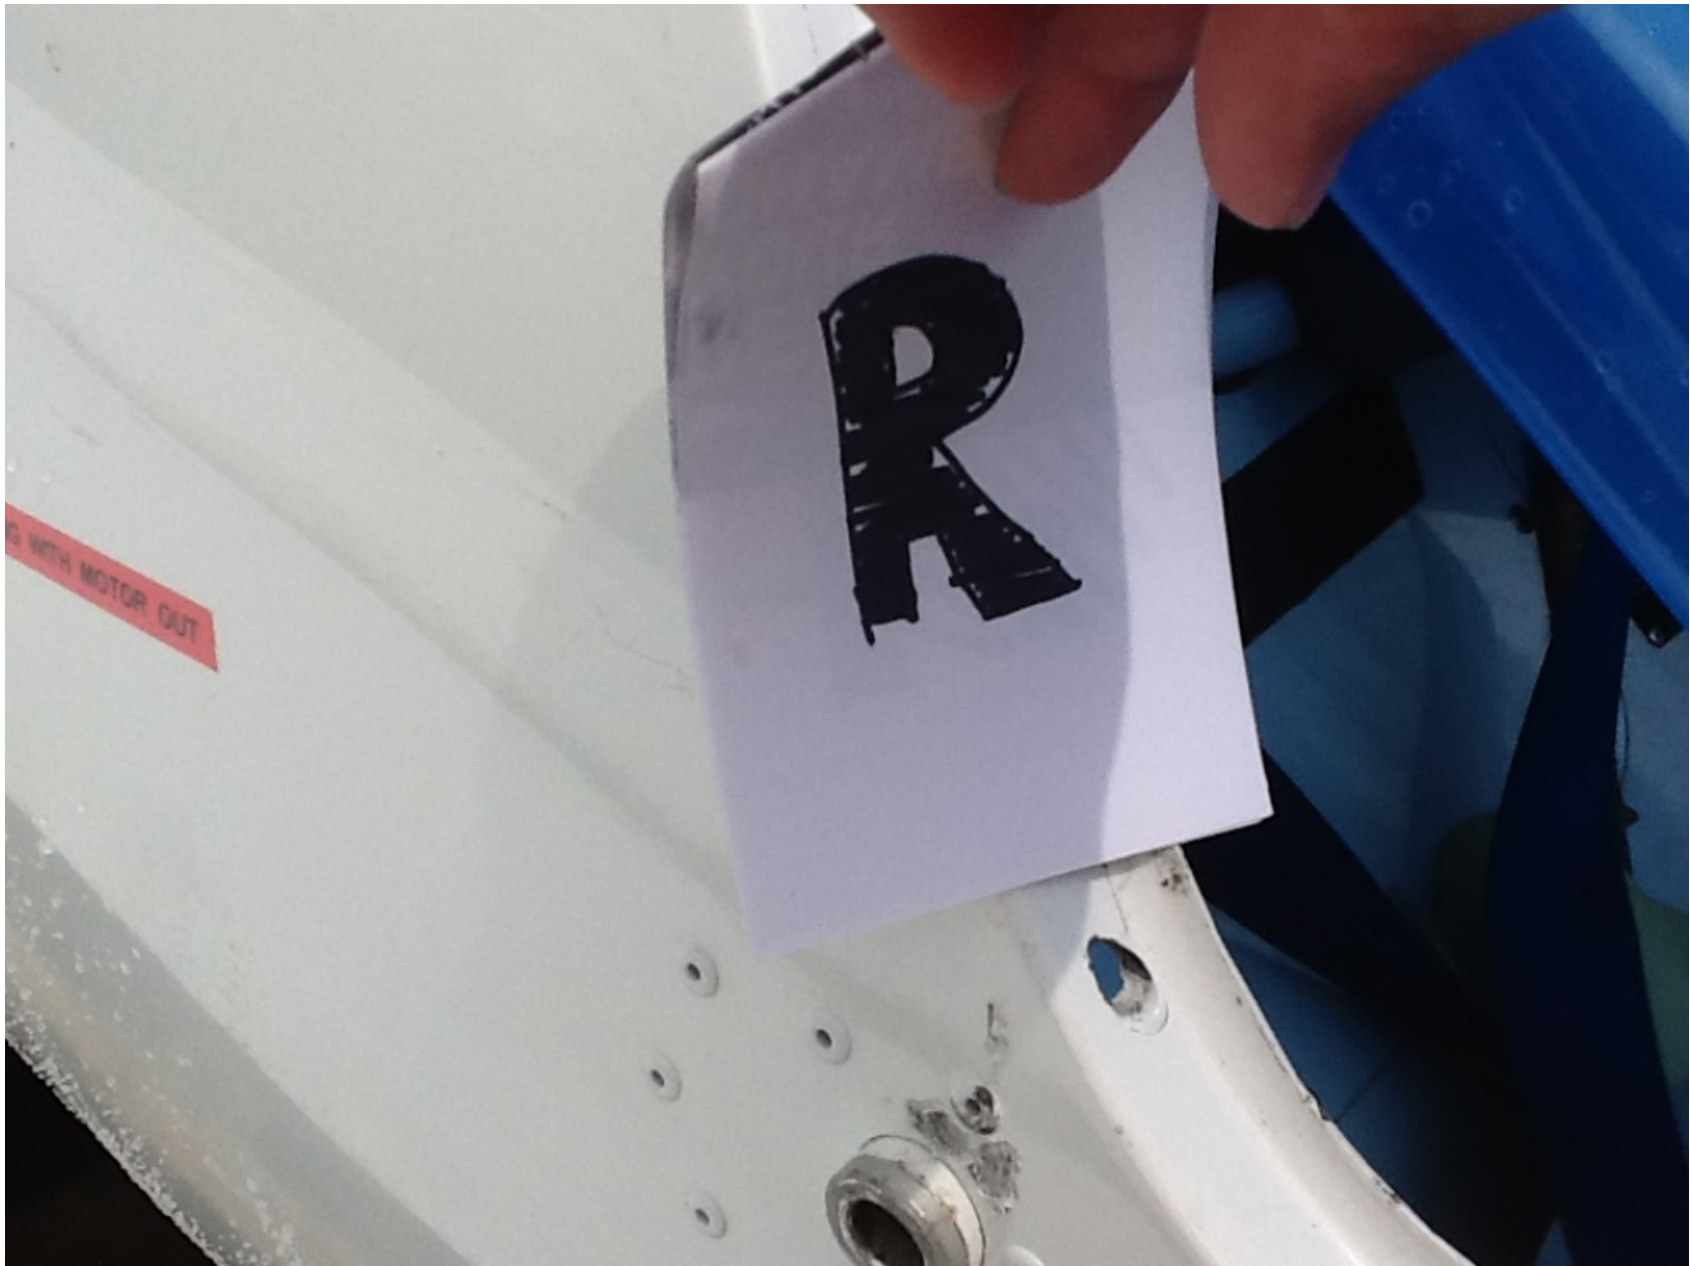
**Photo 11 - Photograph Provided by Recovery Personnel. View of the Right Canopy Latch Pin Receiver**
