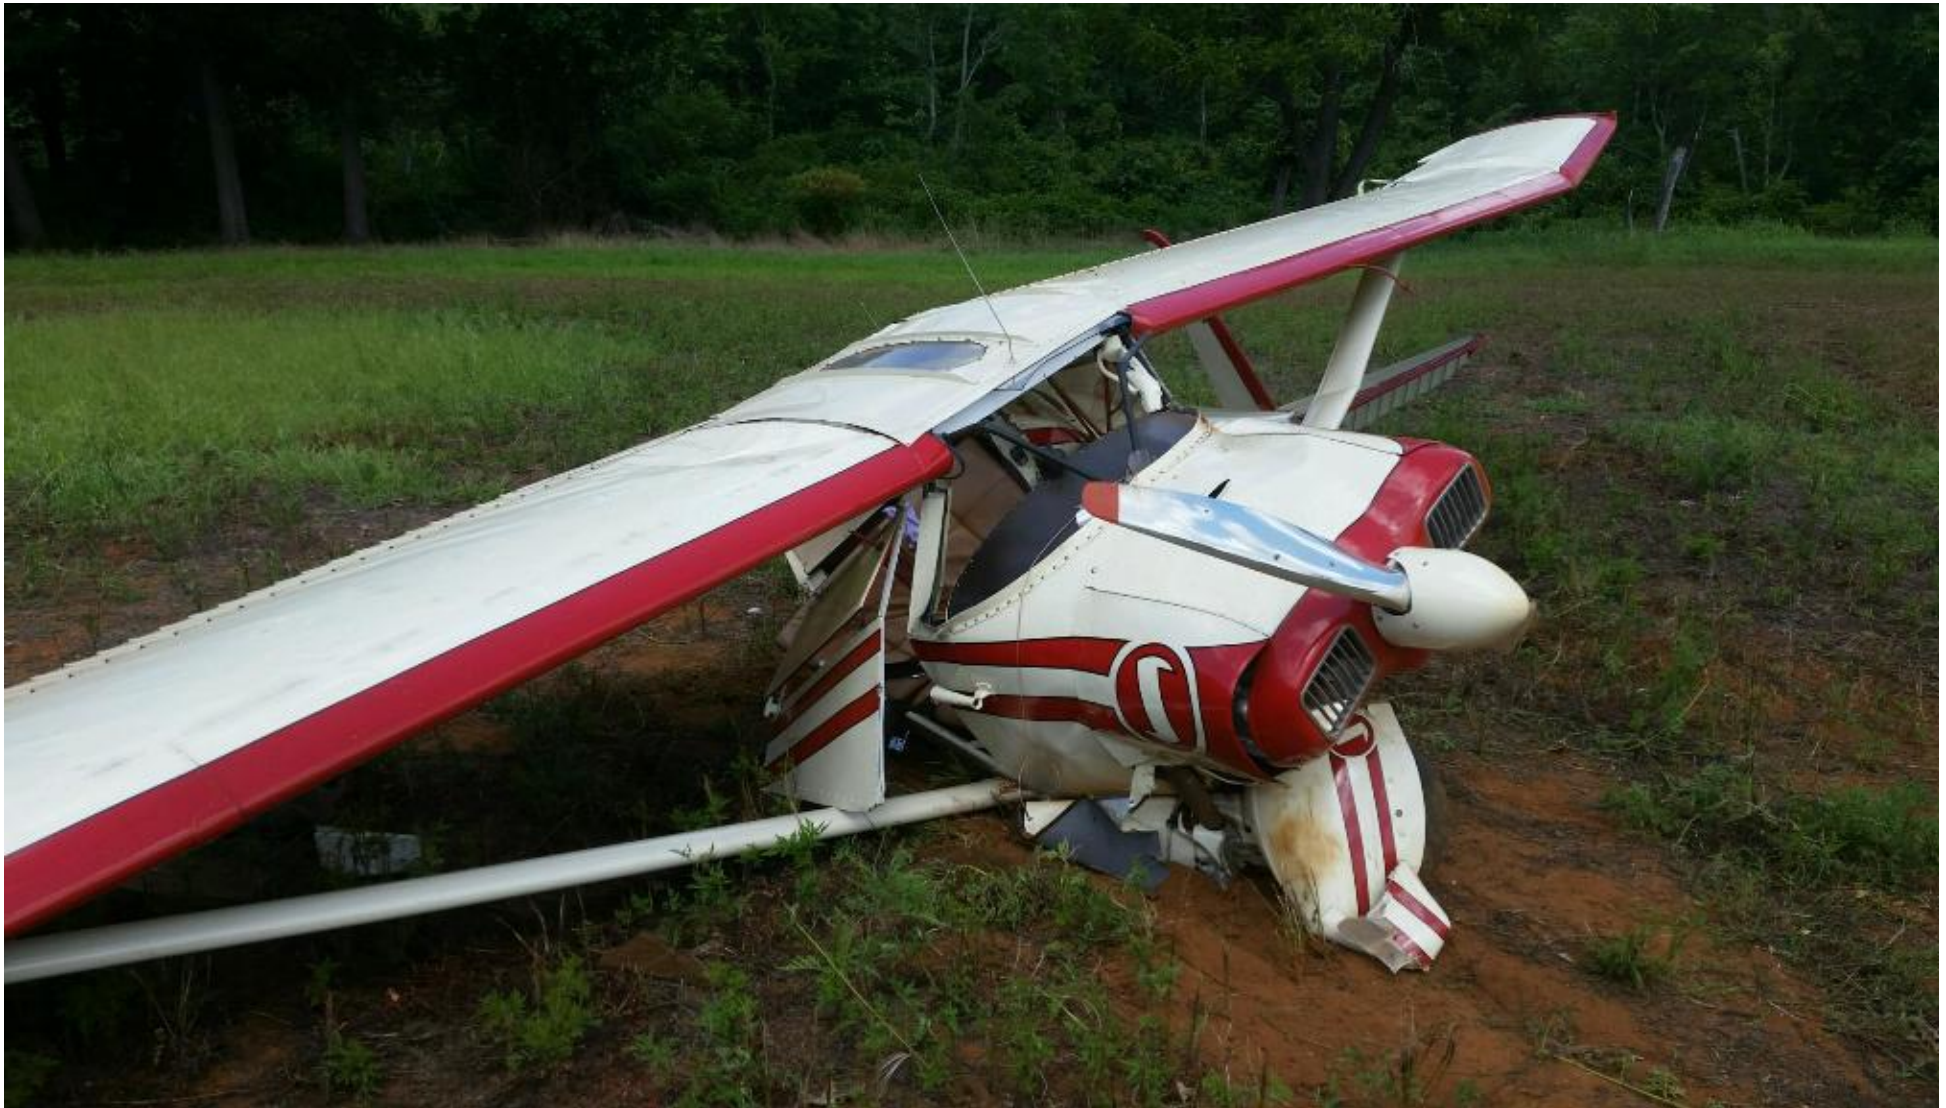
**Photo 1 – Digital Photograph from NTSB Duty Officer. Right Forward Quartering View of the Airplane at the Accident Site.**

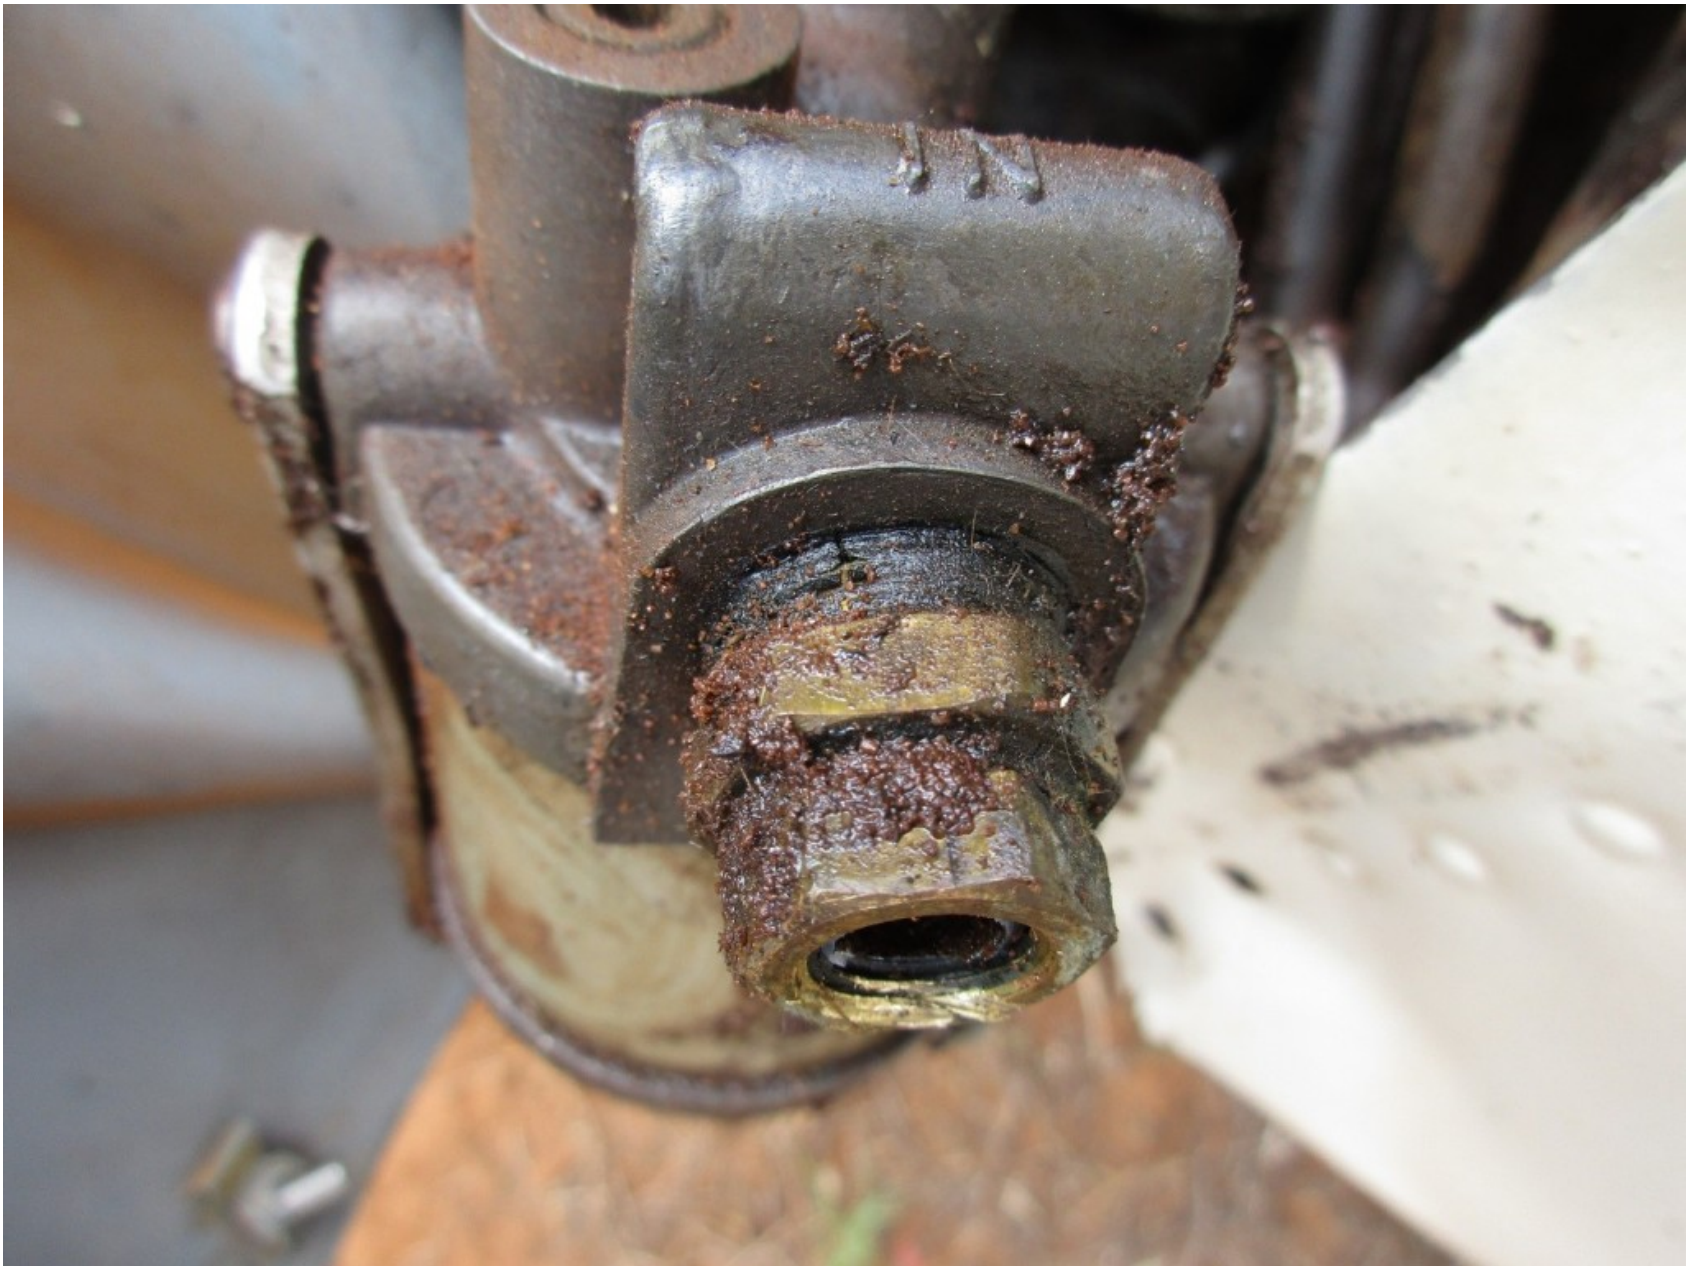
**Photo 2 - FAA Digital Photograph. View of the Fractured Inlet of the Fuel Strainer.**

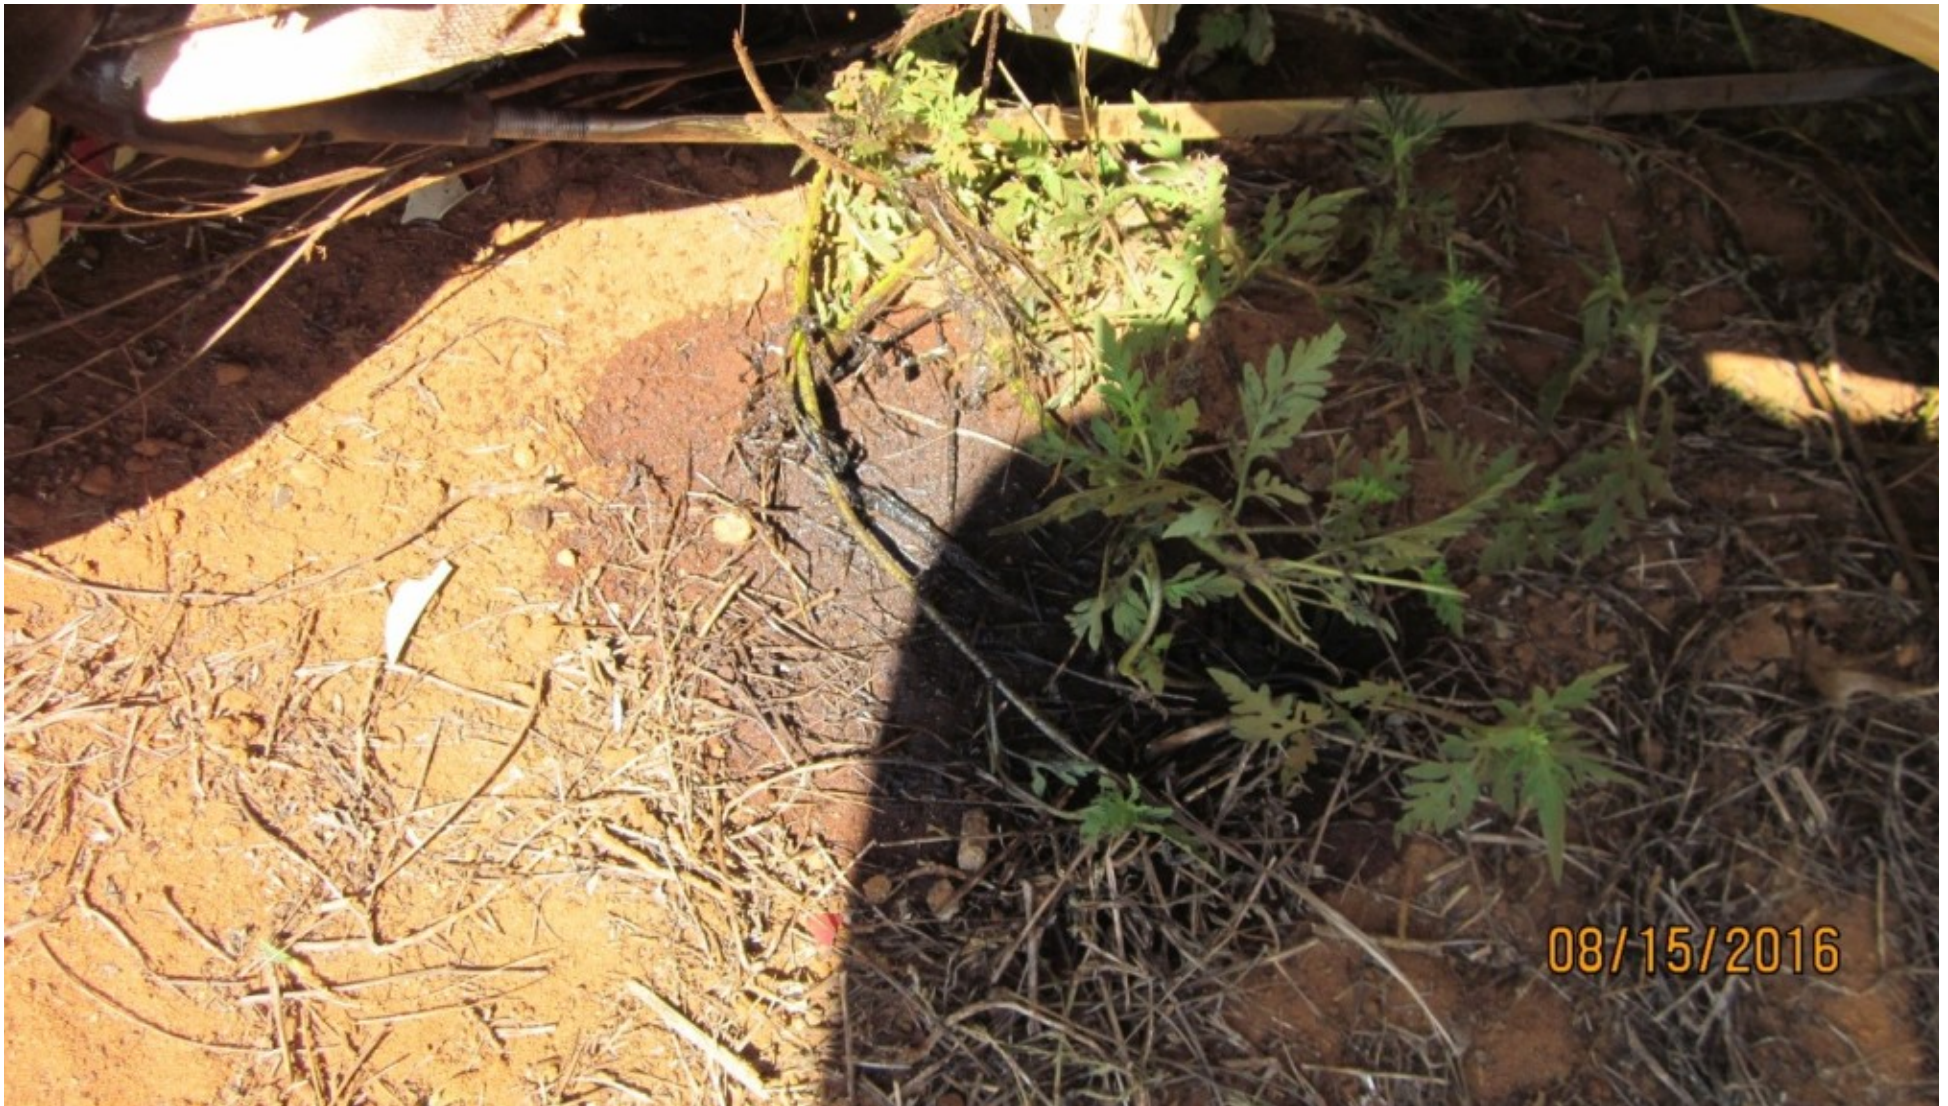
**Photo 3 - FAA Digital Photograph. View of the Stain on the Ground Beneath the Engine.**

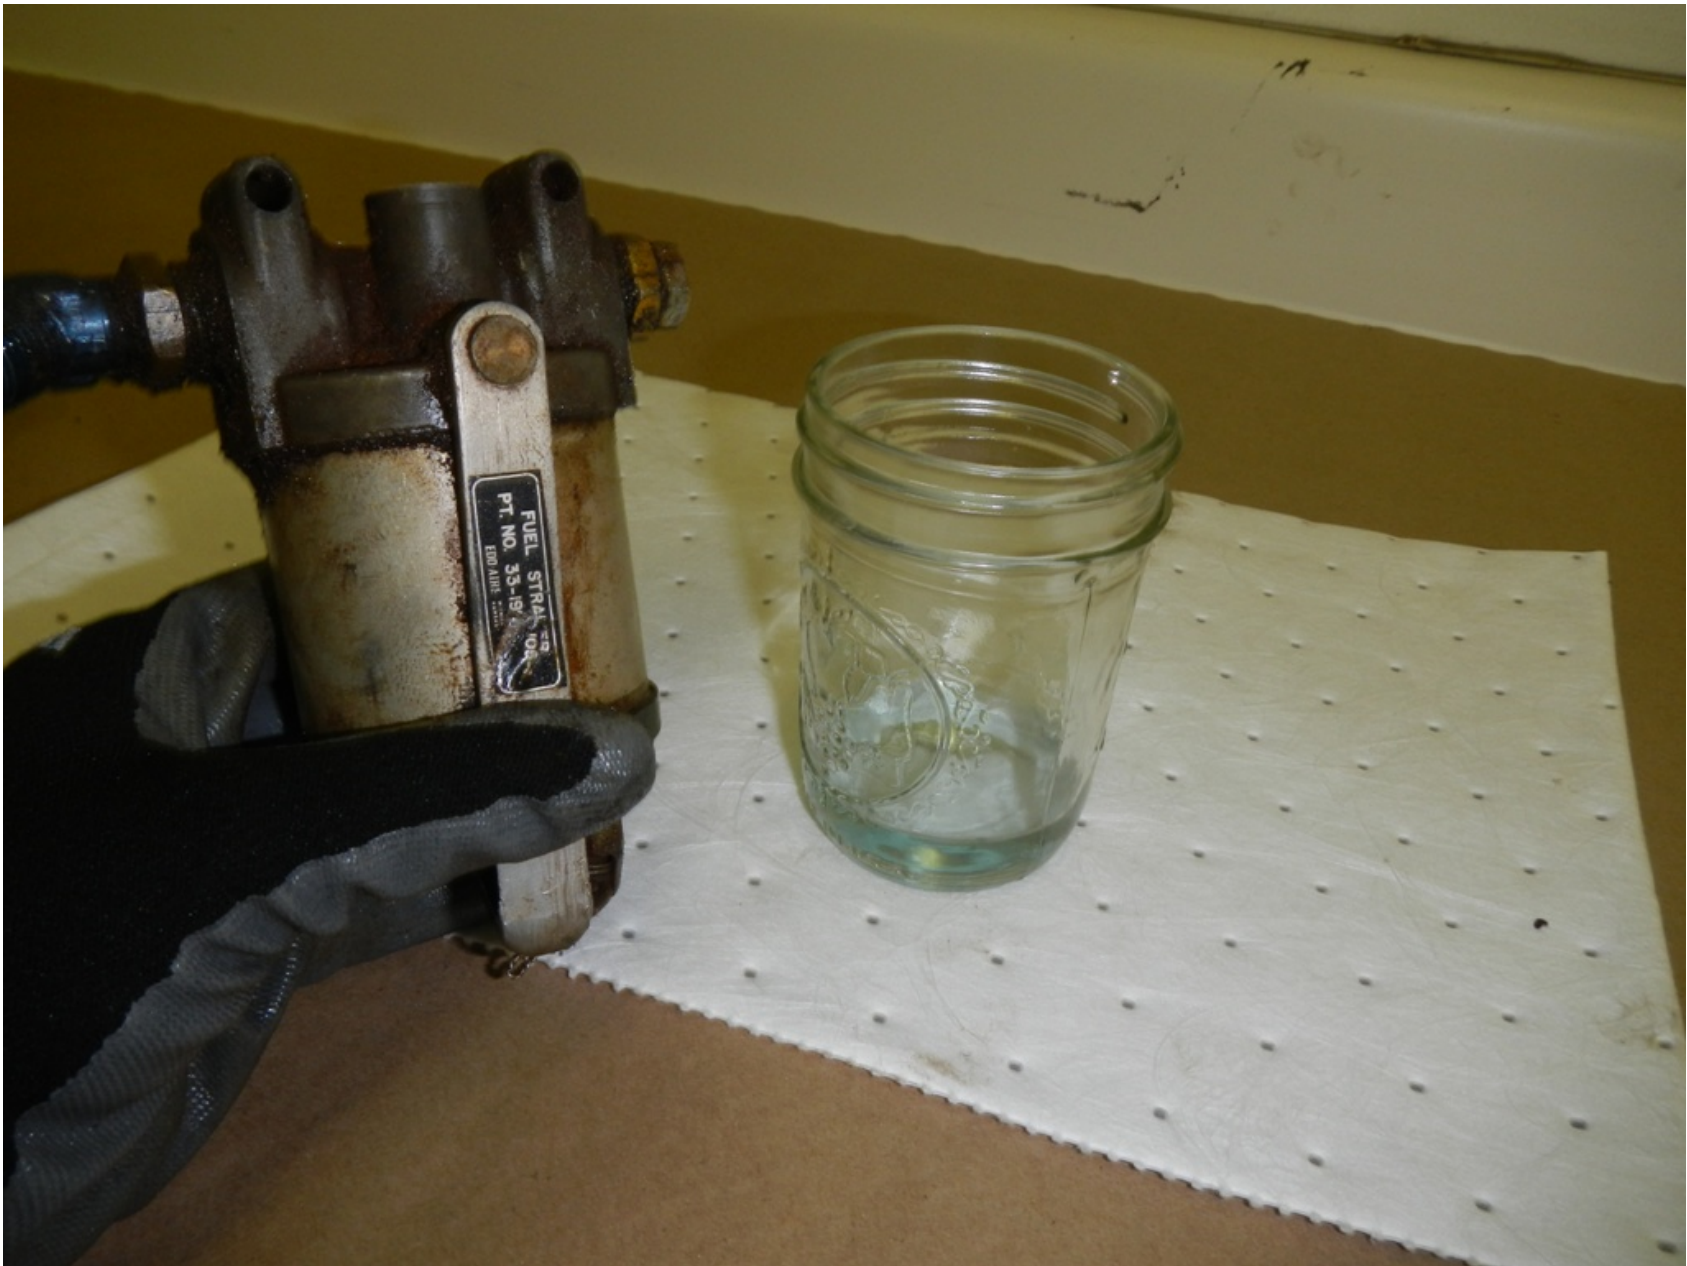
**Photo 4 – CMI Digital Photograph. View of the Fuel Drained from the Fuel Strainer.**

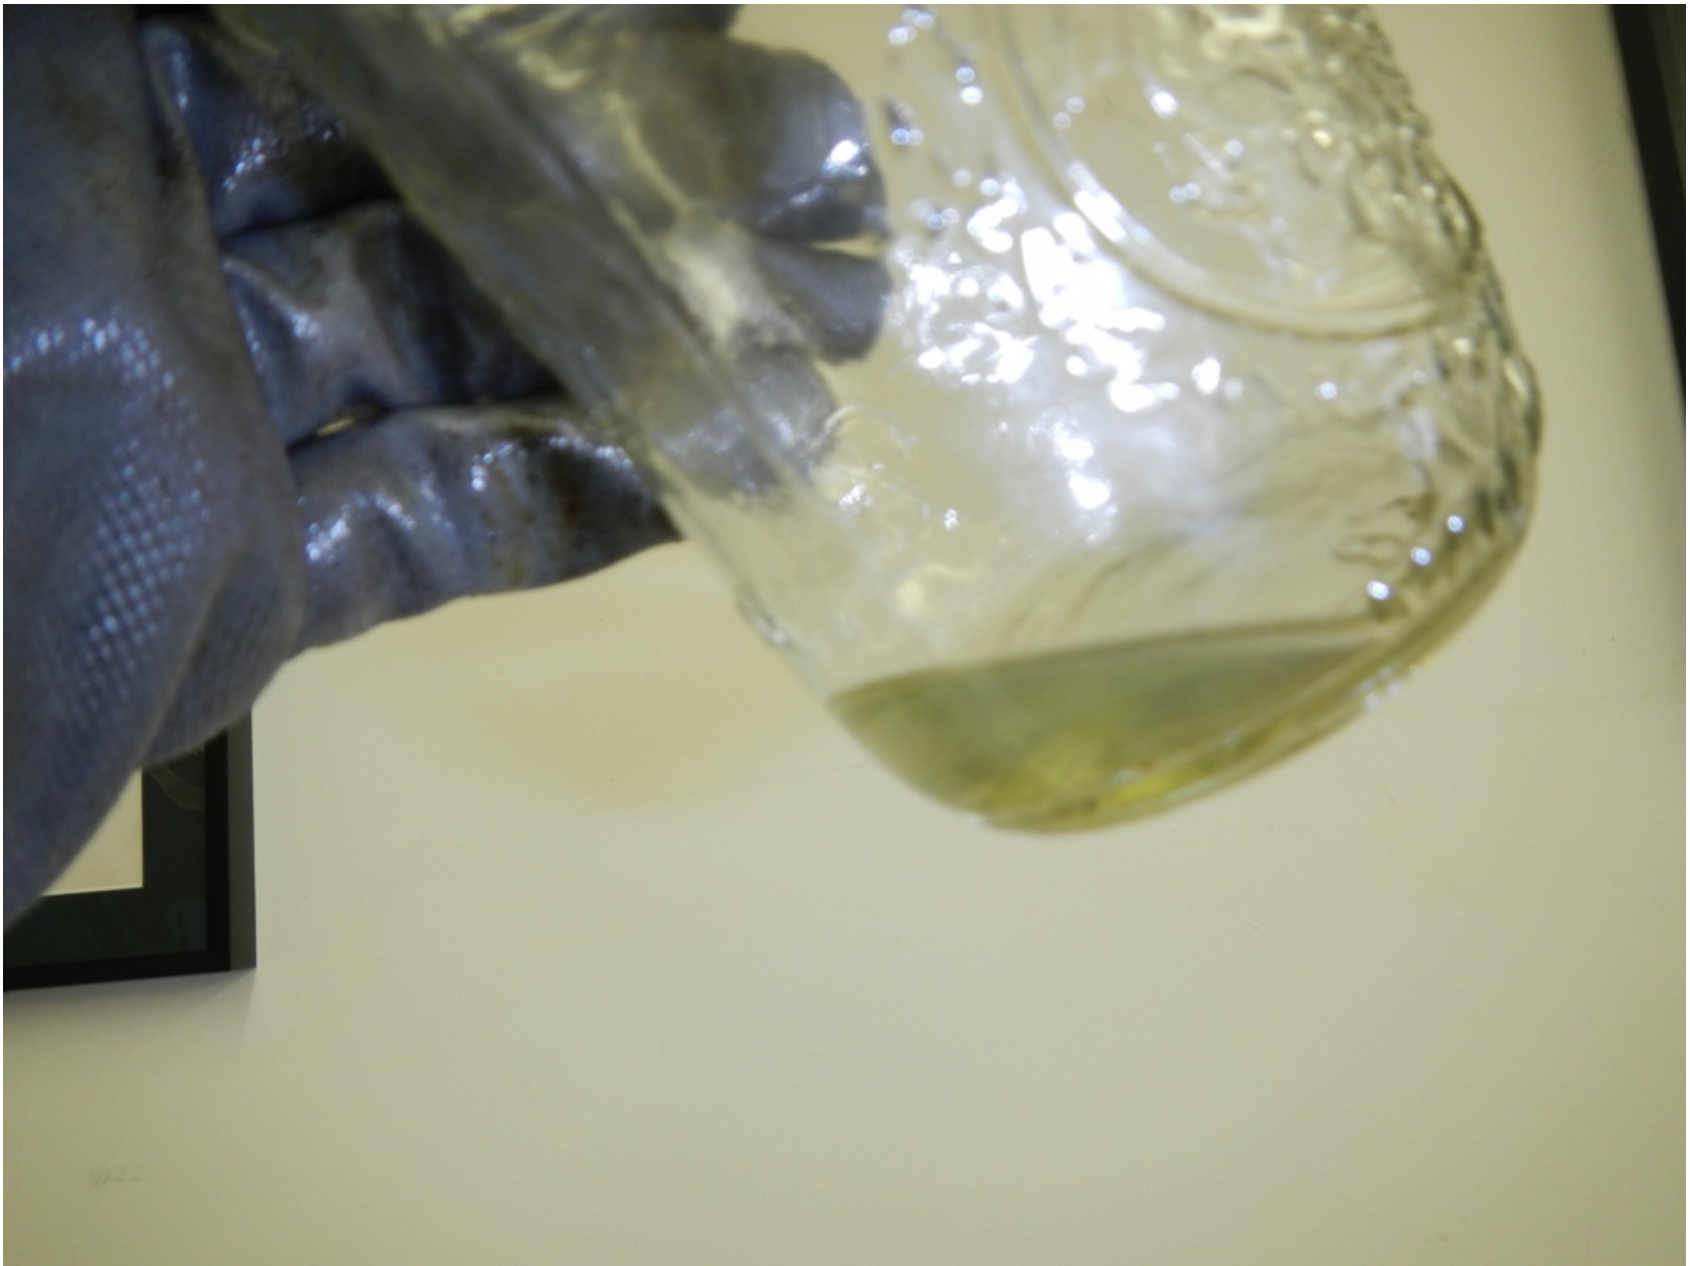
**Photo 5 - CMI Digital Photograph. View of the Fuel Drained from the Carburetor Bowl.**

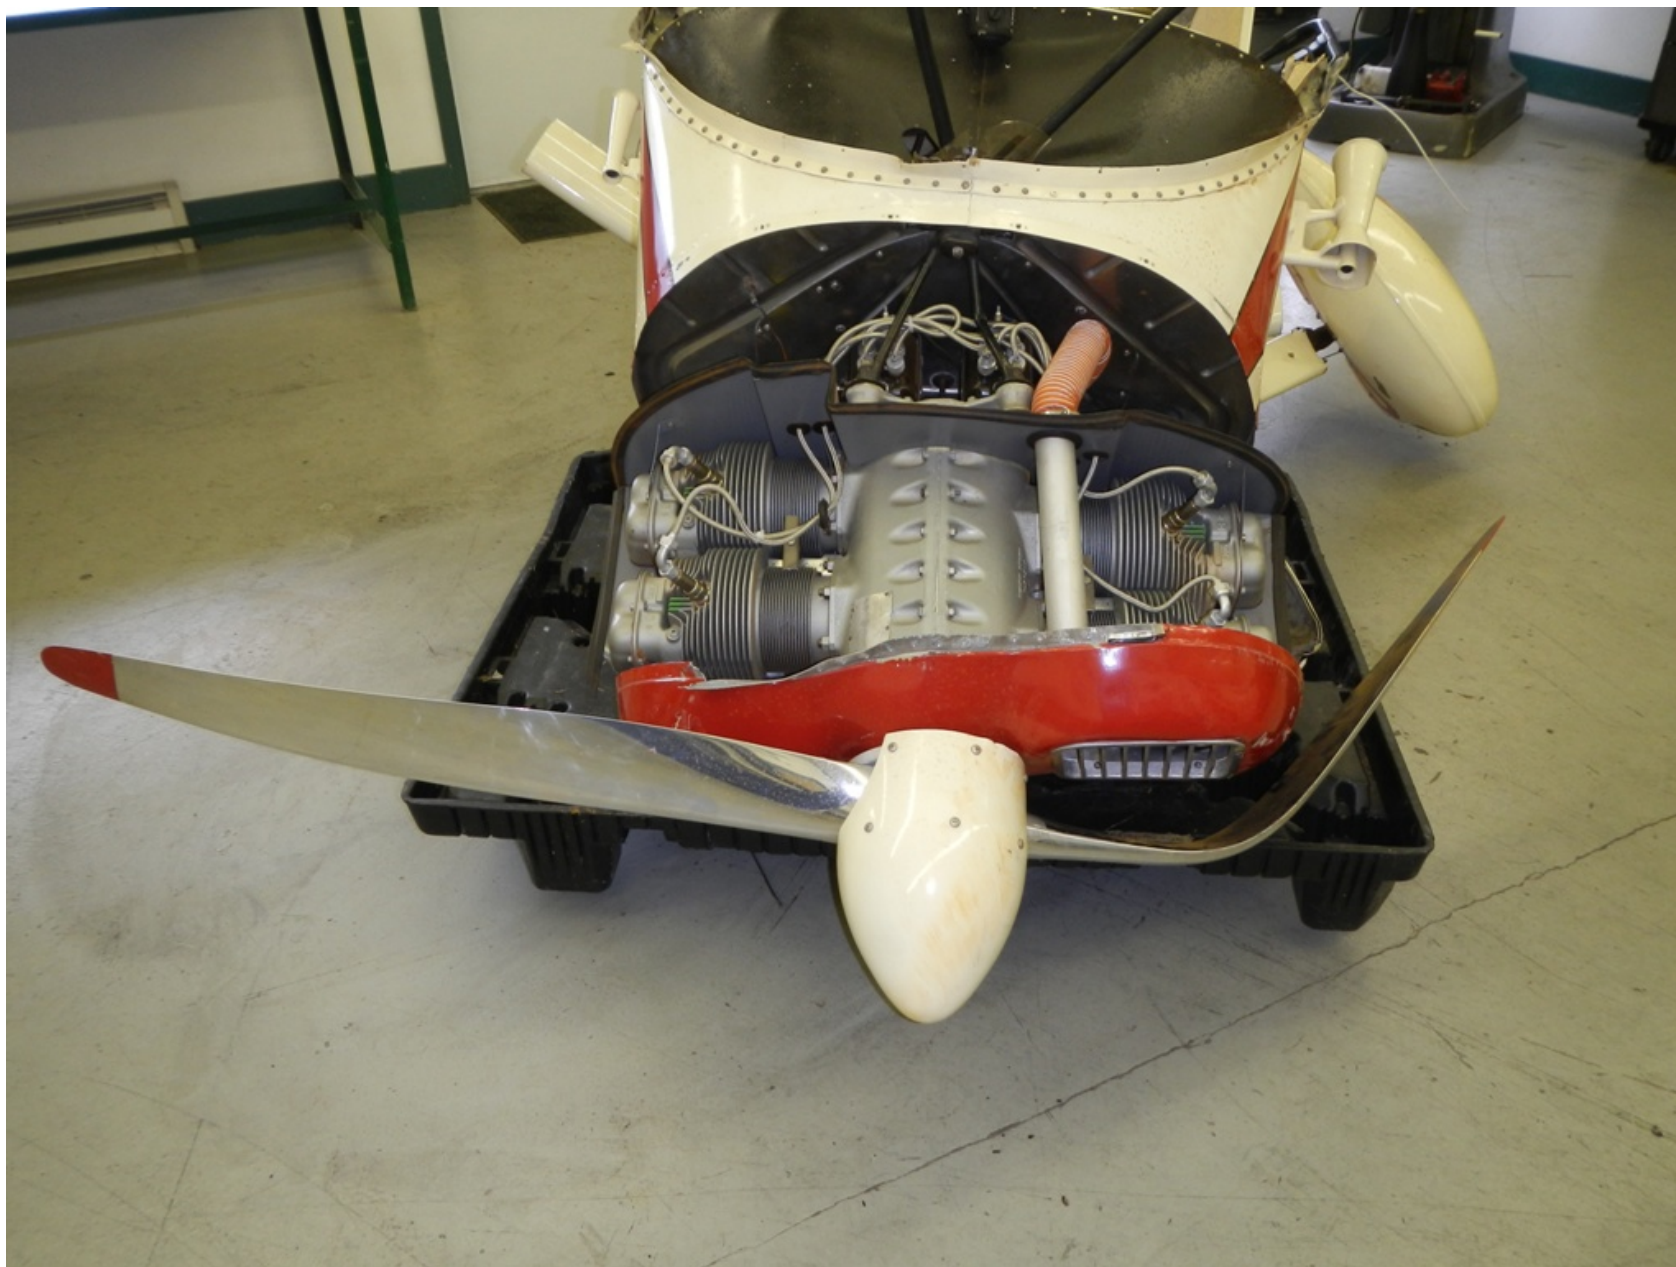
**Photo 6 - CMI Digital Photograph. Forward View of the Propeller and Engine Assembly.**

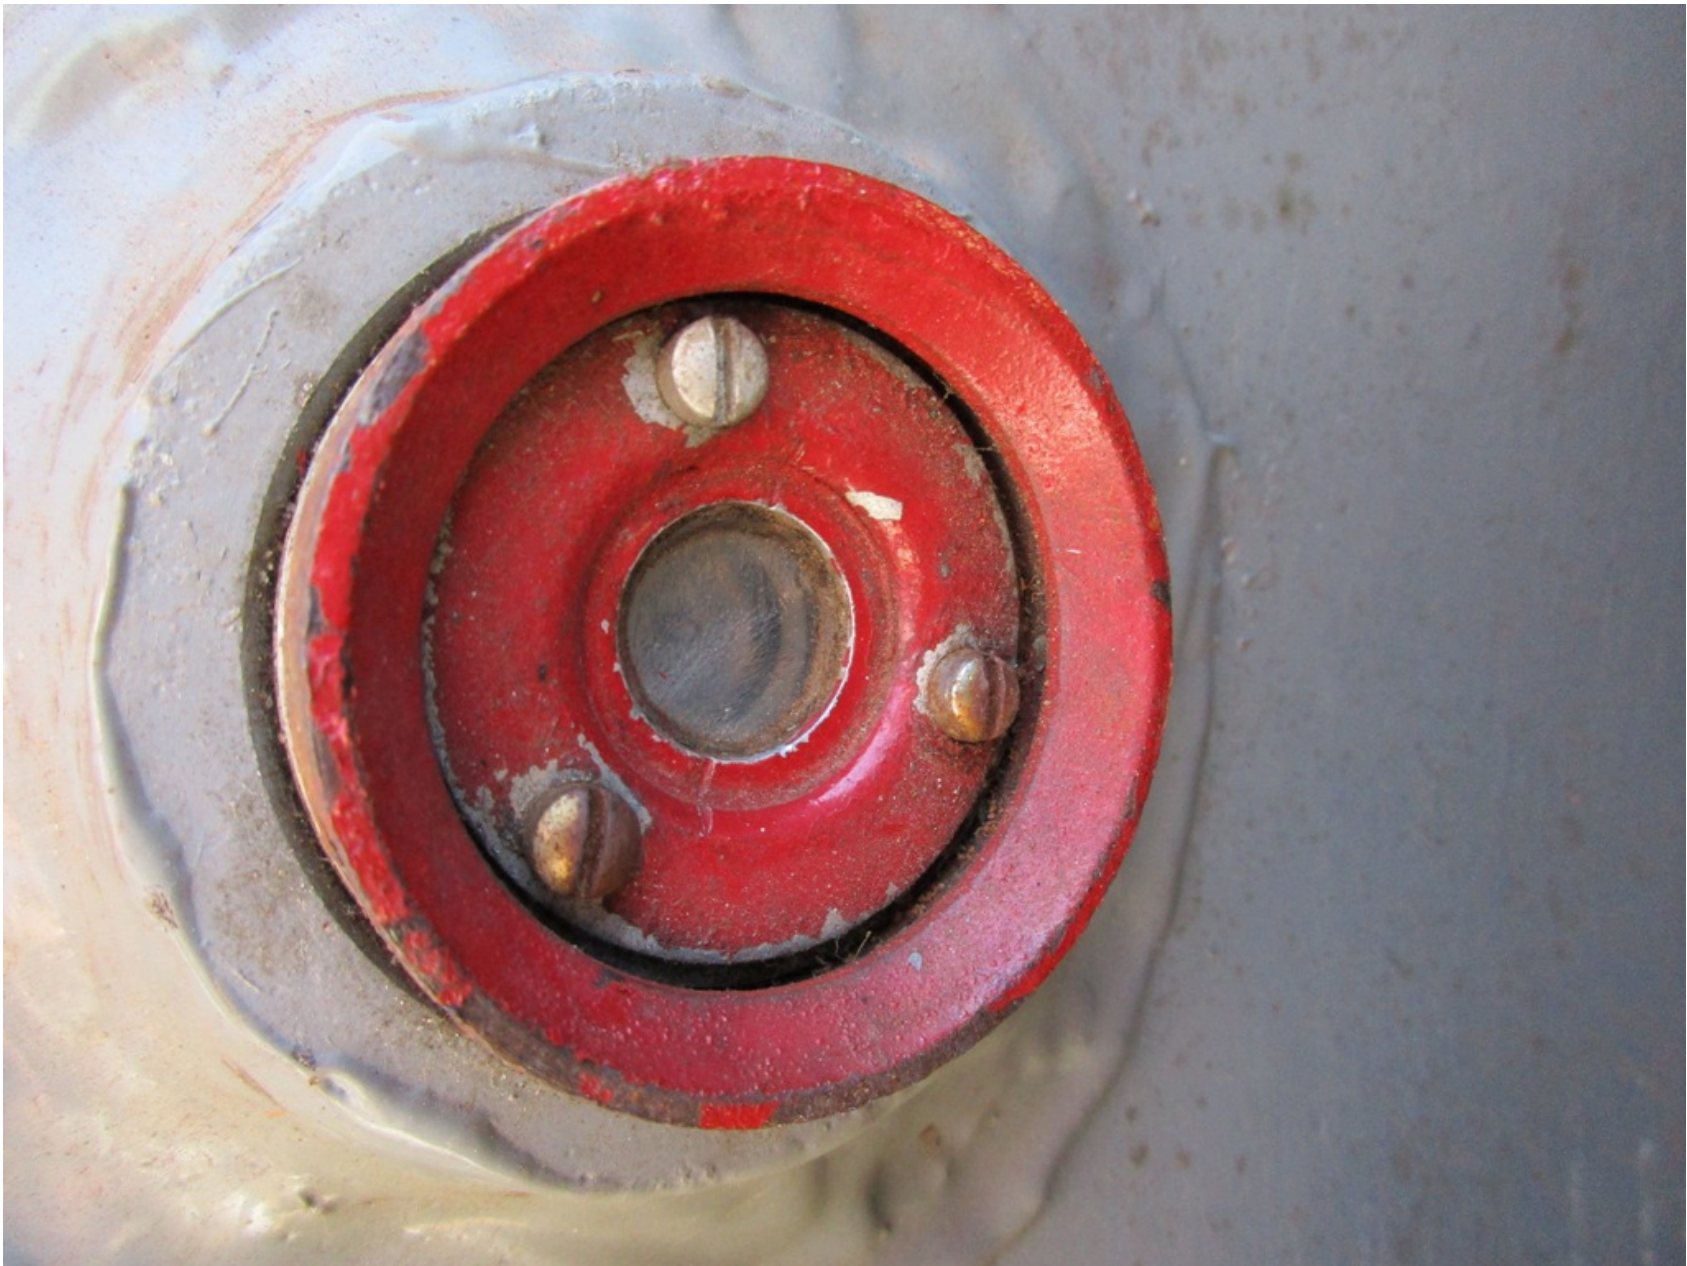
**Photo 7 - FAA Digital Photograph. View of the Fuel Quantity Gauge.**
