# NATIONAL TRANSPORTATION SAFETY BOARD

## MATERIALS LABORATORY FACTUAL REPORT

Report No. 17-003

Place : Hollywood, Florida  
Date : August 19, 2016  
Vehicle : Piper PA-34-200, N16499  
NTSB No. : ERA16LA295  
Investigator : Doug Brazy, AS-ERA

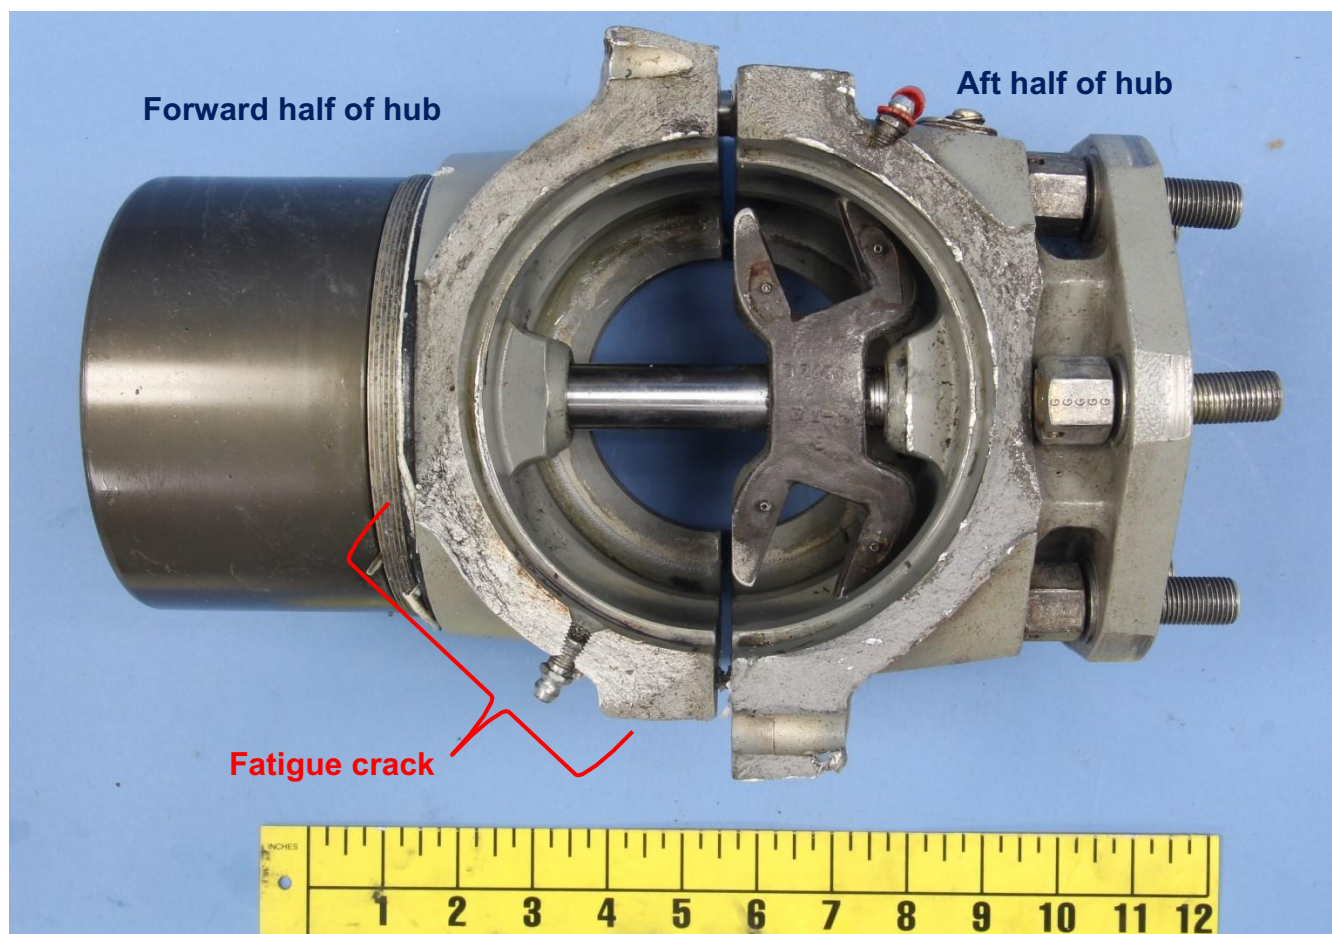
Figure 1 illustrates the portions of the fractured propeller hub, as received, and reconstructed for visual effect. Both halves of the hub had fractured about the circumference of one of the bosses. Figure 2 illustrates a side view of the hub assembly, showing the different depths of the fracture. The forward side hub half contained a deeper fracture location (left in Figure 2).

Figure 1 – The fractured halves of the propeller hub as received.

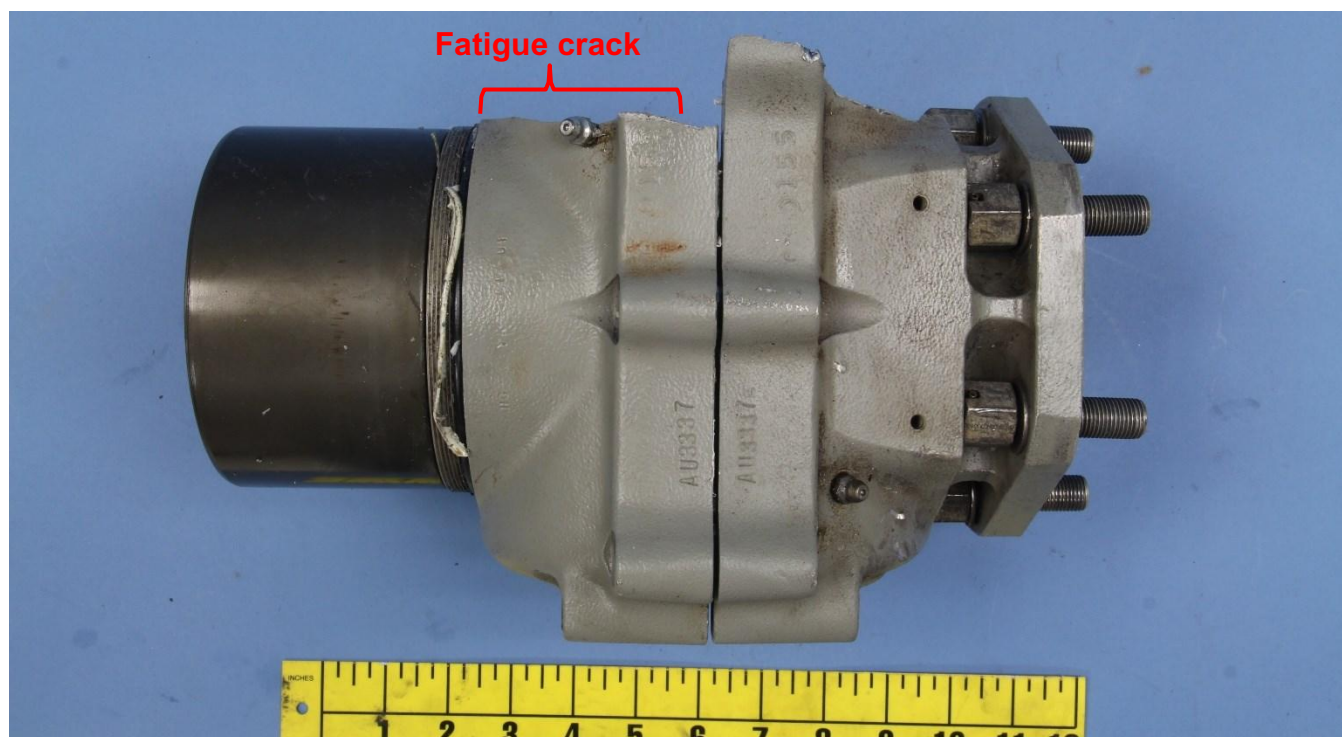
Figure 2 – The propeller hub, rotated 90° from Figure 1. The general location of the fatigue crack is illustrated.

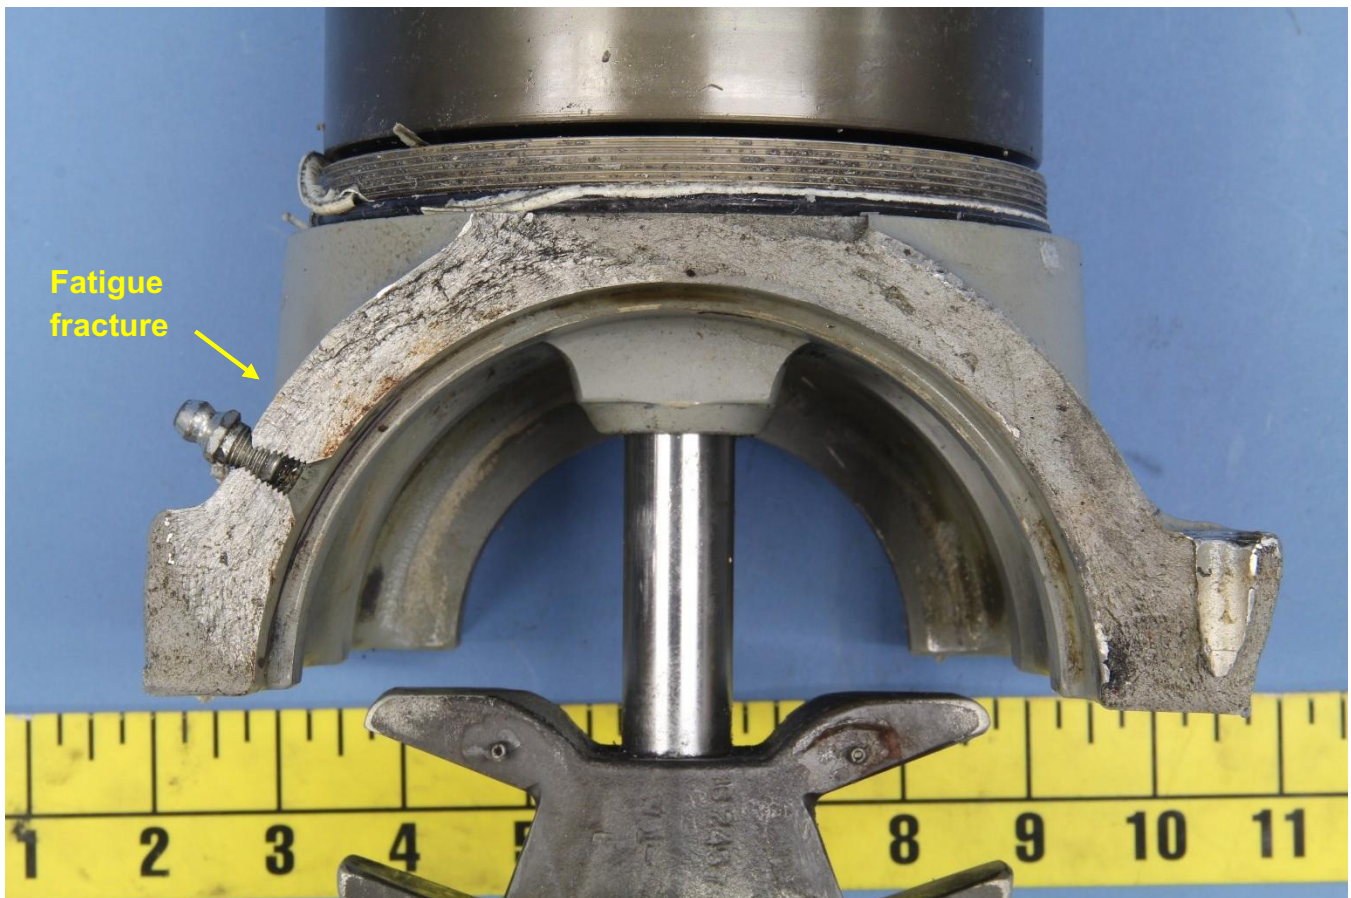
The majority of both fracture surfaces were generally flat, exhibiting a rough texture and a dull luster. For aluminum alloys, these features are typically consistent with overstress fractures. However, as shown in Figures 3 and 4, a portion of the fracture surface on the

forward hub half exhibited a shinier luster than the rest of the fracture surfaces. This region exhibited a general thumbnail shape, consistent with progressive crack growth, later determined to be fatigue. This crack was located about a grease-fitting hole. The length of this crack was measured as 3.39 inches from the inner surface and 2.78 inches from the outer surface. This discrepancy in crack length was consistent with crack growth from the inner surface outward.

Figure 3 – The forward propeller hub half, as received, showing the fatigue cracking about a grease fitting hole.

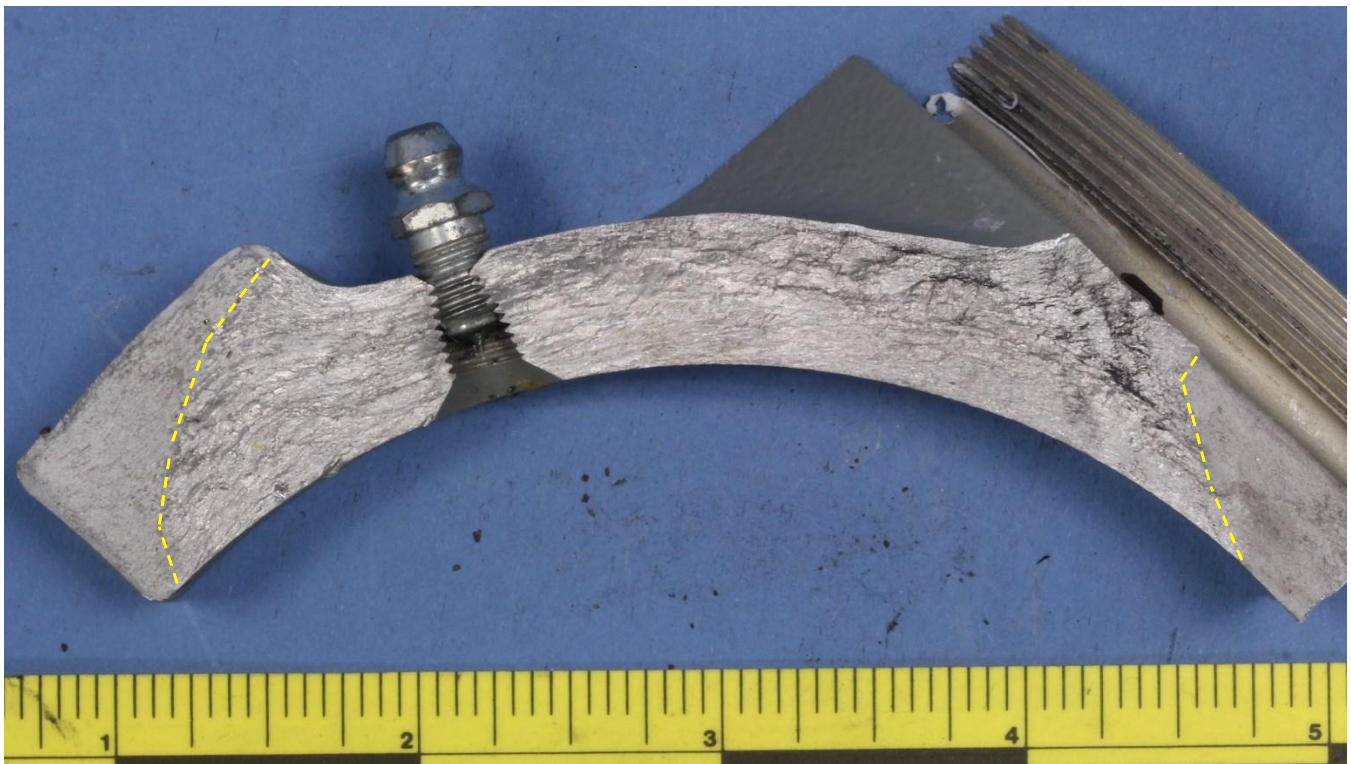
Figure 4 – The fracture surface in Figure 3, after sectioning and cleaning. The fatigue crack edges are labeled.

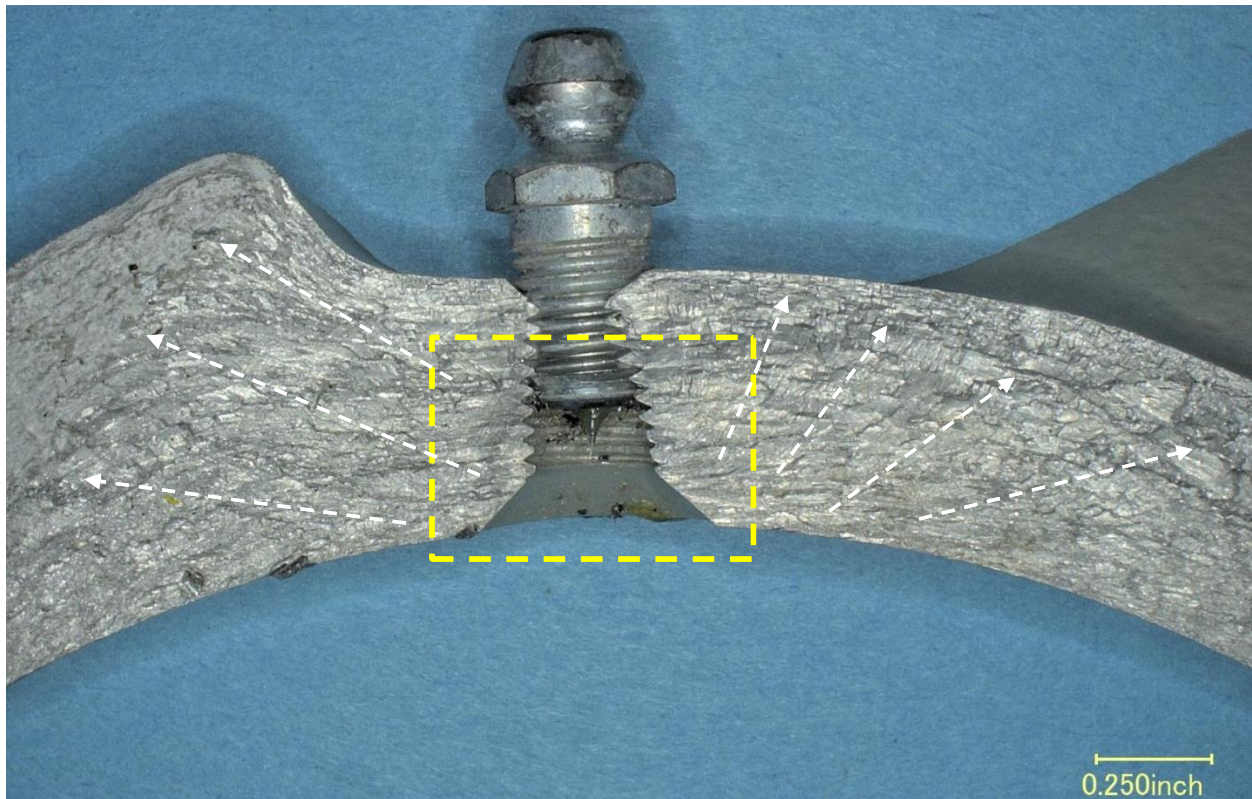
Closer visual inspection of the progressive cracking, as shown in Figures 5 through 7, revealed the presence of crack arrest, or beach, marks. The crack arrest marks emanated from the lower thread root of the fitting bore, as illustrated in Figure 6. Since there were essentially two crack initiation sites on this fracture surface, the right and left sides were labeled 'A' and 'B', respectively, for the purpose of this report. As shown in Figure 7, crack arrest marks were observed propagating from the bottom thread crest.

Figure 5 – Closer view of the grease fitting bore in Figure 4, showing crack arrest marks emanating from the bore. The dashed arrows denote crack growth direction, and the boxed area is shown in Figure 6.

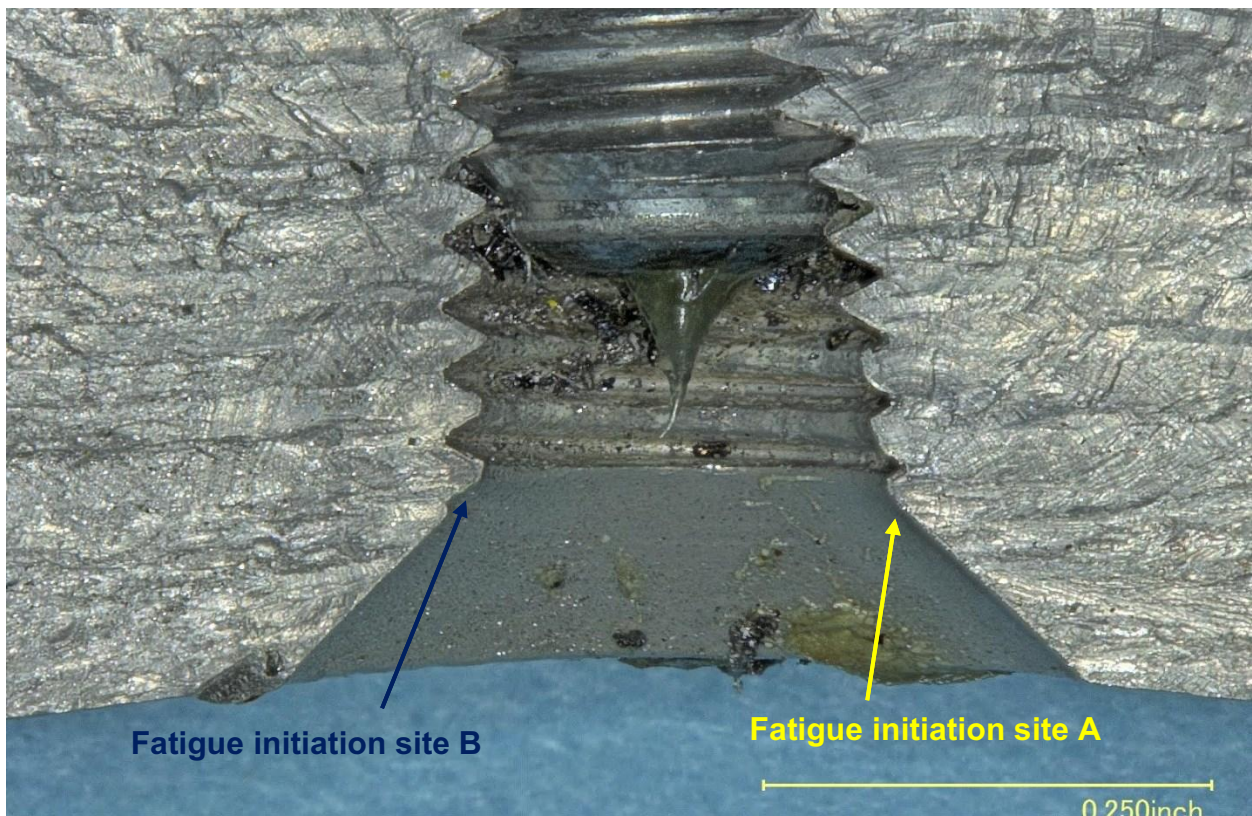
Figure 6 – The boxed area in Figure 5, showing the crack initiation sites at the bore (labeled A and B).

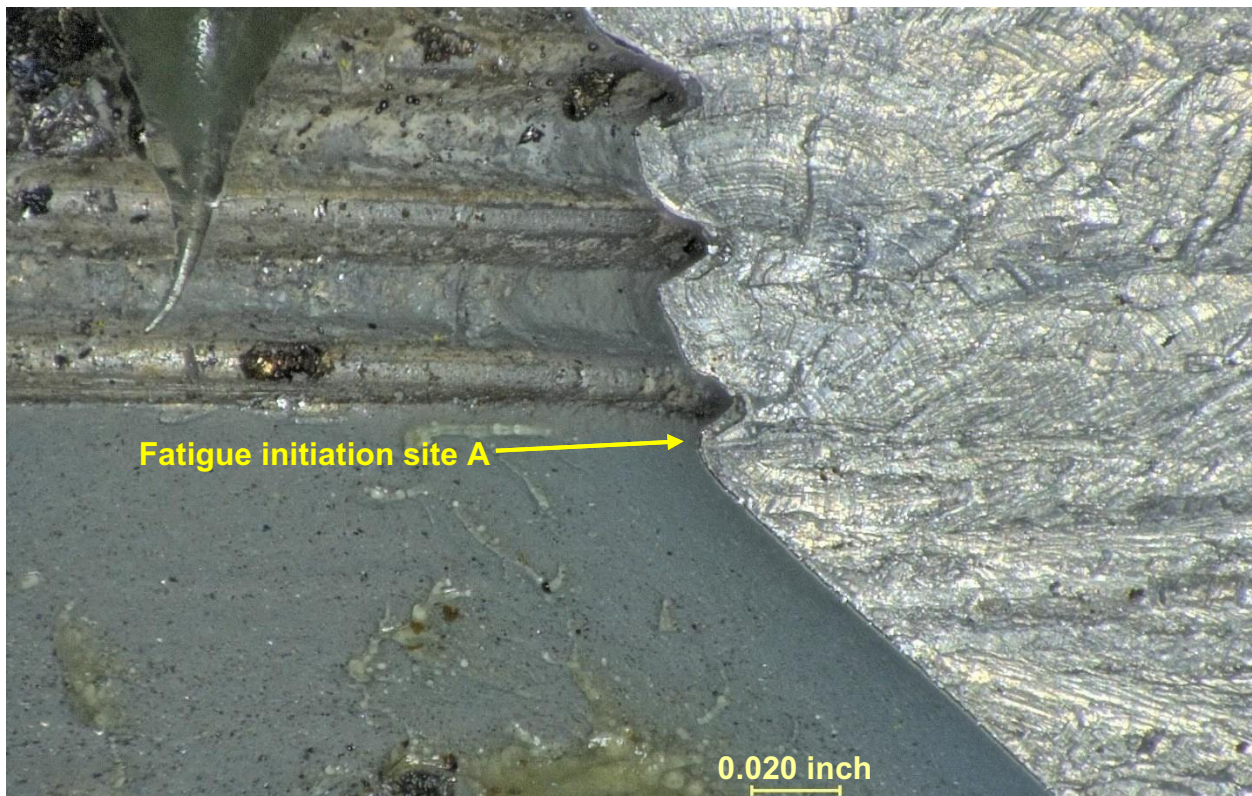
Figure 7 – Closer view of fatigue crack initiation site A (arrow), showing crack arrest marks emanating from a thread crest.

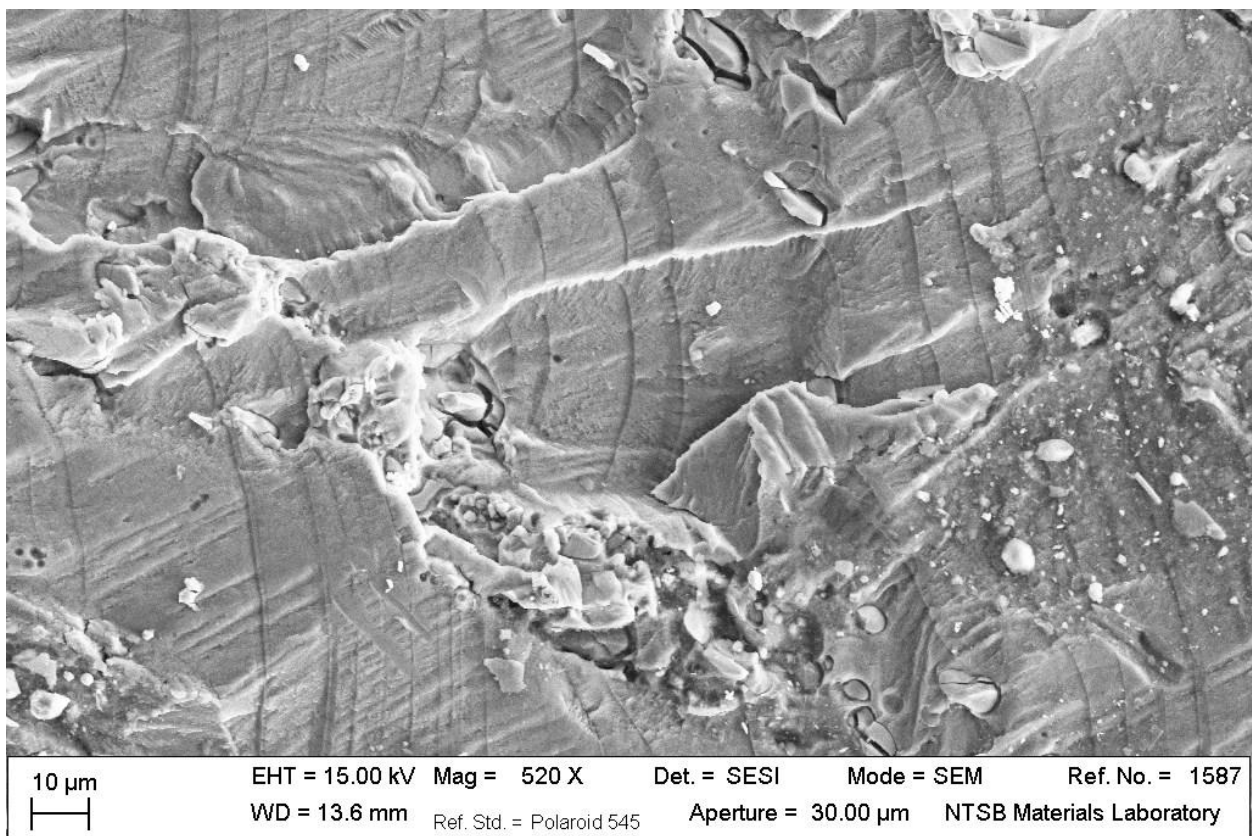
This fracture surface was examined using a scanning electron microscope (SEM). As illustrated in Figure 8, the crack exhibited fatigue striations, consistent with fatigue crack growth. Outside of the fatigue crack, dimple rupture, consistent with subsequent overstress fracture, was observed (see Figure 9). The erratic spacing of the striations was consistent with spectrum stresses or loads. These features are typical for crack propagation in rotating operations under high cycle fatigue.

Figure 8 – Secondary electron (SE) micrograph of fatigue striations on the hub fatigue fracture.

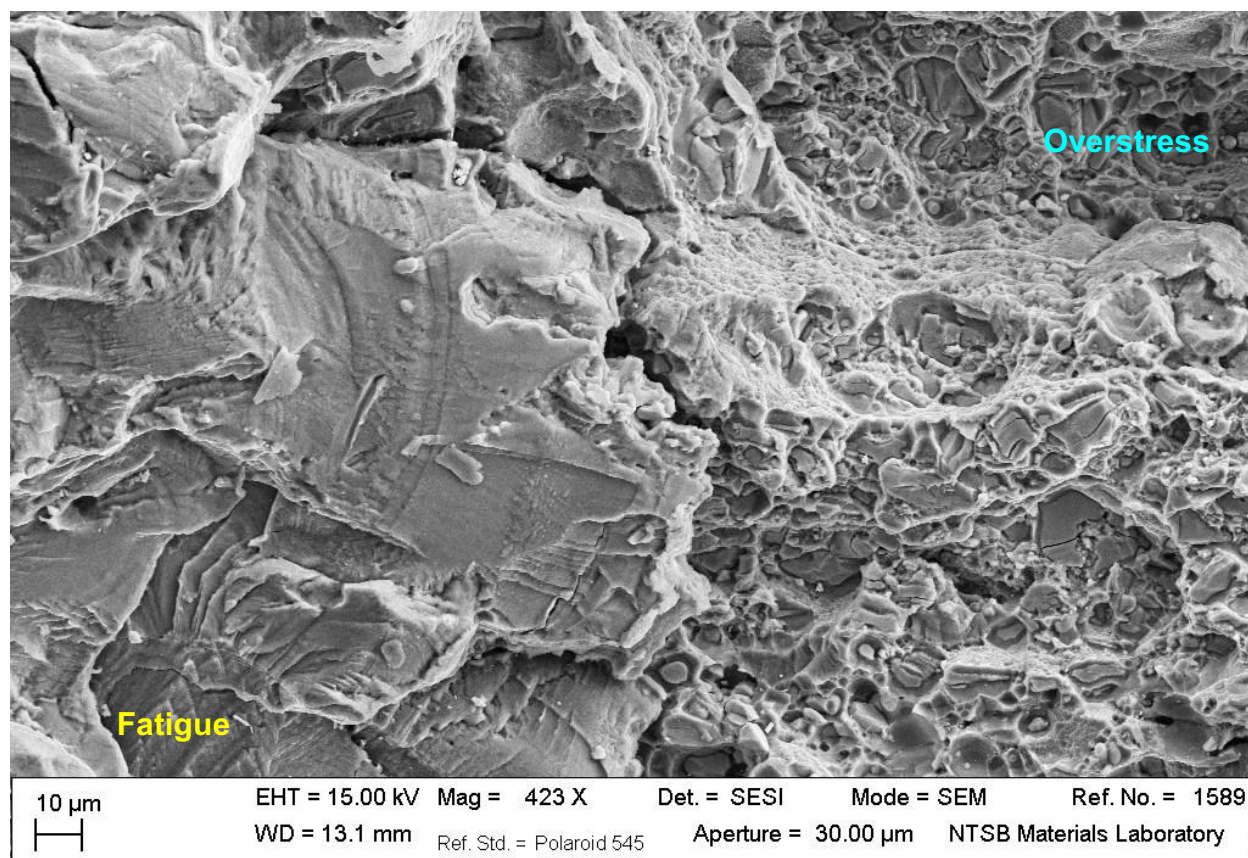
Figure 9 – SE micrograph showing the end of the fatigue crack, transitioning to dimple rupture.

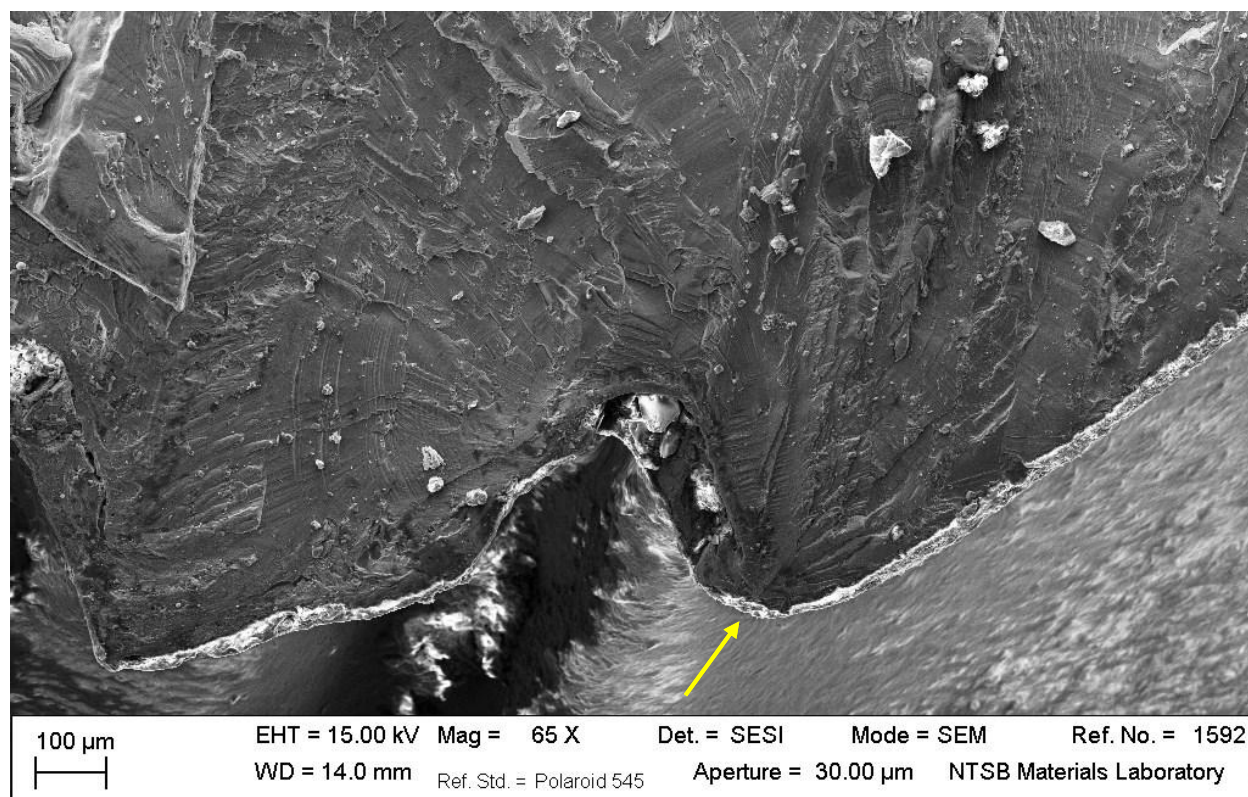
Fatigue crack initiation site A was examined using a SEM, as shown in Figures 10 through 12. As displayed in these figures, the fatigue crack initiated at the innermost thread crest on the flat side. Faint fatigue striations were observed adjacent to the surface propagating inward (Figure 12). However, no material defects such as pits, voids, or inclusions, were observed. Likewise, there were no indications of aggressive machining or wear present at this crack initiation site.

Figure 10 – SE micrograph showing fatigue crack initiation site A (yellow arrow).

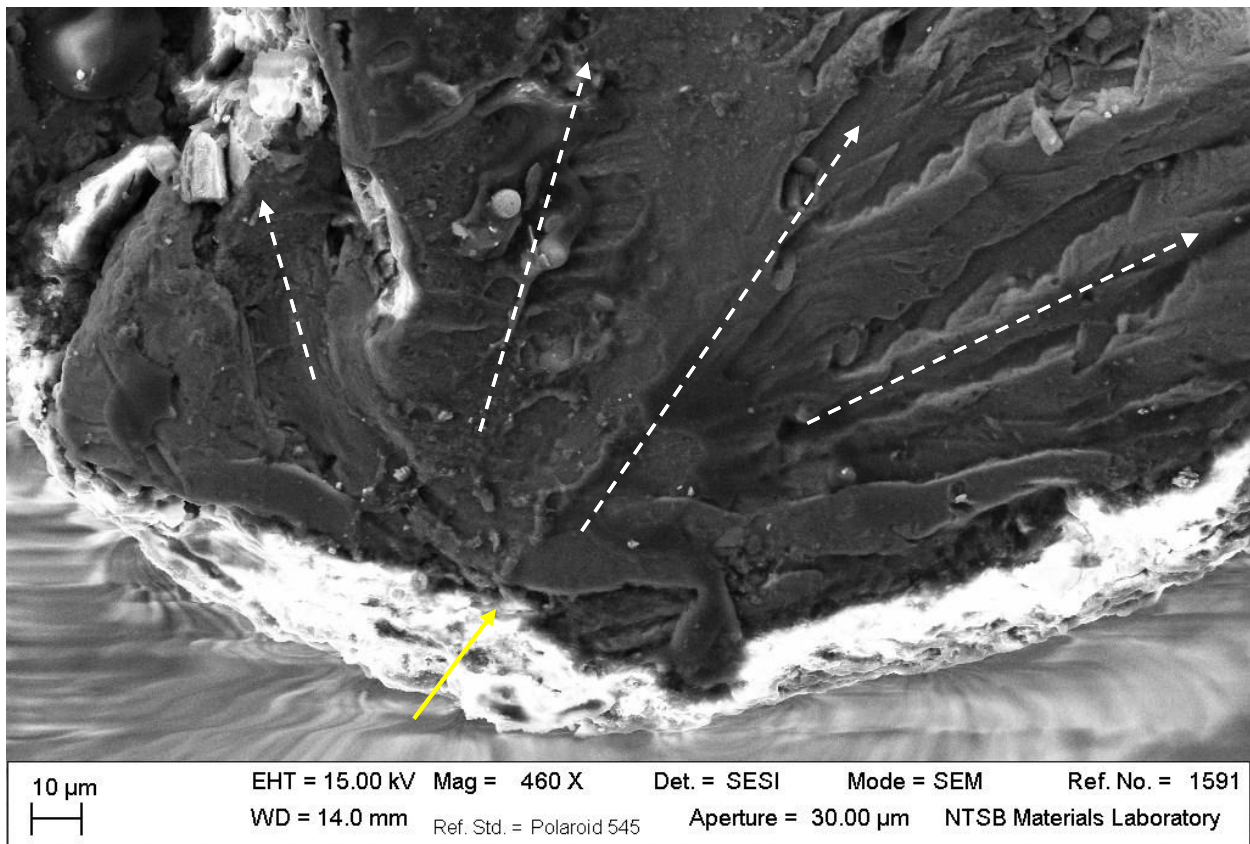
Figure 11 – SE micrograph showing a closeup of initiation site A. The dashed arrows denote crack growth.

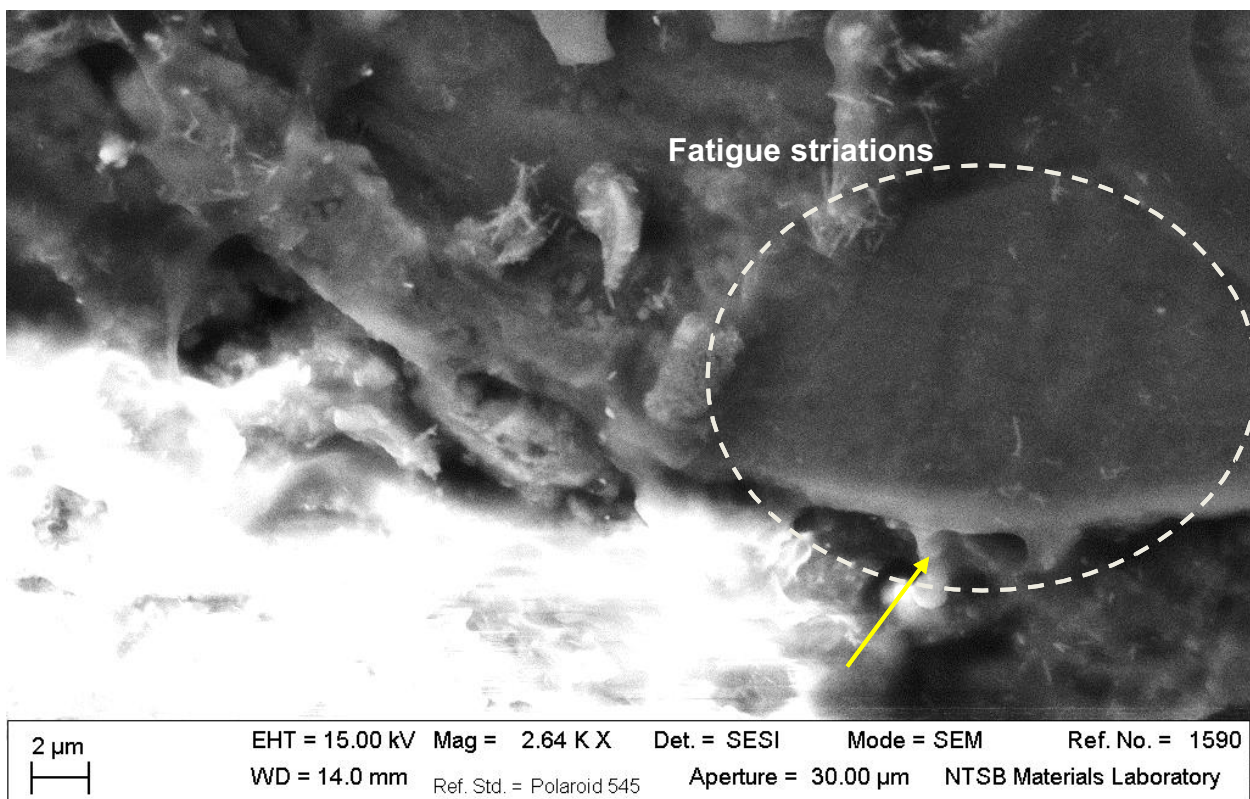
Figure 12 – SE micrograph showing a closer view of the crack initiation site (arrow) in Figure 11.

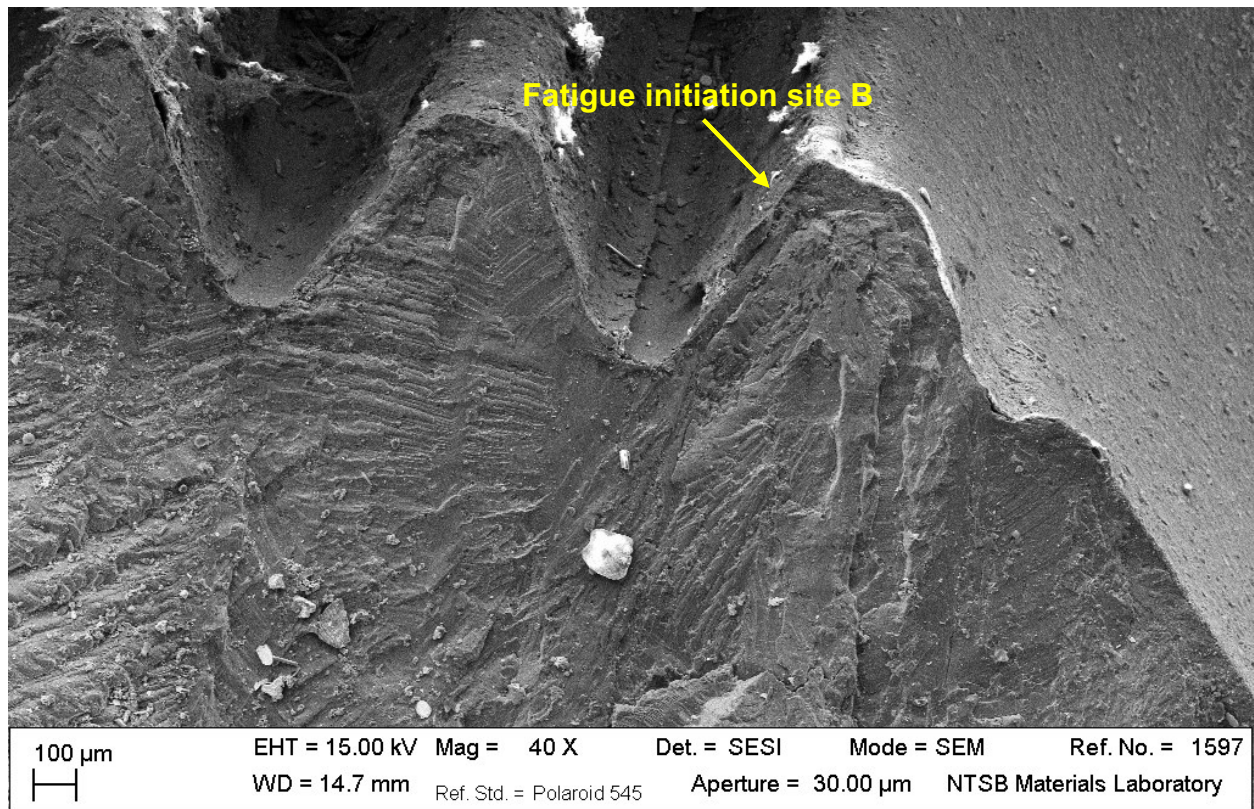
Fatigue crack initiation site B was also examined using a SEM, and is highlighted in Figures 13 through 15. The fatigue cracking on this side of the bore initiated at the upper (or outboard) thread face just below the thread crest (Figure 14). Again, faint striations were observed propagating from this site. There were no discernible material or mechanical imperfections found at this crack initiation site.

Figure 13 – SE micrograph showing fatigue crack initiation site B (arrow).

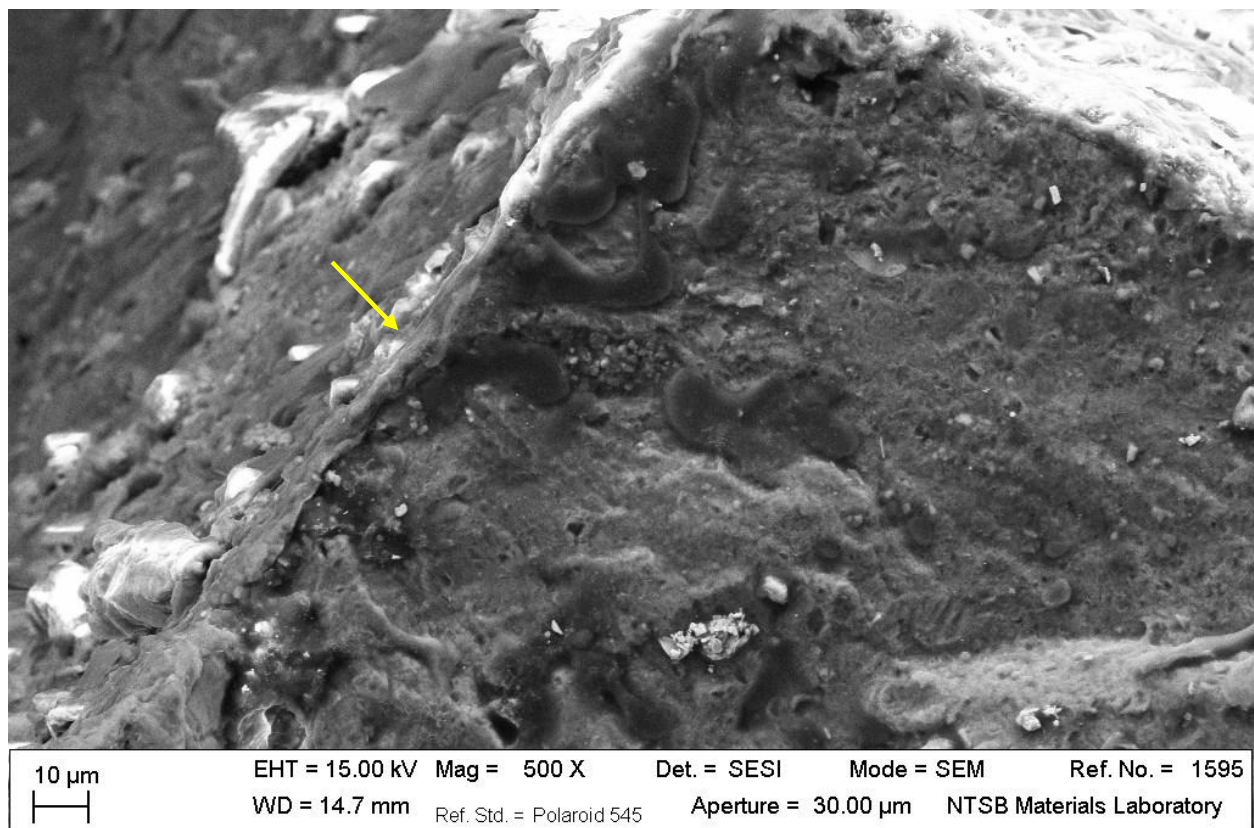
Figure 14 – SE micrograph showing a closer view of crack initiation site B (arrow).

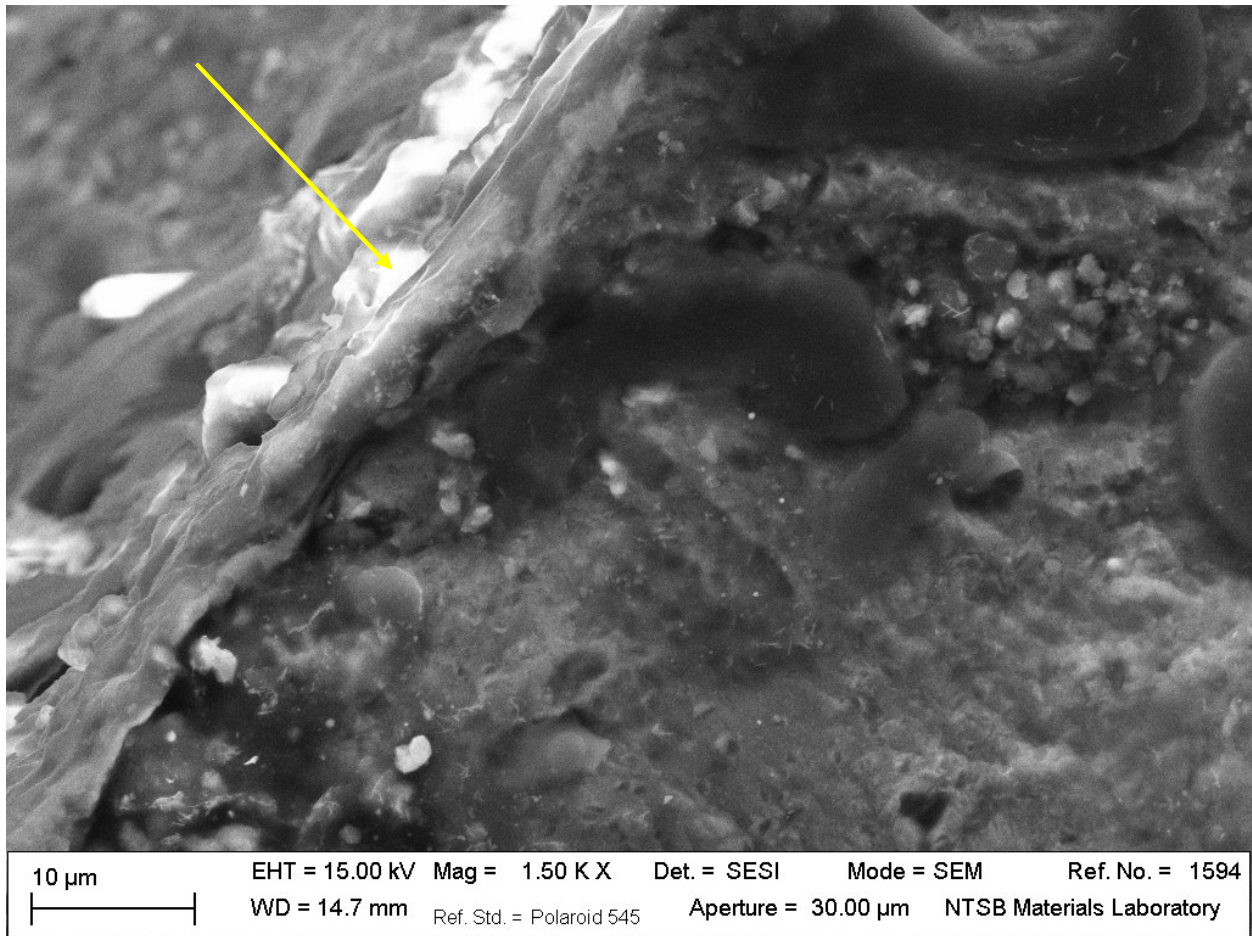
Figure 15 – SE micrograph showing a closer view of the crack initiation site in Figure 14.
