# NATIONAL TRANSPORTATION SAFETY BOARD

MATERIALS LABORATORY FACTUAL REPORT

Report No. 16-103

Place : Canandaigua, NY  
Date : August 20, 2016  
Vehicle : E-AB Kitfox 4-1200, N51TM  
NTSB No. : ERA16LA296  
Investigator : Bob Gretz

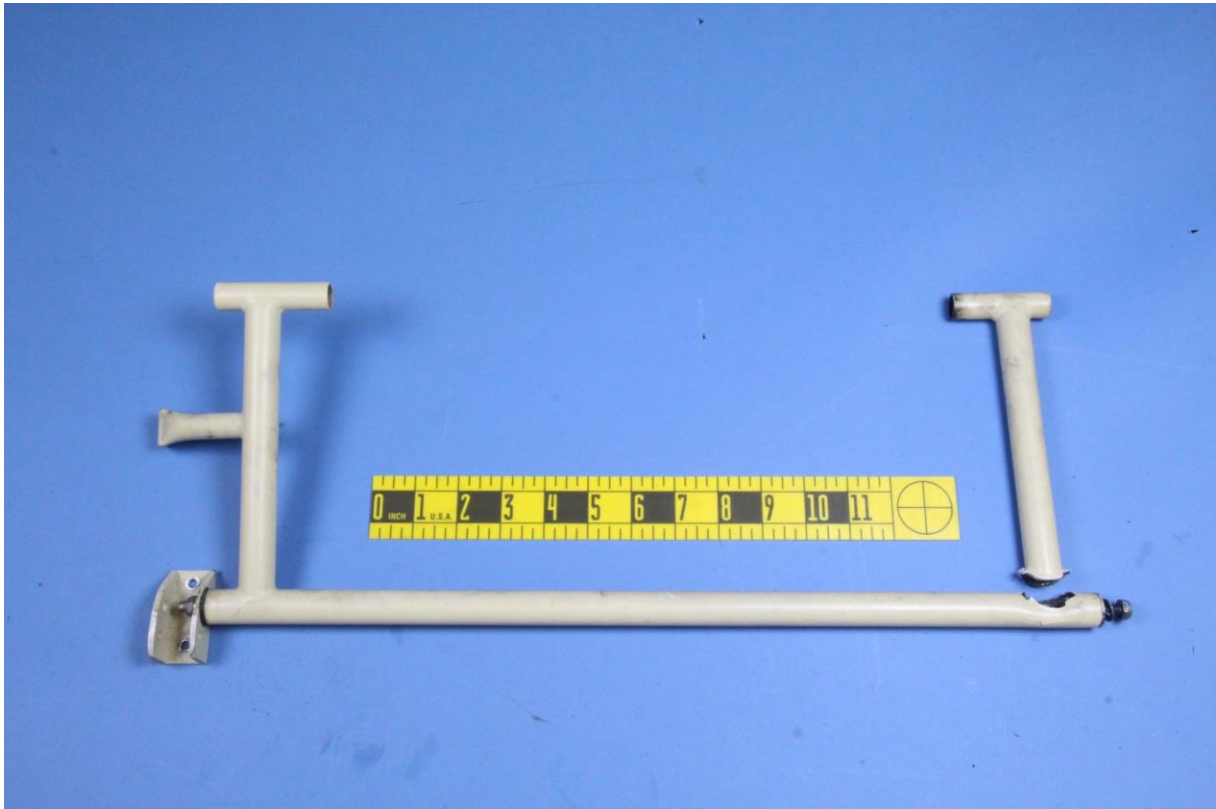
Figure 1: Rudder pedal control tube as received.

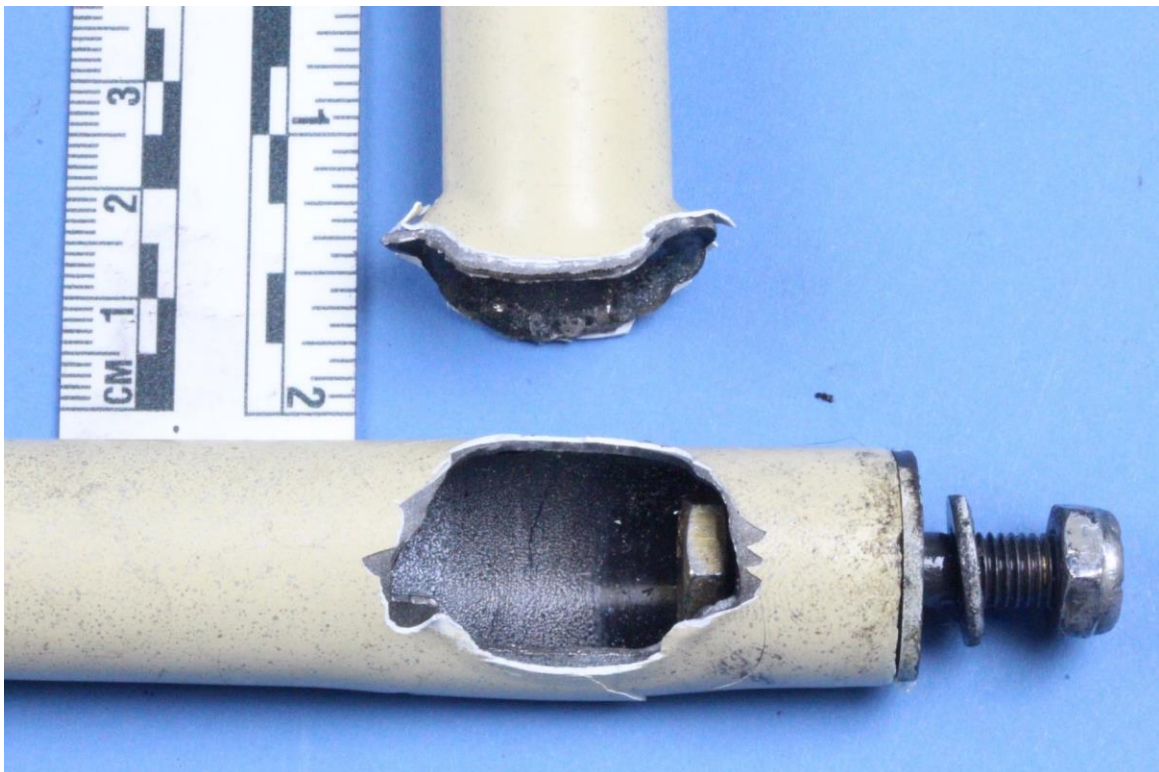
The rudder pedal control tube fractured at a fillet welded, ninety-degree intersection of tubing. The fracture occurred in the base metal of the horizontal tube and the weld deposit remained with the vertical portion of tubing (figure 2). Examination of the fracture surface revealed characteristics of an overstress fracture over the majority of the surface with the exception of one area exhibiting a thumbnail like feature (figure 3). This thumbnail like feature is consistent with a fatigue crack initiating at the toe of the weld (figure 4).

Figure 2: Fracture between the horizontal and vertical portions of the rudder pedal control tube.

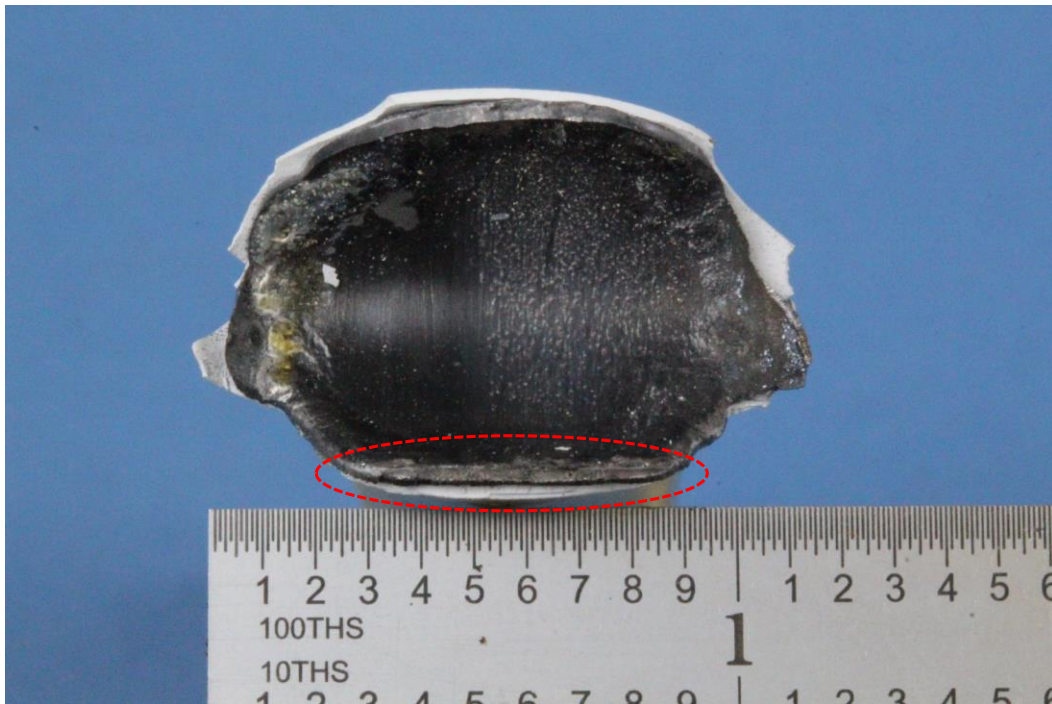
Figure 3: Close up view of fracture surface with thumbnail like feature circled in red.

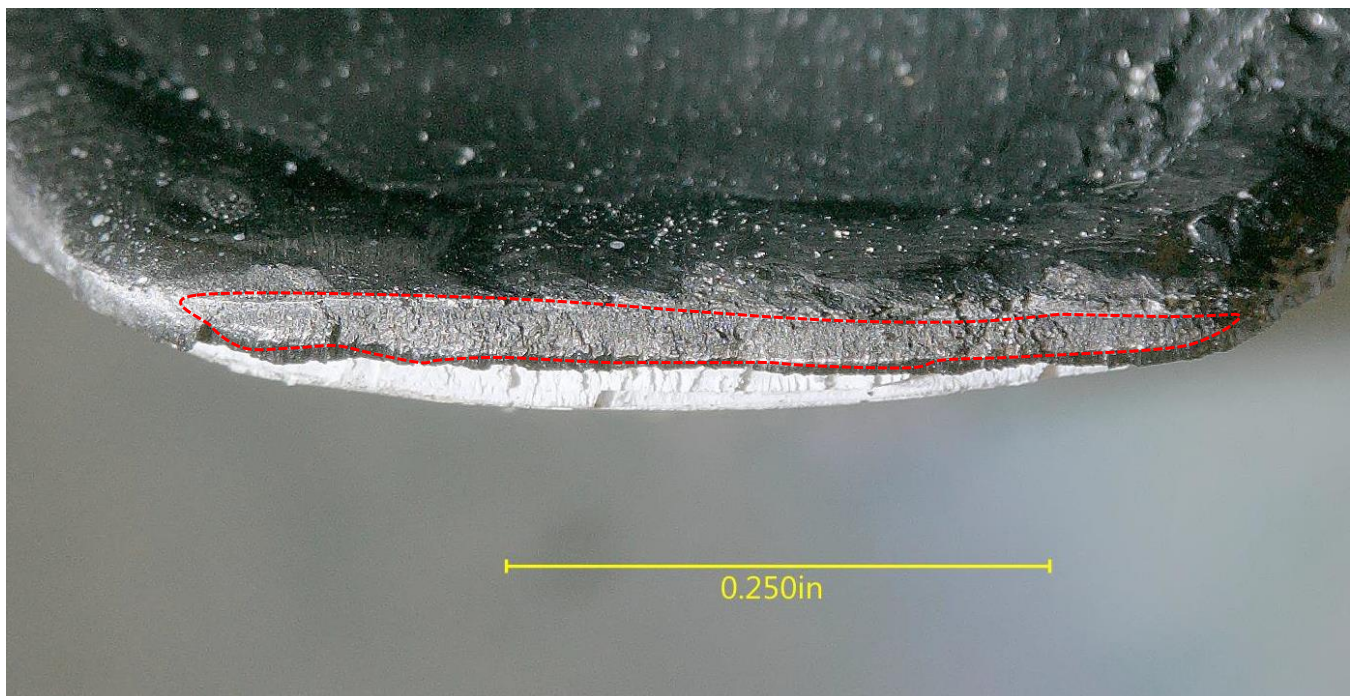
Figure 4: Fatigue crack region on edge of tube. Thumbnail outlined in red.
