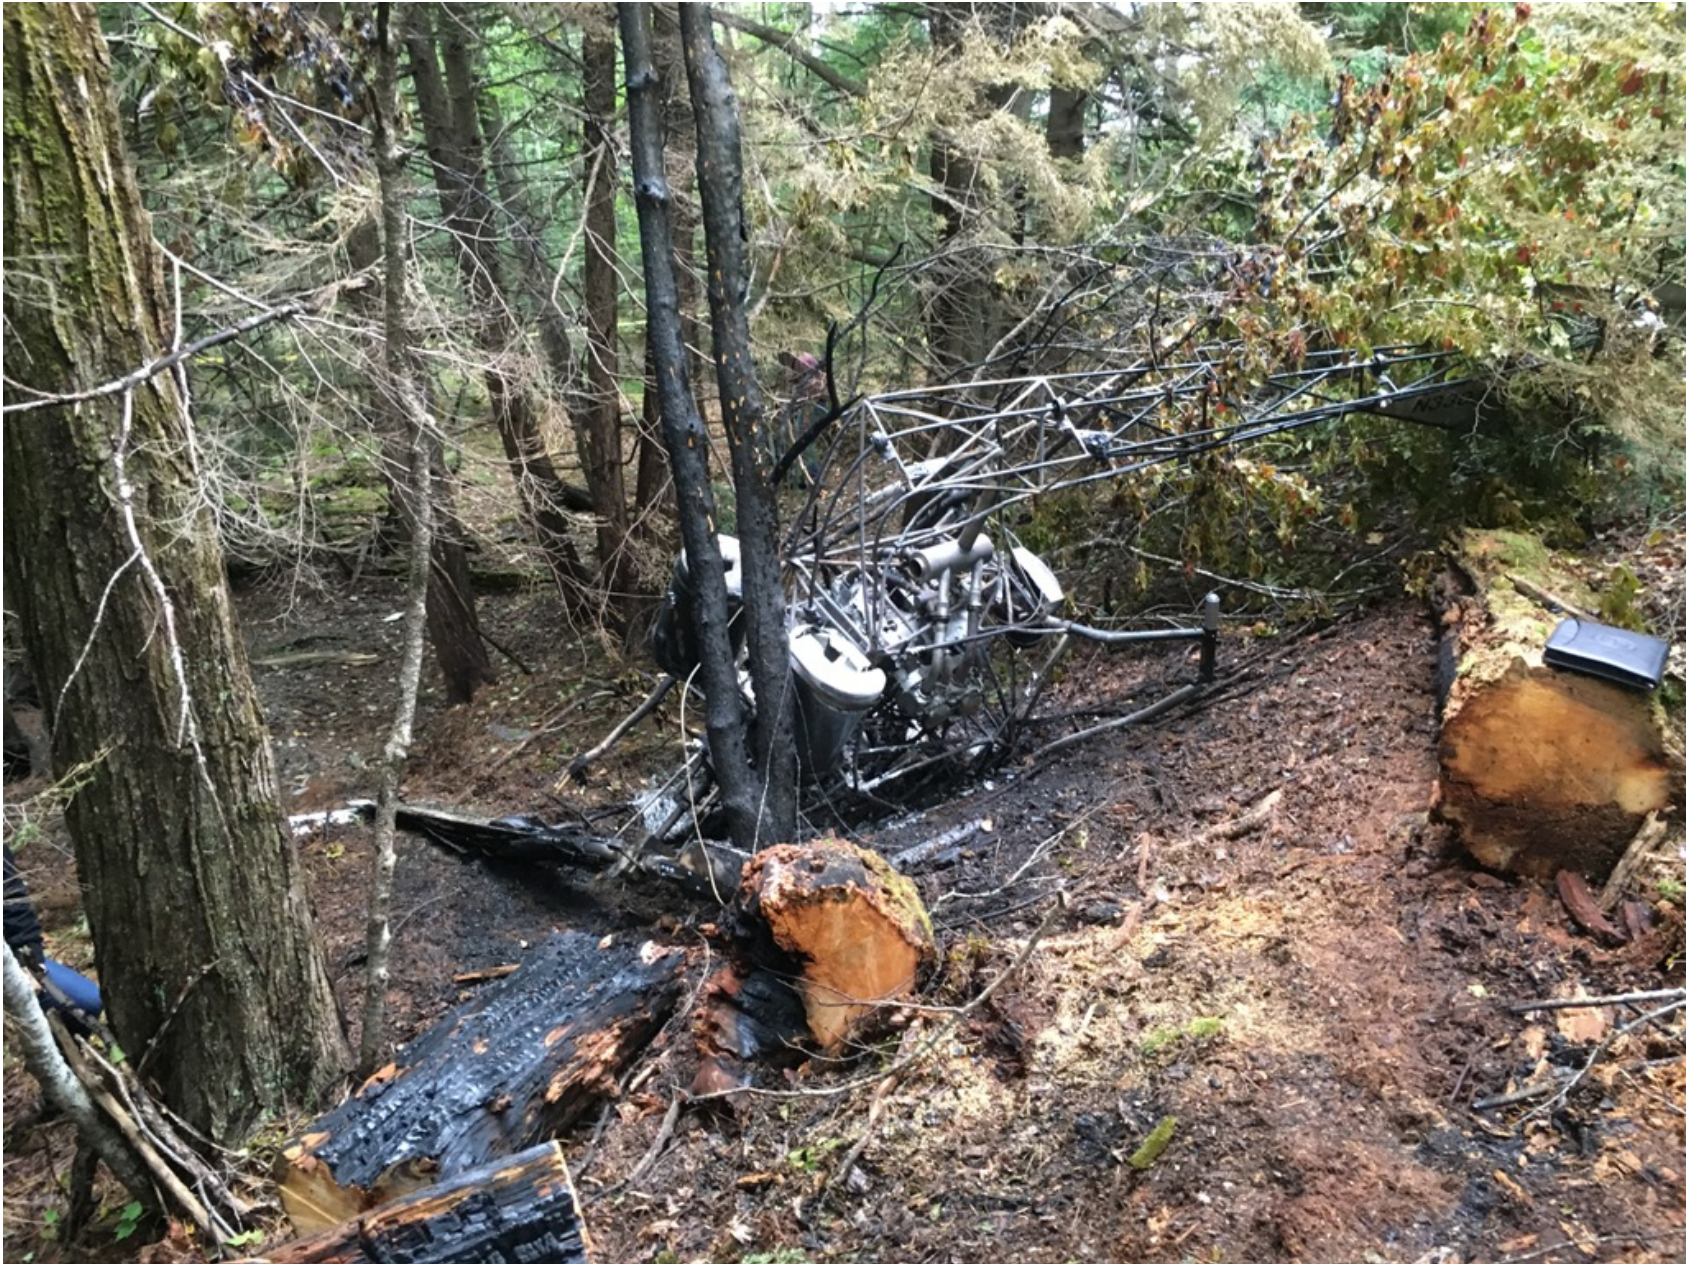
**Photo 1 – FAA Digital Photograph. View of the Helicopter at the Accident Site.**

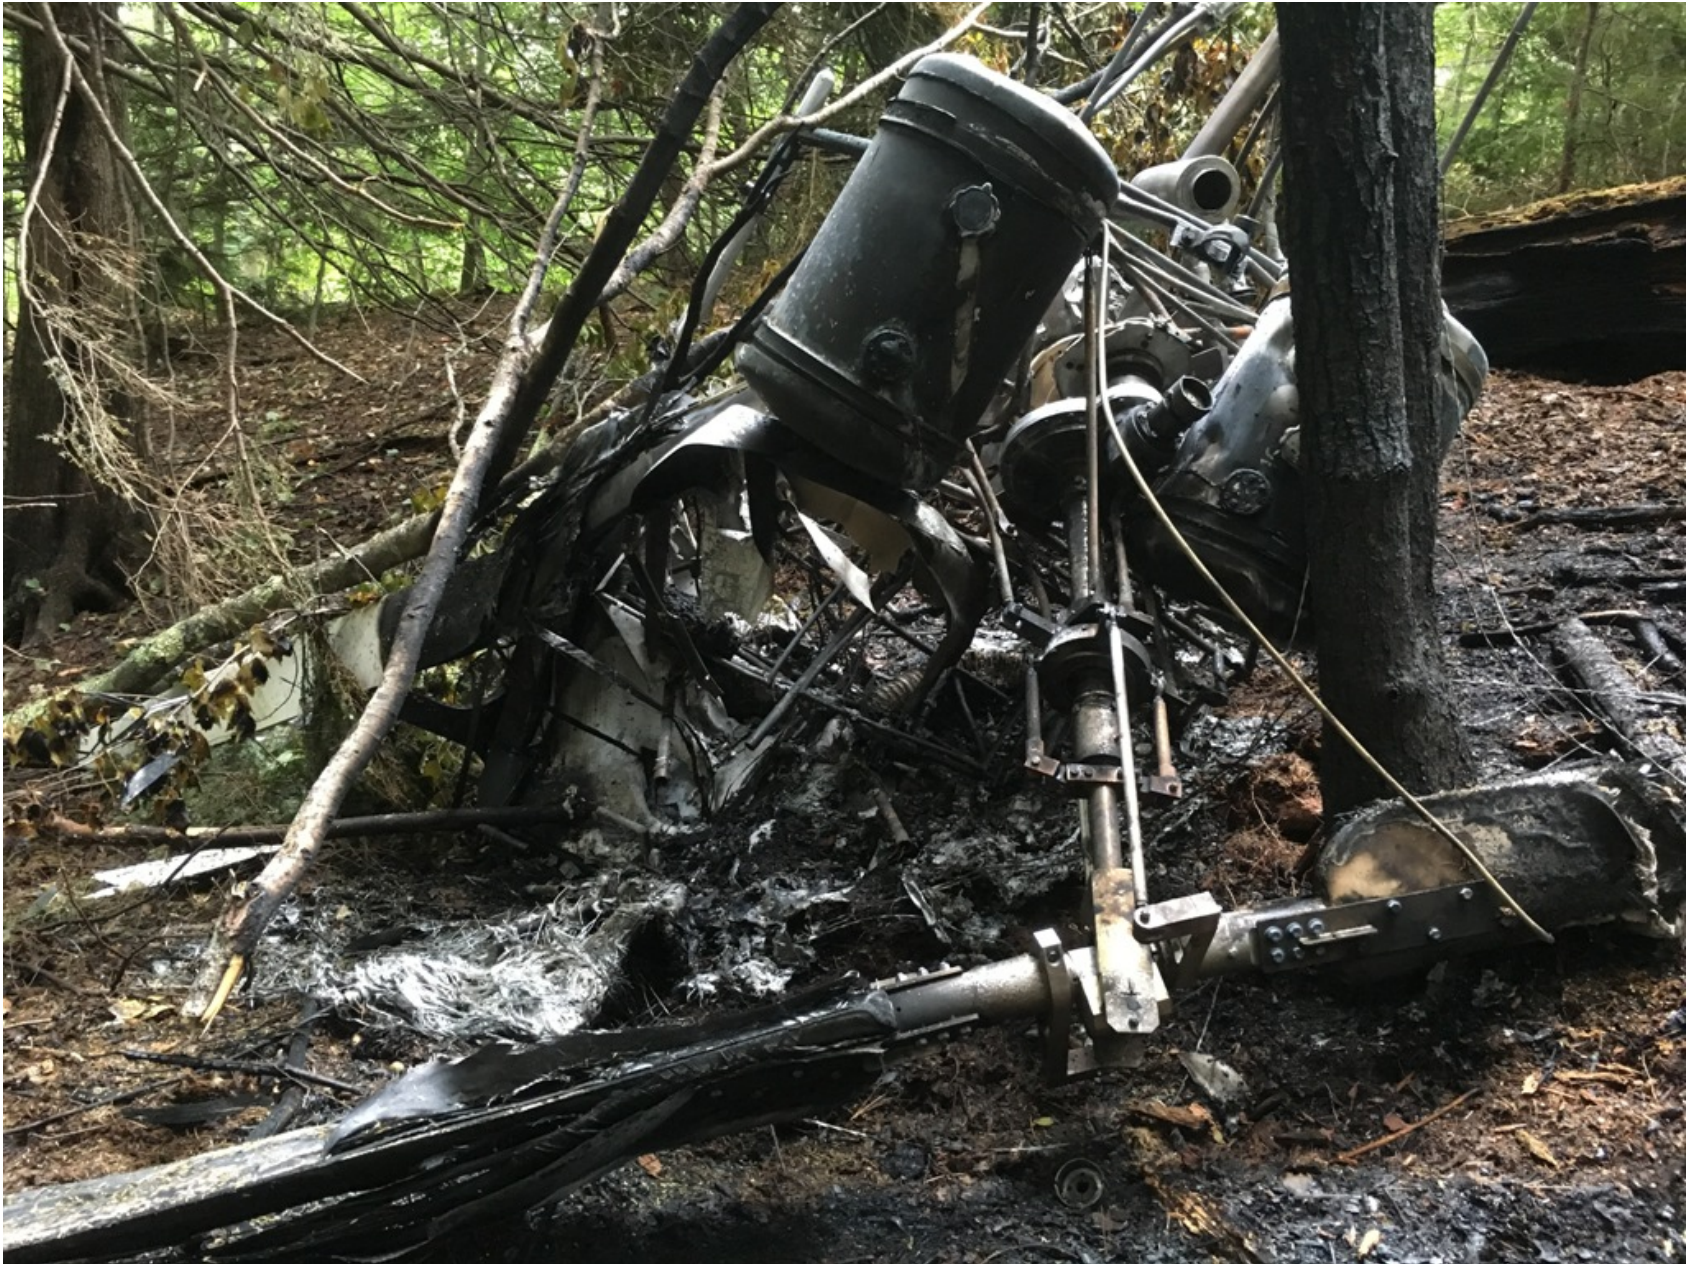
**Photo 2 - FAA Digital Photograph. View of the Helicopter at the Accident Site. Note a portion of the Main Rotor Mast and Portions of Both Main Rotor Blades, with Corresponding Burn Damage.**

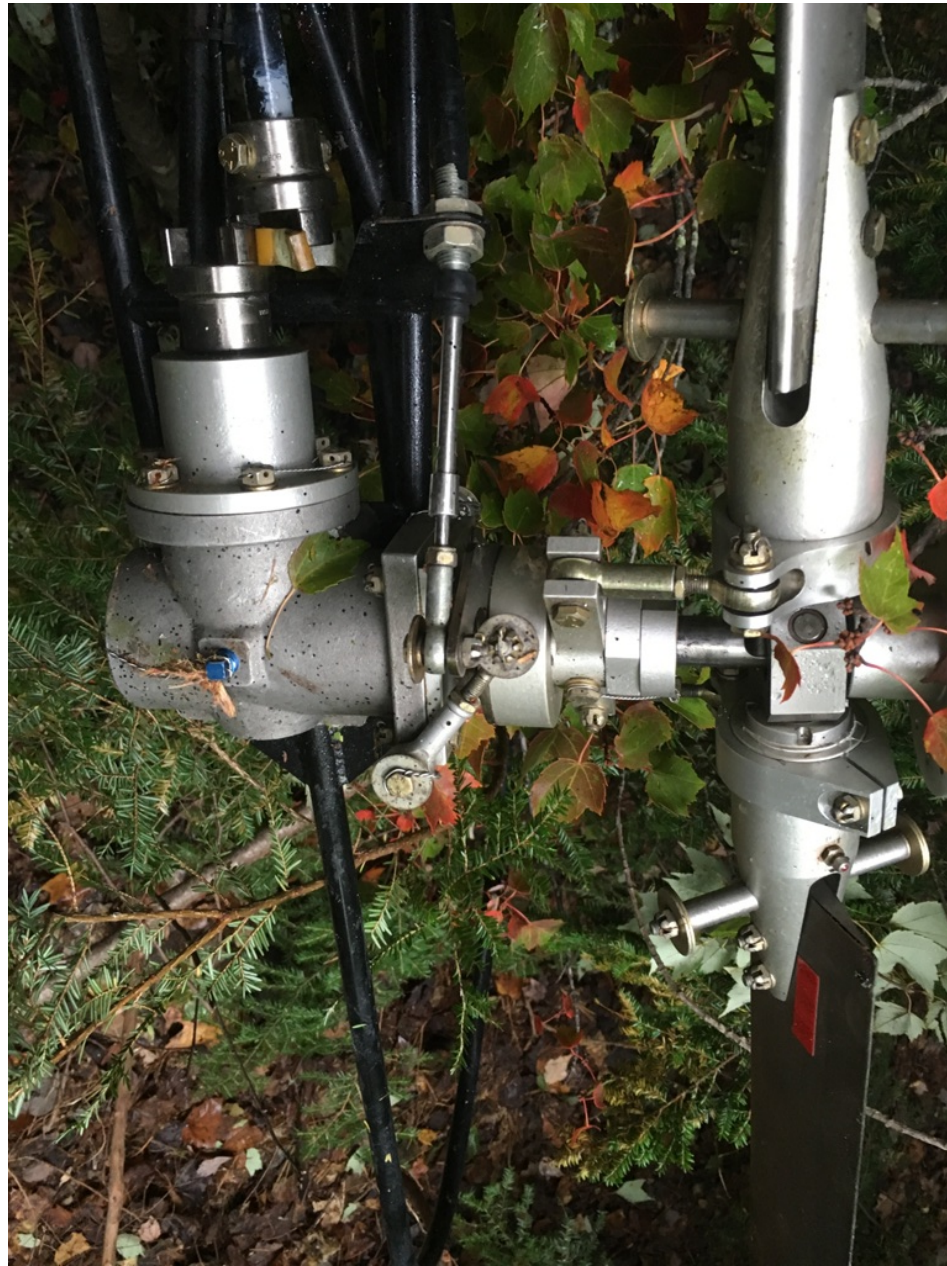
**Photo 3 - FAA Digital Photograph. View of the Tailrotor Gearbox with Portions of both Tail Rotor Blades Visible.**

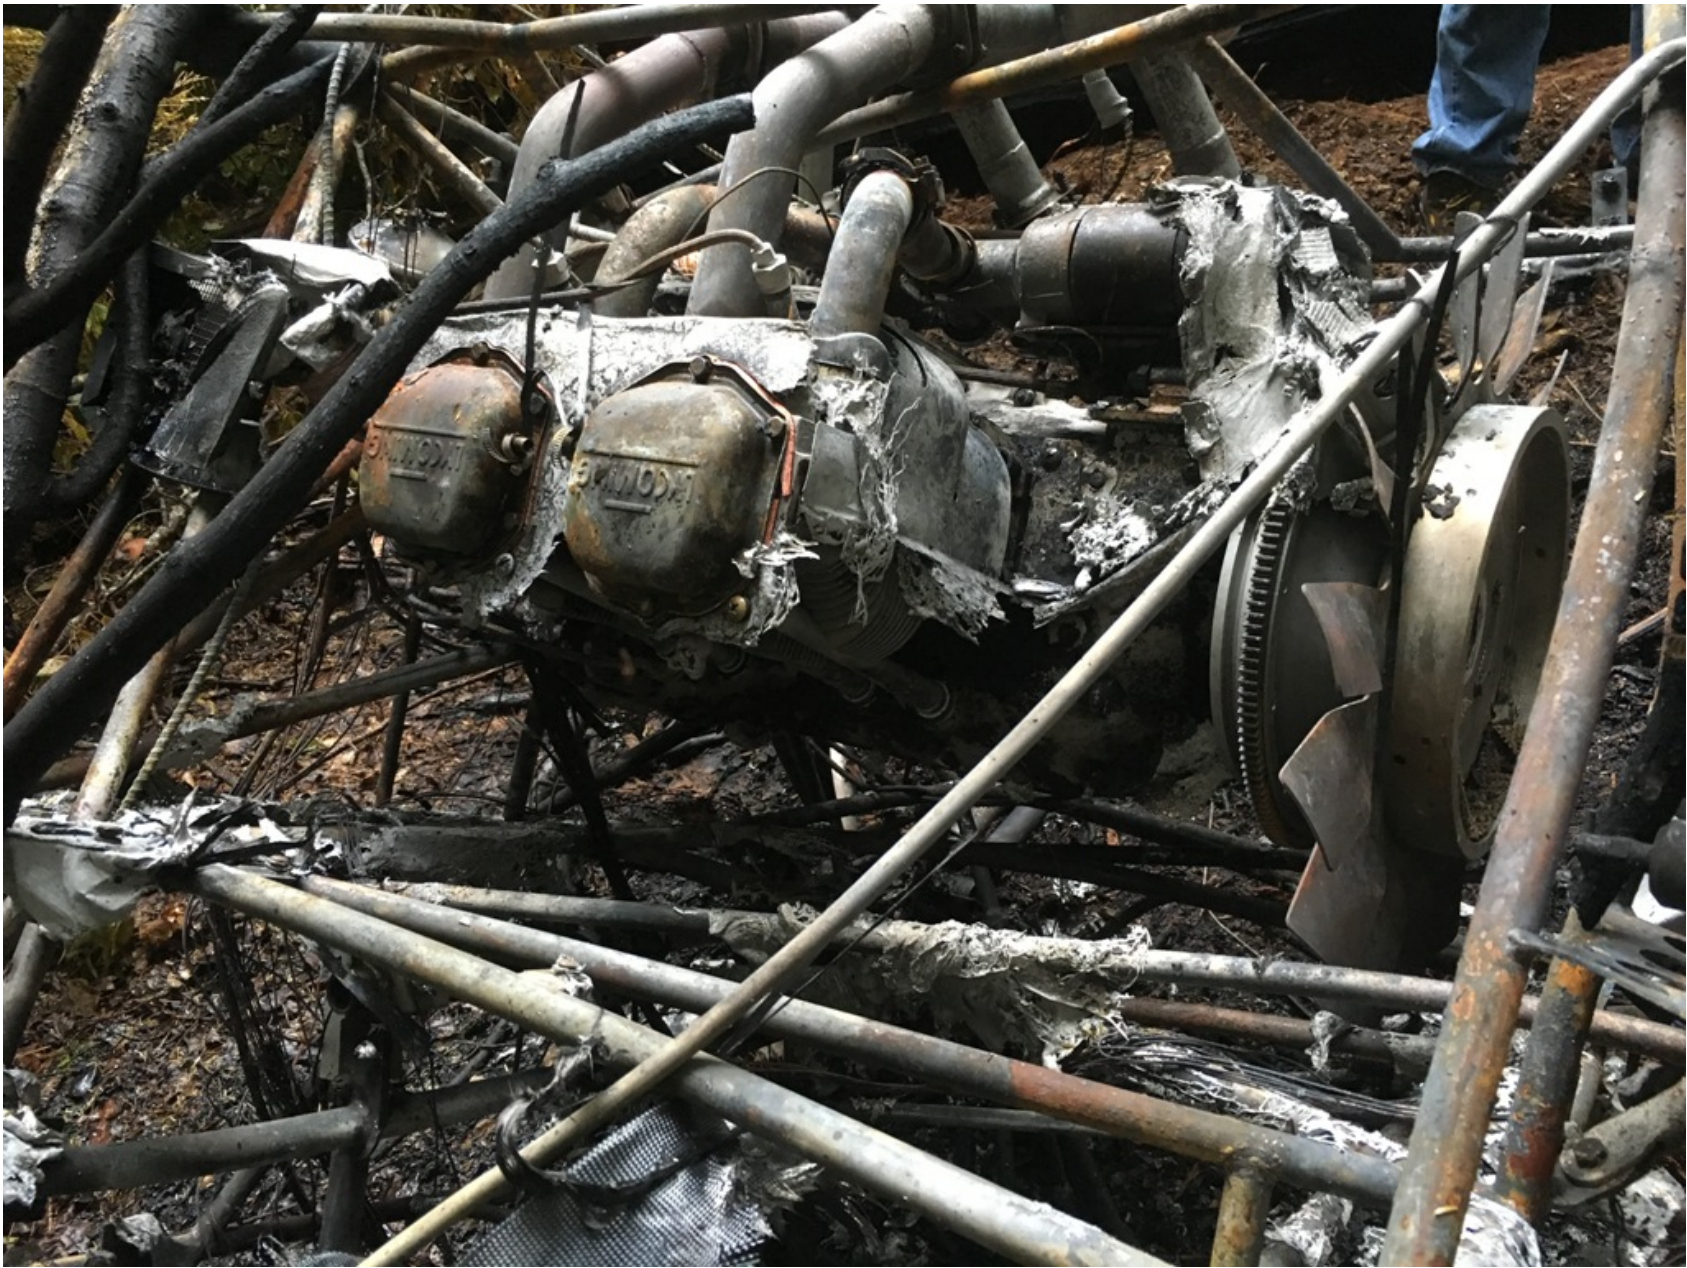
**Photo 4 - FAA Digital Photograph. View of the Engine Assembly**

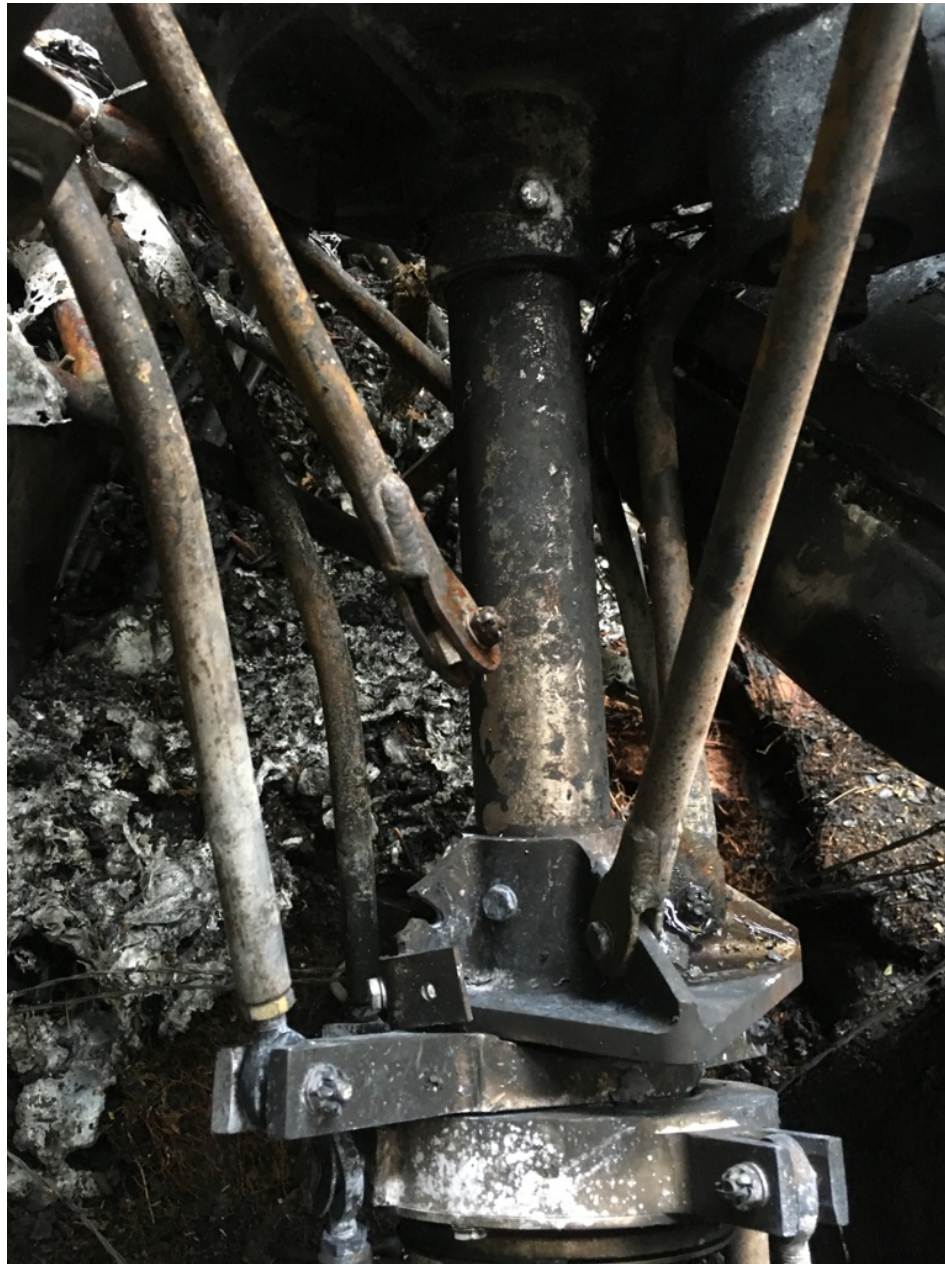
**Photo 5 - FAA Digital Photograph. View Showing 3 of the 4 Transmission Struts, 2 of Which remained connected and 1 was Pulled Free From Its Attach.**

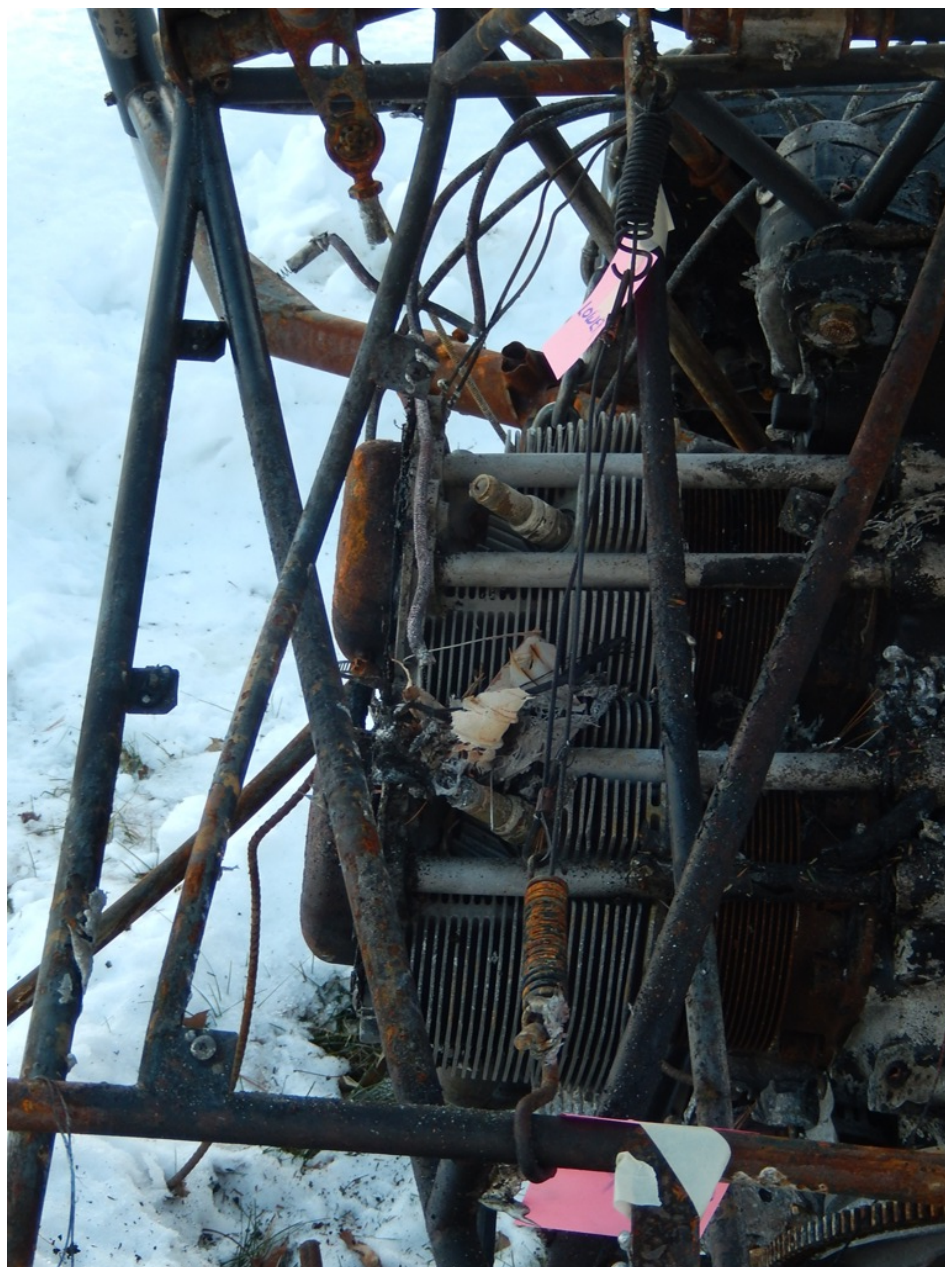
**Photo 6 - Digital Photograph Provided by Pilot. View Depicting Both Collective Springs and Cables.**
