## **ENGINE EXAM NOTES**

**NATIONAL TRANSPORTATION SAFETY BOARD**

### **ENGINE EXAMINATION**

**ERA16LA331**

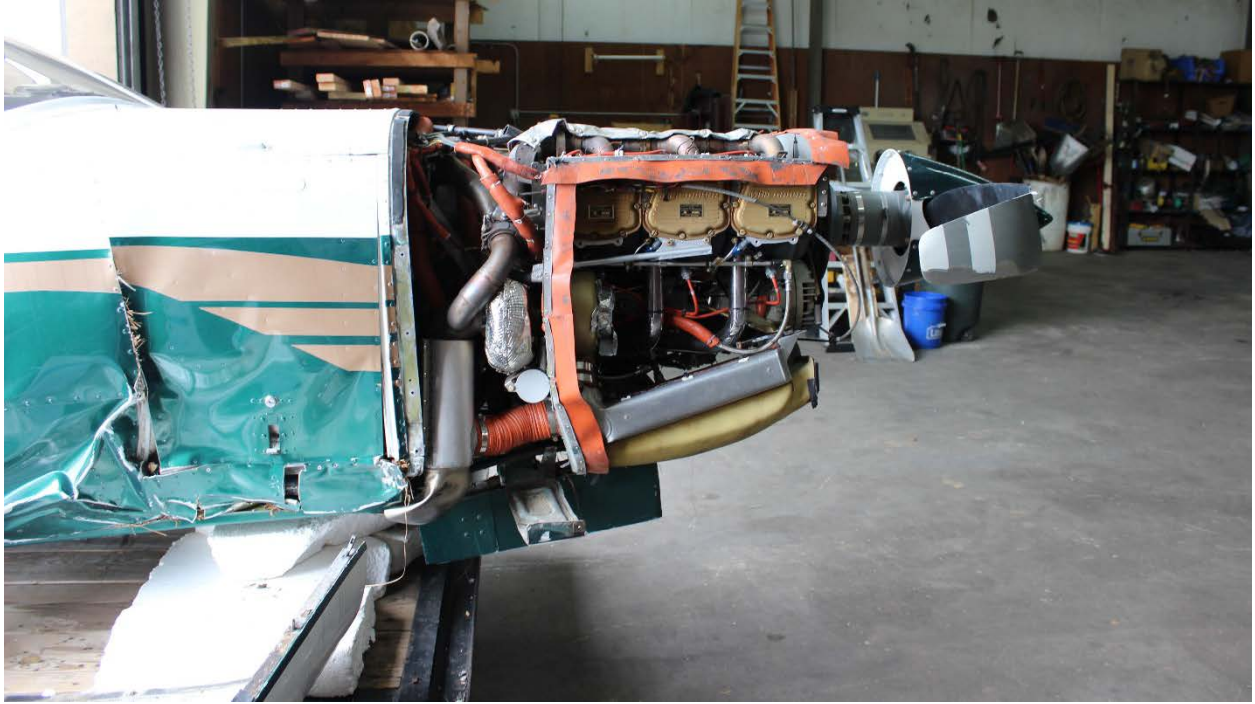
Figure 1 Right side of the engine

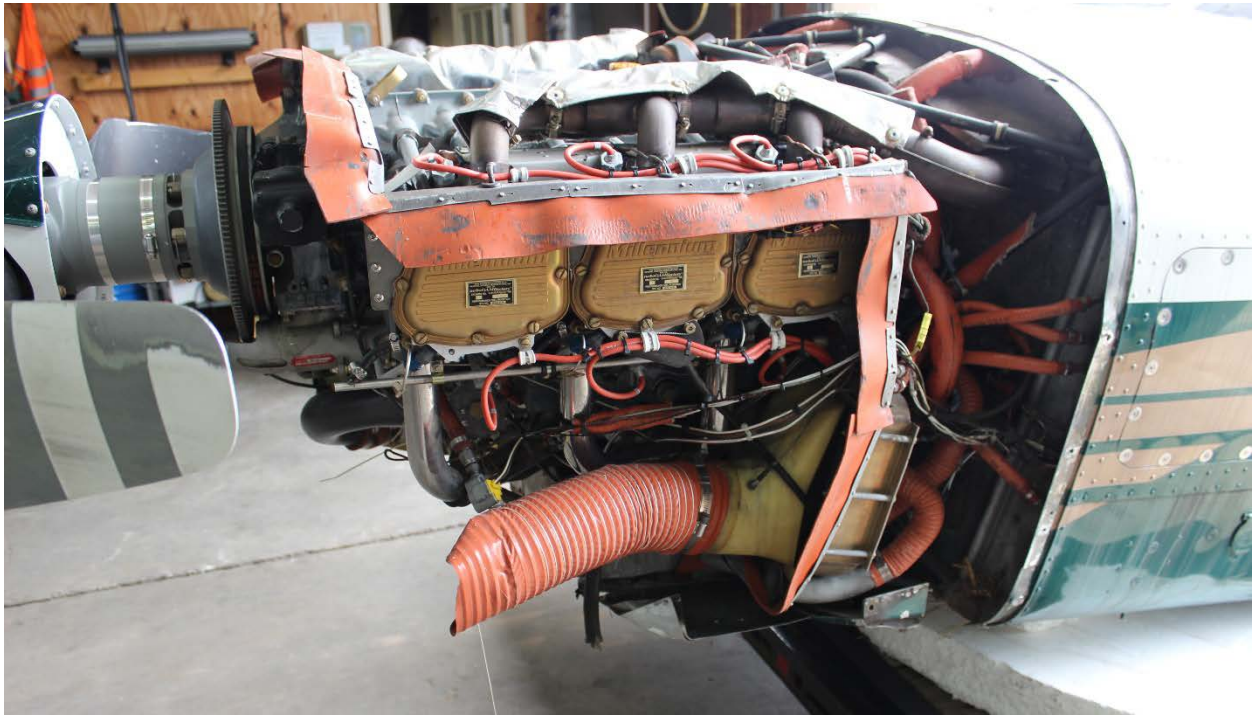
Figure 2 Left side of the engine

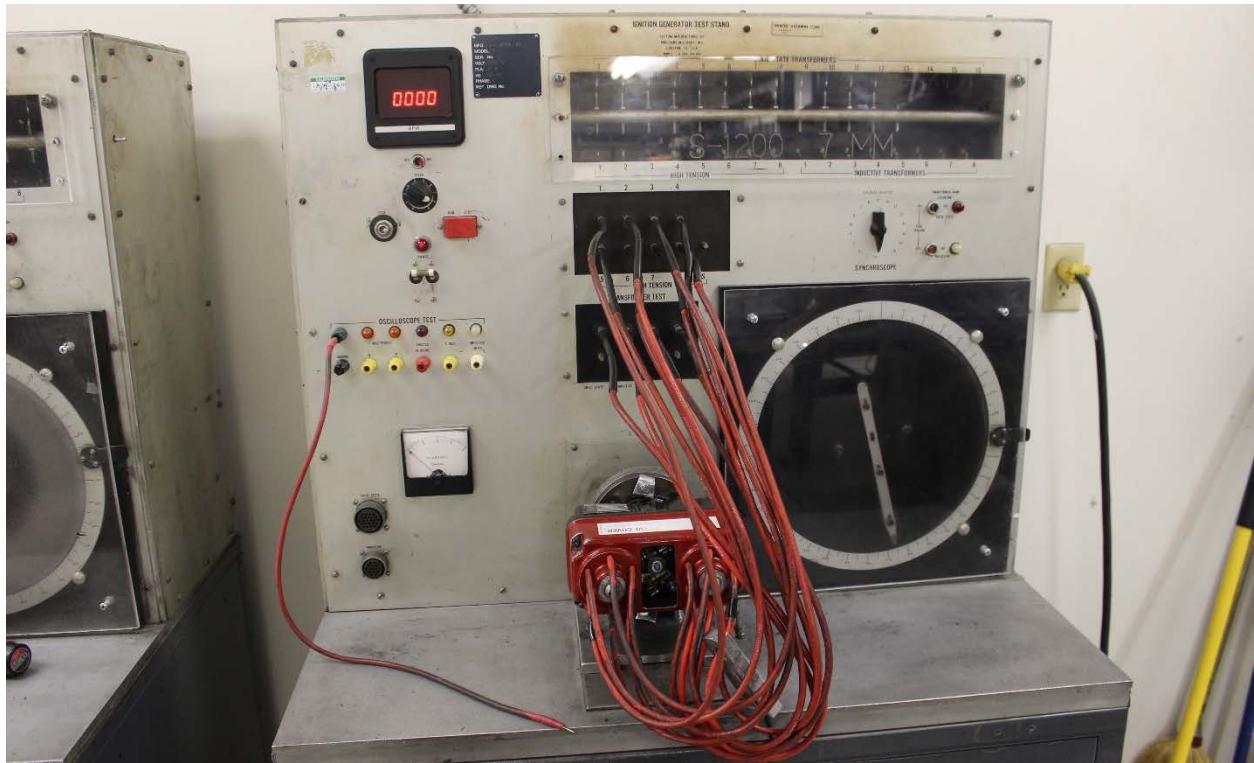
The single drive dual magneto was placed on a test stand, the left side of the magneto did not produce spark. During initial testing the right side produced spark on four of the six leads when

Figure 3 The single drive dual magneto on the test stand.

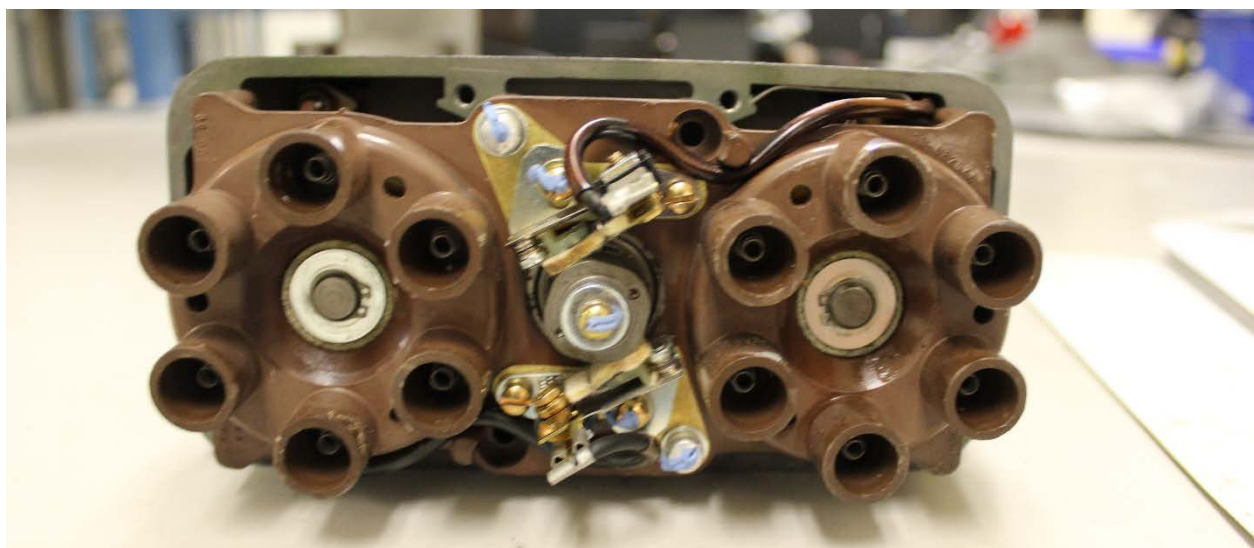
rotated by hand. When planed on a test stand the right side produced spark on all leads. Internal examination of the magneto revealed that the left side cam follower was melted, preventing opening of the points. The left and right capacitor fastenings were not properly torqued, the left nut was loosened by hand and the right nut was loosened easily with a wrench and removed by hand. The cam follower also displayed melting and signatures of intermittent arcing, consistent with inadequate torque observed on the capacitor fastenings.

Figure 4 The internal examination of the single drive dual magneto.

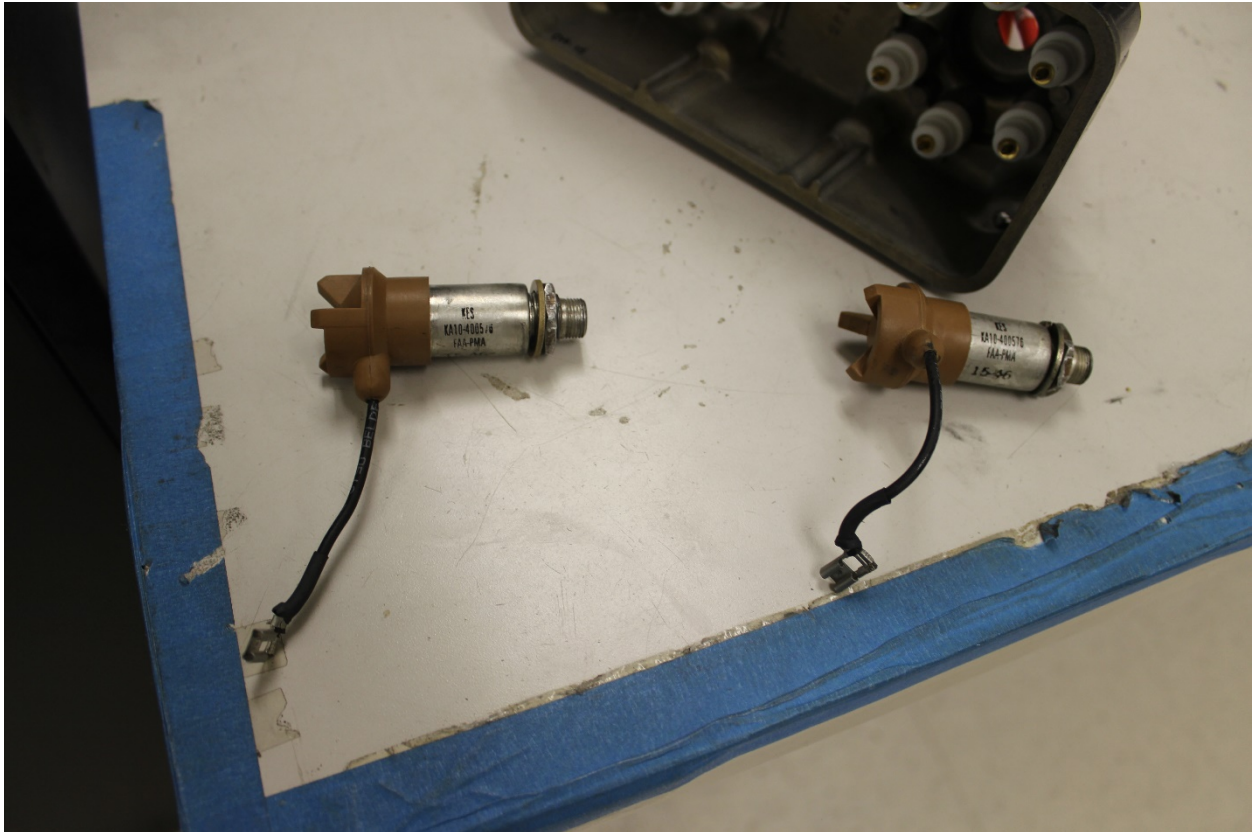
Figure 5 The left and right cam followers.
