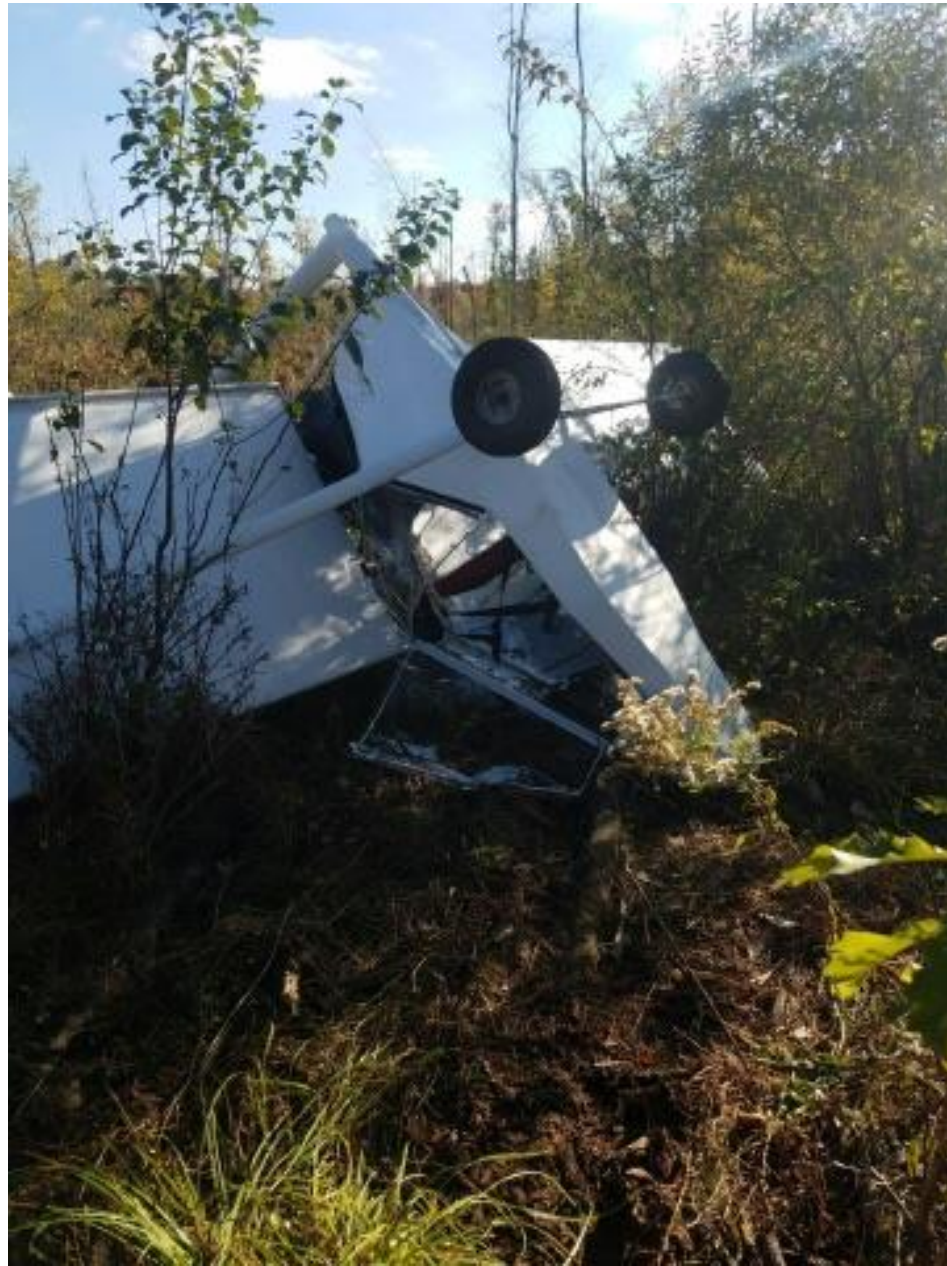
**Photo 1 –View of main wreckage**

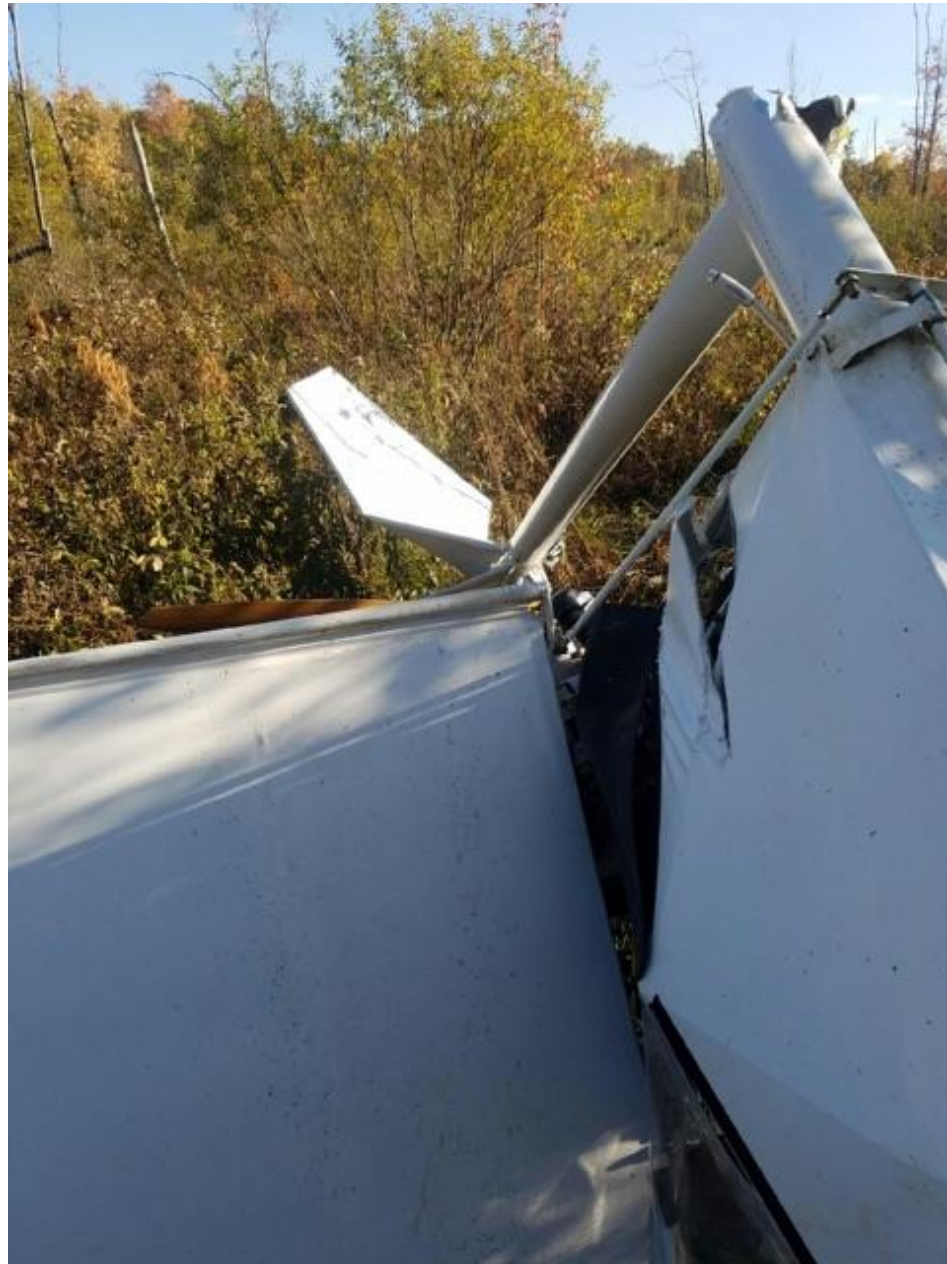
**Photo 2 -View of broken emmpenage**
