| SUBJECT<br>Aircraft Accident on 5/21/2017 west of Manassas Airport | | | |

**From:** Steve Berkey <steve@[REDACTED]>  
**Sent:** Friday, June 9, 2017 10:15 AM  
**To:** DLogan@[REDACTED]  
**Cc:** JJ Anglin; Gunther Todd  
**Subject:** Archer II  
**Attachments:** ATT00001.txt

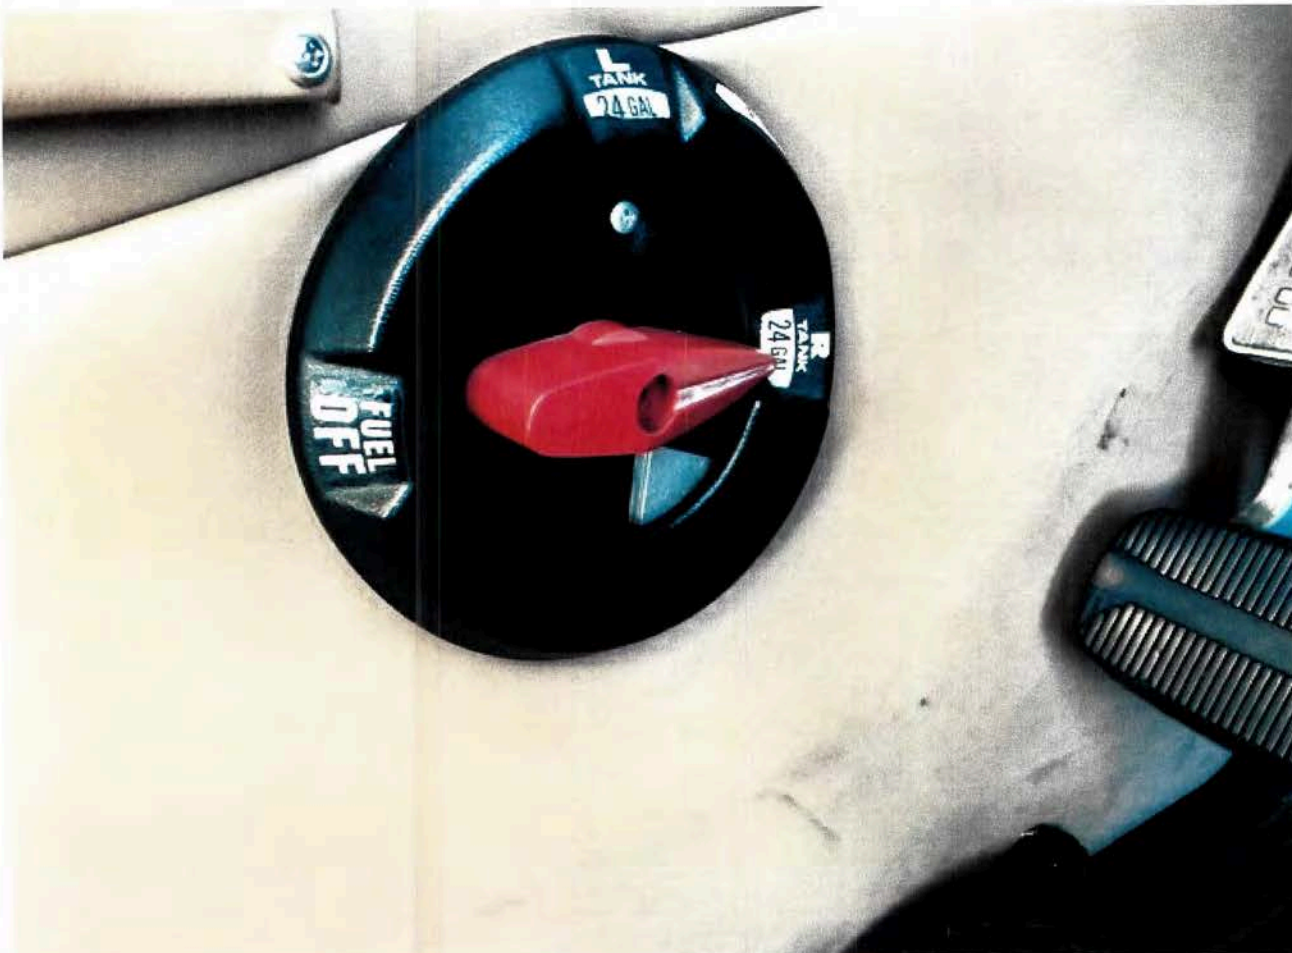
We recovered about a approximately pint of fuel from right tank and approximately 3 gallons from left tank. Fuel selector was selected to right tank. (See attached photo below) If you need anything else please don't hesitate to contact me.
