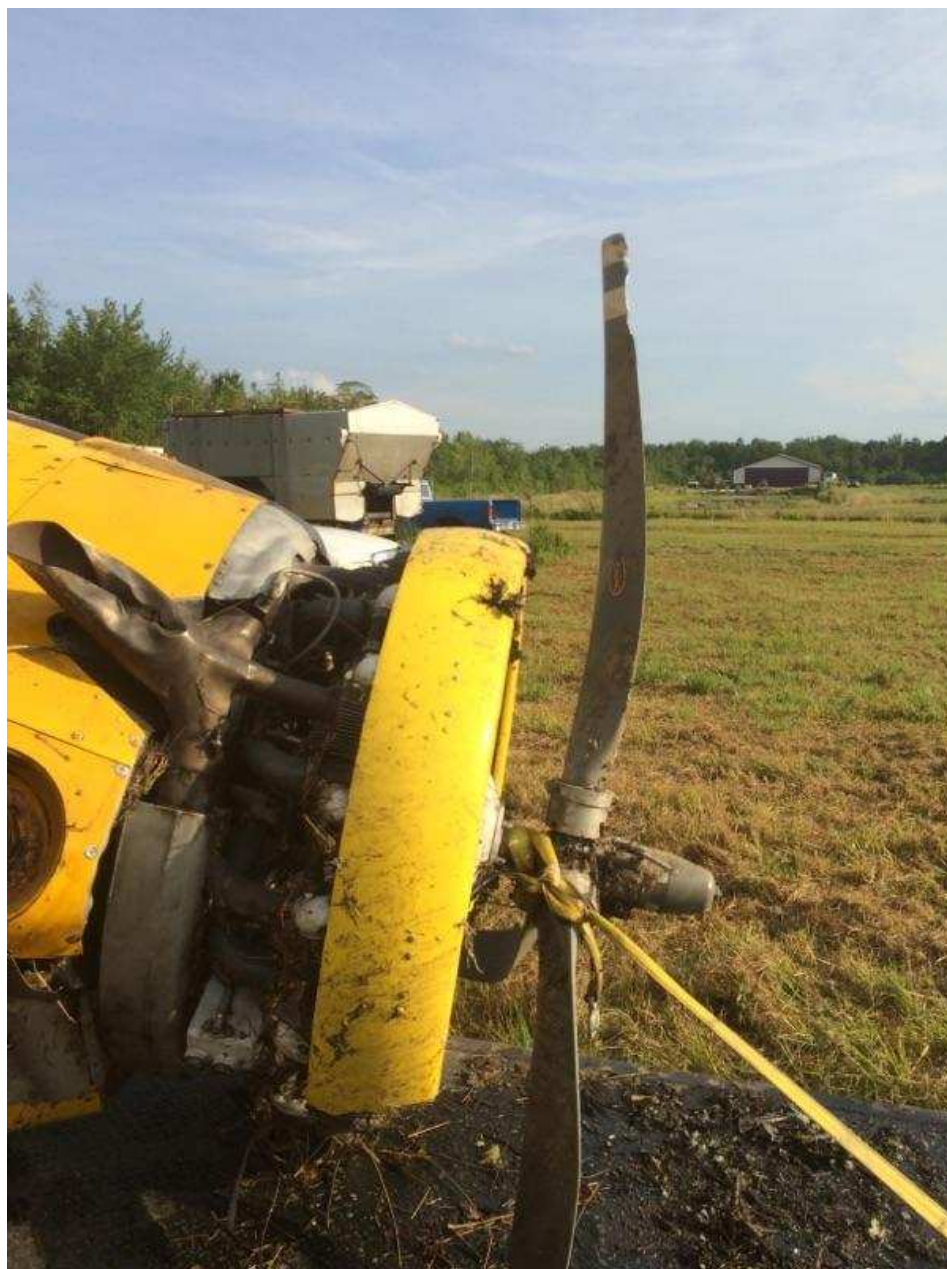
**Photo 1 – Side view of engine with bird feathers in cowling. (Courtesy of FAA)**

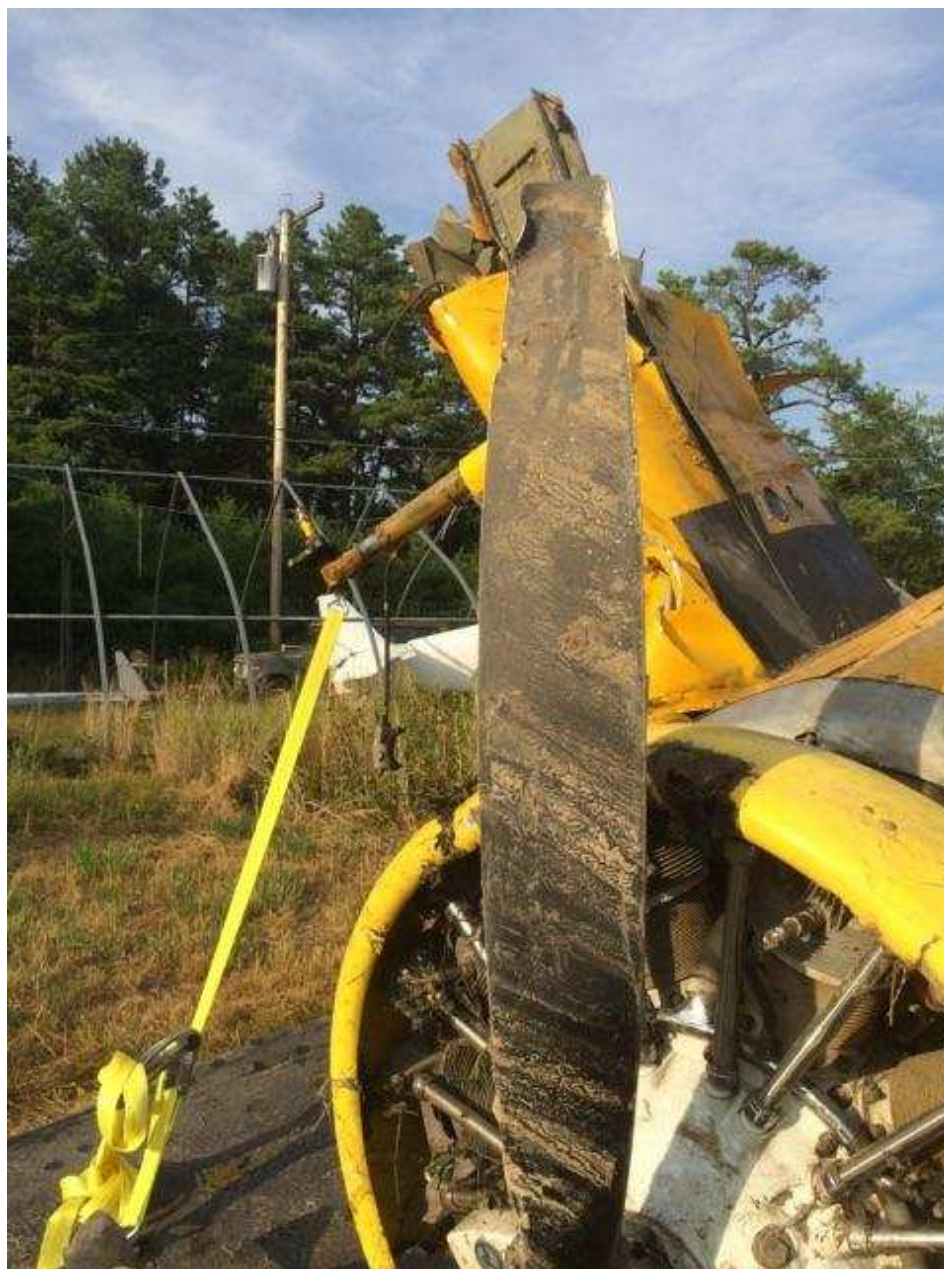
**Photo 2 – Front View of Propeller with View of Damaged Right Wing in Background (Courtesy of FAA)**
