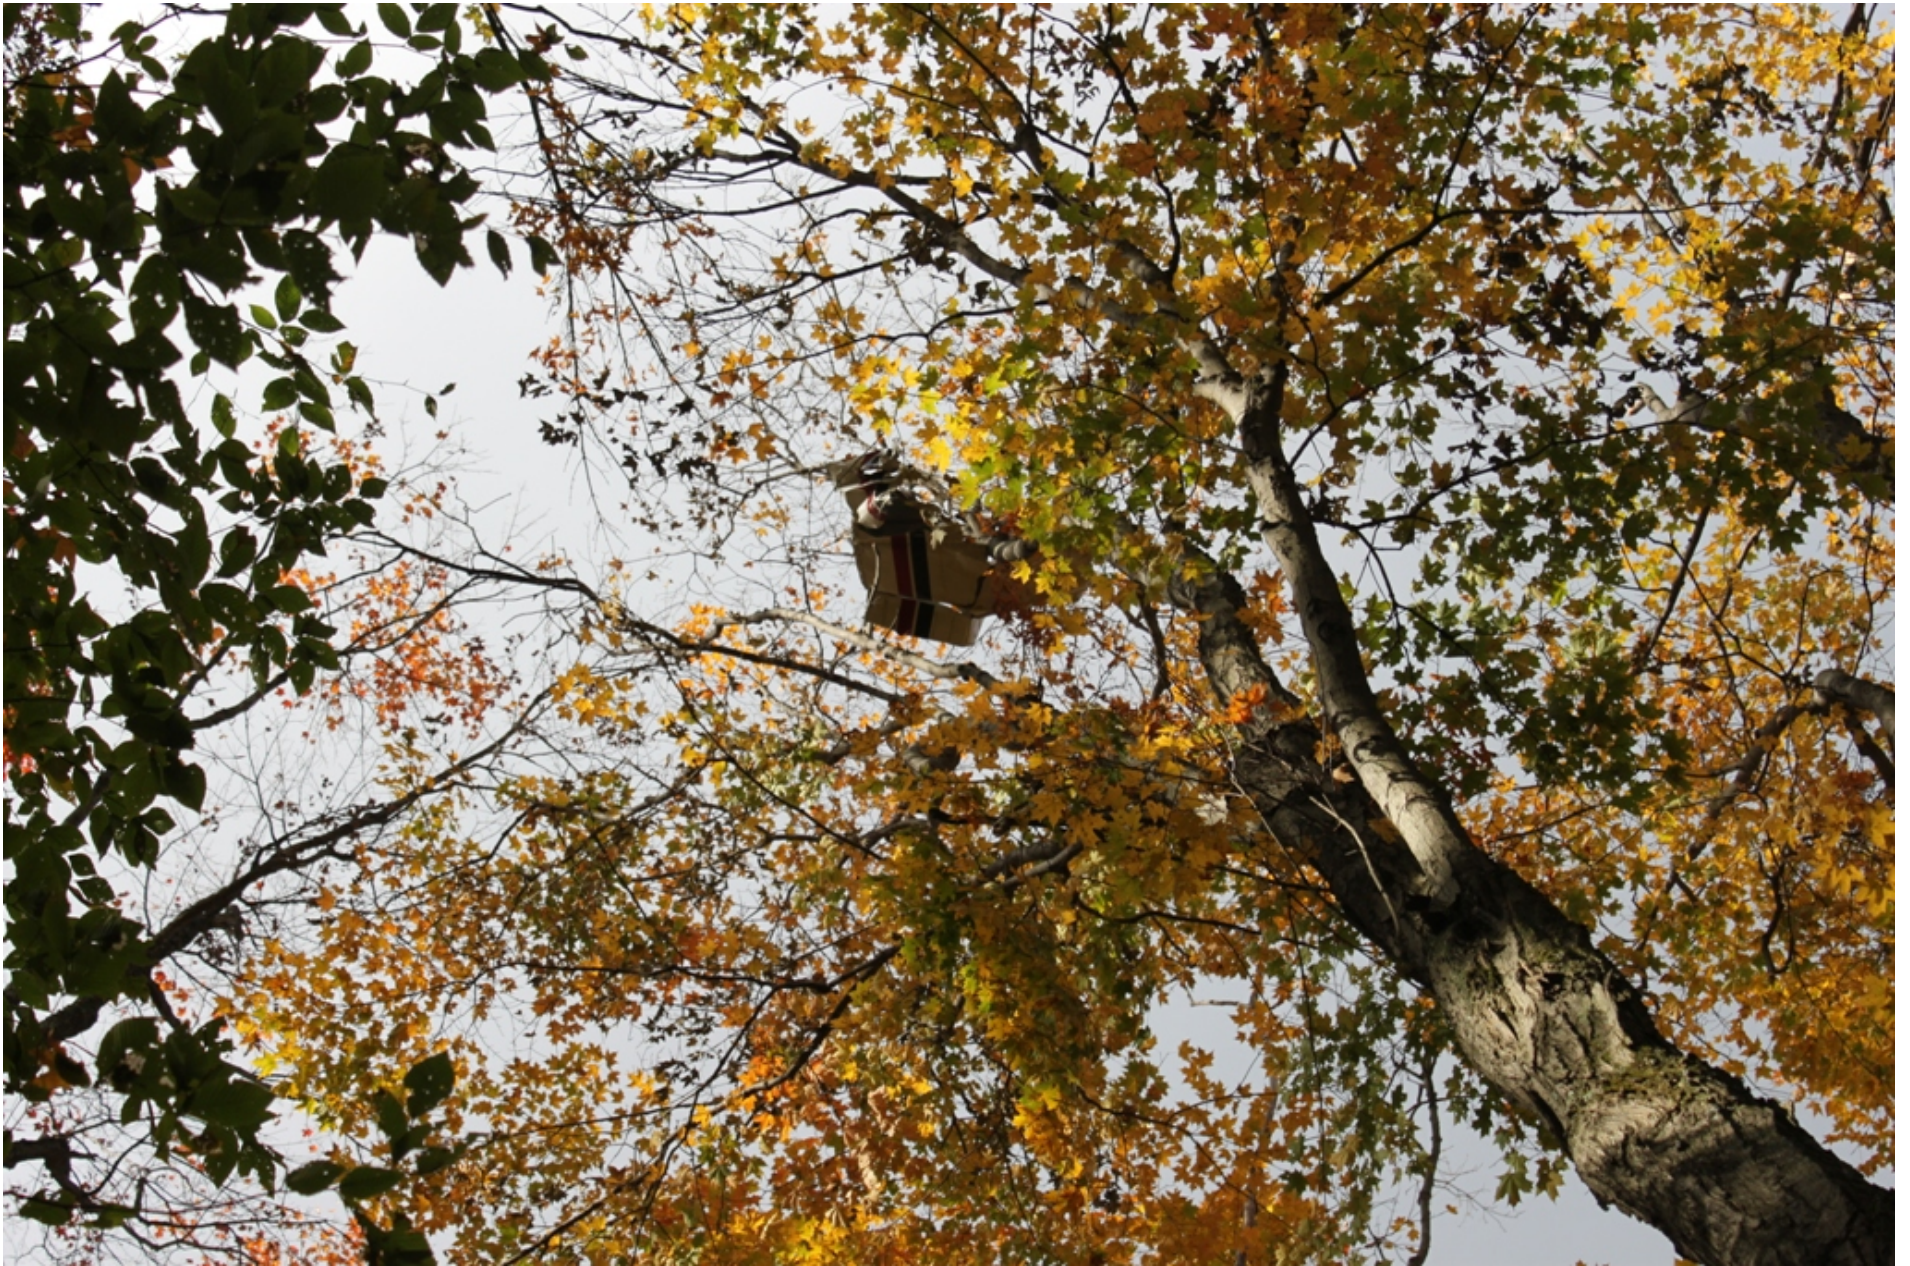
**Photo 2 – NTSB Digital Photograph. View of Outboard Portion of Right Wing Located in Tree.**

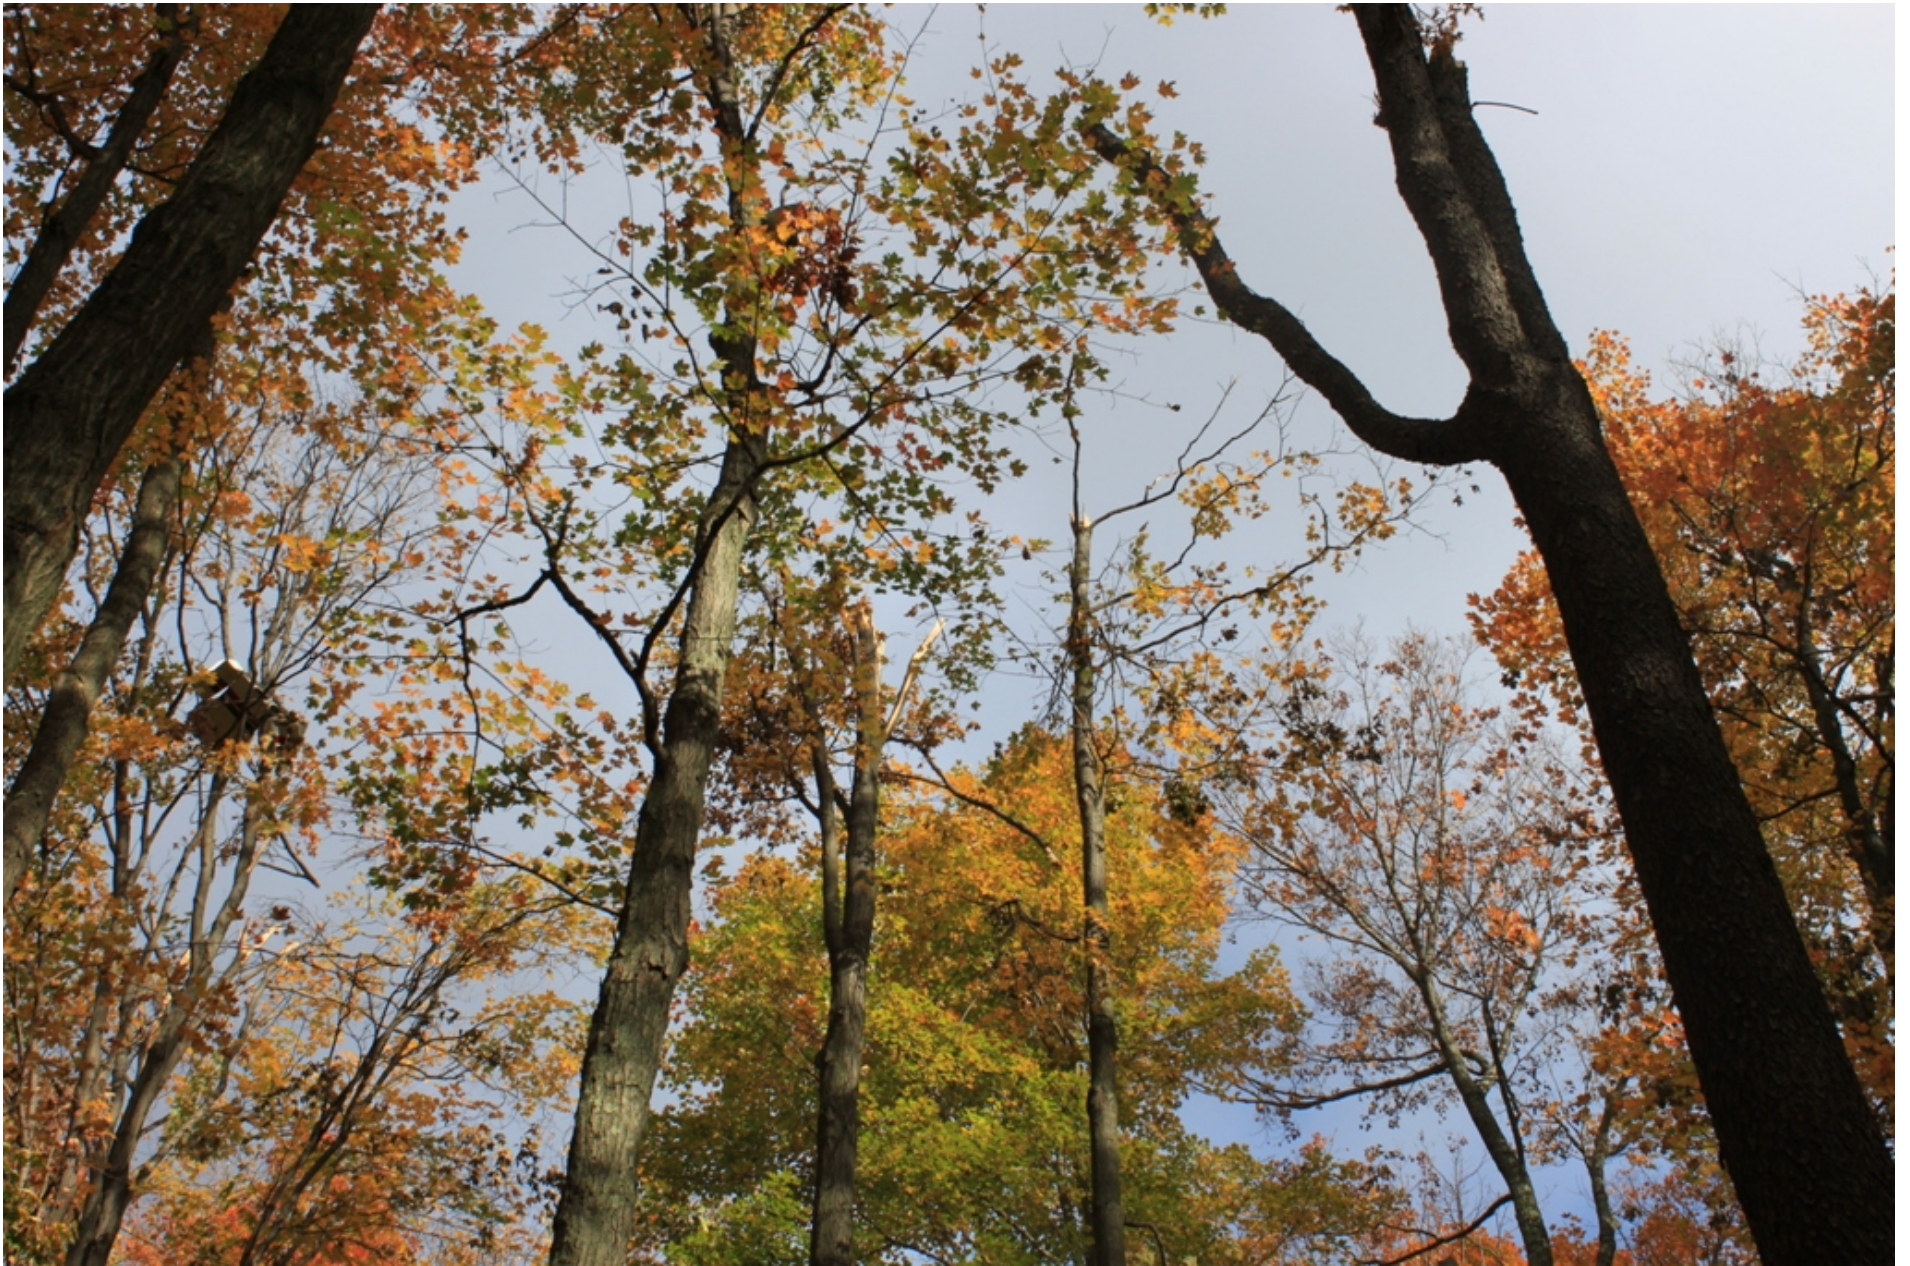
**Photo 3 - NTSB Digital Photograph. View of Outboard Portion of Right Wing Located in Tree, and Tree Damage.**

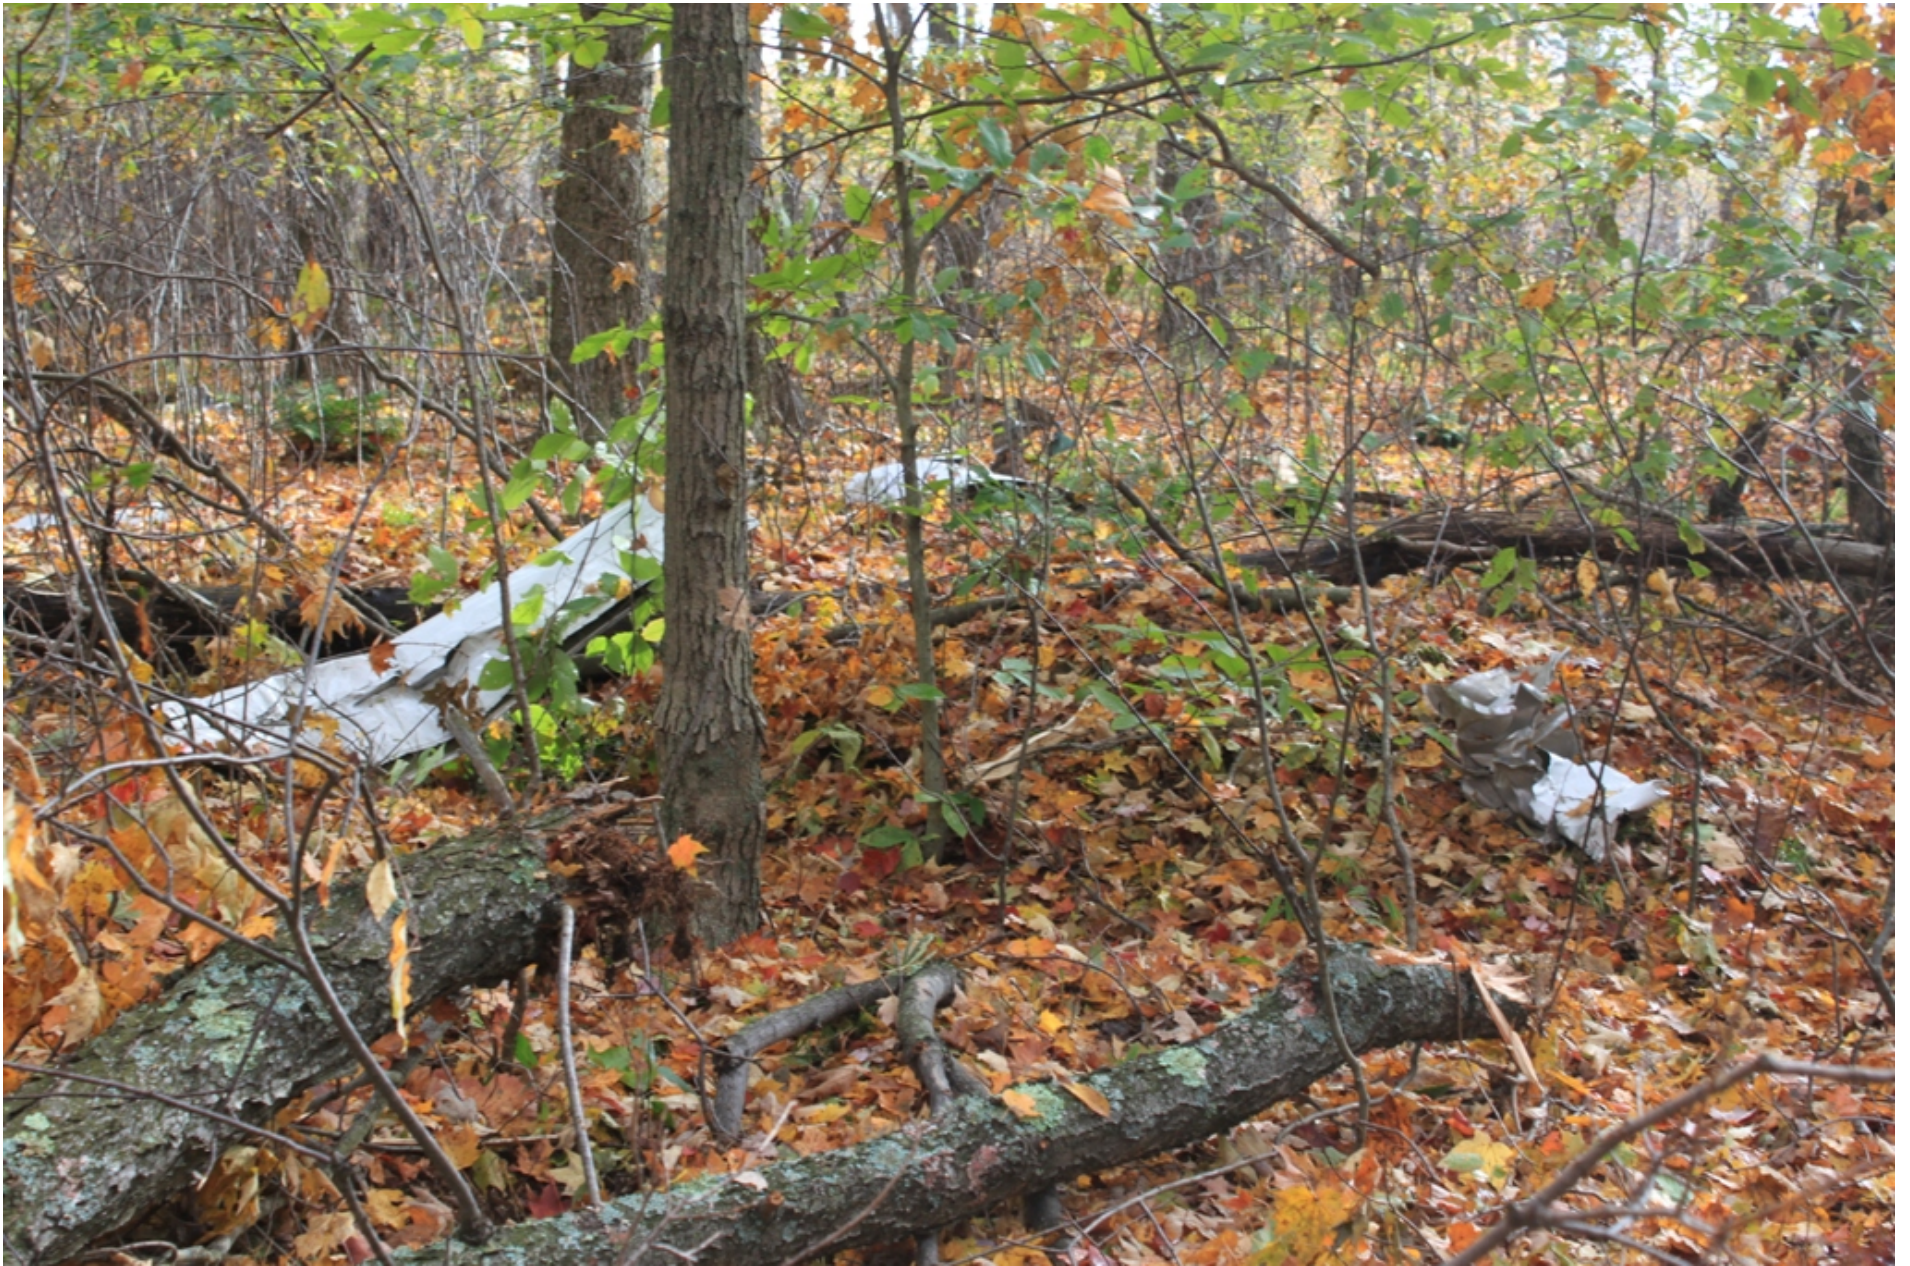
**Photo 4 - NTSB Digital Photograph. View of Wreckage Along Energy Path.**

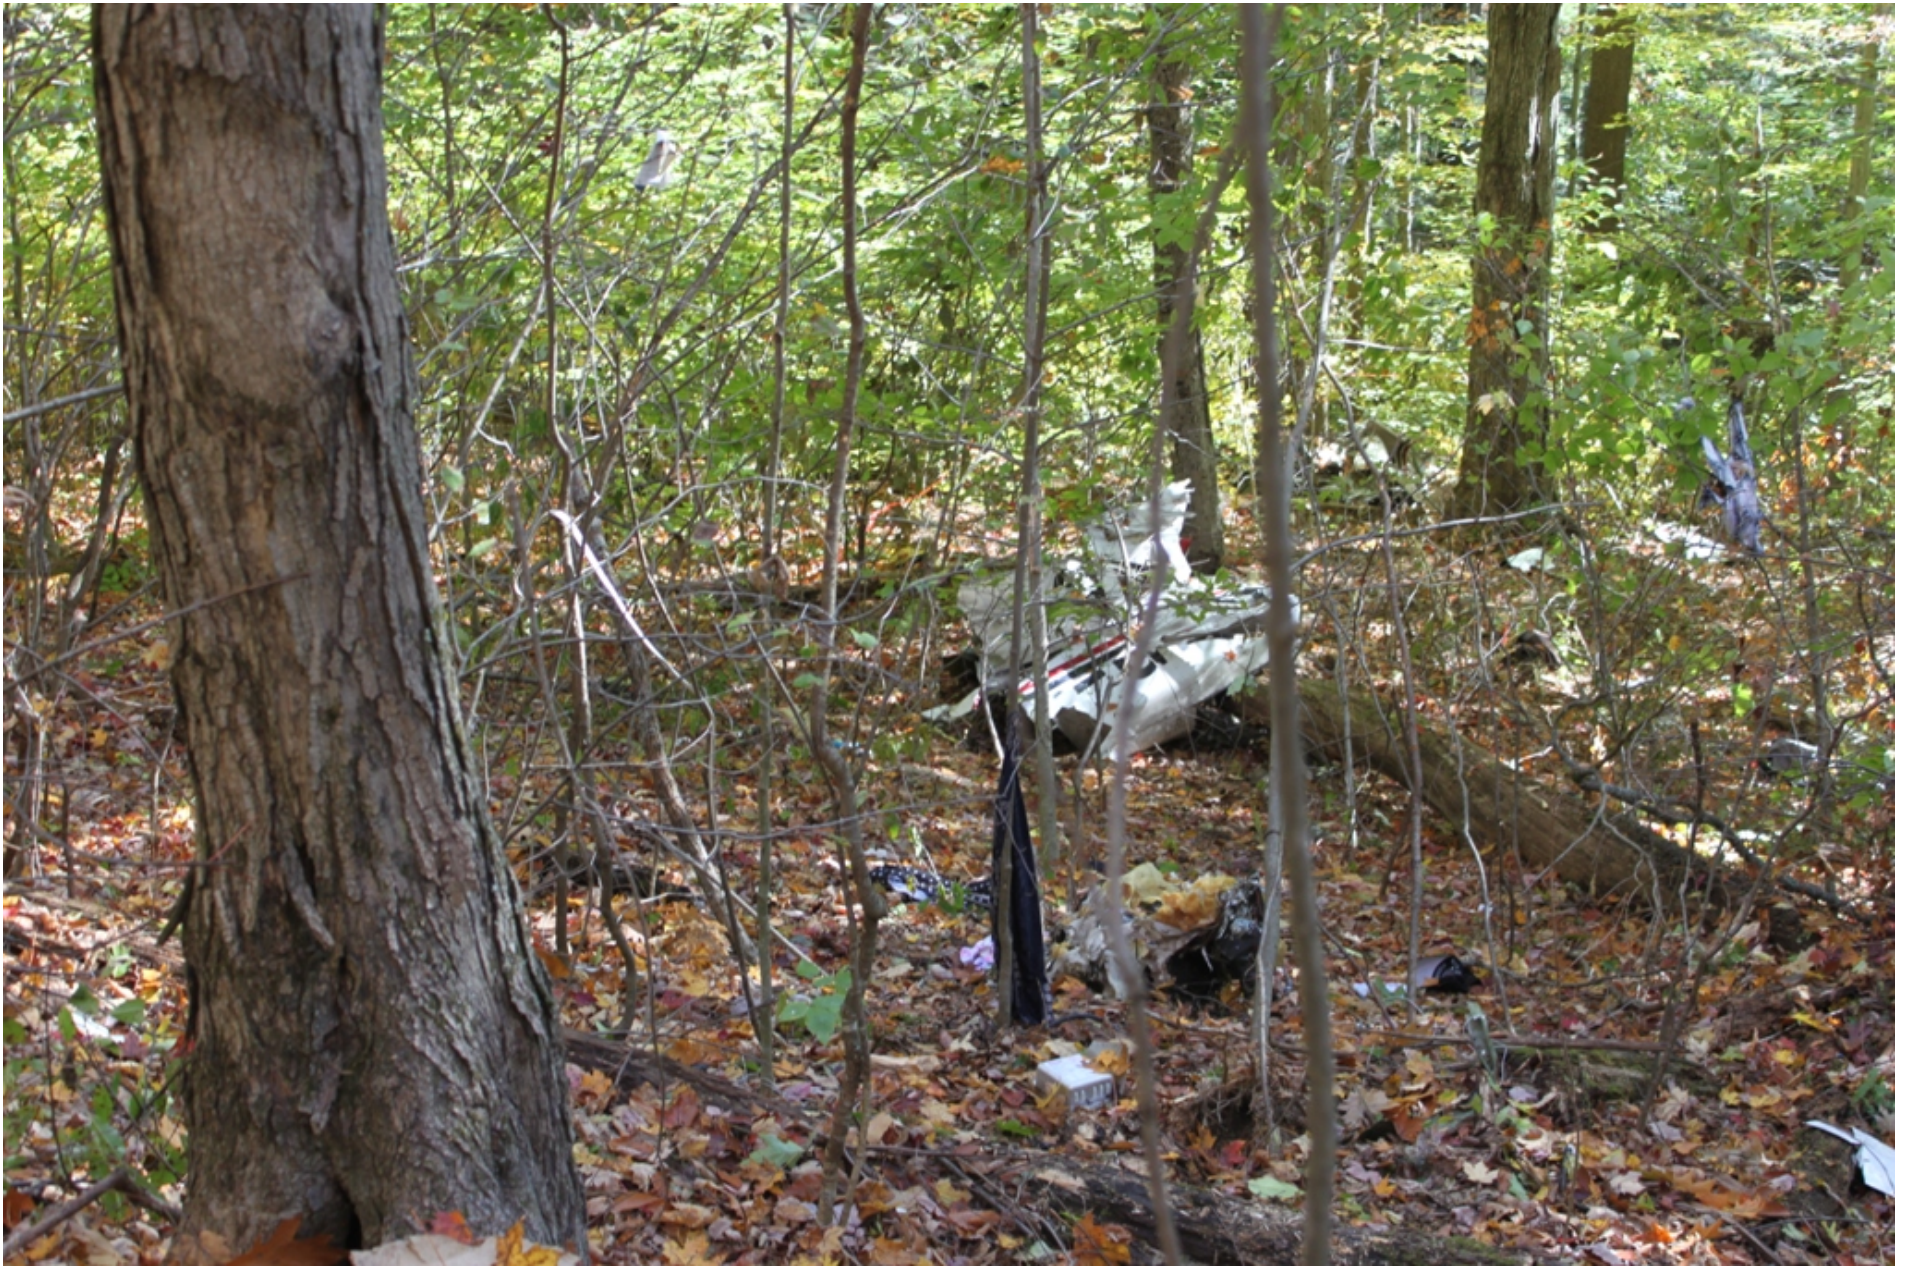
**Photo 5 - NTSB Digital Photograph. Another View of Wreckage Along Energy Path.**

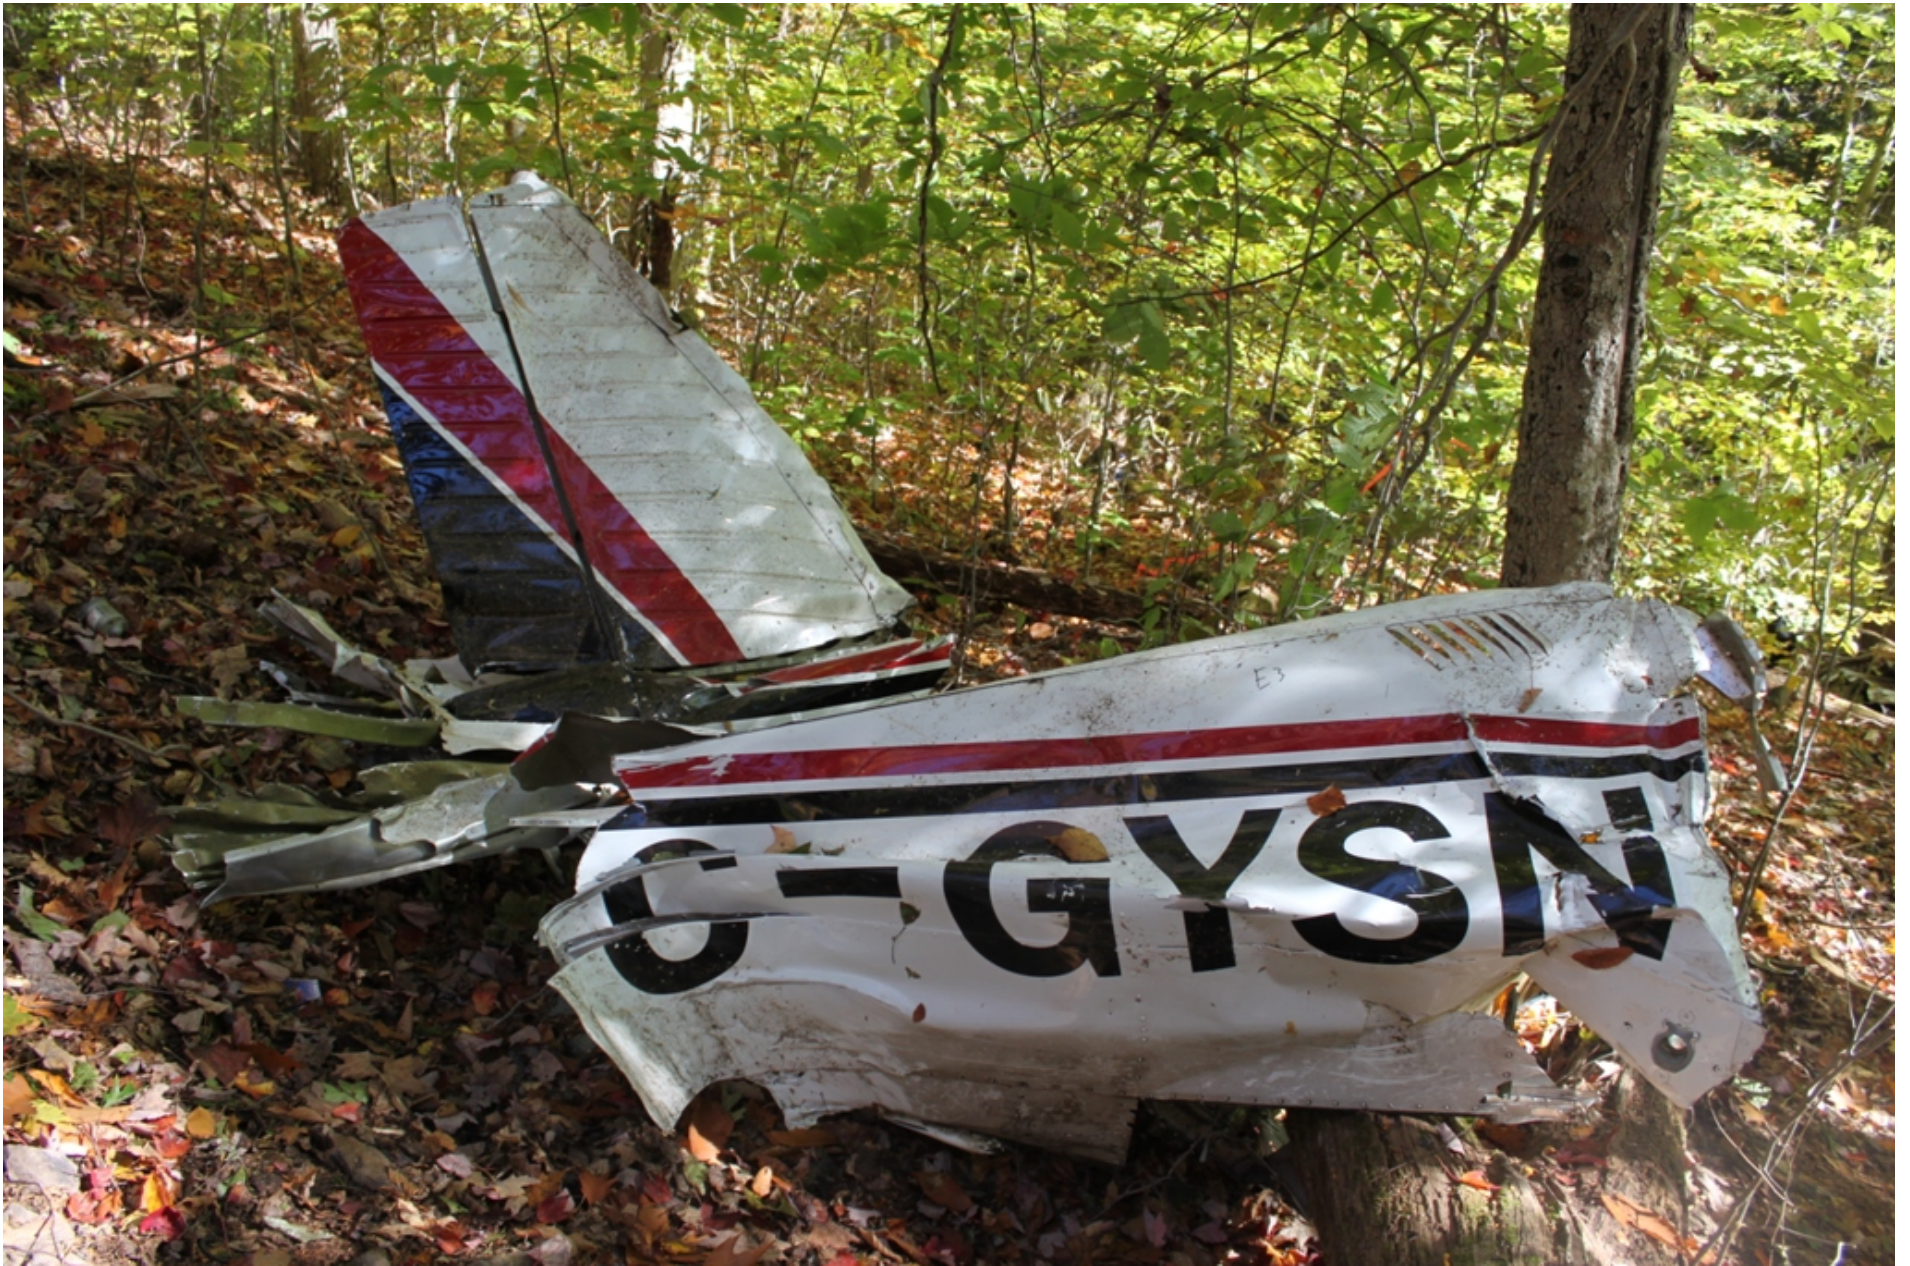
**Photo 6 - NTSB Digital Photograph. Right Side View of Empennage, Vertical Stabilizer, and Rudder.**

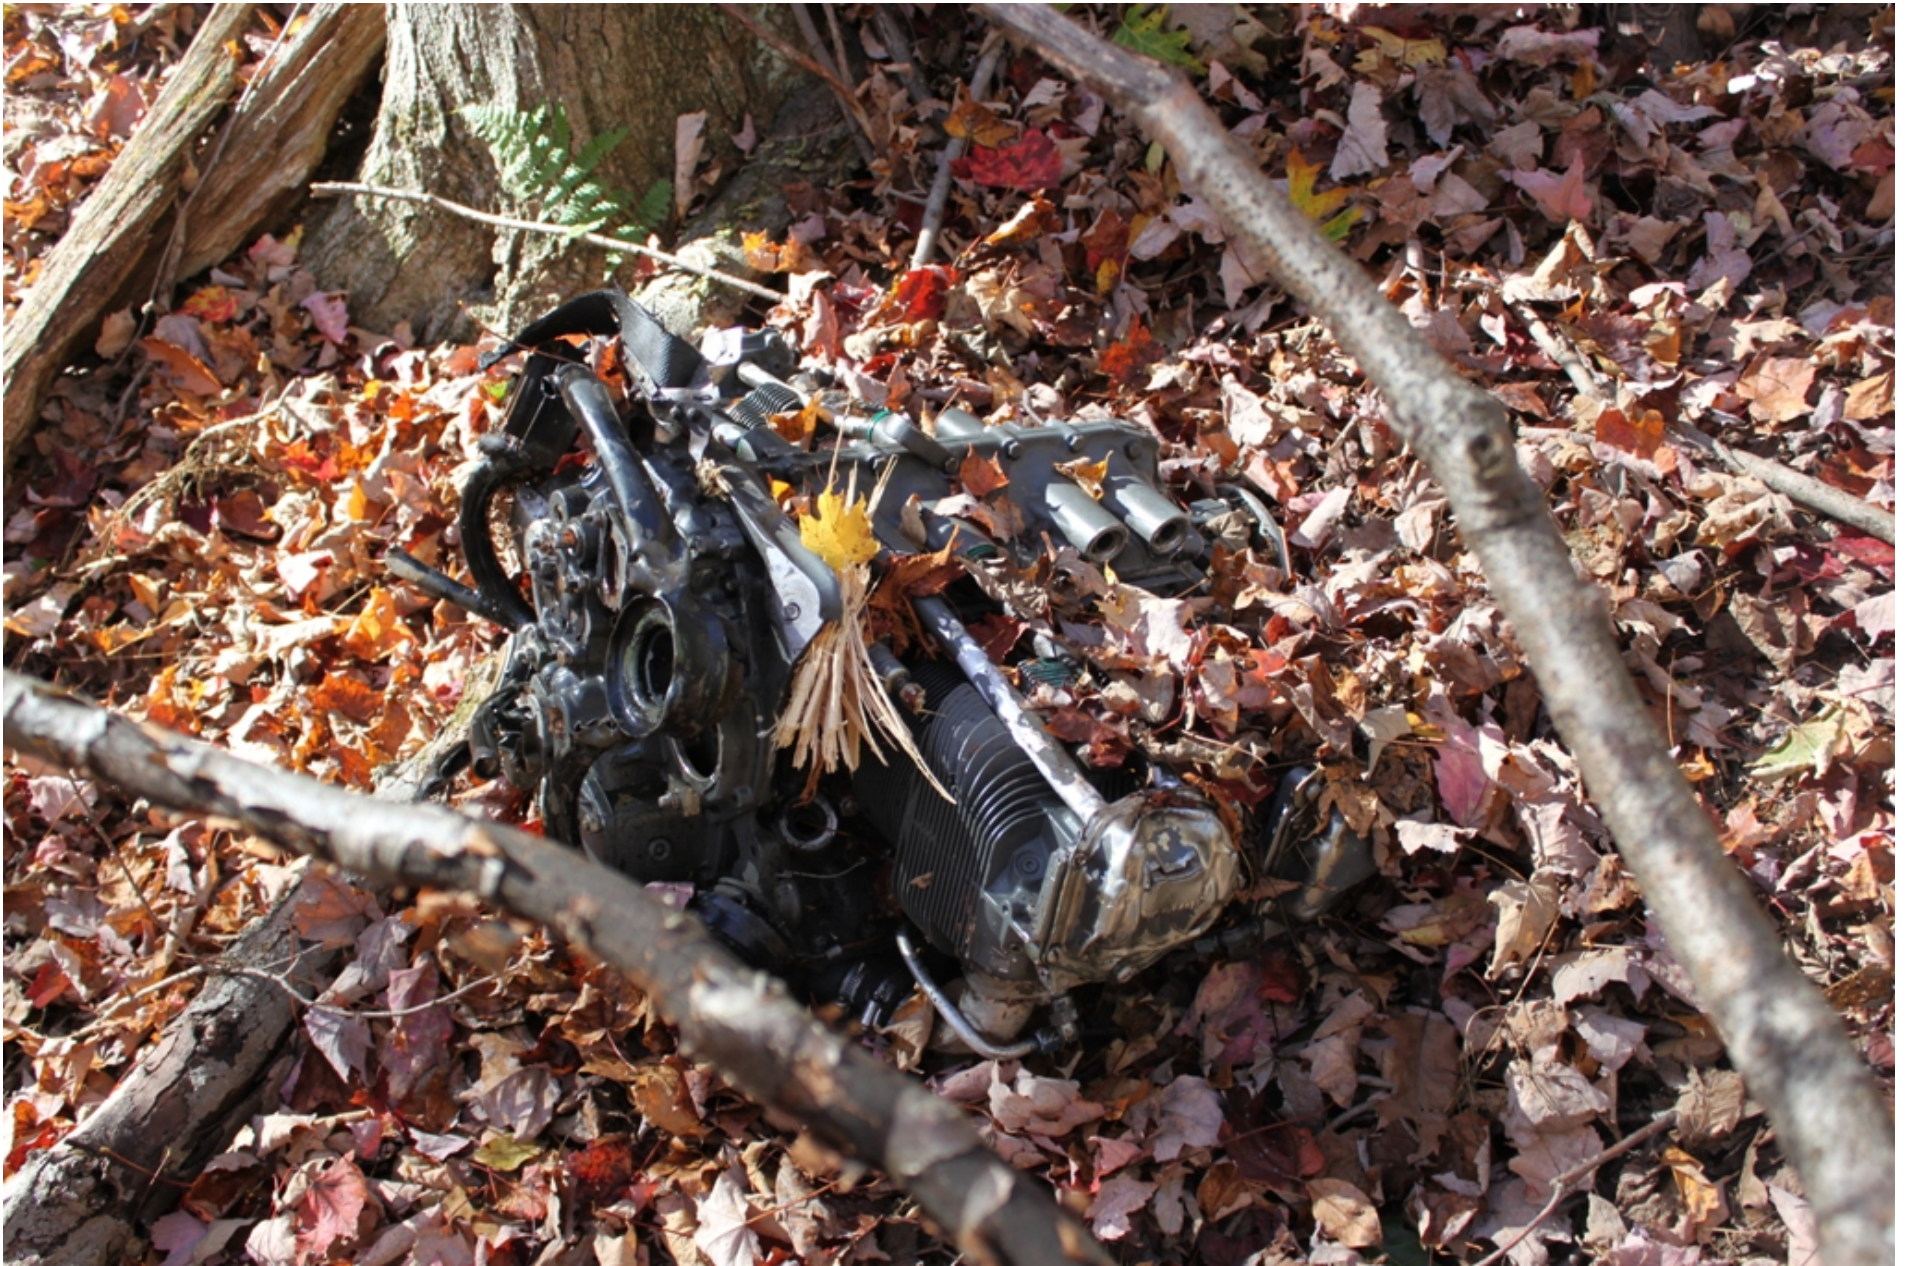
**Photo 7 - NTSB Digital Photograph. View of the Engine Assembly At Accident Site.**

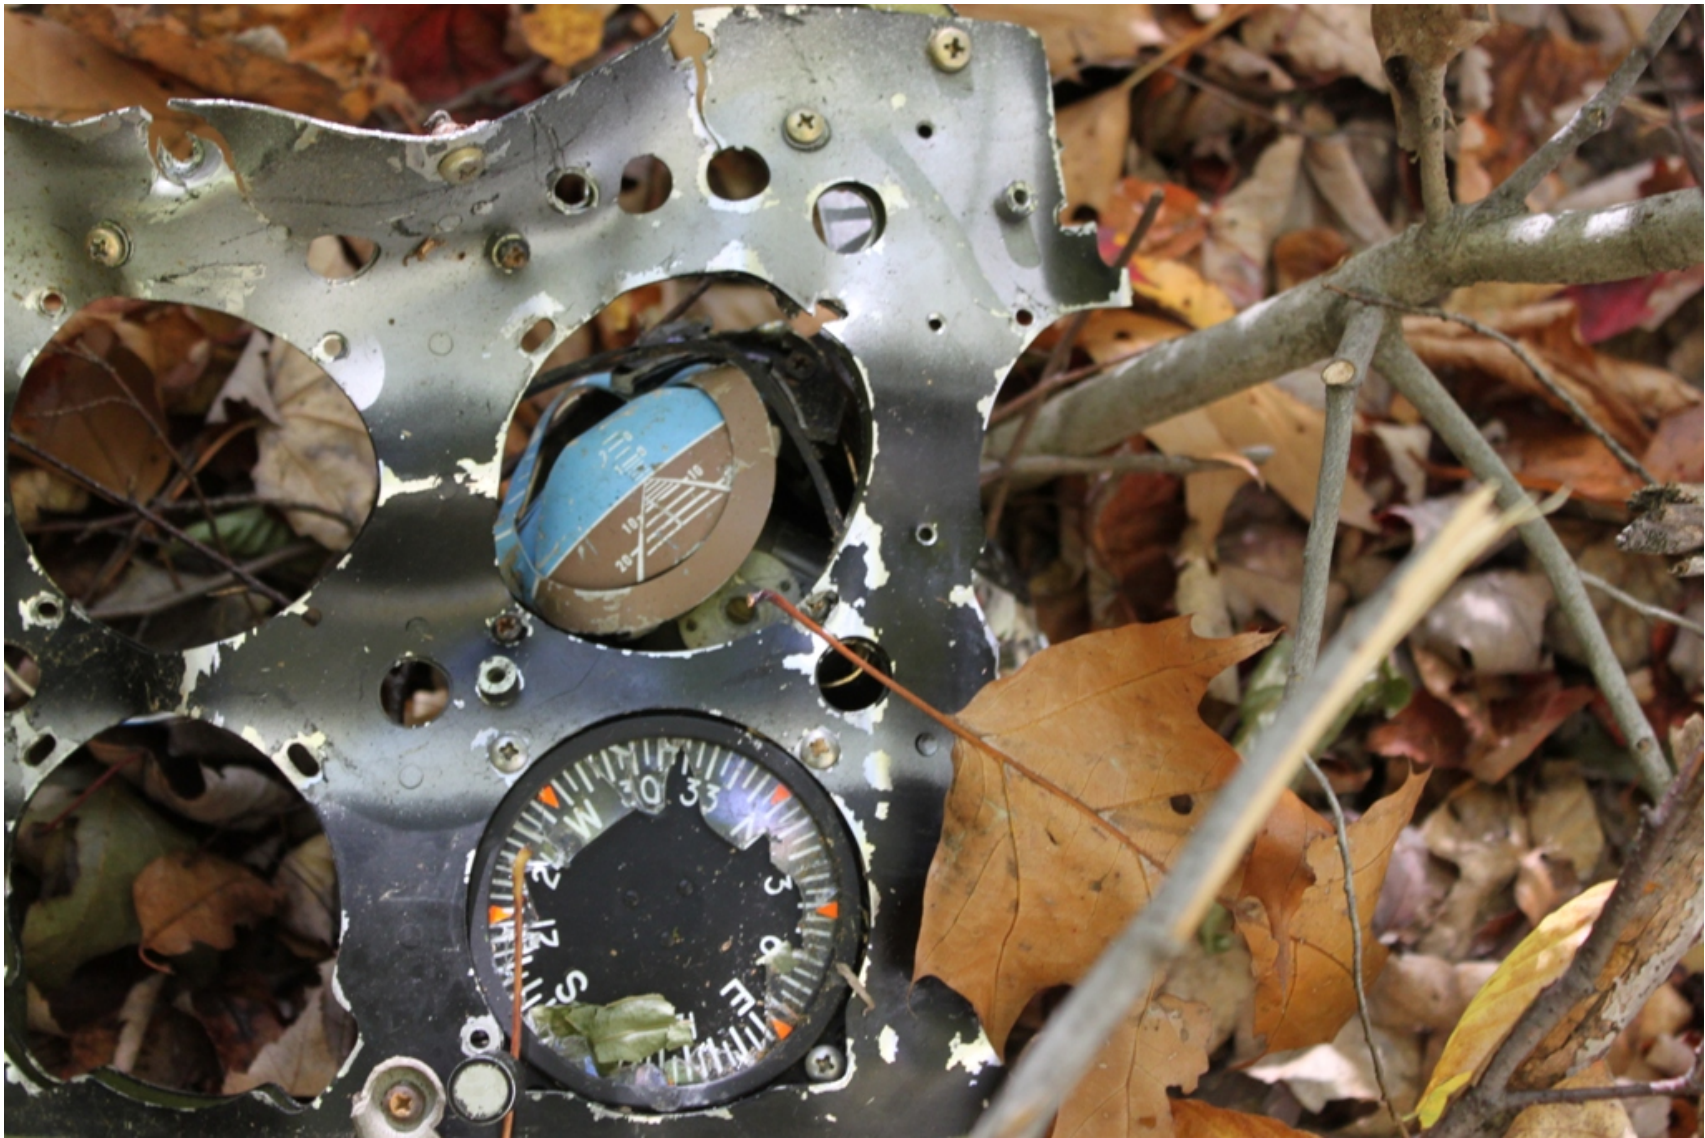
**Photo 8 – NTSB Digital Photograph. View of the Separated Instrument Panel With Attached Attitude Indicator, and Directional Gyro.**

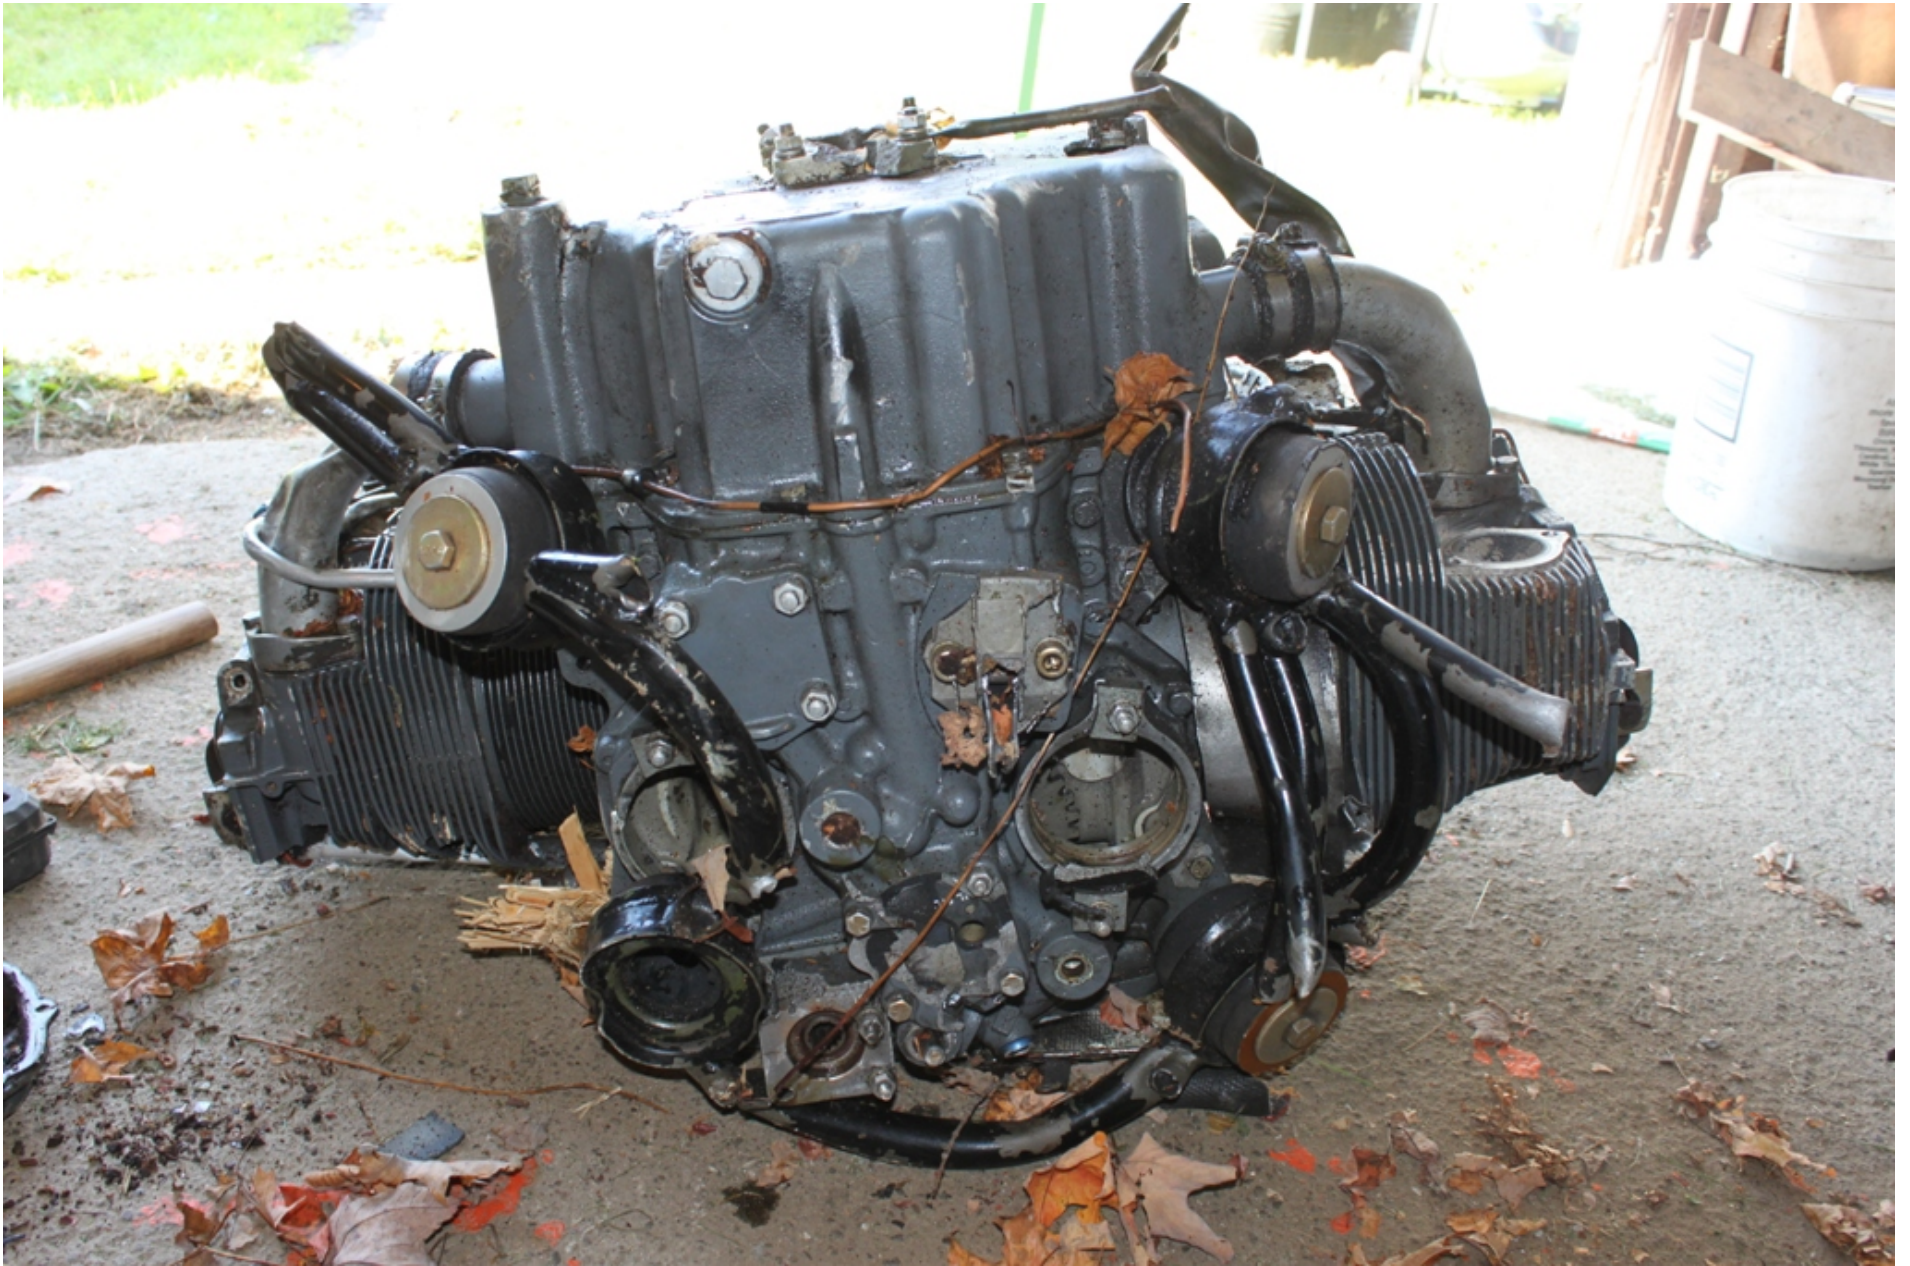
**Photo 9 - NTSB Digital Photograph. View of the Rear Portion of the Inverted Engine Following Recovery. Note the Missing Engine Accessories.**

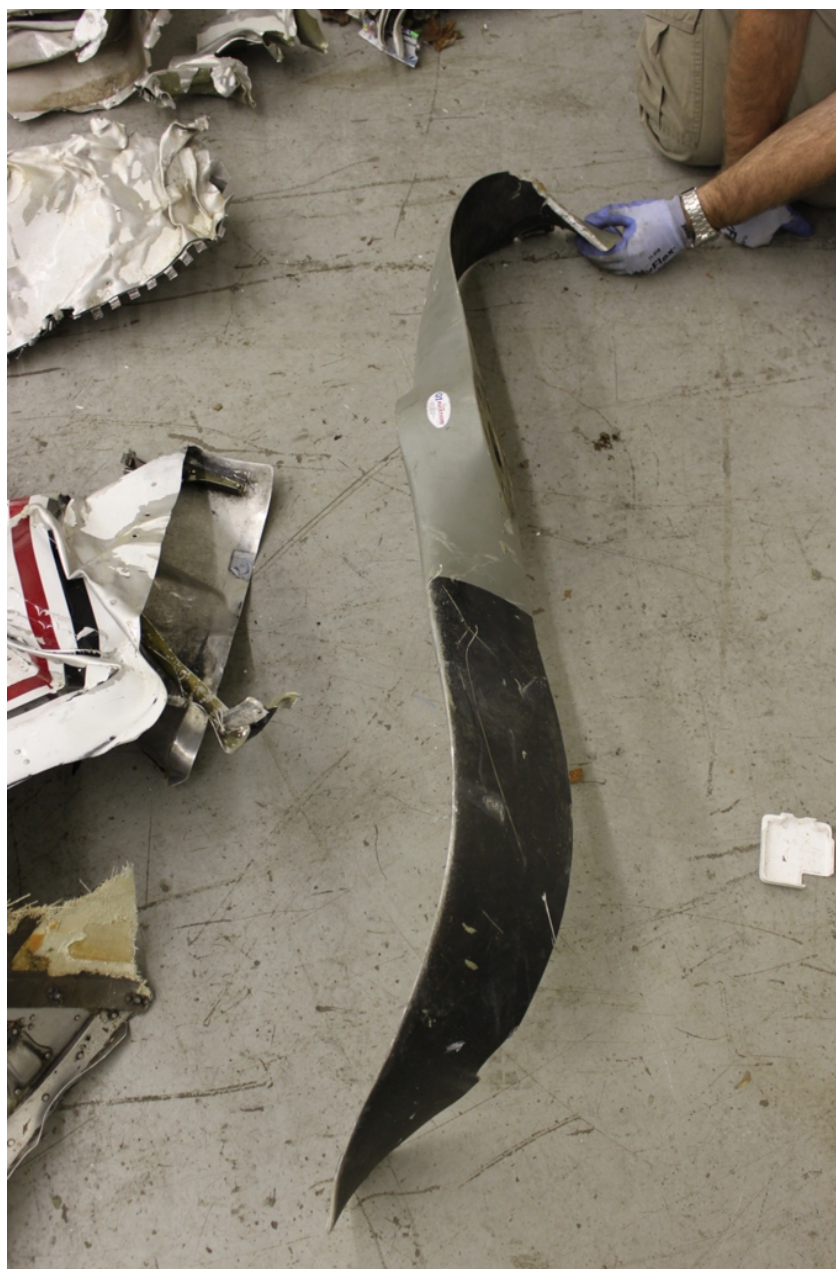
**Photo 10 - NTSB Digital Photograph. View of the Propeller. Note the Blade Bending.**

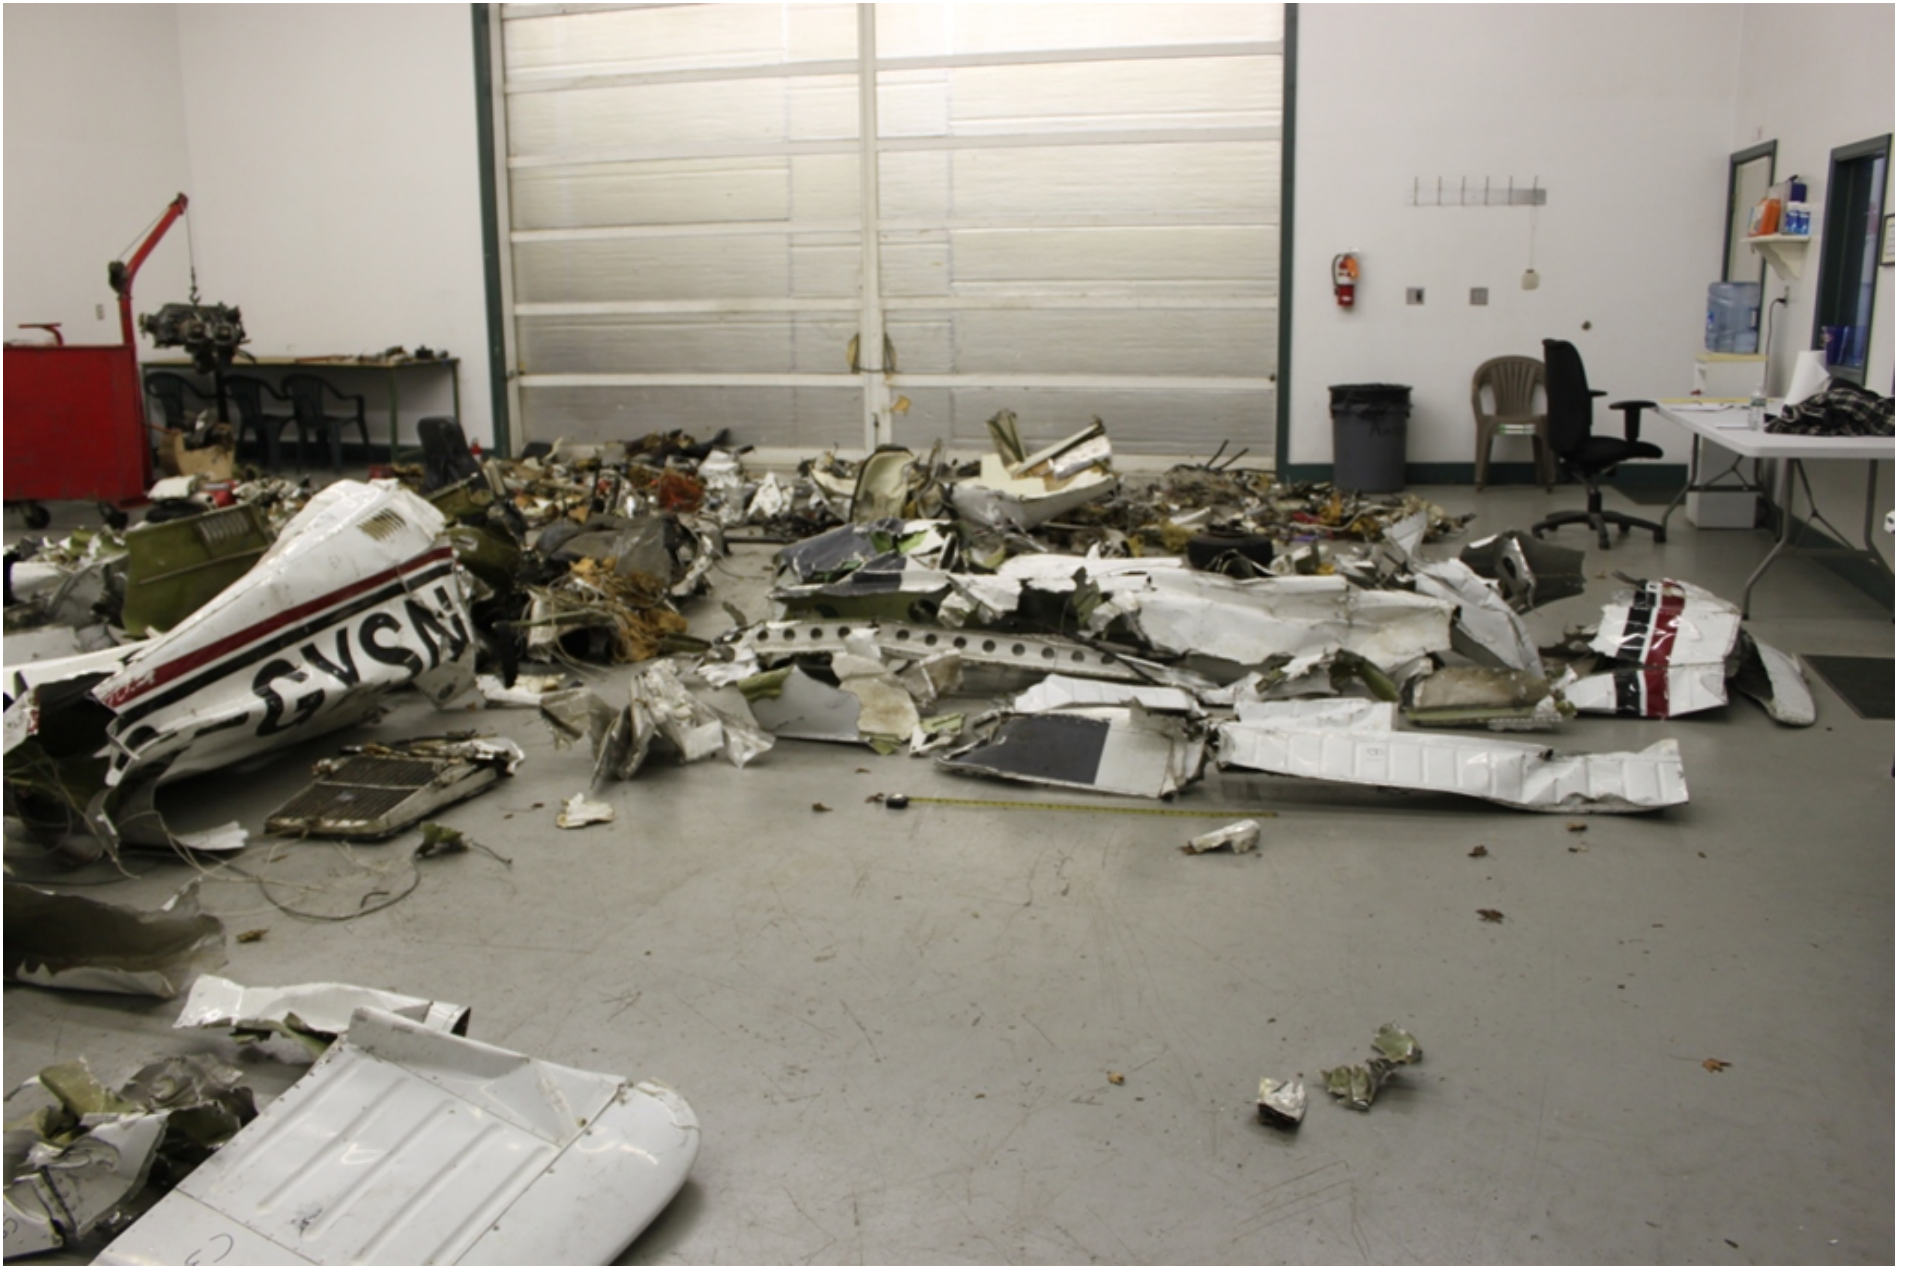
**Photo 11 – NTSB Digital Photograph. Right Rear Quartering View of the Reconstructed Wreckage. Note the Fragmentation.**
