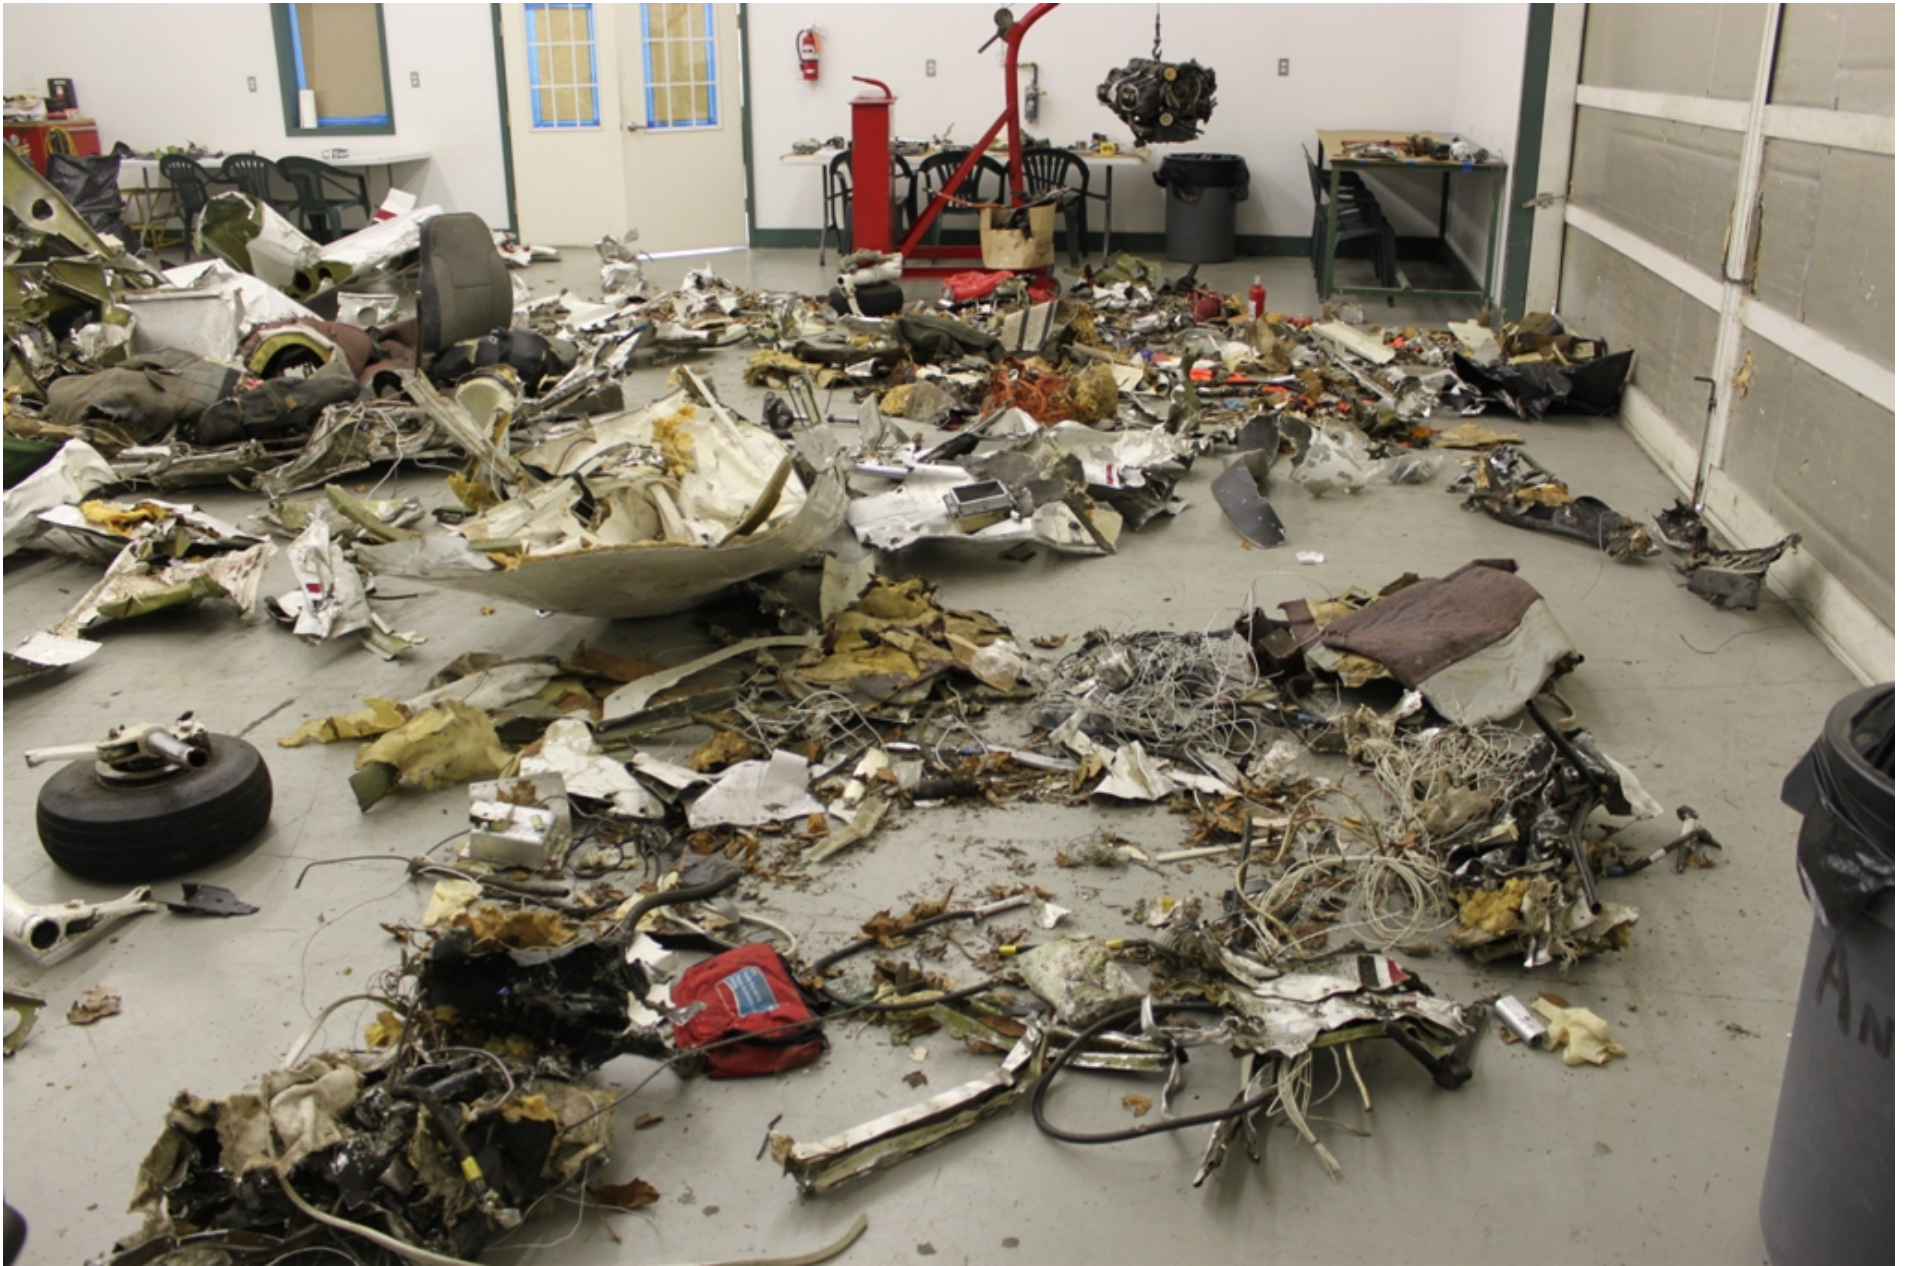
**Photo 12 - NTSB Digital Photograph. View Showing the Fragmented Wreckage.**
