# NATIONAL TRANSPORTATION SAFETY BOARD

MATERIALS LABORATORY FACTUAL REPORT

Report No. 17-013

Place : Austin, Pennsylvania  
Date : October 16, 2016  
Vehicle : Piper PA-28-161, C-GYSN  
NTSB No. : ERA17FA017  
Investigator : Tim Monville, ASI-ERA

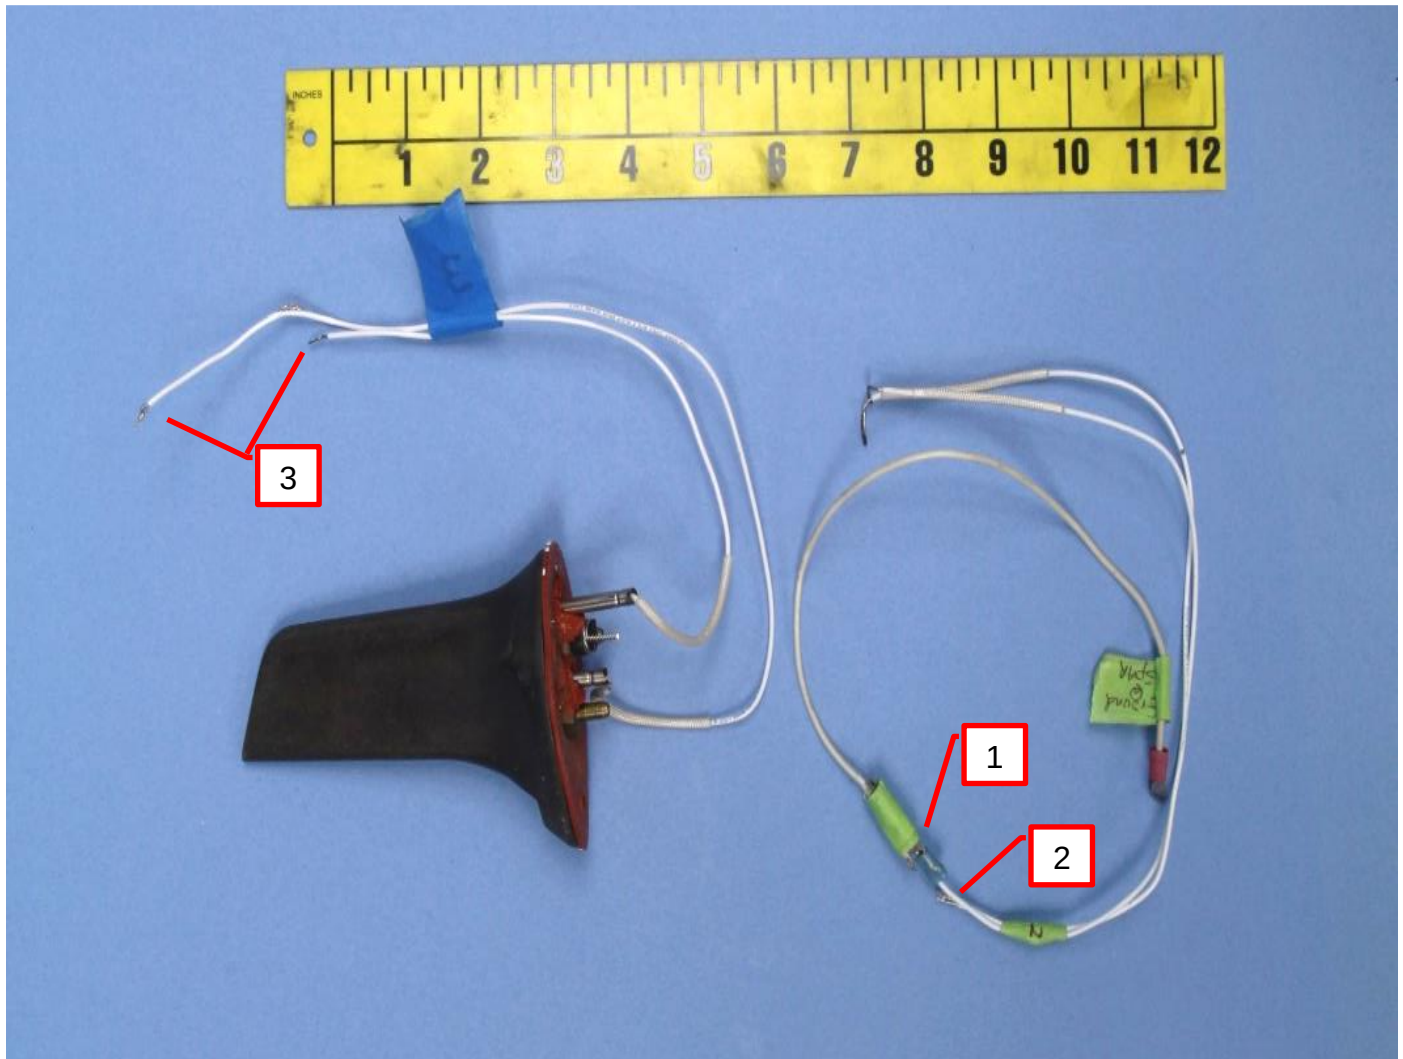
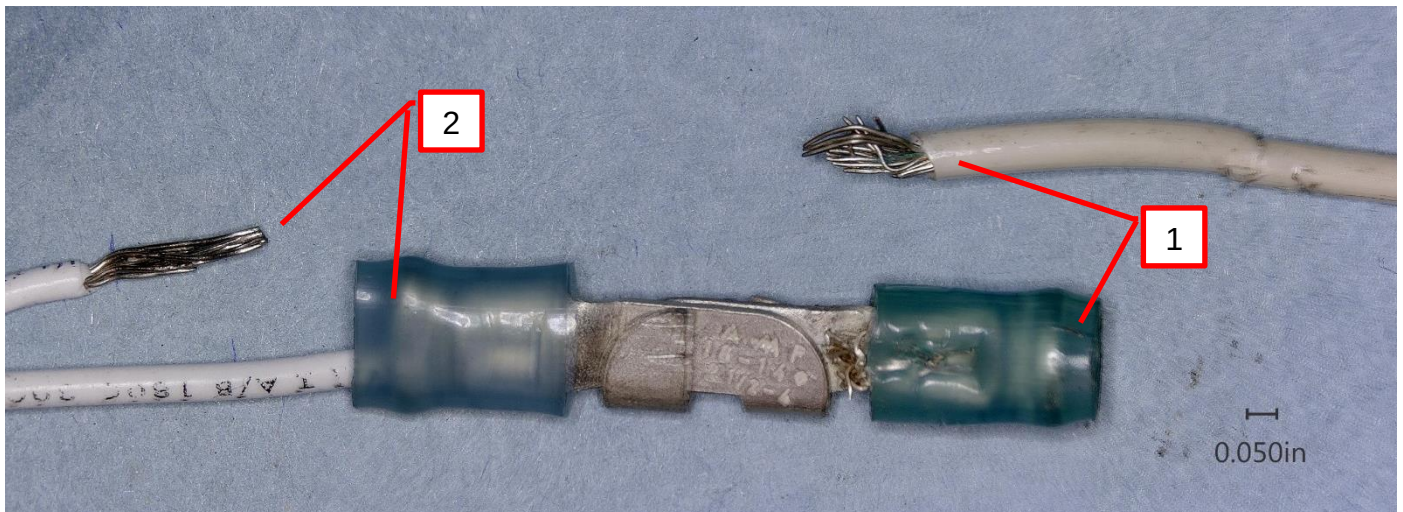
The as-received pitot and wires are displayed in the upper view of figure 1. The wiring consisted of two power wires, one going to each pitot heating element, forward and rear and two ground wires, one from each heater element. The heater ground wires were received separated from the individual elements. All pitot heater wires were stranded copper wire approximately 18 gauge in size. The two heater ground wires were combined into one insulated crimp connector that joined to a second insulated crimp connector. These connectors were marked "AMP 14-16" indicating they were suitable for 14 to 16 gauge wire. This joint was separable. One ground wire continued from the second connector to a spar mounted crimp connector. The ground wire was also stranded copper but about 16 gauge in size.

The ground wire connector joint is displayed in the lower view of figure 1. The wire labeled as going to the spar was separated at the crimp connection, labeled "1" and shown in figure 2. One of two pitot heater ground wires on the other side of the joint was also separated from its connector, as shown and labeled "2". The other ends of the ground wires had been pulled out of the heaters.

The crimp deformation for both ground wire connectors is visible in the lower view of figure 1. The heater side crimp appeared uniformly deformed into an oval consistent with properly sized tool dies. In contrast, the spar side crimp was very localized and the insulation highly deformed and nearly penetrated by the crimp tool. The crimp and insulation deformation were indicative of an undersized die set for the crimping tool.

Figure 1. At top, the as-received pitot and wiring with separations numbered. Ground wires at right. Assumed pitot forward is at the top of the view. The lower view shows the ground wires and connectors with the spar wire at right. Separations 1 and 2.

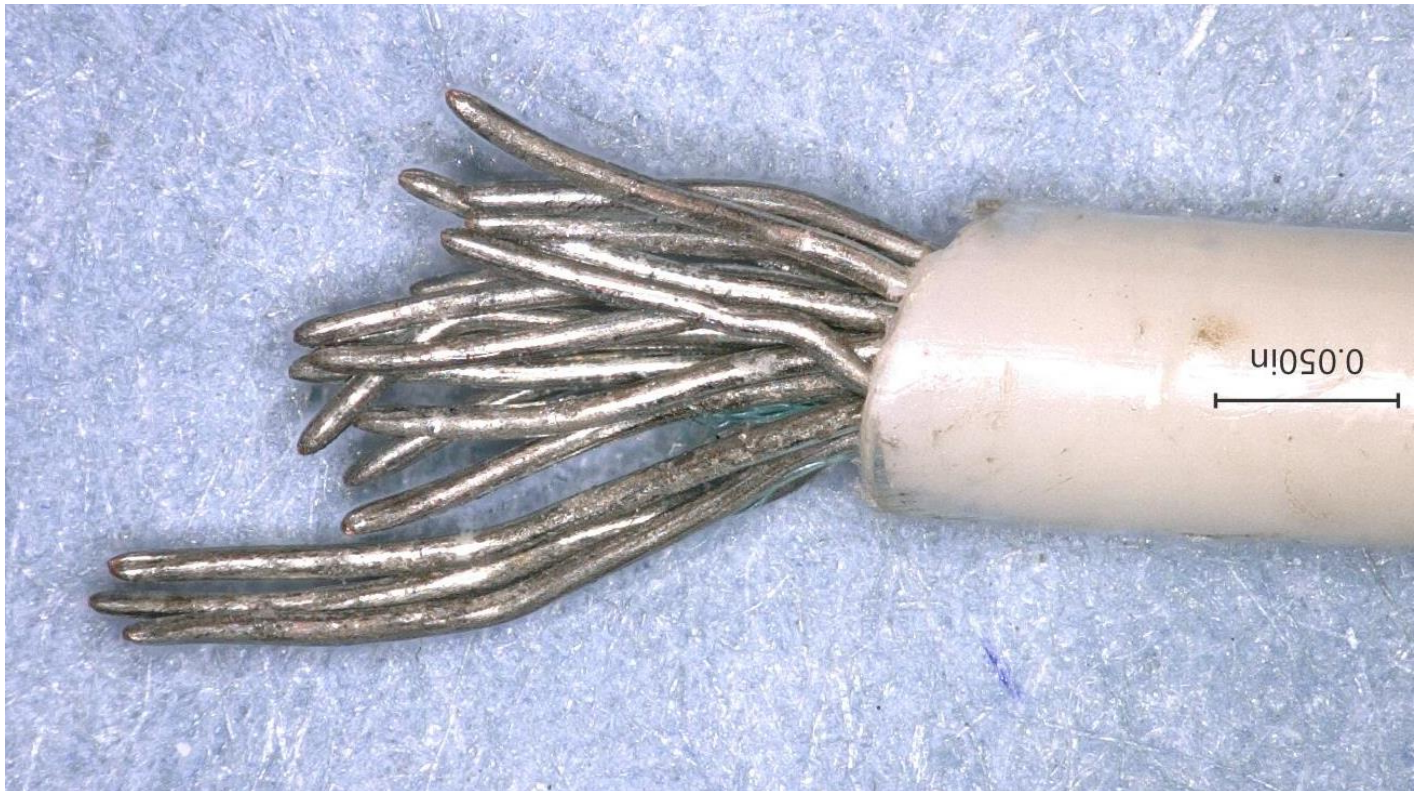
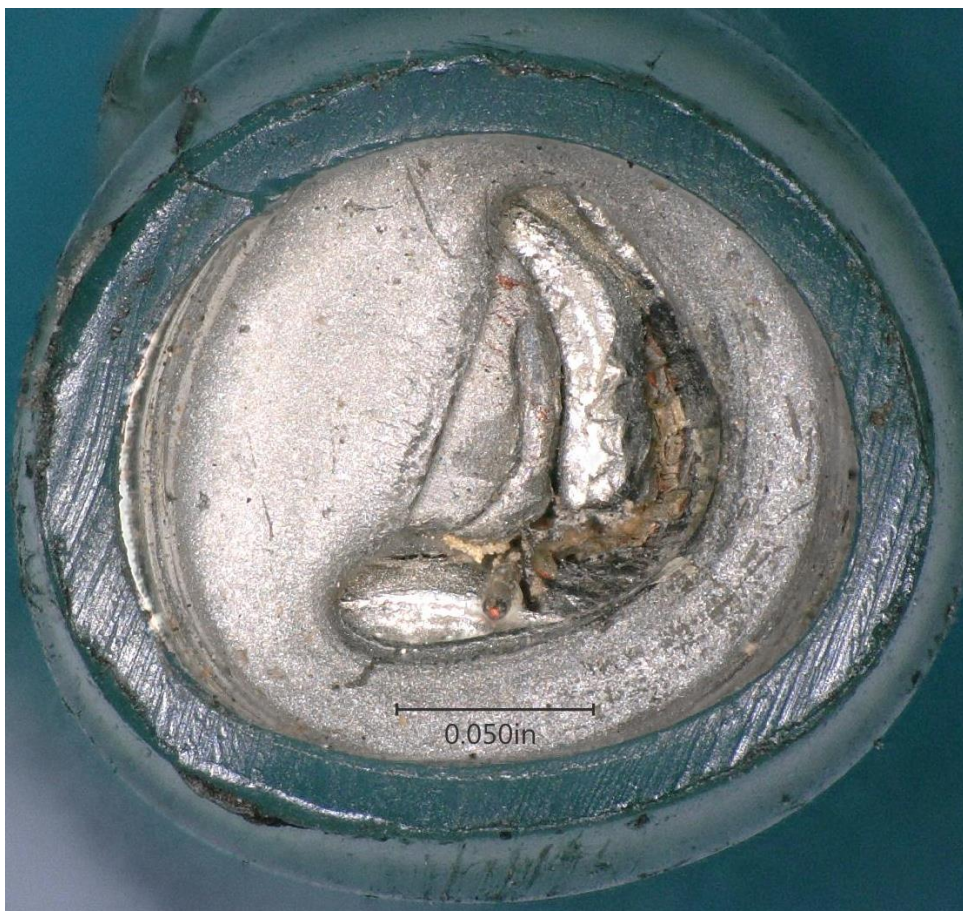
The separated spar ground wire is displayed in the upper view of figure 2. Microscopic examination found that the ends of all wires in the strand were fractured. The fracture features and deformation patterns indicated that they were tensile overstress fractured. Inspection of the terminal found the remnants of the wires trapped in the terminal crimp area as shown in the lower view of figure 2. No indications of electrical arcing were noted on the wires or connector.

Figure 2. Wire separation 1 with tension overstress fractured wires at top and crimp at left.

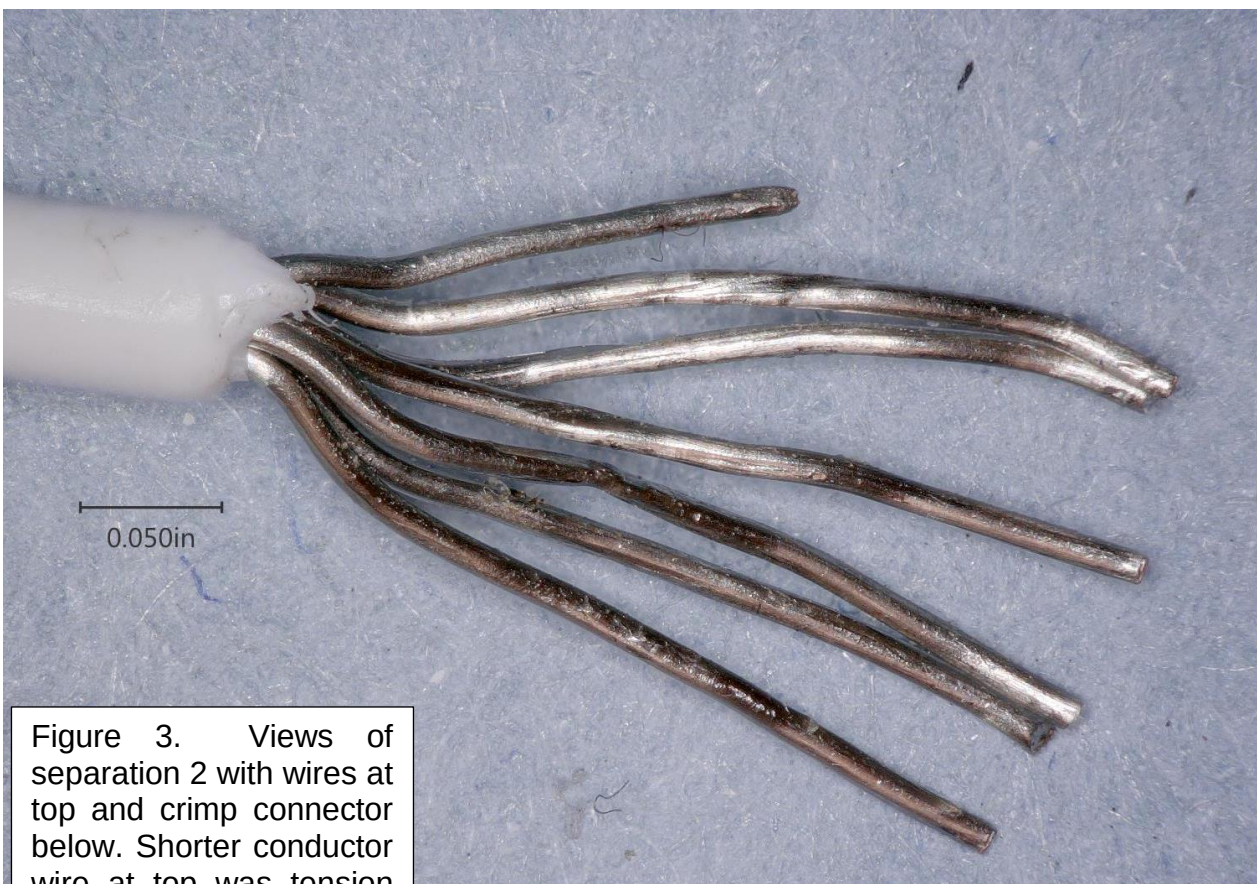
The wires for the separated heater side ground wire are displayed at the top of figure 3 after being manually spread out. One wire was tension overstress fractured while the other conductor wires were intact. The intact wires showed deformation consistent with the crimping action on the connector and additional sliding marks consistent with being pulled from the crimped connector. The lower view shows the wire side of the connector with the other wire in place. No indications of electrical arcing were noted on the wires or connector.

Figure 3. Views of separation 2 with wires at top and crimp connector below. Shorter conductor wire at top was tension fractured.

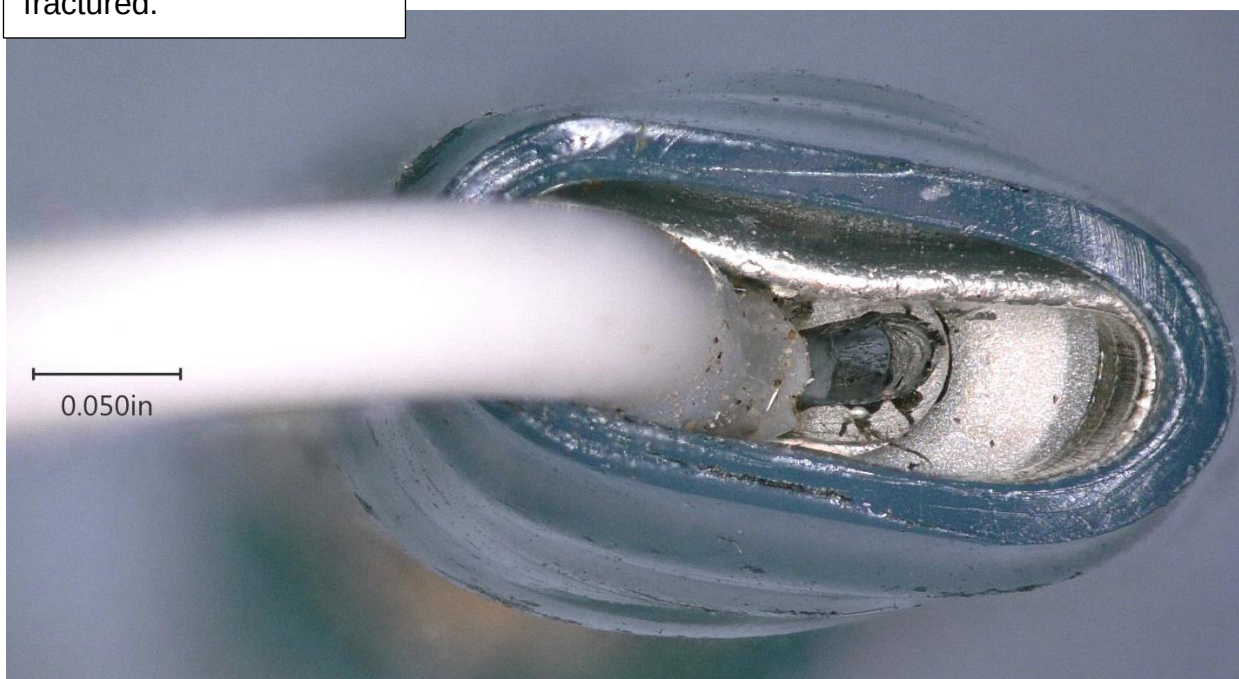
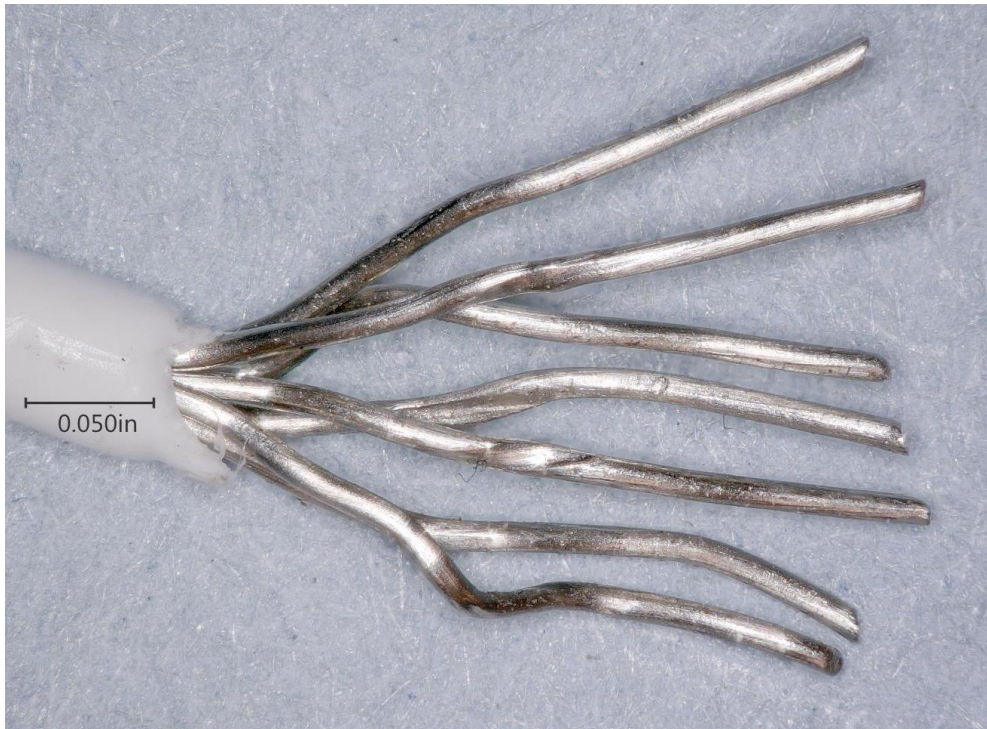
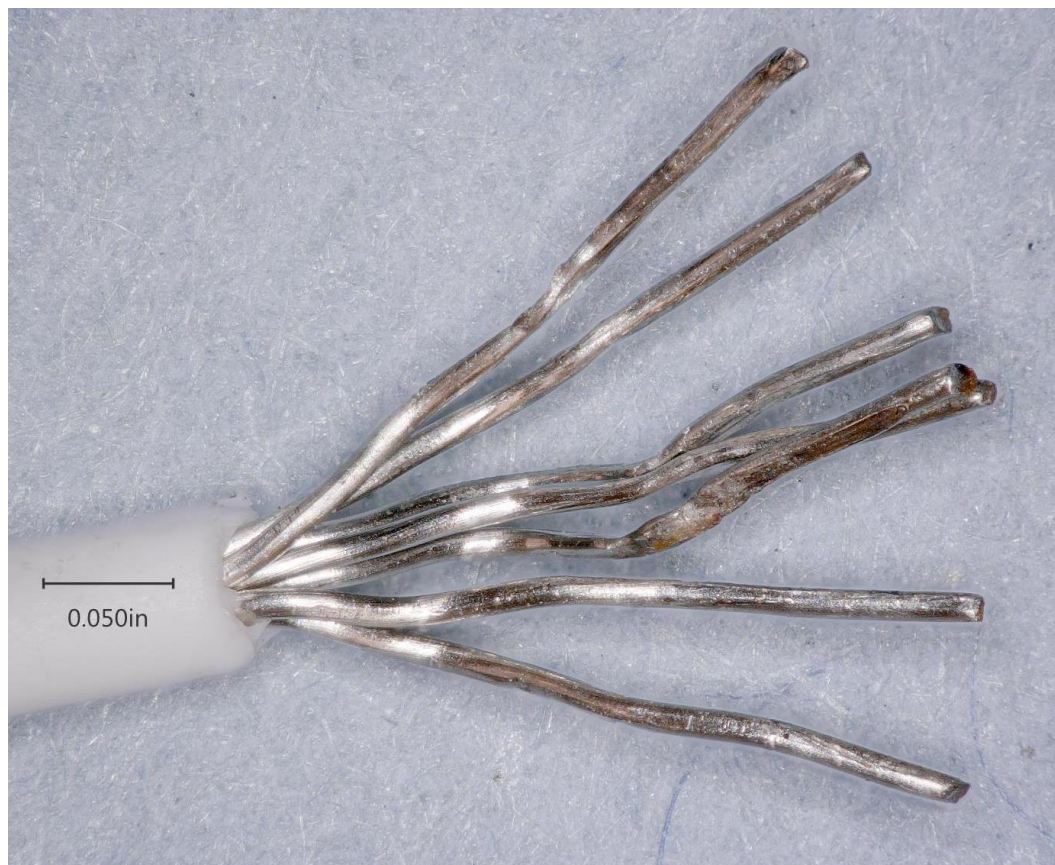
The two power wires for the heater elements were also separated from their connectors, denoted "3" in the upper view of figure 1. The connectors were not received. The separated conductor ends are displayed in figure 4 with the individual wires splayed out for viewing. The individual wires in both conductors showed deformation patterns consistent with crimping forces. The wires also showed sliding marks and deformation indicative of tension separation from crimped connectors similar that noted for separation "2". No indications of arcing were noted on the exposed wire ends.

Figure 4. Power wires from separation 3, Forward wire at left, rear wire below.

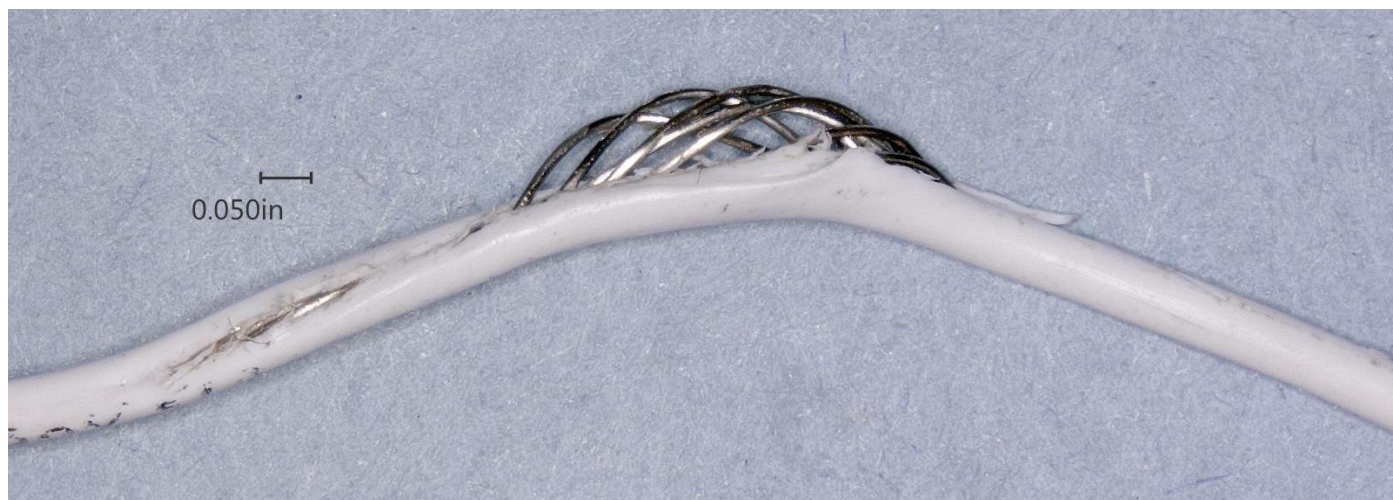
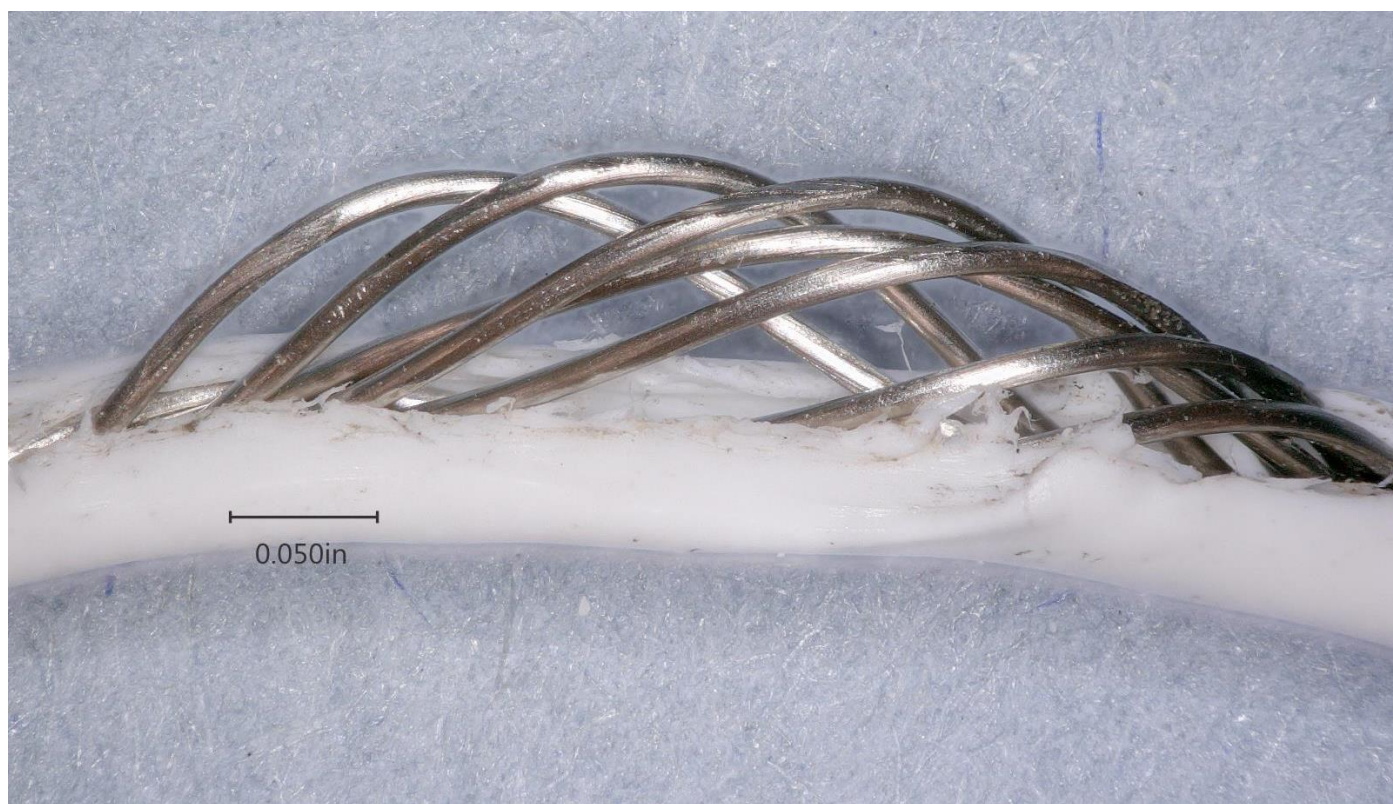
The insulation on the forward power wire was damaged and the conductor wires were exposed as shown in figure 5. Magnified examination found that the insulation had been scraped for approximately 3 inches with conductor wires were exposed for about 1 inch. In the area shown in the lower view of figure 5 the wires themselves were scraped. No indications of arcing were noted on the exposed wires.

Figure 5. Two views of the exposed conductors in the forward pitot heater power wire. Lower view shows scraping damage on conductors.
