# NATIONAL TRANSPORTATION SAFETY BOARD

MATERIALS LABORATORY FACTUAL REPORT

Report No. 17-020

Place : Austin, Pennsylvania  
Date : October 16, 2017  
Vehicle : Piper PA-28-161, C-GYSN  
NTSB No. : ERA17FA017  
Investigator : Timothy W. Monville, AS-ERA

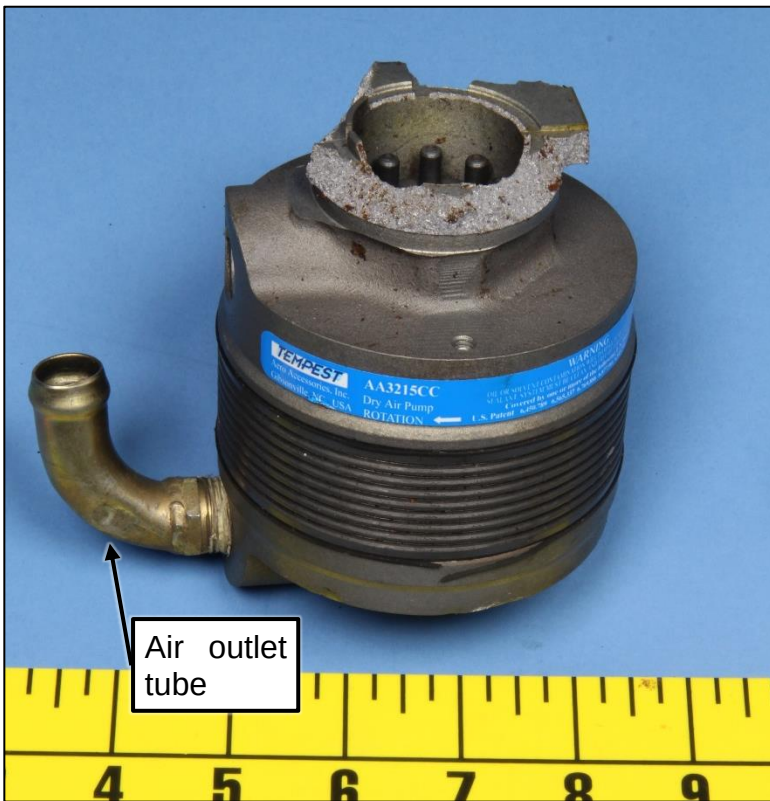
An overall view of the submitted vacuum pump is shown in figure 1. The flange at the drive end of the pump housing was fractured, and the shear coupling for the drive shaft was not recovered. The labels on the pump indicated it was a Tempest model AA3215CC dry air pump with serial number 07M222. According to aircraft maintenance logs, the pump was installed on May 13, 2015, and was stamped with Eaglerock Aviation work order number 3734. Flight records indicated the airframe had 10,723.4 hours time in service (TIS) at the time the pump was installed and had 11,555.8 hours TIS 5 days before the accident, a difference of 832.4 hours TIS.

Figure 1. Overall view of the submitted vacuum pump.

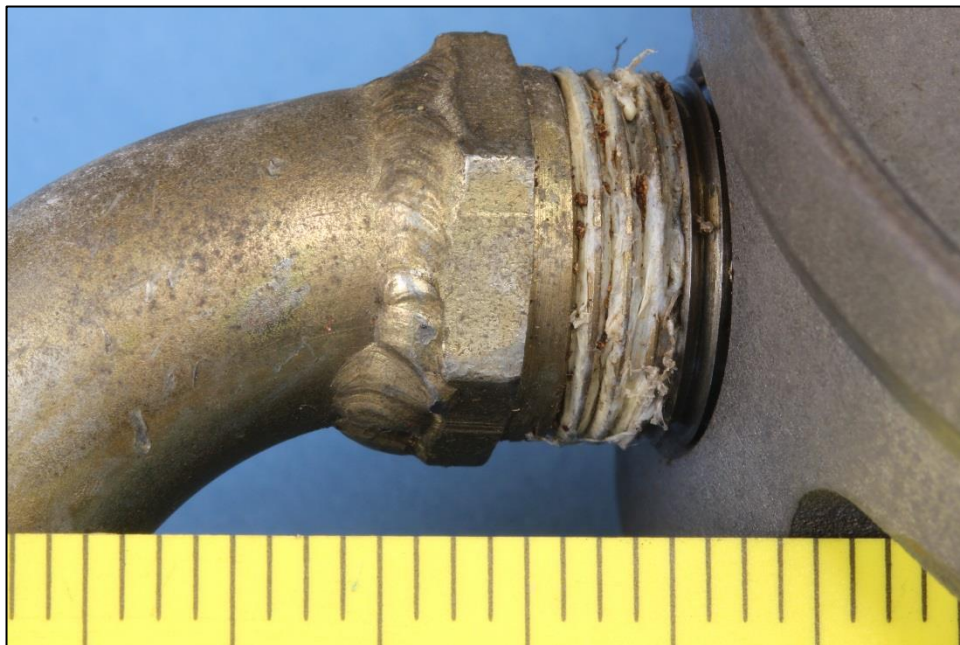
The inlet tube for the vacuum pump was fractured where it intersected the housing. Fracture features on the inlet tube were rough and irregular, consistent with ductile overstress fracture. The outlet tube, indicated in figure 1, was intact and rotated when manipulated by hand forces. The outlet tube is shown in figure 2 partially unscrewed from the housing outlet hole. White material consistent with Teflon thread tape was observed on the threads. A sample of the thread tape was removed and analyzed using Fourier-transform infrared spectroscopy (FTIR). Results showed an FTIR spectrum consistent with Teflon.

The Operators Manual and Installation Instructions for Tempest AA3200, AA240, and AA400 series dry air pumps<sup>1</sup> was reviewed. The manual stated, "Teflon tape or other thread compound on threaded fittings or port threads may be ingested into the pump. These substances will bind up lubrication dust and cause FOD damage leading to failure."

Figure 2. Close view of the outlet tube partially unscrewed from the housing. Teflon thread tape was present on the threads.

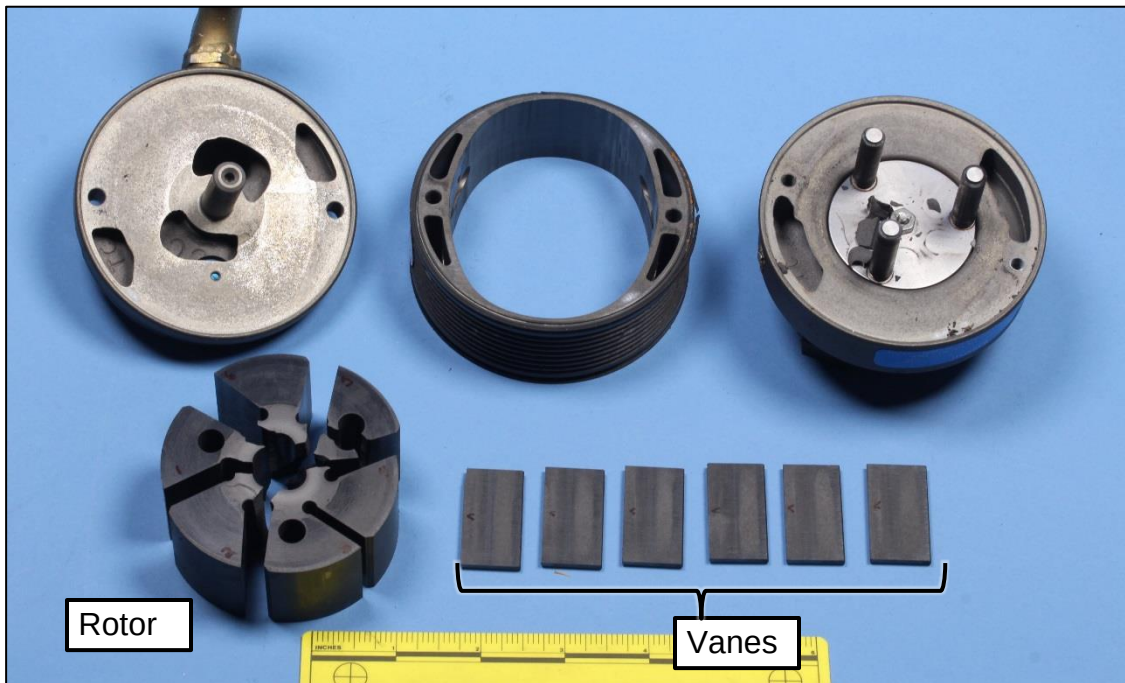
The pump was disassembled, and as it was disassembled, the vanes and corresponding vane slots in the rotor were sequentially numbered from 1 to 6 starting with an arbitrarily-selected vane. An overall view of the pump components after disassembly is shown in figure 3. The rotor was fracture into 6 relatively large pieces and many smaller pieces. The vanes were largely intact as shown in figure 3, but vanes 1 and 4 each had a small piece fractured from the outward face of the vane at the outlet end.

Figure 3. View of the pump components after disassembly.

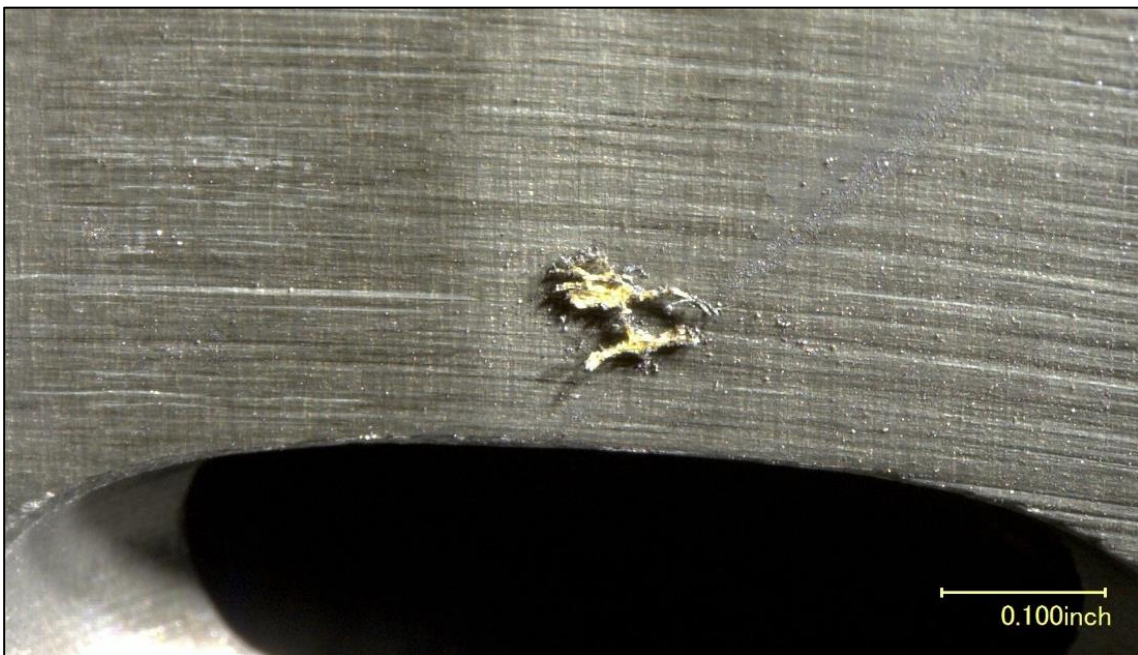
A piece of debris was noted on the interior of the housing near one of the air outlet holes, and a close view of the debris is shown in figure 4. The piece of debris was examined using FTIR, and the results showed a spectrum that was consistent with acrylonitrile butadiene styrene. No evidence of debris consistent with Teflon thread seal was observed.

Figure 4. Piece of debris observed on the interior of the pump housing near an air outlet hole.

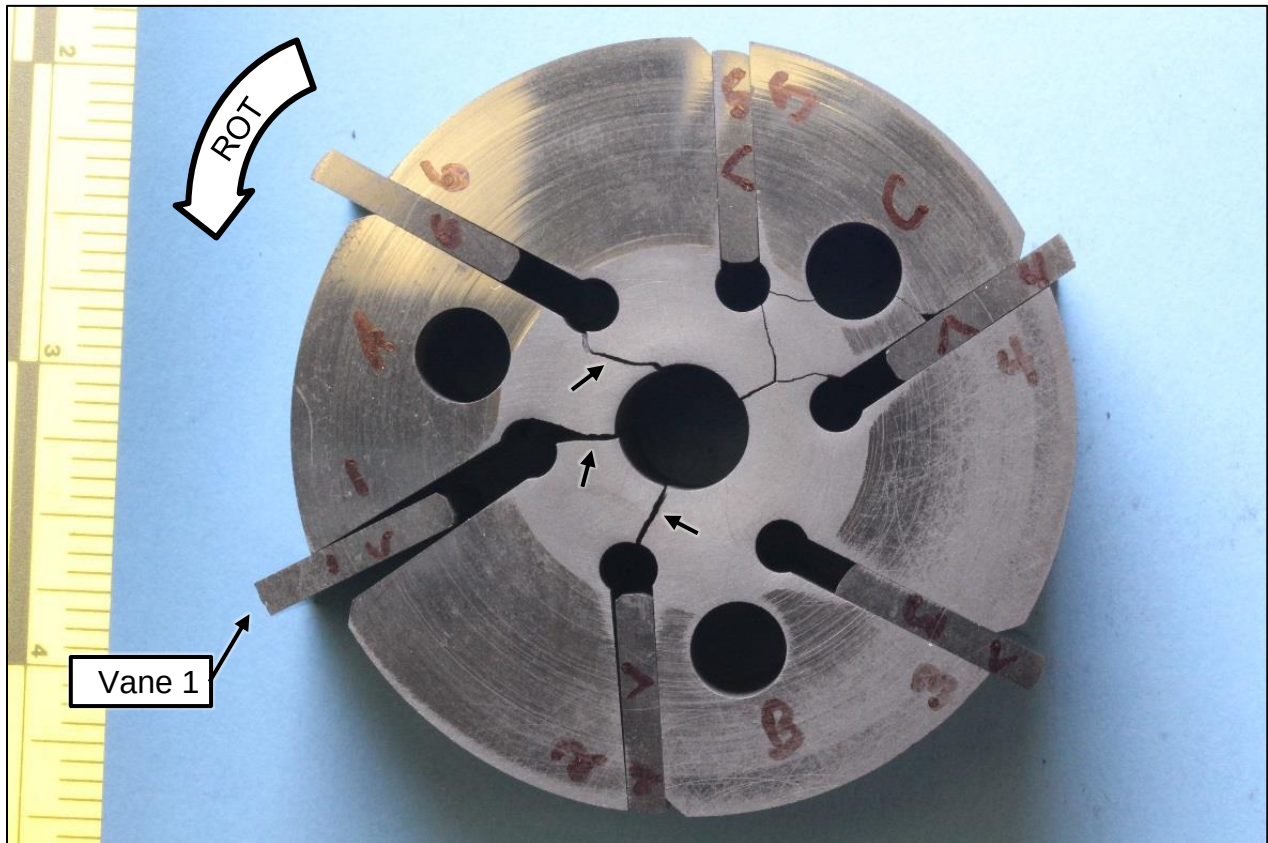
The larger pieces of the rotor were carefully reassembled with mating fractures placed in close proximity and with vanes located in the slots. Next, the outward ends of the vanes 1, 2, and 6 with single cracks intersecting the base of the slots were each pushed away from the direction of rotation as if the core rotated relative to the outer edge of the vane and relative motion of the cracks was noted. After each vane was displaced, the rotor was reassembled before testing the next vane. The result of this displacement on vane 1 is shown in figure 5. Cracks intersecting the slots of vanes 1, 2, and 6 (see unlabeled arrows in figure 5) opened with a tensile crack opening displacement consistent with overstress fracture of the core material. Similar displacements of vanes 2 and 5 resulted in crack openings at the ends of the slot with shear displacements across the crack opening, which is not characteristic of possible fracture mechanisms for the core material. Cracks intersecting the ends of slots 4 and 5 had a crack branching pattern consistent with fracture initiating at the center hole of the rotor then branching to the ends of slots 4 and 5. The slot for vane 3 was intact.

Figure 5. Close view of the fractured core with vanes numbered 1 to 6 starting with an arbitrarily-selected vane. Vane 1 is shown rotated slightly, leading to a tensile opening displacement of several of the fractures intersecting vane slots 1, 2, and 6 as indicated with unlabeled arrows.
