ERA17FA038, N327SH Challenger II 11/9/16 Crescent City, FL

11/22/16 NTSB Materials Lab exam

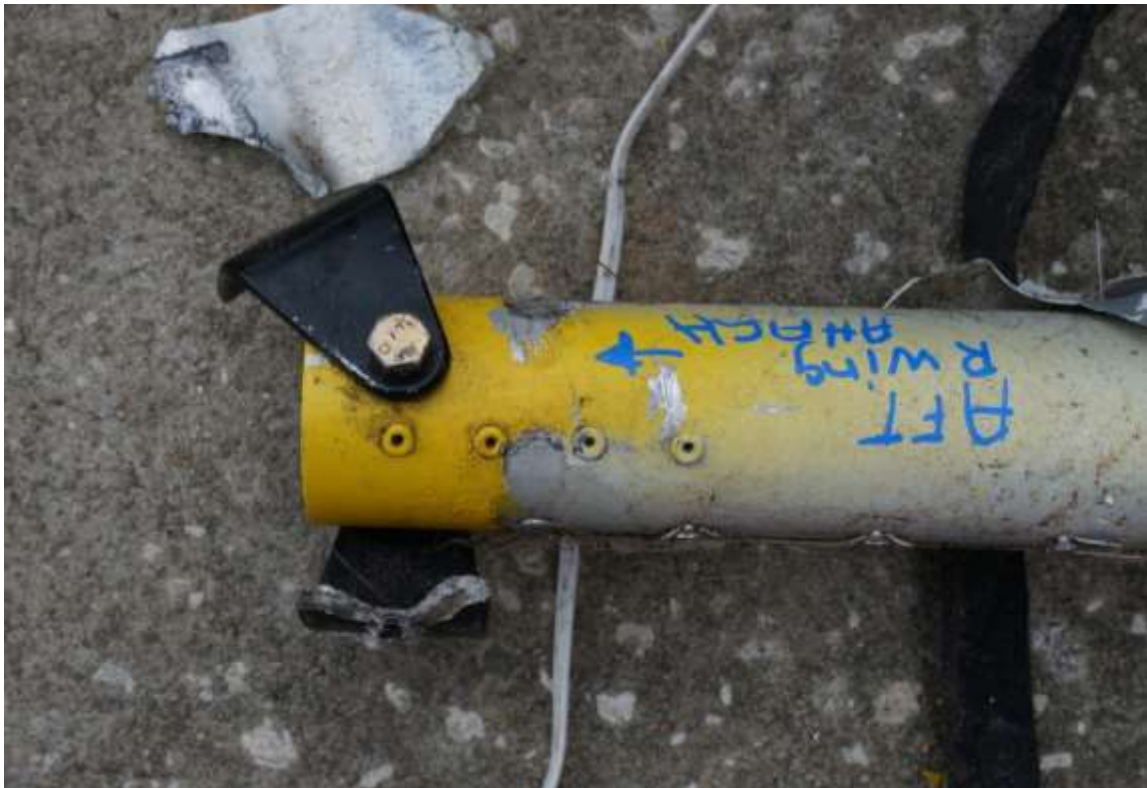
*Figure 1- Right Wing Aft Attach Bracket*

Right wing aft attach bracket (2" Rony Bracket) attached to section of aft spar.

All fracture surfaces were examined visually using laboratory microscope equipment, all fractures were consistent with overload and did not exhibit any evidence of fatigue or pre-existing damage, cracks or corrosion.

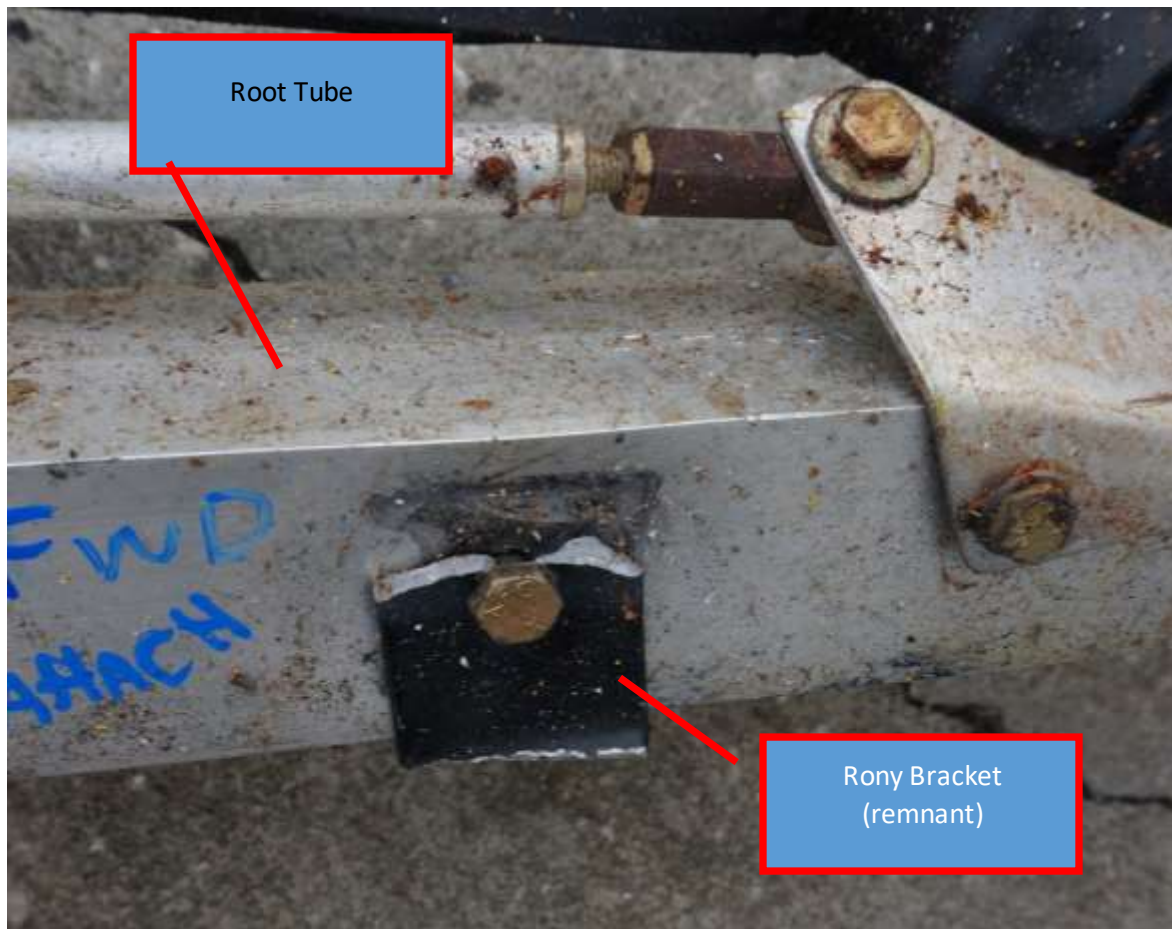
*Figure 2 - Right Wing Forward Attach Bracket*

Right wing forward Rony bracket (remnant, which remained bolted to “Root tube” (centerline square beam).

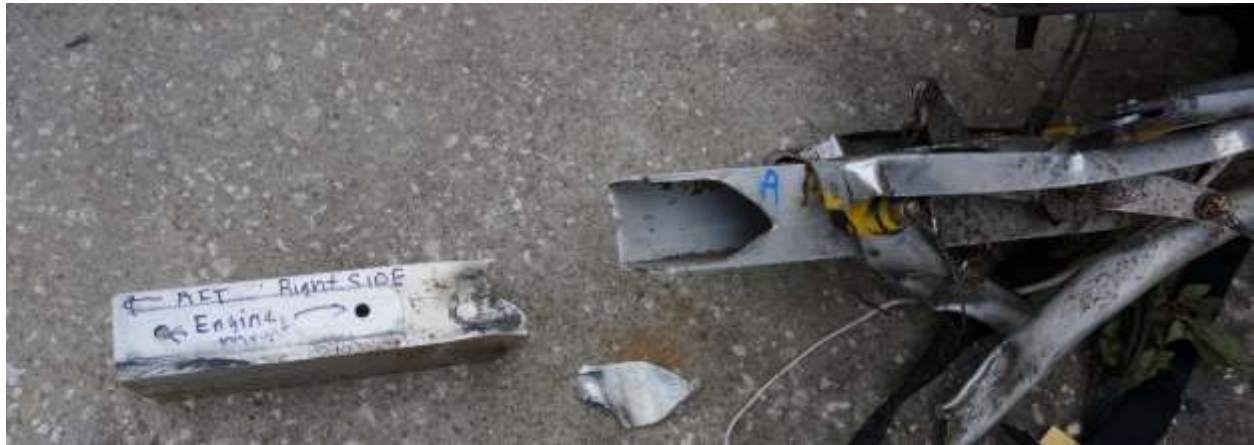
*Figure 4 Root Tube Right Side - at Aft Wing Attach Point*

Two segments of centerline square beam “Root tube” and triangular shaped piece from beam. The beam was fractured on all sides at the bolt hole for the both (left and right) wing attach points).
