# NATIONAL TRANSPORTATION SAFETY BOARD

## MATERIALS LABORATORY FACTUAL REPORT

Report No. 17-032

Place : Williamson, Georgia  
Date : November 17, 2016  
Vehicle : Curtiss JN4D  
NTSB No. : ERA17FA050  
Investigator : Ralph Hicks, AS-ERA

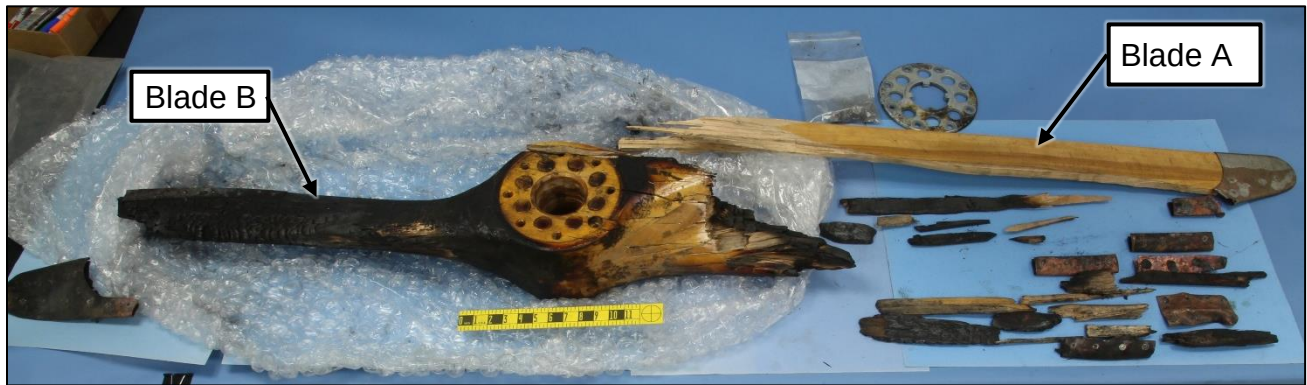
An overall view of the submitted propeller pieces are shown in figure 1. The propeller was a St. Croix fixed-pitch wood-laminate propeller with formed copper sheets with lead/tin filler attached at the tips and leading edges. The propeller had been installed on a Hispano-Suiza E2 engine. Total time on the aircraft at the time of the accident was 58.2 hours. Most of the submitted pieces were recovered on or near the main wreckage and were blackened consistent with exposure to fire, but one piece including the tip and trailing edge of one blade was recovered 670 feet from the main wreckage site. The blade piece recovered away from the main wreckage is shown labeled blade A in figure 1 for reference in this report, and the other blade is shown labeled blade B.

Figure 1. Overall view of the submitted propeller pieces.

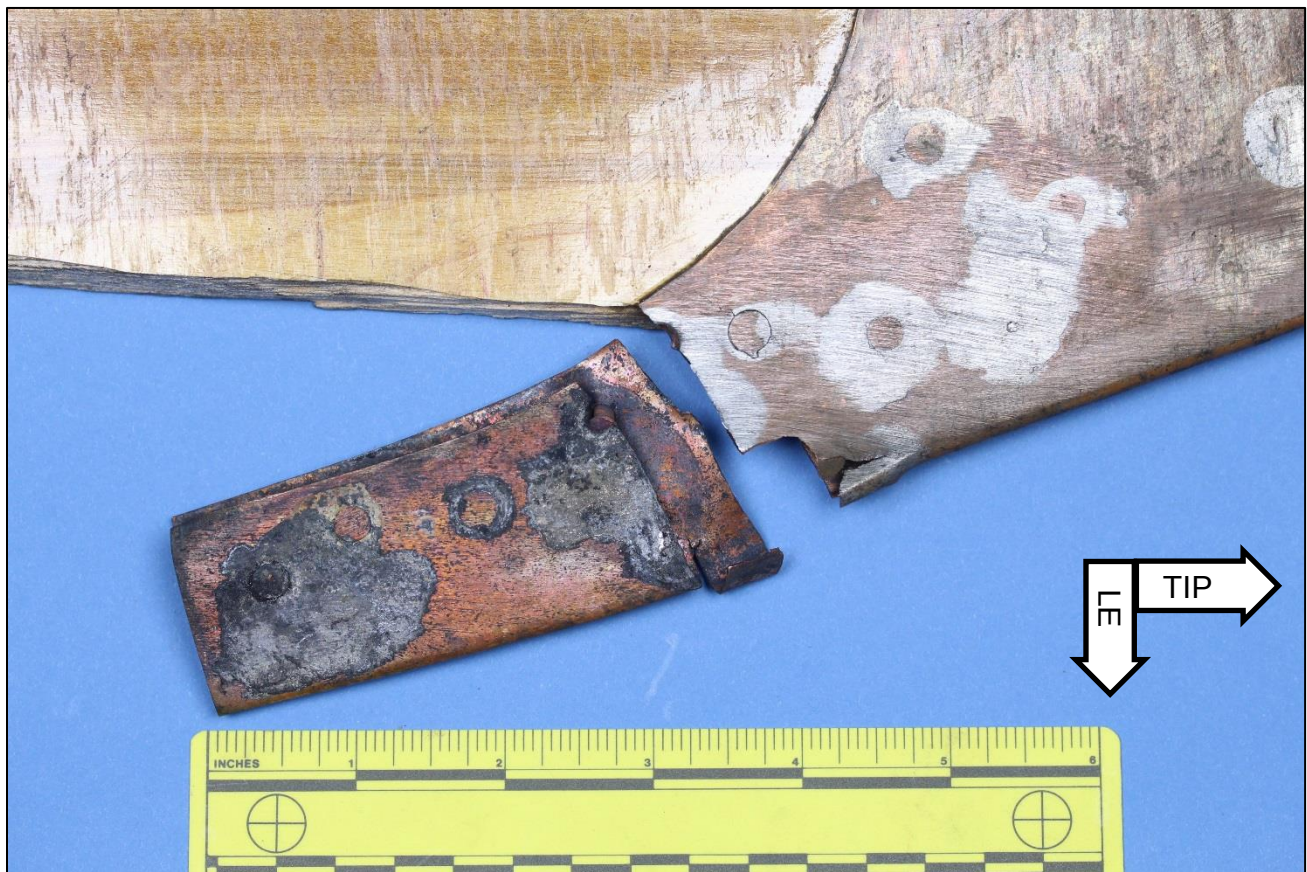
The leading edge strip on blade A had a transverse fracture between the leading and trailing edges of the strip at a location where the piece transitioned from the full-width tip portion to the leading edge strip. Closer views of the mating pieces shown in close proximity to each other as viewed looking at the pressure face and suction face are shown in figures 2 and 3, respectively. The underlying wood of the blade was fractured spanwise along the wood grain, and the fracture intersected two of the rivet holes attaching the leading edge/tip piece. The thickness of the leading edge strip was 0.027 inch.

Figure 2. Mating sides of the copper leading edge fracture in blade A showing the aft (pressure) face of the blade.

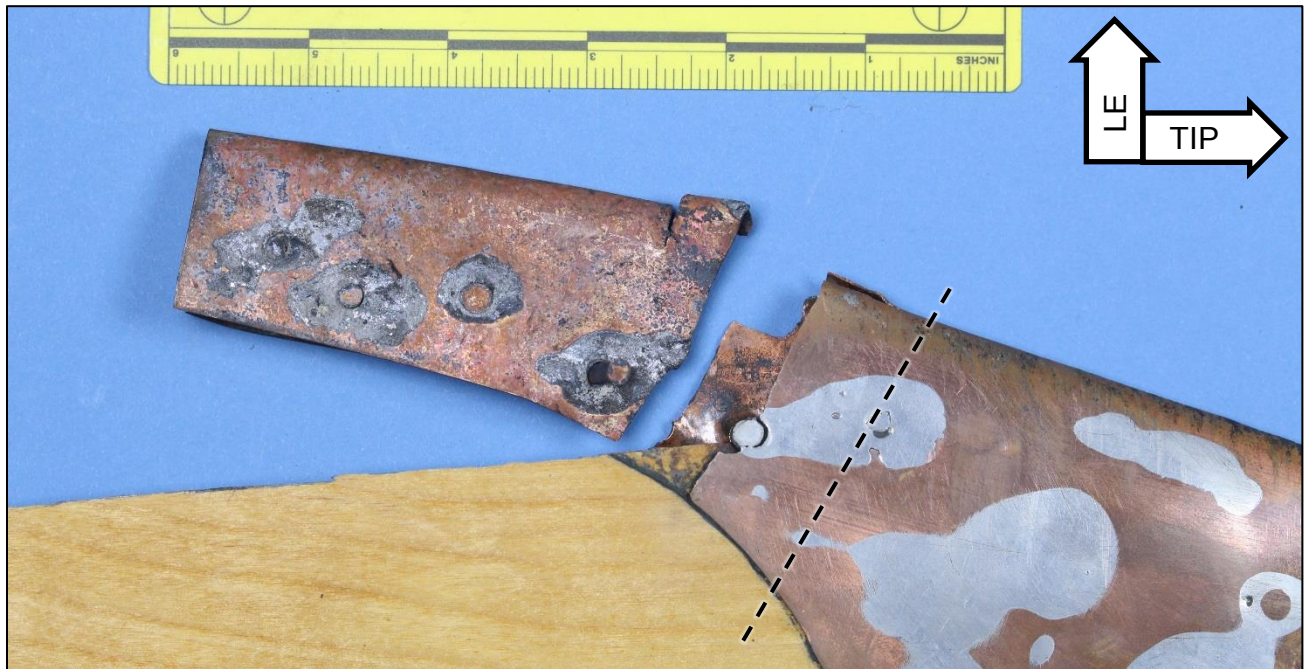
The fracture surfaces were initially examined visually and with an optical stereomicroscope. Fracture features on the inboard (closer to the blade root) leading edge piece were degraded due to high temperature oxidation, so additional examination of the fracture surfaces focused on the mating outboard side of the fracture. In order to facilitate further examination of the outboard side of the fracture, the leading edge piece was cut at the location indicated by a dashed line in figure 3 and was then cleaned with an ultrasonic cleaner while submerged in acetone.

Figure 3. Mating sides of the copper tip and leading edge fracture in blade A showing the forward (suction) face of the blade. A dashed line indicates the approximate location where the leading edge was cut to facilitate further examination of the fracture surface.

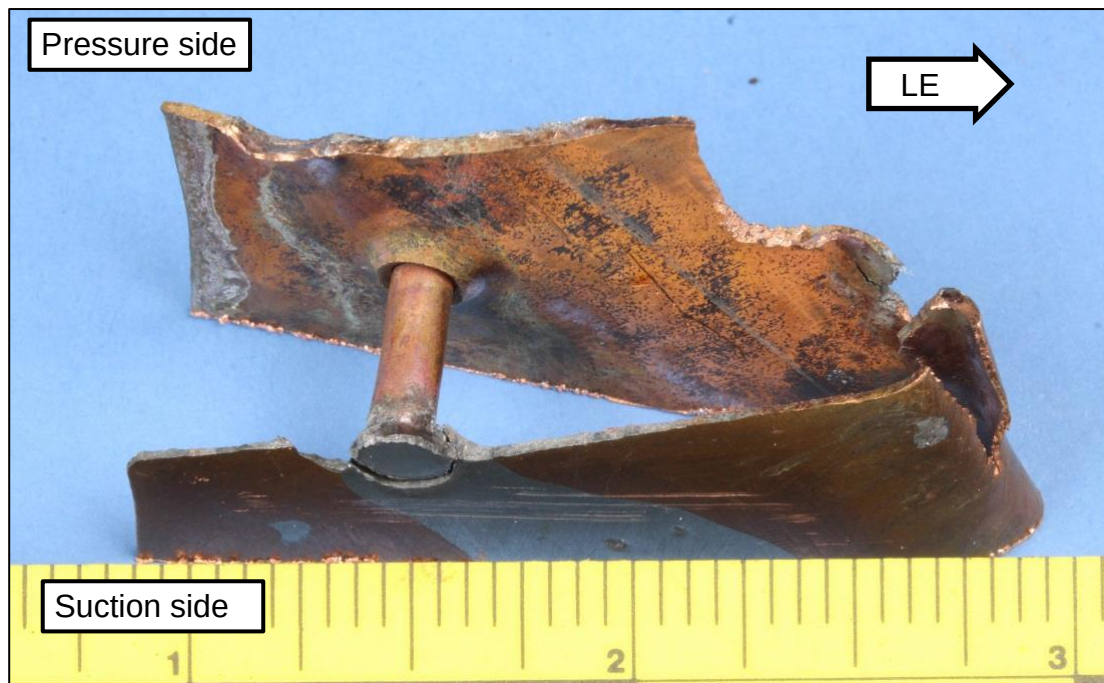
An overall view of the leading edge strip piece from the outboard side of the fracture after cleaning is shown in figure 4, and closer views of fracture surfaces at the pressure and suction sides of the piece are shown in figure 5. Fractures on each side of the leading edge strip intersected rivet holes for two rivets. Fracture features showed substantial damage consistent with fracture surface recontact. As indicated in the upper image in figure 5, green-colored deposits were observed on some areas of the fracture surface at the pressure side of the fracture. On the suction side of the strip shown in the lower image in figure 5, gray deposits covered most of the fracture surface.

Figure 4. Close view of the fractured leading edge piece after sectioning and ultrasonic cleaning in an acetone bath.

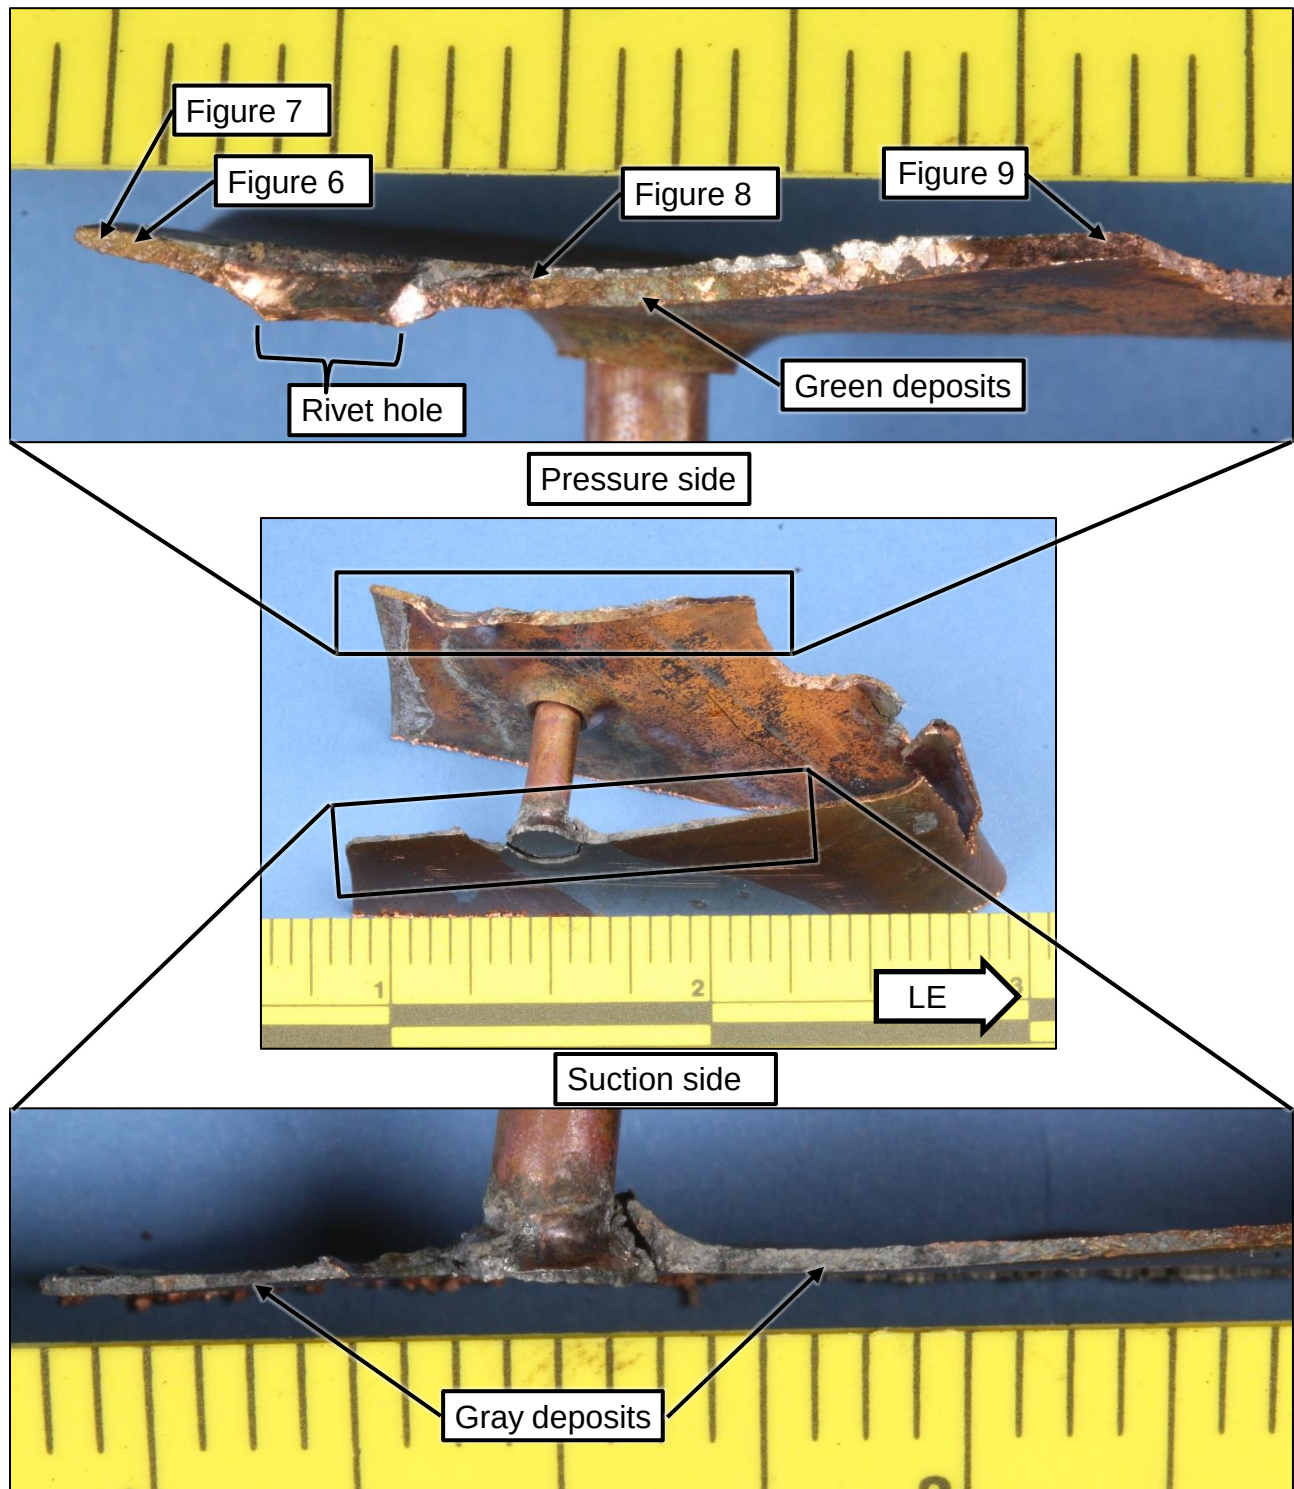
Figure 5. Close views of fracture surfaces on the leading edge piece. Approximate locations of SEM images in subsequent figures are indicated in the upper image.

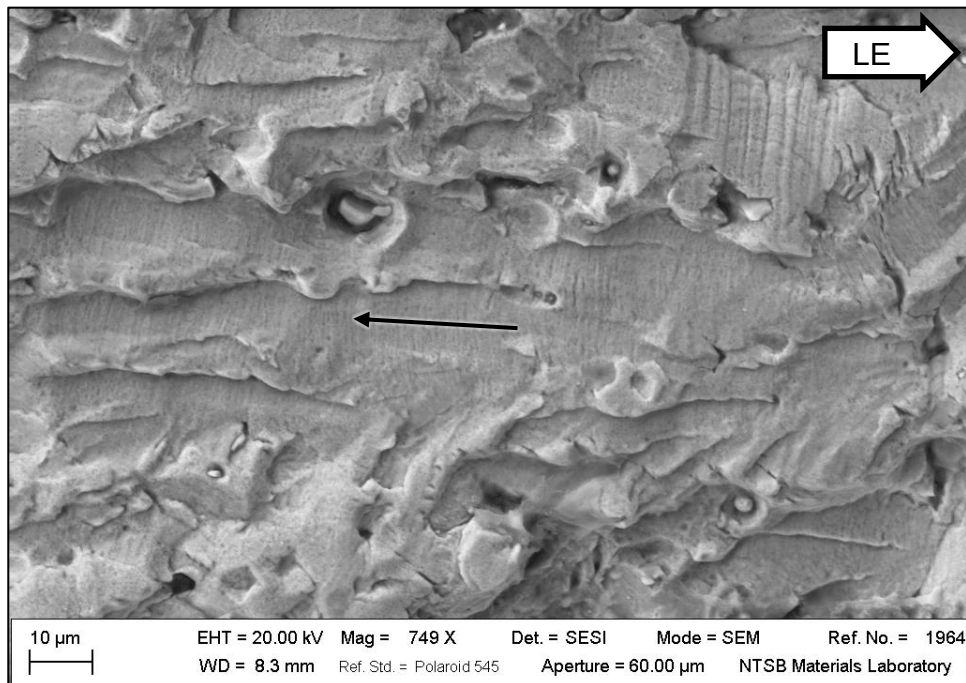
The leading edge piece shown in figures 4 and 5 was examined next using a scanning electron microscope (SEM). Most of the fracture surfaces were damaged from post-fracture recontact or were obscured by oxides or deposits. However, pockets of protected fracture features were observed as shown in figures 6 through 9. As indicated in the upper image in figure 5, figures 6 and 7 show two areas to the trailing side of the rivet hole, and figures 8 and 9 show two areas to the leading side of the rivet hole on the pressure side of the strip. In these areas, transgranular fractures with curving crack arrest lines were observed, features consistent with fatigue. Fatigue features emanated from origins at the filled depression associated with the rivet, and unlabeled arrows in figures 6 through 9 show the observed direction of crack propagation toward the trailing edge in figures 6 and 7 and toward the leading edge in figures 8 and 9.

Fatigue striations were counted in the images shown in figures 6 through 9. The areas in figure 6 and 7 were located 0.052 inch and 0.091 inch from the trailing side of the rivet hole, respectively. The striation density at these locations was estimated to be 22,770 striations per inch at the figure 6 location and 20,250 striations per inch at the figure 7 location. The areas in figures 8 and 9 were located 0.11 inch and 0.79 inch from the leading side of the rivet hole, respectively. The estimated striation densities at the locations to the leading side of the rivet were 79,320 striations per inch at the figure 8 location and 20,895 striations per inch at the figure 9 location.

Figure 6. Fatigue features on the pressure side of the leading edge strip 0.052 inch from the trailing edge of the rivet hole (see figure 5). An arrow indicates the general direction of crack propagation.

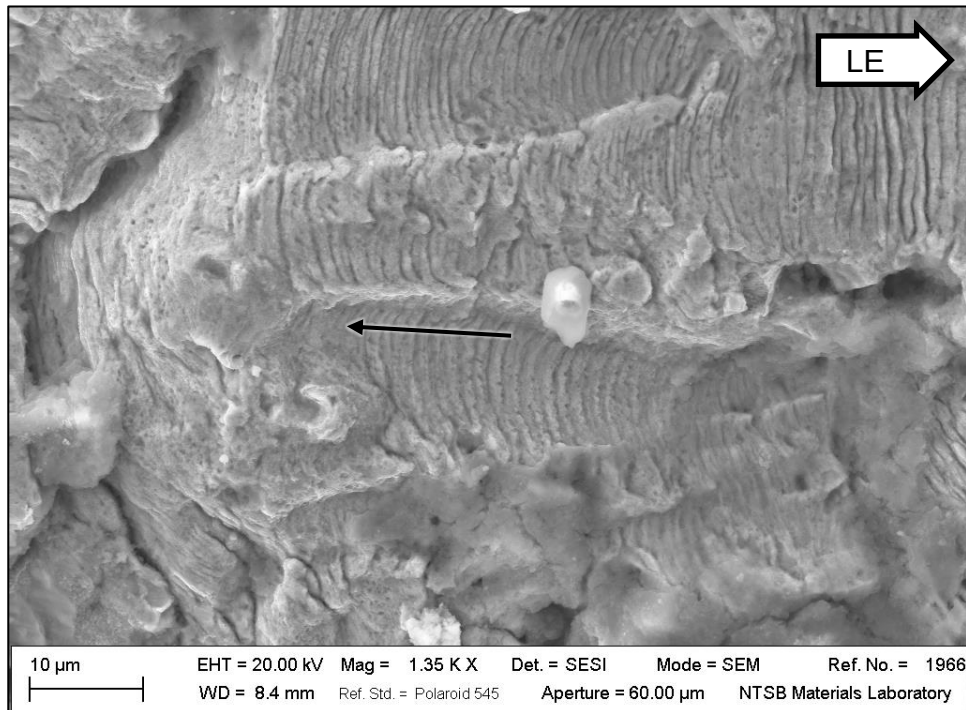
Figure 7. Fatigue features on the pressure side of the leading edge strip 0.091 inch from the trailing edge of the rivet hole (see figure 5). An arrow indicates the general direction of crack propagation.

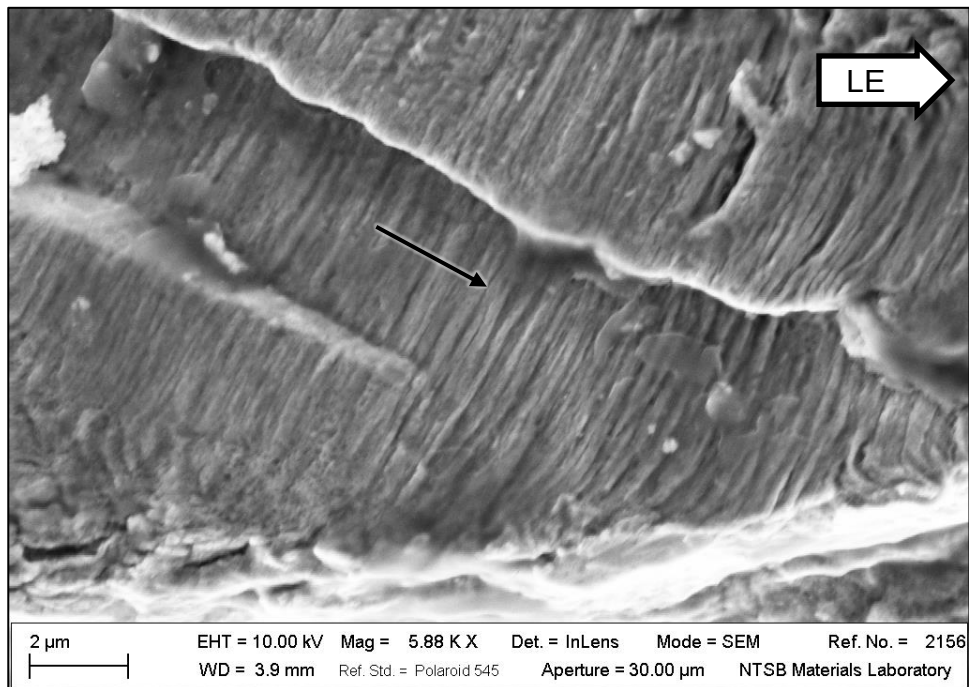
Figure 8. Fatigue features on the pressure side of the leading edge strip 0.11 inch from the leading side of the rivet hole (see figure 5). An arrow indicates the general direction of crack propagation.

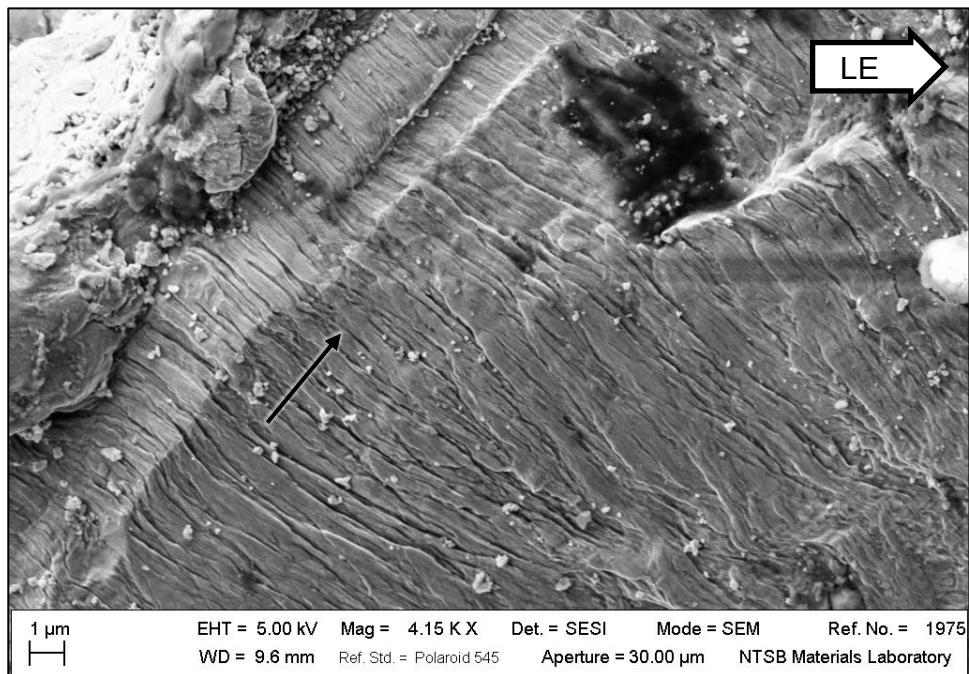
Figure 9. Fatigue features on the pressure side of the leading edge strip 0.79 inch from the leading side of the rivet hole (see figure 5). An arrow indicates the general direction of crack propagation.

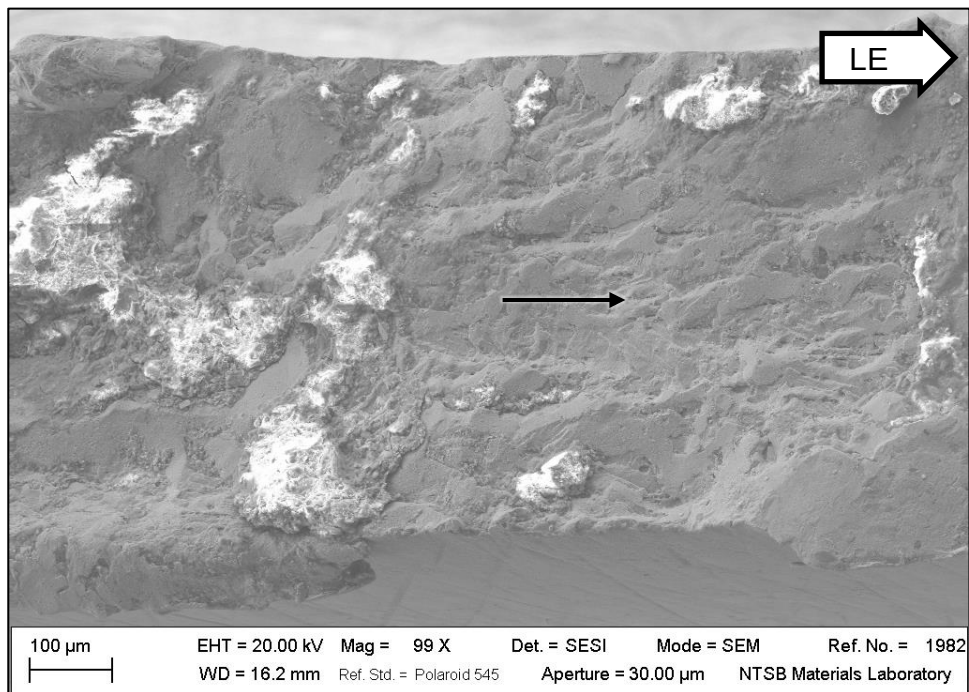
An SEM image of the fracture surface near the middle of the leading edge piece on the suction side is shown in figure 10. Fracture features were rubbed consistent with fracture surface recontact, and the general direction of fracture propagation is indicated with an unlabeled arrow. Although no fatigue striations were detected in this area, the more prominent fracture features were similar to those in fatigue regions shown in figures 6 through 9. Toward the leading edge, the fracture surface on the suction side was completely obliterated by post-fracture contact. Closer to the trailing edge, the fracture surface was largely covered by the gray deposits shown in figure 5.

Figure 10. Rubbed fracture features on the suction side of the leading edge strip 0.5 inch from the leading side of the rivet hole. An arrow indicates the general crack propagation direction.

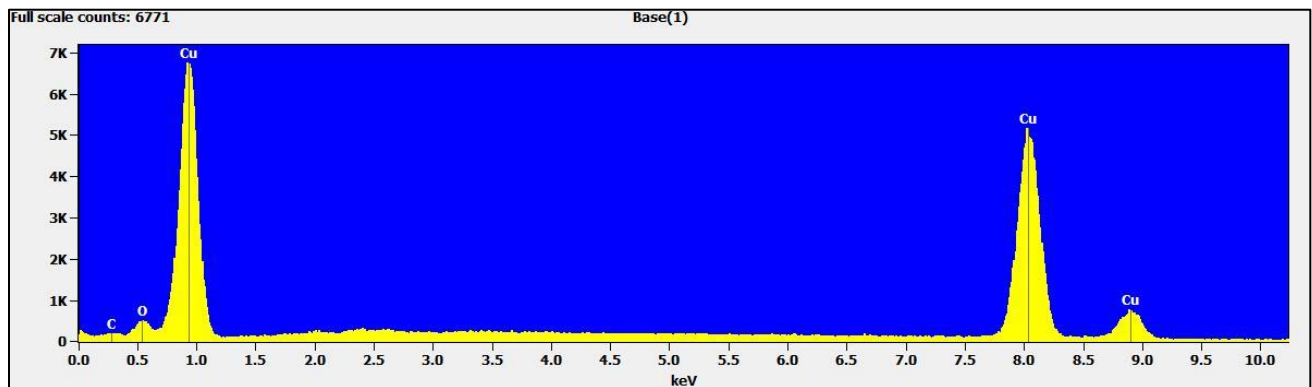
Areas of the fracture surface and deposits on the surface were analyzed using energy dispersive x-ray spectroscopy (EDS). An area of the fracture appearing relatively free of deposits revealed a spectrum shown in figure 12 with large peaks of copper and smaller peaks of oxygen and carbon. The filler material was observed on the exterior surface adjacent to the rivet holes, and a typical spectrum of the filler is shown in figure 13, where large peaks of lead and tin were observed with smaller peaks of carbon, oxygen,

Figure 11. Typical EDS spectrum of the leading edge strip metal showing copper peaks with smaller peaks of oxygen and carbon.

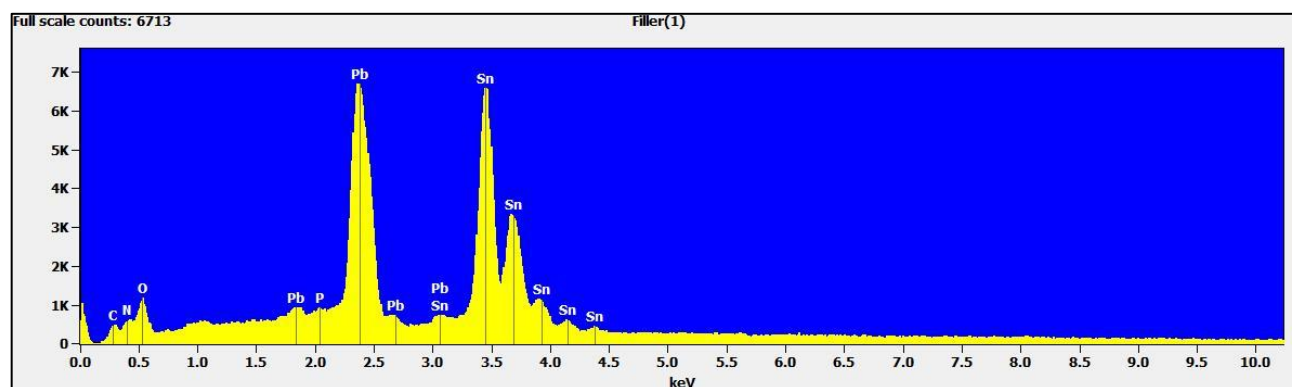
Figure 12. Typical EDS spectrum of filler metal on the leading edge strip showing peaks of lead and tin with smaller peaks of carbon, oxygen, and phosphorus.

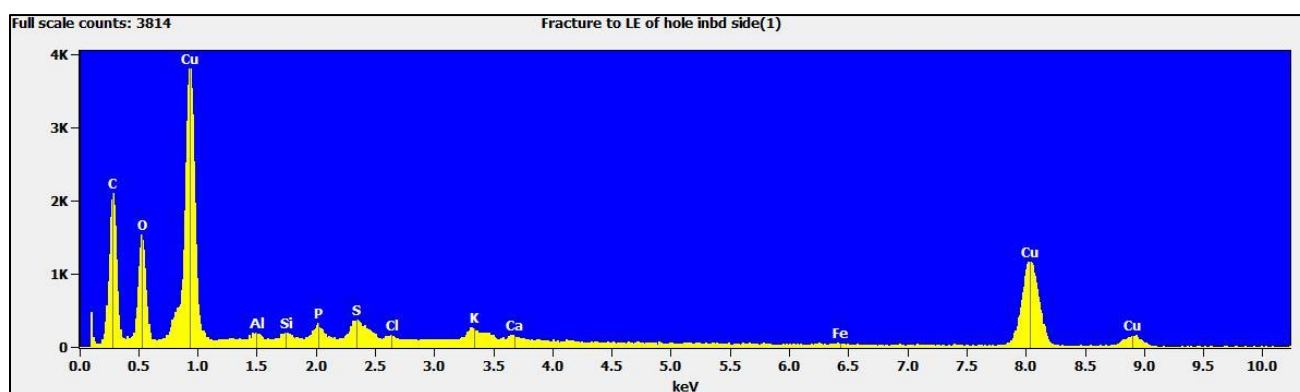
and phosphorus. An area of green deposits on the fracture surface at the pressure side of the leading edge piece was analyzed, and a typical EDS spectrum is shown in figure 14. In the area of green deposits, large peaks of copper, carbon, and oxygen were observed with smaller peaks of aluminum, silicon, phosphorus, sulfur, chlorine, potassium, calcium, and iron. Gray deposits on the suction side fracture surface produced an EDS spectrum such as the spectrum shown in figure 15, where large peaks of aluminum, carbon, and oxygen were observed with smaller peaks of phosphorus, lead, chlorine, tin, and copper.

The airplane was housed in a museum, and according to the builder's blog, the propeller was polished on at least one occasion as noted in the April 23, 2014, entry. The type of polish used was not specified. However, various brands of metal polish can contain oxides of either aluminum or silicon.

Figure 14. Typical EDS spectrum of green deposits on the surface on the pressure side of the fracture (see figure 5). Large peaks of copper, carbon, and oxygen were present along with smaller peaks of aluminum, silicon, phosphorus, sulfur, chlorine, potassium, calcium, and iron.

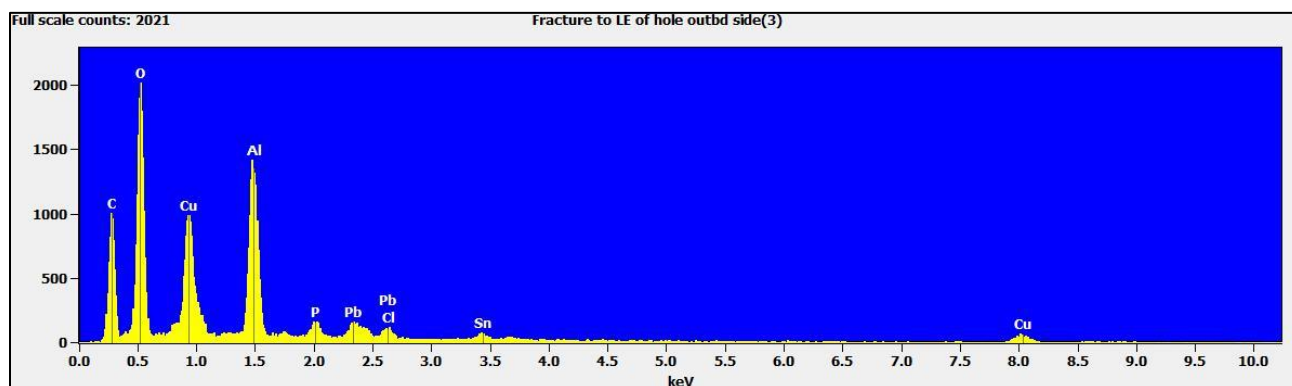
Figure 13. Typical EDS spectrum of gray deposits on the suction side of the fracture (see figure 5). Large peaks of aluminum, oxygen, and carbon were present along with smaller peaks of phosphorus, lead, chlorine, tin, and copper.
