# NATIONAL TRANSPORTATION SAFETY BOARD

MATERIALS LABORATORY ADDENDUM REPORT

Report No. 17-032B

Place : Williamson, Georgia  
Date : November 17, 2016  
Vehicle : Curtiss JN4D  
NTSB No. : ERA17FA050  
Investigator : Ralph Hicks, AS-ERA

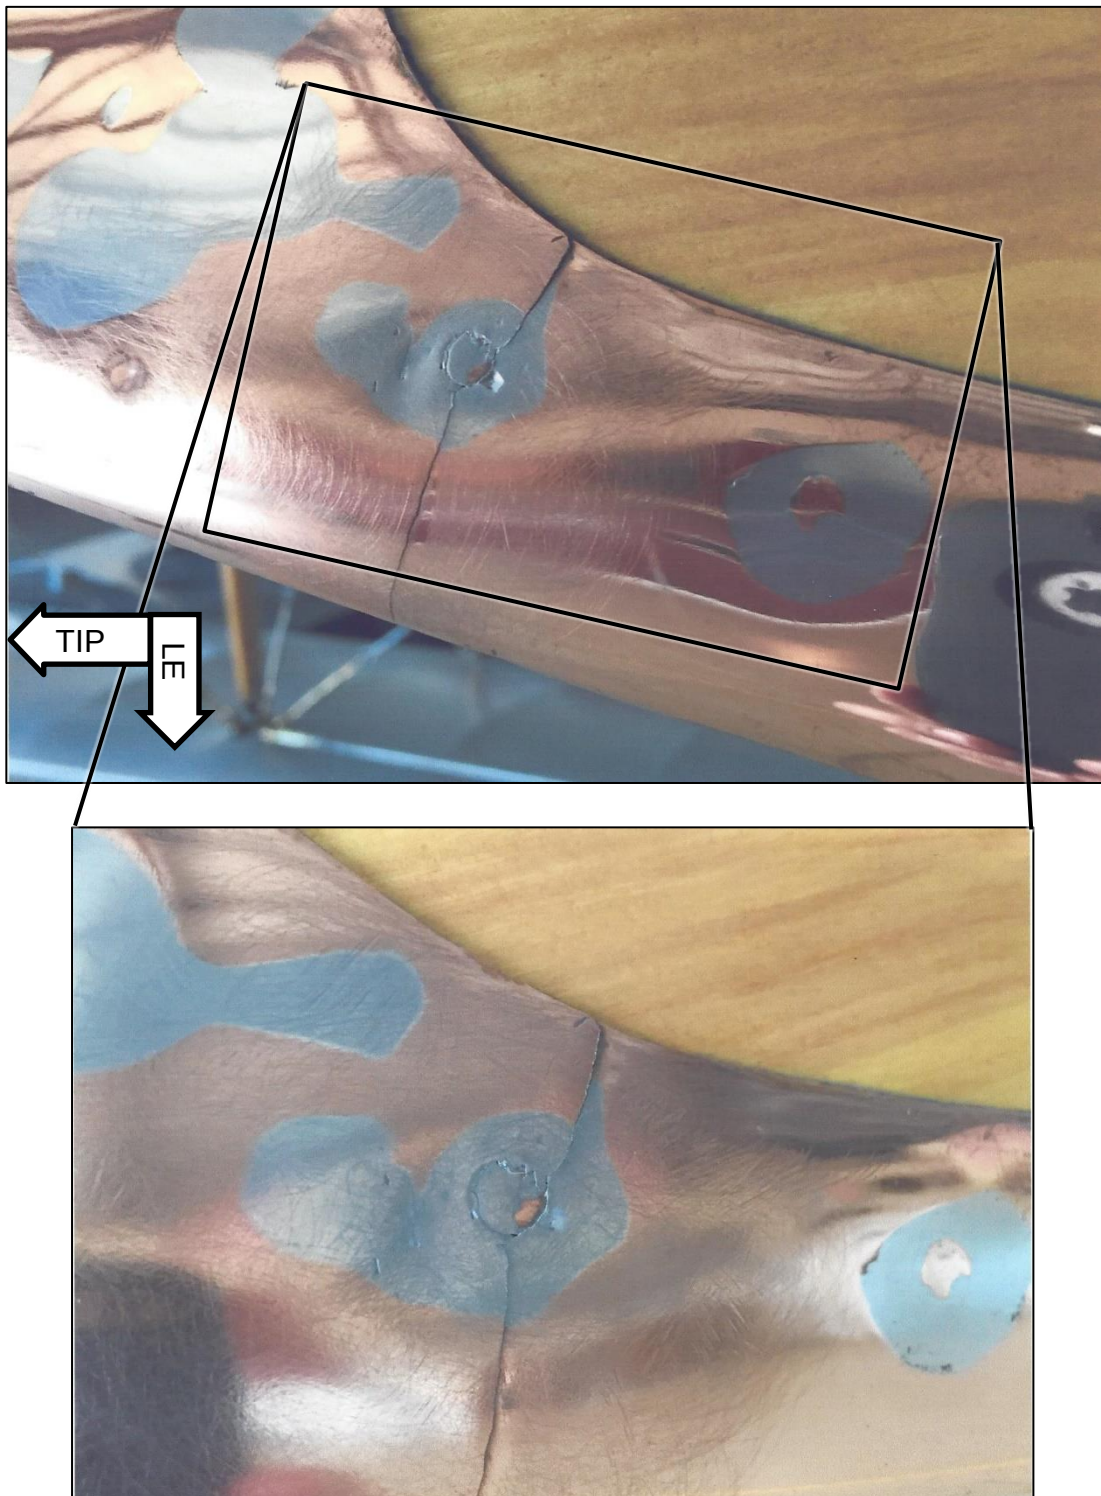
According to the primary restorer and caretaker of the accident airplane, a crack was observed in the brass leading edge of the propeller near the tip in July 2015. A photograph of the crack prior to the repair is shown in figure 1. The propeller was sent back to the manufacturer, St. Croix Propeller, where it was repaired. According to an October 13, 2015 email from the propeller manufacturer, there was a "fatigue cracked rivet exactly halfway down inside the wood." To repair the problem, the rivets in the area were "doubled up". The repair was completed in October, 2015, and the propeller was reinstalled on the airplane in November, 2015.

Figure 1. Forward (suction) side of the blade showing the crack found by inspection in July, 2015, before the blade was repaired (photographs provided courtesy of the primary restorer and caretaker).

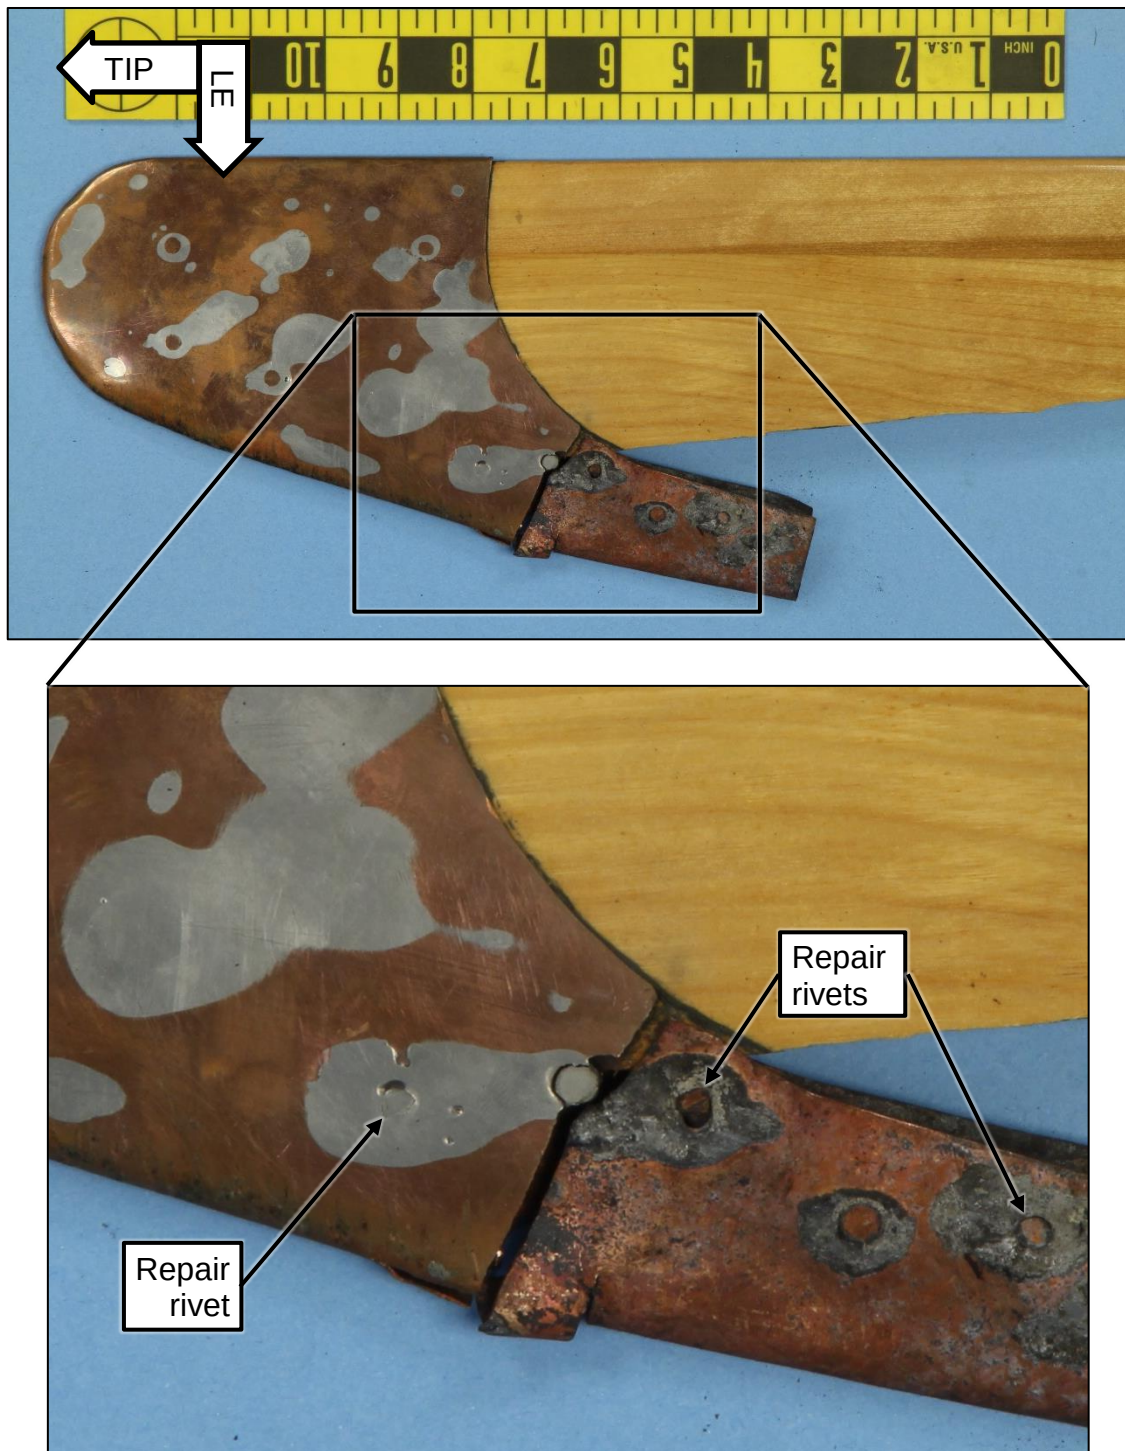
For comparison, photographs of the accident blade in the same area shown in figure 1 is presented in figure 2. Repair rivets visible in figure 2 are indicated. The fatigue fracture through the leading edge strip intersected the original rivet at the crack location shown in figure 1 and through the adjacent repair rivet closer to the hub. The fracture in the underlying wood intersected the original rivet hole and the adjacent repair rivet closer to the blade tip.

Figure 2. Overall view of the blade tip showing the forward (suction) side (upper image) with a closer view of the same area shown in figure 1.
