# PILOTS: Ensure Your Fuel Selector Works

Worn components can lead to fuel starvation and sudden loss of engine power

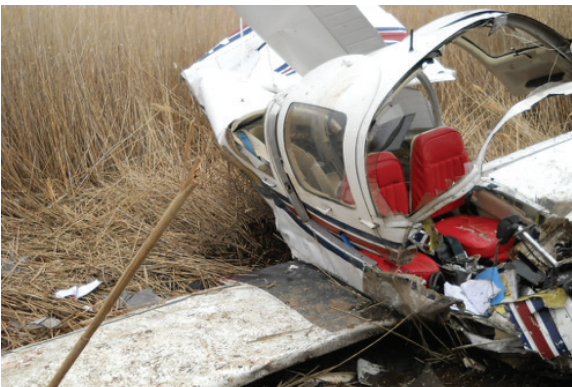
Figure 1. Photograph of accident airplane.

- During the initial climb after a touch-and-go landing in a Piper PA-38-112, the flight instructor reported an emergency and indicated that he would return to the airport. The airplane then spun to the left and impacted a marsh. The airplane was destroyed (figure 1); the flight instructor sustained serious injuries, and the student pilot died. Although the fuel selector handle was positioned to the right main fuel tank, an insert in the fuel selector had fractured into multiple pieces that showed overstress and wear (figure 2, next page). The fuel selector handle likely had been difficult to move for some time, and excessive force would have been required to move the handle from one position to another, thus causing the wear. **The failure of the fuel selector valve in a position that**

**restricted fuel flow to the engine led to the total loss of engine power due to fuel starvation.** The operator failed to detect and resolve the wear of the fuel selector valve. ([ERA17FA112](#))

- **Check the fuel selectors for proper operation during your preflight assessment, ensuring that the fuel selector moves freely and stays in the correct detent when selected and that fuel selector placards are accurate and legible.**

- **Do not force a handle that is difficult to turn; it could lead to fractured components inside the fuel selector that may prevent proper operation.**

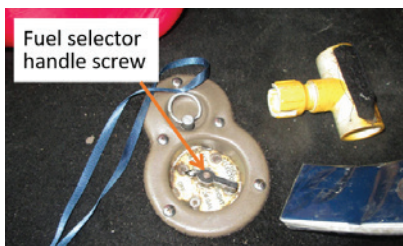
■ The pilot of a Mooney M20 airplane reported that, during the initial climb from the airport, he noted the engine power slowing, turned on the boost pump, checked the magnetos and fuel mixture, and then attempted to switch the fuel selector to the other fuel tank, which had usable fuel. The engine experienced a total loss of power, and the airplane impacted the ground. A passenger sustained minor injuries, and the pilot and another passenger were uninjured. **The fuel selector handle screw was loose and prevented the fuel selector from moving to the fuel tank position for the tank with usable fuel, resulting in fuel starvation and the subsequent total loss of engine power** (see figure 3). ([GAA17CA260](#))

**Figure 3.** Photograph of fuel selector.  
(Source: FAA)
