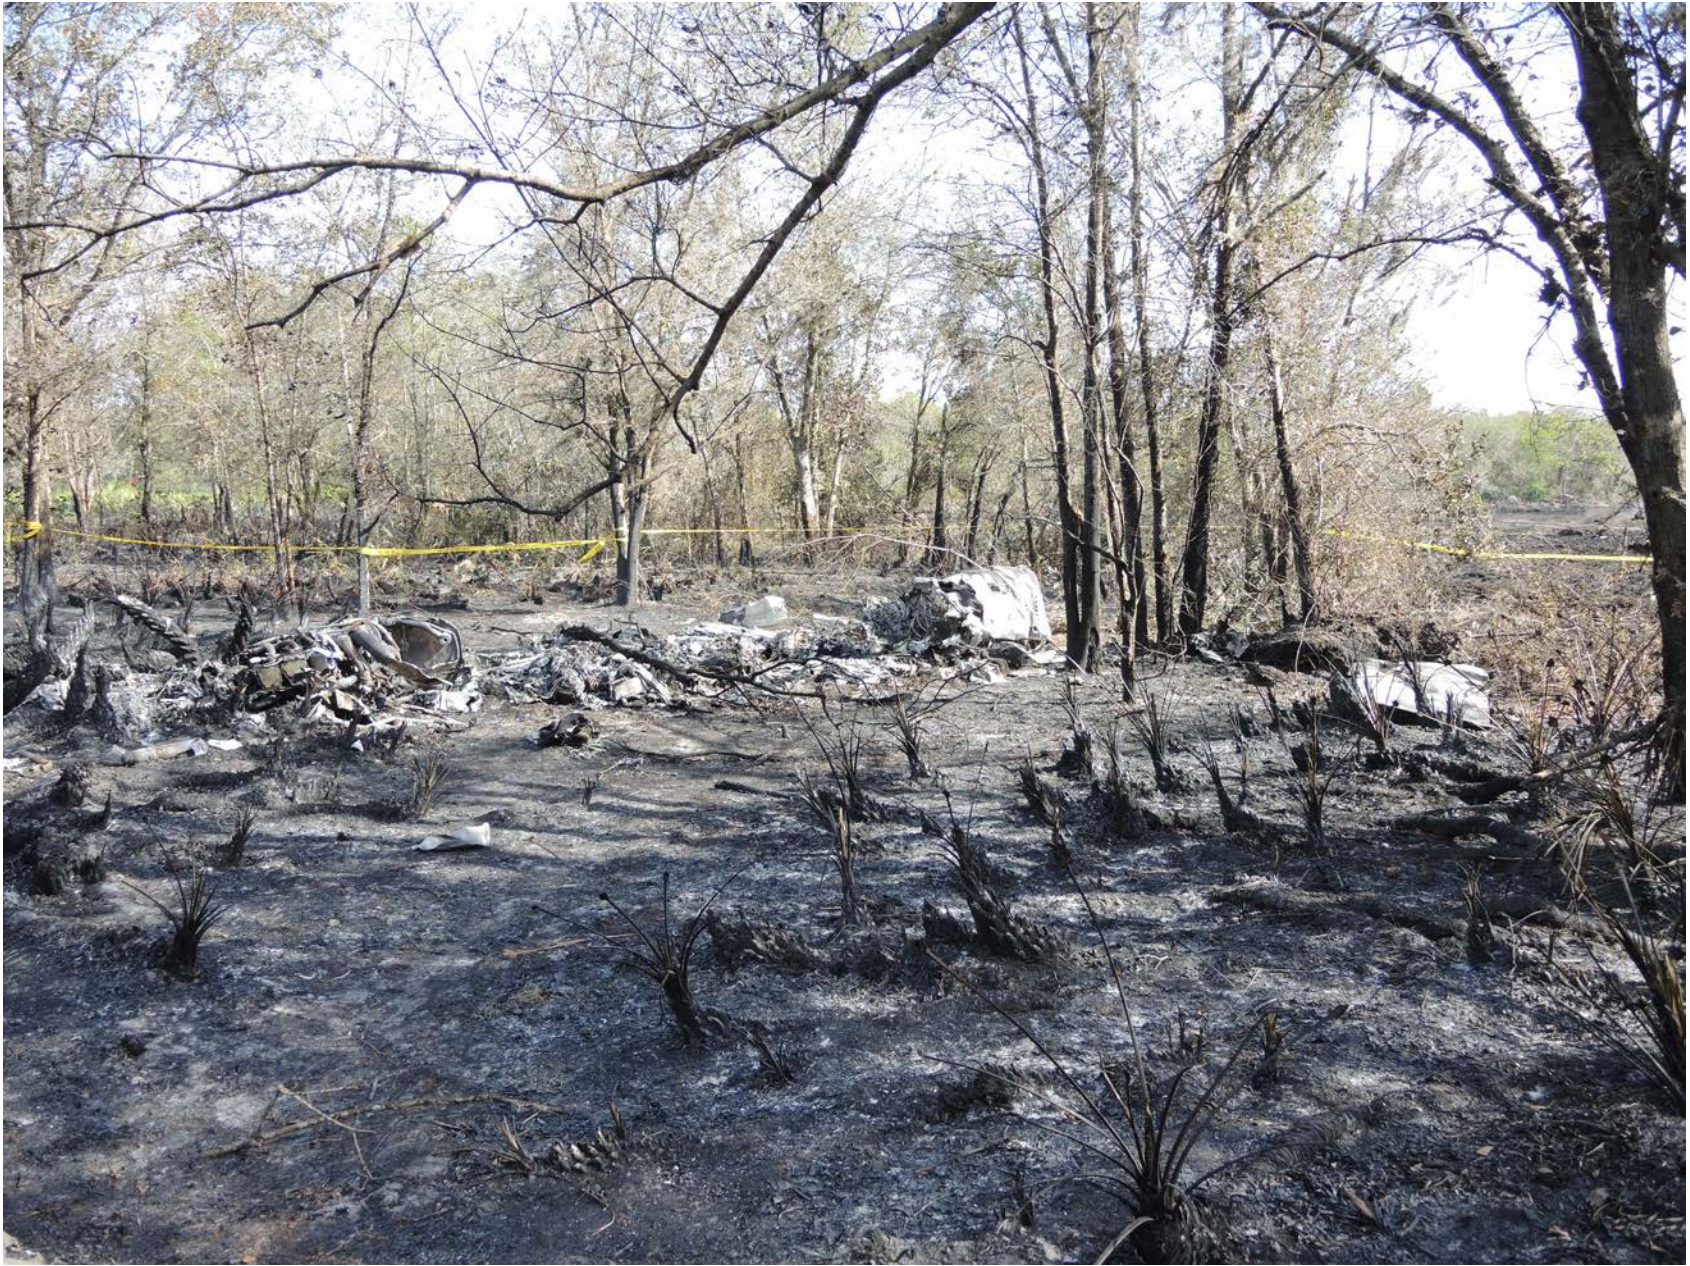
**Photo 1 – View of Main Wreckage as Found (Textron)**

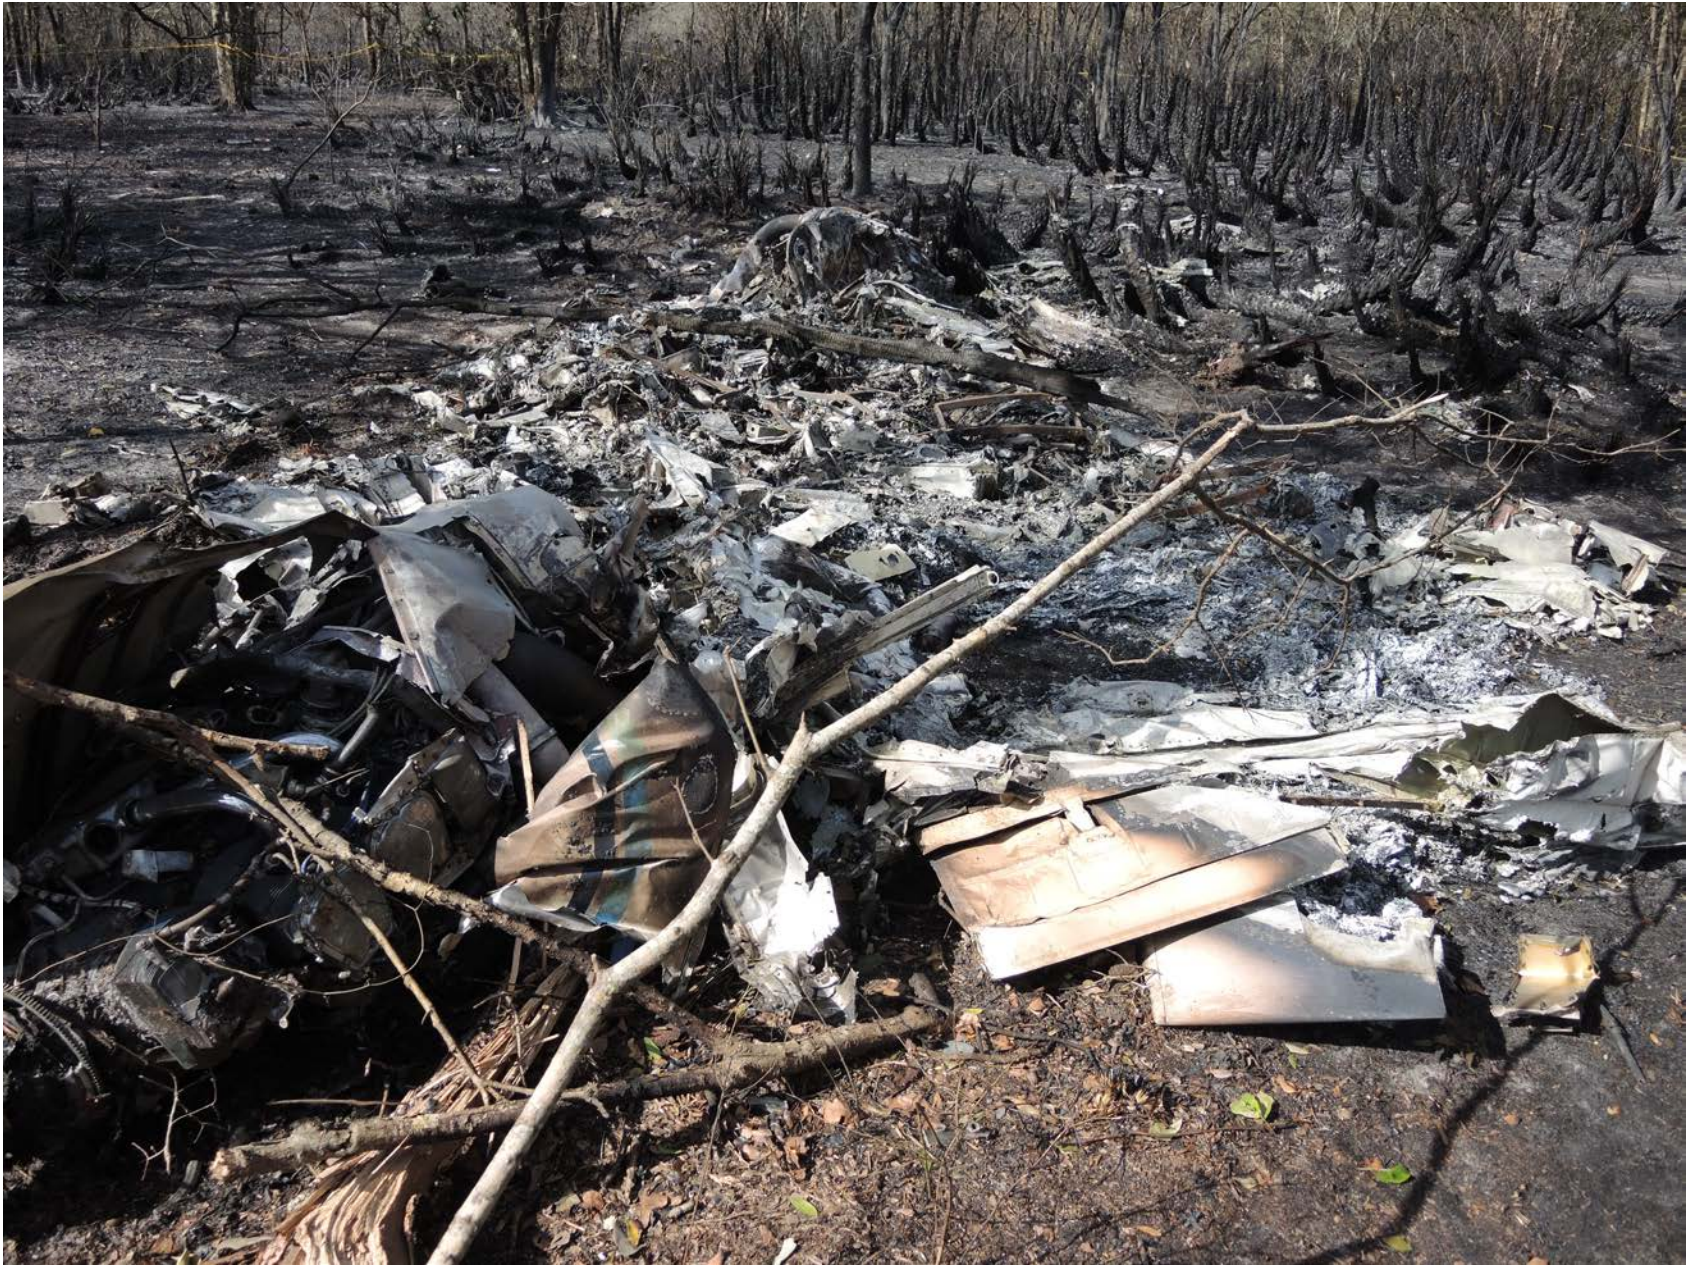
**Photo 2 – View of Engines as Found (Textron)**

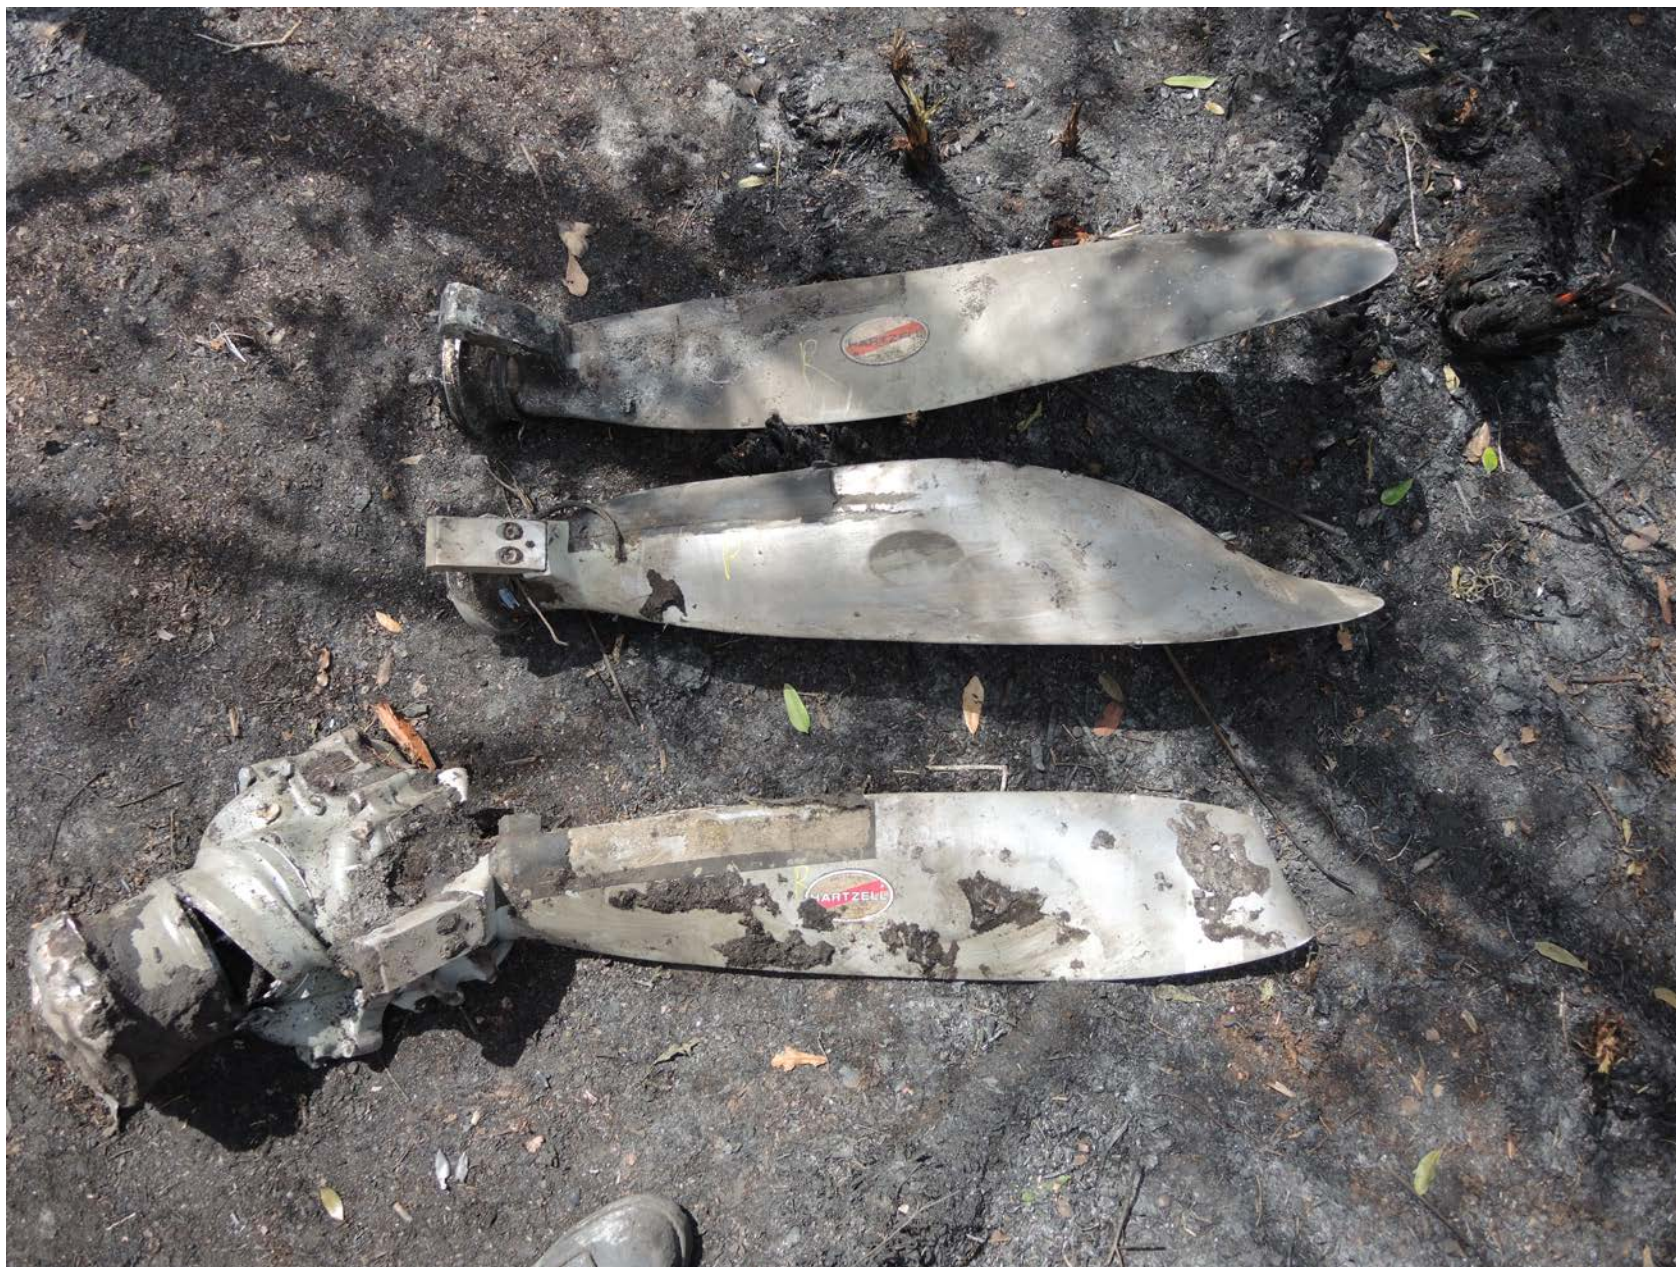
**Photo 3 – View of Right Engine Propeller Blades after Recovery (Textron)**

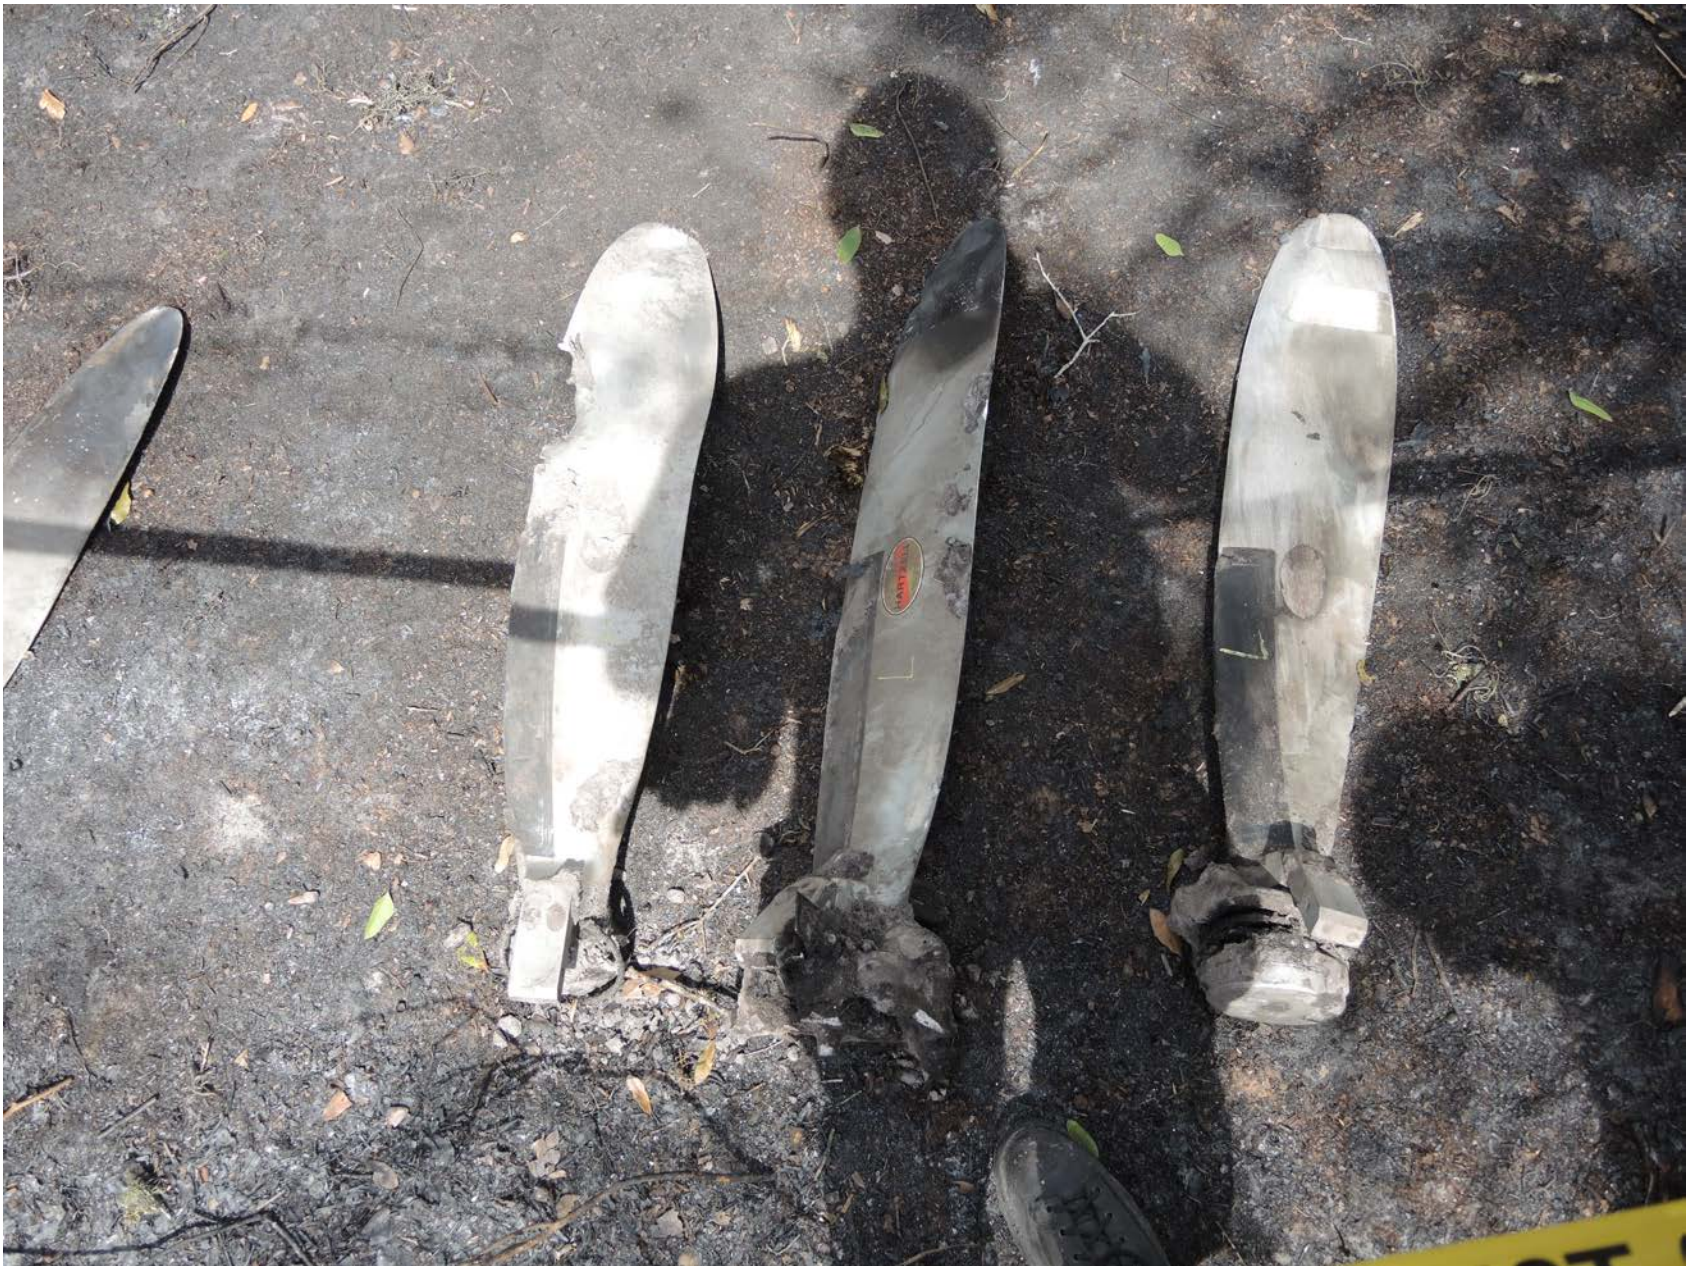
**Photo 4 - View of Left Engine Propeller Blades after Recovery (Textron)**

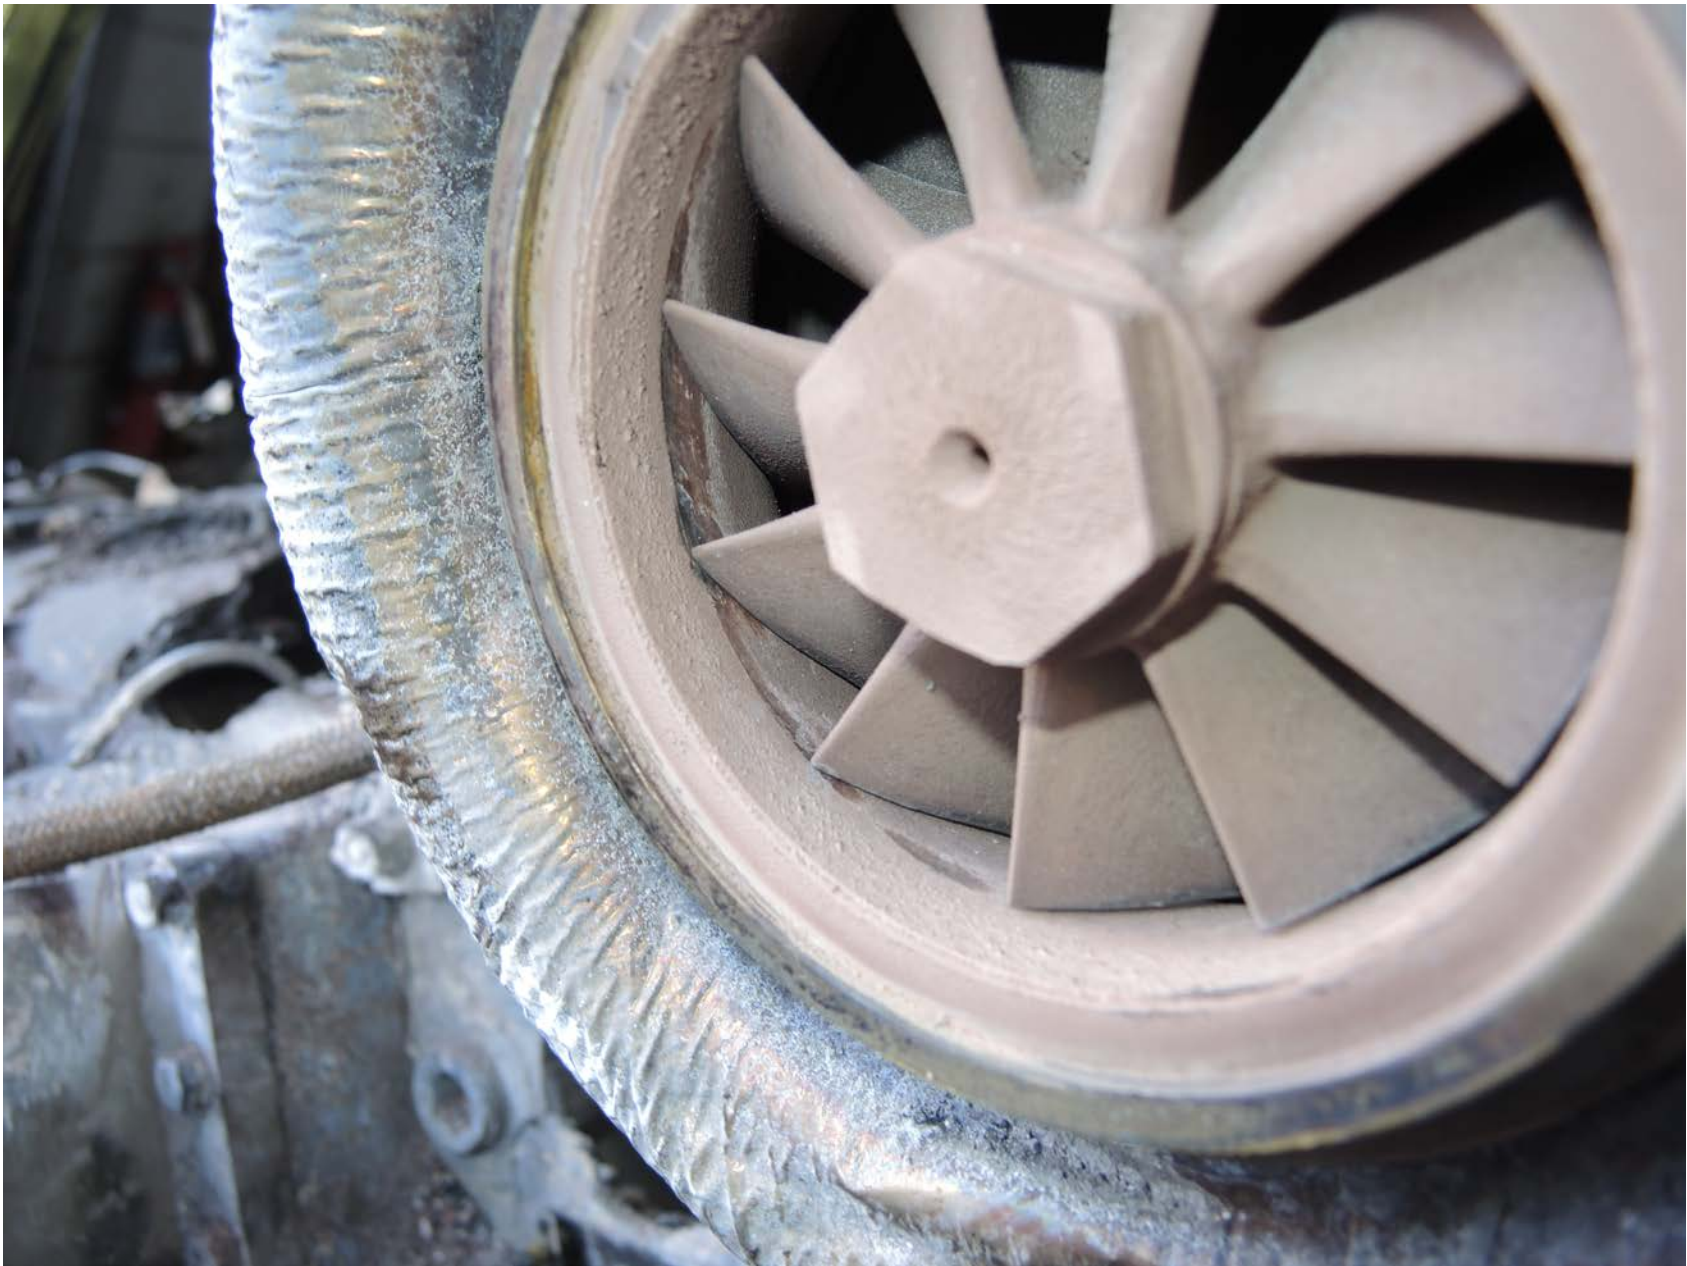
**Photo 5 – View of Left Engine Turbocharger Impeller (Textron)**

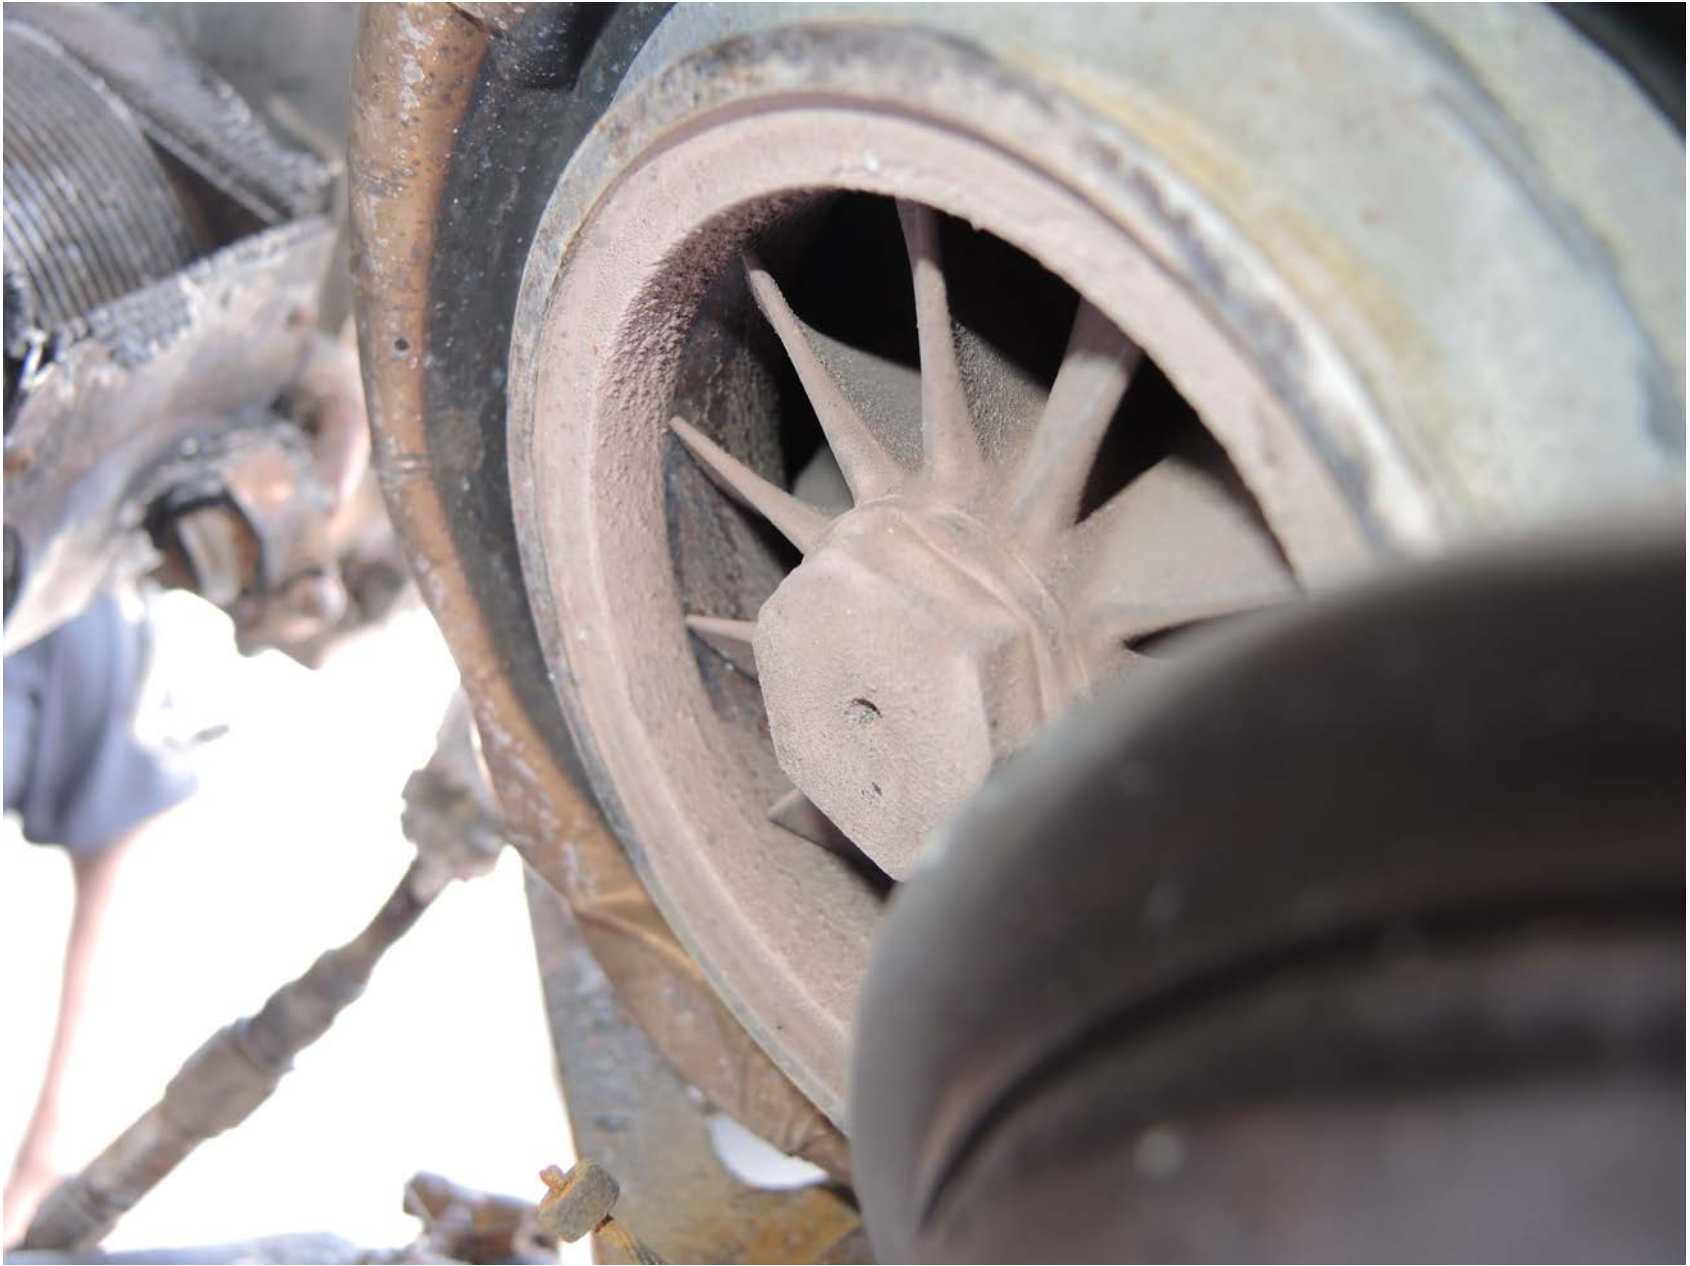
**Photo 6 - View of Right Engine Turbocharger Impeller (Textron)**

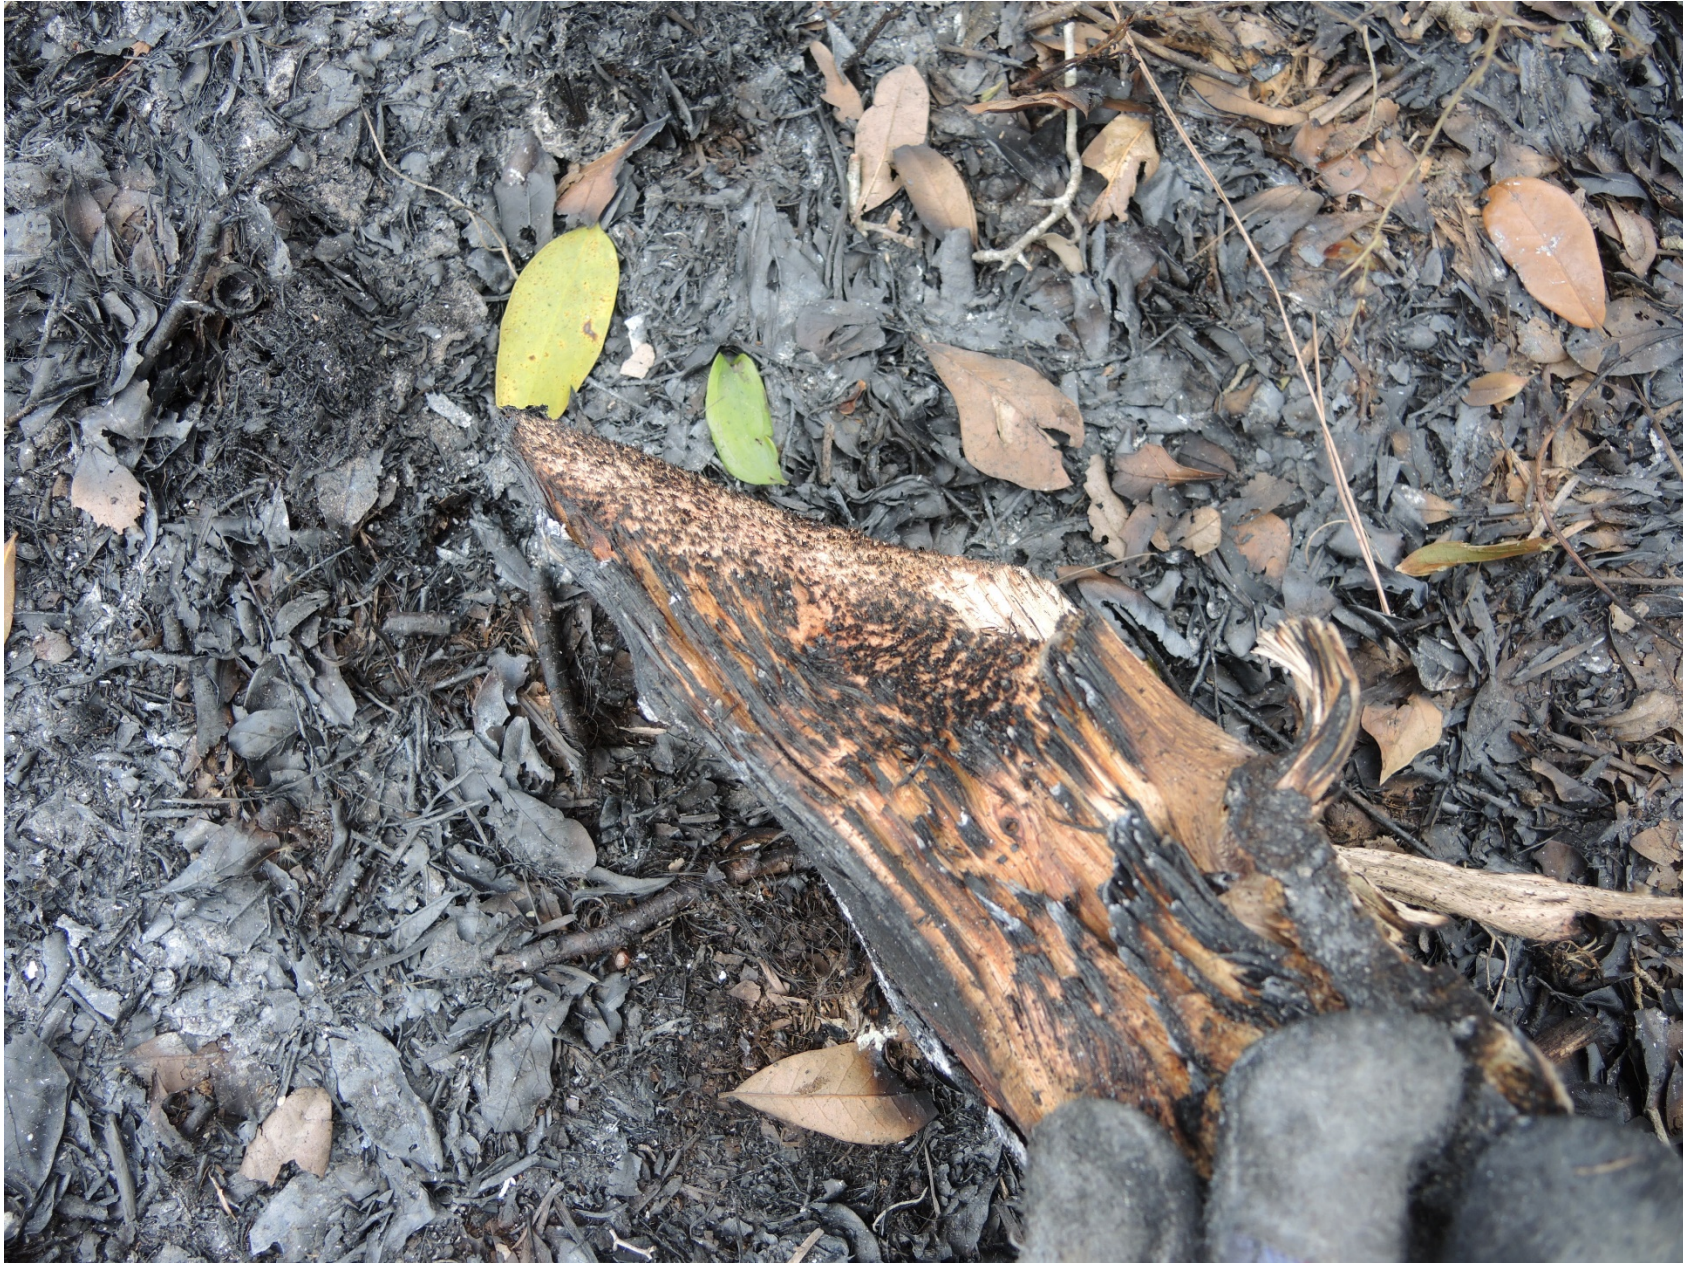
**Photo 7 - View of Angularly Cut Wood at Crash Site (Textron)**
