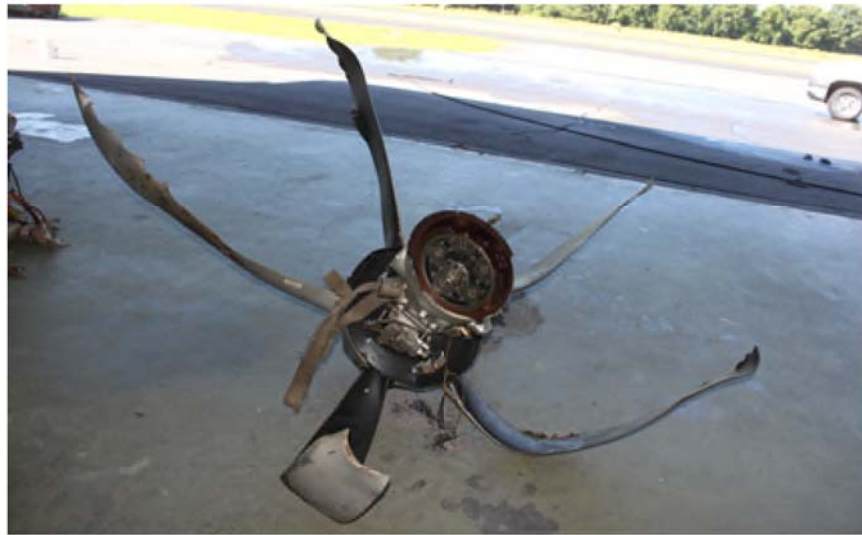
- 3.1 **External Condition:** The propeller assembly was still attached to the propeller shaft (Photo No. 1). The 5 propellers all exhibited mechanical damages. The propeller shaft was still attached to the front reduction gearbox which was fractured at the “A” flange. The aircraft engine frame with the four aircraft mounts were still attached to their respective mount pads on the gas generator case (Photo No. 2). The gas generator case showed compression and mechanical deformation near the “C” flange along the 6 o’clock region (Photo No. 3). The gas generator case was fractured at the front inlet “F” flange resulting in the ejection of the first stage integrally bladed rotor (Photo No. 4). The exhaust case which showed mechanical damages was fractured at the “A” and “C” flanges exposing the first stage reduction gearbox carrier planet gear assembly and the first stage power turbine blades respectively (Photo Nos. 5 and 6 respectively). Both exhaust ducts showed mechanical damages and deformation, one exhaust duct was fractured from the exhaust case (Photo No. 6). The engine exhibited staining and burnt regions from exposure to the post flight fire. The engine data plate showed the serial number was PCE-RG0181 (Photo No. 7).

Photo No. 1  
Propellers and front reduction gearbox housing

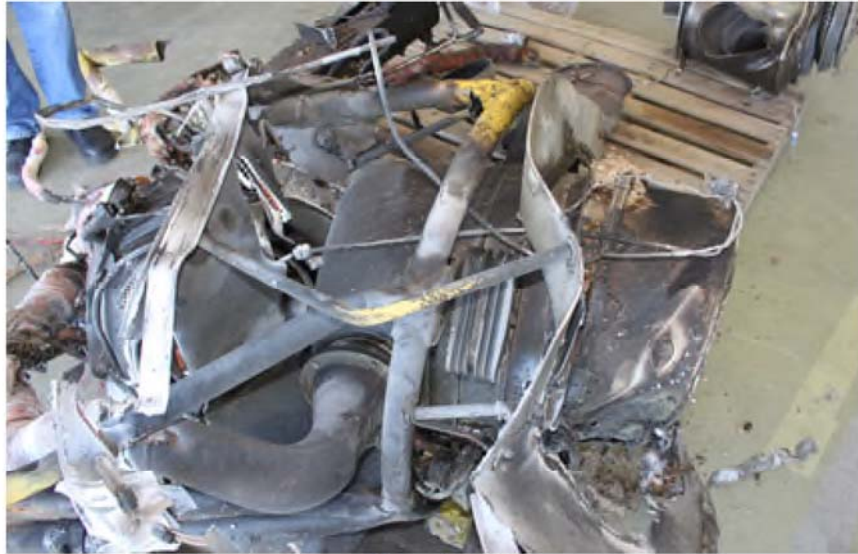
Photo No. 2

Aircraft frame with engine mounts was still attached to the gas generator case

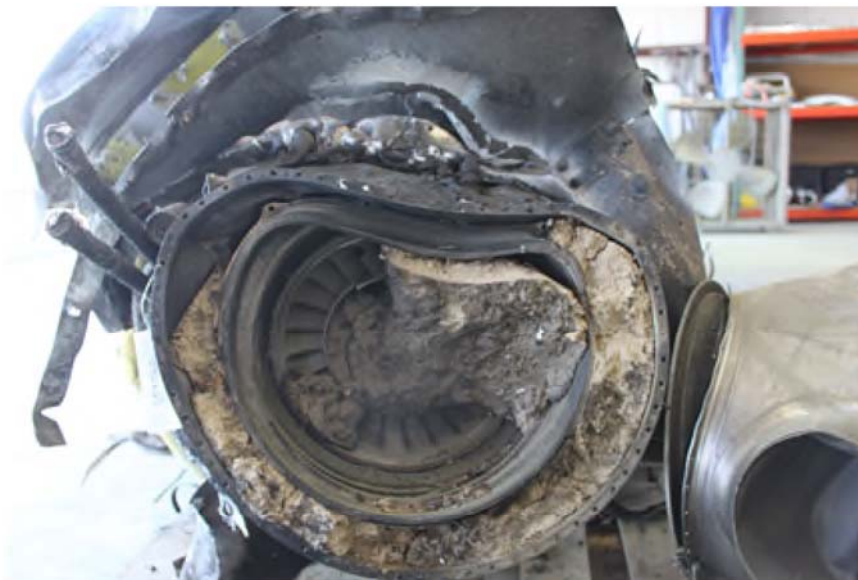
Photo No. 3

Gas generator case fractured at the "C" flange, note the case is rotated 180°

**Gas Generator Case:** The gas generator case showed the first stage power turbine stator assembly and the power turbine support case entrapped inside the gas generator due to the external deformation of the gas generator case and partially encased in hard packed earth (Photo No. 3). The first stage compressor integrally bladed rotor and drum spacer were no longer in place exposing the first stage compressor stator (Photo No. 8).

**Power Turbine Housing:** The power turbine housing was deformed and entrapped within the gas generator case (Photo No 3). The housing was also surrounded by hard packed earth and the first stage stator was also entrapped within the power turbine housing (Photo No. 3). The power turbine housing had to be cut free from the gas generator case (Photo Nos. 52 and 53).

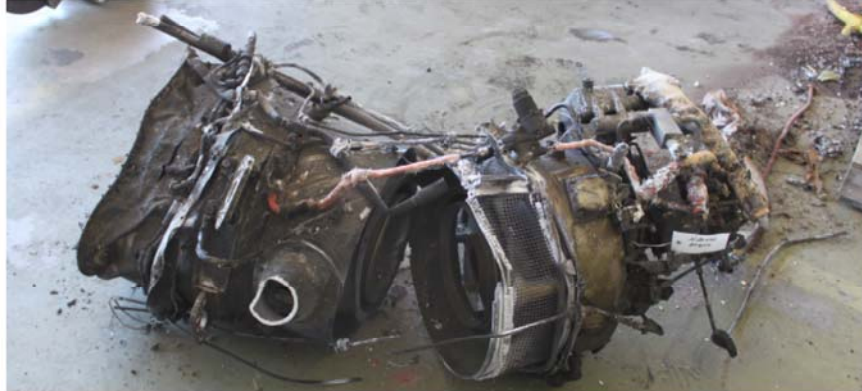
Photo No. 4

Gas generator case fractured at "F" flange

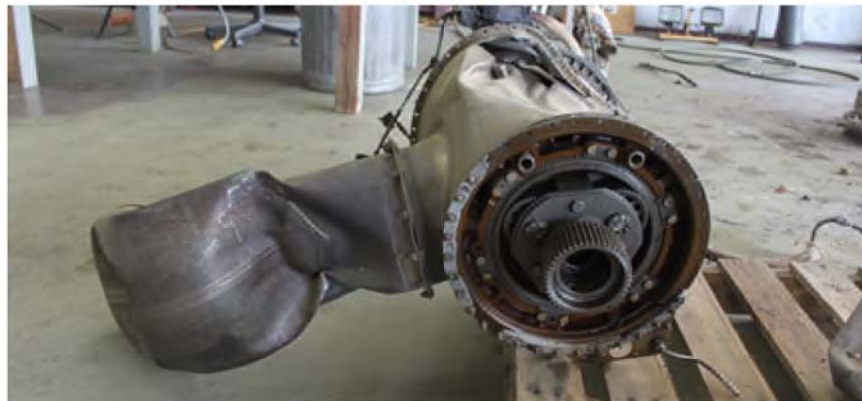
Photo No. 5

Exhaust duct, first stage reduction gearbox carrier assembly and left side exhaust stack.

**Exhaust Duct:** The exhaust duct showed compressional deformation inwards from approximately 5 to 9 O'clock (Photo Nos. 5 and 6).

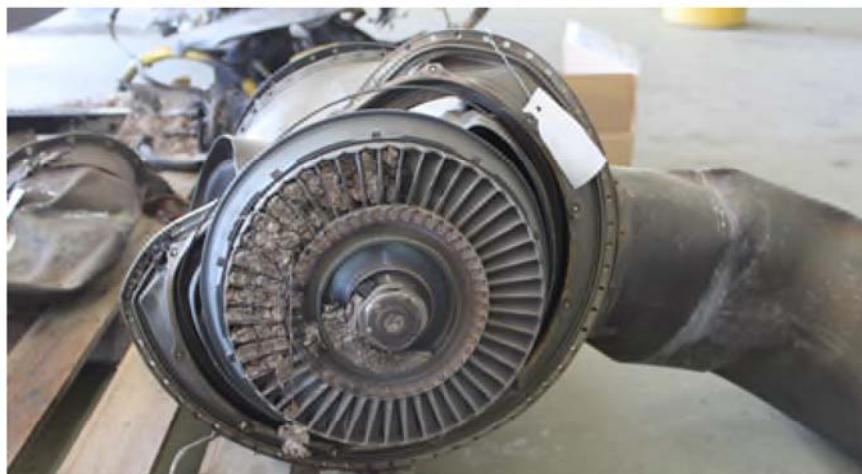
Photo No. 6

Exhaust case separated at the "C" flange

**First Stage Power Turbine:** The power turbine assembly retaining nut showed some mechanical damage, however it was found secure (Photo Nos. 6 and 55). The first stage power turbine blades were partially packed with earth (Photo No. 6). All the power turbine blades were observed displaced slightly rearwards (Photo No. 55 and red arrow, Photo No. 56). Circumferential shroud tip rubbing with occasional fracture / loss of material was observed on first stage power turbine blades (black arrow, Photo No. 56 and red circle Photo No. 57). Circumferential rubbing contact was observed in the blades firtree at the platform region from contact with the downstream inner wall of the power turbine stator (arrow, Photo No. 55).

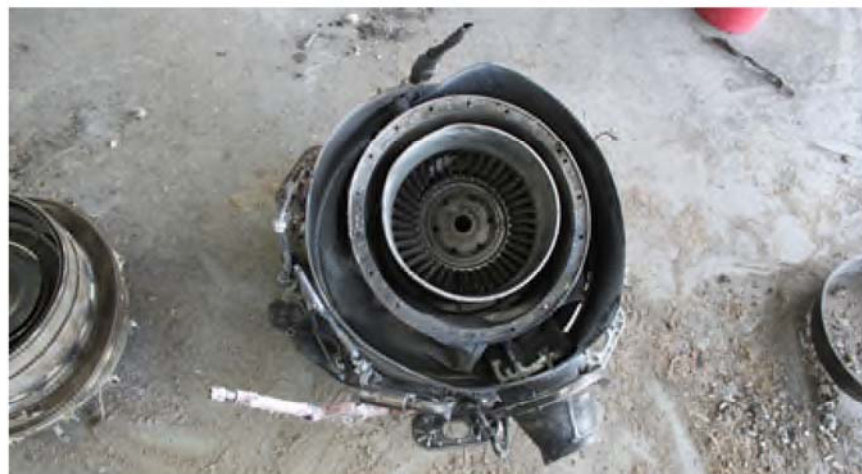
Photo No. 8  
First stage compressor stator

**Compressor Stators and Shrouds:** The first stage compressor stator as received insitu was missing the drum spacer and as a result exposing the second stage rotor disc (Photo Nos. 8). The stator airfoils showed occasional hard debris impact damage (arrows) and deformation of the airfoils (circled) in the direction of rotation of the drum spacer (Photo No. 35) (The missing drum spacer was put back in place for the photo). Circumferential rubbing of the airfoils was also observed resulting in raised material on the airfoil tip edges from contact with the drum spacer surface (white arrow, Photo No. 36). The shroud housing for the first stage integrally bladed rotor showed impact damages and circumferential rubbing contact (Photo No. 35). The trailing edge of the stator airfoils were observed to have rubbed with the leading edge of the second stage compressor rotor blades (Photo No. 36).

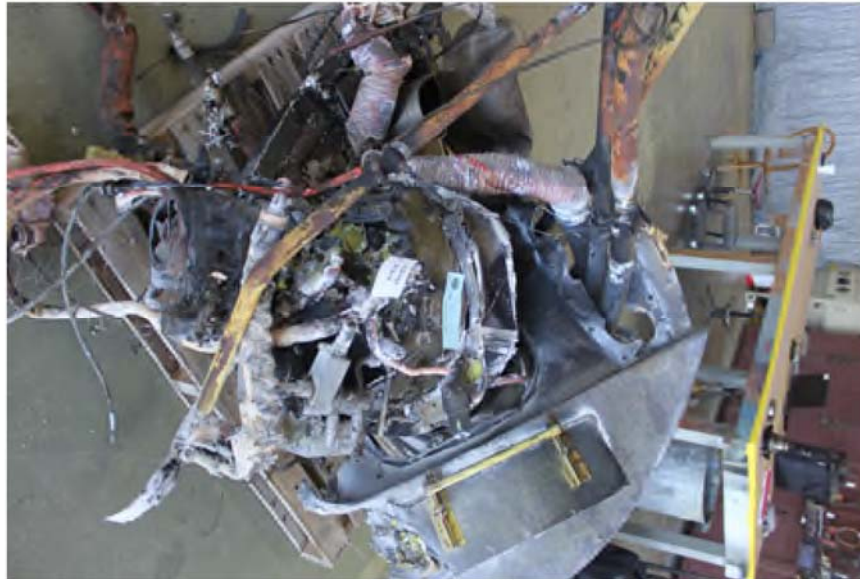
**Accessory Gearbox:** The accessory gearbox was in one piece with all the accessories still in place. The surface of the accessory gearbox and the accessories exhibited staining and burnt regions from exposure to the post flight fire (Photo No. 9).

Photo No. 9  
Accessories gearbox

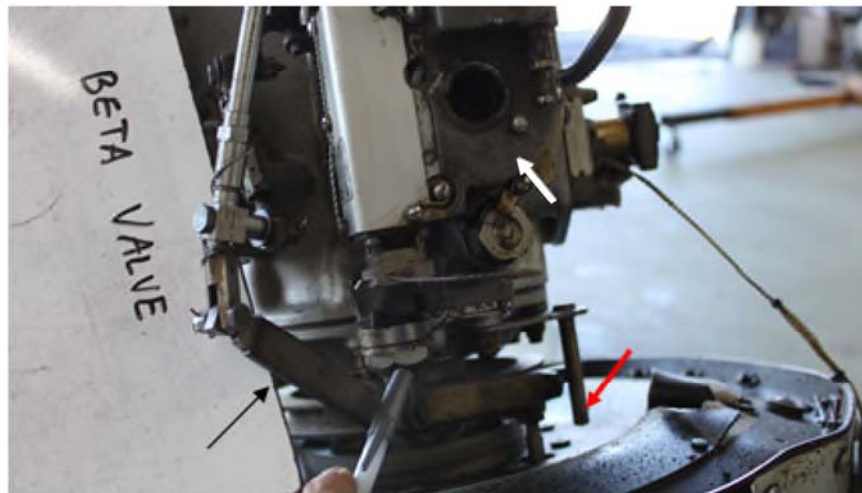
3.1.2 **Power Control and Reversing Linkage:** The beta lever guide pin was in place (red arrow, Photo No. 10). The propeller reversing lever was in place and secure (black arrow, Photo No. 10). The propeller speed control lever was missing from the governor (white arrow, Photo No. 10). The reset interconnect rod was complete and secure but was bent (red arrow, Photo No. 11). The linkage was severed towards the CAM box at the “C” flange region and also bent at the front clevis attachment to the propeller reversing lever (black arrow, Photo No. 11). The linkage was attached and secure on the CAM, which was fractured from the CAM box (black arrow, Photo No. 12). The CAM input lever was mechanically damaged and the airframe power cable was attached but found severed about a foot away (dashed yellow arrow and red arrow respectively, Photo No. 13). The interconnect rod between the CAM box and the fuel control unit was bent but observed to be in place and secure (black arrow, Photo No. 13). The fuel condition lever and linkage were mechanically damaged (white arrow, Photo No. 14). The aircraft cable to the fuel condition lever was connected but severed towards the aircraft end (black arrow, Photo No. 14).

Photo No. 10  
Beta guide pin and the propeller reversing lever

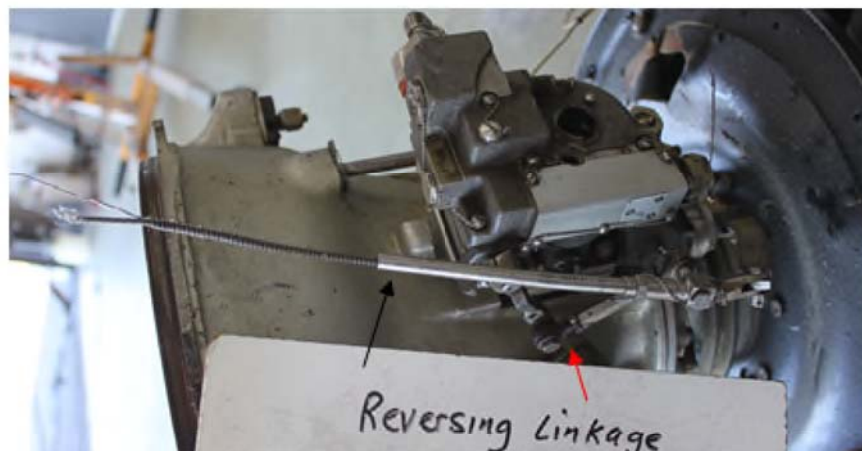
Photo No. 11  
Reversing linkage

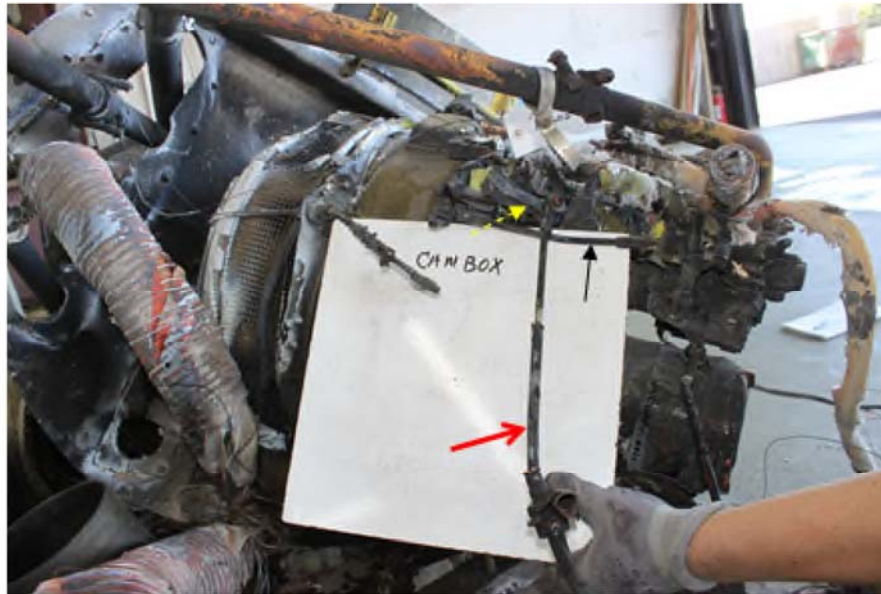
Photo No. 13

CAM input lever and airframe power lever cable

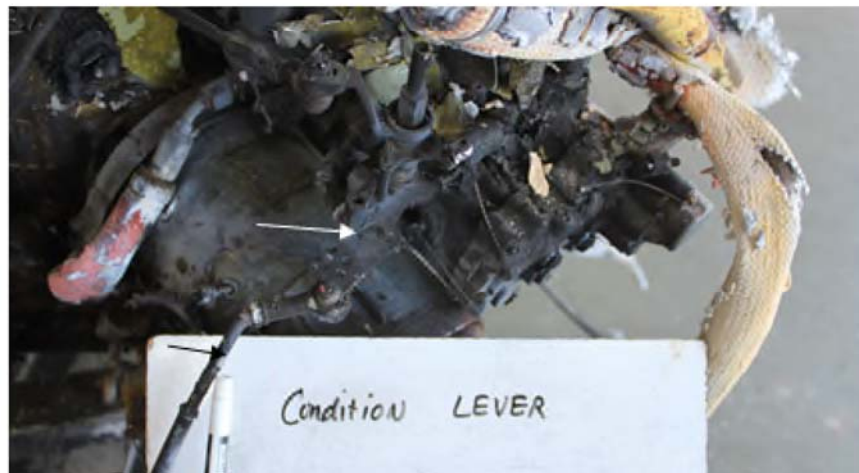
Photo No. 14

Condition lever and aircraft cable

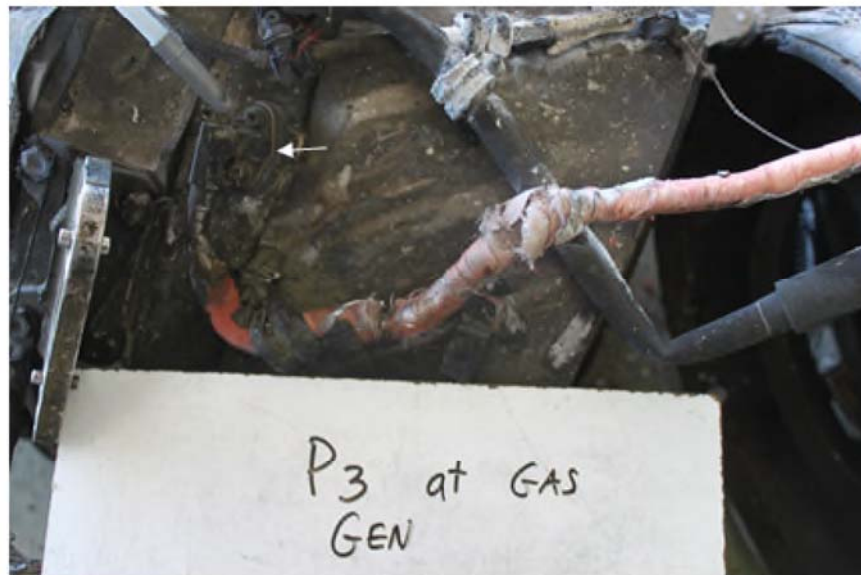
Photo No. 15

**Compressor Discharge Air (P3):** The tube from the gas generator although damaged was in place and the retaining bolts secure (white arrow, Photo No. 15). The P3 line “B” nut at the filter housing inlet, which showed heat exposure and the lock wire fractured due to localized mechanical damage, was found loose (white arrow, Photo No. 16). Applying a black line at the location the of “B” nut as found and applying force in the direction of tightening with a wrench resulted in the rotation of approximately 1 “flat” before the fitting was tight. The P3 line at the outlet of the P3 filter bowl was tight and secure (circled, Photo No. 17). The P3 “B” nut to the P3 elbow fitting was tight and secure (white circle, Photo No. 18). The P3 elbow fitting nut to the fuel control adapter manifold which showed heat exposure was lock wired but found loose (circled, Photo No. 19). Applying a black line to the fitting nut as found and applying force in the direction of tightening with a wrench resulted in the rotation of approximately 1/2 “flat” before the fitting was tight. The P3 filter housing (black arrow, Photo No. 17) which had been heat exposed, was found lockwired and loose. The P3 filter exhibited some heat discoloration and staining from exposure to the post flight fire (Photo No. 20). A small region of the inner filter element that had not been heat affected appeared clean (red circle, Photo No. 20).

P3 at gas generator case

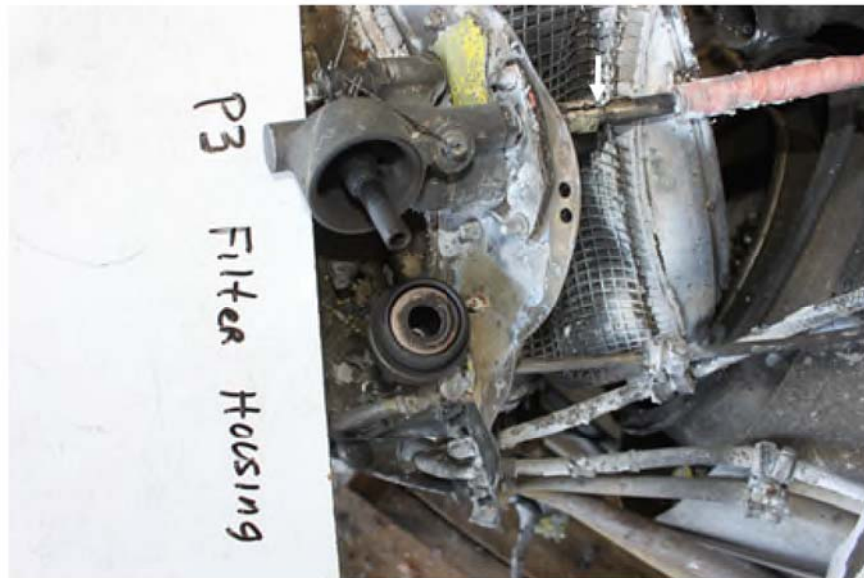
Photo No. 16  
P3 at filter inlet

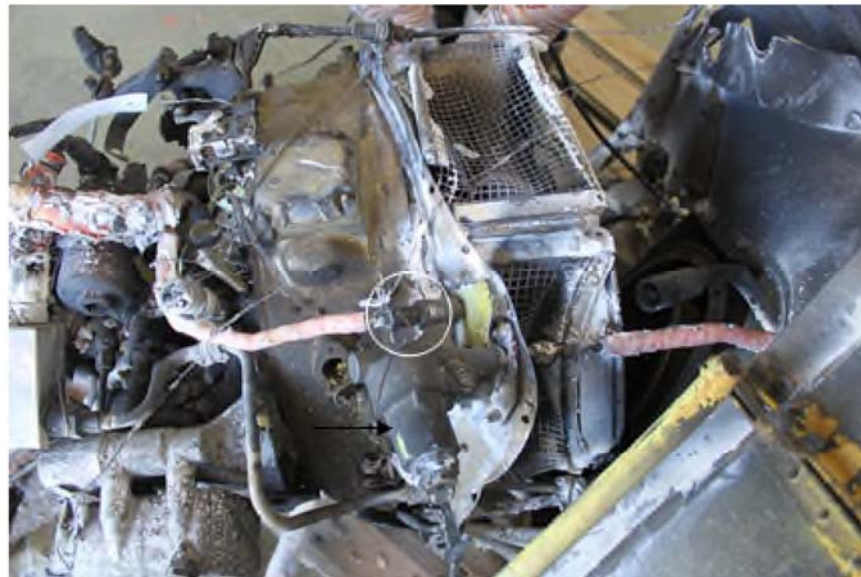
Photo No. 17  
P3 filter bowl

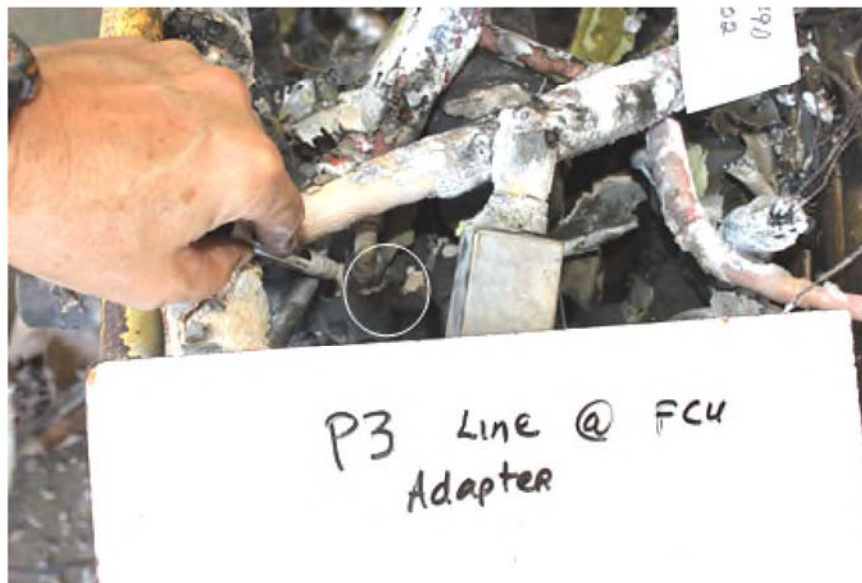
Photo No. 19

P3 retaining nut at fuel control adapter manifold

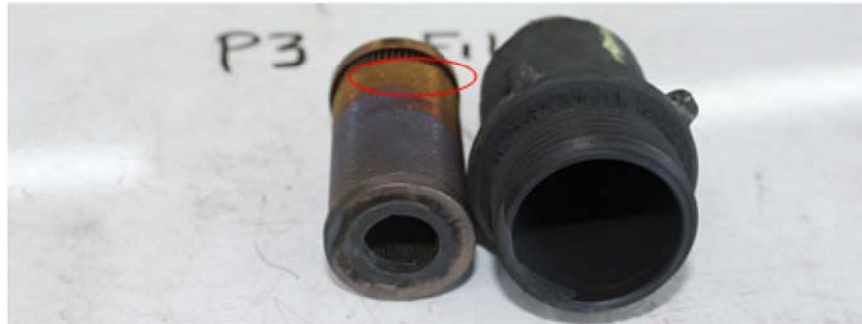
Photo No. 20  
P3 filter and housing

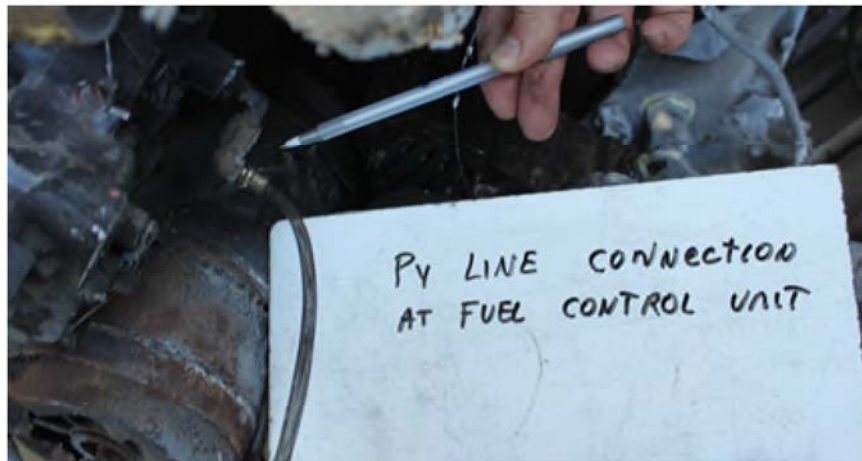
**Power Turbine Control (Py):** The Py line was found connected to the fuel control unit (Photo No. 21). The Py line (arrow, Photo No. 22), which was fractured near the connection at the propeller governor, was found to show damages from heat exposure. The fractured end at the propeller governor was found secure (arrow, Photo No. 23).

Photo No. 21  
Py line at the fuel control unit

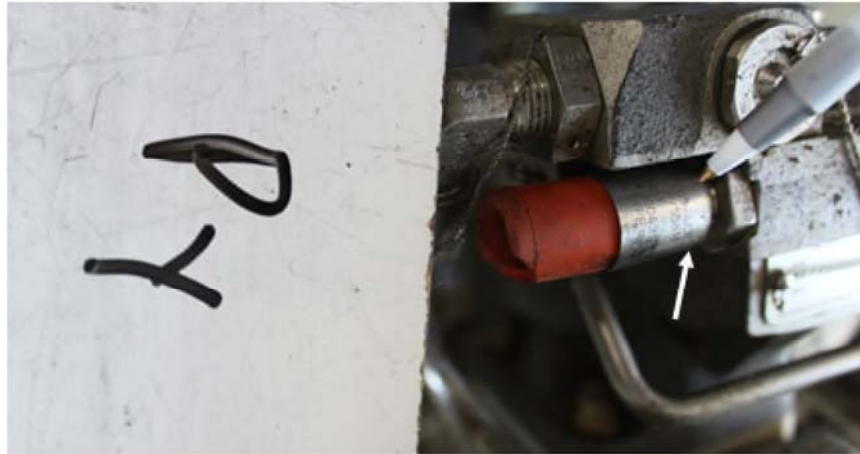
Photo No. 23

Py line at the propeller governor

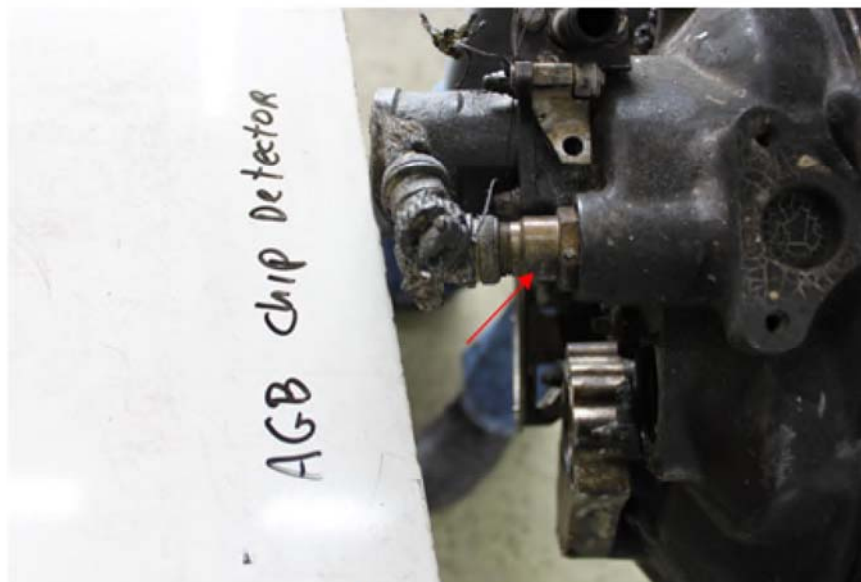
Photo No. 24

**Accessories Gearbox:** The accessories gearbox magnetic chip detector in place was found secure and exhibited impact damages and heat exposure (arrow, Photo No. 24). Removal of the chip detector revealed the magnetic chip detector potting material to have deteriorated due to heat exposure freeing the two metal poles from the body of the detector (Photo No. 25).

Accessories gearbox magnetic chip detector in place

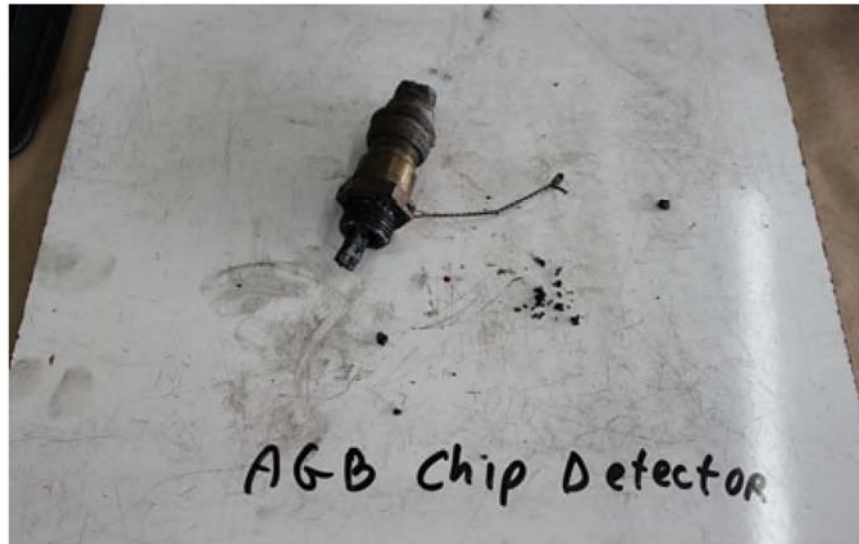
Photo No. 25

Accessories gearbox magnetic chip detector

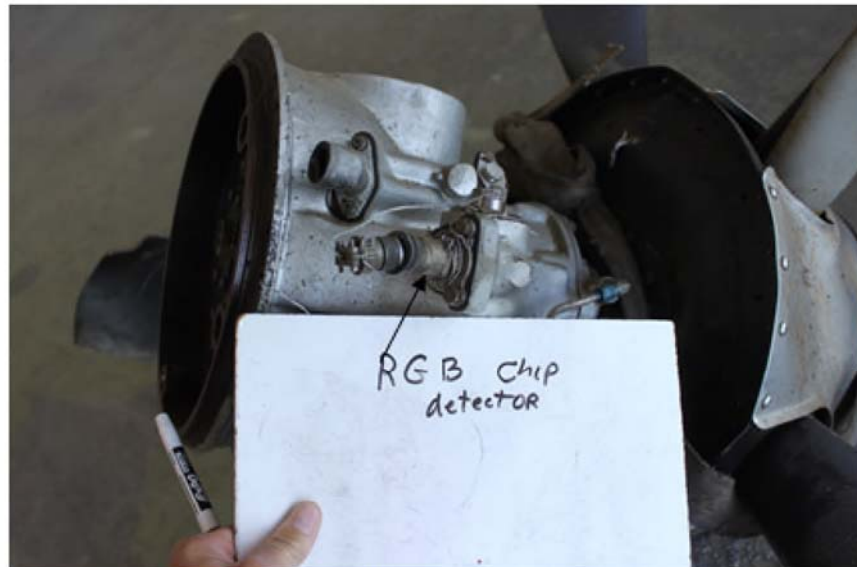
Photo No. 26

**Reduction Gearbox Chip Detector:** The reduction gearbox magnetic chip detector was found in place and secure although the connector showed mechanical damage and the cable was sheared (arrow, Photo No. 26). The magnetic chip detector was clean (Photo No. 27). The scavenge strainer was clean (Photo No. 28).

Reduction gearbox magnetic chip detector in place

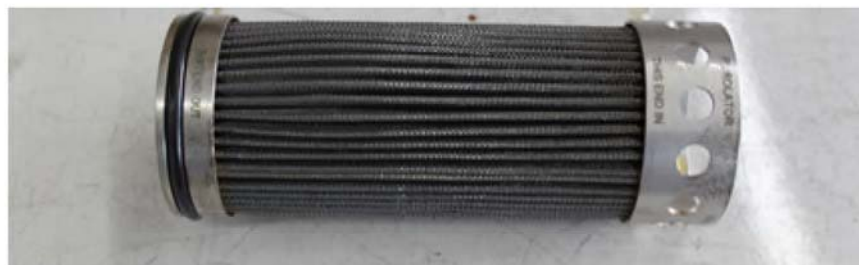
Photo No. 29

**Oil Filter:** The oil filter was removed and found clean with no metal debris contamination (Photo No. 29).

Oil filter

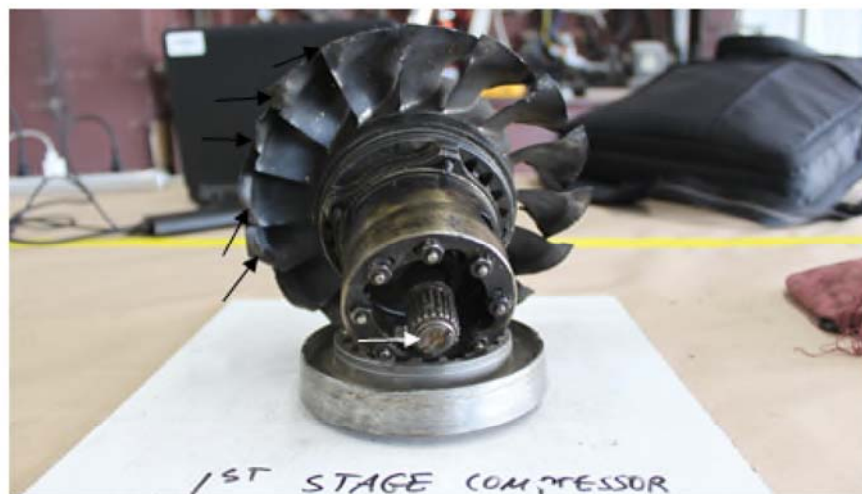
Photo No. 30

**First Stage Compressor Integrally Bladed Rotor:** The first stage compressor integrally bladed rotor was received separated from the engine (Photo No. 30). The blades showed rubbing damages to the blade tips in the opposite direction of rotation (black arrows, Photo No. 30). The trailing edge view of the blades showed circumferentially oriented rubbing and deformation as well as hard debris contact damages (Photo Nos. 31 and 32). Circumferential rubbing contact of the upstream face of the first stage integrally blade rotor was observed (arrow, Photo No. 31). The sheared remnants of two tie-rods were observed within two of the tie-rod holes (arrows, Photo No. 32). A fractured metal alloy debris was found wedged between two of the blades (Photo No. 33). The compressor drive shaft splines showed earth wedged between the teeth and inside the centre of the spring lock (white arrow, Photo No. 30). The spring lock insert was removed and found intact (Photo No. 34).

Leading edge view of first stage integrally bladed rotor, No. 1 bearing housing and compressor drive shaft

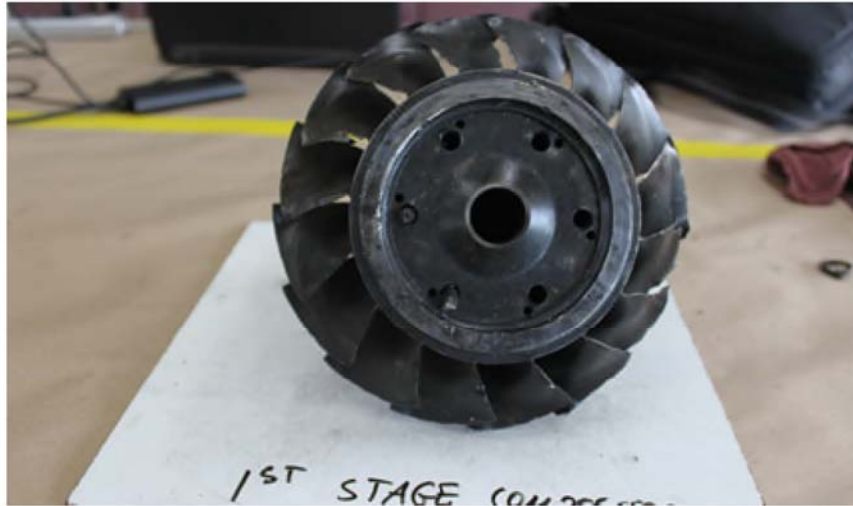
Photo No. 31

First stage compressor integrally bladed rotor downstream view

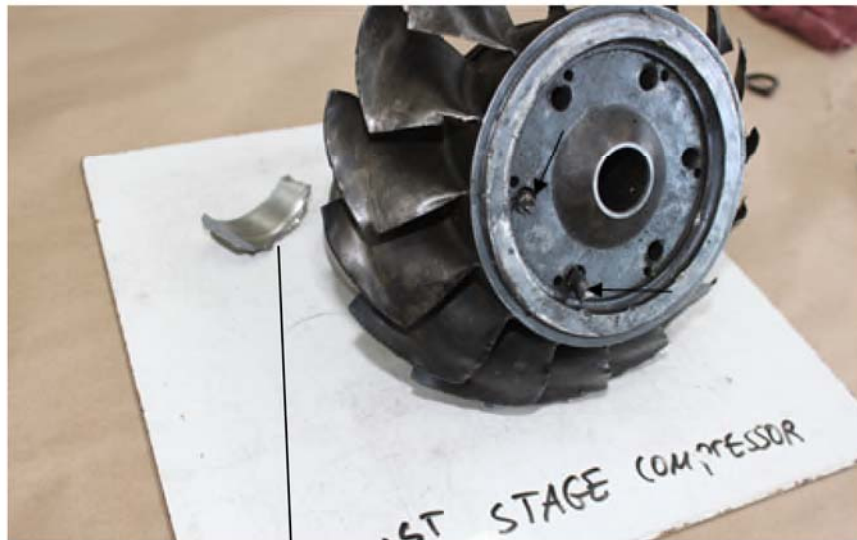
Photo No. 32

First stage compressor integrally bladed rotor sheared tie shaft bolts

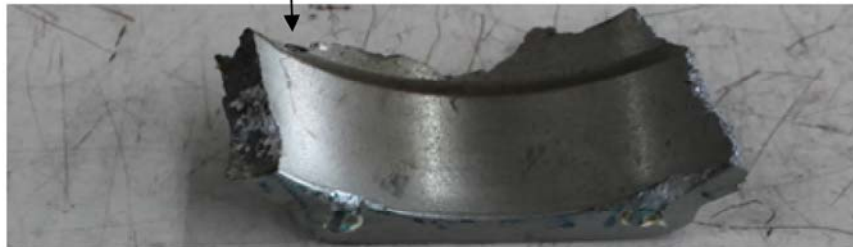
Photo No. 33

Fractured light metal debris found lodged in between two first stage integrally bladed rotor blades

**Overspeed Governor:** The overspeed governor was fractured (Photo No. 77). Upon removal of the overspeed governor the front reduction gearbox could be rotated. It was also observed that the debris (Photo No. 33) removed from between two blades on the first stage integrally bladed rotor was matched to be a fractured fragments from the overspeed governor (arrow, Photo No. 77).

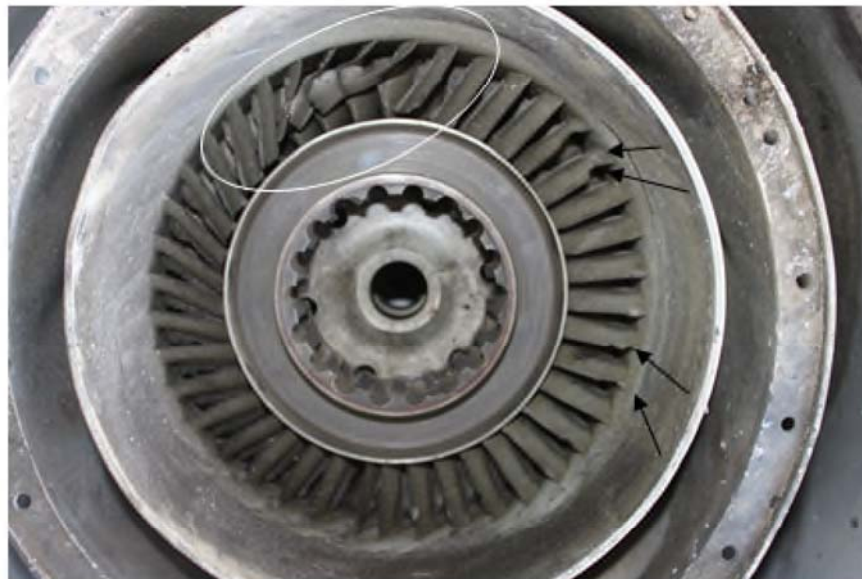
Photo No. 35  
First stage stator and shroud

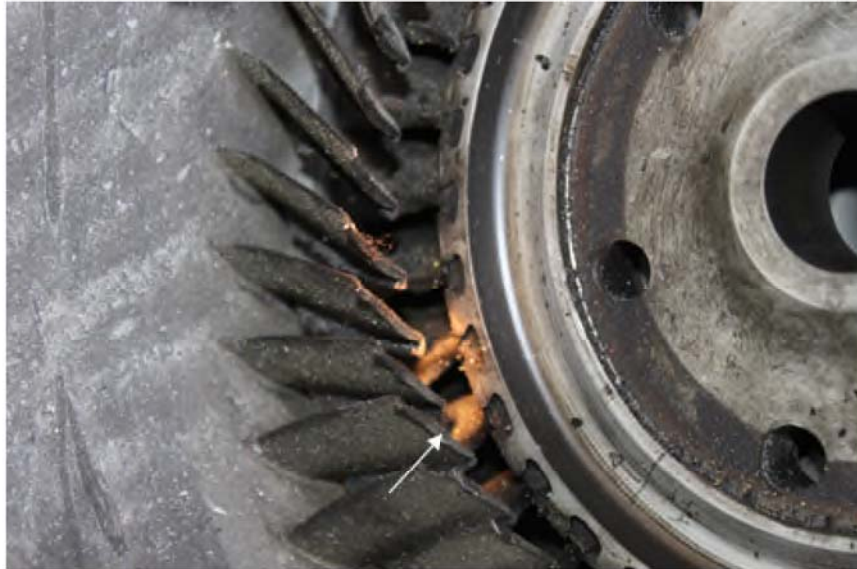
Photo No. 36

First stage stator airfoils showing rubbing contact at the tips and trailing edge

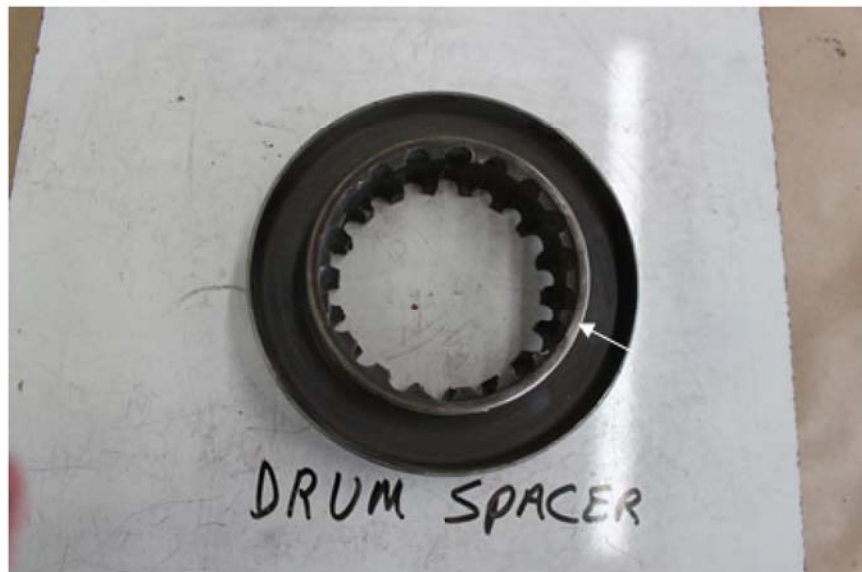
Photo No. 37

**First Stage Compressor Drum Spacer:** The first stage compressor drum spacer exhibited circumferential rubbing wear from contact with the first stage integrally bladed rotor (white arrow, Photo No. 37). The spacer outer diameter surface also exhibited circumferential rubbing marks from contact with the stator airfoil tips (Photo No. 38).

First stage compressor drum spacer

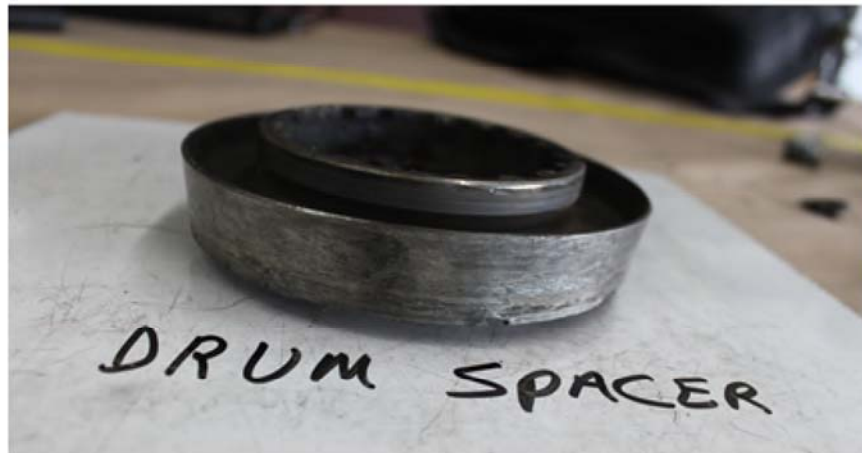
Photo No. 38

First stage compressor drum spacer outer diameter surface

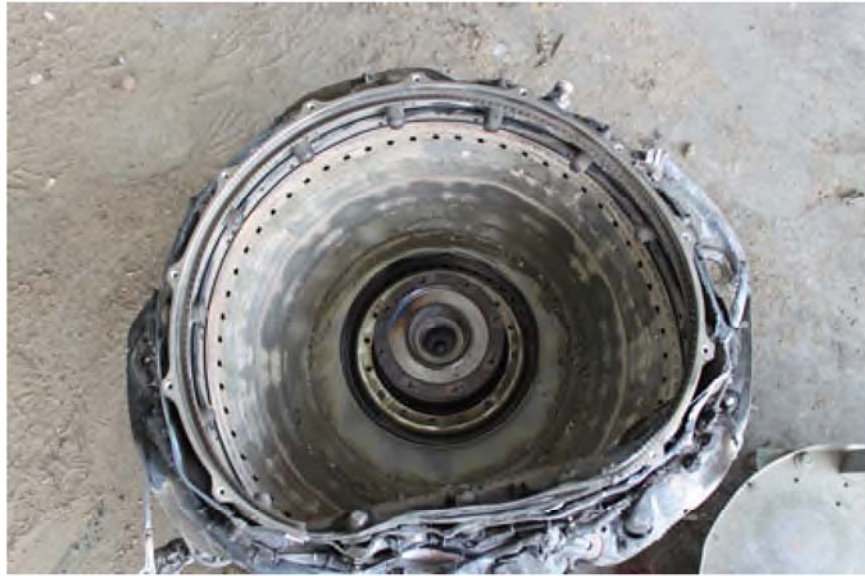
Photo No. 39

**Combustion Chamber Liner:** The combustion outer liner could not be removed due to impact damages to the gas generator case resulting in the mechanical deformation of the liner as well as some damages from the disassembly of the inner combustion liner and turbine support housing (Photo No. 39). The outer combustion liner chamber which exhibited normal in-service wear showed no distress prior to the impact. Some material consistent in appearance to ground was observed inside the combustion liner (Photo No. 39). The inner liner which showed some disassembly damages was removed with the entrapped turbine support housing due to impact damages. The outer surface of the liner which exhibited normal in-service wear showed no distress prior to the impact (Photo No. 40).

Outer combustion liner and fuel nozzles

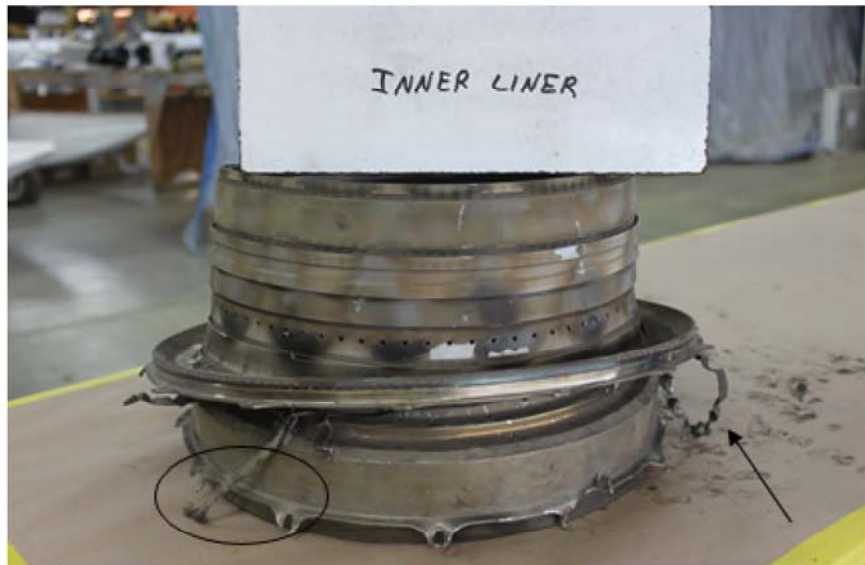
Photo No. 40

Inner combustion liner

**ITT Probes, Busbar, and Harness:** The inter turbine temperature probes were damaged due to the deformation of the power turbine stator (Photo No. 52). The harness cable towards the trim junction block was sheared (circled, Photo No. 40). The temperature probes harness showed mechanical damages from impact deformation and from the disassembly (arrow, Photo No. 40).

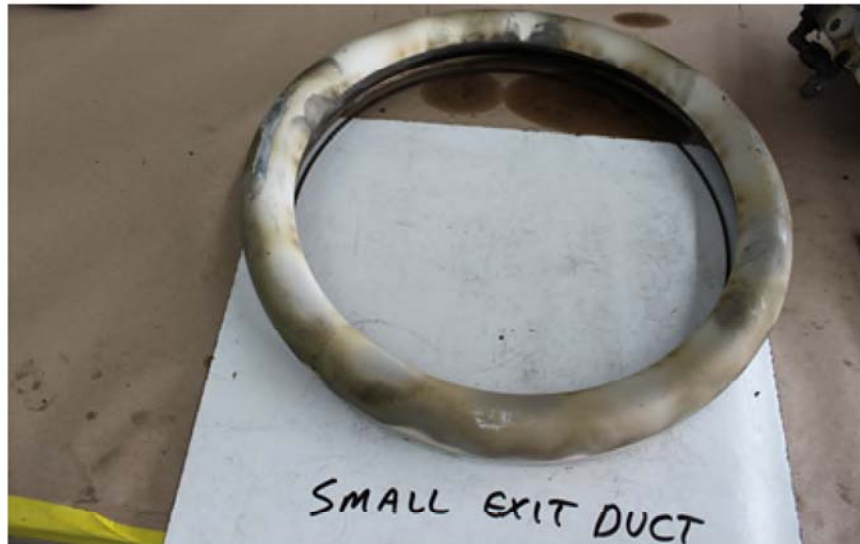
**Small Exit Duct:** The small exit duct showed only some damages to the plasma coating due to disassembly but otherwise exhibited no distress (Photo No. 41)

Photo No. 41  
Small exit duct

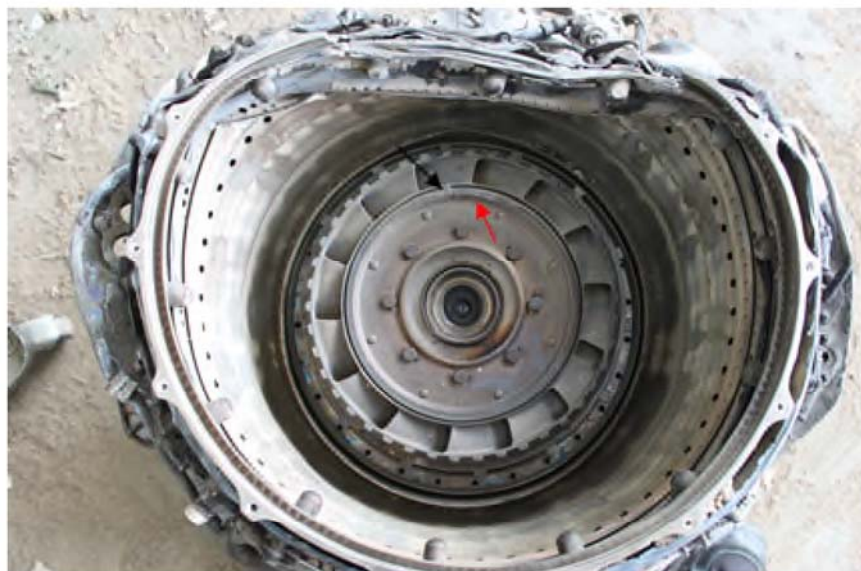
**Compressor Turbine Vane Ring:** The compressor turbine vane ring downstream showed no prior distress (Photo No. 42). The inner wall showed circumferential rubbing with some material loss (arrow, Photo Nos. 42 and 43). The upstream side showed no distress or evidence of any foreign object damage (Photo No. 44). The inner baffle plate showed some circumferential rubbing at the surface adjacent the stator inner wall (red arrow, Photo No. 42).

Photo No. 42  
Downstream view of compressor turbine stator and fuel nozzles

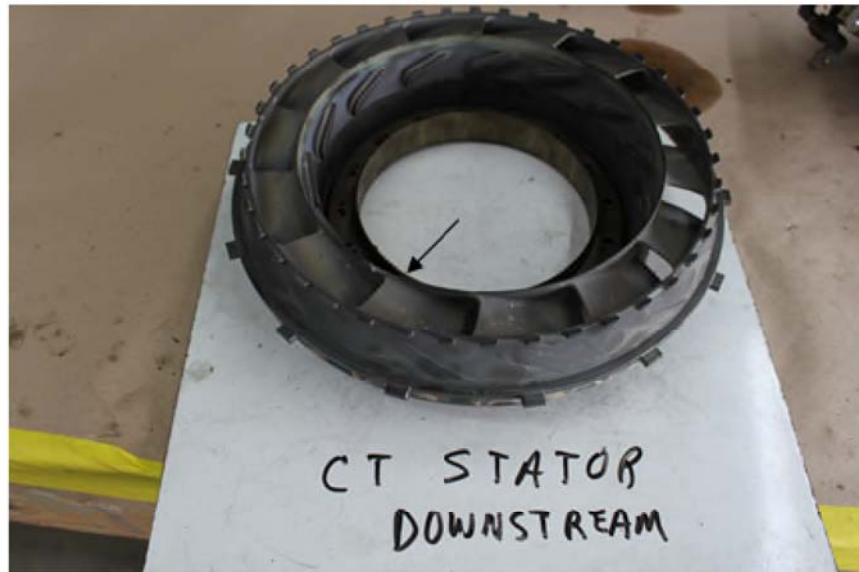
Photo No. 43

Compressor turbine stator removed

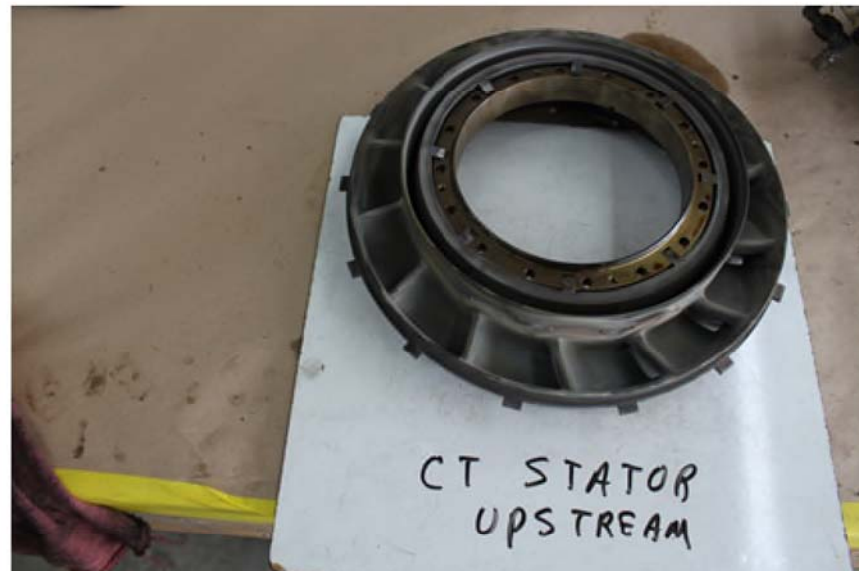
Photo No. 44

Compressor turbine stator upstream view

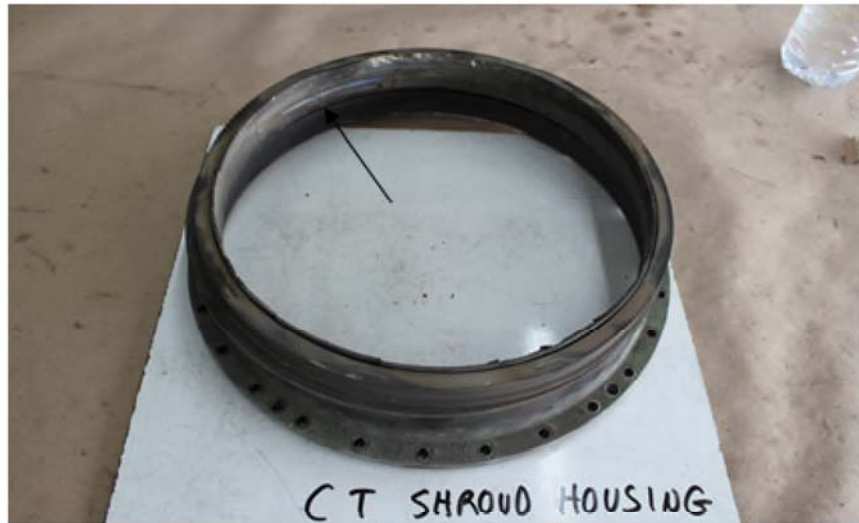
Photo No. 45

**Compressor Turbine Shroud:** The compressor turbine shroud segments showed rubbing wear, heat discoloration and material transfer from contact with the compressor turbine blades (arrow, Photo Nos. 45 and 46).

Compressor turbine shroud segments housing

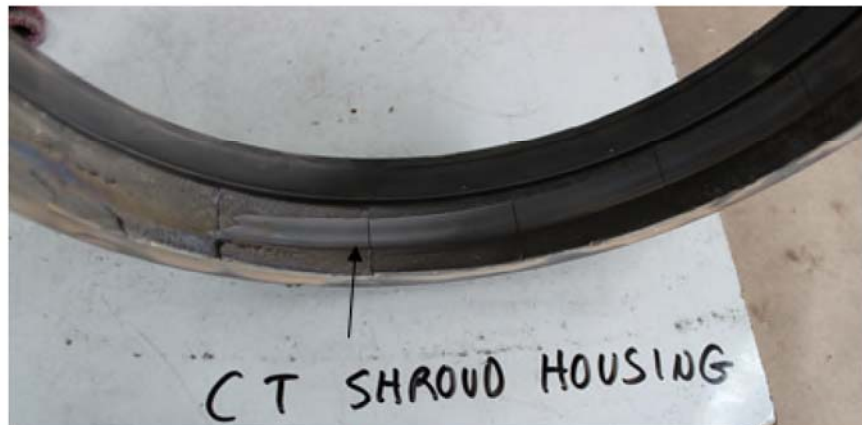
Photo No. 46

Compressor turbine shroud segments

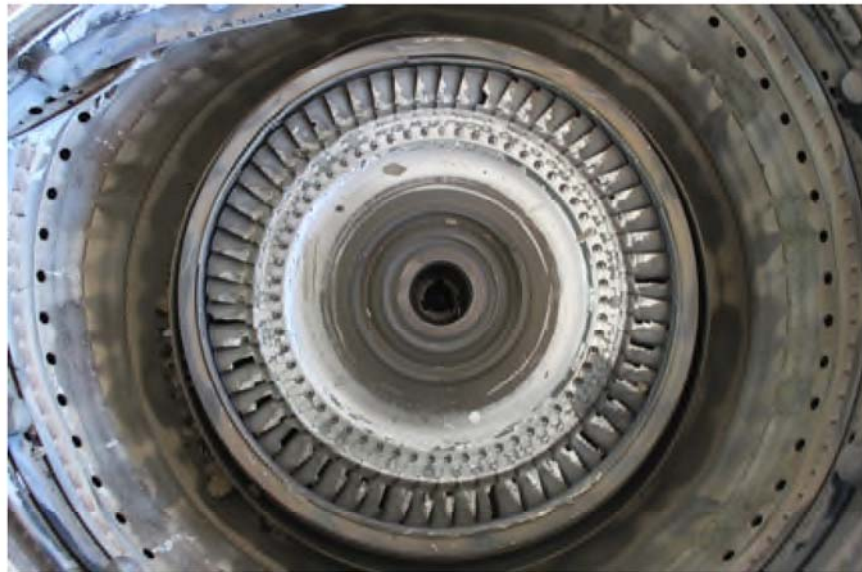
**Compressor Turbine:** The compressor turbine trailing edge view showed circumferential rubbing, scoring and wear on the trailing edge disc face, firtree region, blade platforms and airfoils (Photo No. 47). Circumferential rubbing marks were also observed at the disc inner diameter surface adjacent the retention bolt bore (arrow, Photo No. 48). The trailing edge wear on the airfoils also resulted in material removal, deformation, and cracking and /or fracture of sections of some airfoils (Photo Nos. 49 and 50). The blade tips showed rubbing wear and heat discoloration from contact with the compressor turbine shroud segments (arrow, Photo No. 50). The leading edge view of the compressor turbine disc showed rubbing contact with the inner wall of the compressor turbine stator at the leading edge blade platforms and the adjacent disc firtree region (arrow, Photo No. 51).

Photo No. 47  
Compressor turbine in-situ

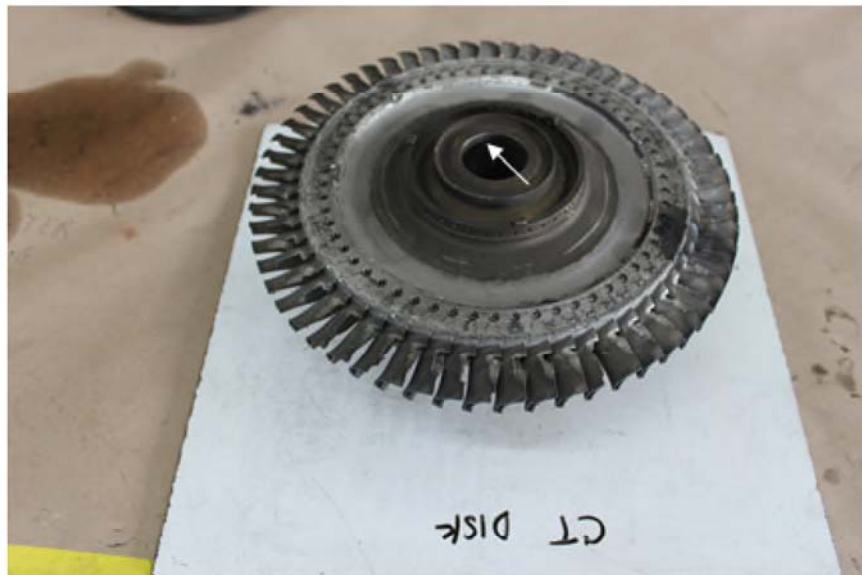
Photo No. 48  
Compressor turbine disc inner diameter surface adjacent the retention bolt bore

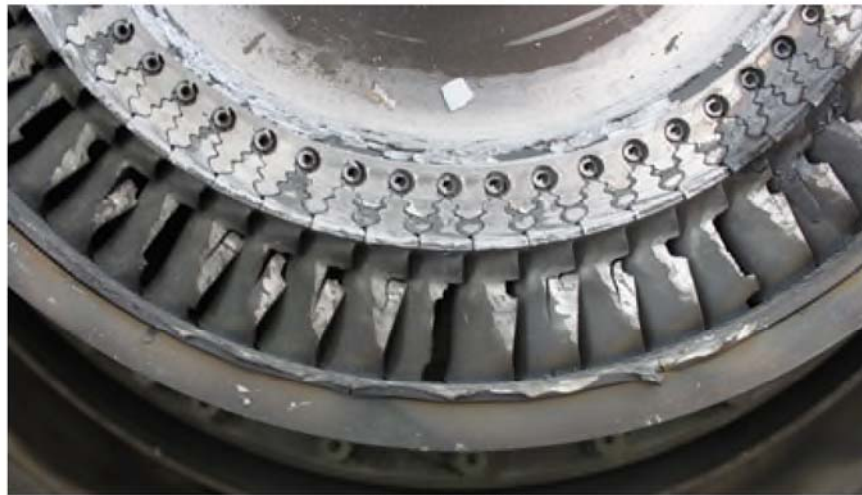
Photo No. 49

Closer view of compressor turbine blades damages
