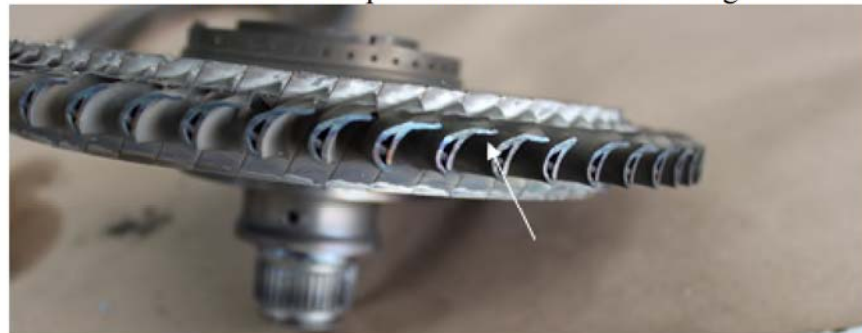
Photo No. 50

**Compressor Turbine:** The compressor turbine trailing edge view showed circumferential rubbing, scoring and wear on the trailing edge disc face, firtree region, blade platforms and airfoils (Photo No. 47). Circumferential rubbing marks were also observed at the disc inner diameter surface adjacent the retention bolt bore (arrow, Photo No. 48). The trailing edge wear on the airfoils also resulted in material removal, deformation, and cracking and /or fracture of sections of some airfoils (Photo Nos. 49 and 50). The blade tips showed rubbing wear and heat discoloration from contact with the compressor turbine shroud segments (arrow, Photo No. 50). The leading edge view of the compressor turbine disc showed rubbing contact with the inner wall of the compressor turbine stator at the leading edge blade platforms and the adjacent disc firtree region (arrow, Photo No. 51).

View of compressor turbine blade tips

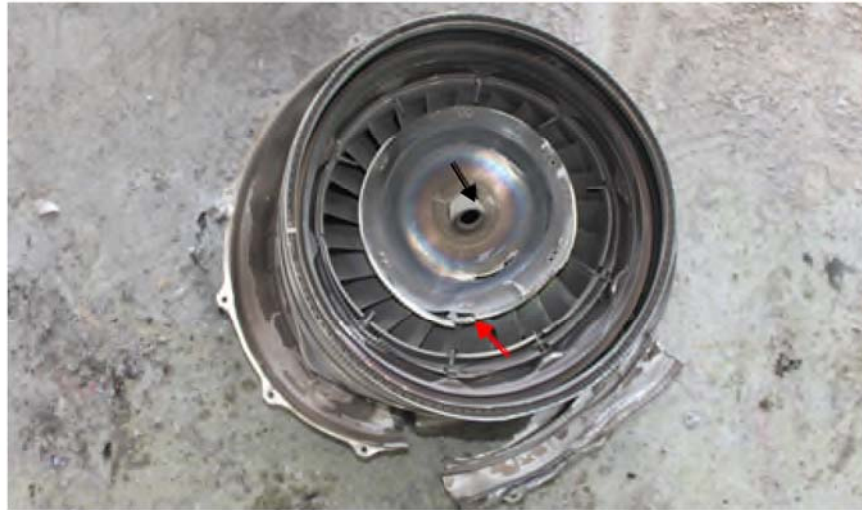
Photo No. 52

**ITT Probes, Busbar, and Harness:** The inter turbine temperature probes were damaged due to the deformation of the power turbine stator (Photo No. 52). The harness cable towards the trim junction block was sheared (circled, Photo No. 40). The temperature probes harness showed mechanical damages from impact deformation and from the disassembly (arrow, Photo No. 40).

Power turbine housing, inter turbine temperature probes and upstream view of first stage power turbine stator

**Power Turbine Housing:** The power turbine housing was deformed and entrapped within the gas generator case (Photo No 3). The housing was also surrounded by hard packed earth and the first stage stator was also entrapped within the power turbine housing (Photo No. 3). The power turbine housing had to be cut free from the gas generator case (Photo Nos. 52 and 53).

**First Stage Power Turbine Vane Ring:** The leading edge of the first stage vane ring airfoils showed no prior distress or any impact damages (Photo No. 52). The power turbine stator baffle showed circumferential rubbing marks, and the centre “button” was deformed and rubbed from contact with the compressor turbine inner diameter adjacent the retaining bolt bore (black arrow, Photo No. 52). The power turbine stator upstream inner wall was fractured through and showed circumferential rubbing wear from contact with the compressor turbine disc (red arrow, Photo No. 52). The downstream view of the power turbine stator shows an approximately 90° arc of circumferential rubbing on the inner and outer wall of the stator (white arrows, Photo No. 53). Within this arc the stator air foils show rubbing and loss of material in the direction of rotation (circled, Photo No. 53). Note that these damages correspond to the region of mechanical deformation not caused by disassembly on the turbine support housing (black arrow, Photo No. 53).

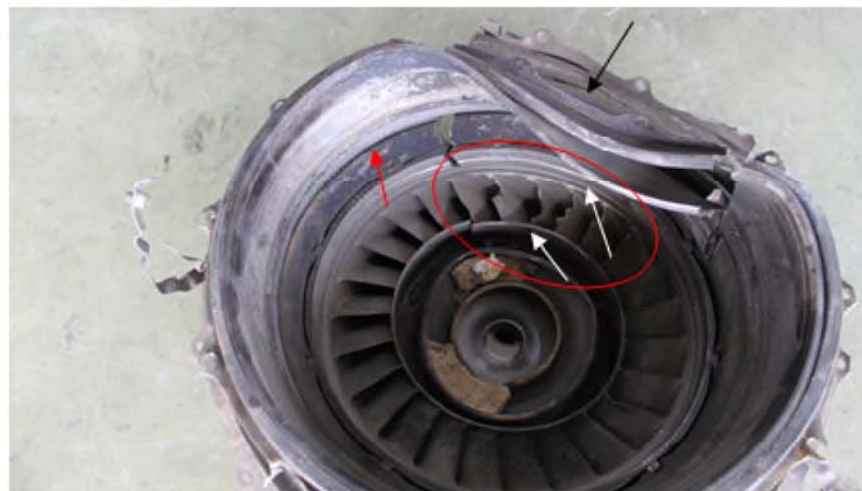
Downstream view of first stage power turbine stator

**Second Stage Power Turbine Shroud:** The second stage power turbine shroud which was deformed and cut during removal of the power turbine shroud housing showed circumferential rubbing contact with the second stage power turbine blades (red arrow, Photo No. 53 and black arrows, Photo No. 60).

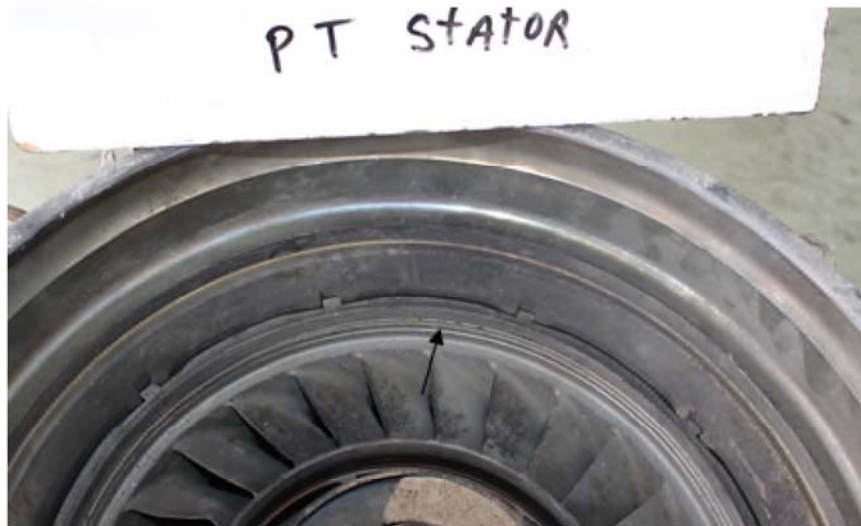
Photo No. 54

**First Stage Power Turbine Shroud:** The first stage power turbine shroud shows circumferential wear from contact with the first stage power turbine shroud tips (arrow, Photo No. 54).

First Stage Power Turbine Shroud

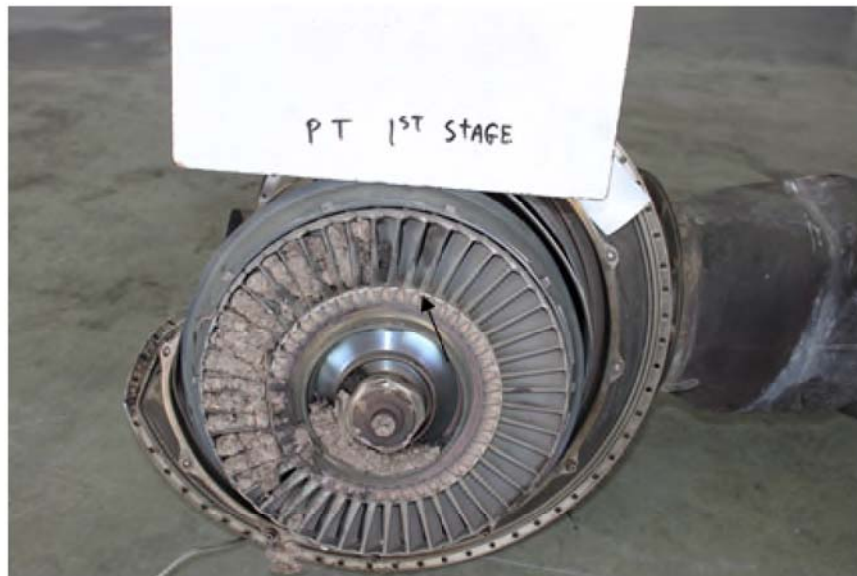
**First Stage Power Turbine:** The power turbine assembly retaining nut showed some mechanical damage, however it was found secure (Photo Nos. 6 and 55). The first stage power turbine blades were partially packed with earth (Photo No. 6). All the power turbine blades were observed displaced slightly rearwards (Photo No. 55 and red arrow, Photo No. 56). Circumferential shroud tip rubbing with occasional fracture / loss of material was observed on first stage power turbine blades (black arrow, Photo No. 56 and red circle Photo No. 57). Circumferential rubbing contact was observed in the blades firtree at the platform region from contact with the downstream inner wall of the power turbine stator (arrow, Photo No. 55).

Photo No. 55  
First stage power turbine

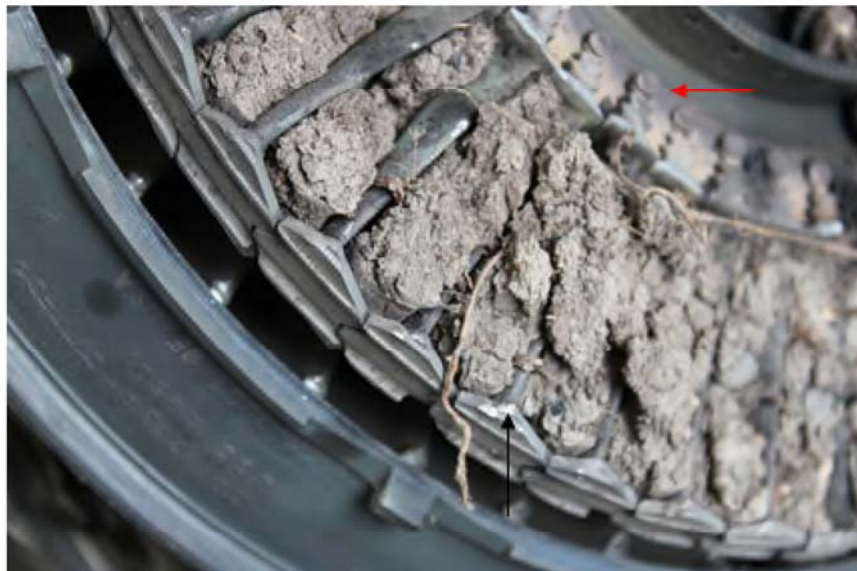
Photo No. 56  
Closer view showing first stage power turbine blades displacement

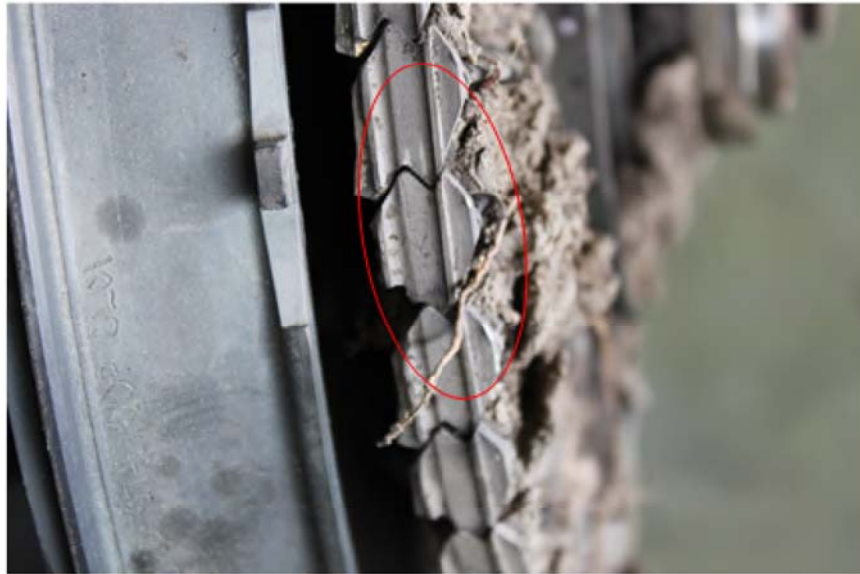
Photo No. 57

First stage power turbine

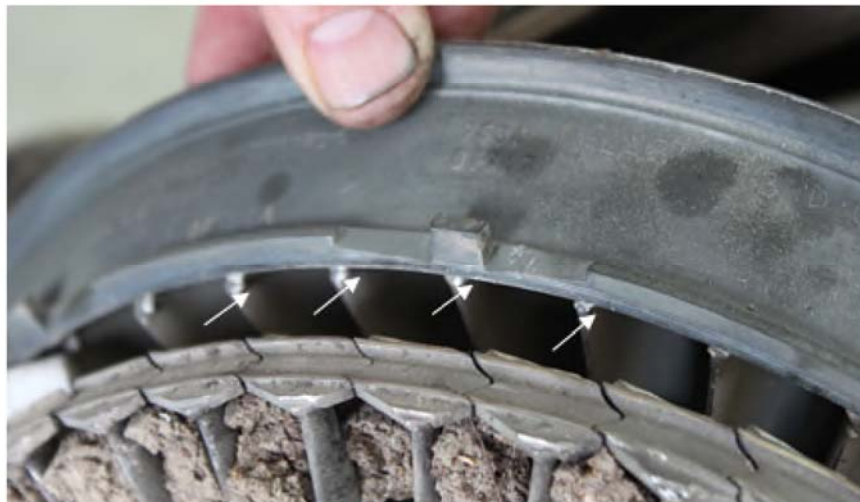
Photo No. 58

**Second Stage Power Turbine Vane Ring:** The second stage power turbine vane ring was not disassembled, however the limited access showed circumferential notch wear into the downstream airfoils near the outer wall from contact with the first stage power turbine shroud tips (white arrows, Photo No. 58). The limited access downstream view showed circumferential rubbing wear and deformation from contact with the fractured second stage power turbine blades (arrow, Photo No. 59).

Partial upstream view of second stage stator vane

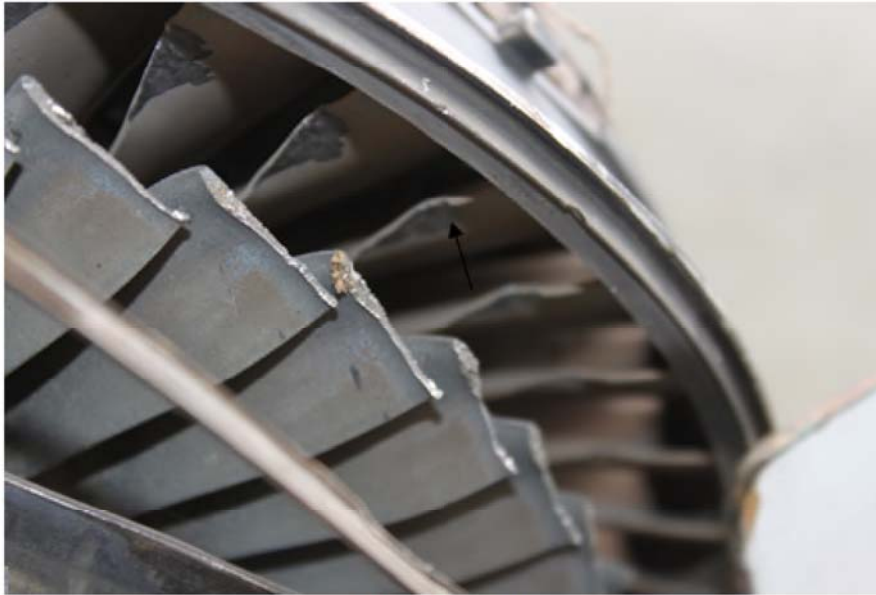
Photo No. 59

Partial downstream view of second stage stator vane

**Second Stage Power Turbine:** Partial view of the second stage power turbine blades revealed all the blades to have fractured uniformly near the shroud tips (Photo No. 59).

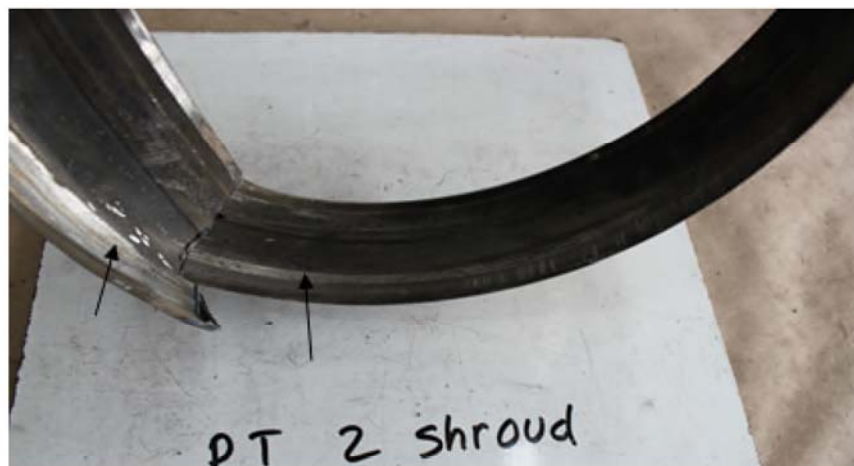
Photo No. 60

Second stage power turbine shroud

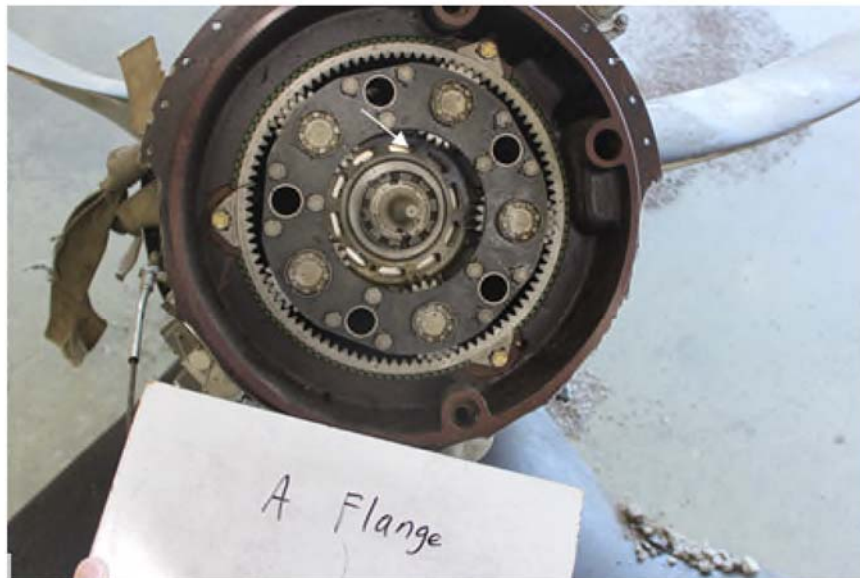
Photo No. 61

The reduction gearbox had fractured at the front housing to rear housing mating flange "A". Although the reduction gearbox was not accessed further for this investigation, the first stage reduction gearbox carrier planet gear assembly, ring gear and second stage sun-gear and coupling showed no distress (Photo No. 5). The second stage reduction gearbox carrier showed a barely perceptible deformation of the carrier lighting slots (arrow, Photo No. 61). The second stage carrier planet gear assembly and ring gear showed no distress (Photo No. 61)

Second stage reduction gearbox carrier assembly

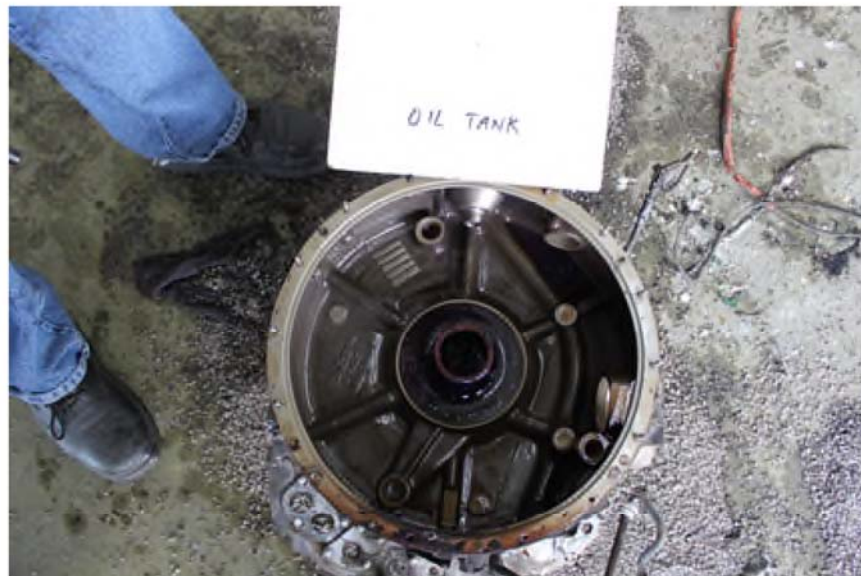
3.2.5 **Accessory Gearbox:** The accessories gearbox was removed from the main oil tank with no contaminants observed in the main oil tank (Photo No. 62). Rotation of the accessories gearbox input drive shaft showed mechanical continuity of the accessories gear-train. The accessories rear housing was separated from diaphragm with no distress observed to the accessories gearshafts (Photo No. 63) or accessories bearings in the rear housing and diaphragm (Photo Nos. 64 and 65 respectively).

Photo No. 62  
Accessories gearbox main oil tank

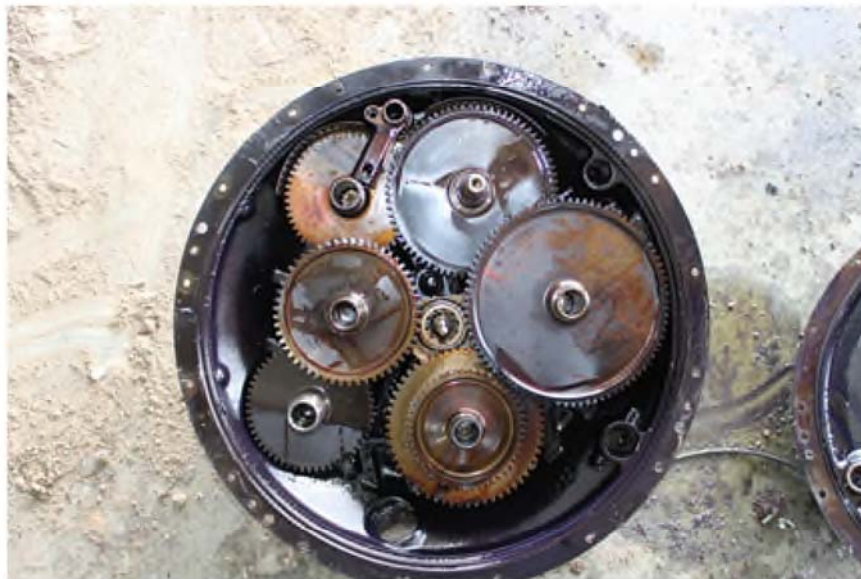
Photo No. 63  
Accessories gearbox gear train

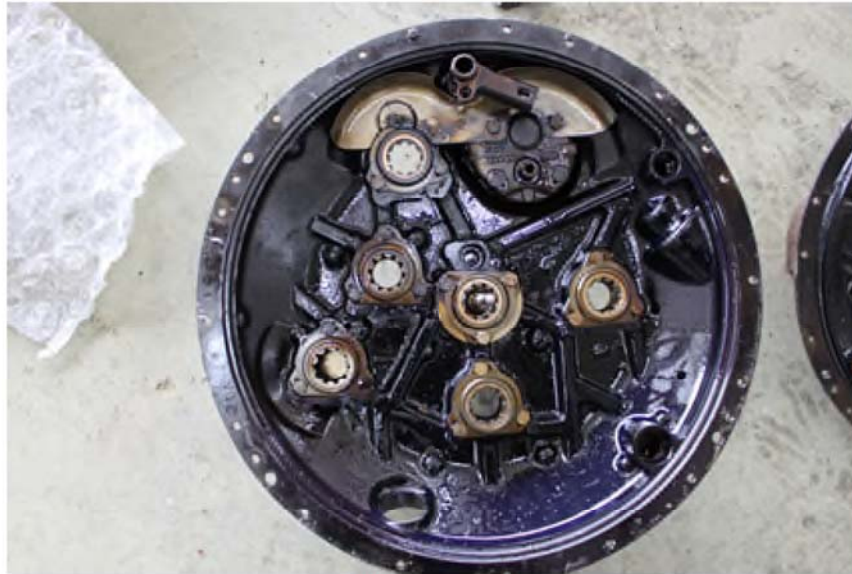
Photo No. 64

Accessories gearbox rear cover bearings

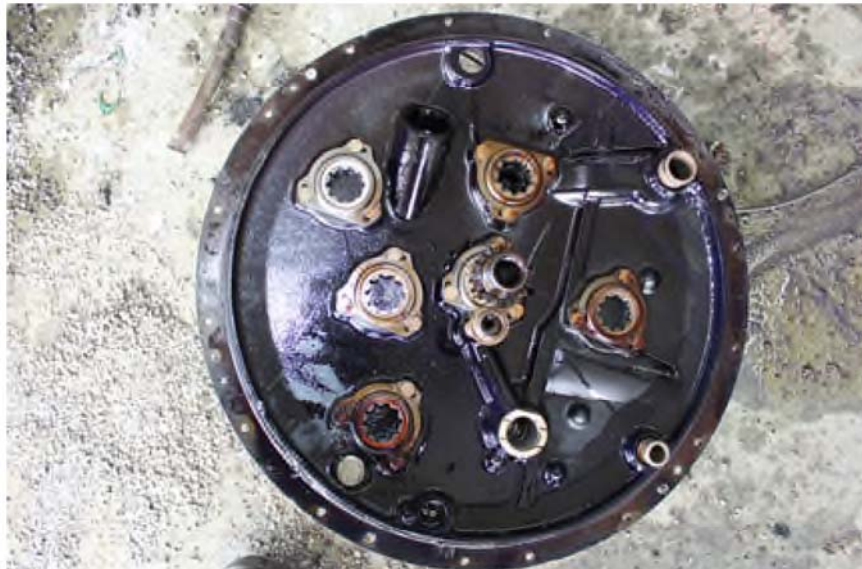
Photo No. 65

Accessories gearbox diaphragm bearings

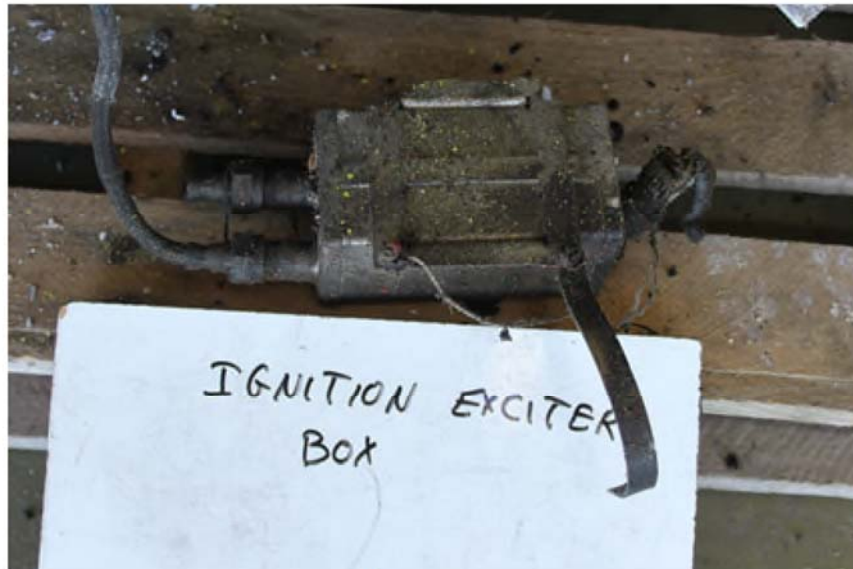
**Exciter Box:** The exciter box which showed heat exposure and mechanical damages was only attached by one ignitor lead (Photo No. 66).

Photo No. 66  
Ignition exciter box

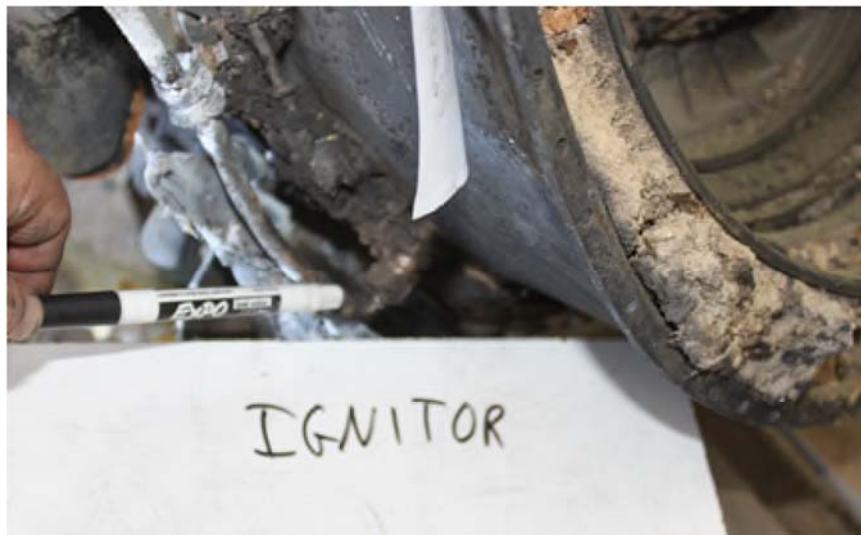
**Ignition Leads:** The ignition leads showed heat exposure and mechanical damages with one ignition lead sheared at the ignitor box connector. The connections at the ignitor ends were connected (Photo Nos. 67 and 68).

Photo No. 67  
One of the ignitor leads at the gas generator case

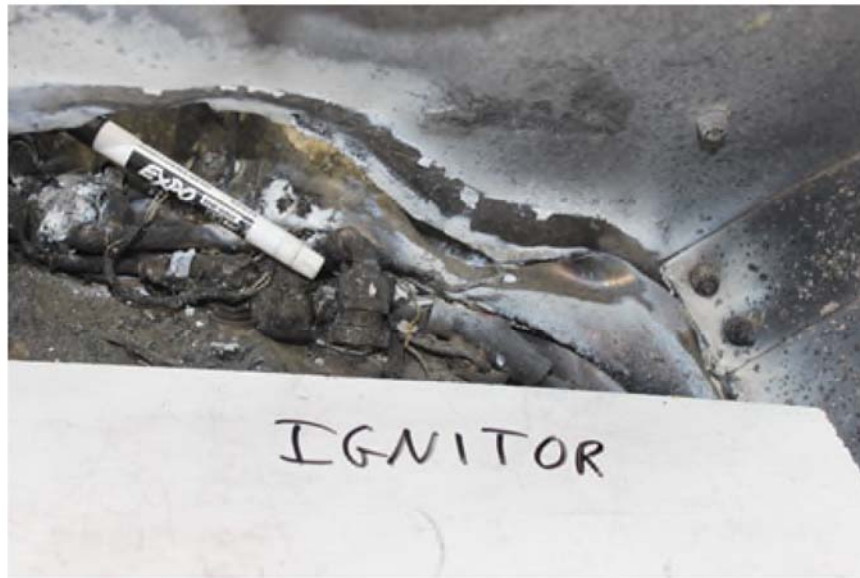
Photo No. 68

The other ignitor lead at the gas generator case

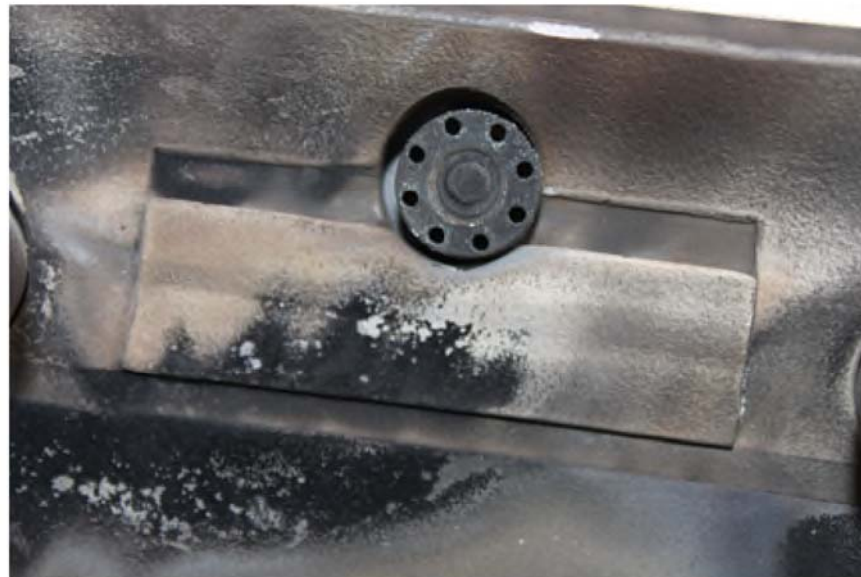
Photo No. 69

**Ignition Plugs:** One plug was in place, secure and intact, however it could not be removed, the other plug was also in place but showed mechanical damage from impact (Photo Nos. 69 and 70 respectively).

Intact ignitor plug

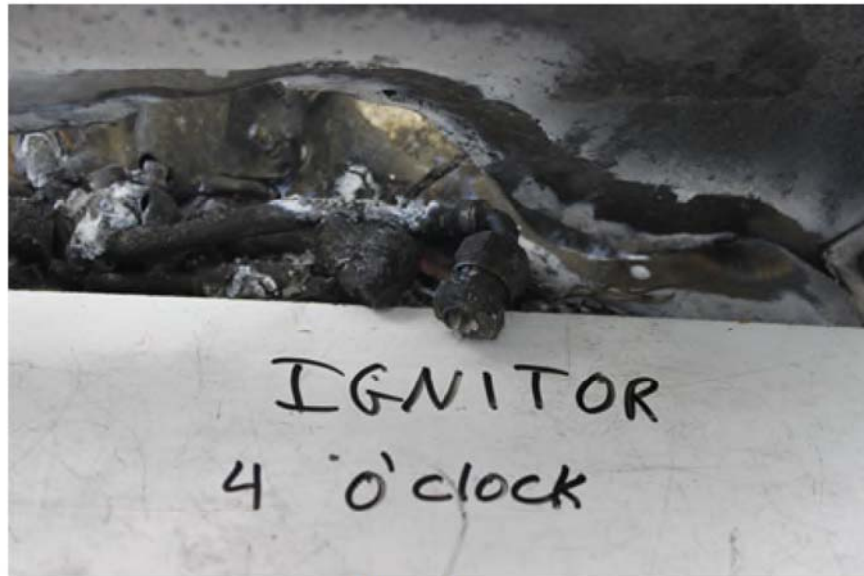
Photo No. 70

Fractured ignitor with lead still attached.

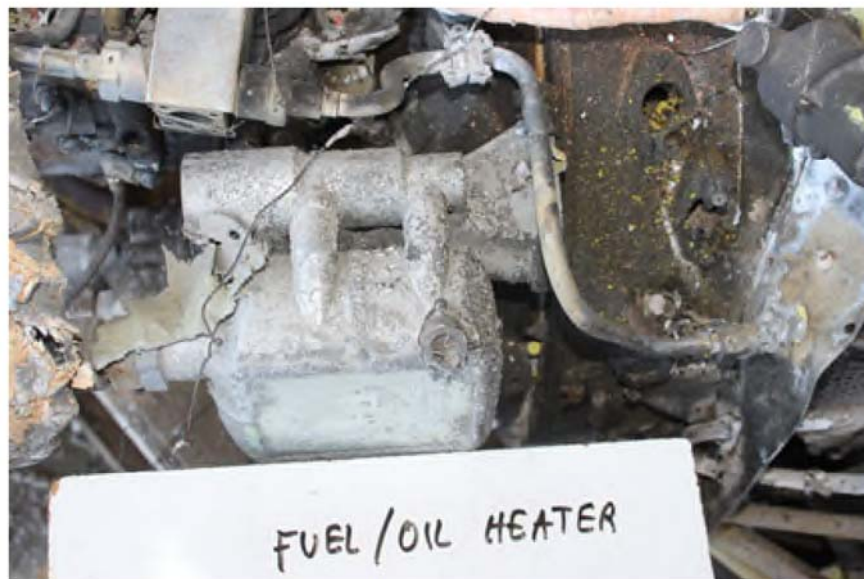
Photo No. 71

**Fuel Heater:** The heater was in place and secure. The housing exhibited heat distress from exposure to the post flight fire (Photo No. 71).

Fuel heater

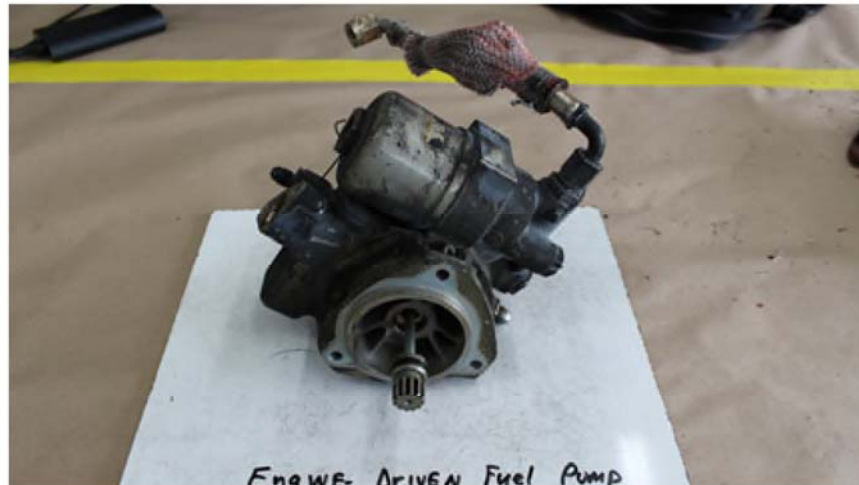
Photo No. 72

**Fuel Pump:** The fuel pump was in place and secure. Some discoloration from heat exposure was observed (Photo No. 72).

Fuel pump

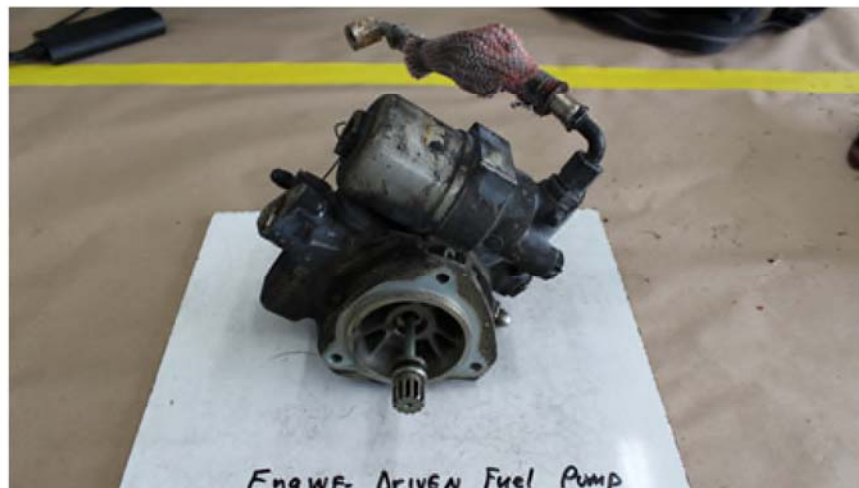
Photo No. 73

**Fuel Control Unit:** The unit which showed heat discoloration was in place and secure. Mechanical damage in the region of the power lever mechanism prevented its movement (Photo No. 73). The fuel pump metal drive splines were intact and could be rotated. The fuel control unit (P/N 3071071-01 S/N 17718651) was submitted by the NTSB to the original equipment manufacturer (OEM) for further analysis (Photo No. 73).

Fuel control unit

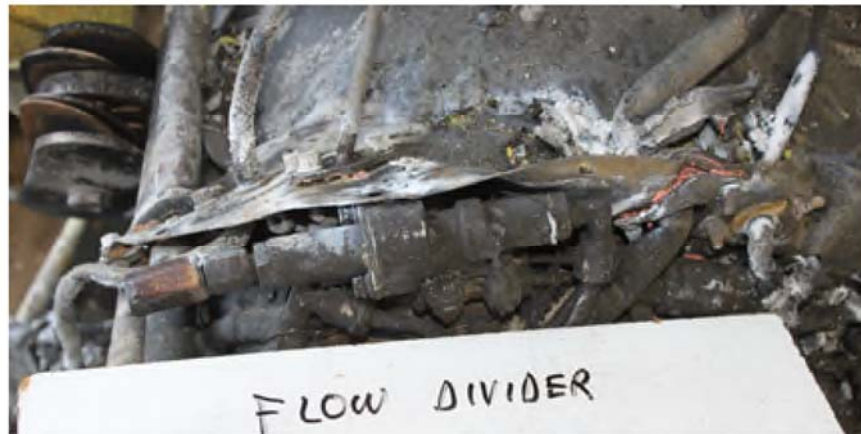
**Flow Divider:** The flow divider was in place but had been impacted. The flow divider showed heat exposure and the fuel line at one end was fractured (Photo No. 74).

Photo No. 74  
Flow divider

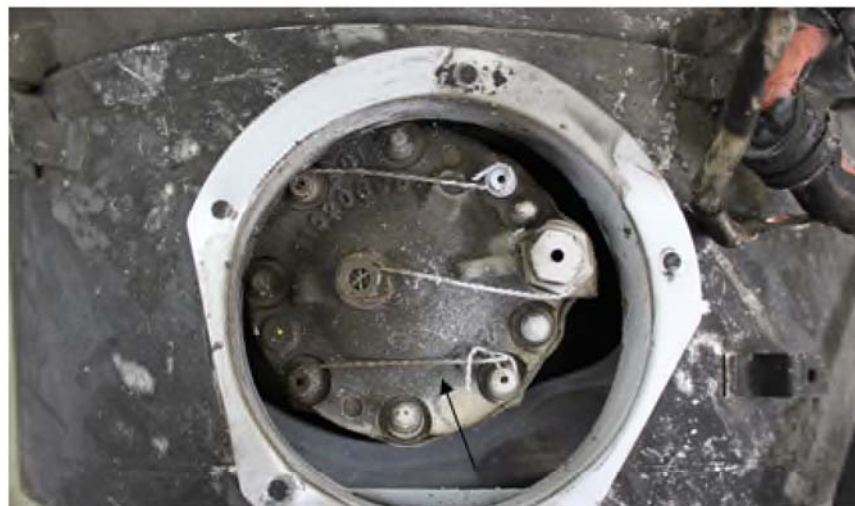
**Compressor Bleed Valve:** The compressor bleed valve was in place and secure (arrow, Photo No. 75). Due to mechanic deformation of the gas generator case it could not be removed.

Photo No. 75  
Bleed off valve

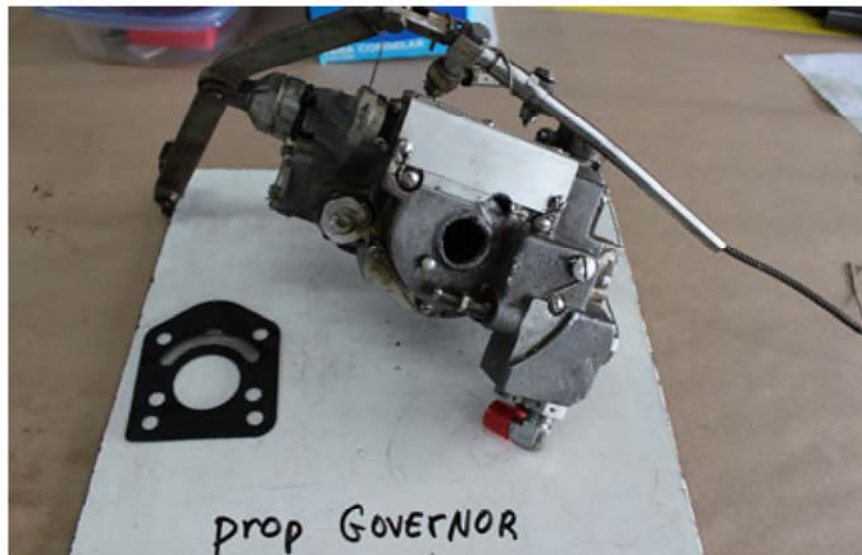
**Propeller Governor:** The propeller governor P/N 3075321-01 (supplier P/N 66503-8210-311), S/N 17844063) showed mechanical damages and was in place and secure. The Beta valve was found free to move. The propeller governor was submitted by the NTSB to the OEM for further analysis (Photo No. 76).

Photo No. 76  
Propeller governor

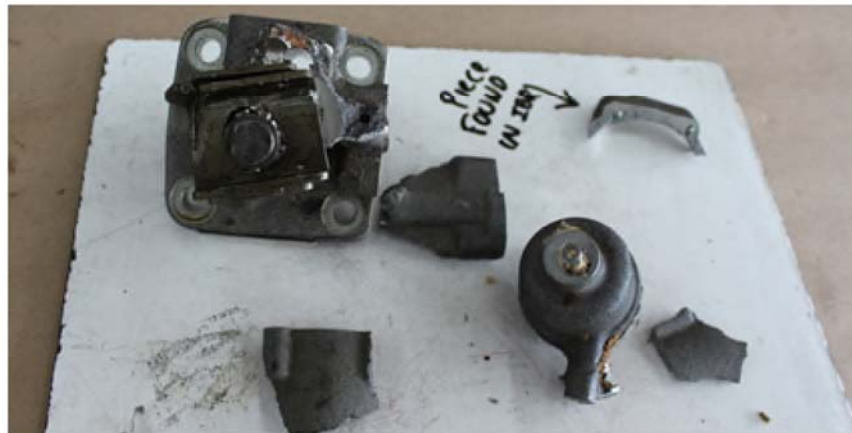
**Overspeed Governor:** The overspeed governor was fractured (Photo No. 77). Upon removal of the overspeed governor the front reduction gearbox could be rotated. It was also observed that the debris (Photo No. 33) removed from between two blades on the first stage integrally bladed rotor was matched to be a fractured fragments from the overspeed governor (arrow, Photo No. 77).

Photo No. 77  
Overspeed governor
