**Date of Accident:** March 19, 2017

**NTSB File No.:** ERA17FA131

**Aircraft:** Air Tractor AT-602

**PROPELLER TEARDOWN REPORT**

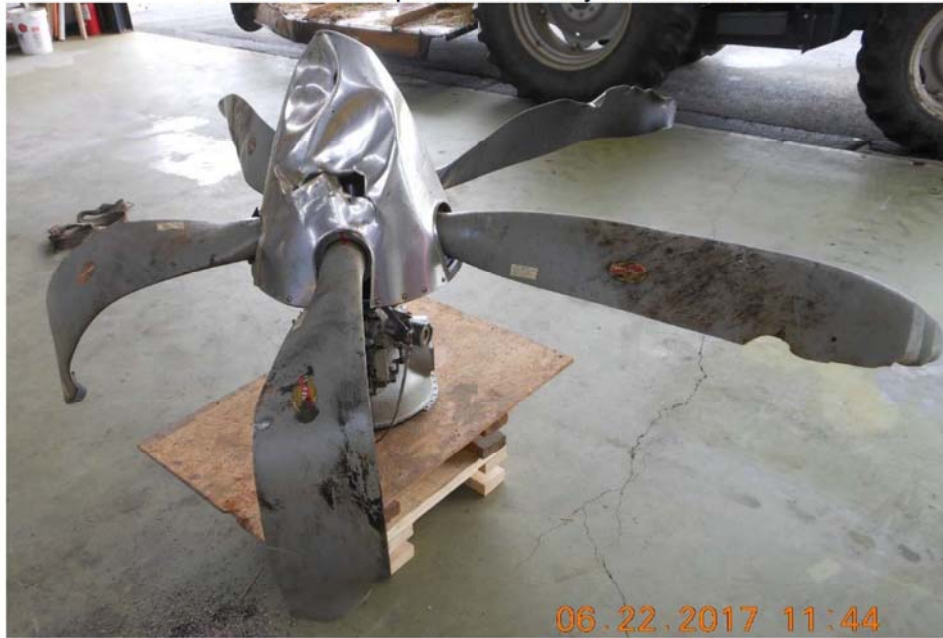
**“As Received” Condition:** The engine Reduction Gear Box (RGB) fractured from the engine during the impact sequence with the propeller still attached to the propeller shaft. It was recovered to Dawson’s and presented for examination as shown in Photo #1. All five blades remained attached to the propeller assembly. All blades were bent aft in varying degrees and exhibited leading edge bends characteristic of tree strikes. One blade was fractured approximately 10.5” from the tip. The spinner dome was dented and buckled in some areas but roughly maintained its shape. There was a counterweight impression formed in the dome. The propeller assembly is shown in Photo #2 after removal of the spinner dome. The piston was extended approximately 2.42” from the beta rod guide collar to a flight idle/low pitch stop position and jammed in that position by blade/clamp rotation beyond the reverse angle. The feathering spring was holding tension against three immovable/bent link arms. All blades were retained by the clamps and all clamps were intact with no fractured bolts. One blade (#5) showed slippage towards low pitch of approximately 10 degrees. One link arm (#1) had pulled from and fractured the piston attachment point; hole deformation was towards high pitch. The #4 link arm was detached from the link screw on the clamp. The #1 counterweight appears to have rotated more than 90° lower than the reverse range and punctured the spinner bulkhead.

Photo #1 – Propeller assembly as-received

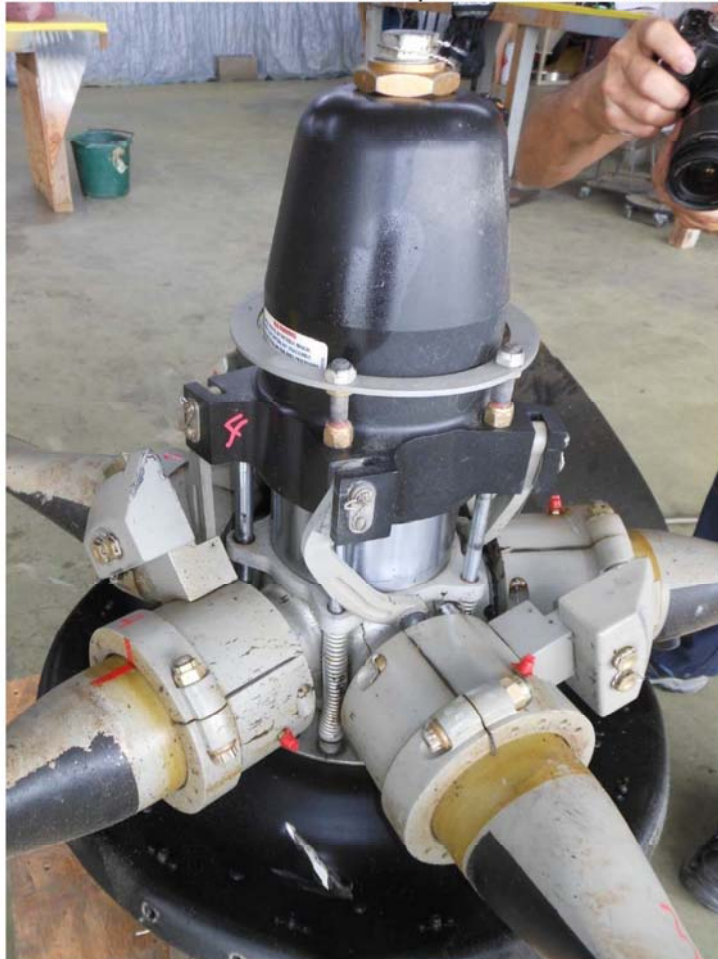
Photo #2 – As-received with spinner dome removed

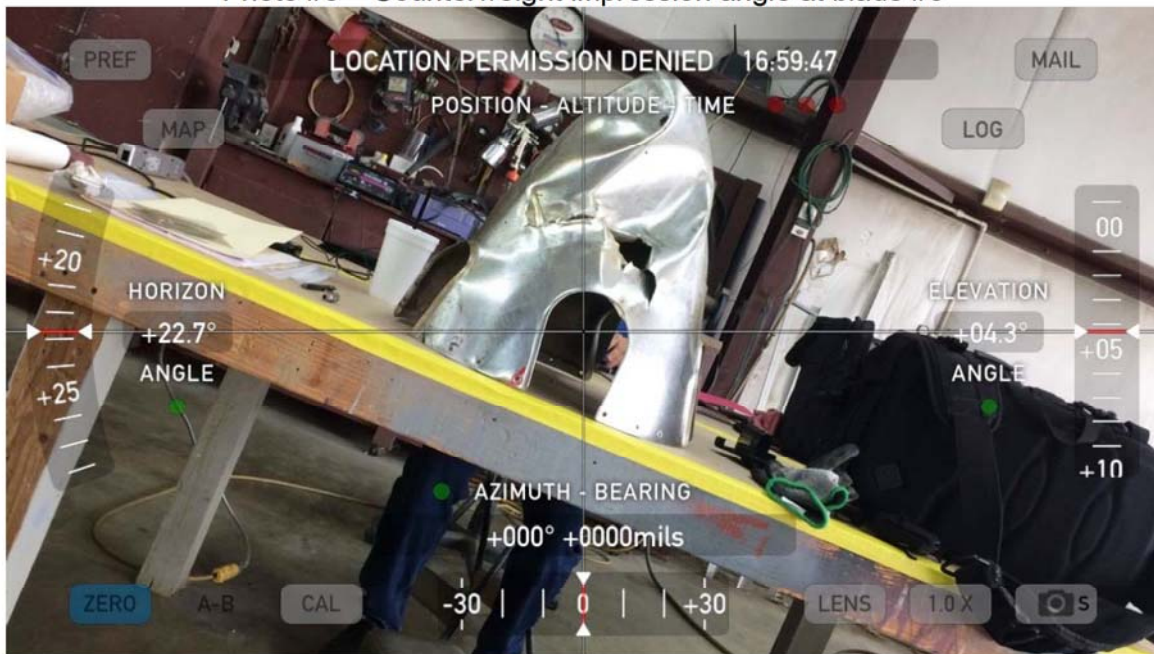
**Spinner Dome:** The spinner dome was dented and torn. There was a counterweight impression in the spinner dome at the blade #5 position with a counterweight angle of approximately 23 deg. (Photo #3). This is approximately equivalent to a blade angle of 11°.

Photo #3 – Counterweight impression angle at blade #5

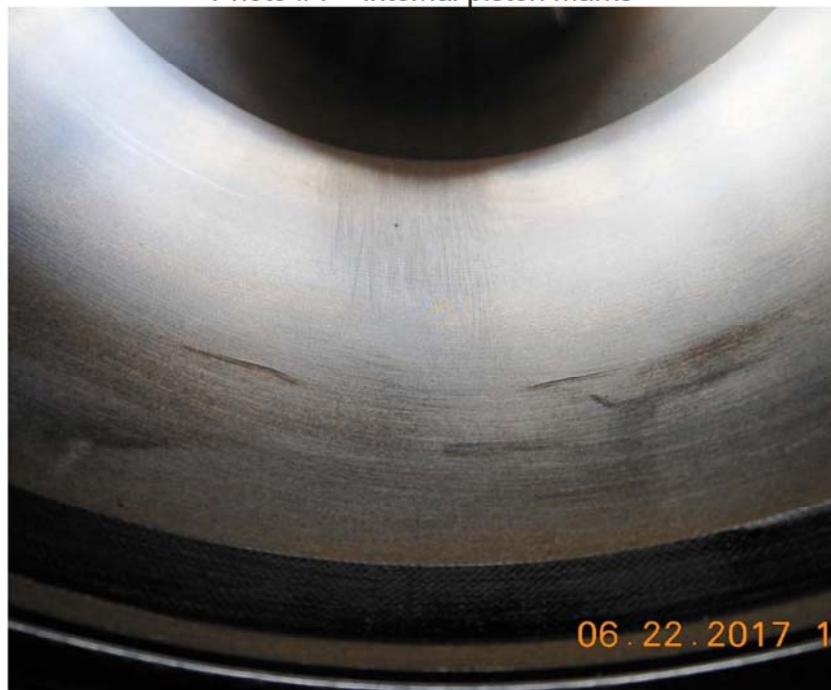
**Piston:** The piston was intact except for the #1 link arm attachment point; the link pin hole deformation was in the direction of high pitch. The piston appeared rotated on cylinder; one of two guide rods was bent opposite this rotation. There was scuff/scrape on the forward end of the piston between blades #1 and #5. There was a measureable amount of oil in the piston/prop shaft cavity that drained when the feathering spring was released and piston removed. The piston showed internal impact marks at several locations (see Photo #4):

1. 3.4" from the bottom edge, approximately equivalent to  $50^{\circ}$  blade angle
2. 2.07" from the bottom edge, approximately equivalent to  $10^{\circ}$  blade angle

3. Several marks in the range 1.87-1.93", approximately equivalent to 4-6° blade angle
4. Scuff marks starting at 2.88" extending to the forward break corner (feather end) of the piston stroke

Photo #4 – Internal piston marks

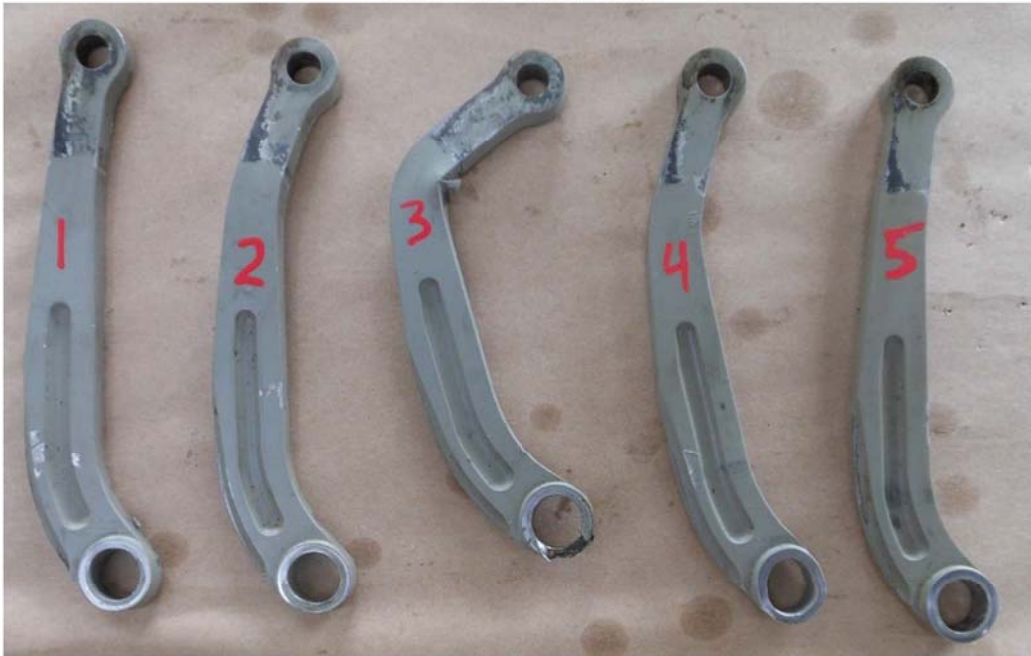
**Link Arms:** All five link arms remained on the propeller assembly (see Photo #5). The #2, #3 and #5 link arms remained attached to the link pins and screws. The #1 link arm pulled from the piston and fractured the link pin attachment. The #4 link arm separated from the clamp link screw.

Photo #5 – Link arms

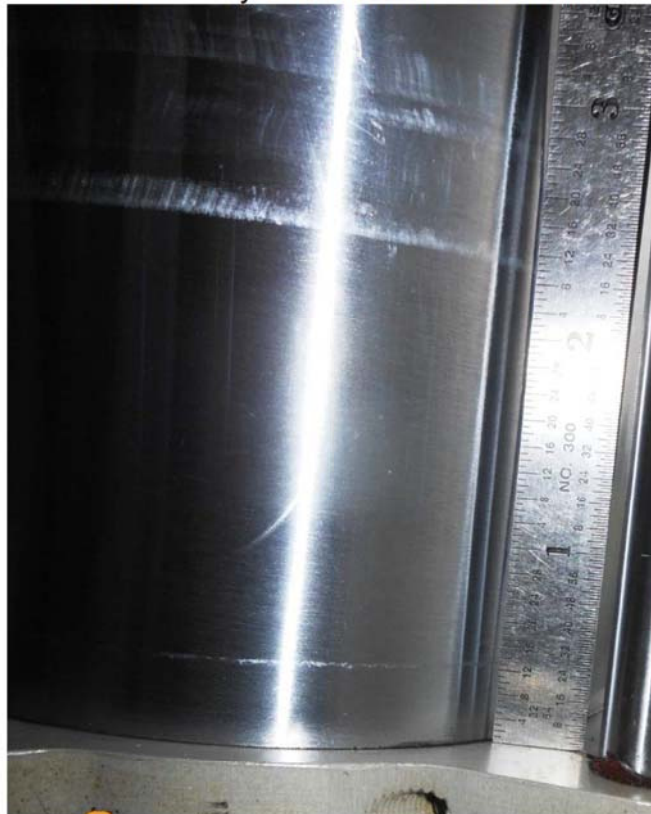
**Cylinder:** The cylinder appeared undamaged but had some rub marks at approximately 2.31 to 2.9" from the top of the beta rod guide collar (see Photo #6). The marks closely match the positions of the piston O-ring and phenolic rub strip grooves. The piston displacement needed to make these marks is approximately equivalent to a blade angle of 10°. The forward spring cup/retainer hardware remained in place and appeared undamaged.

Photo #6 – Cylinder mark measurements

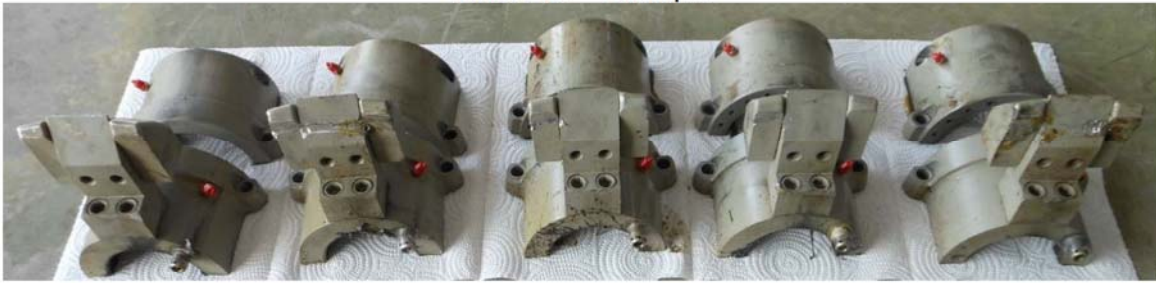
**Clamps and Counterweights:** (Photo #7) There was adequate and clean grease in the blade bearings and clamp interior surfaces.

Photo #7 – Clamps

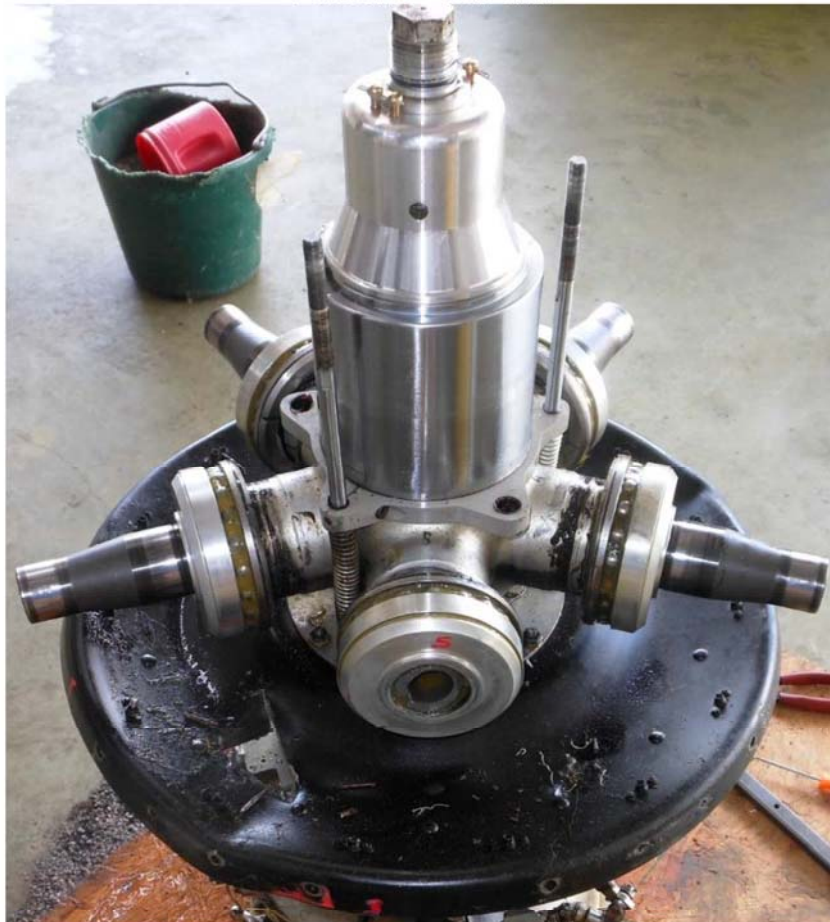
**Hub Unit:** (Photo #8) The #5 pilot tube fractured, all others were intact. The four other blades were easily removed from their clamps and pilot tubes. Blade arm #5 had blade

Photo #8 – Hub unit

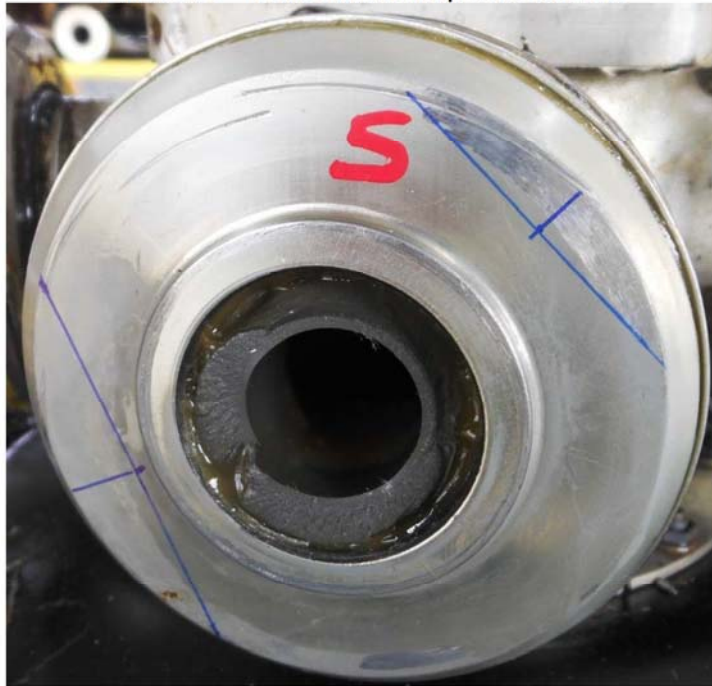
impact marks in the trail/face quadrant, lead/camber quadrant and rotational scoring on both the blade butt and hub arm surfaces (Photos #9 and #10). The cylinder mounting was intact and beta/piston guide ring was in place with contact damage from the link arms and screws. The propeller mounting flange was intact and appeared undamaged. All the mounting hardware was intact with safety wiring.

Photo #9 – Hub arm #5 impact crescent

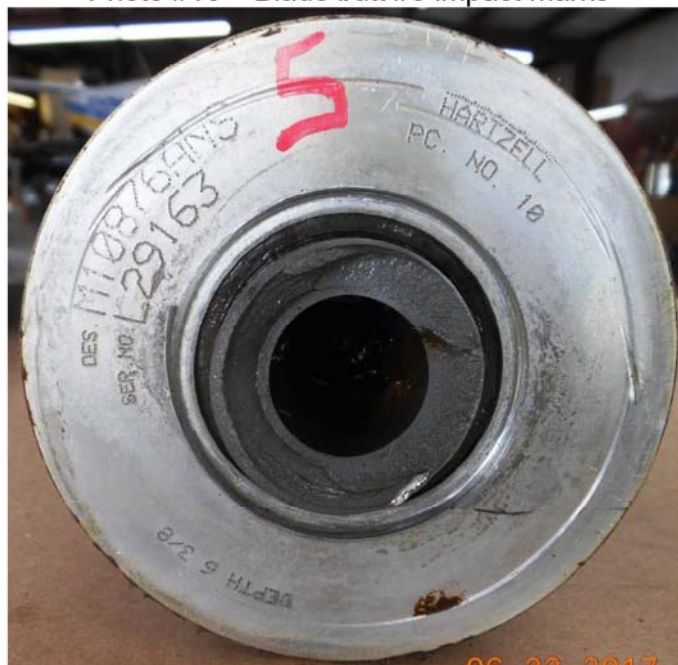
Photo #10 – Blade butt #5 impact marks

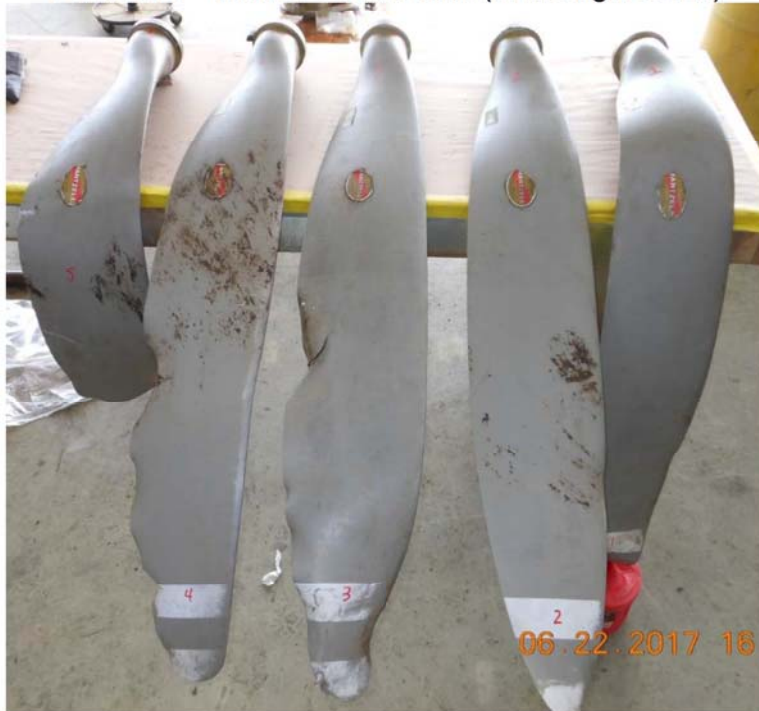
Photo #11 – Blades camber side (#1-#5 right to left)

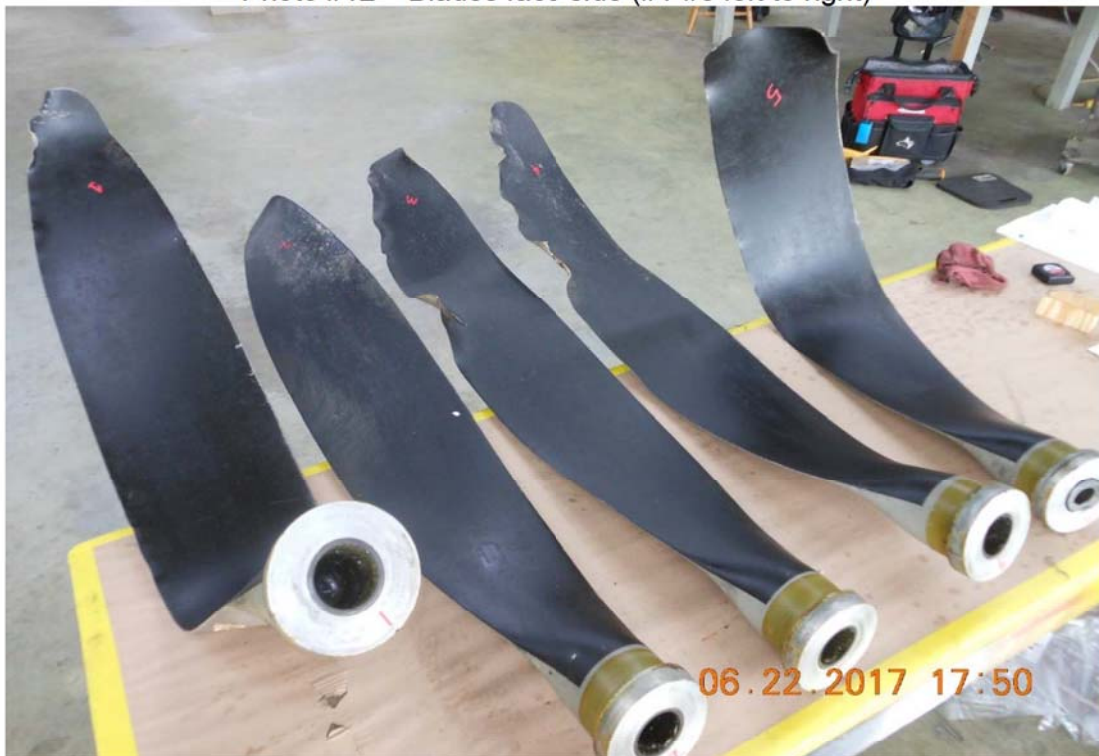
Photo #12 – Blades face side (#1-#5 left to right)

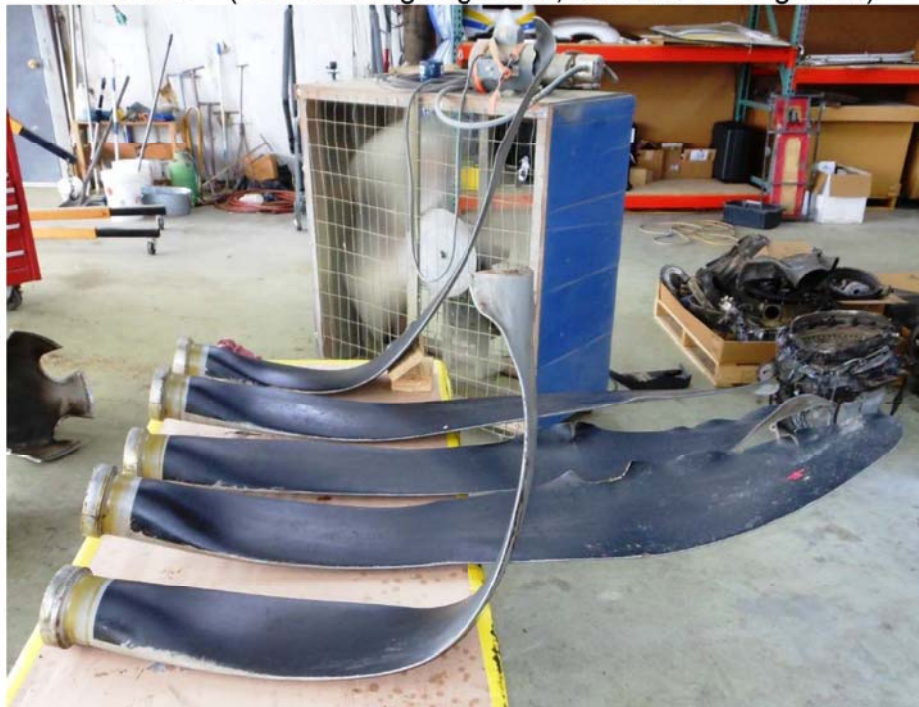
## Blade # 5 – Blade portion fractured 39.5" from butt (~10.5" from tip) and piece not recovered

Photo #13 – (Blade leading edge view, blade #5 in foreground)

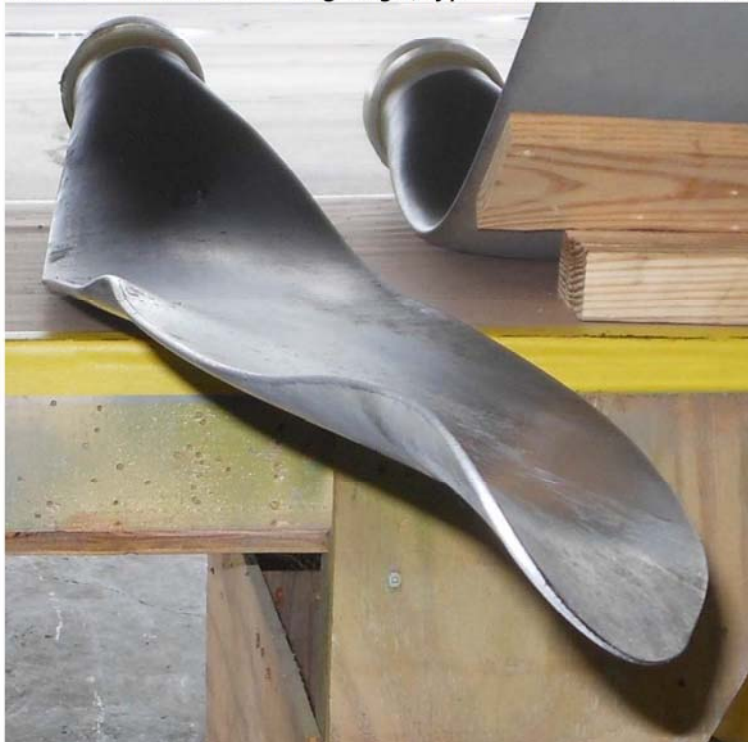
| Lead edge damage | Tree strike waves/bends, accelerated abrasion |

Photo #14 – Blade #2 leading edge, typical tree strike wave/bends
