| CUSTOMER<br><b>NATIONAL TRANSPORTATION SAFETY</b> | | INVESTIGATION NO<br><b>1130524</b> | |
| PROGRAM/ENGINE TYPE<br><b>P&amp;WC PT6</b> | | ITEM RECEIVED<br><b>8063-098</b> | ENGINE MFR MODEL RECEIVED<br><b>N/A</b> |

Reported Issue: UNIT WAS REPORTED INVOLVED IN AN INCIDENT ON MARCH 19, 2017 IN MINTER CITY MS. DURING AERIAL APPLICATION FLIGHT, AIRCRAFT COLLIDED WITH TRESS AND TERRAIN. AIRPLANE WAS DESTROYED BY IMPACT AND POSTCRASH FIRE. AIR TRACTOR AT-602 TAIL NUMBER N2049D

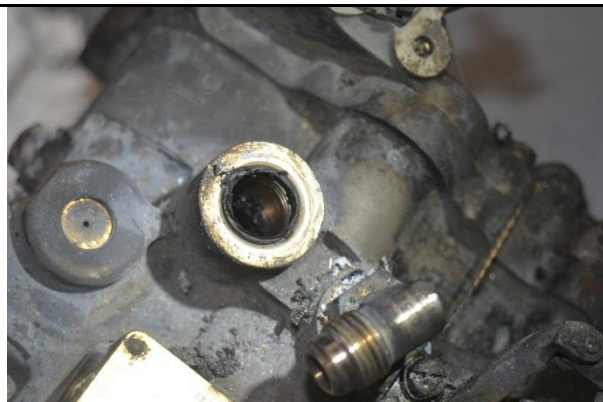
**Figure 3 -** Typical port with degraded seal visible

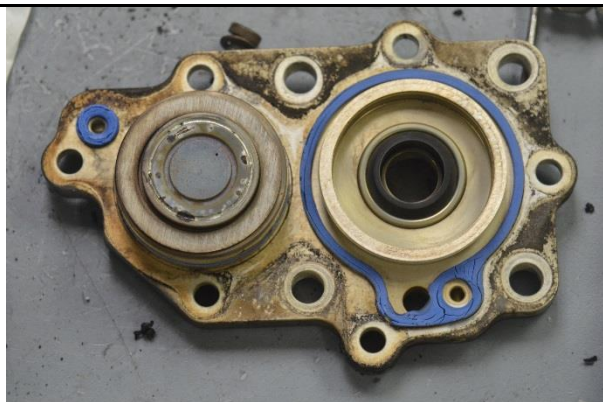
**Figure 4 –** Baseplate showing bellows bottom plate (left) with re-flowed solder joint

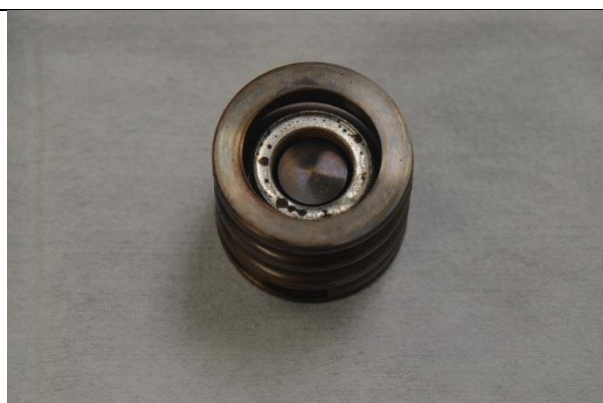
**Figure 5 –** Remainder of bellows showing other side of re-flowed solder joint

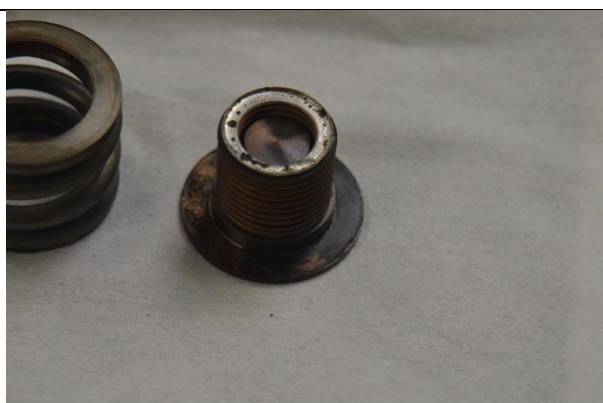
**Figure 6 –** Spring removed from bellows

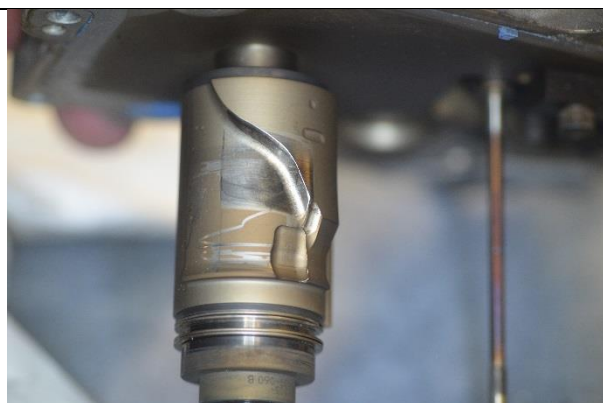
Confirmation Text: DID NOT CONFIRM REASON FOR INVESTIGATION/RETURN OR NO PREEXISTING FAULT FOUND  
 Discrepant Item Number: NA  
 Discrepancy: Product Not Testable  
 Finding: Other  
 Conclusion: Unit was investigated 06 Nov2017 under FAA and NTSB supervision. Removal of fittings from ports showed that packings had been damaged by heat from fire, making it unlikely that unit could be tested (see Figure 3). Removal of base plate confirmed packing degradation and found that the soft solder joints of the CDP bellows had re-flowed. Since the CDP bellows is under a slight extension spring force at rest, the bellows joints separated when the solder re-flowed, making testing impossible (see Figures 4 through 6). A complete tear down was then performed, which did not find anything that could have affected the operation of the fuel control (see Figures 7 through 10).

**Figure 7 –** Wear pattern showing operational area of cam

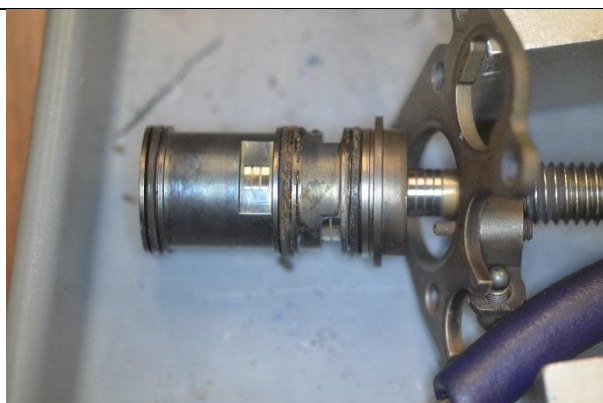
**Figure 8 –** Fuel Valve assembly showing heat degraded packings.
