**NATIONAL TRANSPORTATION SAFETY BOARD**

**Airworthiness Group Chairman's Factual Report**

**A. ACCIDENT ERA17FA135**

Location: Marietta, Georgia  
Date: March 24, 2017  
Time: 1922 Local Time  
Aircraft: Textron Aviation Citation 500 N8DX

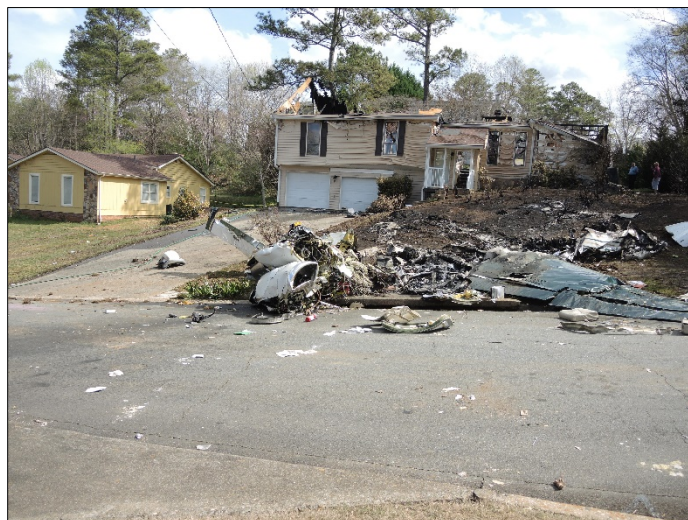
The accident impact and post-crash fire damaged or consumed most of the forward portions of the airplane, including the wings, fuselage, flight deck, and nose areas. See Figure 1.

Figure 1 - Main wreckage site showing burned wreckage and residence.

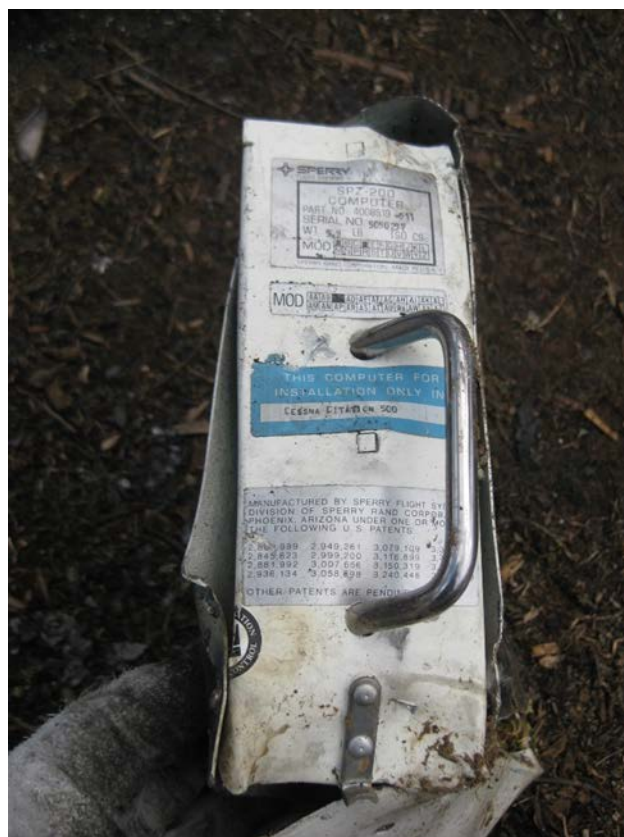
On scene, the autopilot system was examined in the airplane wreckage prior to removal of components. No evidence of an autopilot failure was noted during the on-scene examination. The components showed evidence of fire damage, sooting, and/or physical damage from impact. See Figure 3.

Figure 3 - Sperry SPZ-200 Autopilot Computer, as found.

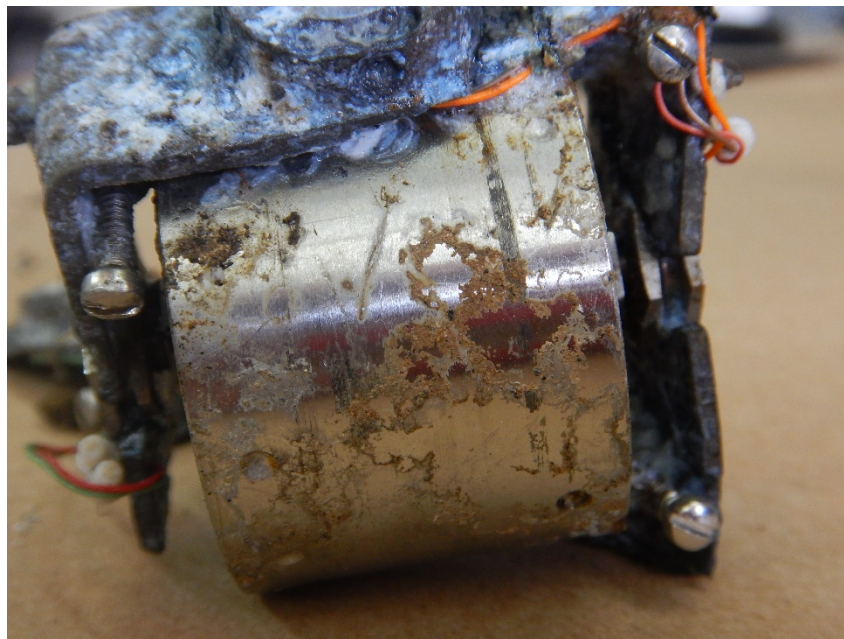
The gimbal was cleaned and examined. Some rotational scoring was noted on the mass. See Figure 4.

Figure 4 - Rotor identified from Directional Gyro Number 1, showing rotational scoring.

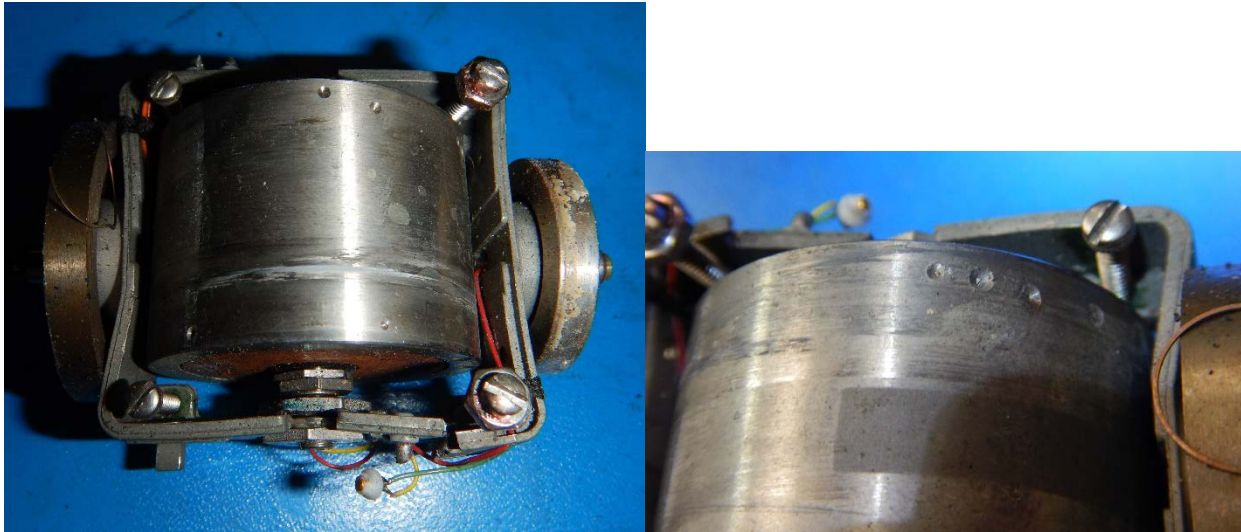
- The base plate was fractured.
- The upper and lower dust covers were cut (by the group) away from the internal components.
- All three of the synchro transmitters and the motor were missing.
- The rotor and assembly were removed from the can. The rotor still rotated freely but had some roughness/pitting of internal bearings. Rust was noted on the rotor bearing surface. The rotor had scoring along the direction of rotation and some scoring along the edge; one score mark was noted 180 degrees around the rotor surface. See Figures 5a and 5b.

Figure 5a and 5b - Rotor from Directional Gyro Number 2, showing rotational scoring.

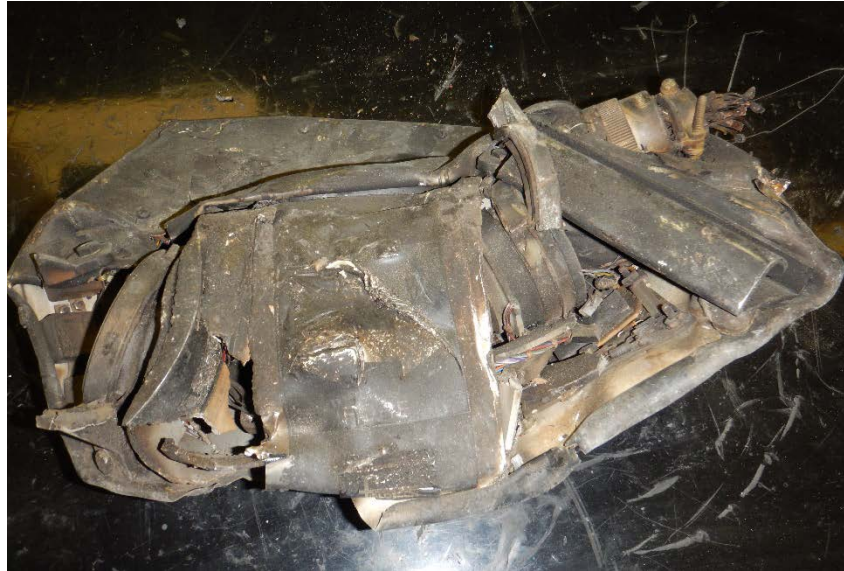
- The base was crushed against the component's gyro cover. The base was cut away from the crushed component. Then the outer case was cut away. See Figure 6.

Figure 6 - General view of VG Number 1, prior to disassembly.

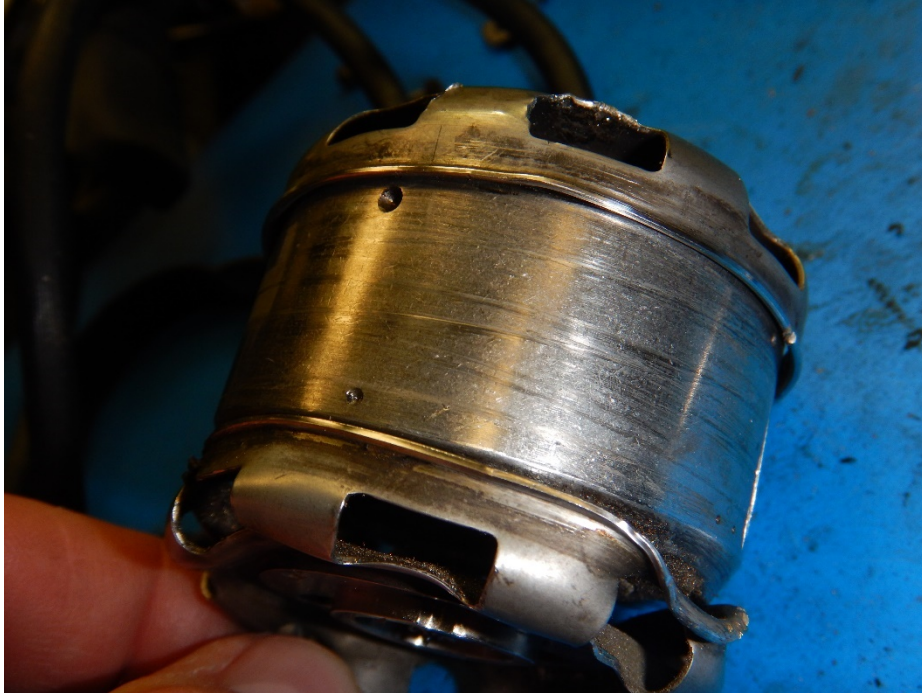
- The top hemisphere and the outer ring were cut away and removed. The rotor surface was coated with a black material/greasy material.
- The rotor was cleaned of the black, greasy material and exposed circumferential scoring on the rotor surface. See Figure 7.

Figure 7 - Rotor removed from Vertical Gyro Number 1 (after cleaning), showing rotational scoring.

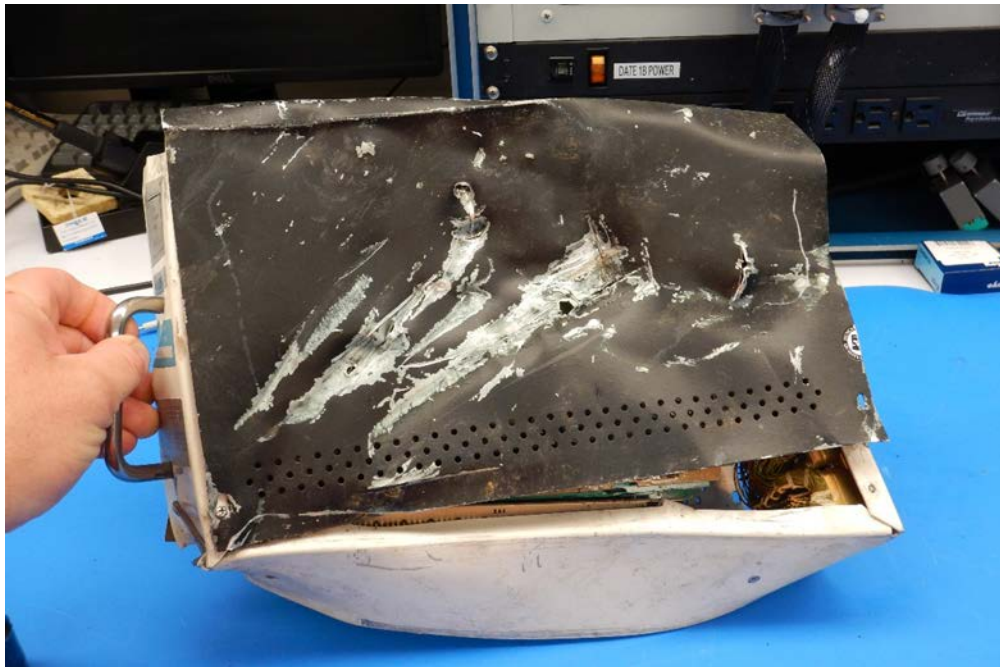
- The unit's chassis was crushed and deformed. See Figure 8. The cover sleeve was peeled back and removed. The circuit card assemblies (CCA) were inspected and retaining screws removed. Each CCA appeared deformed from impact damage.

Figure 8 - The side of the Autopilot Computer, showing dust cover and chassis deformation.

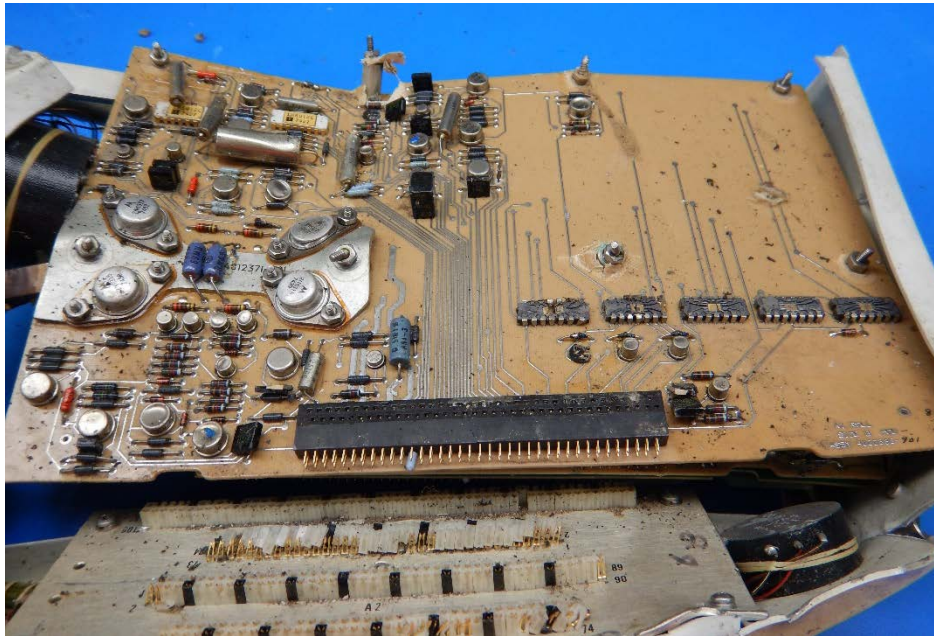
- The Roll CCA was removed and examined. The card was bent and cracked in areas. Some integrated circuit components exhibited damage such as top cover missing, was bent, etc. See Figure 9.

Figure 9 - Autopilot Computer Roll Circuit Card Assembly.

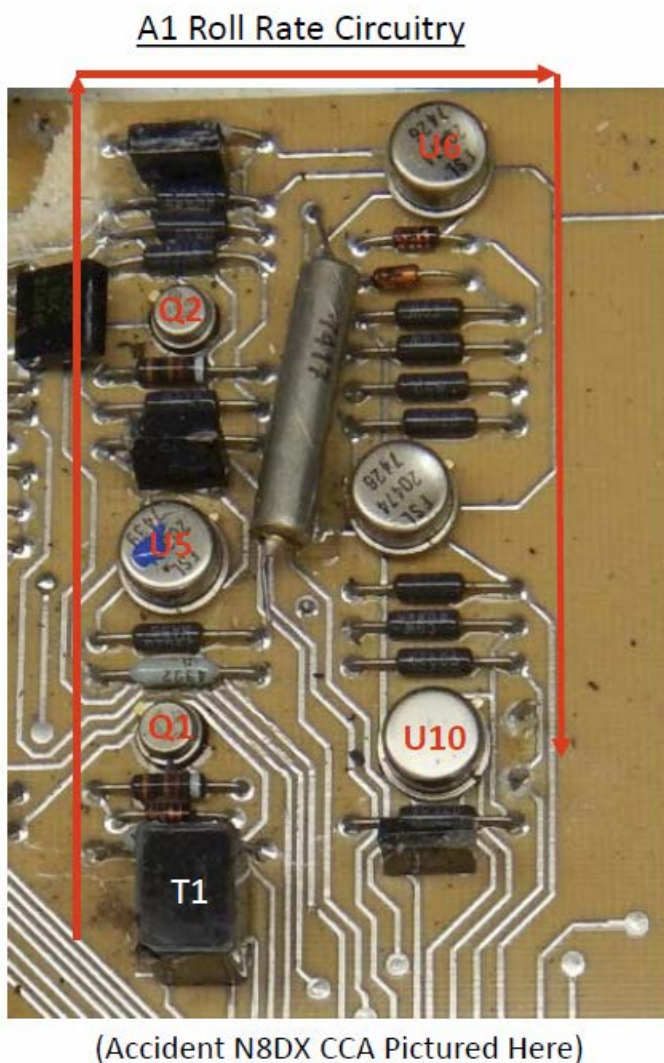
During the previous investigation, Duncan attempted to replicate an intermittent failure of an isolation transformer (component A1T1) on the roll CCA A1, from the removed SPZ-200 Autopilot Computer. Based on the previous investigation, the group determined to further examine the roll circuit on the roll CCA and specifically at the A1T1 isolation transformer. See Figure 10.

Figure 10 - Roll Rate Circuit Components, as located on the accident airplane's Autopilot Computer A1 Circuit Card Assembly. Component labelled T1 is the transformer.

The transformer is part of the roll CCA feedback loop circuit. Honeywell indicated that a failure of the A1T1 isolation transformer could cause the autopilot to roll the aircraft if the autopilot was still engaged and the commanded heading was different than the current heading. As the A1T1 is a component in the circuitry that determines roll rate feedback for the autopilot computations, if the A1T1 transformer fails (assumed to go to no output, voltage = 0), then the calculated roll rate would be zero and thus the autopilot would continue to command an increase in roll angle in order to try to get the heading rate to increase in order to turn to the desired heading.

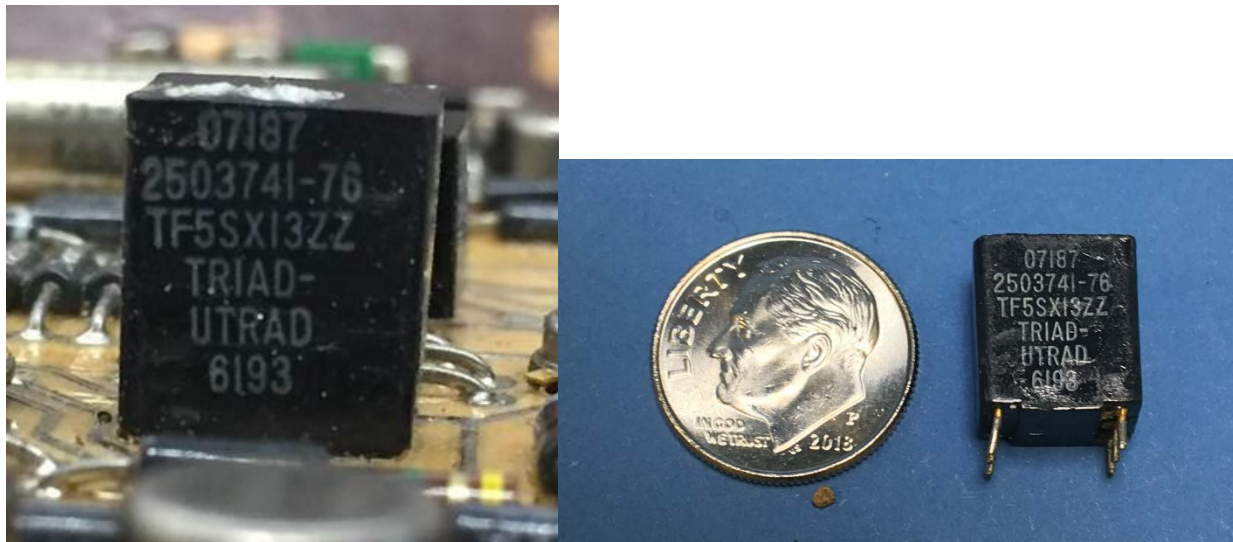
Examination of the transformer (See Figures 12a and 12b) identified the component as follows:

Figure 12a and 12b - The A1T1 Transformer as located on the circuit card and removed.

None of the tests conducted on the accident A1T1 transformer resulted in a failure or loss of function.

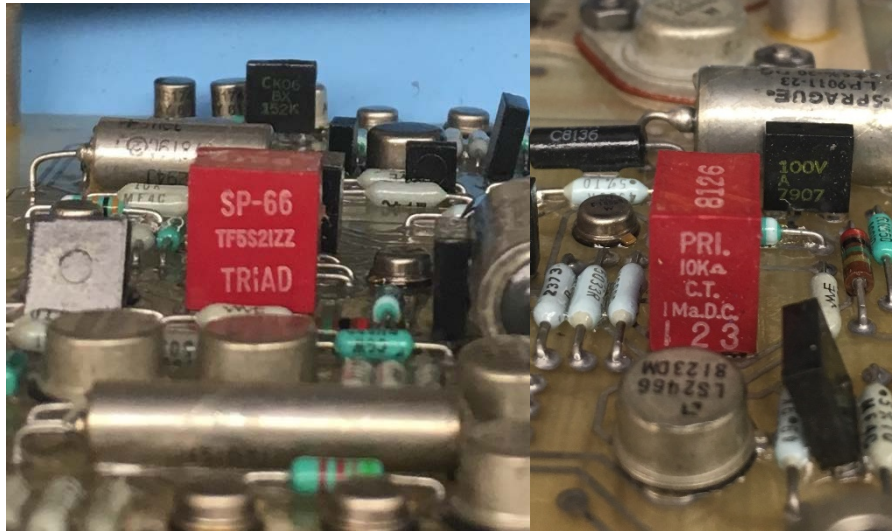
Following the identification of the A1T1 for further examination, a request was made to Duncan Aviation to identify and provide any additional failed transformers from SPZ-200 Autopilot computers submitted to Duncan for repair. In July 2017 Duncan notified the group of a failed transformer from an ancillary Sperry SPZ-200 computer. The failed component was removed from the Pitch CCA and provided to the group for examination. This additional A2T1 transformer, red in color, was identified as follows (see Figures 13a and 13b):

Figures 13a and 13b – Views of the "Red Transformer" prior to removal from an ancillary Pitch CCA by Duncan Aviation.

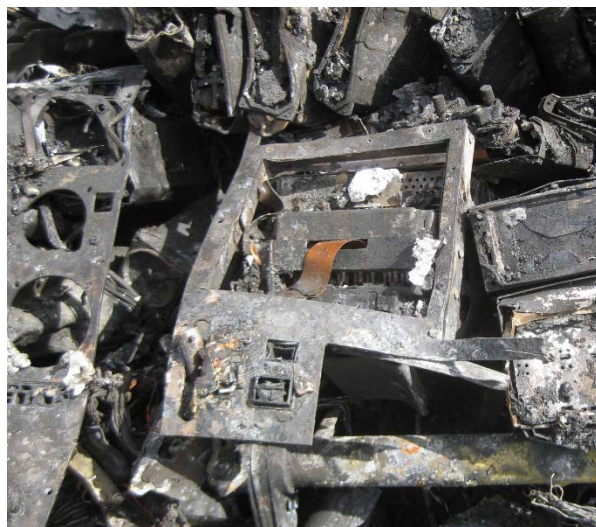
The airplane’s Garmin 750 unit was removed from the airplane. However, due to the severe heat and fire damage to the unit, no further examination of the Garmin 750 was accomplished. See Figure 14.

Figure 14 - Garmin GTN 750 Display, as found.

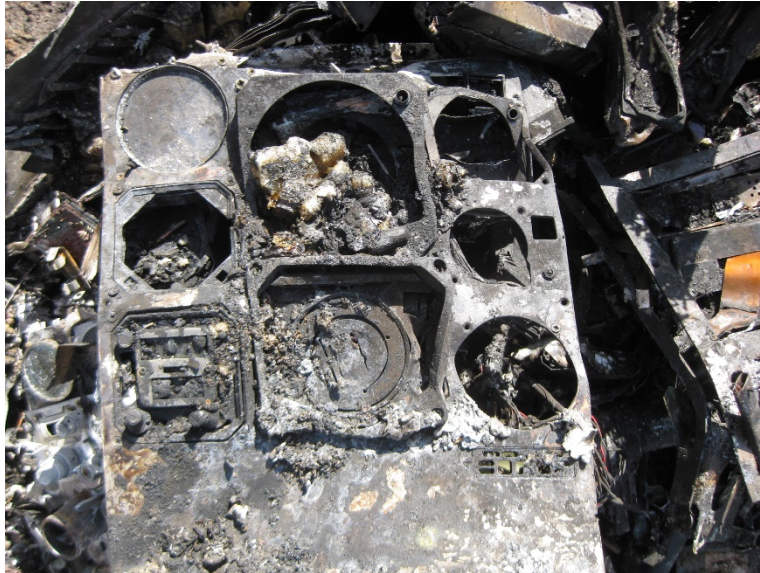
The flight deck instrument panels were damaged by fire and impact; no indication assessment was possible. See Figure 15.

Figure 15 - The Left Main Flight Instrument Panel, as found. The Garmin GTN 750 is to the right of the panel.

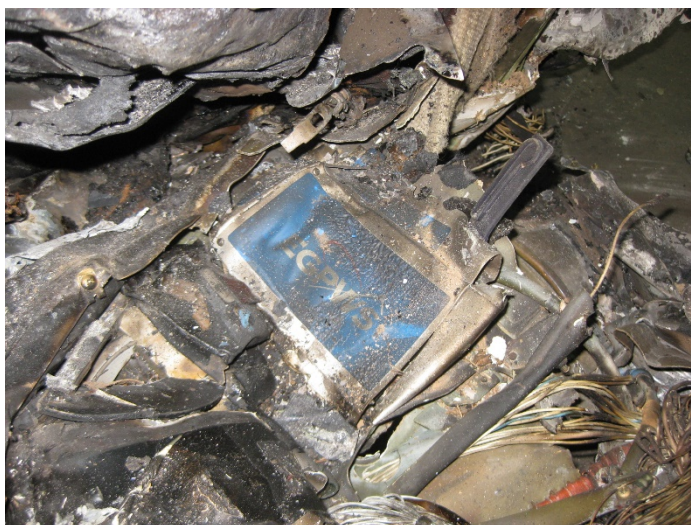
Figure 17 - The airplane's TAWS unit, prior to removal from the wreckage.

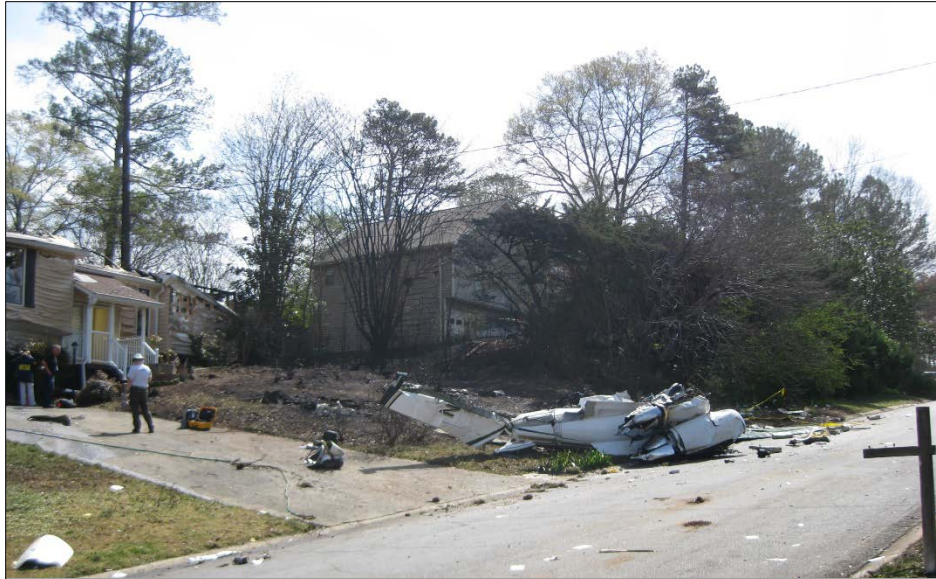
The aircraft wreckage was found on the front yards and street of a residential neighborhood. The aircraft impacted the ground in an approximate nose level/wings level attitude with little to no forward momentum. An indentation in the ground of approximately same size and shape as left wing was noted in the front yard of the house. The wires and trees close to house and driveway did not appear to have been struck by the airplane. Based on the initial impact indentation of the left wing, the airplane bounced aft approximately 3 feet.

Figure 18 - Airplane wreckage as found at arrival. Note intact overhead house wires.

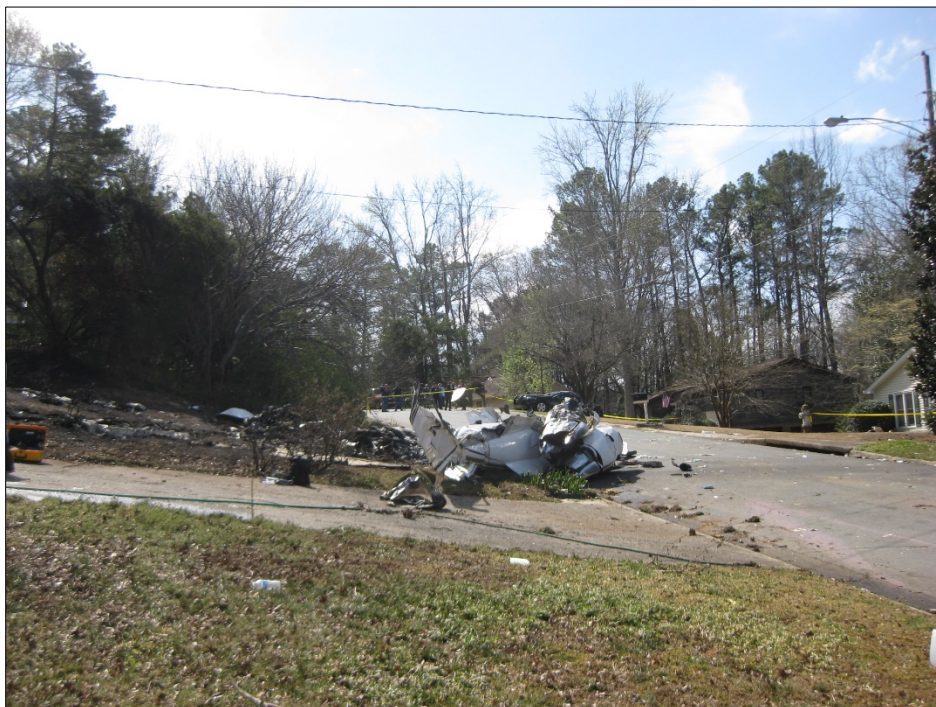
Figure 19 - Airplane orientation at accident site. Note intact overhead wires to the house.

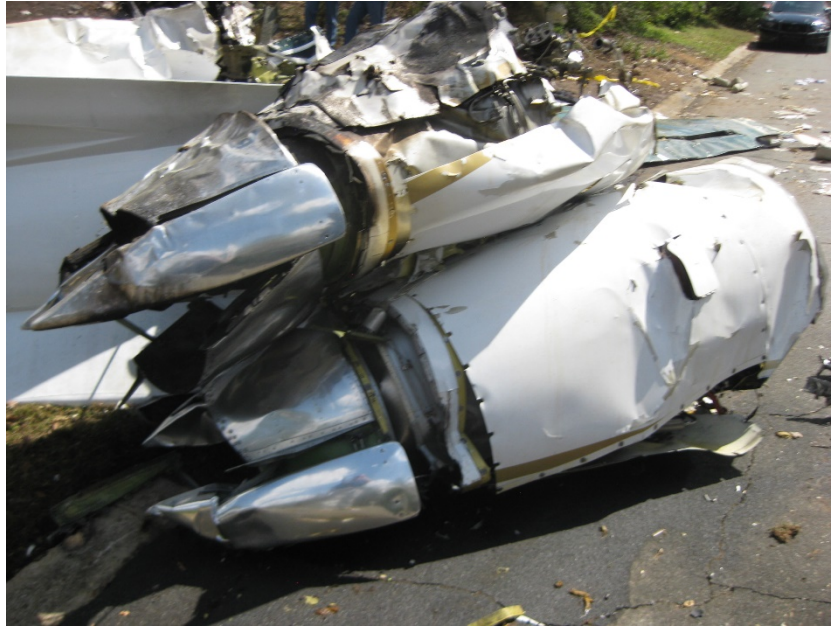
The left (number 1) engine pylon was separated from the aft fuselage. The pylon and engine were folded on top of the right (number 2) engine. See Figure 20.

Figure 20 - The airplane engines, with Engine 1 found on top of Engine 2.

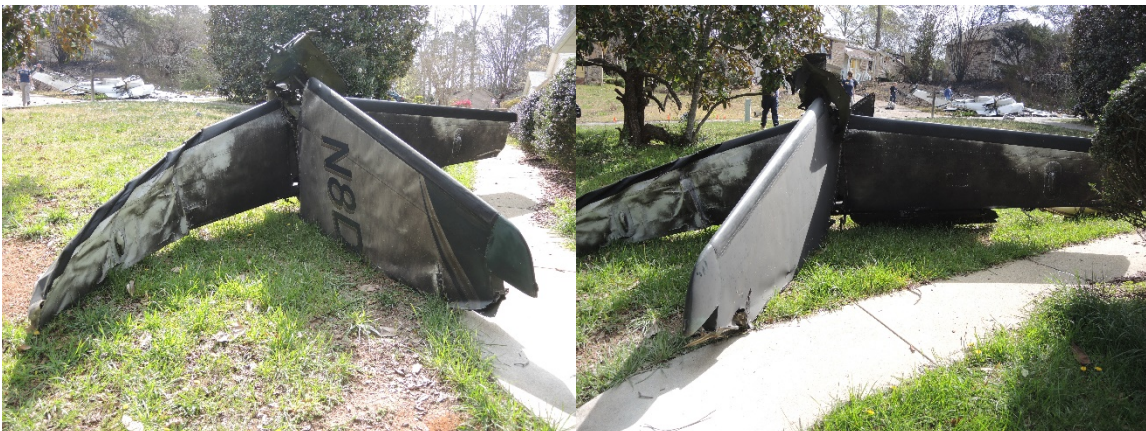
The horizontal and vertical stabilizers remained attached to each other but separated from the fuselage. The stabilizers were in the front yard of the house across the street from the main wreckage site. See Figures 21a and 21b.

Figures 21a and 21b - Found Location of Vertical and Horizontal Stabilizers; Note Main Wreckage in Background.

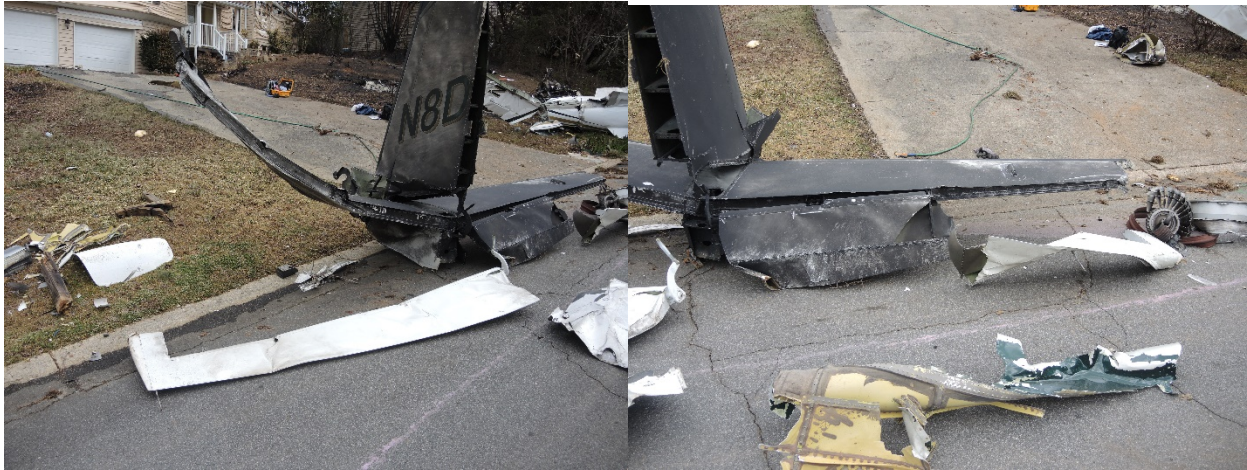
Figure 22a and 22b - The left and right elevator laid out near horizontal stabilizer.

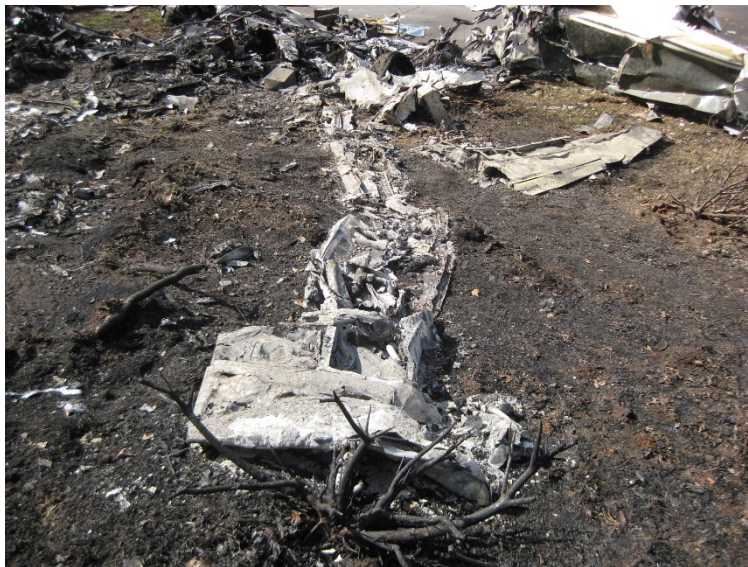
The left wing was almost completely consumed by the post-impact fire.

Figure 23 - Left wing, looking inboard.

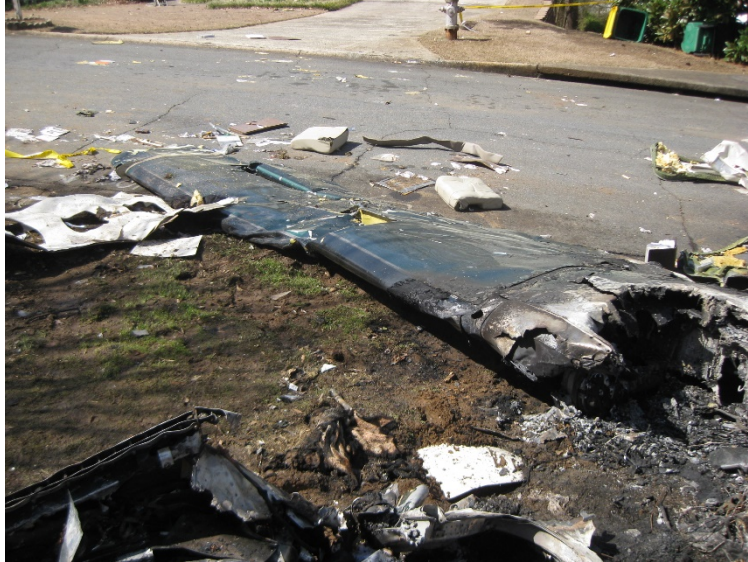
The right wing was noted with some fire damage inboard, with impact damage the outboard portion. The spar was broken on the outboard section of the wing.

Figure 24 - Right wing, looking outboard, and noting fire at the inboard forward section.
