**NATIONAL TRANSPORTATION SAFETY BOARD**

**Computed Tomography Specialist's Factual Report**

ERA17FA135

Location: Marietta, Georgia  
Date: March 24, 2017  
Time: 1924 eastern daylight time  
Airplane: Textron Aviation Citation 500, N8DX

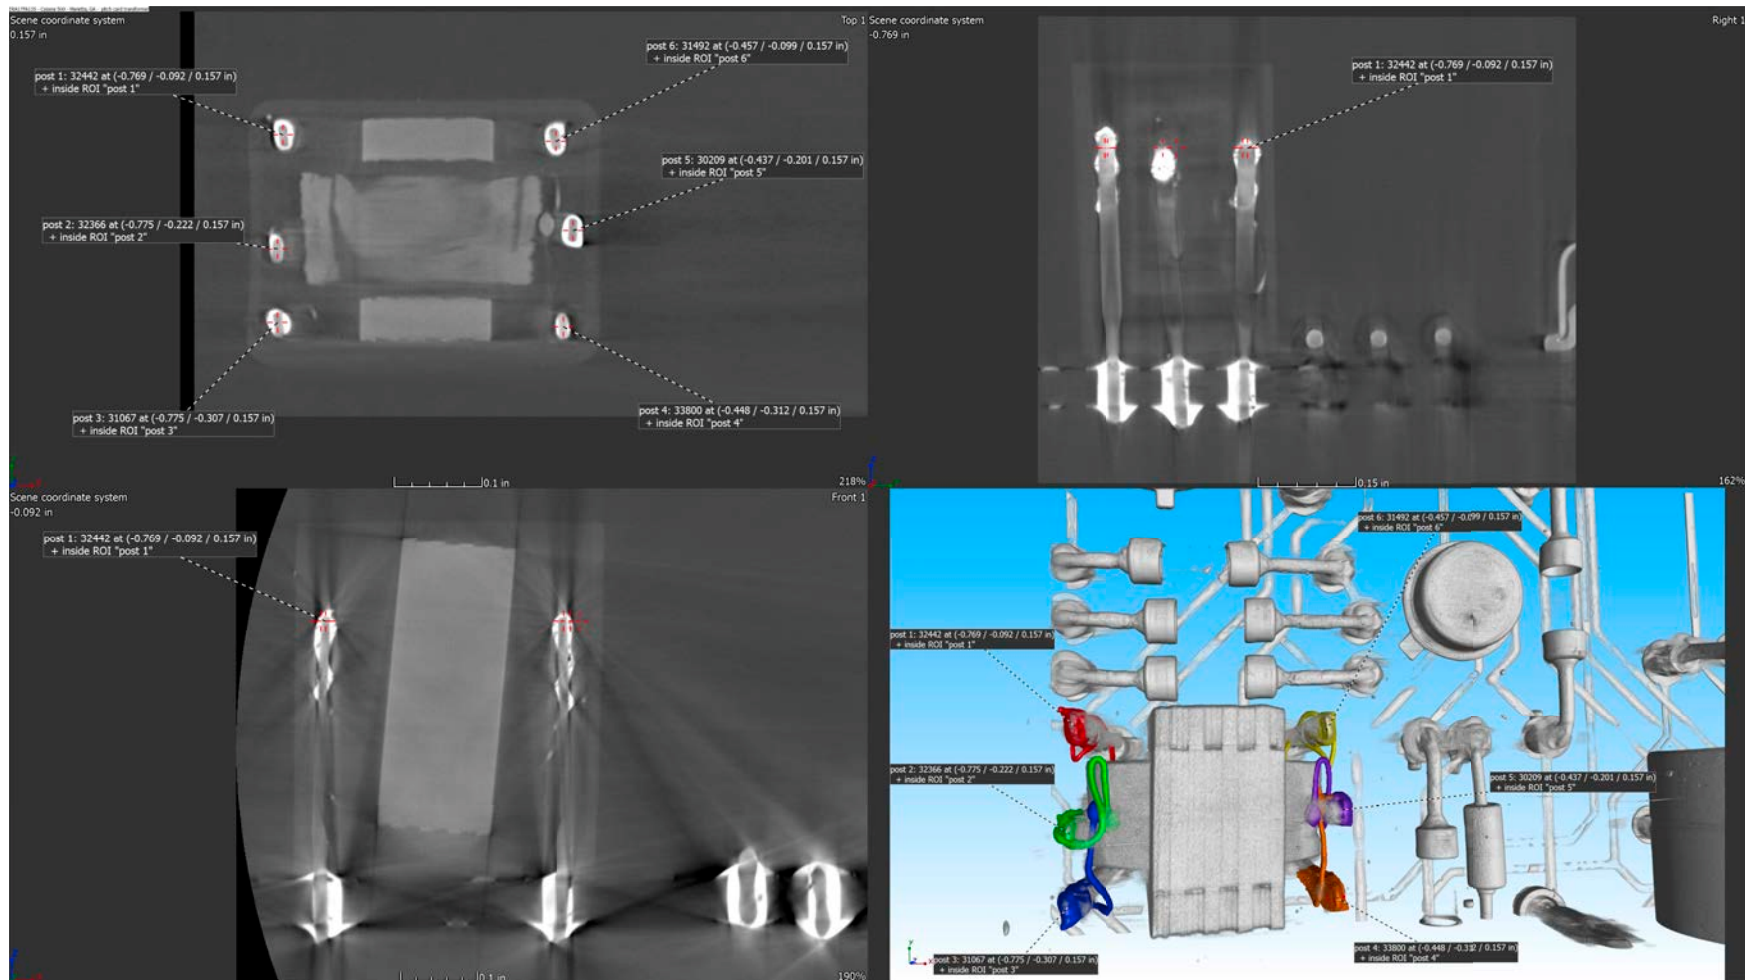
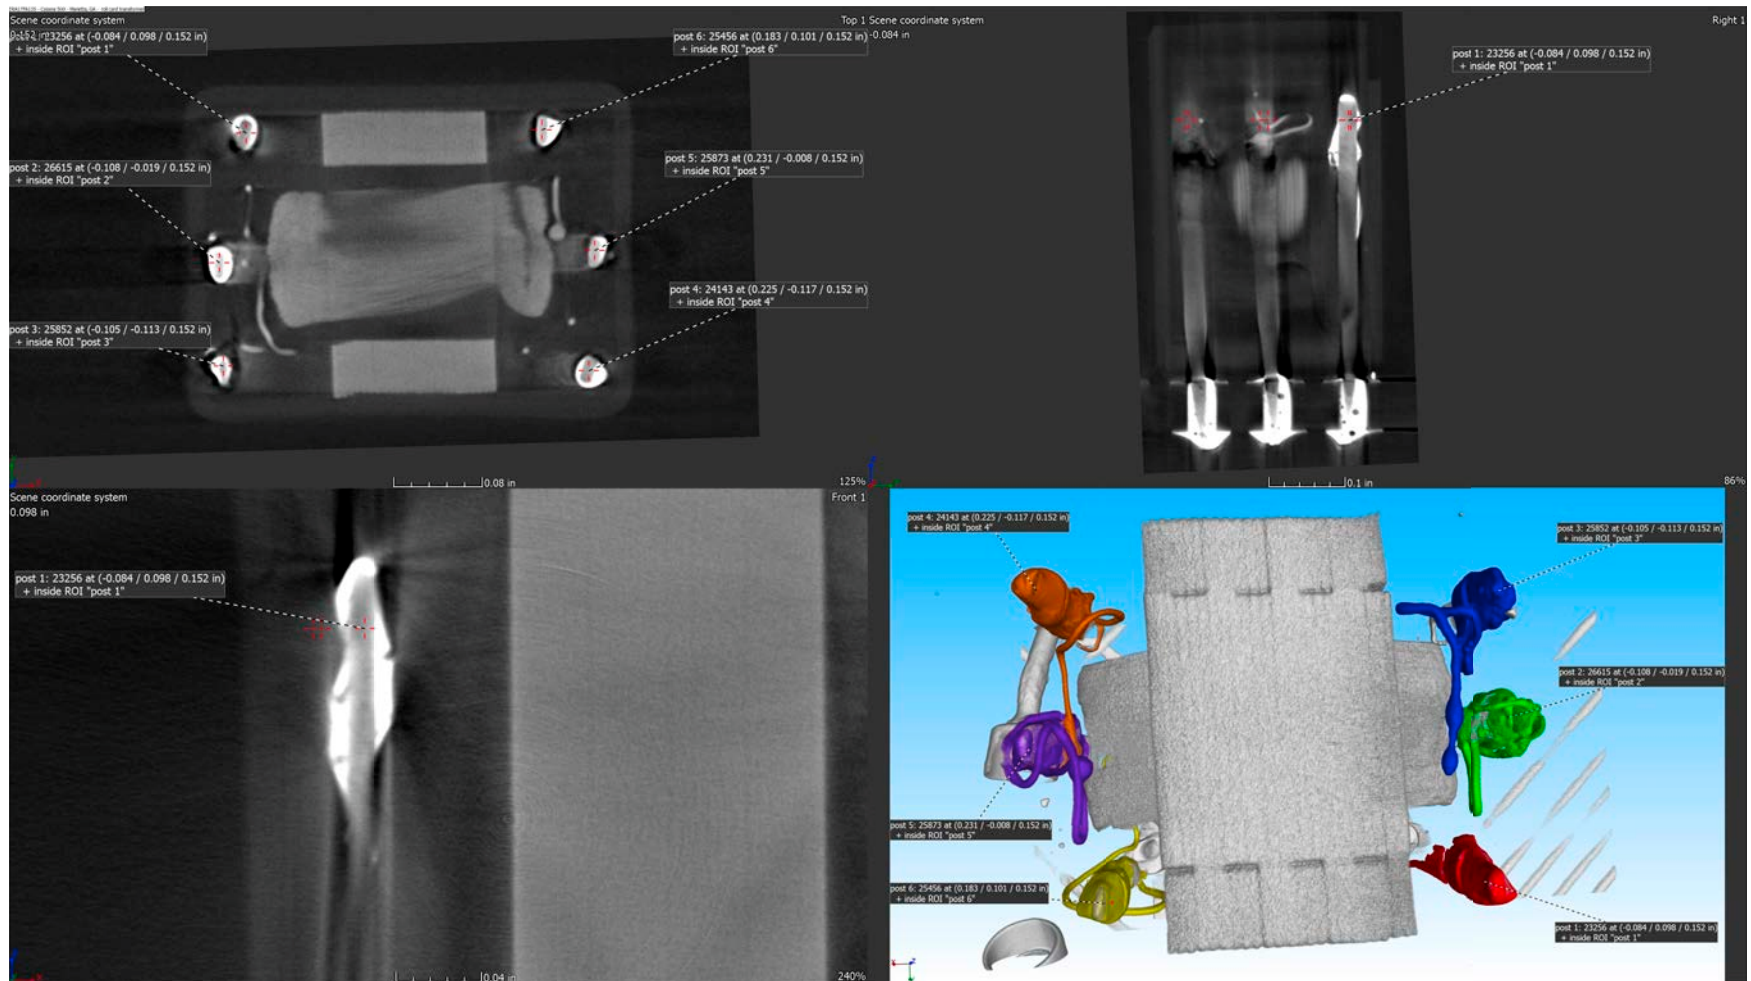
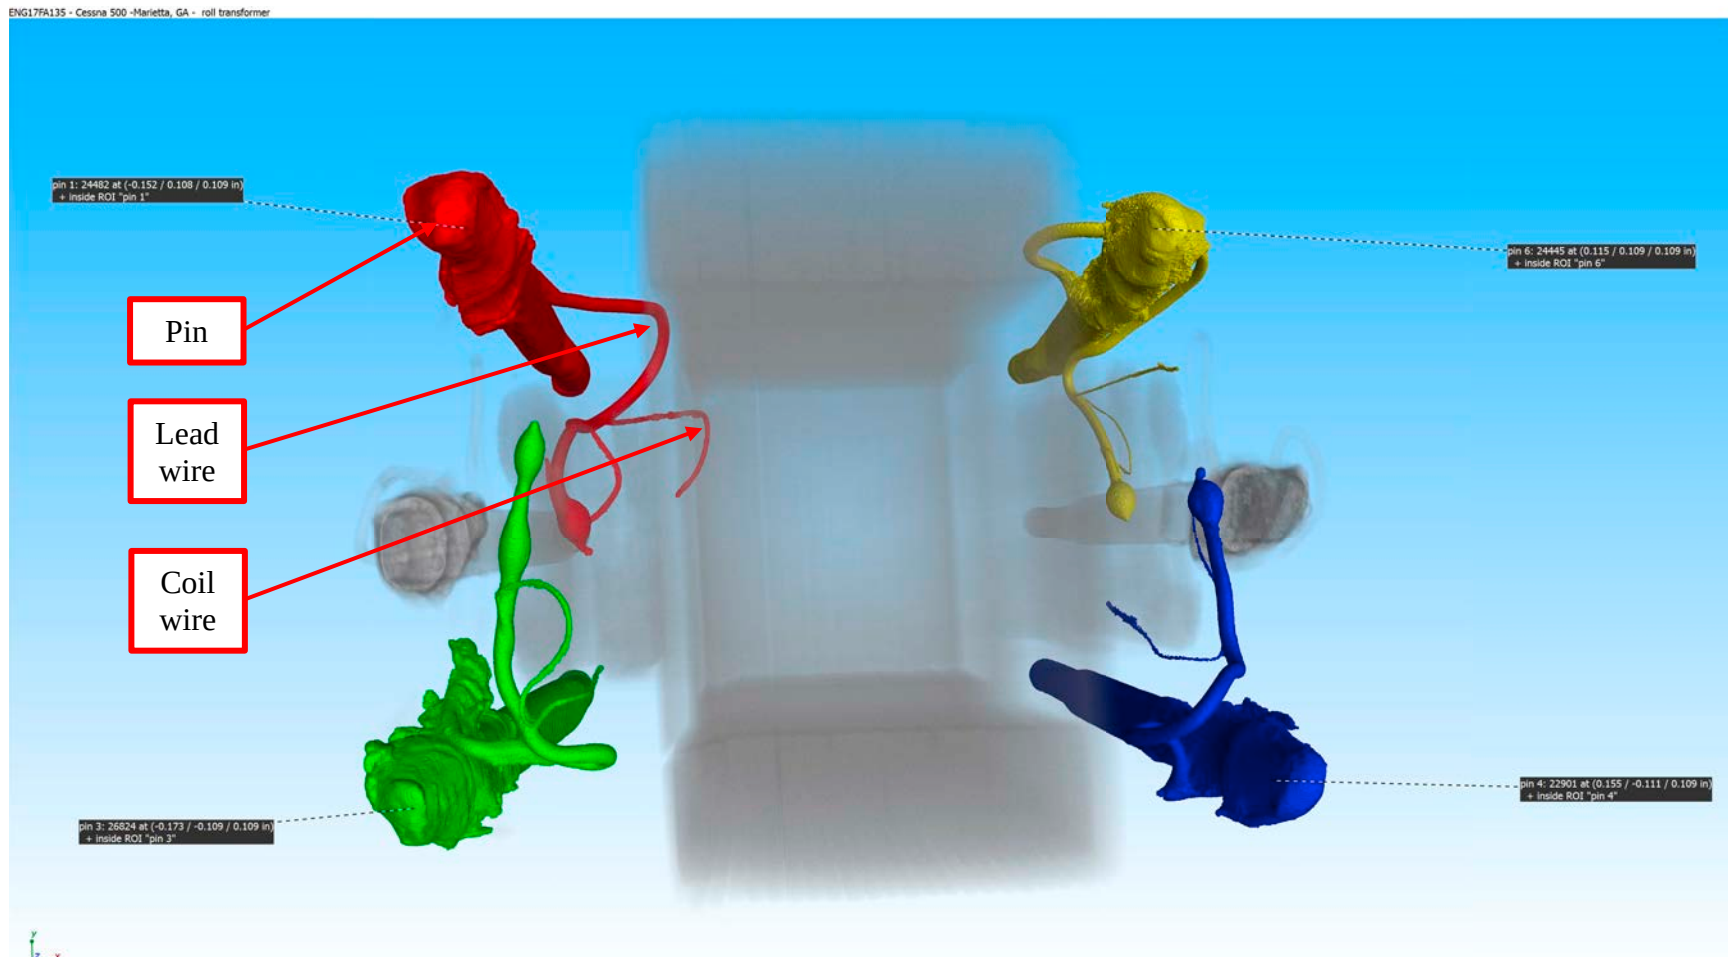
- the attachment points and routing of the lead and coil wires associated with each pin of the roll and pitch transformers appeared to be different (figures 1-3);

Figure 1  
Pitch transformer on printed circuit board – overall view

Figure 2  
Roll transformer on printed circuit board – overall view

Figure 3  
Roll transformer – overall view – 3D

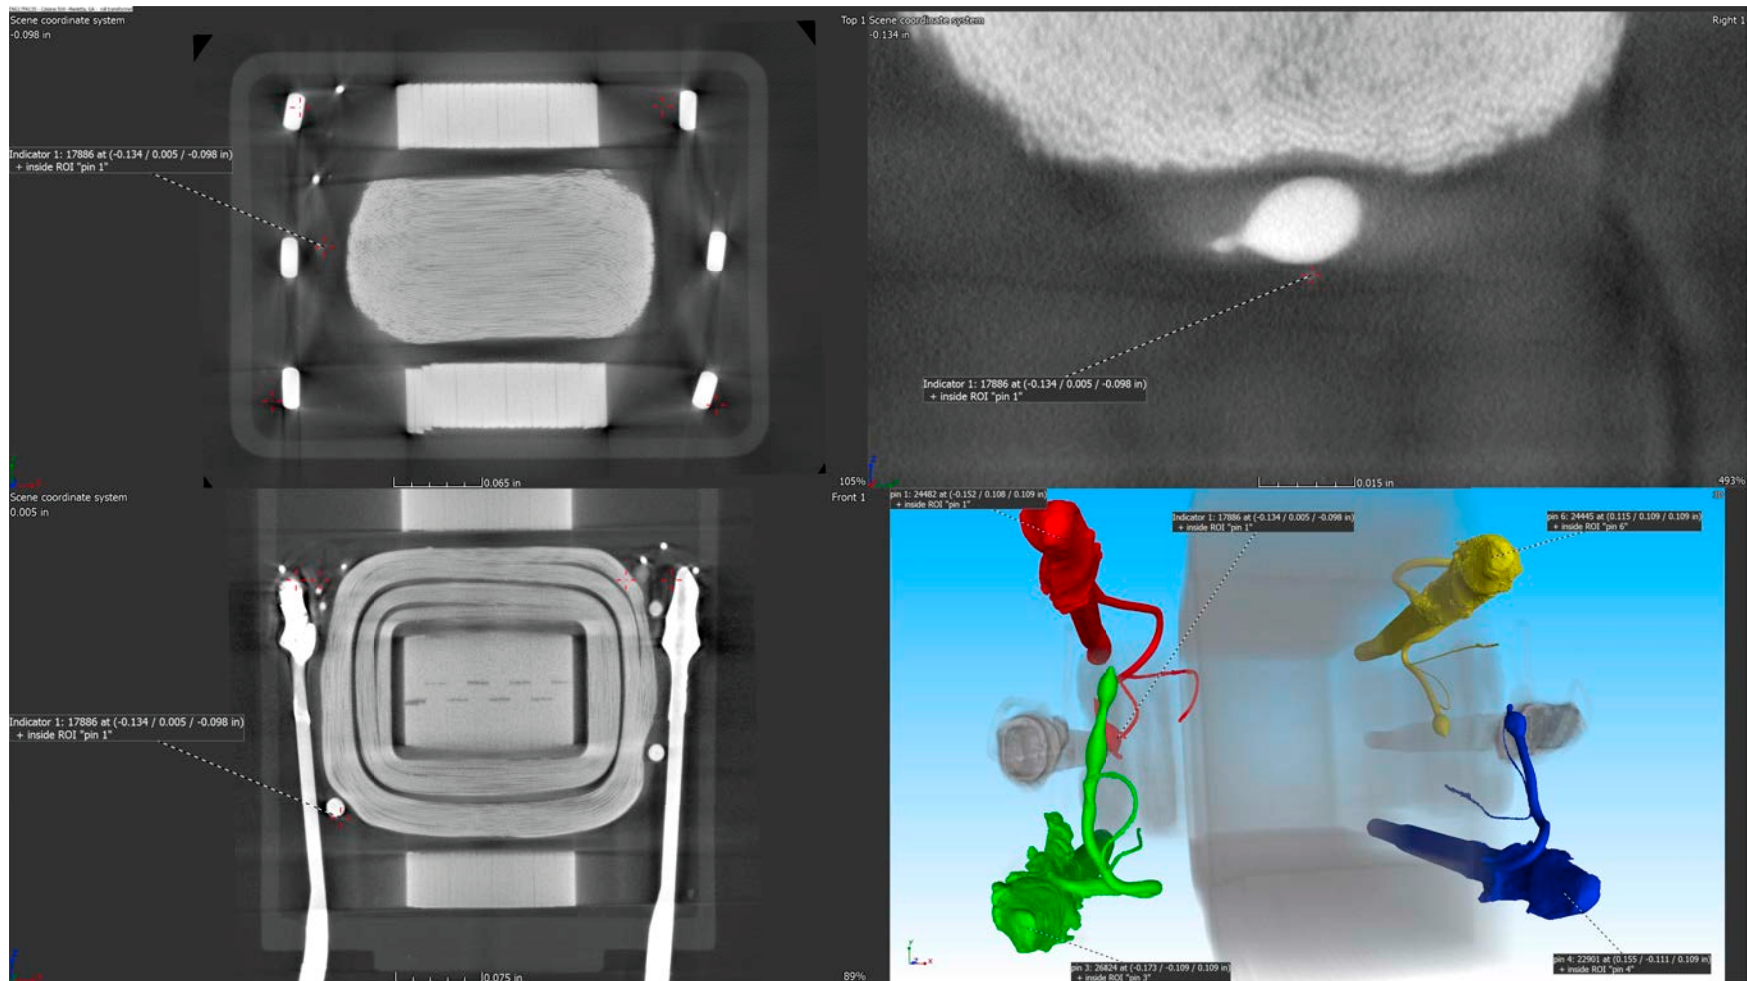
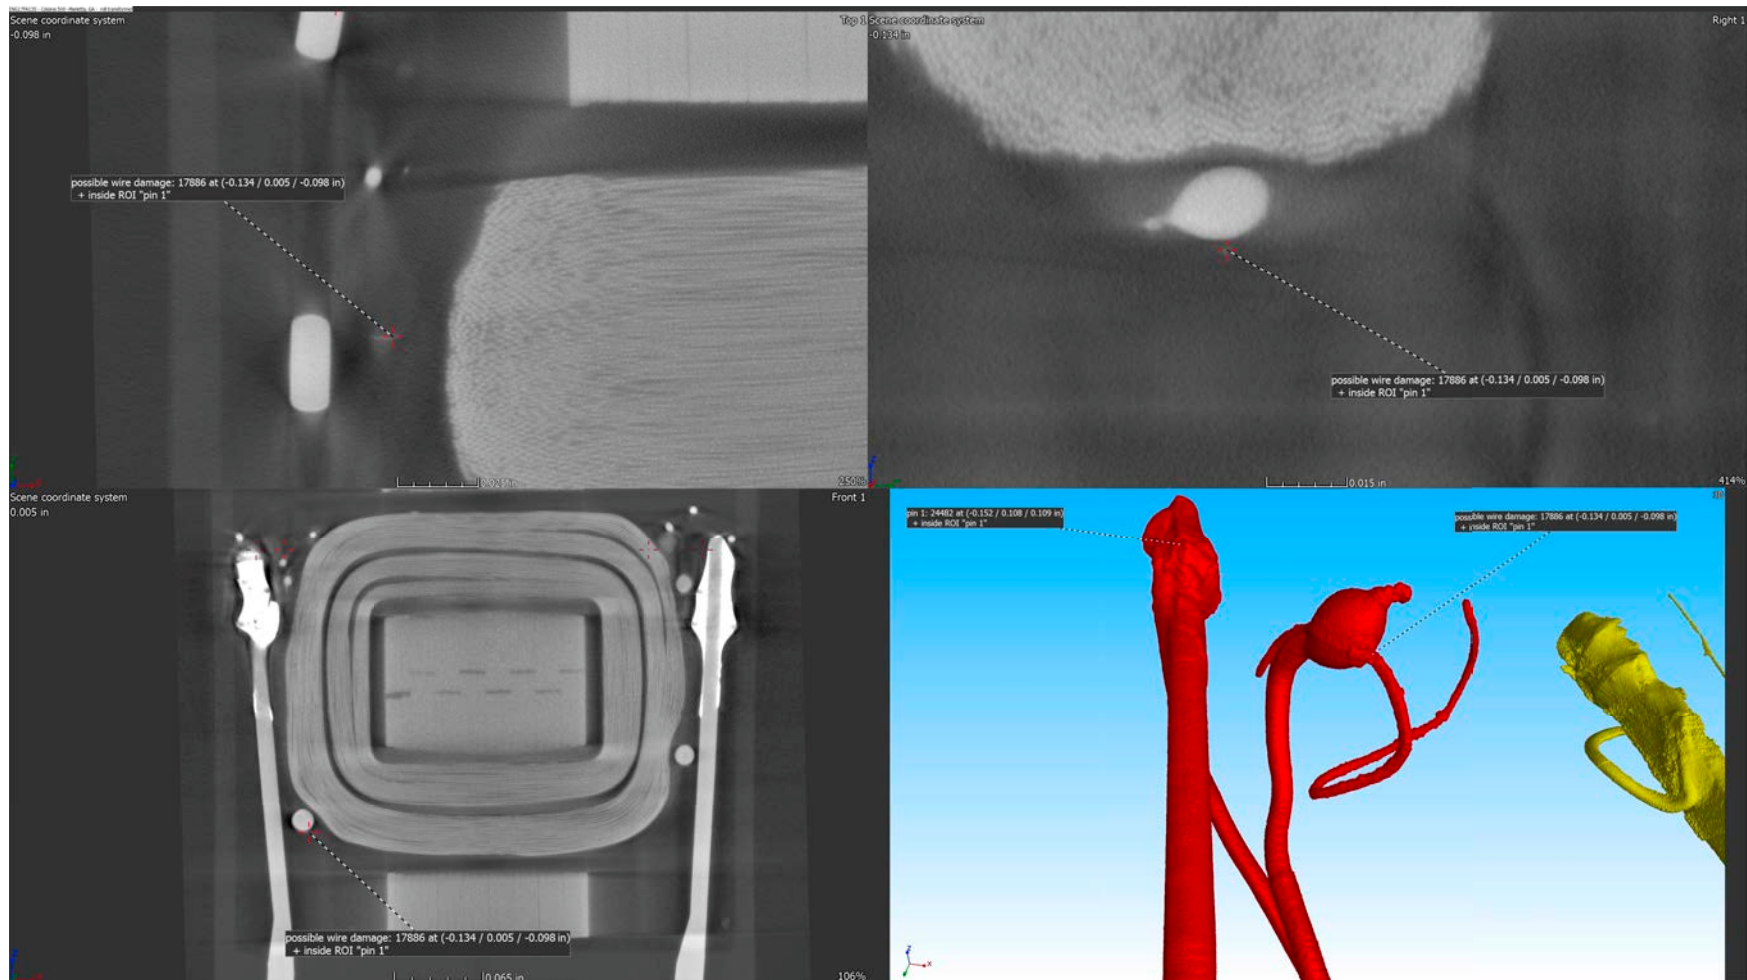
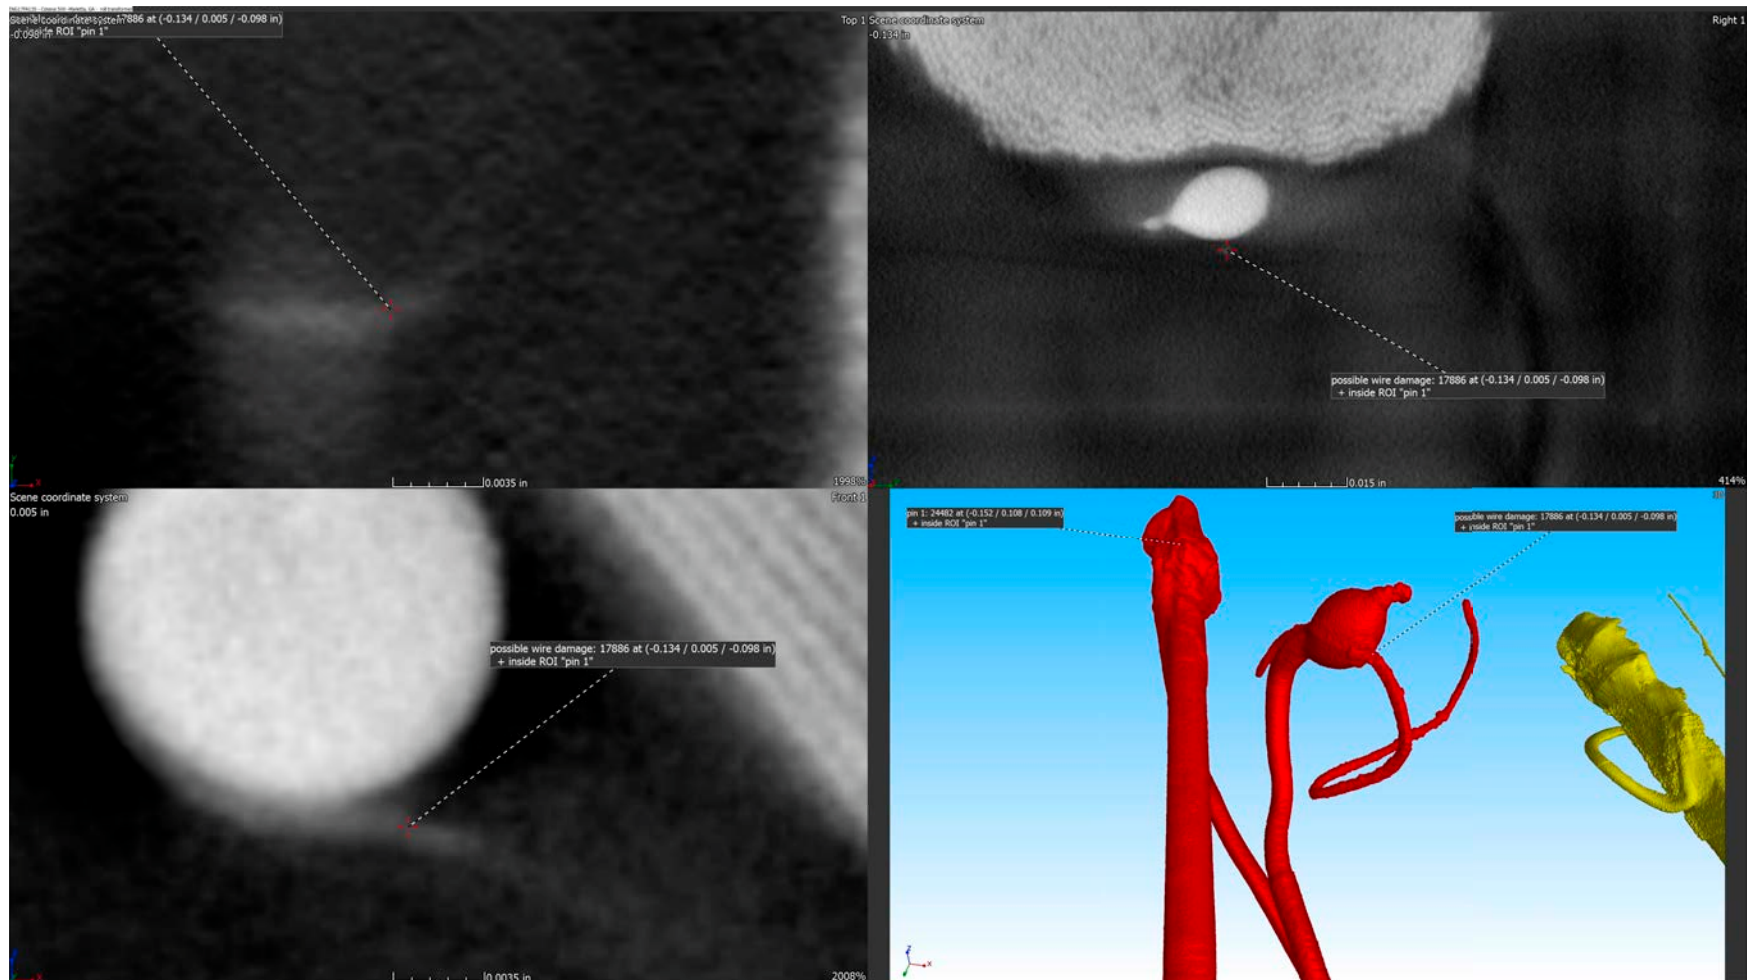
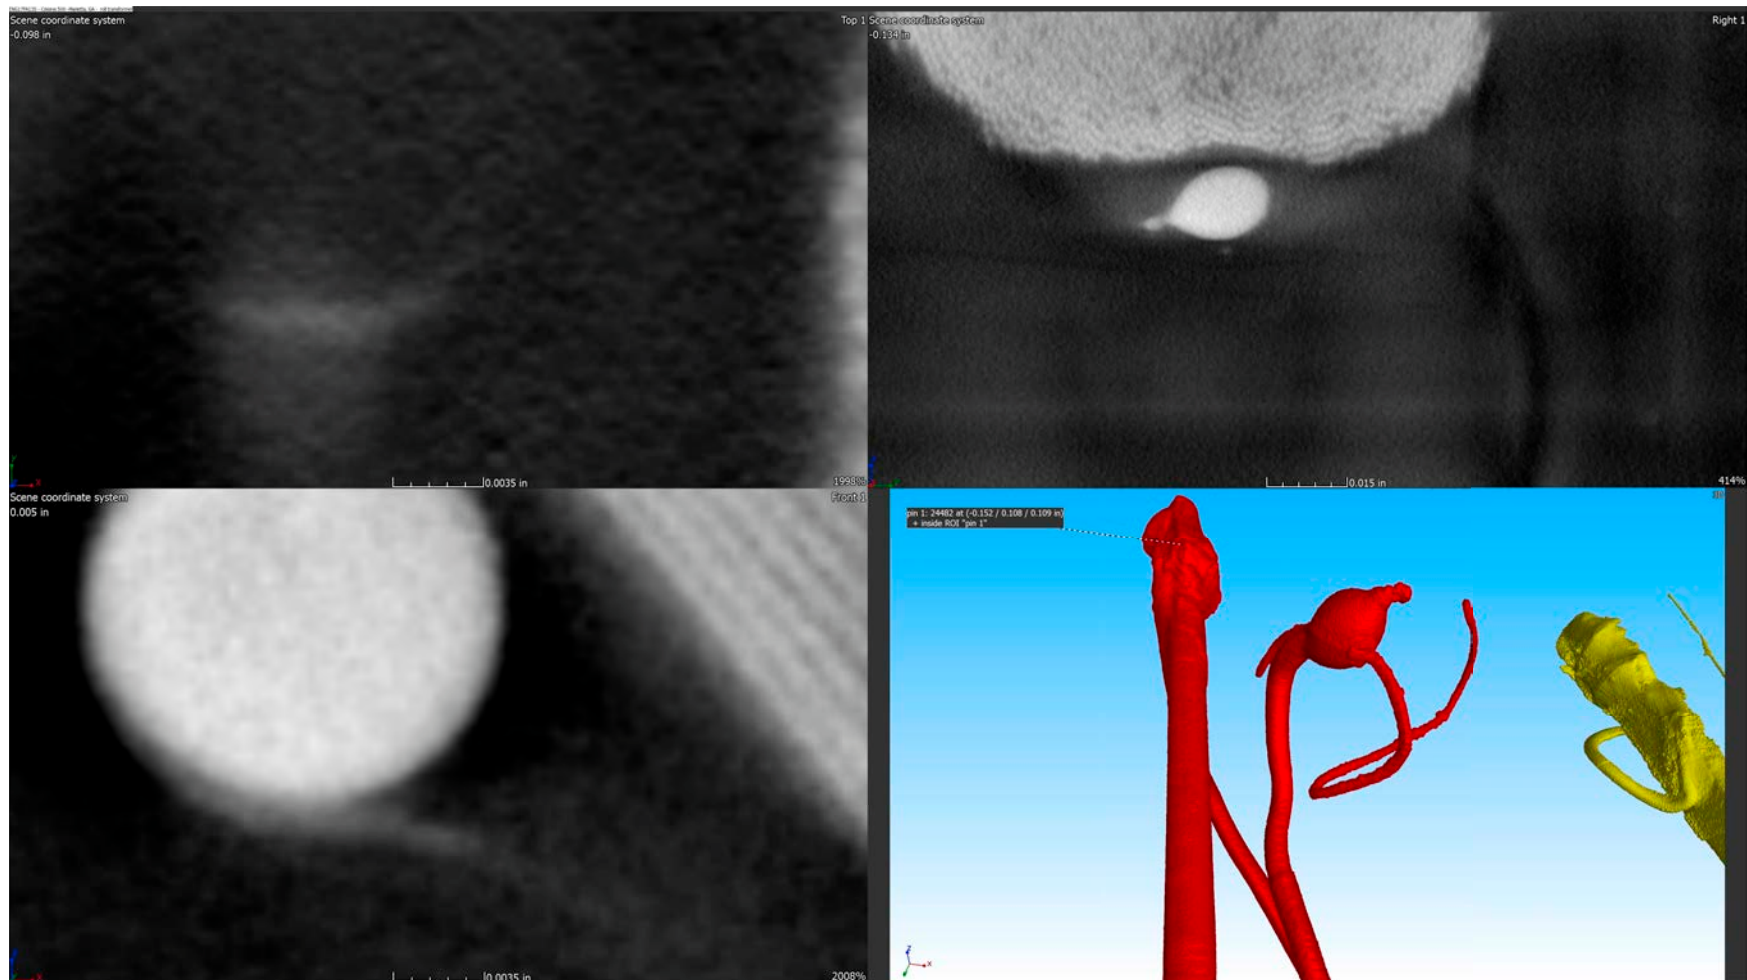
- there was possible wire damage noted in the microfocus scans associated with the coil wire from pin 1 of the roll transformer (figures 4-7);
- the attachment points and routing of the lead and coil wires associated with each pin of the Duncan Aviation unairworthy transformer appeared to be different (figure 8);

Figure 4  
Roll transformer – possible wire damage associated with pin 1 – top view

Figure 5  
Roll transformer – possible wire damage – view 2

Figure 6  
Roll transformer – possible wire damage – close up view

Figure 7  
Roll transformer – possible wire damage – close up view without indicators

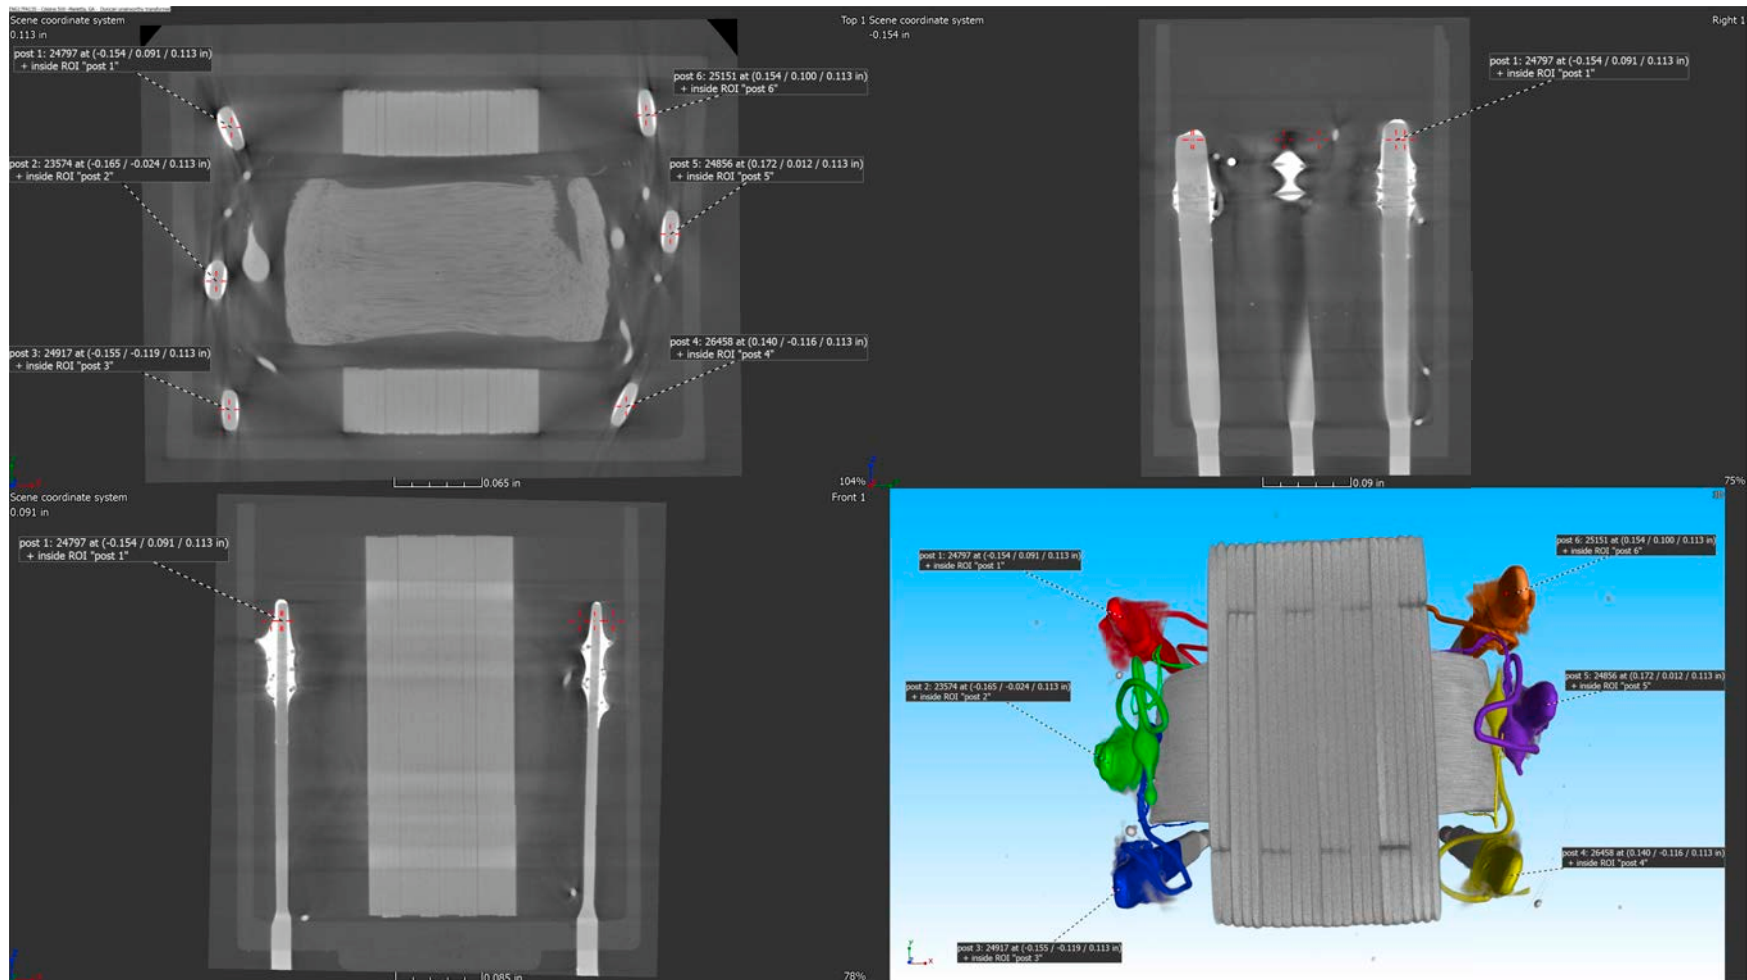
Figure 8  
Duncan Aviation unairworthy transformer – overall view

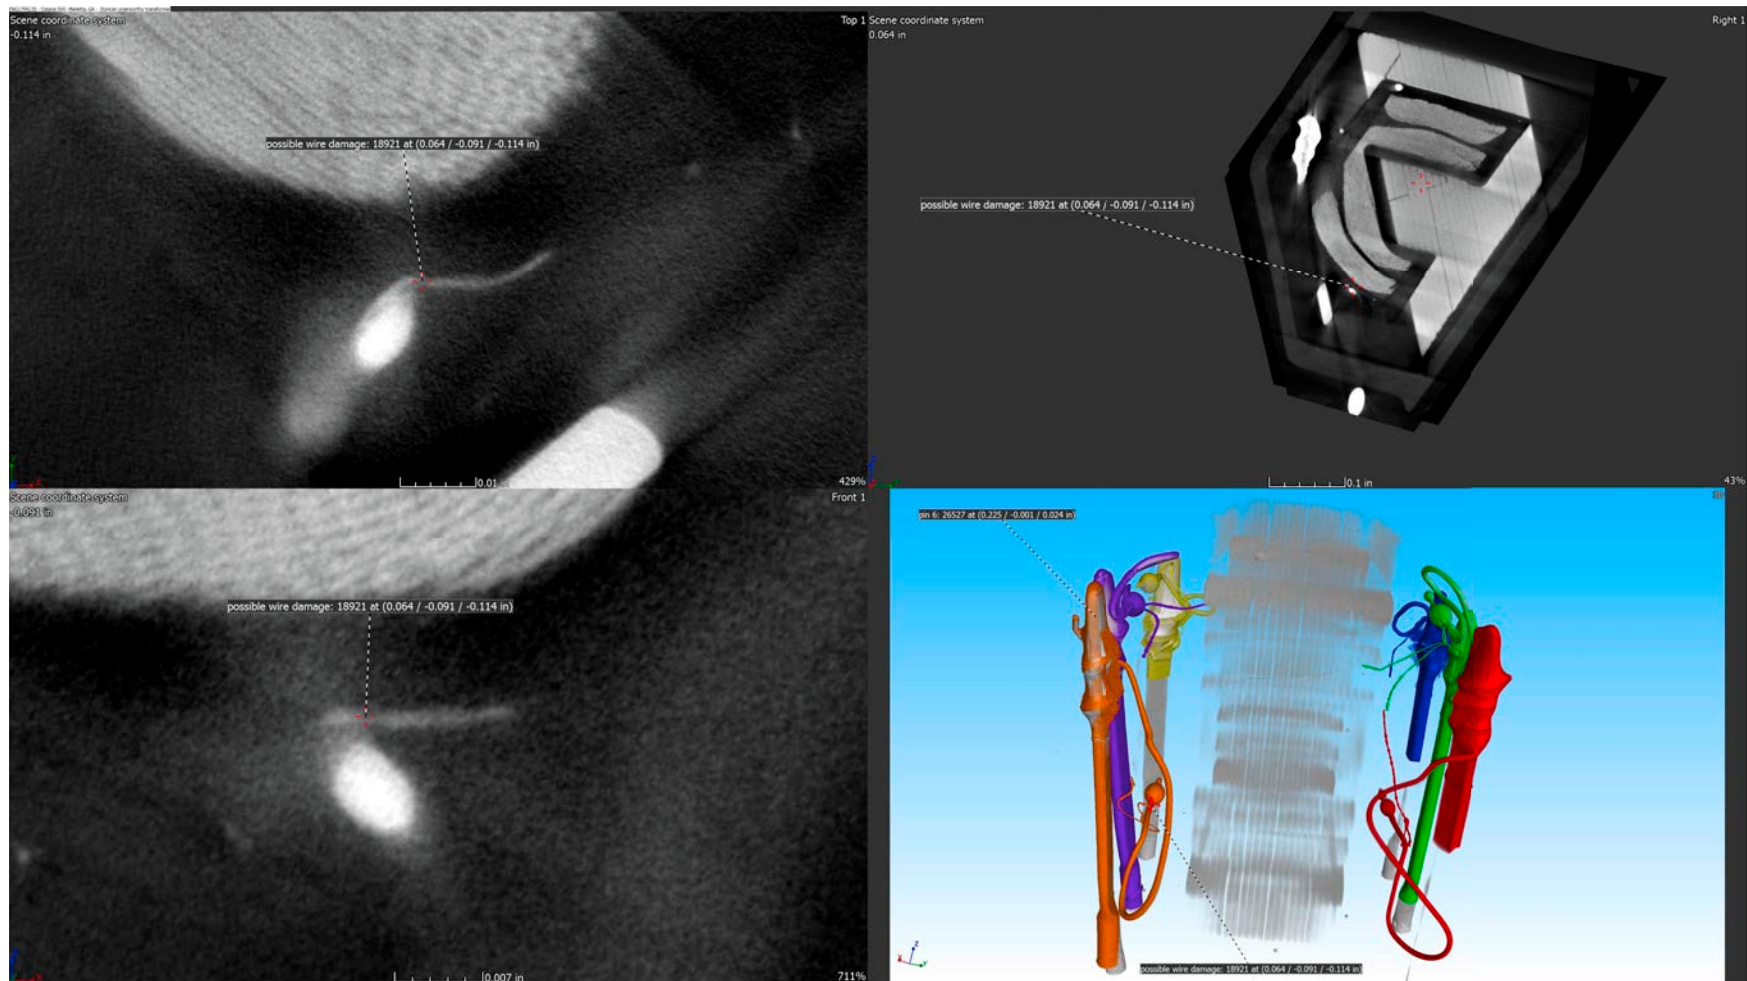
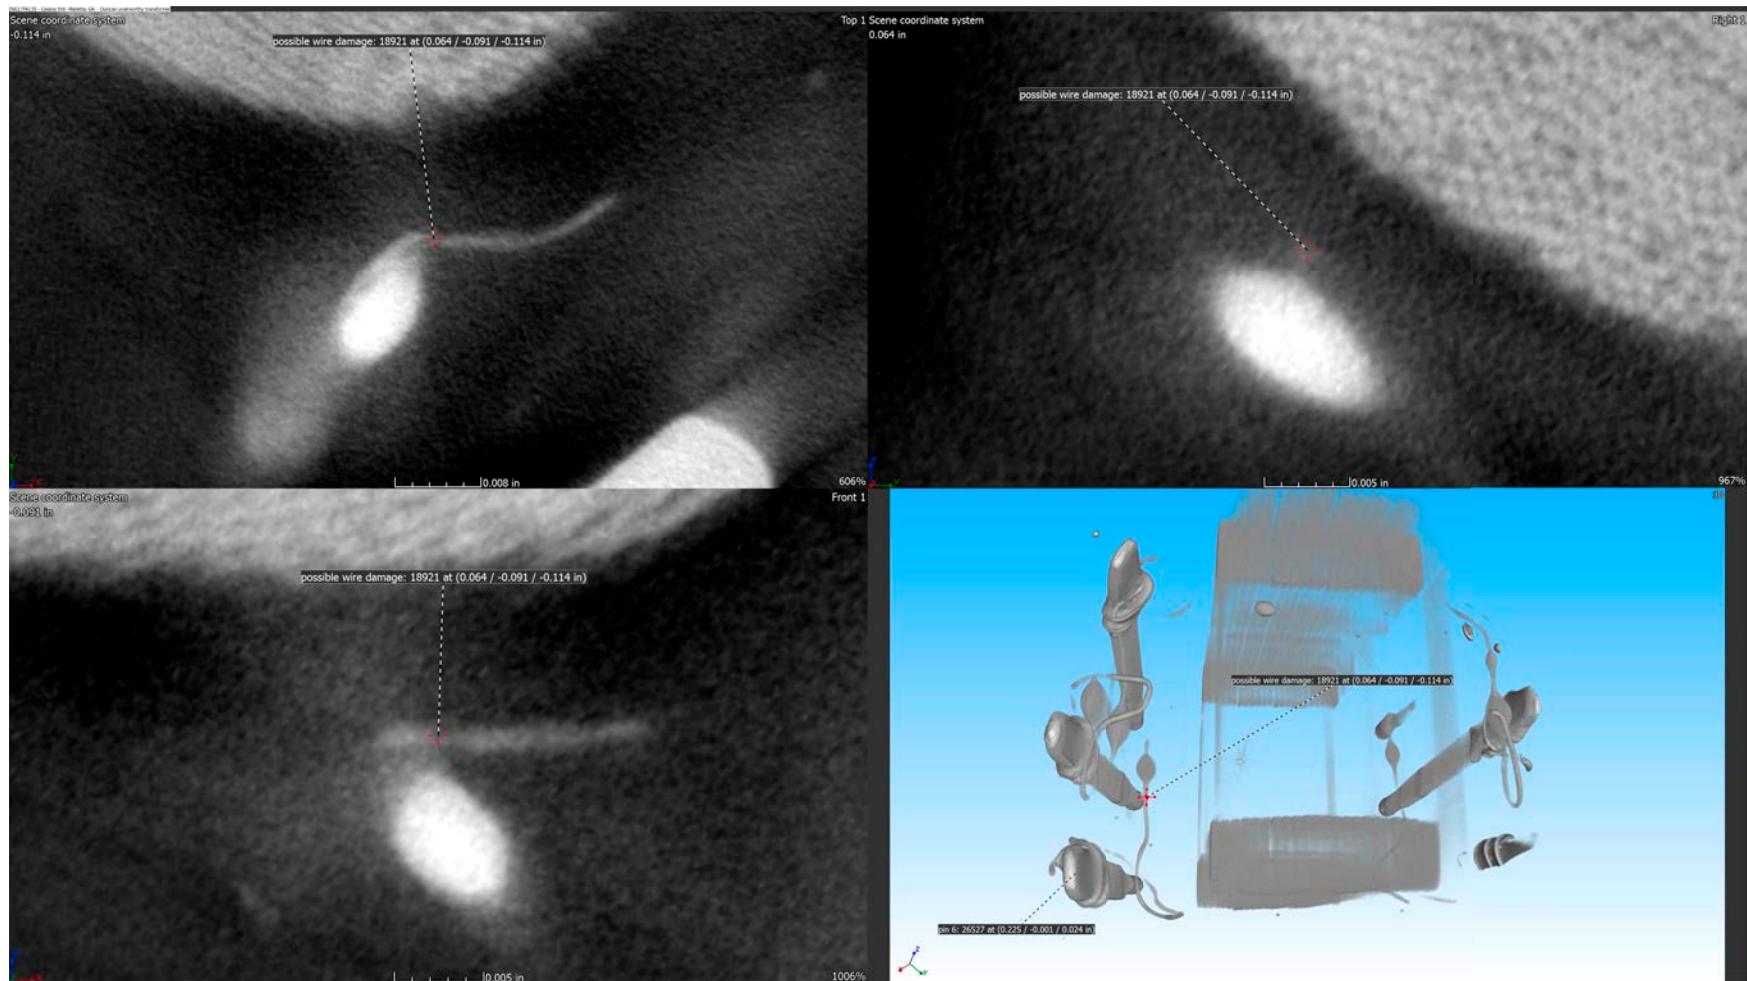
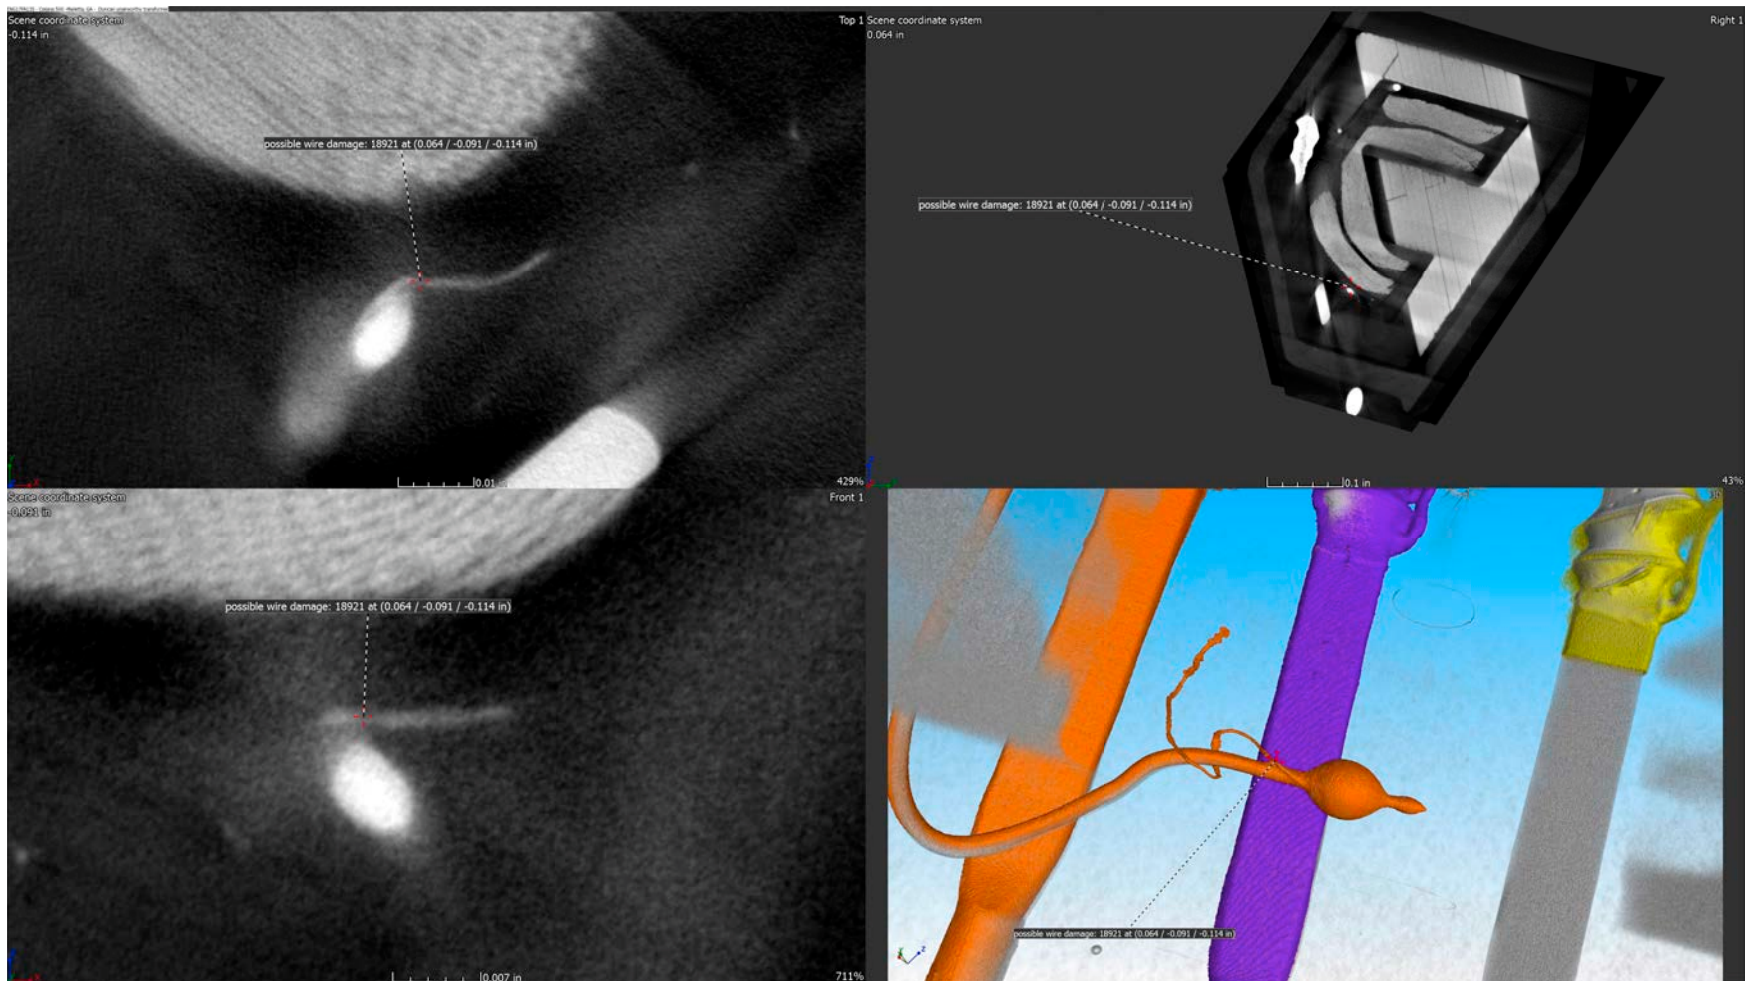
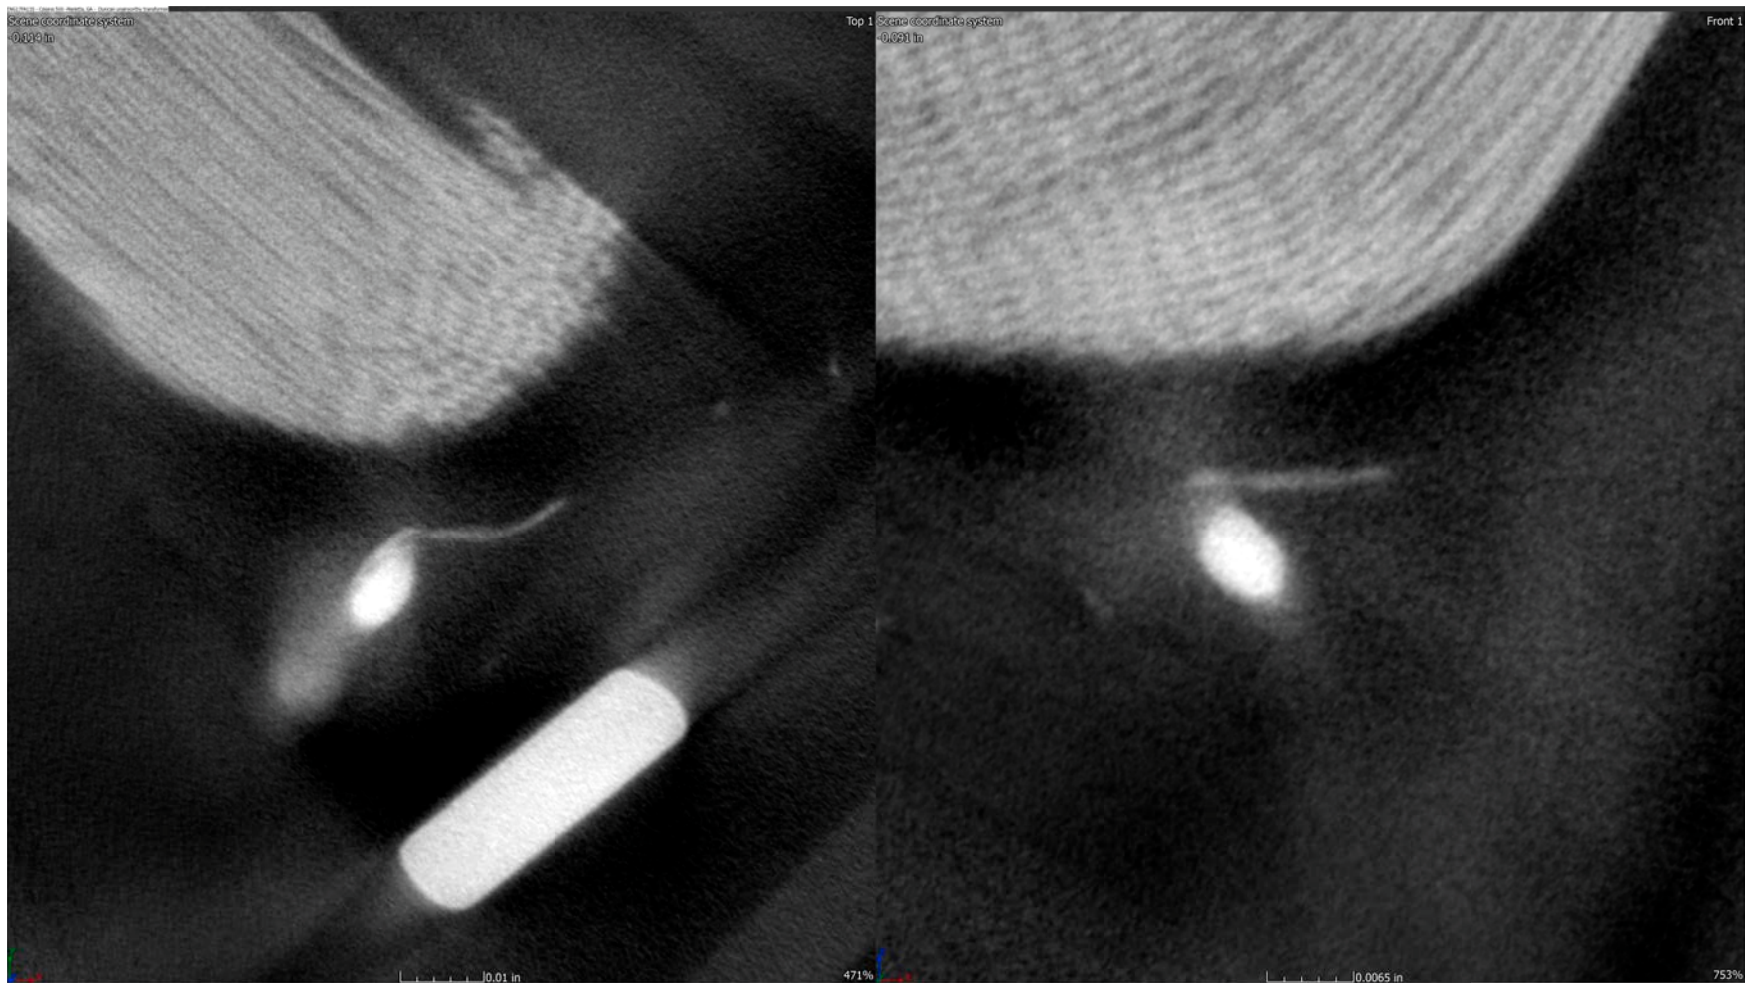
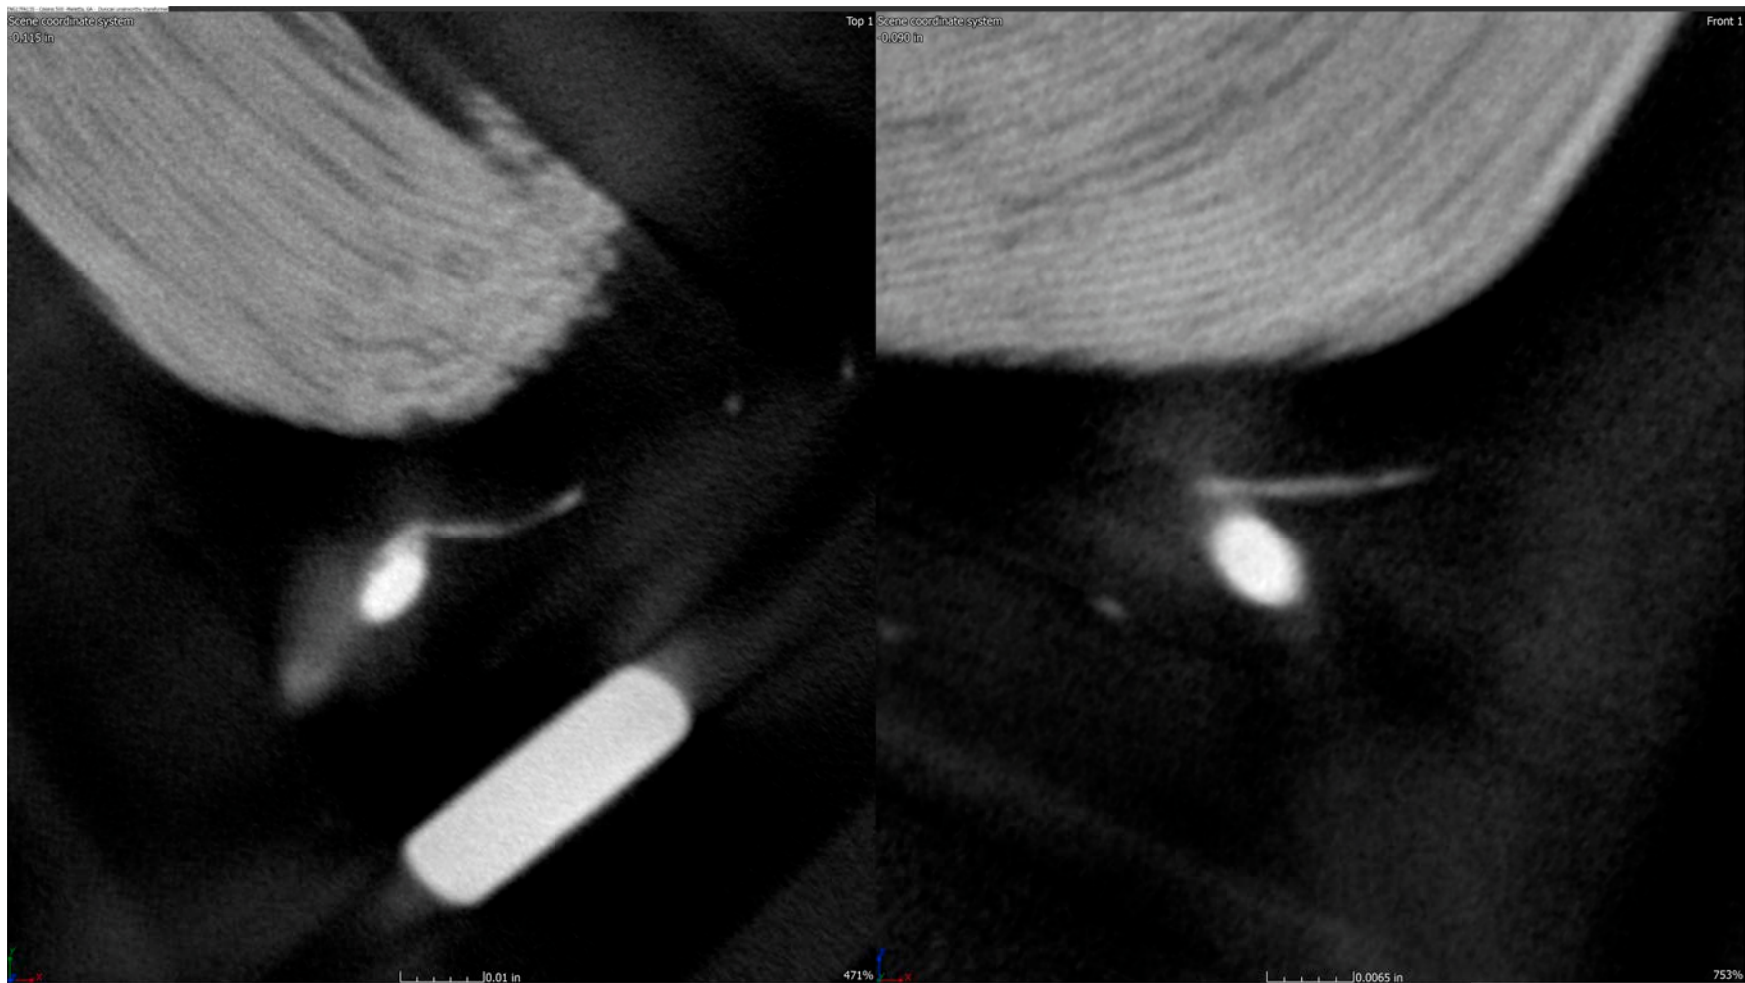
- there was possible wire damage noted in the microfocus scans associated with pin 6 of the Duncan Aviation unairworthy transformer – the coil wire appearance varied when pressure on pin 6 was applied and removed (figures 9-13);

Figure 9  
Duncan Aviation unairworthy transformer – with pressure applied to pin 6 – possible wire damage - overall view

Figure 10  
Duncan Aviation unairworthy transformer – with pressure applied to pin 6 – possible wire damage - overall view 2

Figure 11  
Duncan Aviation unairworthy transformer – with pressure applied to pin 6 – possible wire damage - overall view 3

Figure 12  
Duncan Aviation unairworthy transformer – with pressure applied to pin 6 – possible wire damage – close up view

Figure 13  
Duncan Aviation unairworthy transformer – with no pressure applied to pin 6 – possible wire damage – close up view
