**NATIONAL TRANSPORTATION SAFETY BOARD**

**Computed Tomography Specialist's Factual Report**

ERA17FA135

Location: Marietta, Georgia  
Date: March 24, 2017  
Time: 1924 eastern daylight time  
Airplane: Textron Aviation Citation 500, N8DX

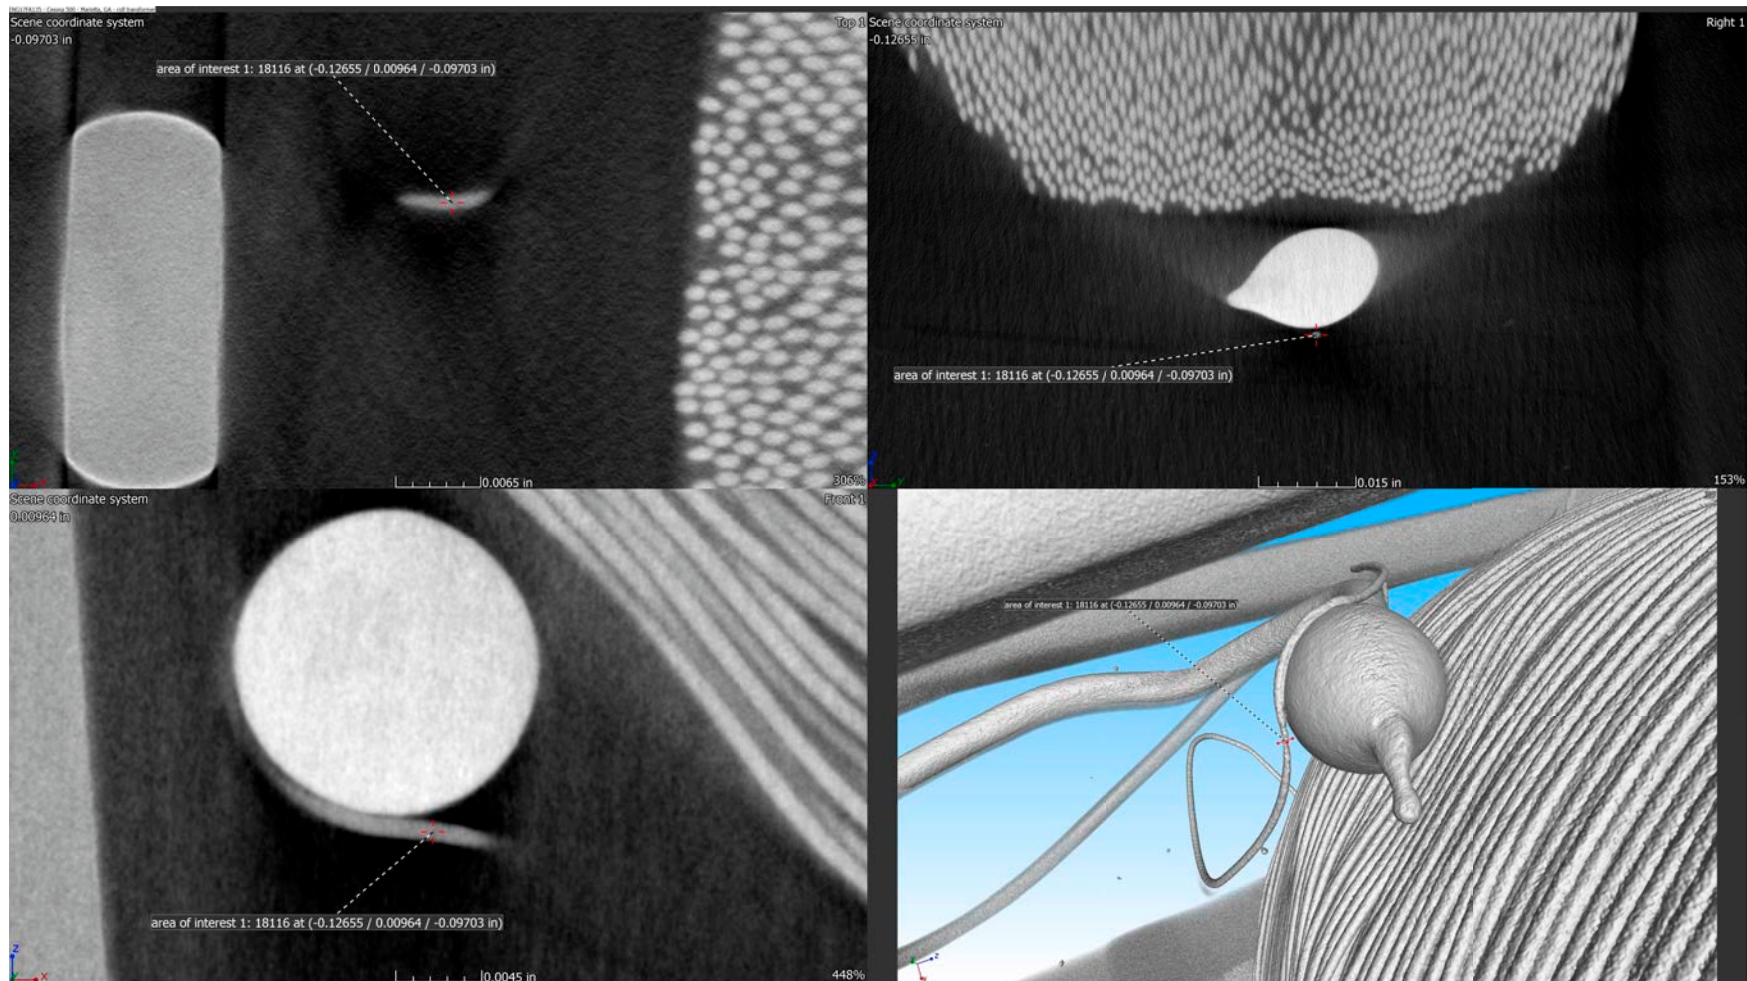
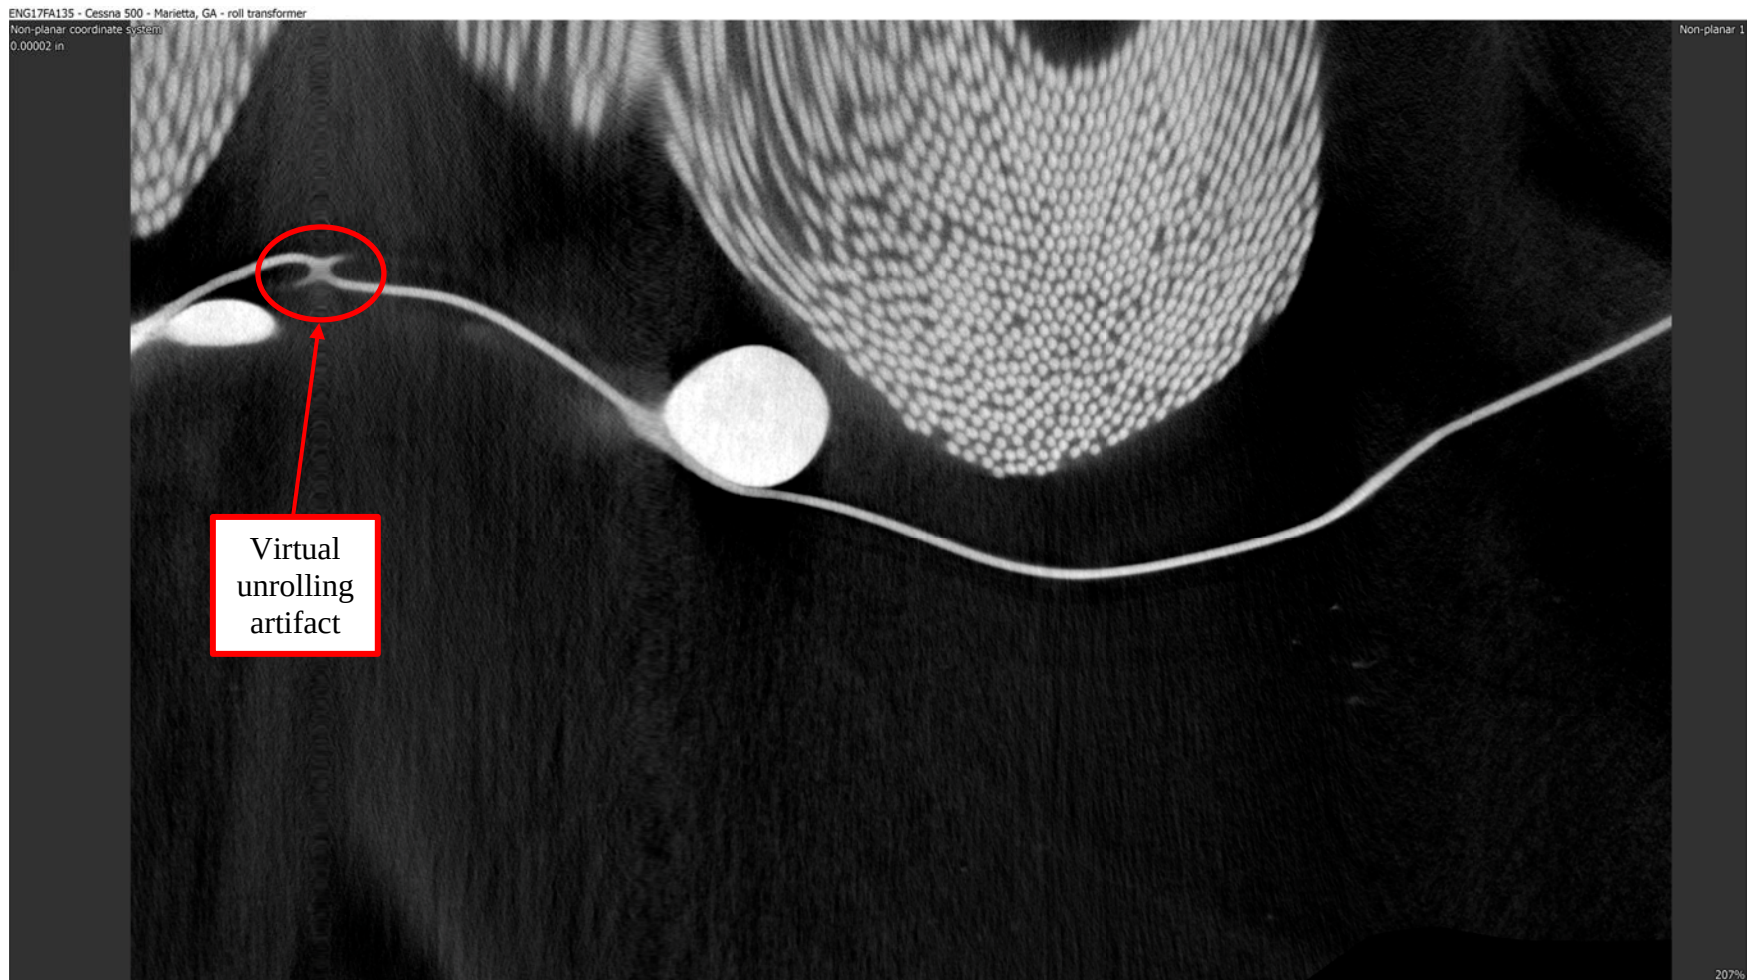
- the LLNL scans did not show any indications of wire damage in the coil wires associated with pins 1, 3, 4, and 6 of the roll transformer (example images showing the area of interest shown in figures 6 and 7 as well as the complete coil wire length of pin 1’s coil wire are shown in figures 14 and 15);

Figure 14  
Roll transformer – LLNL scans - possible wire damage area noted in figures 6 and 7 – close up view

Figure 15  
Roll transformer – LLNL scans – coil wire for pin 1 – virtually unrolled

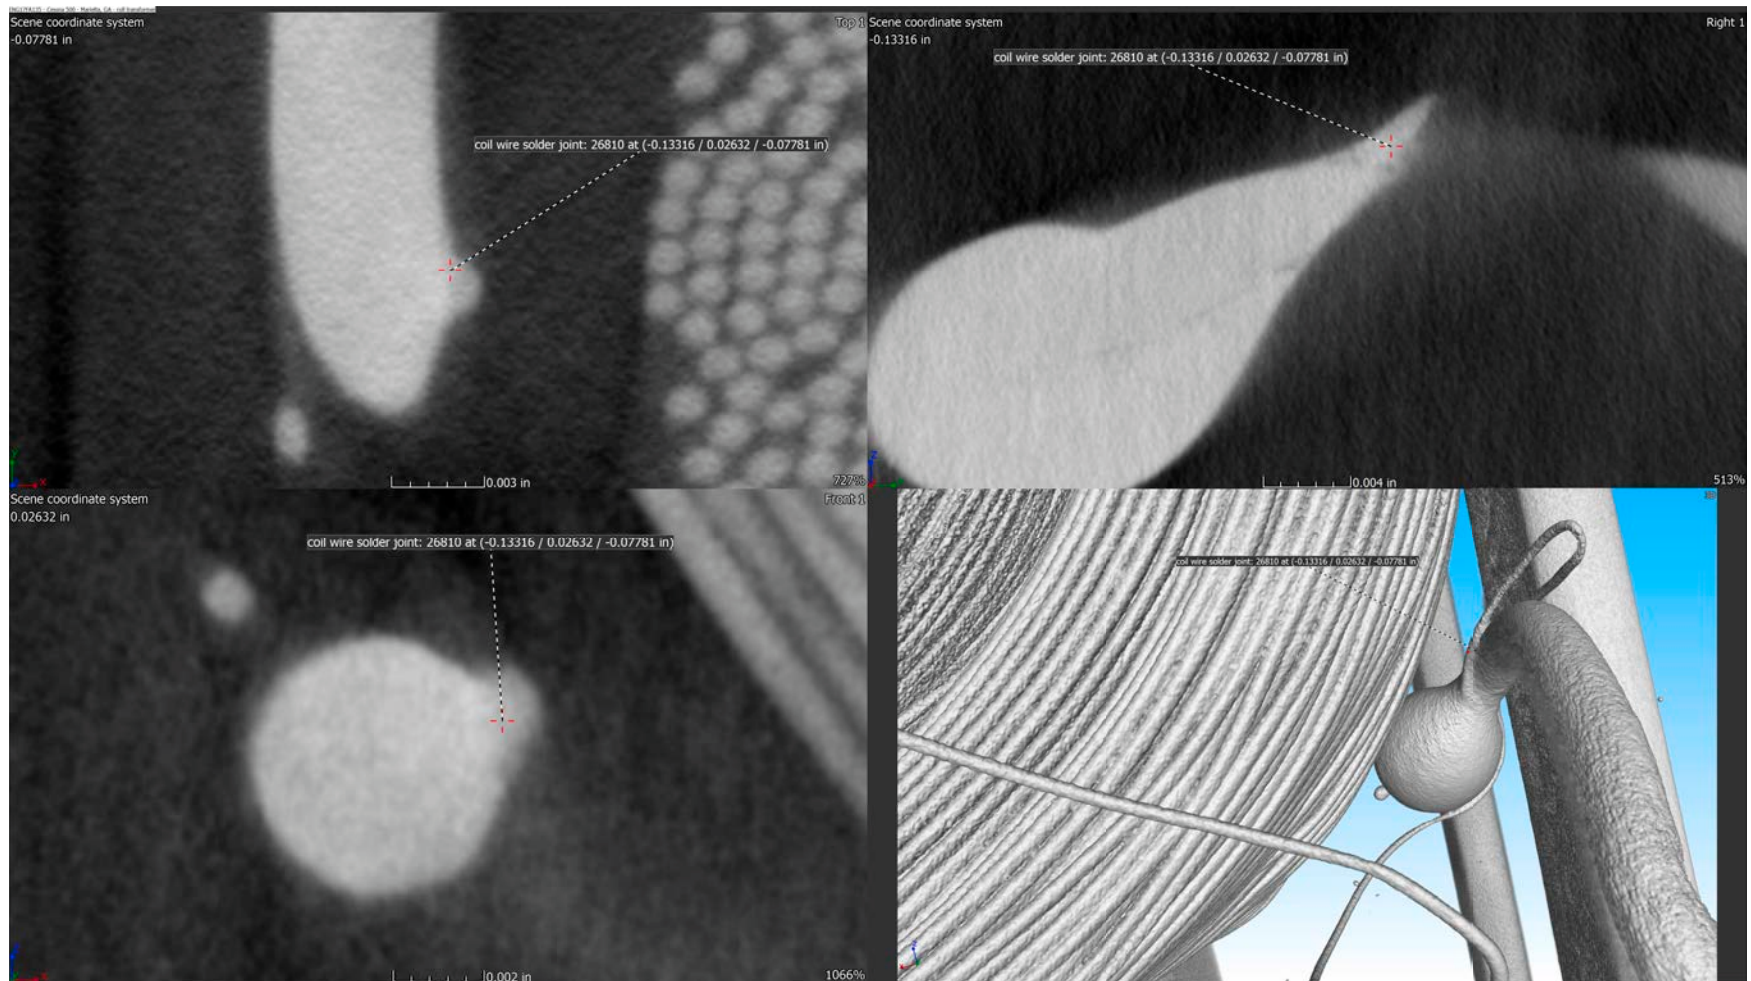
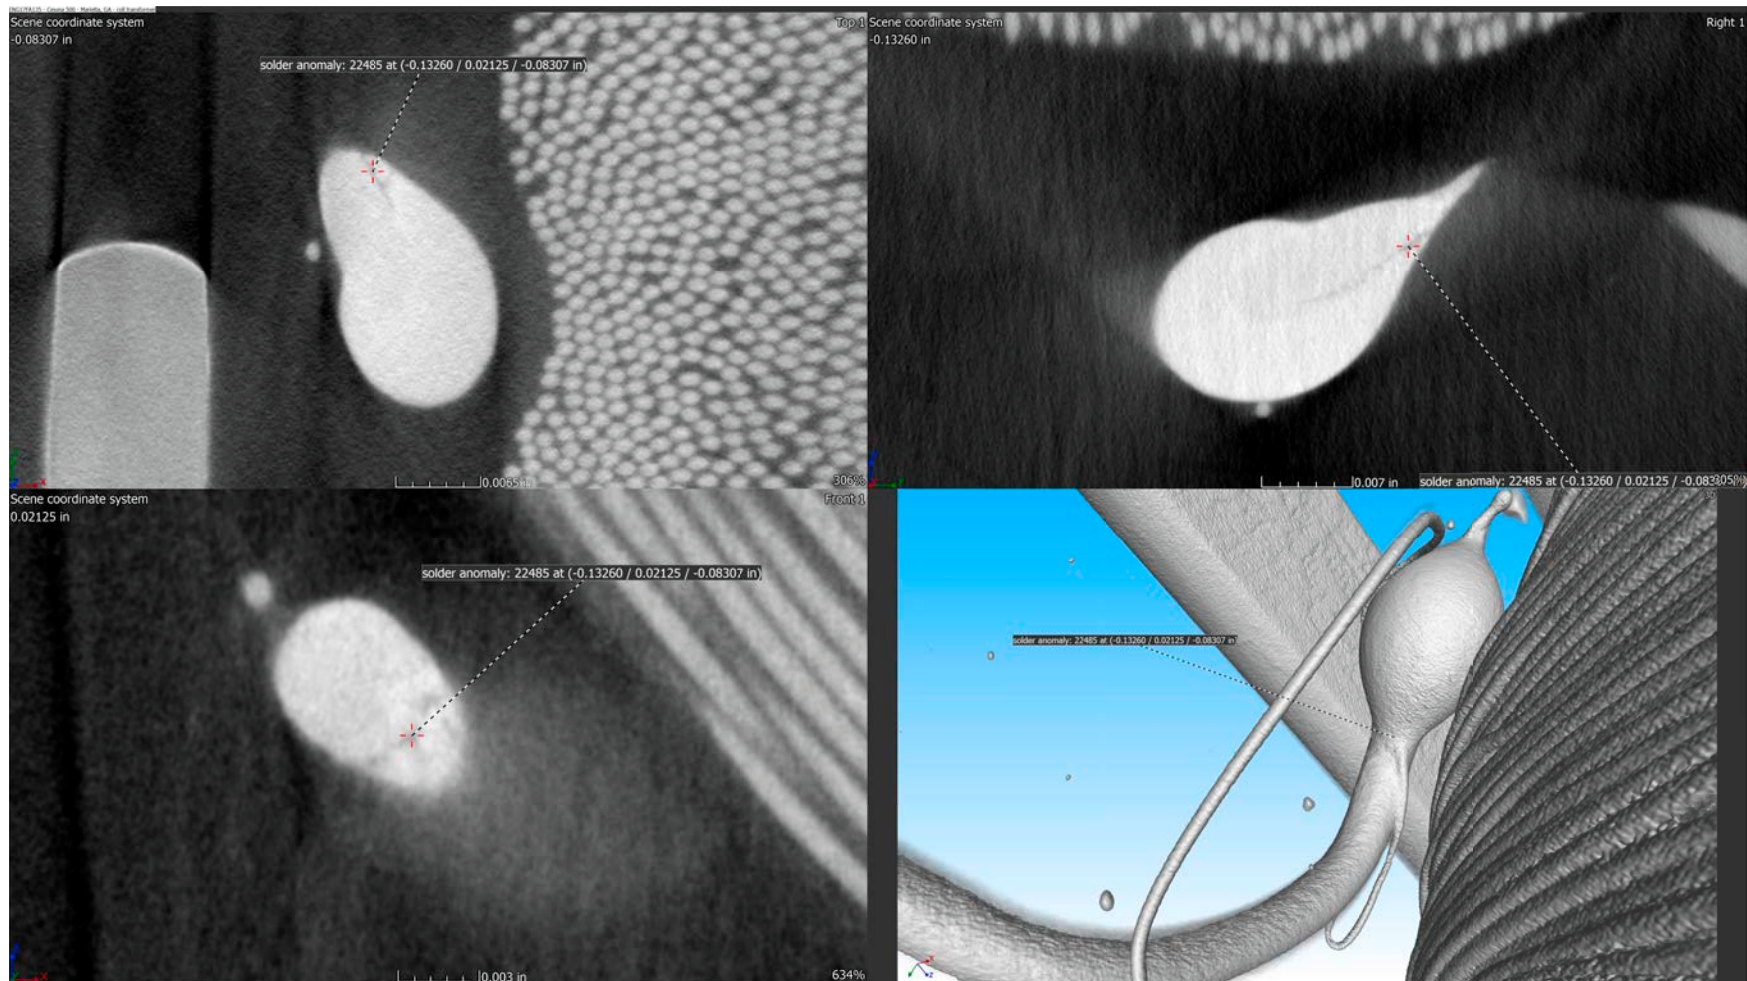
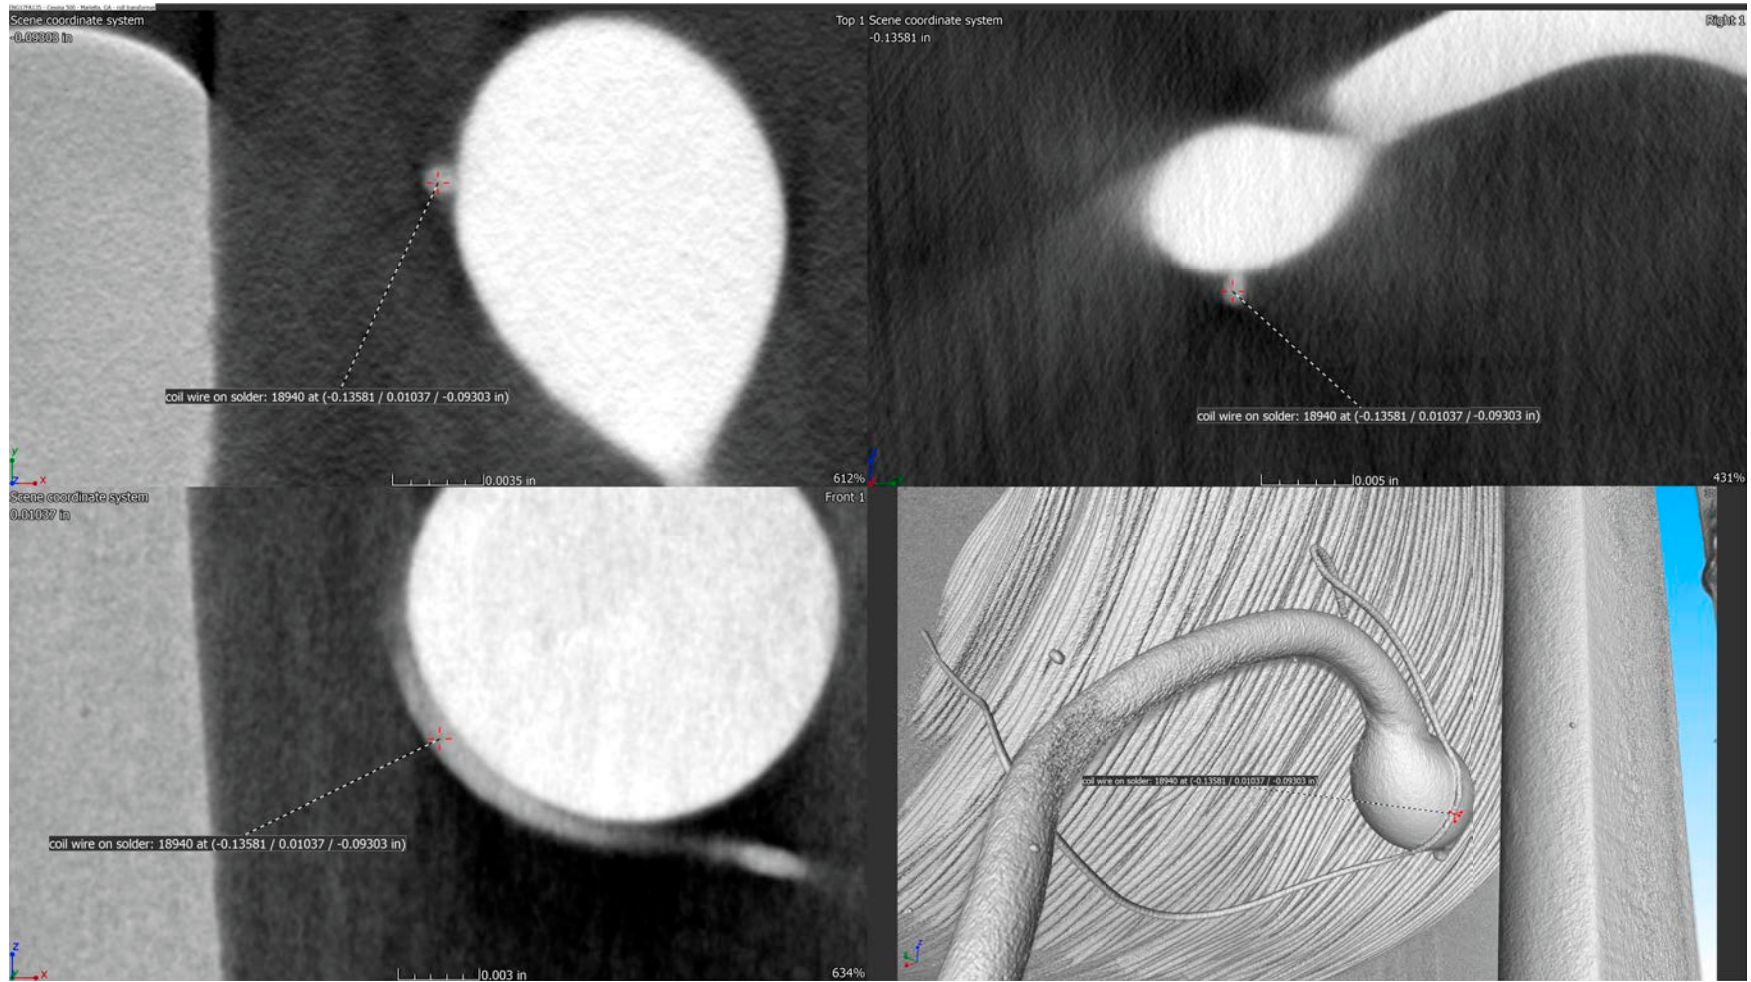
- the LLNL scans showed additional details regarding the coil wire for pin 1 of the roll transformer (figures 16 – 18);
- the LLNL scans indicated several areas within the roll transformer which included high density particles, medium density particles, medium density areas, and voids (figures 19 – 33);

Figure 16  
Roll transformer – LLNL scans – lead wire to coil wire solder contact

Figure 17  
Roll transformer – LLNL scans – lead wire to coil wire solder joint – anomaly area

Figure 18  
Roll transformer – LLNL scans – coil wire on solder connection

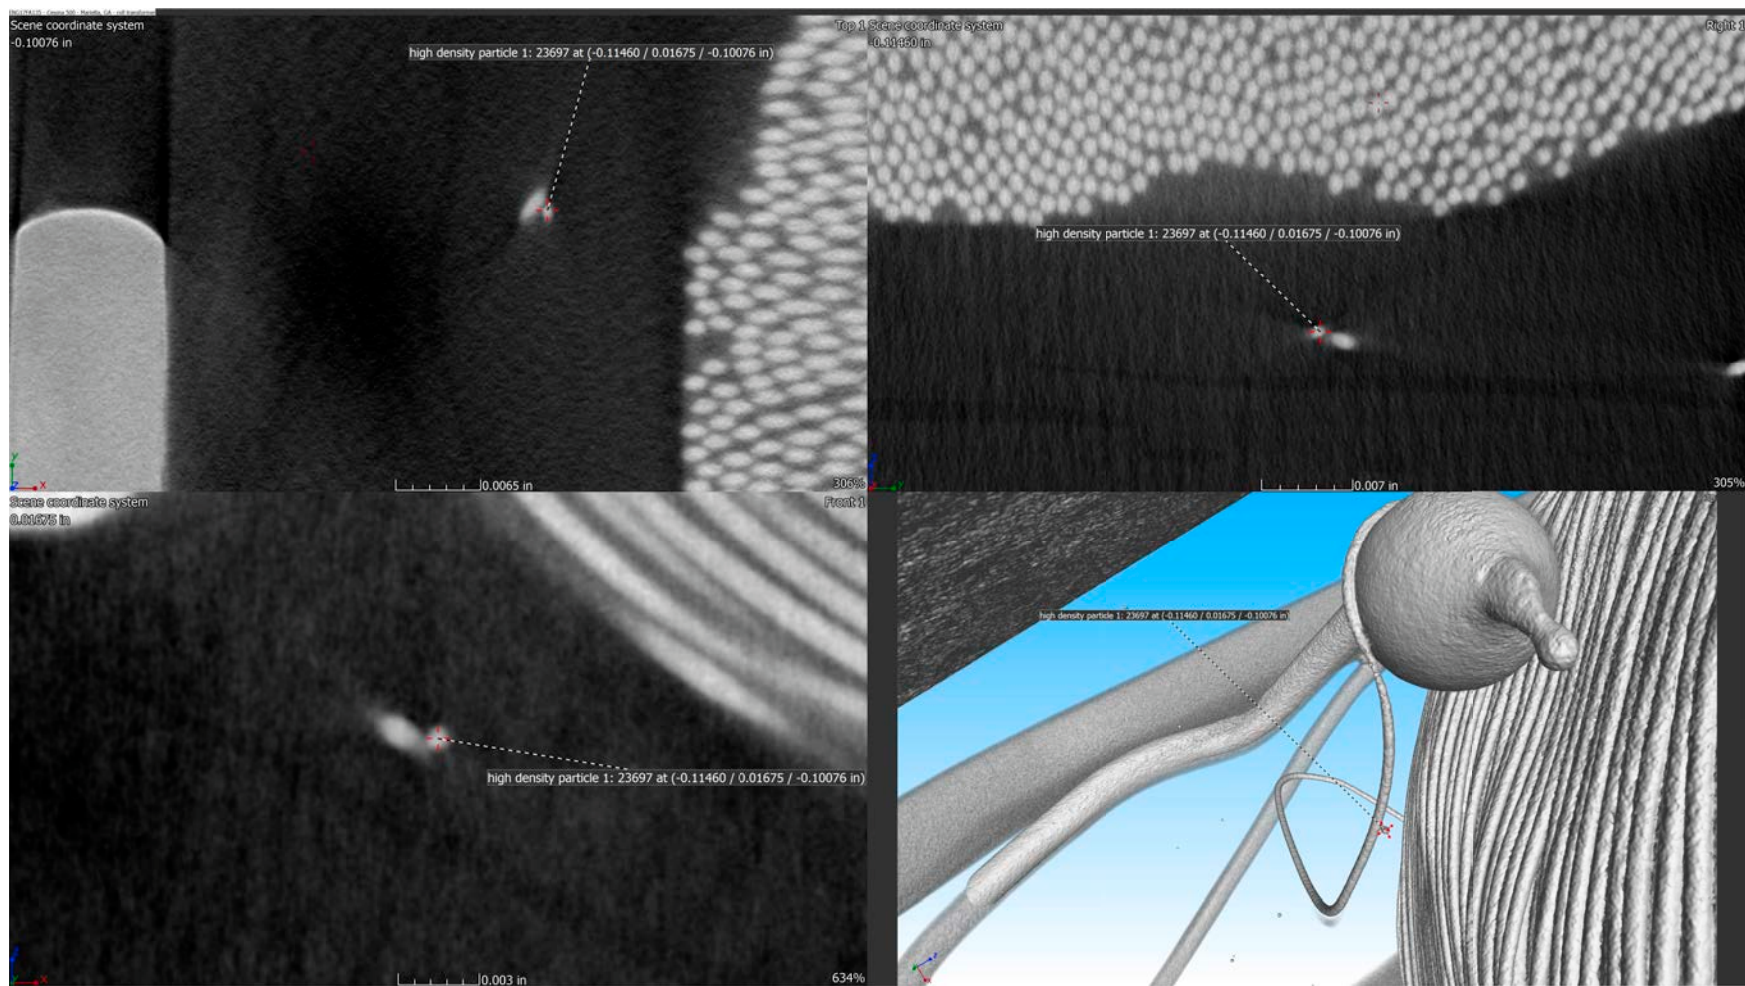
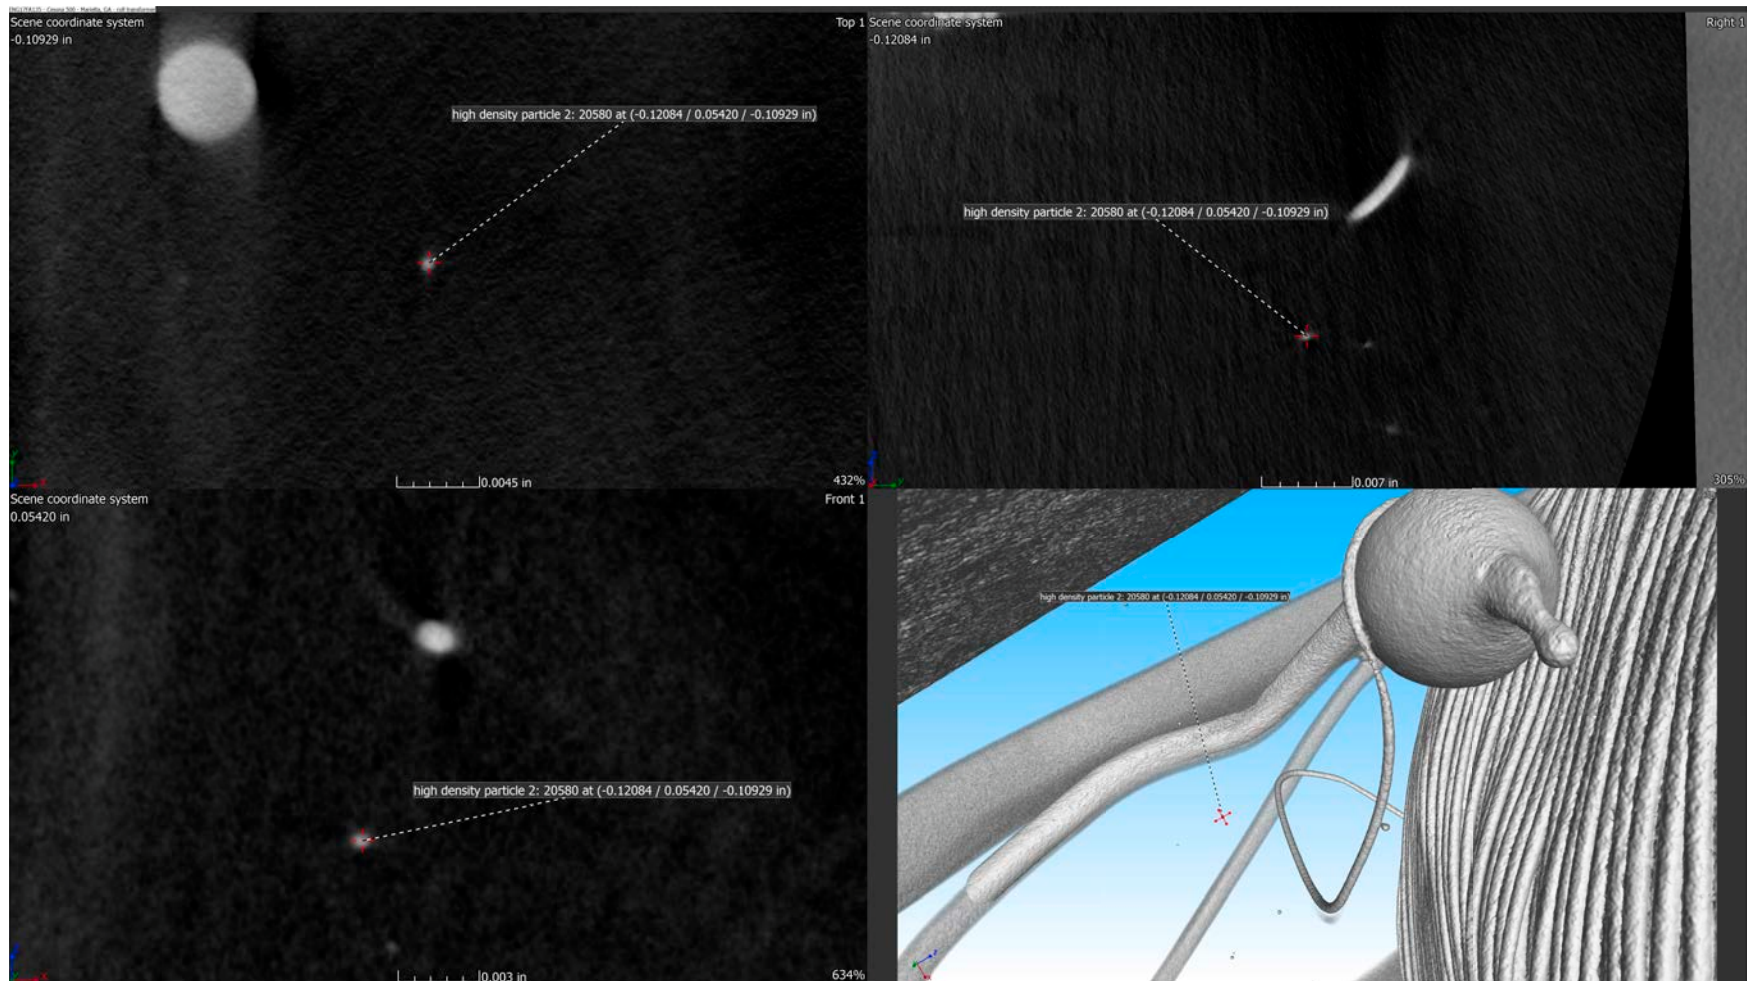
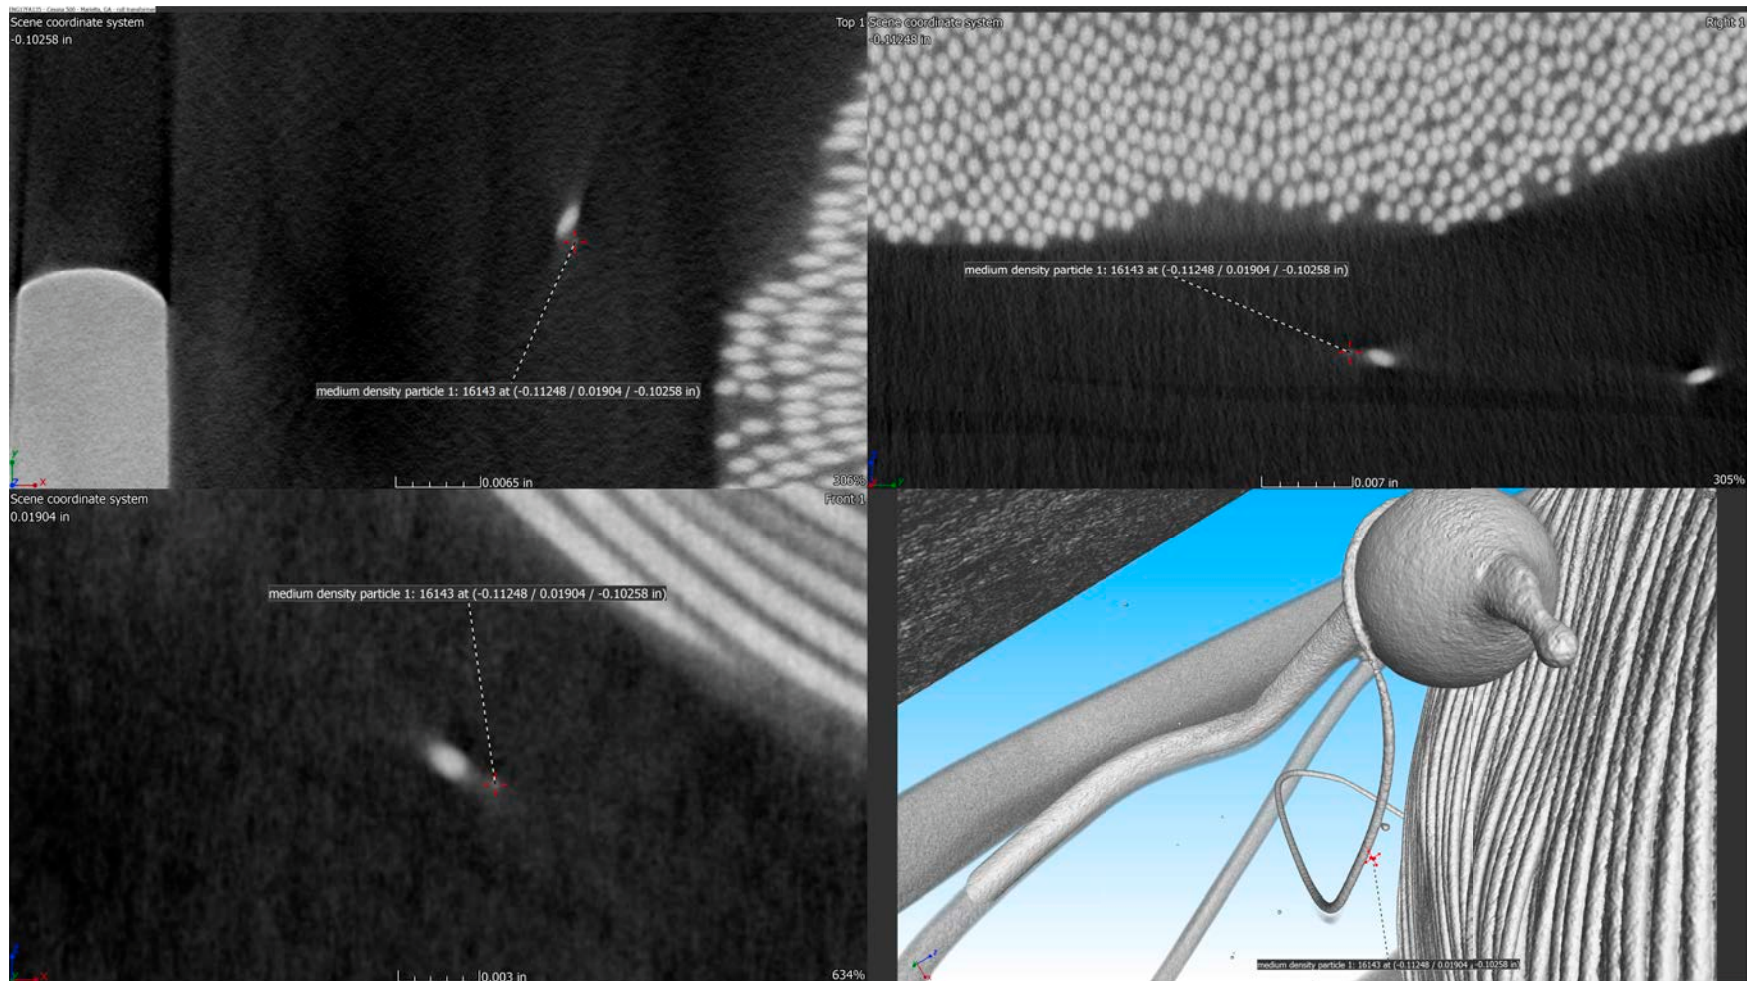
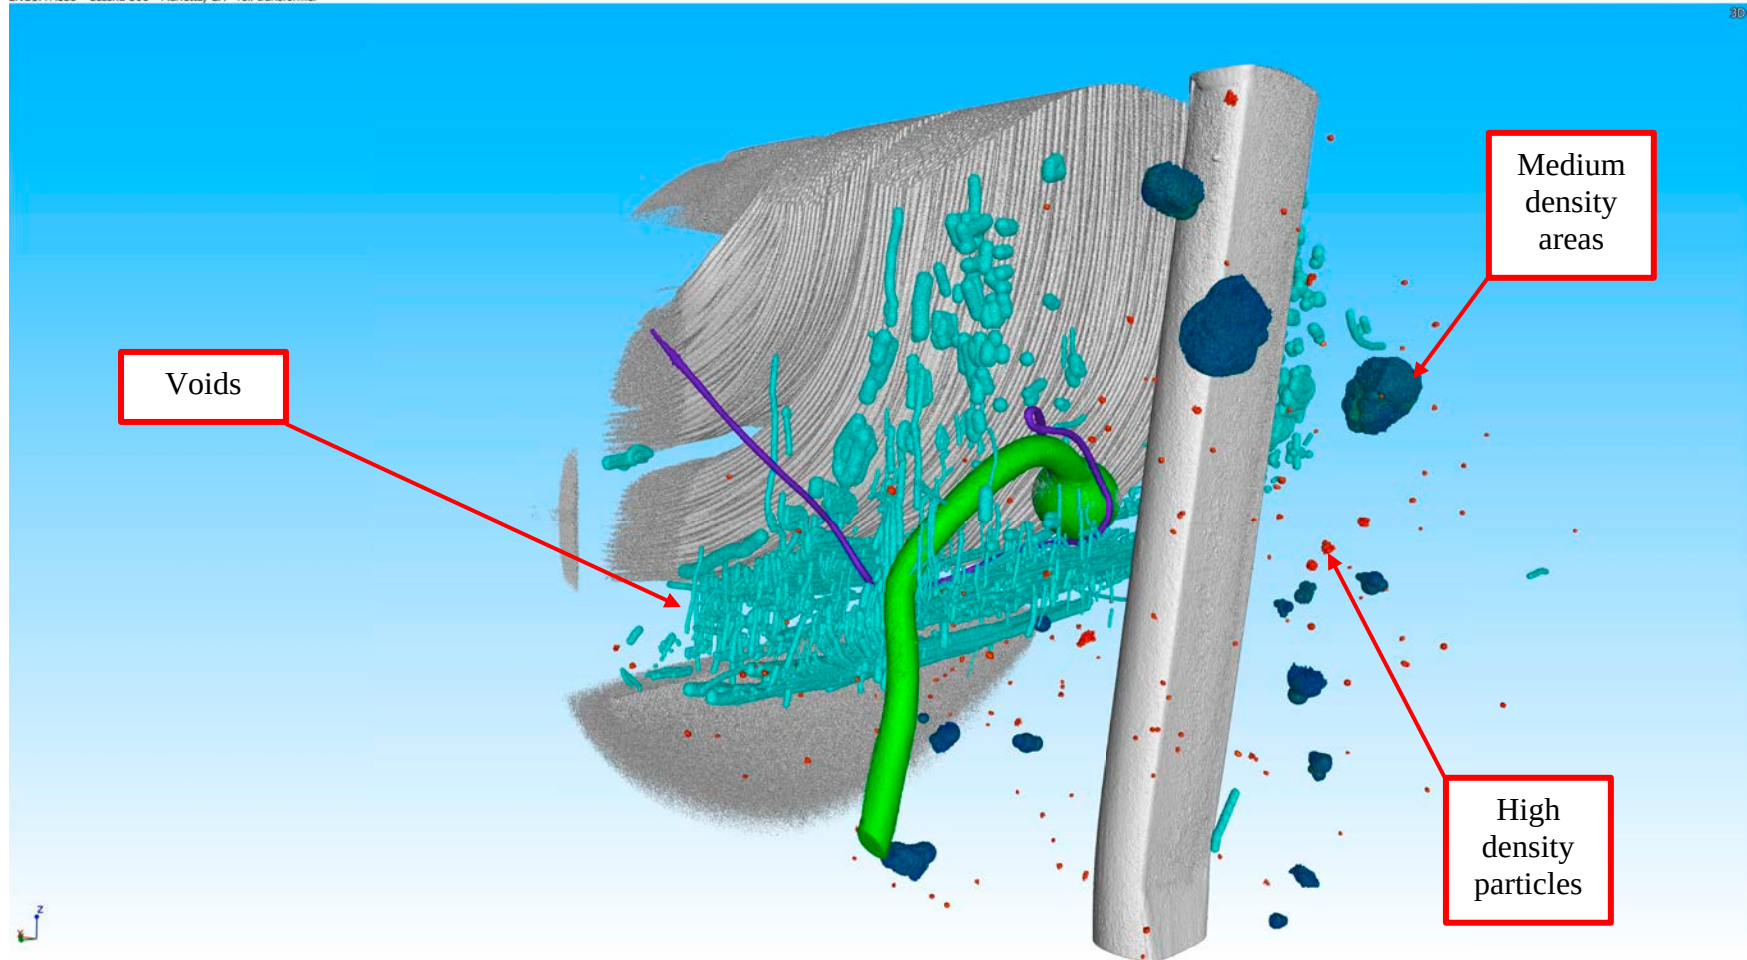
Figure 19  
Roll transformer – LLNL scans – high density particle

Figure 20  
Roll transformer – LLNL scans – high density particle 2

Figure 21  
Roll transformer – LLNL scans – medium density particle

Figure 22  
Roll transformer – LLNL scans – voids, high density particles, and medium density areas
