**NATIONAL TRANSPORTATION SAFETY BOARD**

**Computed Tomography Specialist's Factual Report**

ERA17FA135

Location: Marietta, Georgia  
Date: March 24, 2017  
Time: 1924 eastern daylight time  
Airplane: Textron Aviation Citation 500, N8DX

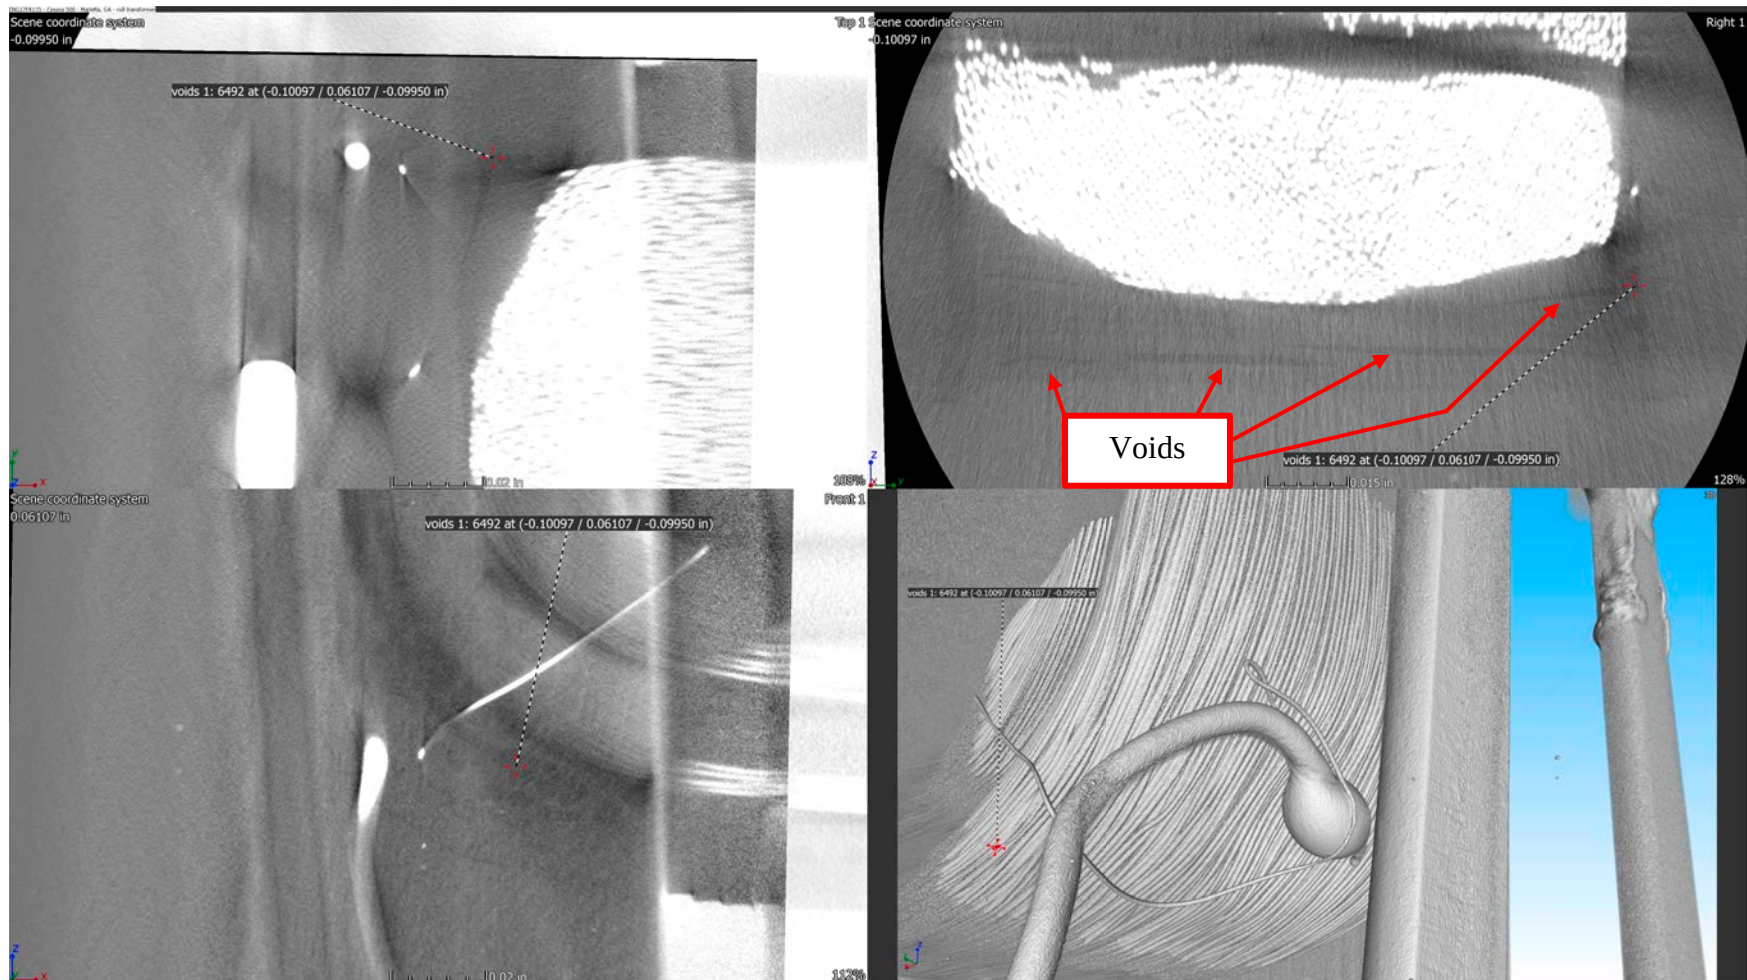
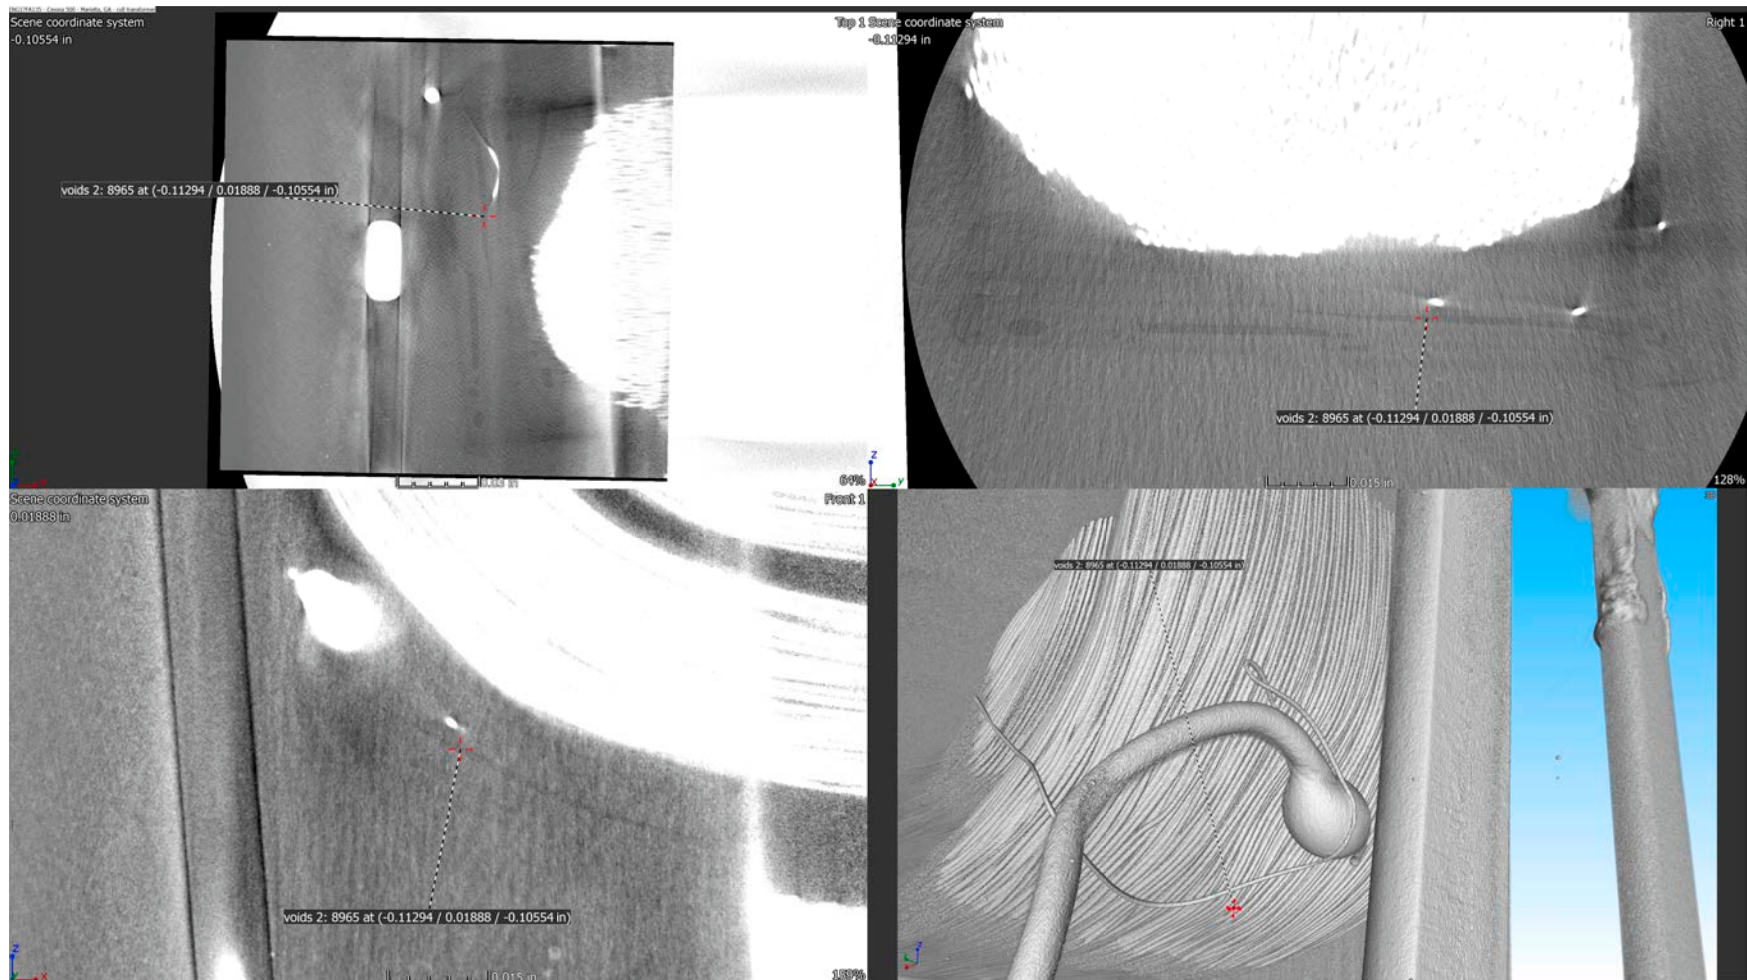
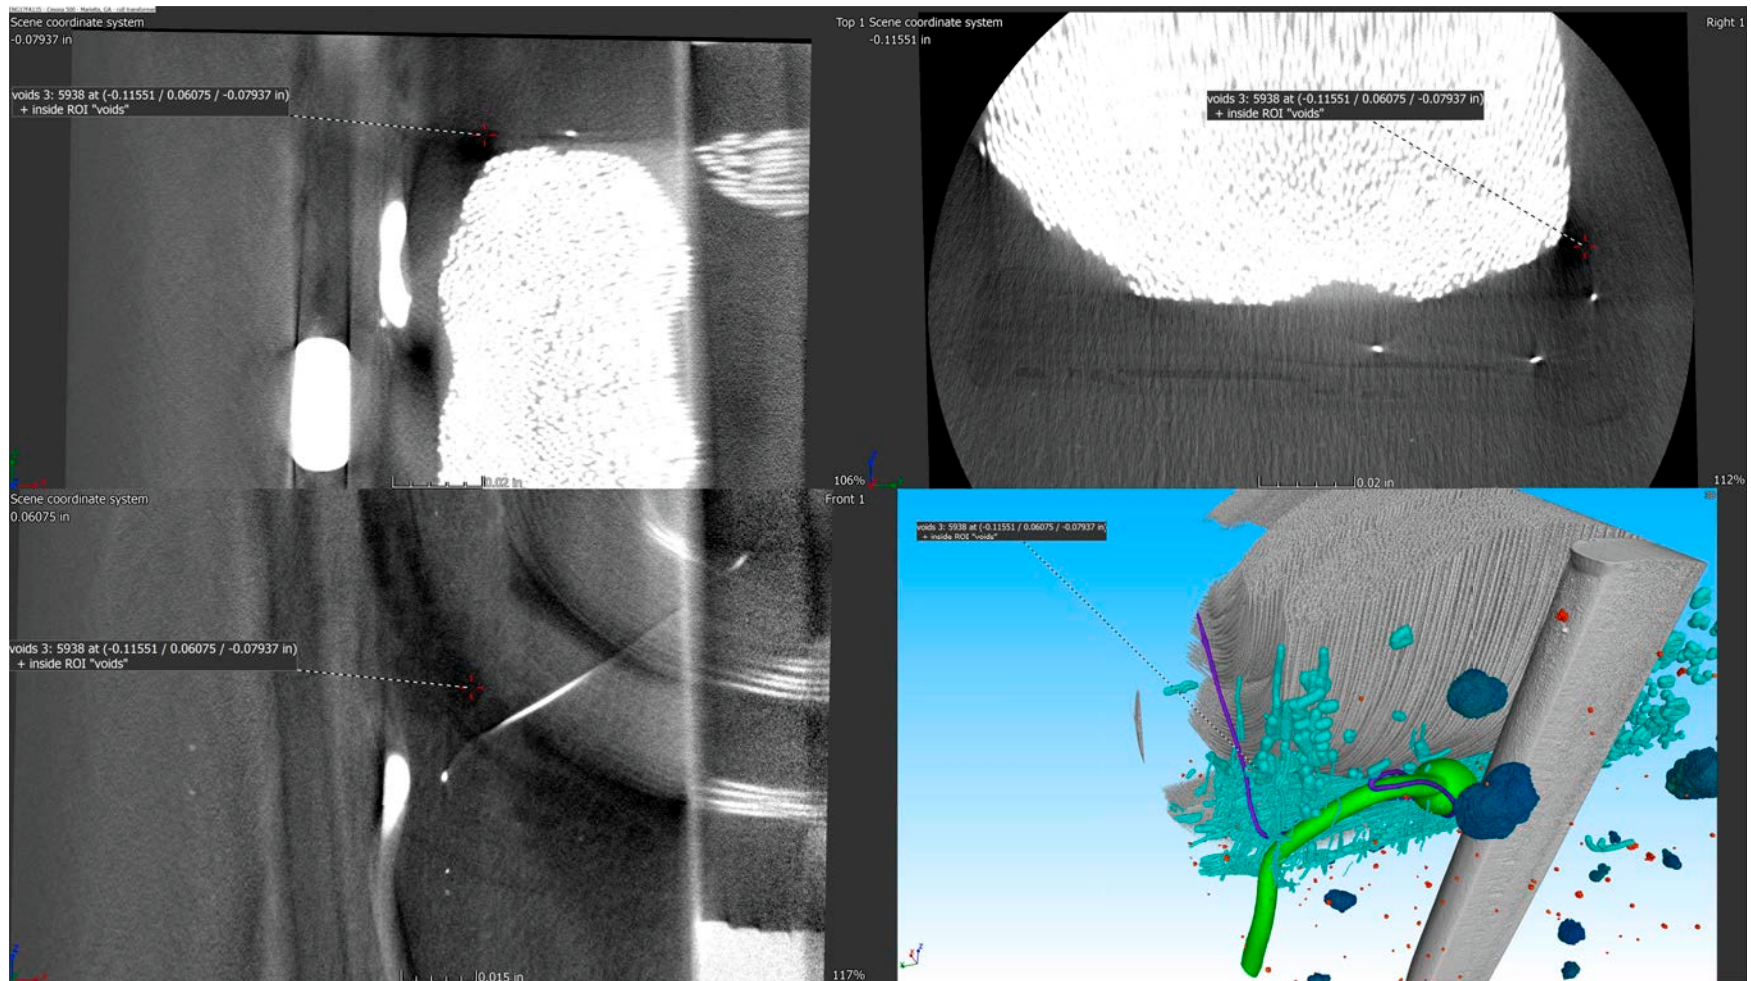
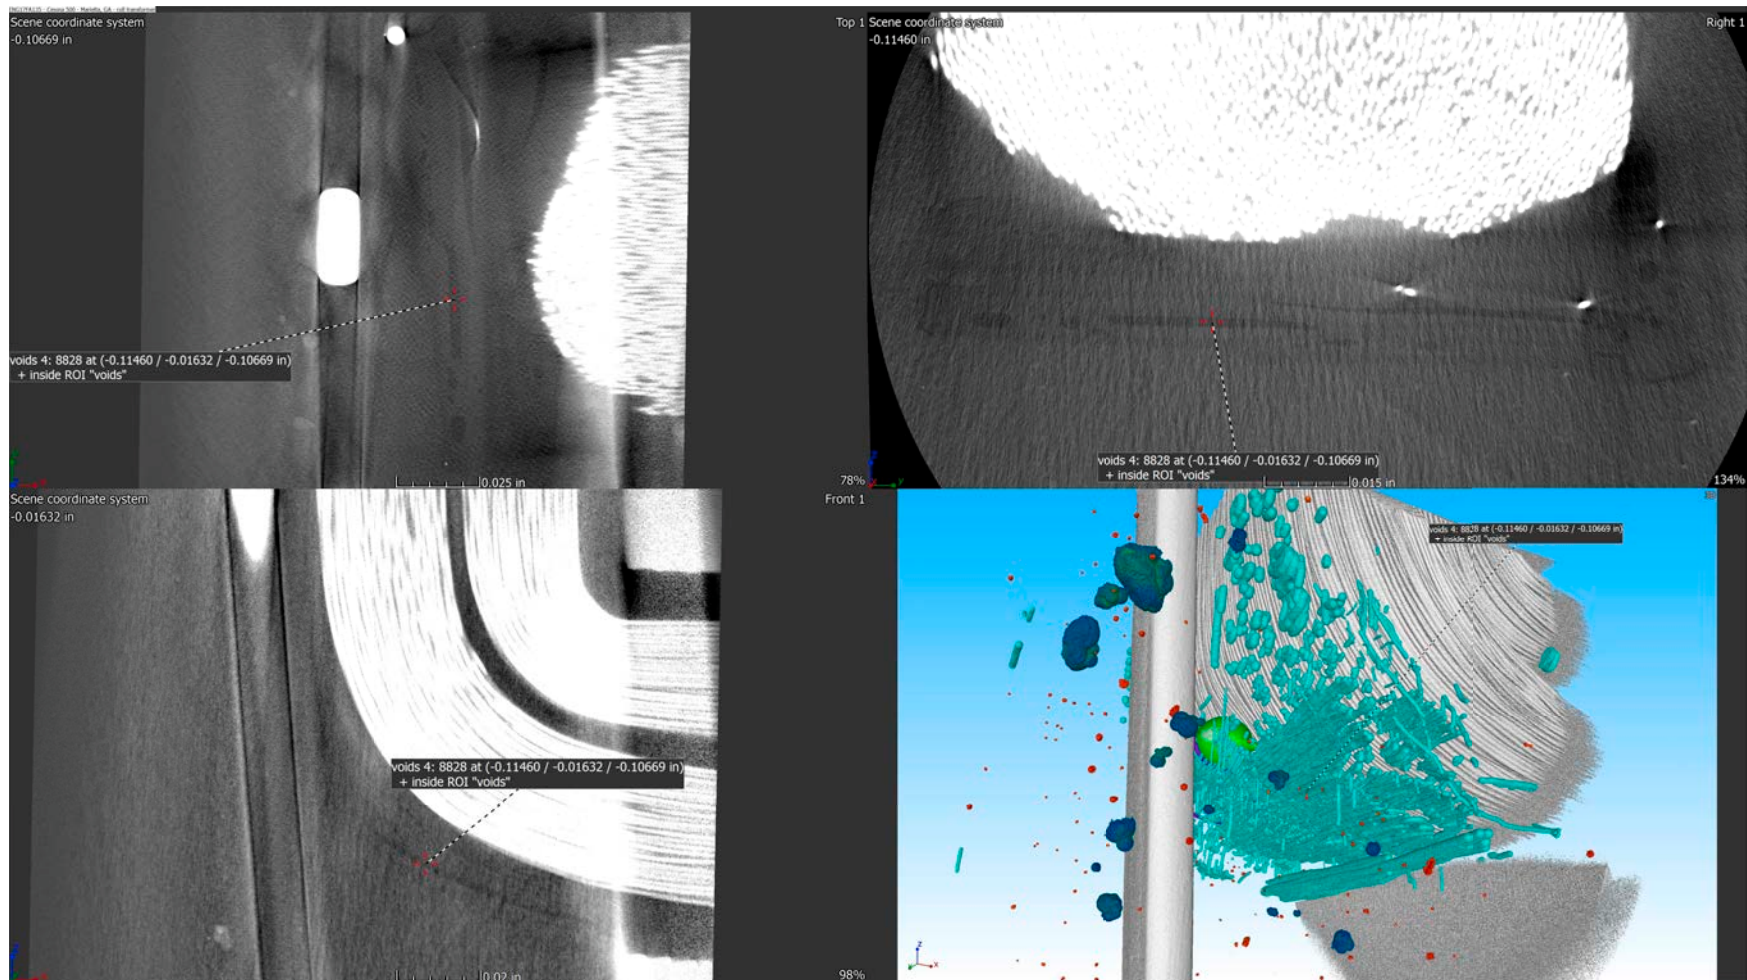
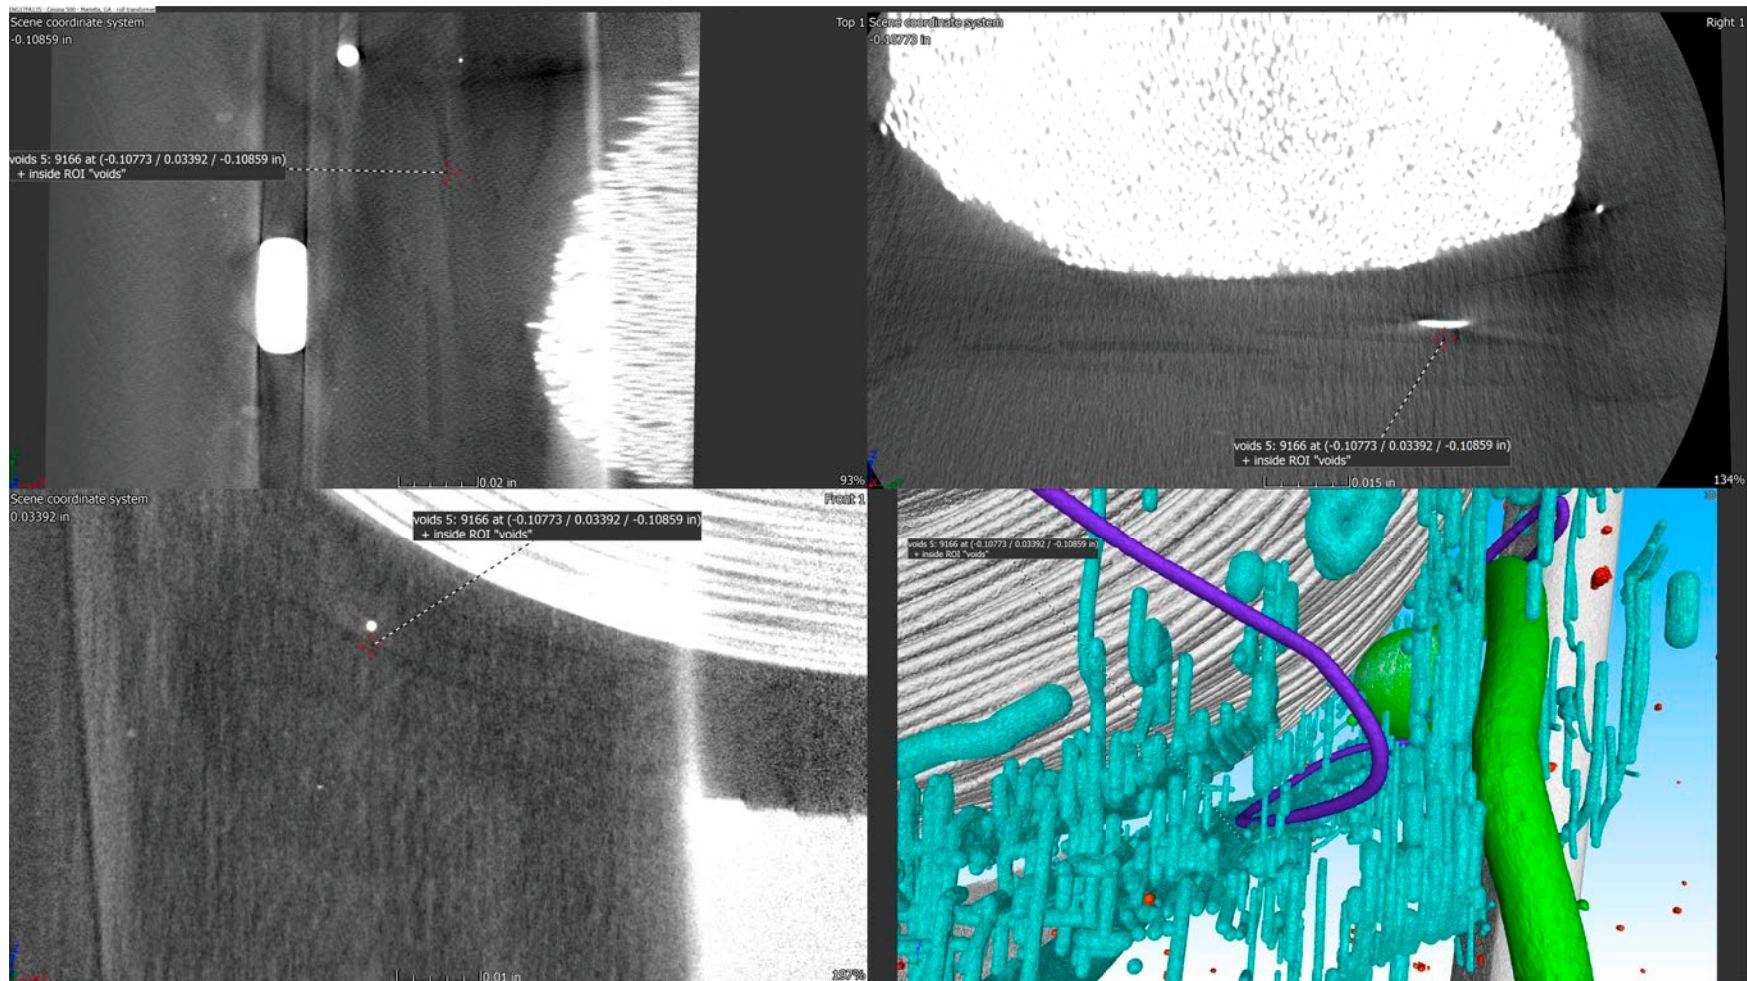
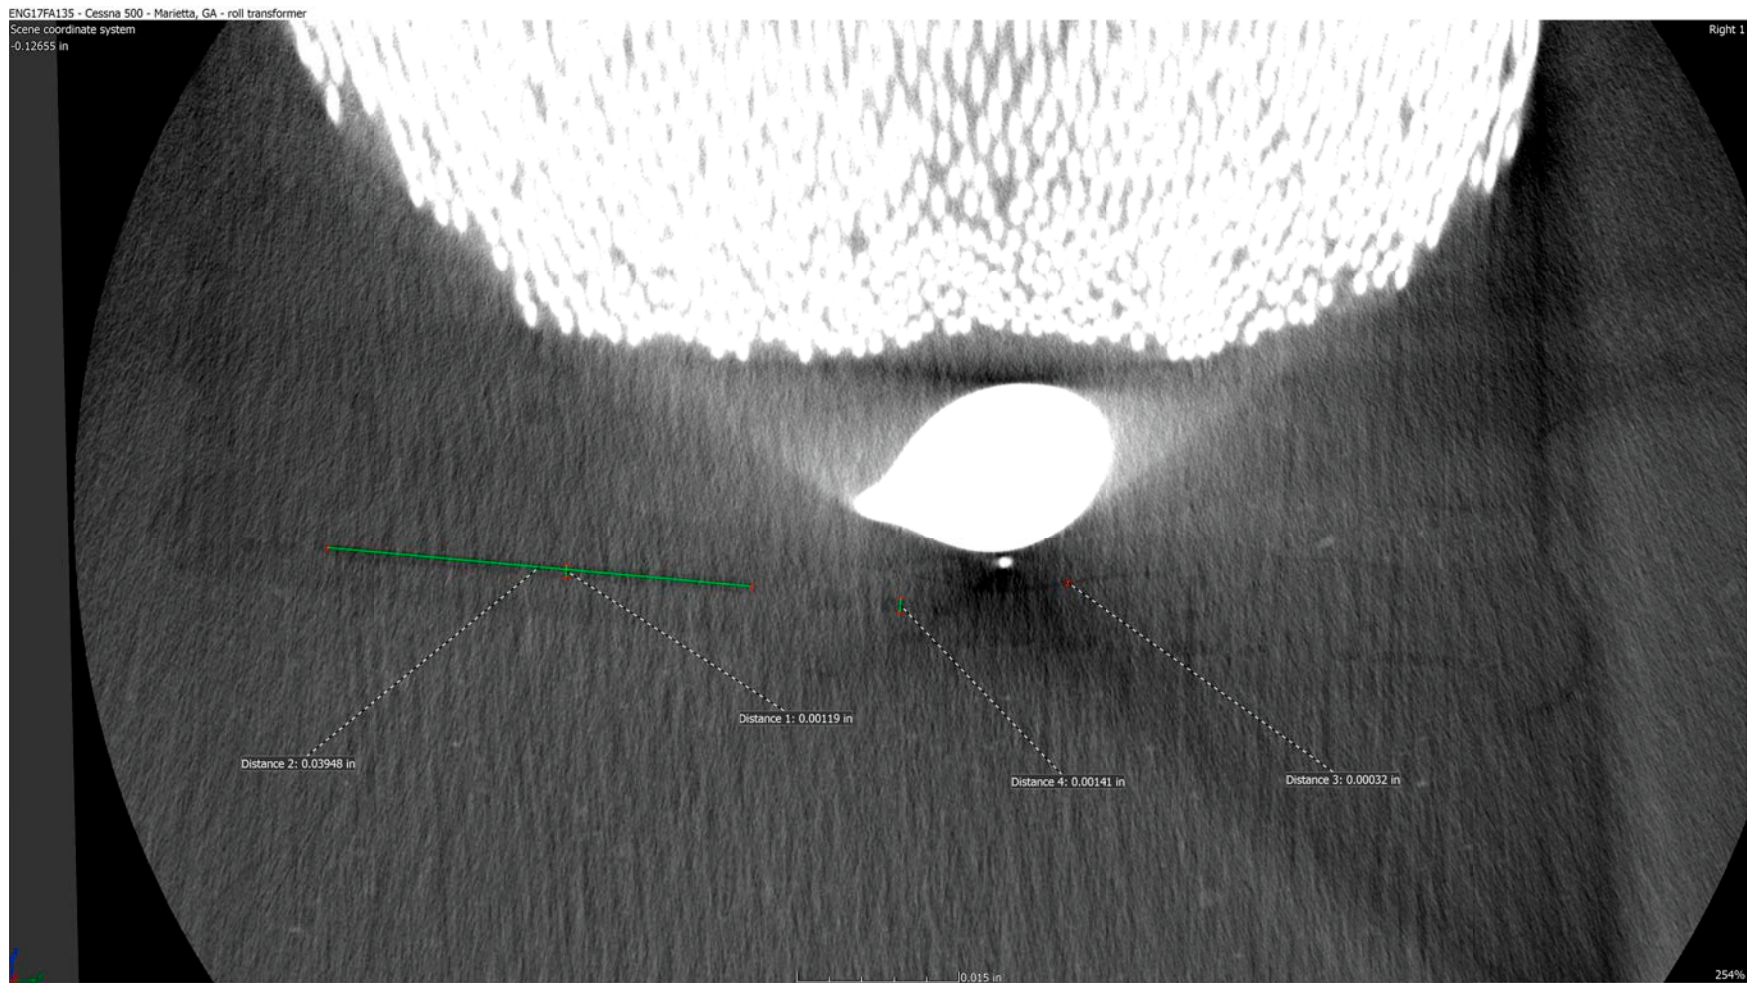
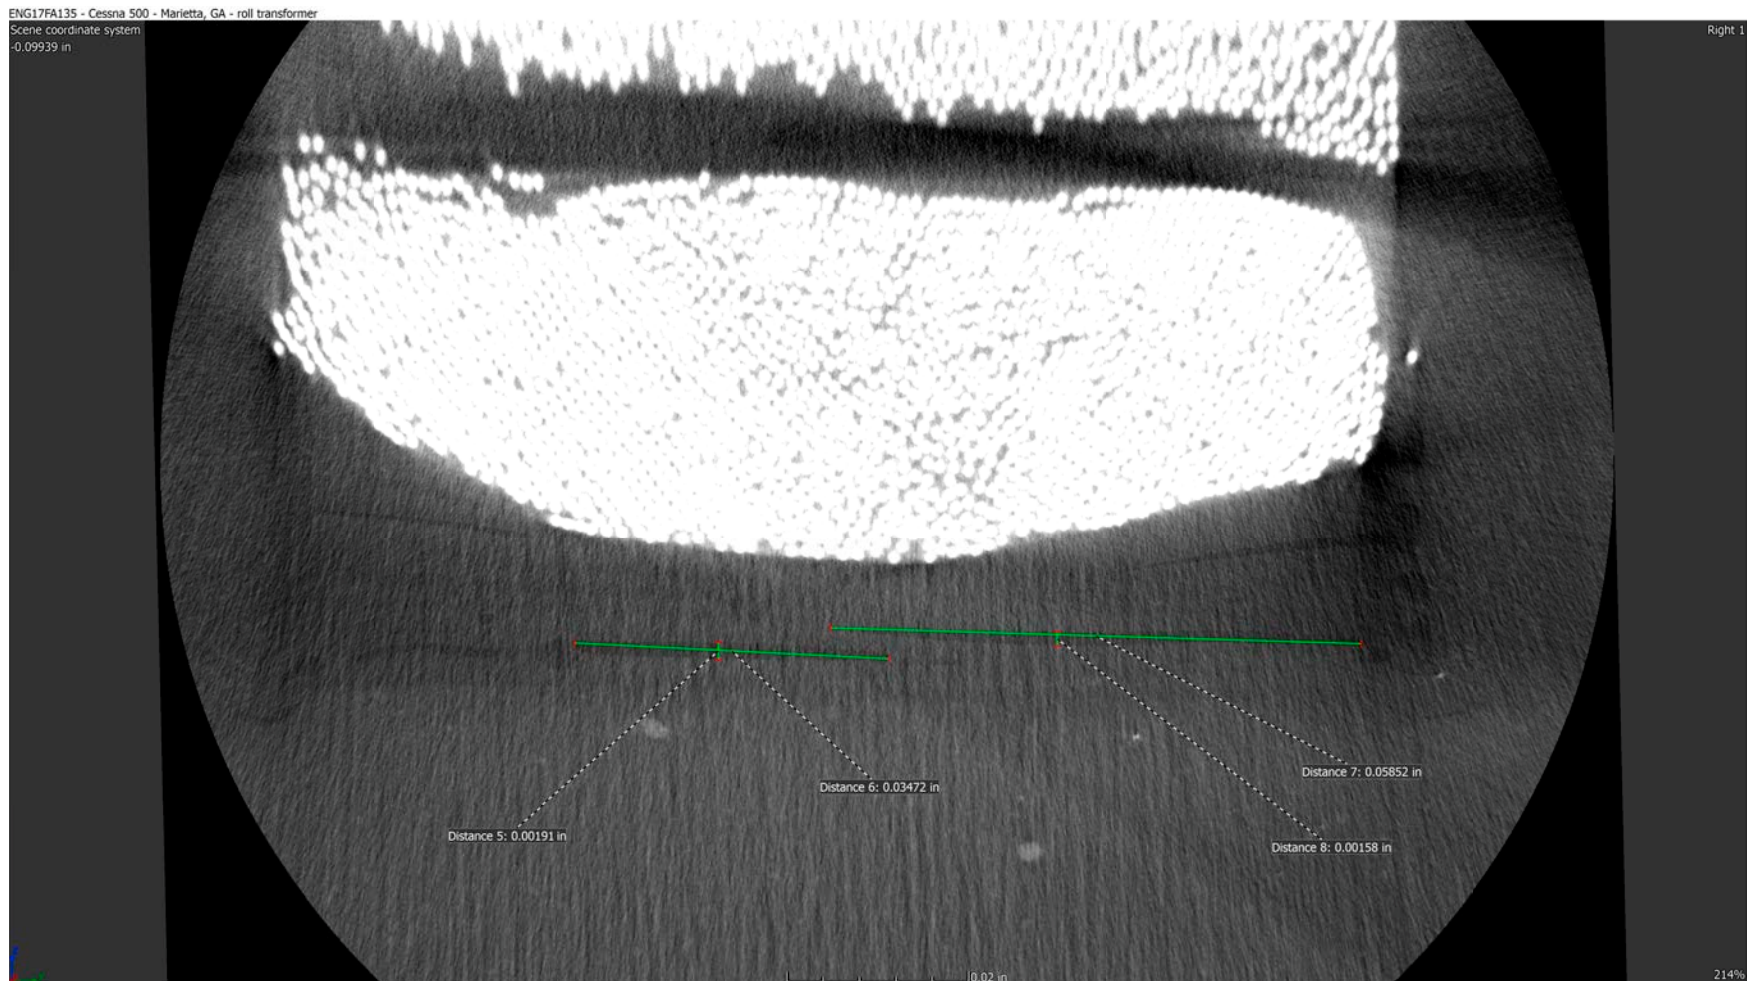
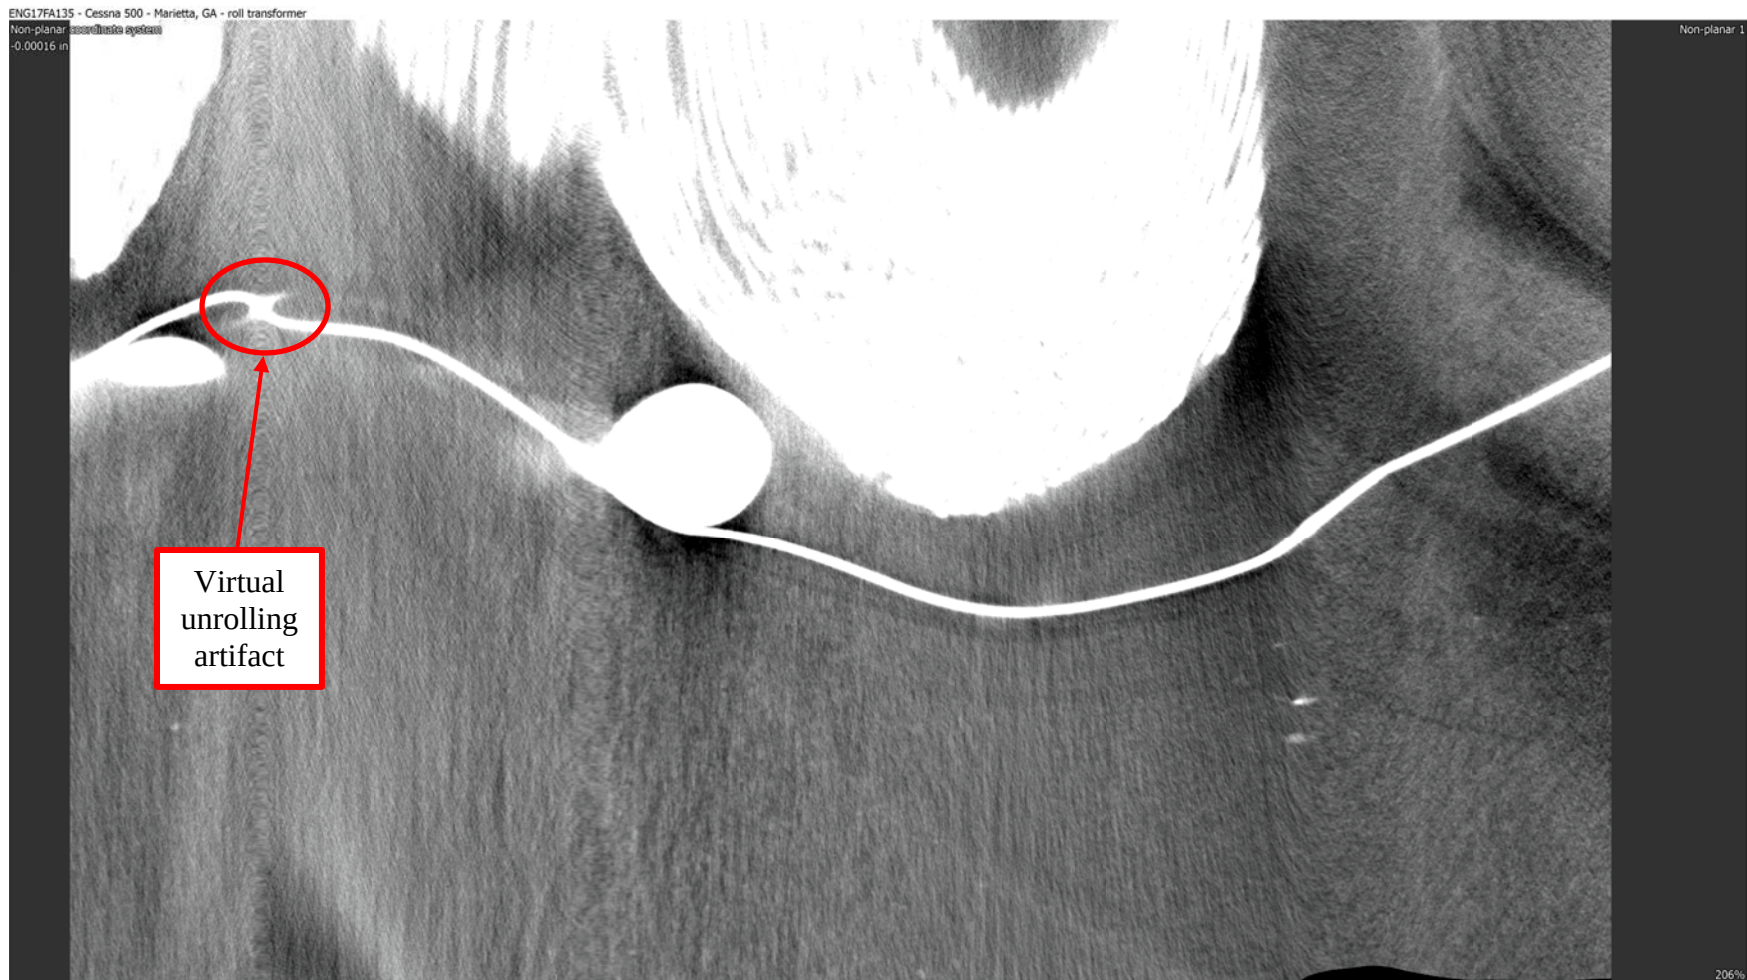
Figure 23  
Roll transformer – LLNL scans – resin voids 1

Figure 24  
Roll transformer – LLNL scans – resin voids 2

Figure 25  
Roll transformer – LLNL scans – resin voids 3

Figure 26  
Roll transformer – LLNL scans – resin voids 4

Figure 27  
Roll transformer – LLNL scans – resin voids 5

Figure 28  
Roll transformer – LLNL scans – resin voids dimensions 1

Figure 29  
Roll transformer – LLNL scans – resin voids dimensions 2

Figure 30  
Roll transformer – LLNL scans – coil wire virtually unrolled with voids

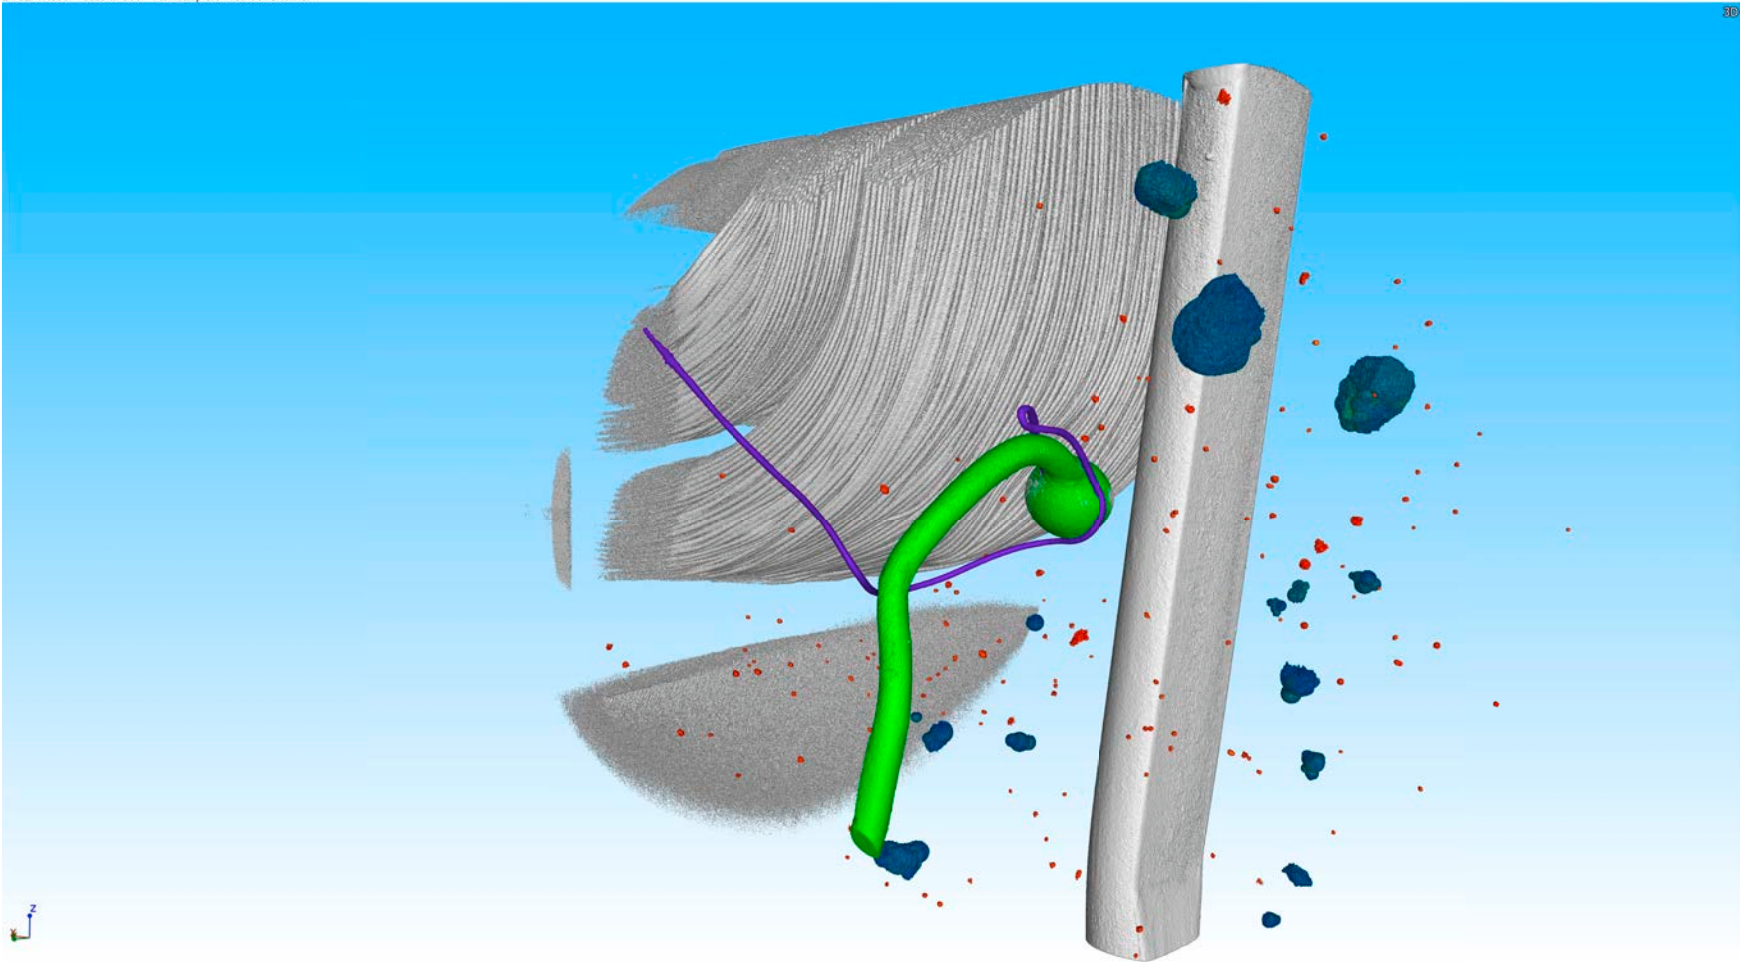
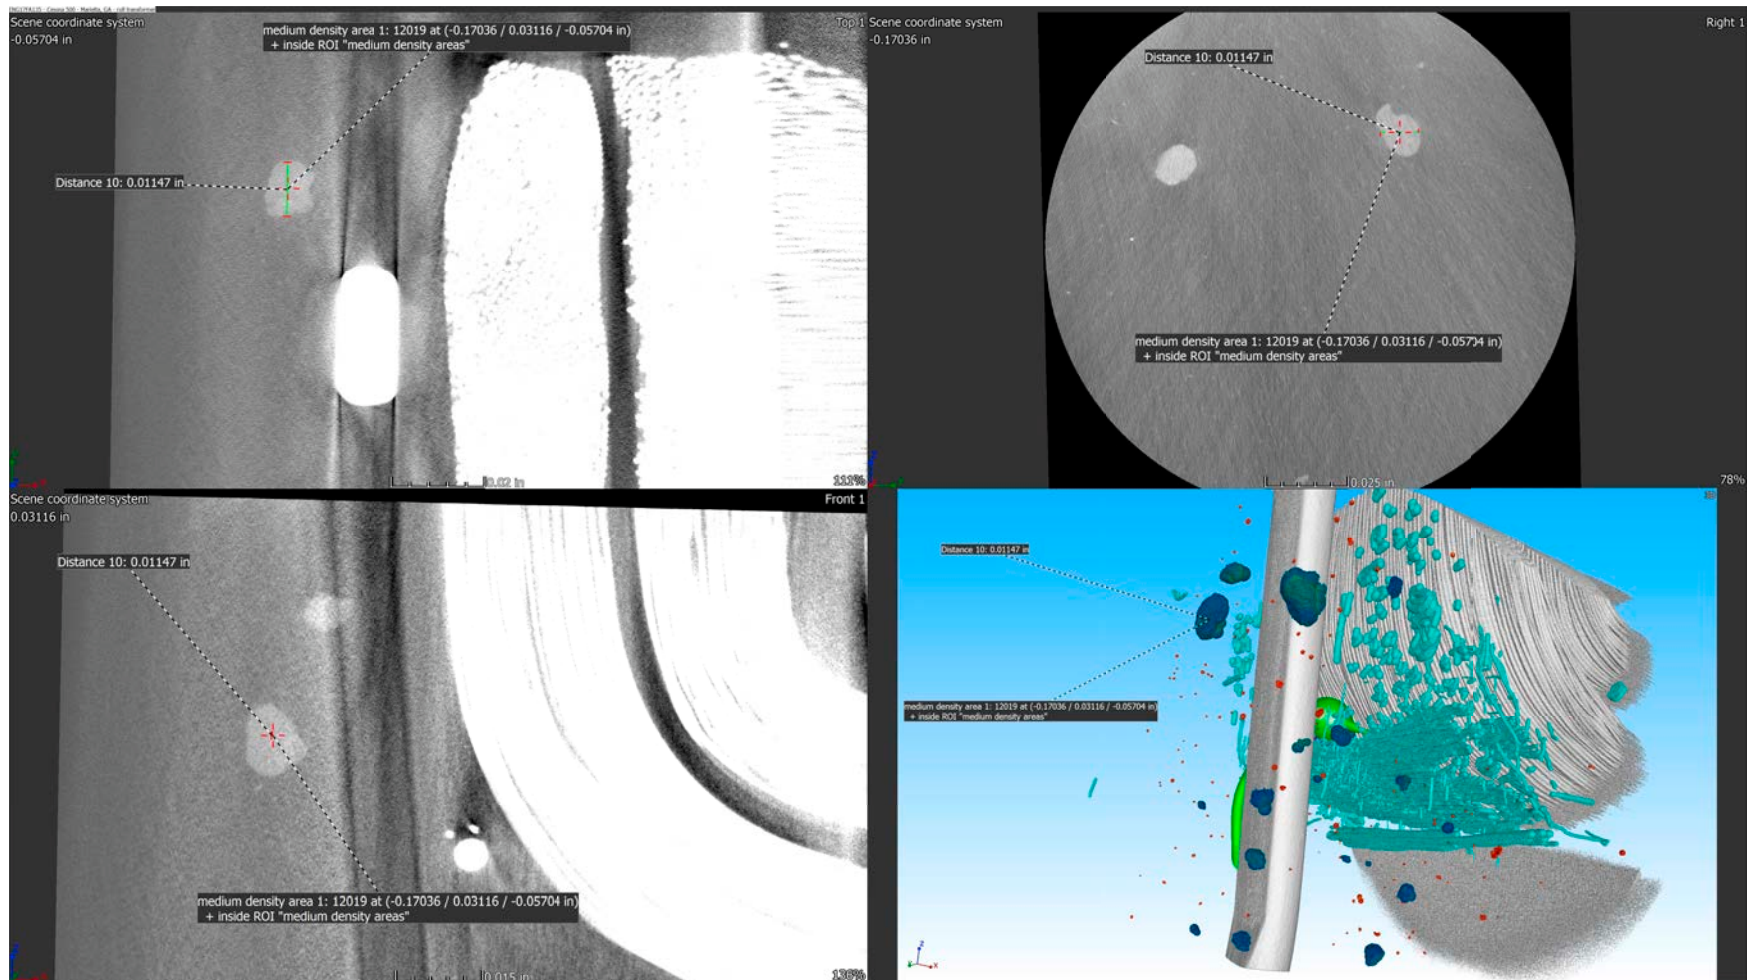
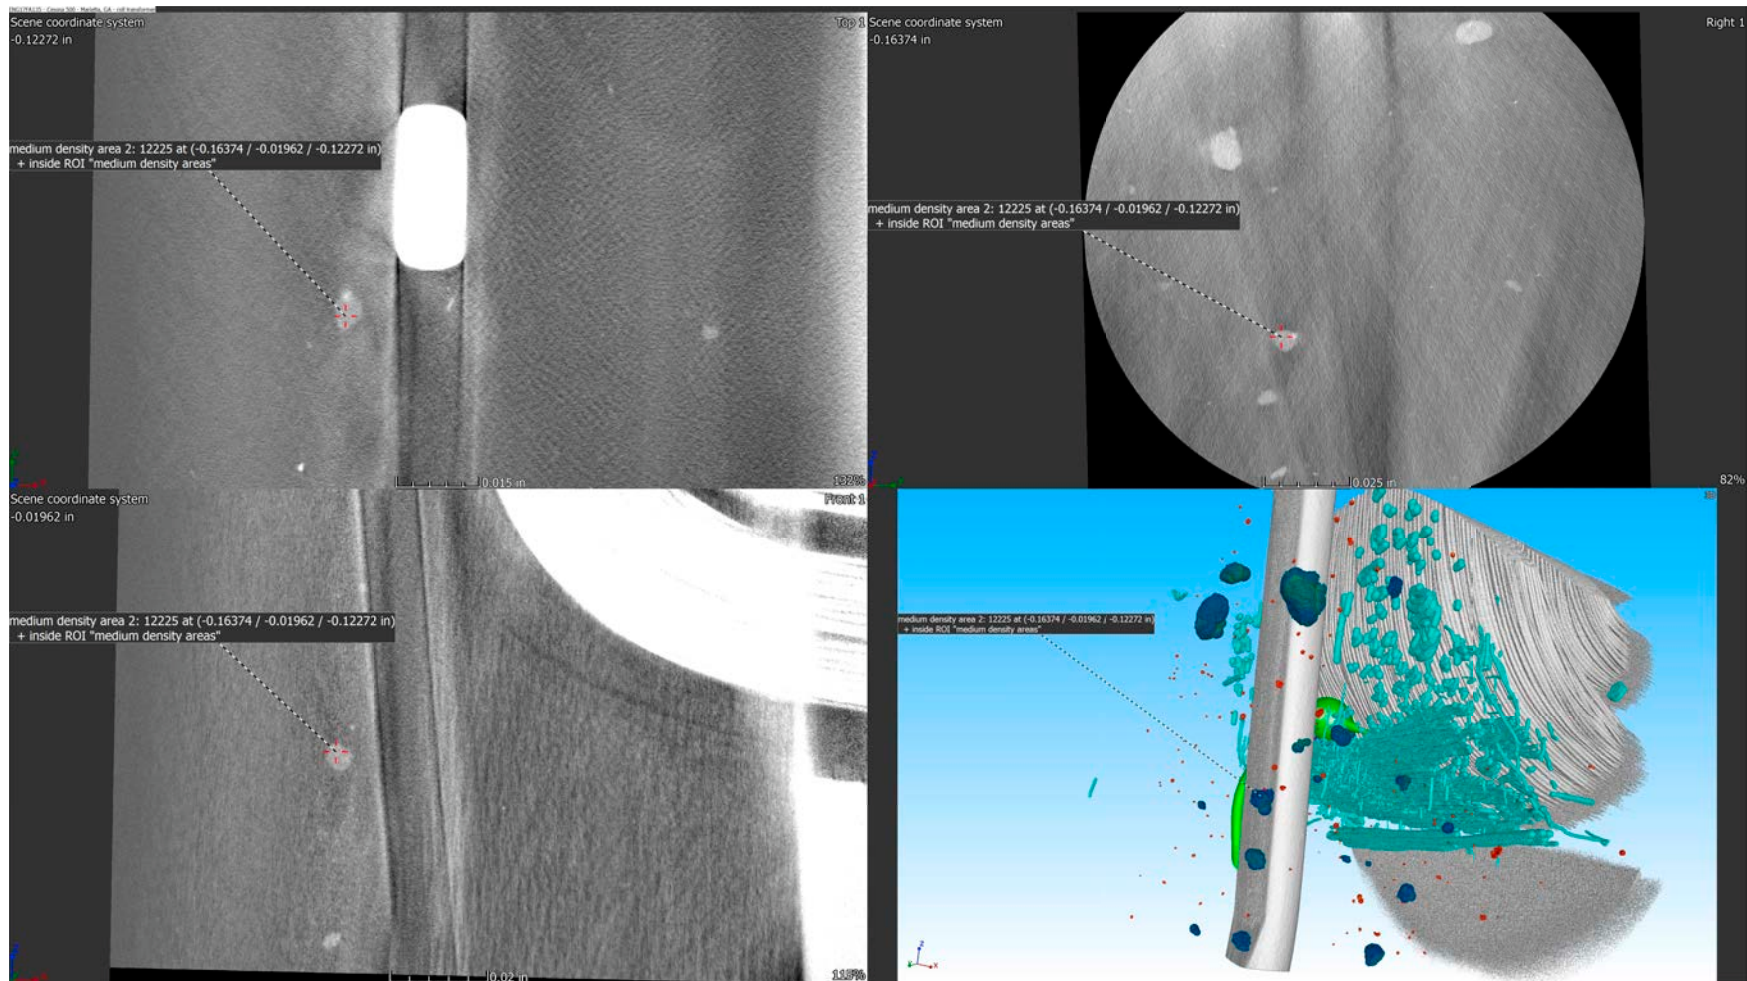
Figure 31  
Roll transformer – LLNL scans – overall view – medium density areas

Figure 32  
Roll transformer – LLNL scans – medium density area 1 with dimension

Figure 33  
Roll transformer – LLNL scans – medium density area 2
