**NATIONAL TRANSPORTATION SAFETY BOARD**

**Computed Tomography Specialist's Factual Report**

ERA17FA135

Location: Marietta, Georgia  
Date: March 24, 2017  
Time: 1924 eastern daylight time  
Airplane: Textron Aviation Citation 500, N8DX

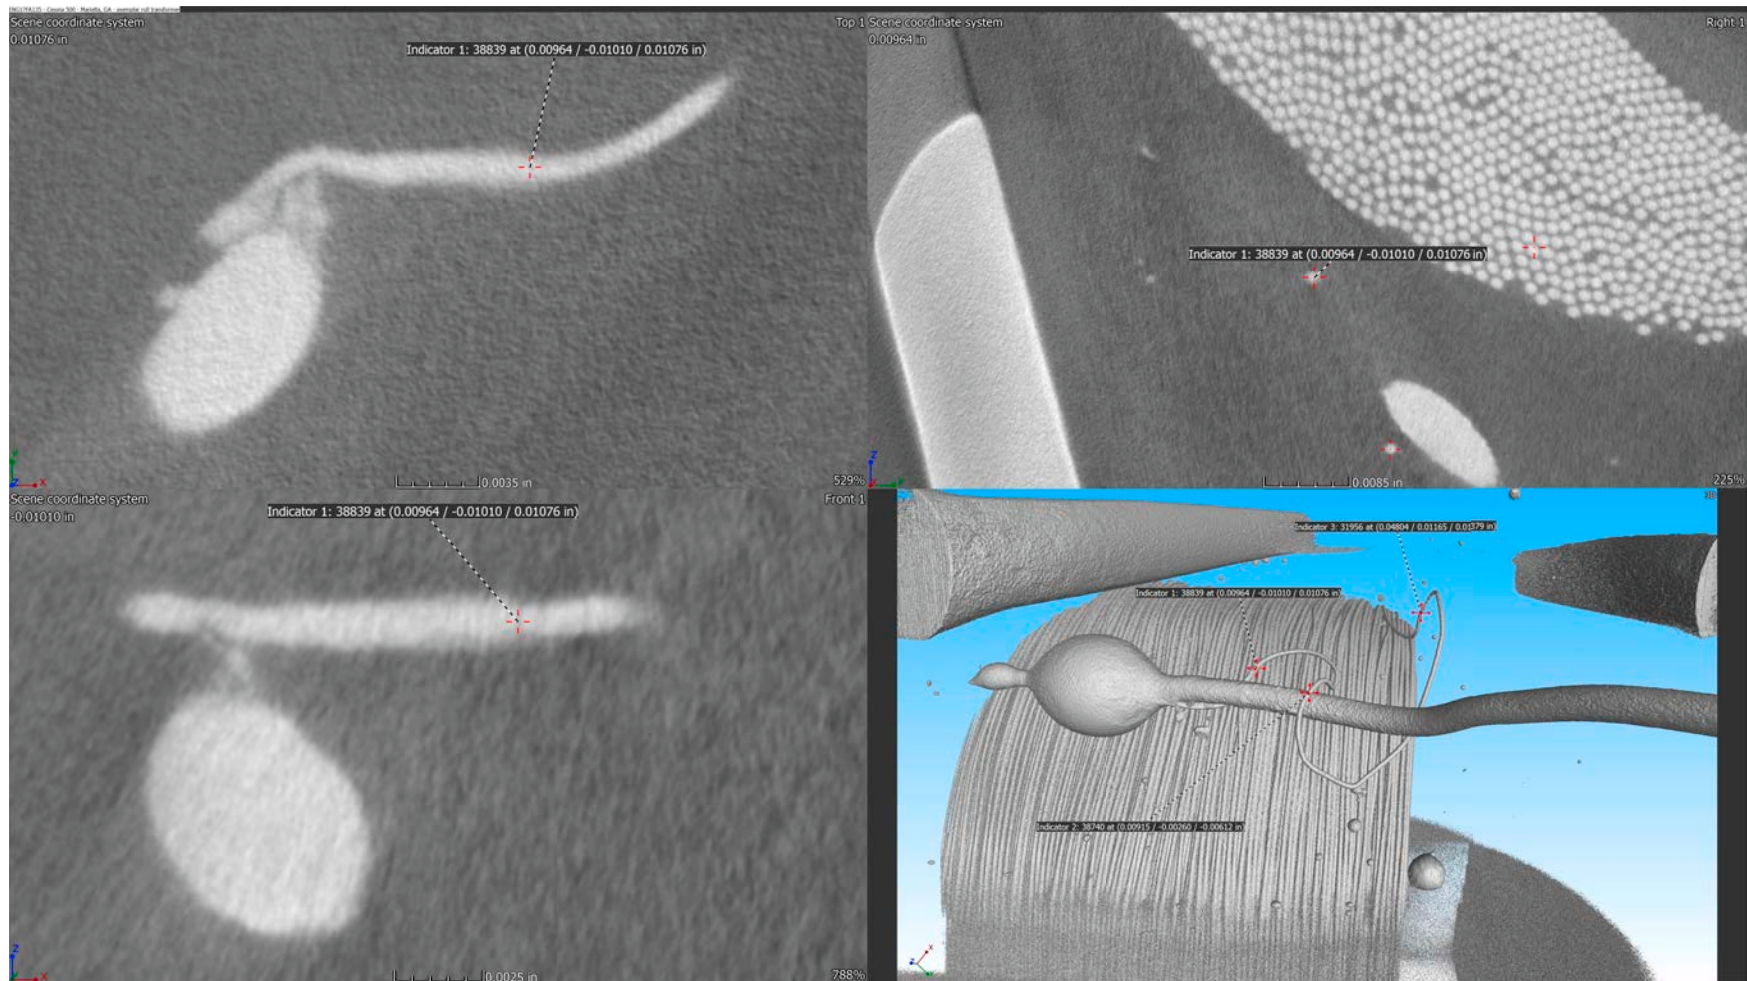
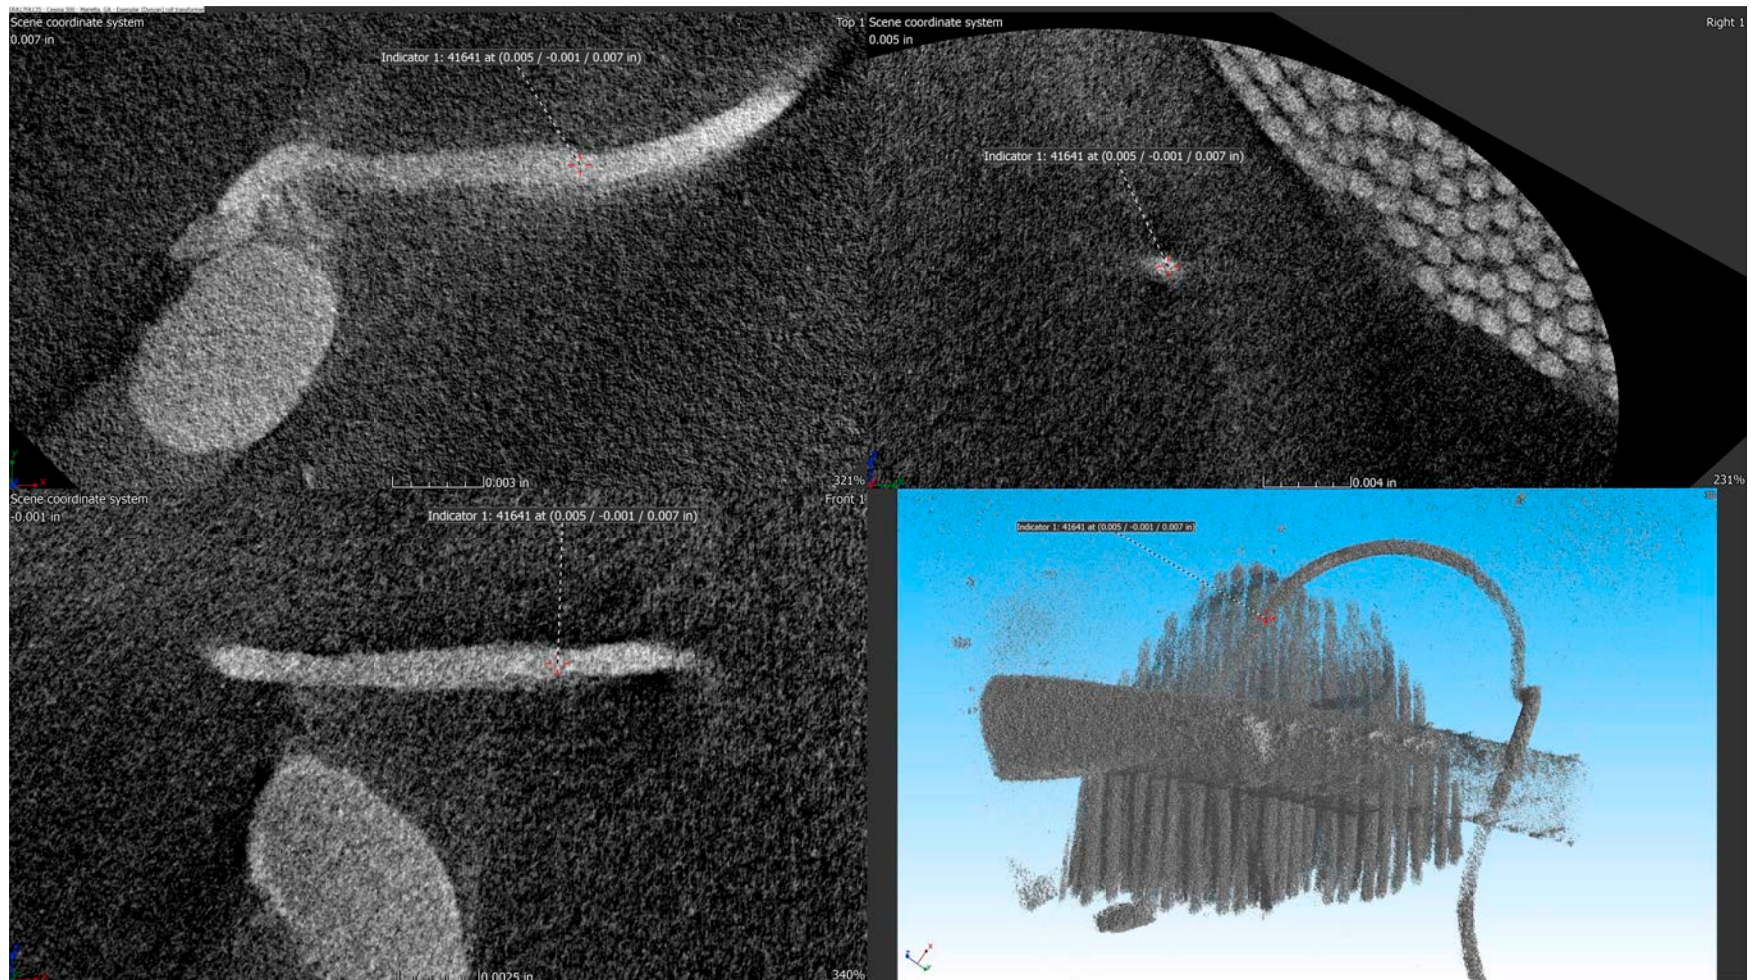
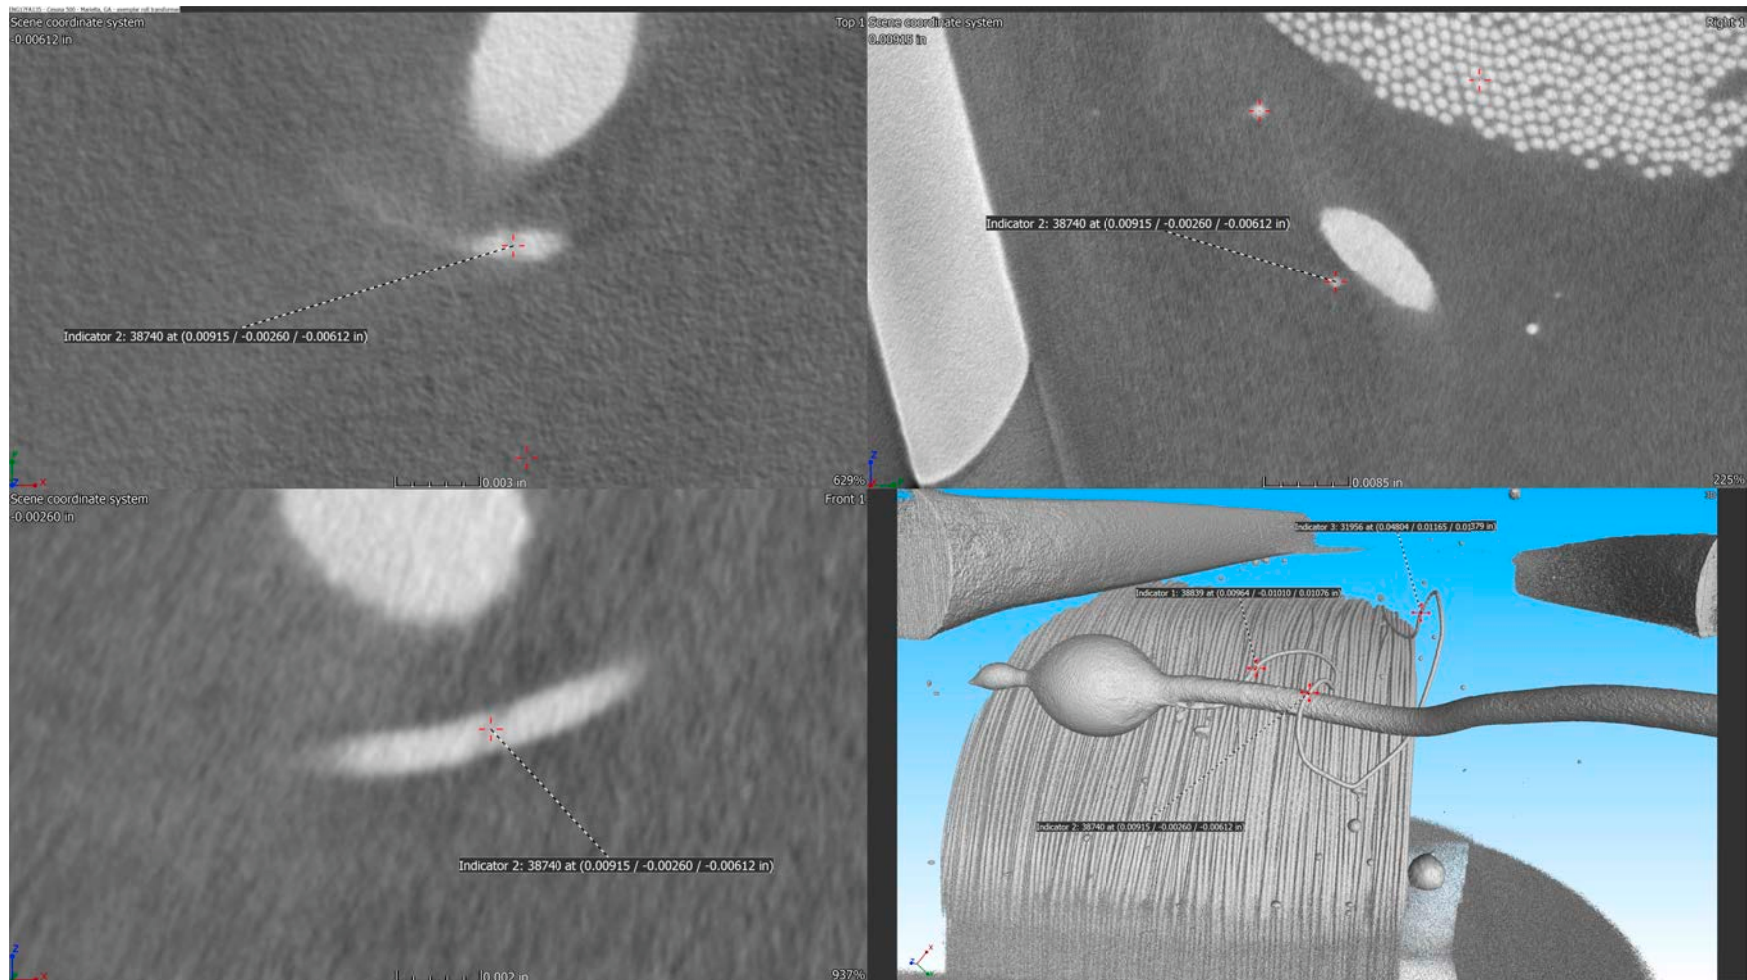
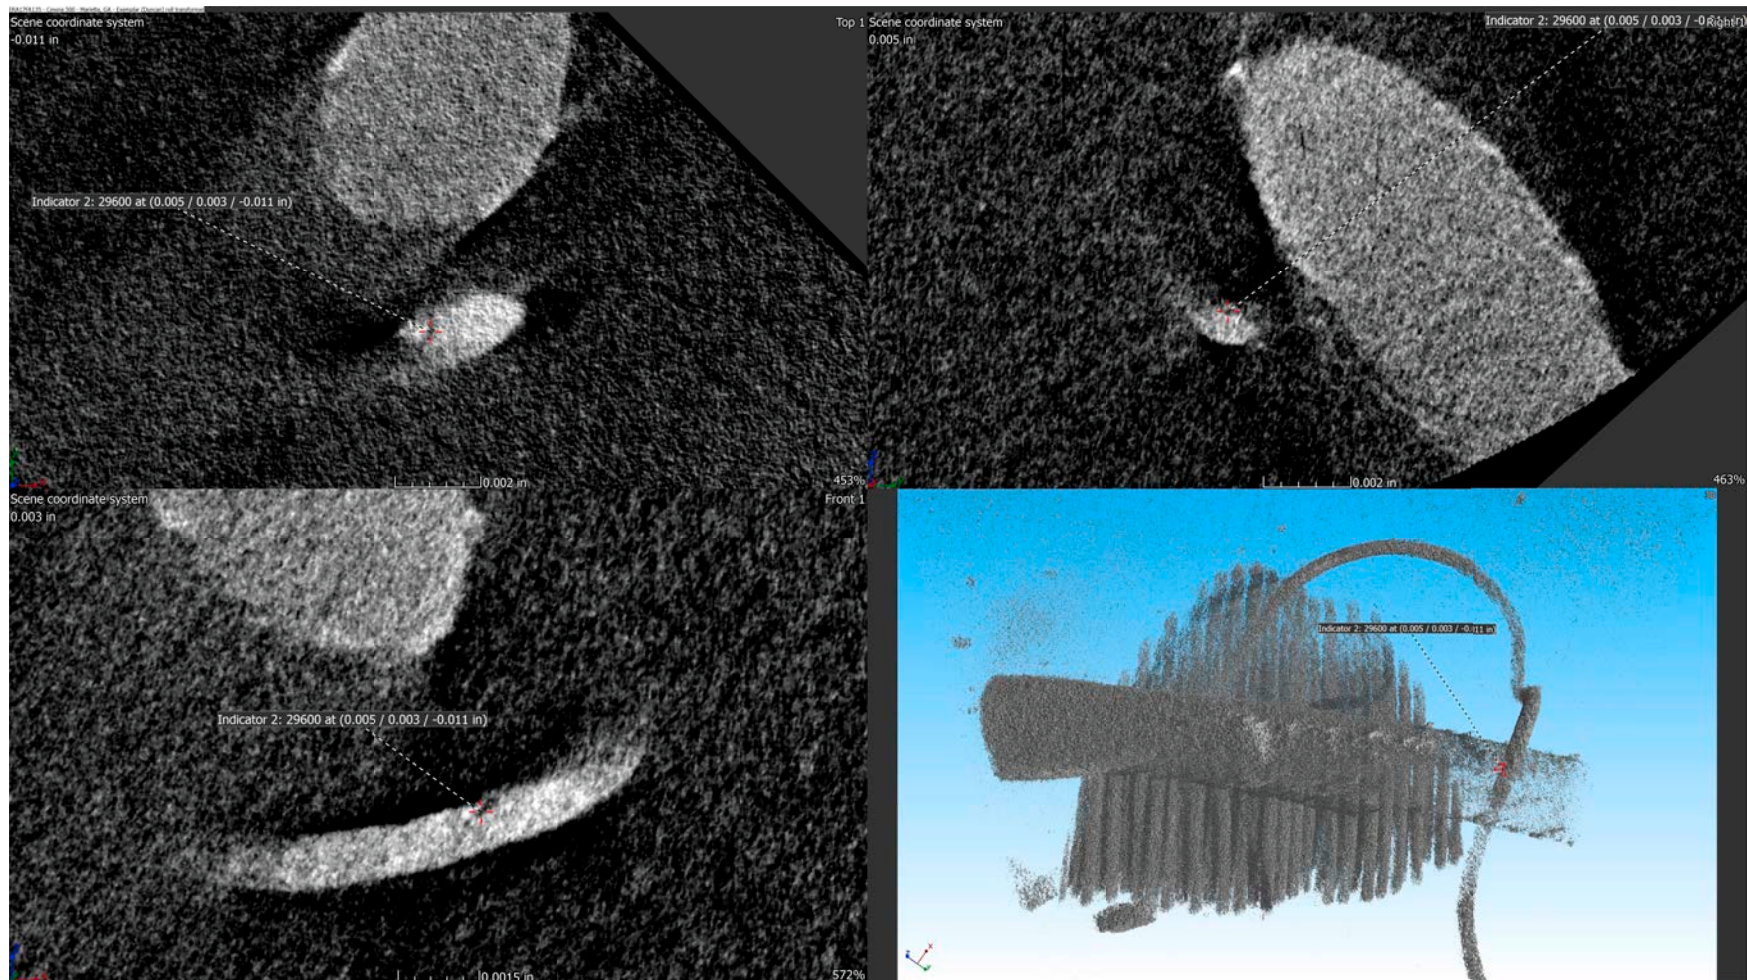
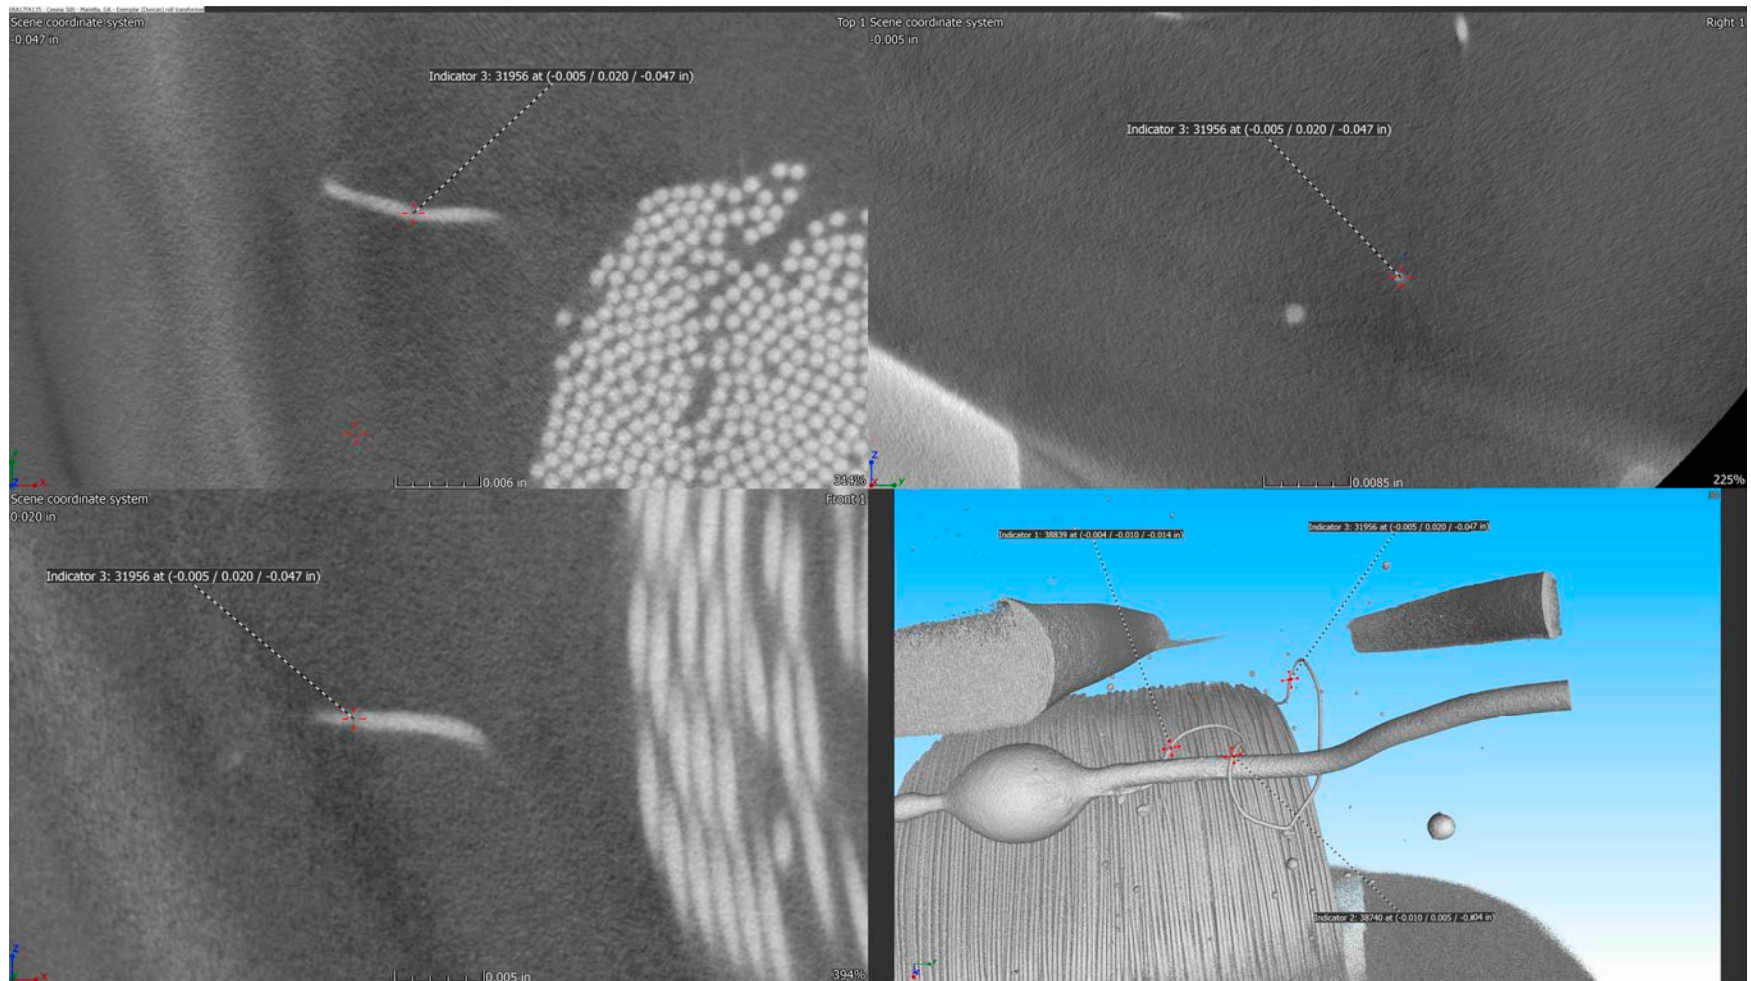
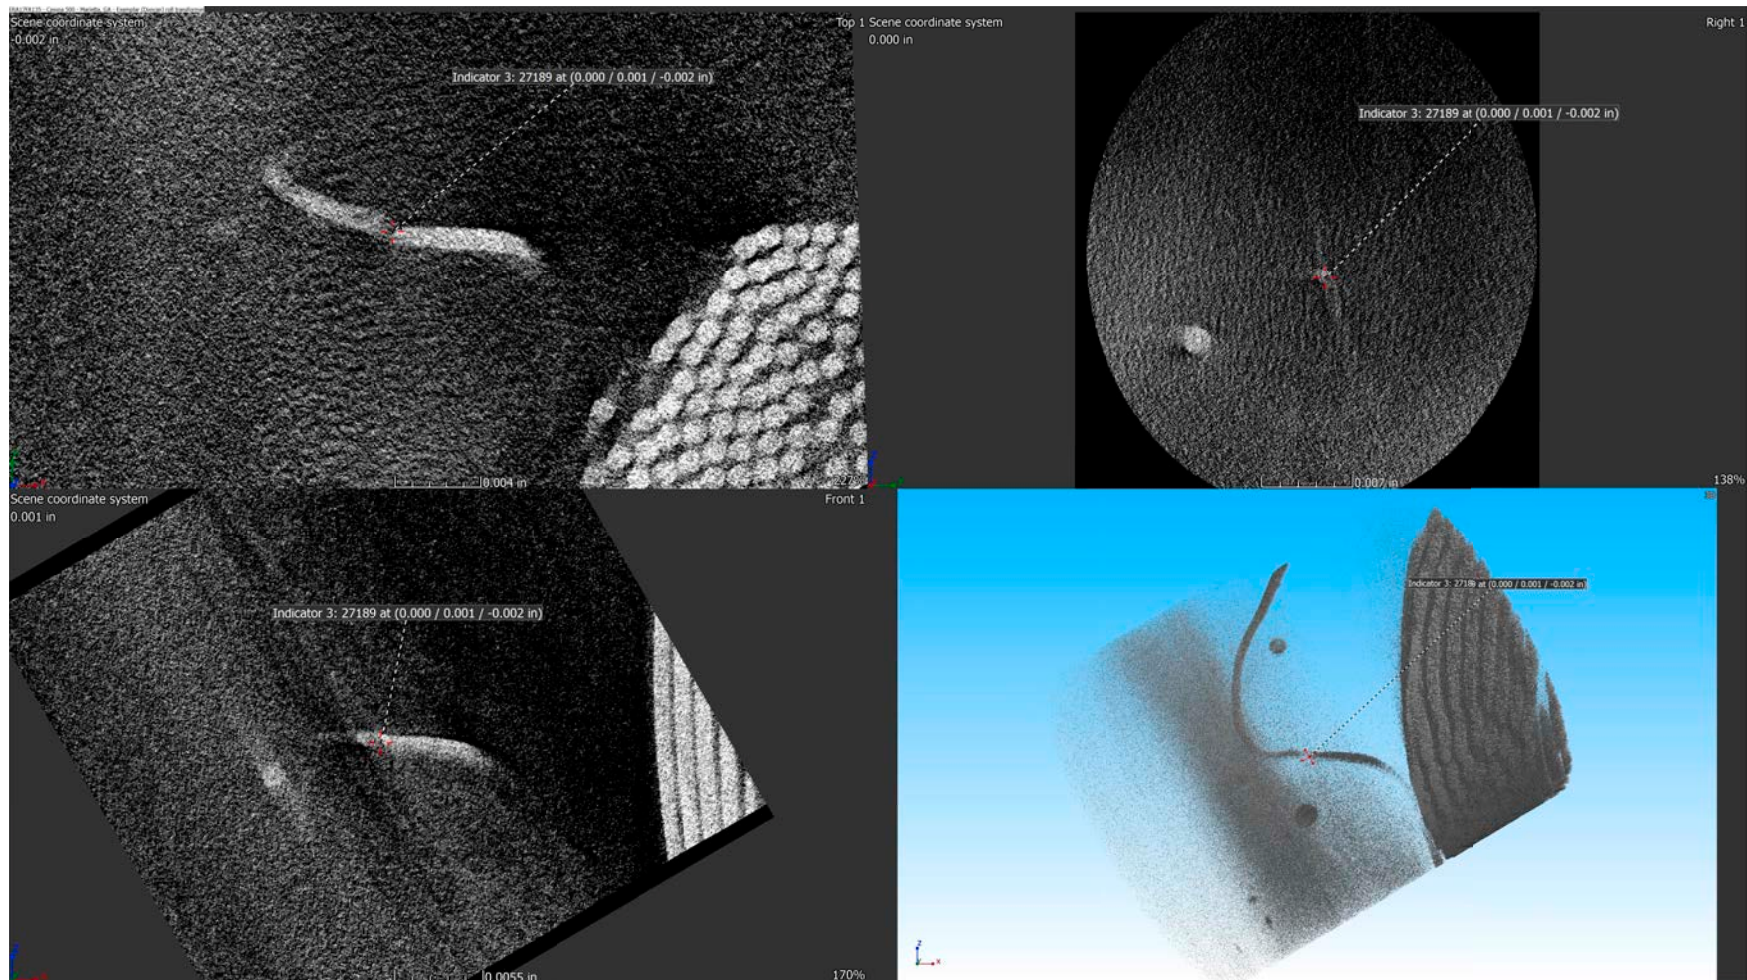
- initial LLNL scans indicated anomalous areas of the coil wire associated with pin 6 of the Duncan Aviation unairworthy transformer. These areas were imaged further at LLNL with high resolution scans, and these scans confirmed

the anomalies were not artifacts. This confirmation indicated that the lower resolution LLNL scans were adequate for finding anomalous areas within the coil wires (figures 34-39).

Figure 34  
Duncan Aviation unairworthy transformer – LLNL scans – wire anomaly area 1

Figure 35  
Duncan Aviation unairworthy transformer – LLNL scans – wire anomaly area 1 – high resolution view

Figure 36  
Duncan Aviation unairworthy transformer – LLNL scans – wire anomaly area 2

Figure 37  
Duncan Aviation unairworthy transformer – LLNL scans – wire anomaly area 2 – high resolution view

Figure 38  
Duncan Aviation unairworthy transformer – LLNL scans – wire anomaly area 3

Figure 39  
Duncan Aviation unairworthy transformer – LLNL scans – wire anomaly area 3 – high resolution view
