**ERA17FA140**  
**Hartzell Propeller Air Safety Investigator Field Notes**

NTSB File No. ERA17FA140

Aircraft: Beechcraft A36 Bonanza, N8169Y, S/N E-2598

**Propeller Examination**

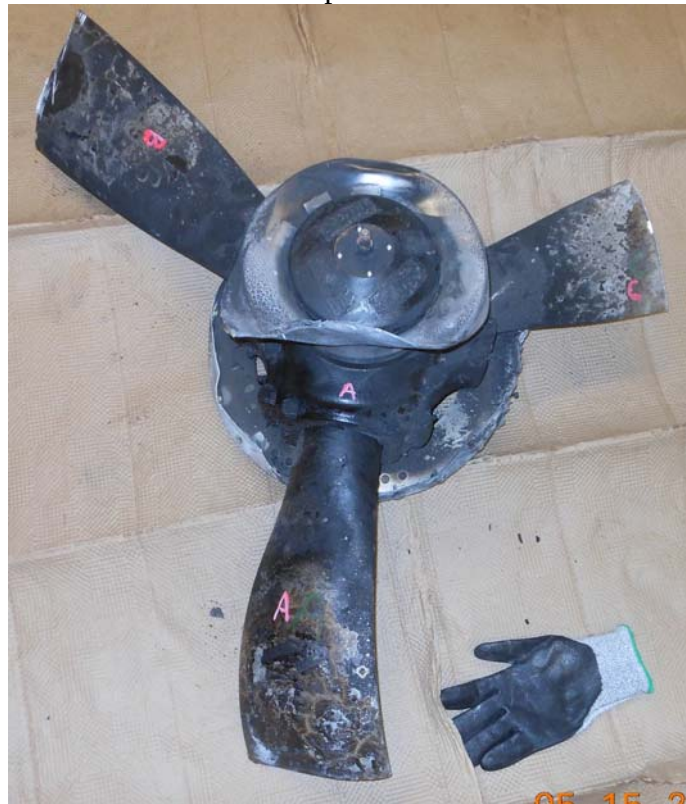
According to on-scene investigators the propeller assembly remained attached to the engine crankshaft mounting flange during the impact sequence. It was removed at the crash scene and shipped with the engine to the Continental Motors Analytical Lab in Mobile, AL in the condition shown in Photos #1 and #2. All three propeller blades were cut to facilitate shipping. The spinner dome and approximately 30% of one blade was consumed by the post-crash fire. One blade rotated by hand force in the hub. The propeller assembly displayed significant charring and sooting heat damage.

Photo #1 – Propeller As-Received

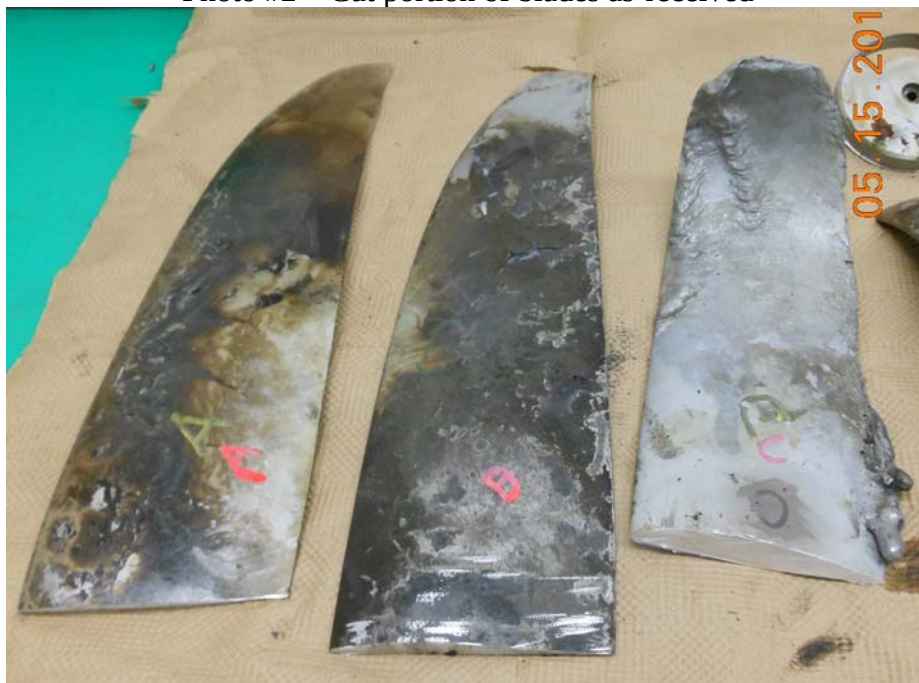
Photo #2 – Cut portion of blades as-received

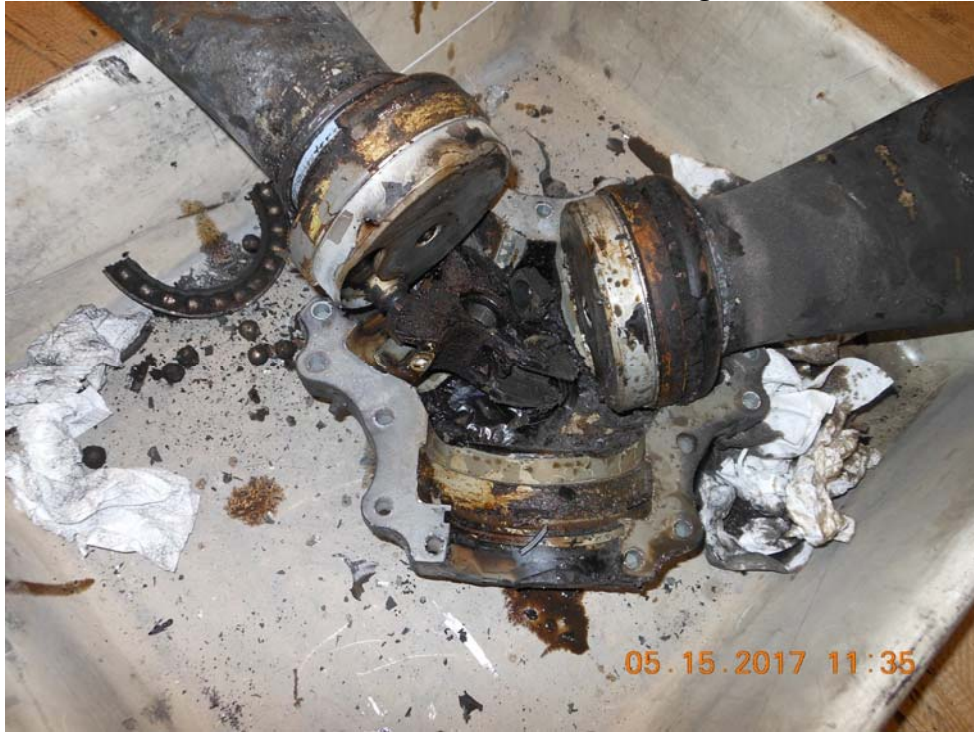
The hub halves separated easily and internal heat damage included heavy charring and evidence of grease coking/hardening on the hub surfaces, blade bearings and blade retention pockets (see Photo #3). The blade seals were also charred and hardened. The fork was sooted with pitch change knob block impact marks in the slots, including chatter marks in one slot.

Photo #3 – Internal hub heat damage

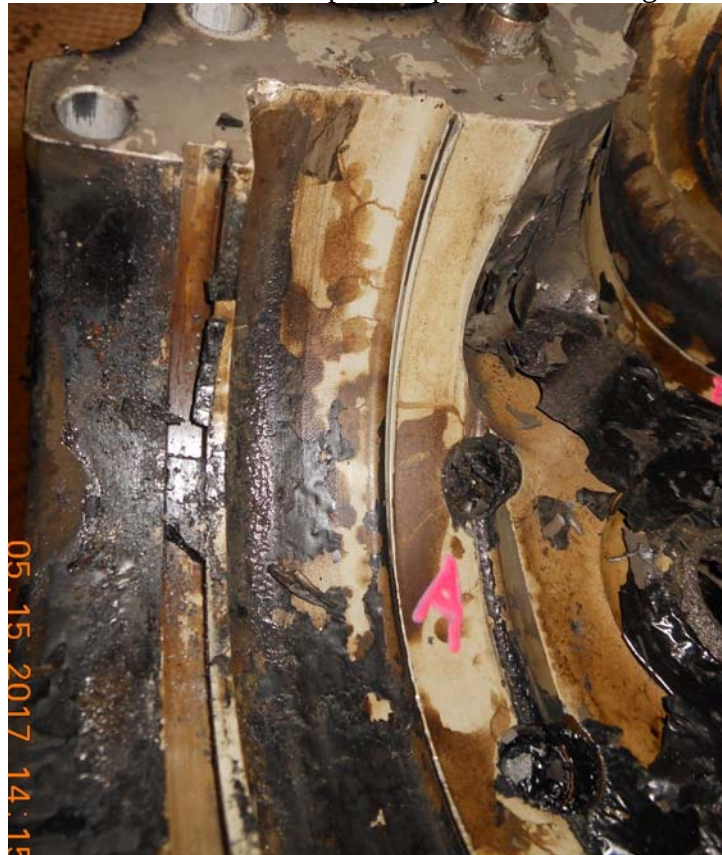
The preload plate shelf on blade A retention pocket was damaged in the face side/trailing edge quadrant, suggesting impact forces lead-to-trail, opposite rotation direction (see Photo #4). The preload plate shelf on blade B was also damaged on face side/leading edge quadrant.

Photo #4 – Blade A preload plate shelf damage

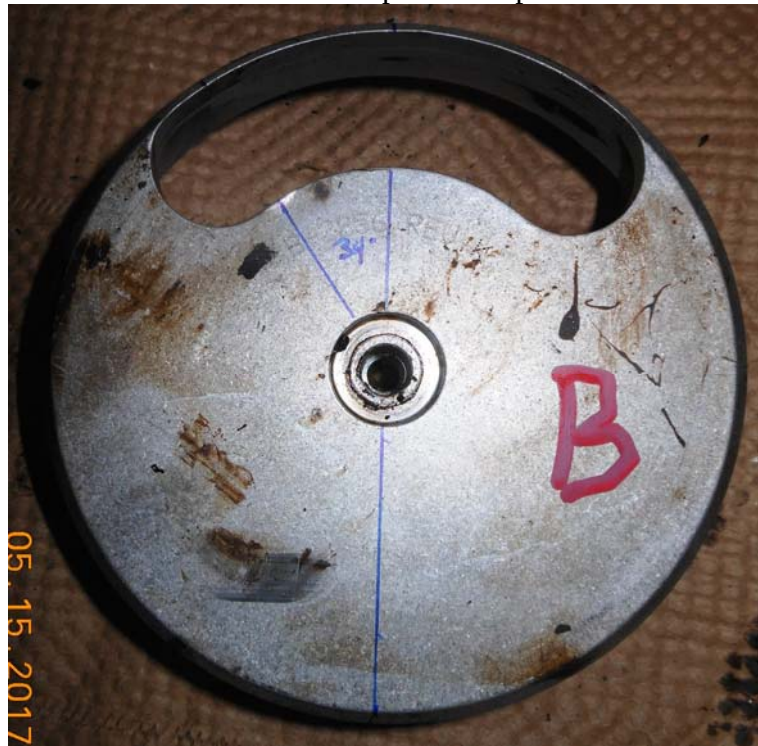
The preload plates were intact with only minor damage: the lip was partially fractured/sheared on preloads A and B. Preload plate B had a knob impact mark at 34 degrees equating to a blade angle of 14 degrees (see Photo #5).

Photo #5 – Preload plate B impact mark

The overall damage was consistent with low/no power. A preload plate impact mark, blade retention pocket damage and blade damage suggested the propeller was windmilling at low or no power near the low pitch stop at time of impact. The preload plate impact mark equated to a blade angle of 14 degrees suggesting the propeller was being governed and thus suggesting rotation to generate oil pressure. There were no discrepancies noted that would prevent or degrade normal propeller operation prior to impact. All damage was consistent with high impact forces.

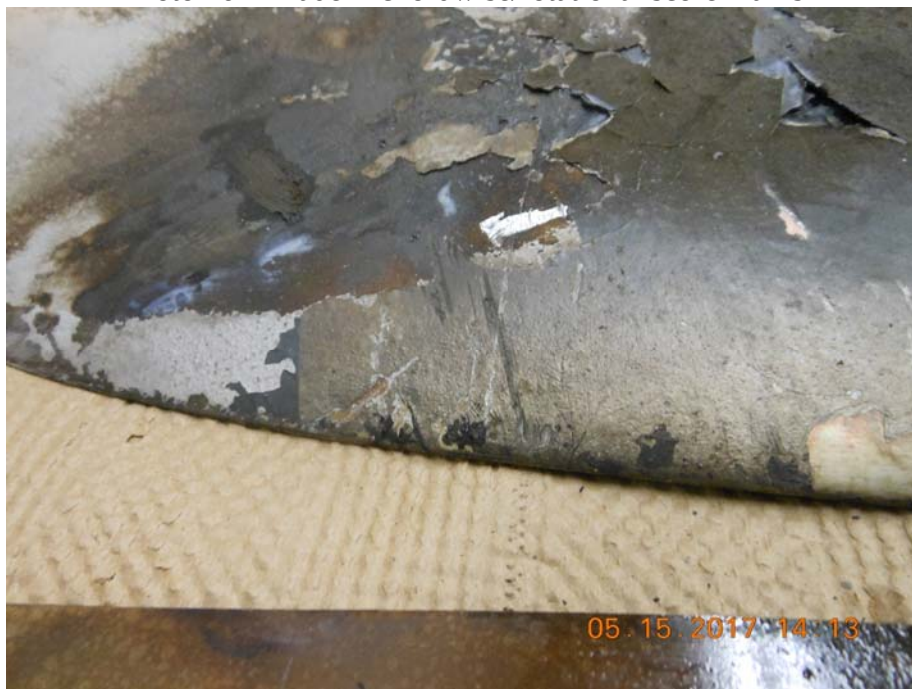
Blade B had a leading edge “wave” near the tip consistent with tree impact/slices observed at the crash scene. This “wave” suggested a camber side strike consistent with a low/no power windmilling condition. Blade B also had some chordwise/rotational score marks on the camber side near the leading edge (see Photo #6). There were no discernable scoring marks on the face side of the blades.

Photo #6 – Blade B chordwise/rotational score marks
