## ENGINE EXAMINATION REPORT

| ENGINE MODEL | IO550B (6F) |
| AIRCRAFT MAKE & MODEL | Beechcraft A36 Bonanza |
| FILE NUMBER | 16-507 |

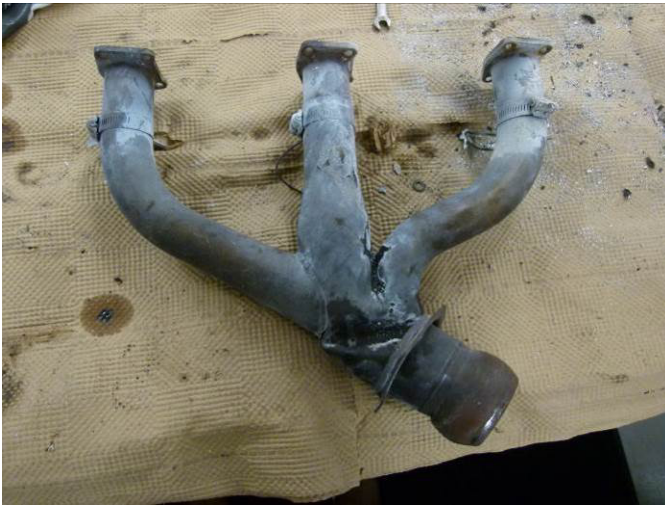
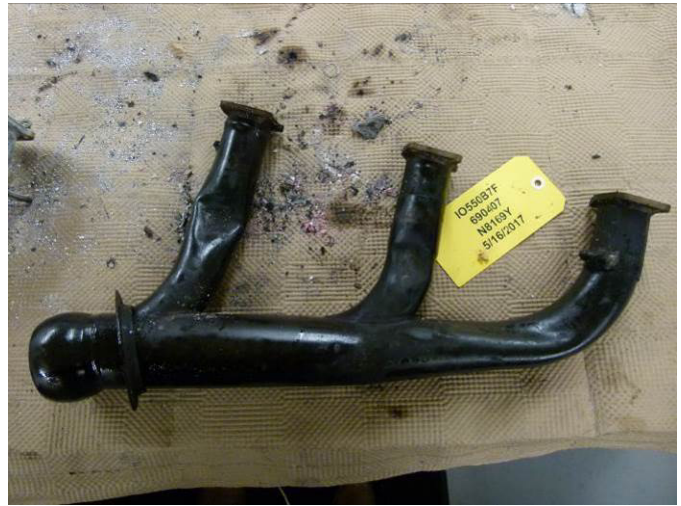
#### EXHAUST SYSTEM

The right and left exhaust headers/collectors remained attached but exhibited impact damage.

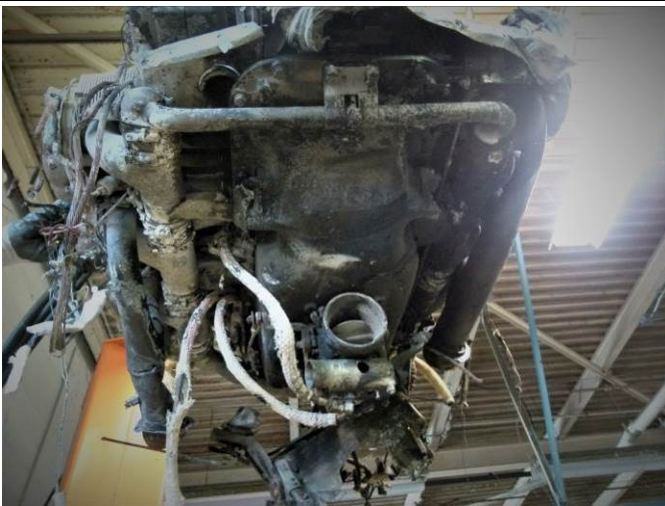
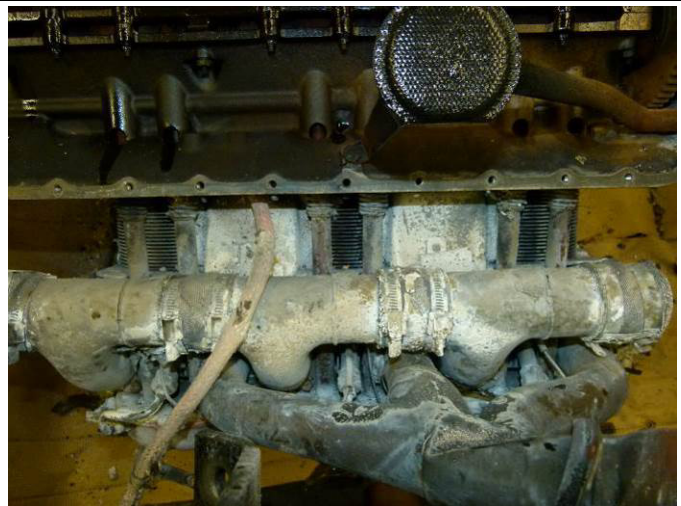
#### INDUCTION SYSTEM

The right and left induction elbows remained intact but the rubber connectors were thermally damaged. The forward balance tube was impact damaged but remained attached. The rear mounted wye induction pipes were thermally damaged.

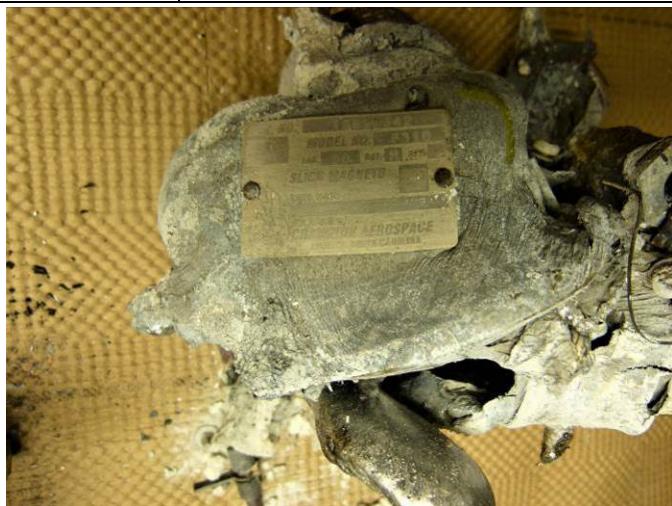
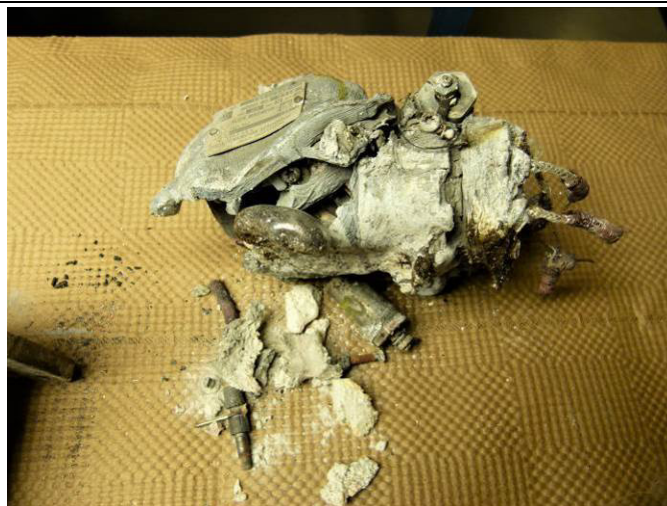
| MAGNETO-TO-ENGINE TIMING | Specification: 22° BTDC | L/H Magneto: Undetermined | R/H Magneto: Undetermined |
|---|---|---|---|
| MAGNETO | Manufacturer: Slick | M/N: 6310 | S/N: 15030342 |

| MAGNETO-TO-ENGINE TIMING | Specification: 22° BTDC | L/H Magneto: Undetermined | R/H Magneto: Undetermined |
|---|---|---|---|
| Condition: | The orientation of this magneto could not be determined. The magneto was thermally destroyed and could not be tested. | | |

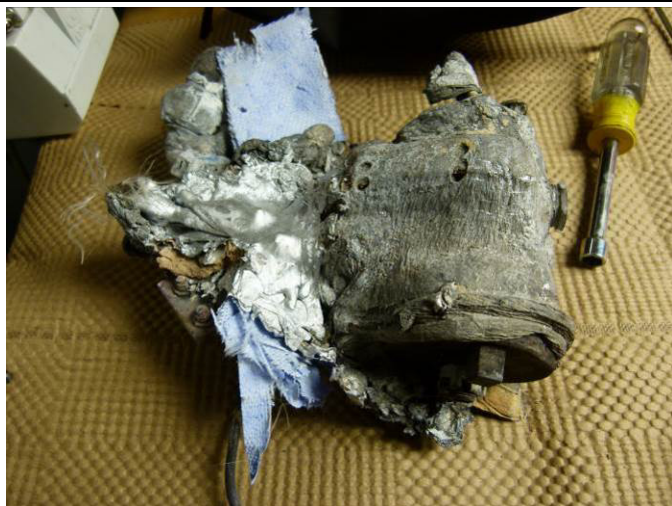
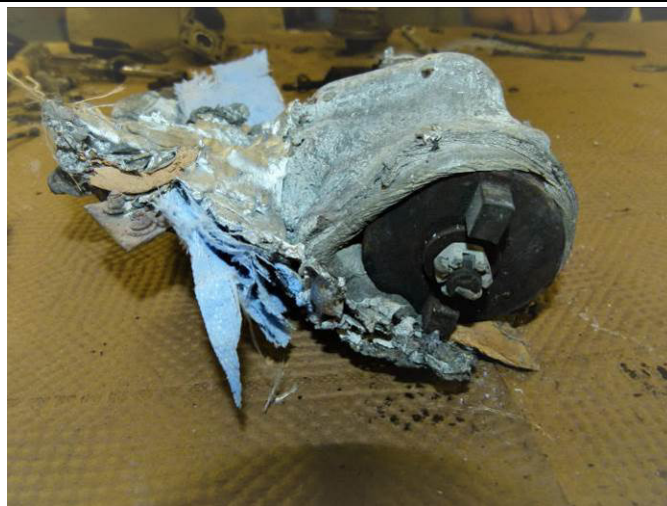
| MAGNETO | Manufacturer: Slick | M/N: Undetermined | S/N: Undetermined |

| MAGNETO | Manufacturer: Slick | M/N: Undetermined | S/N: Undetermined |
|---|---|---|---|
| Condition: | The orientation of this magneto could not be determined. The magneto was thermally destroyed and could not be tested. Data plate was destroyed. | | |

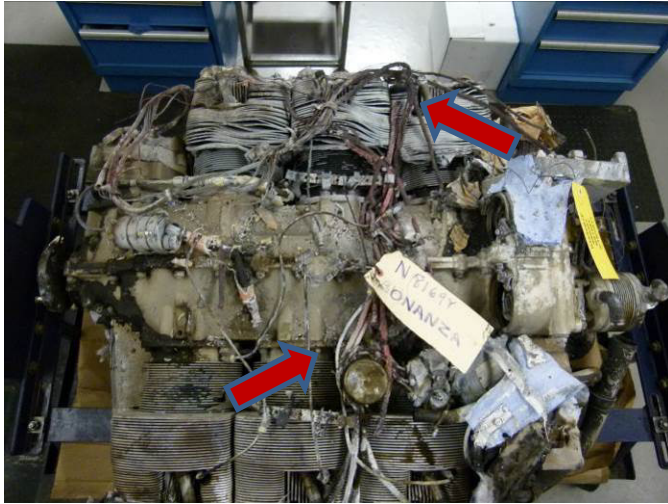
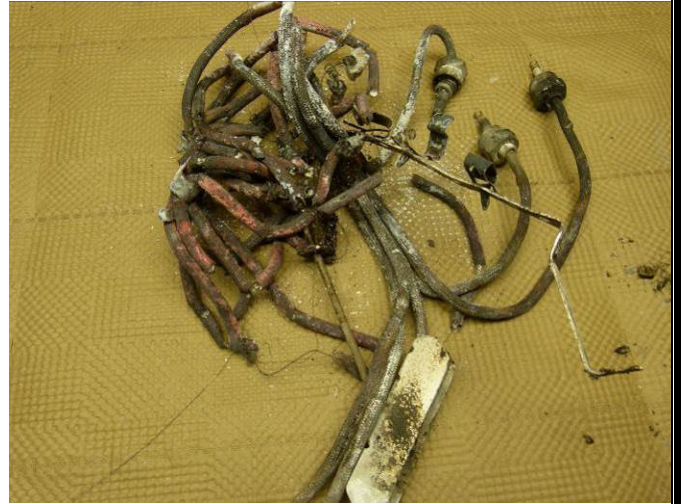
| <b>IGNITION HARNESS</b> | Manufacturer: Undetermined | P/N: Undetermined | S/N: Undetermined |

| Condition: | The ignition harness was thermally damaged. | | |

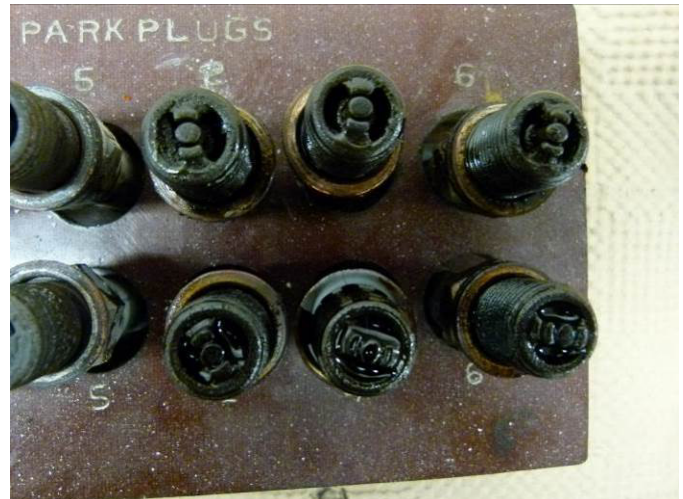
| Condition: | Sparkplugs from cylinders one, three and five appeared normal in wear and coloration when compared to a Champion Check-A-Plug chart. Sparkplugs from cylinders two, four and six were oil contaminated. This oil contamination is possibly the result of the engine orientation at the accident site. | |

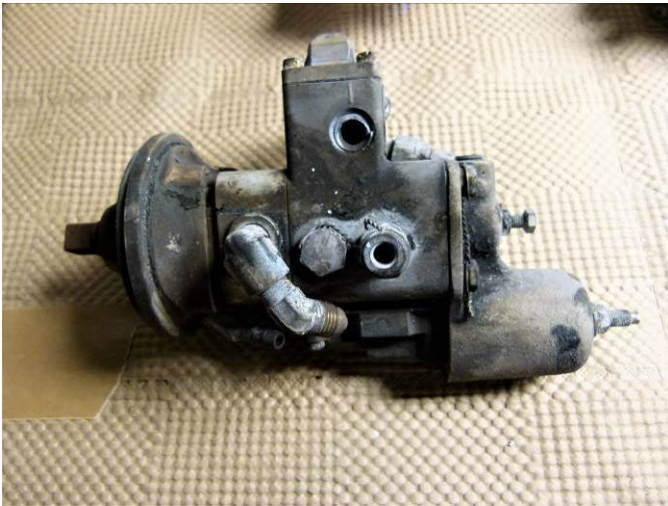
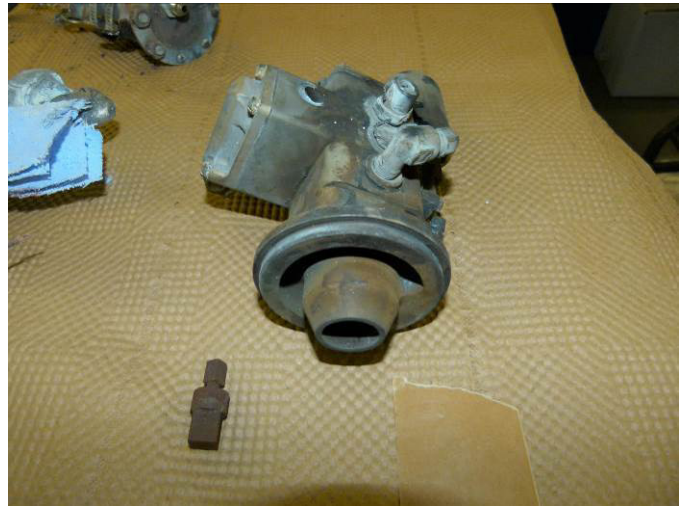
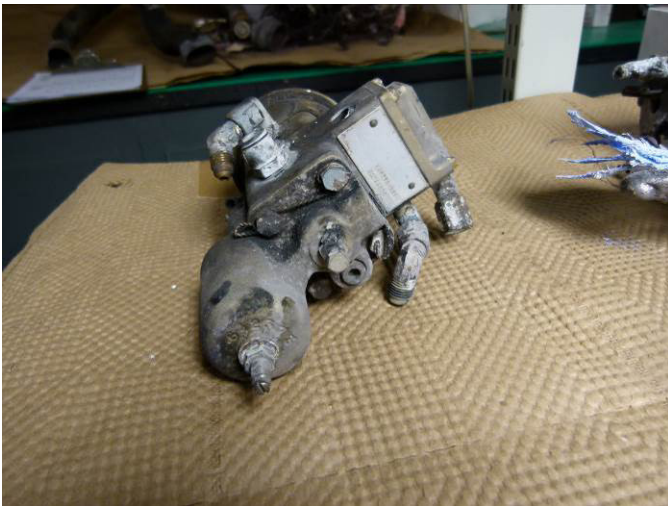
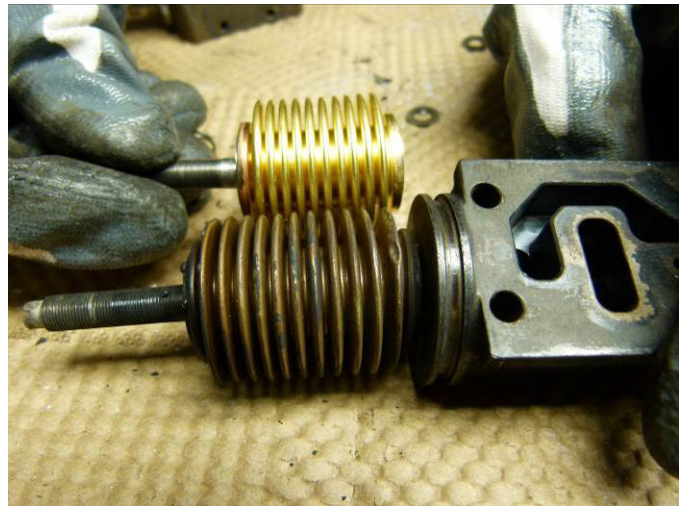
#### FUEL PUMP

Condition: The fuel pump had been removed at the accident site, photographed and secured to ship with the engine. The drive coupling was intact. The pump could not be rotated due to thermal damage. The aneroid bellows were elongated due to thermal damage when compared to an exemplar. No fuel was present in the fuel pump.

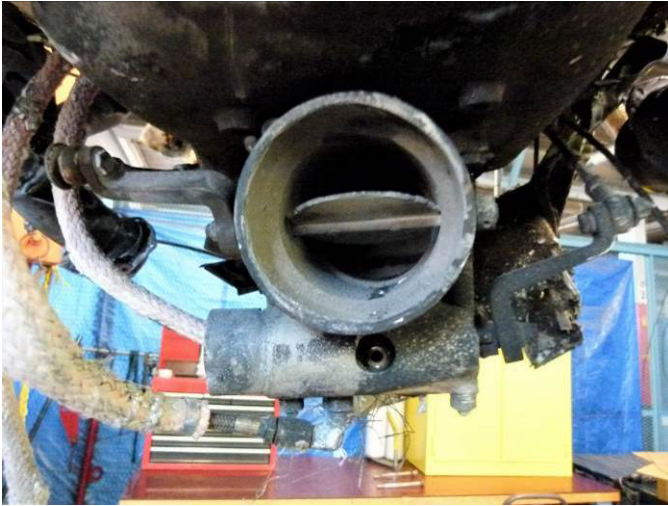
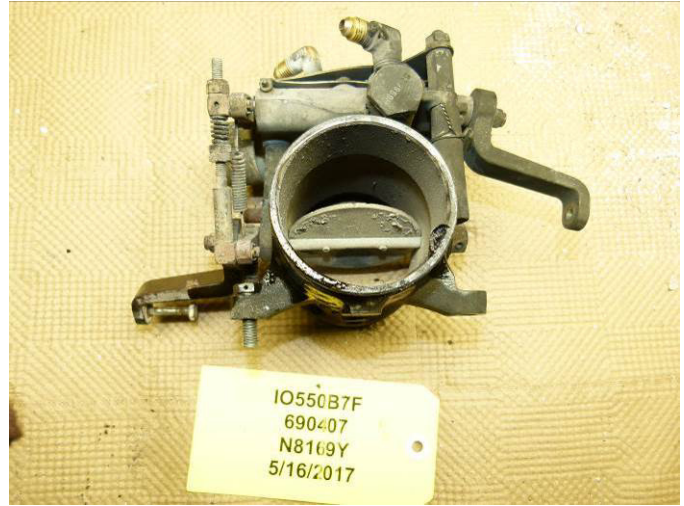
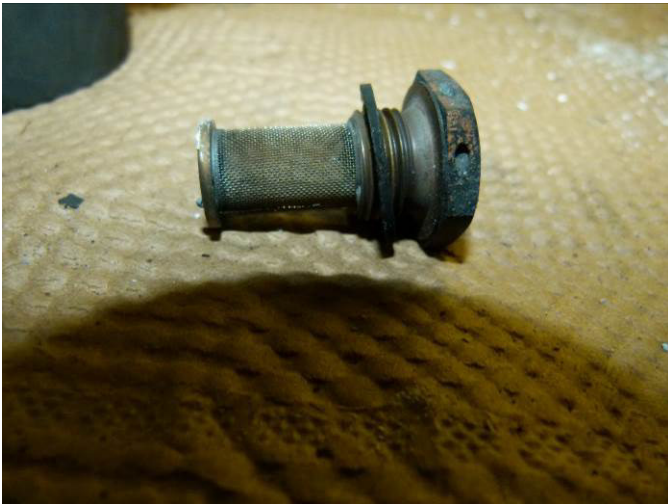
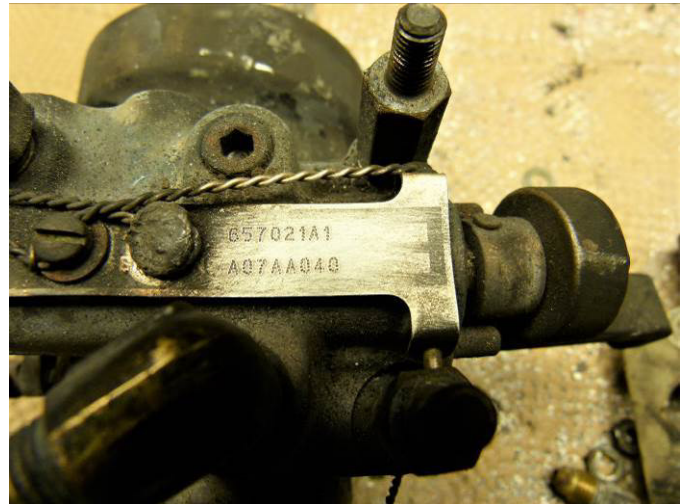
## THROTTLE BODY METERING UNIT

Condition: The throttle body/metering unit received thermal damage but remained intact. The fuel screen was removed and inspected. No contamination was noted. Both the throttle and mixture control arms remained secured to their respective shaft. No fuel was present in the metering unit.

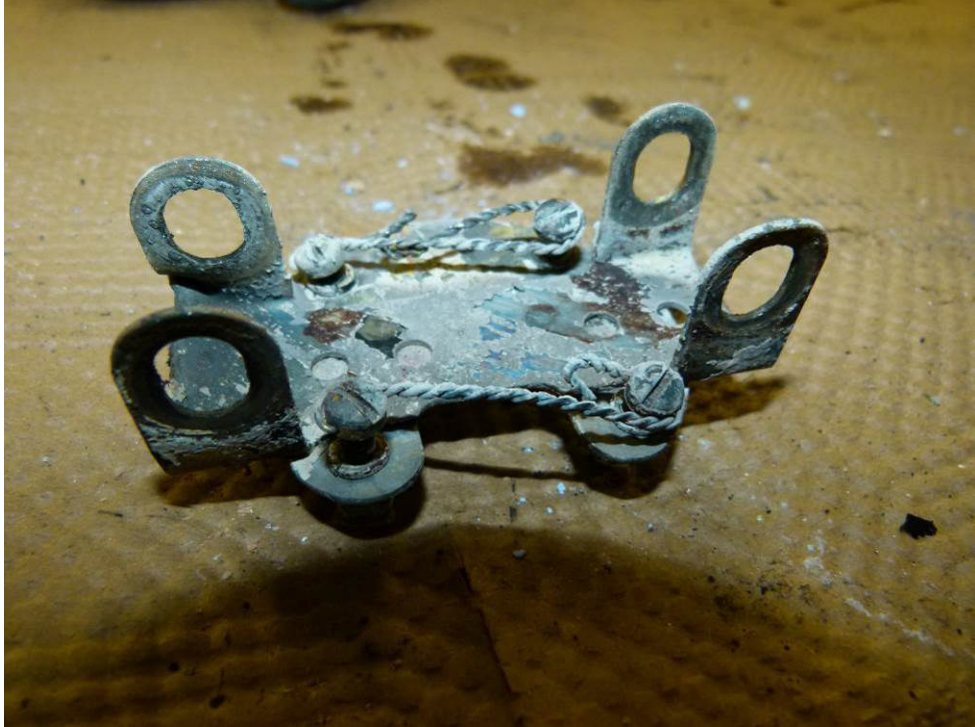
| FUEL MANIFOLD VALVE | Manufacturer:<br>Undetermined | P/N: Undetermined | S/N: Undetermined |

| Condition: | Not recovered at accident site. Only the mounting base was recovered. The four screws remaining are assembly screws for the valve body which separated. | | |

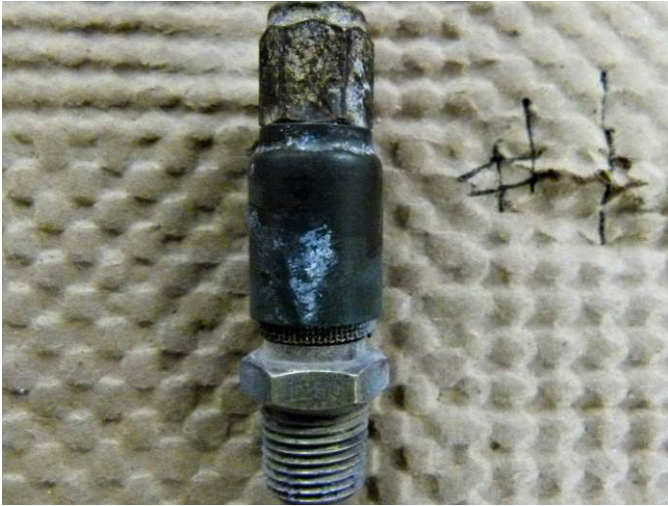
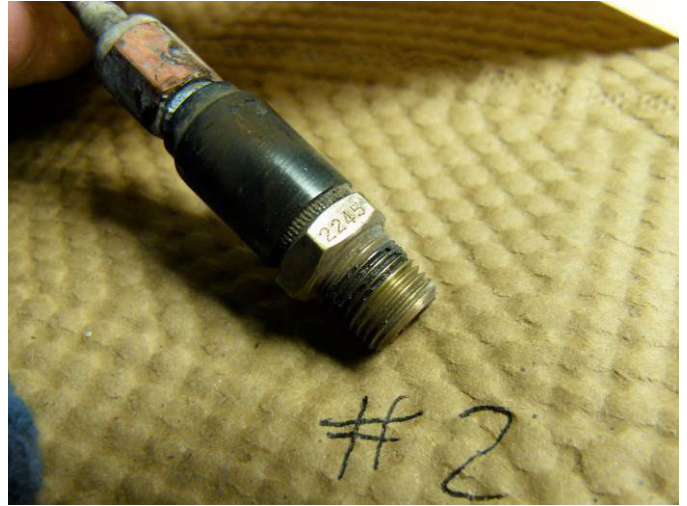
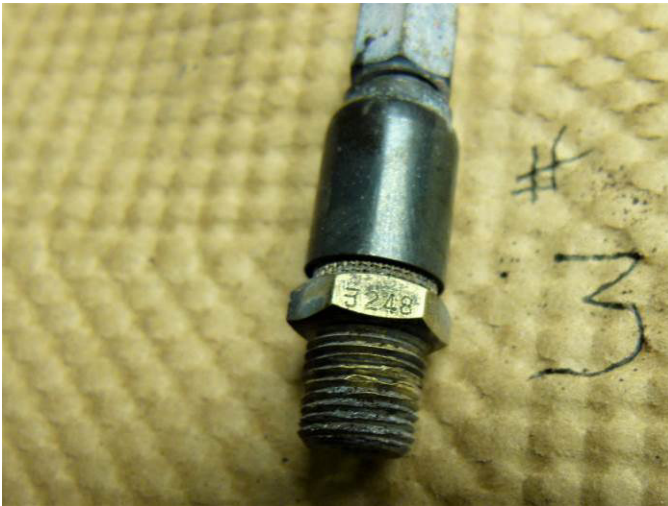
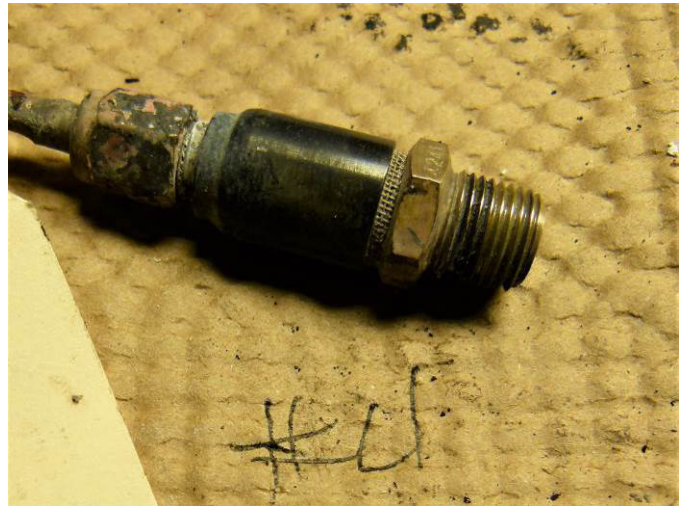
## FUEL NOZZLES AND LINES

| Position | #1 | #3 | #5 | #2 | #4 | #6 |
|---|---|---|---|---|---|---|
| Condition: | All fuel injectors were intact except # 5 which was not recovered. All injectors were open and appeared normal except thermal damage to exterior surfaces. | | | | | |

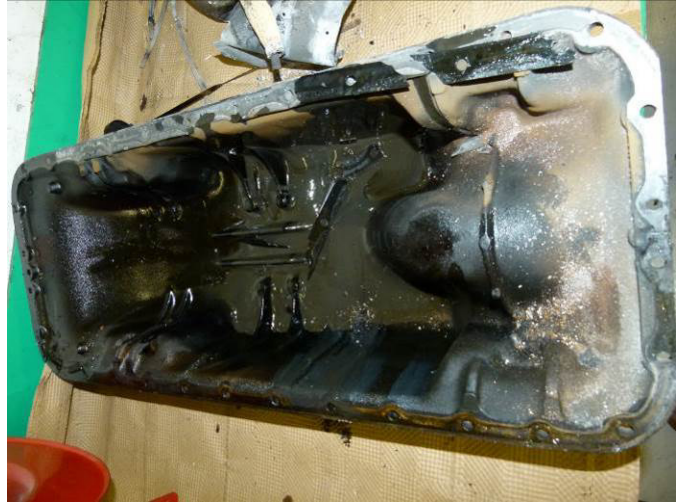
#### OIL SUMP

The oil sump was thermally damaged but remained intact.

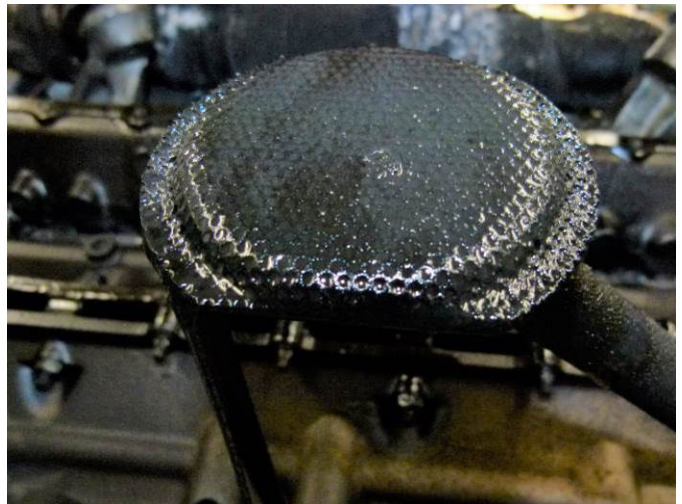
#### OIL PICK-UP TUBE & SCREEN

The oil pick-up screen was intact and no contamination was present.

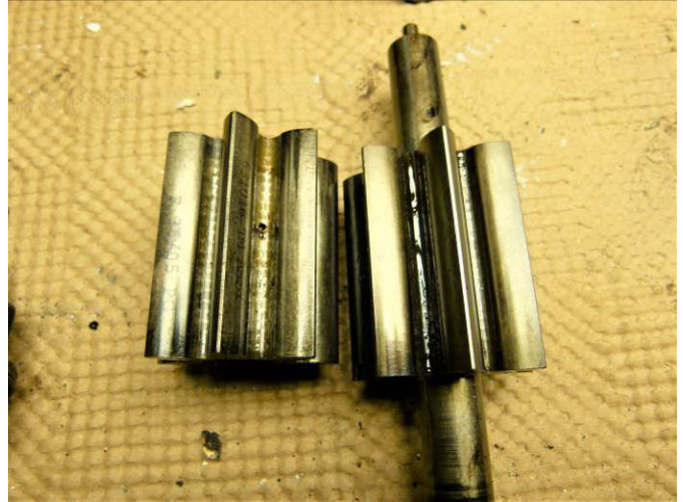
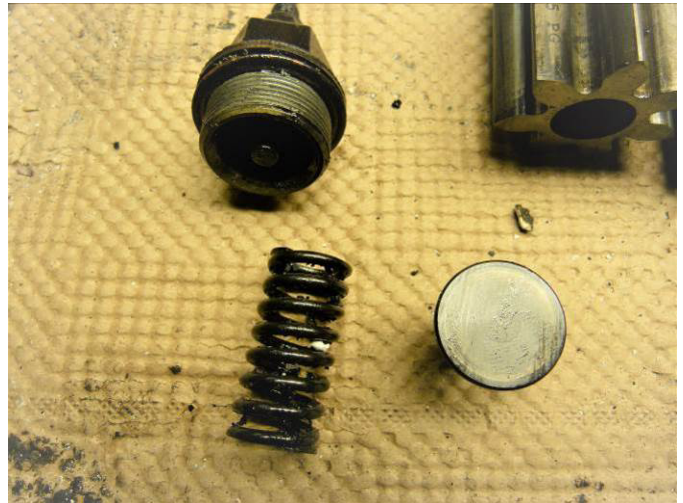
### OIL PUMP

The pump was disassembled and inspected. There was no scoring or scratching in the pump chamber to indicate hard particle passage. The gears were normal in condition and the oil pressure relief valve and spring were intact.

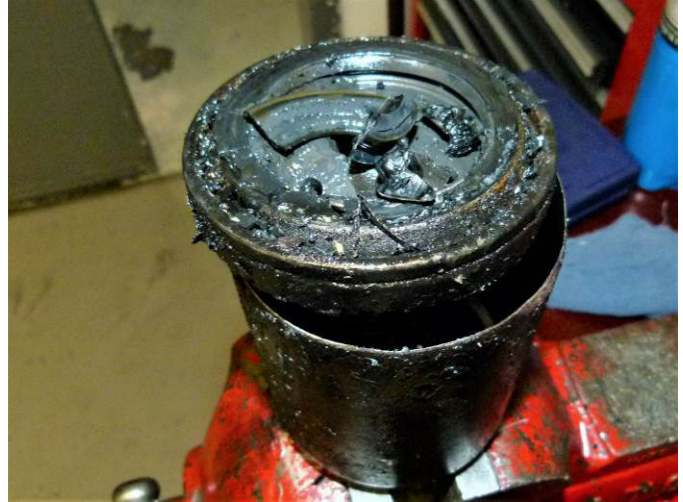
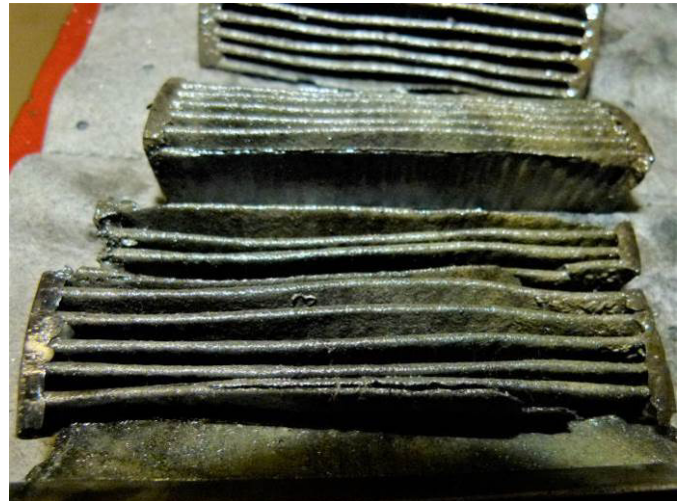
## OIL FILTER

The exterior of the oil filter was thermally damaged and manufacturer and model number were unreadable. The filter was opened and the filter media inspected. No metal contamination was exhibited.

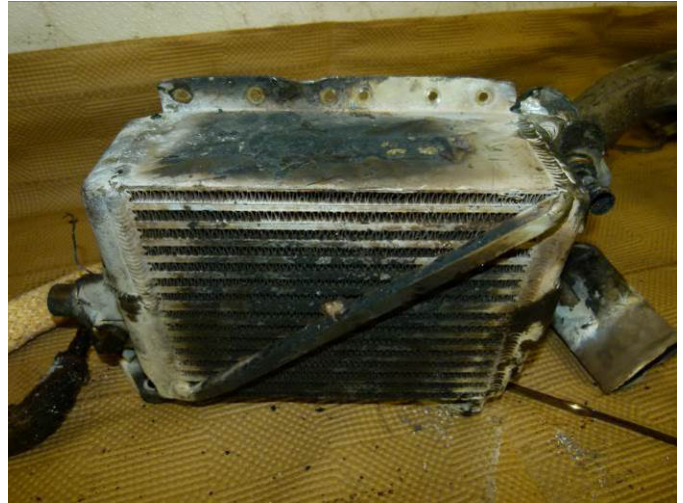
### OIL COOLER

**Condition:** The oil cooler was intact. No data plate was found. The exterior surfaces of the oil cooler exhibited thermal damage.

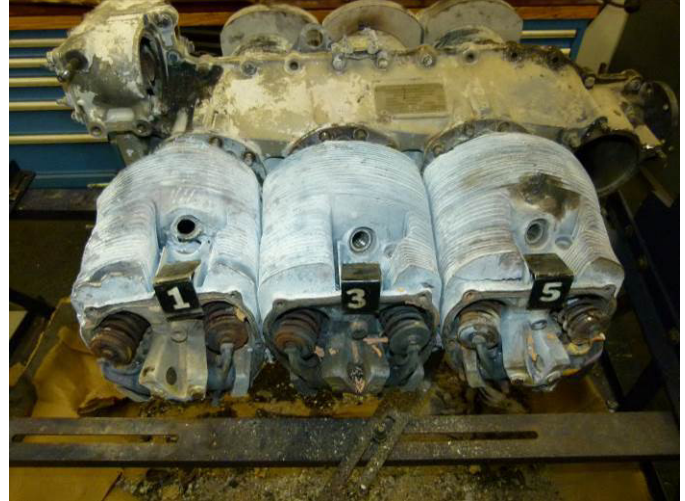
| <b>CYLINDER #1</b> | P/N: 658175A1 | S/N: AC14IA | Head Date: 10-14 |

| Condition: | Cooling fins were damaged by impact forces and thermal distress. | | |

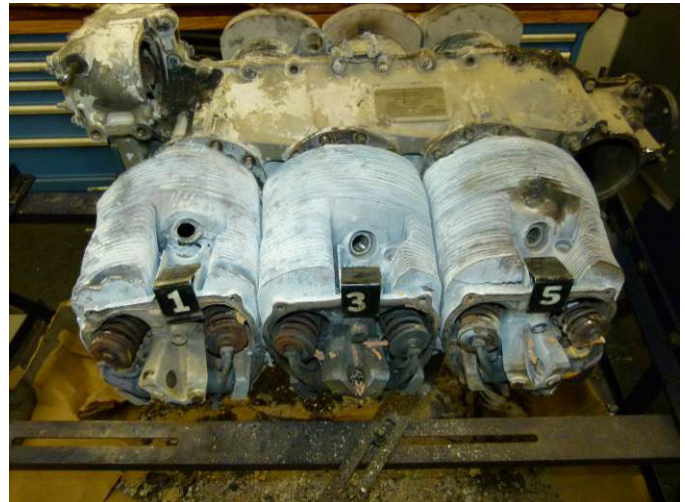
| <b>CYLINDER #3</b> | P/N: 658175A1 | S/N: AC14IA | Head Date: 10-14 |

| Condition: | Cooling fins were damaged by impact forces and thermal distress. | | |

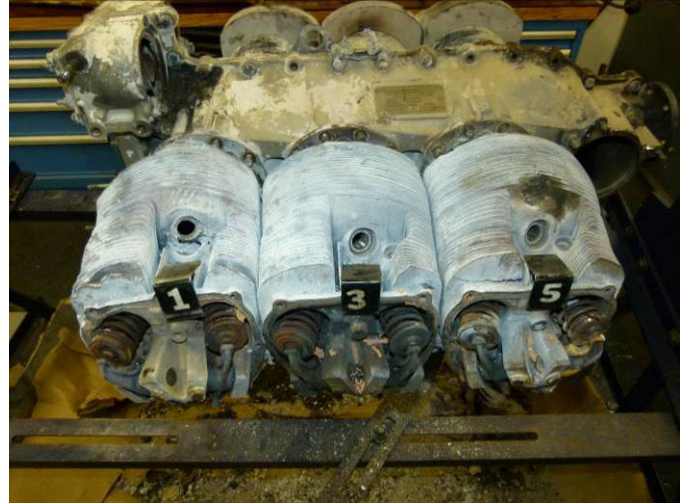
| <b>CYLINDER #5</b> | P/N: 658175A1 | S/N: AC14IA | Head Date: 10-14 |

| Condition: | Cooling fins were damaged by impact forces and thermal distress. | | |

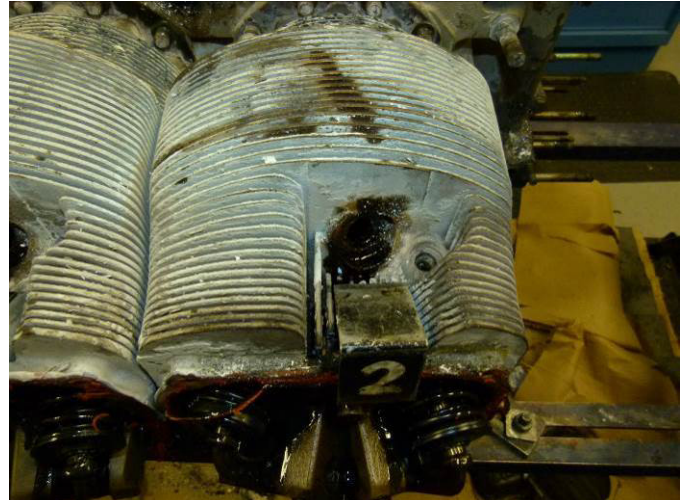
| <b>CYLINDER #2</b> | P/N: 658175A1 | S/N: AC14IA | Head Date: 10-14 |

| Condition: | Cylinder was intact with minor external thermal distress. | | |

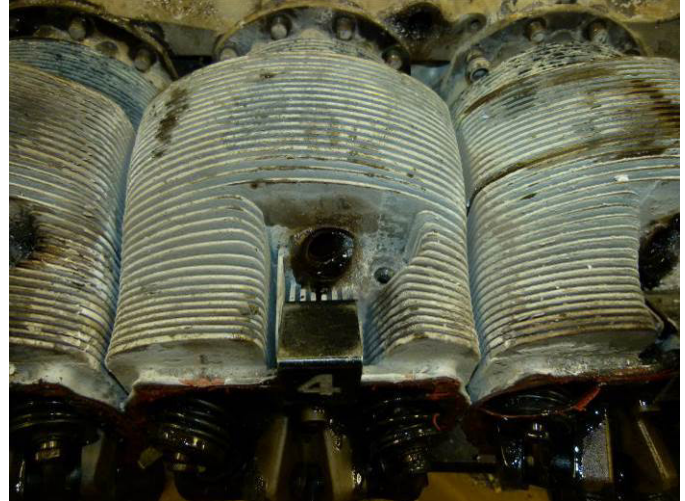
| <b>CYLINDER #4</b> | P/N: 658175A1 | S/N: AC14IA | Head Date: 9-14 |

| Condition: | Cylinder was intact with minor external thermal distress. |

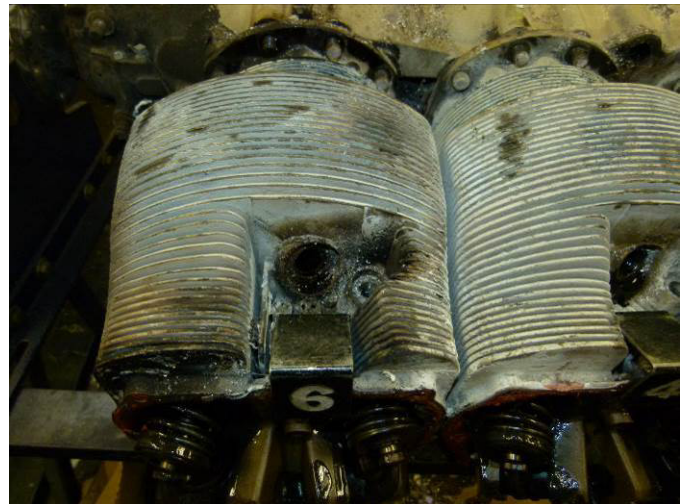
| <b>CYLINDER #6</b> | P/N: 658175A1 | S/N: AC14IA | Head Date: 10-14 |

| Condition: | Cylinder was intact with minor external thermal distress. |

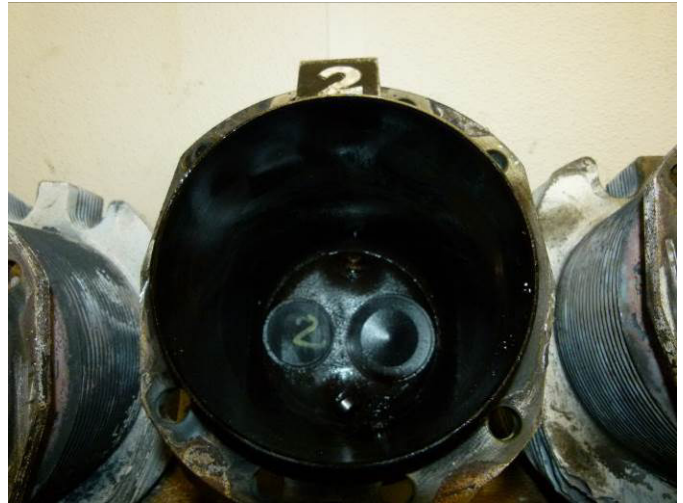
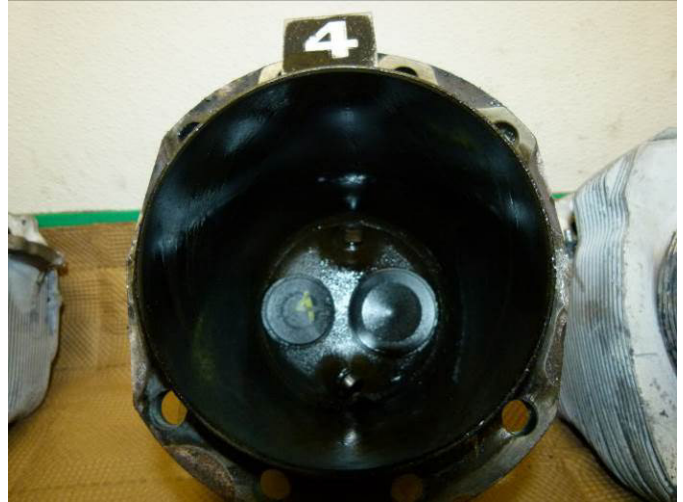
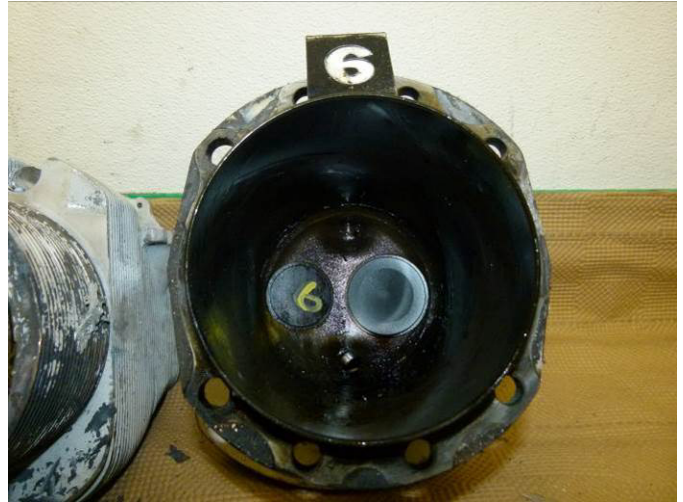
## VALVES

Condition: All valves were intact and in place.

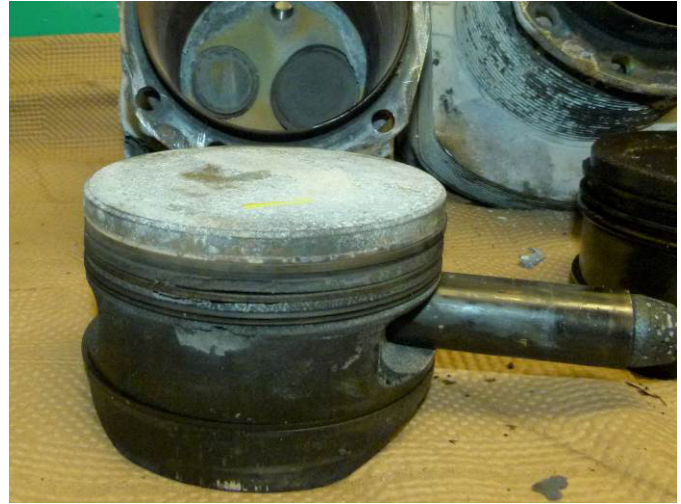
### #1 PISTON, RINGS AND PIN

Normal wear. Surface oxidation due to normal lubrication being destroyed by external fire after impact. This piston was stuck inside of the cylinder and manual manipulation was required to remove it.

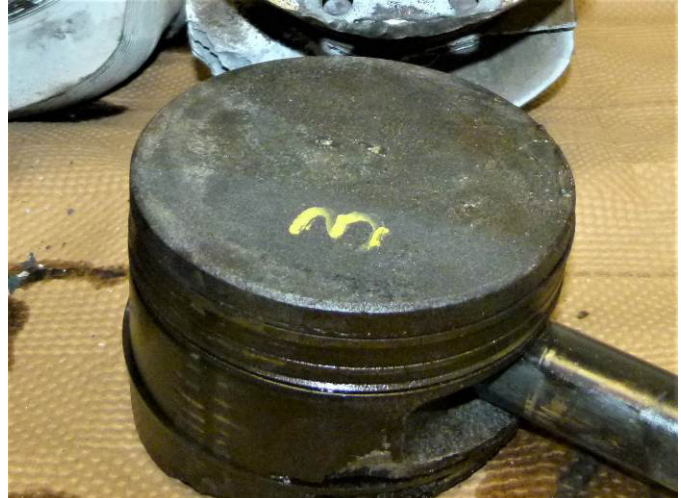
### #3 PISTON, RINGS AND PIN

Normal wear patterns and combustion signatures.

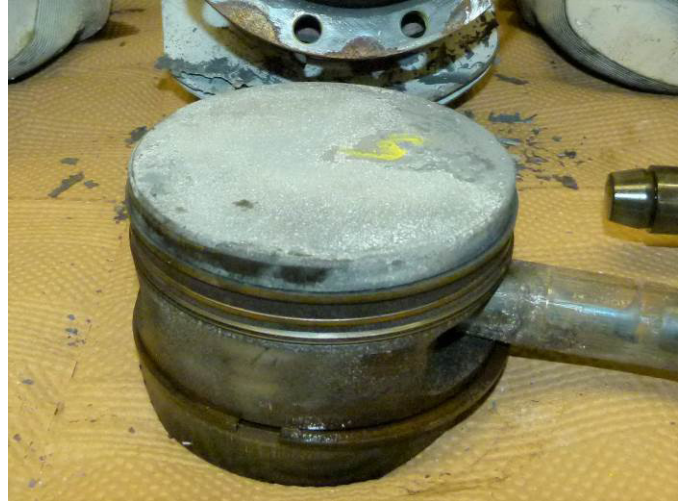
### #5 PISTON, RINGS AND PIN

Normal wear. Surface oxidation due to normal lubrication being destroyed by external fire after impact.

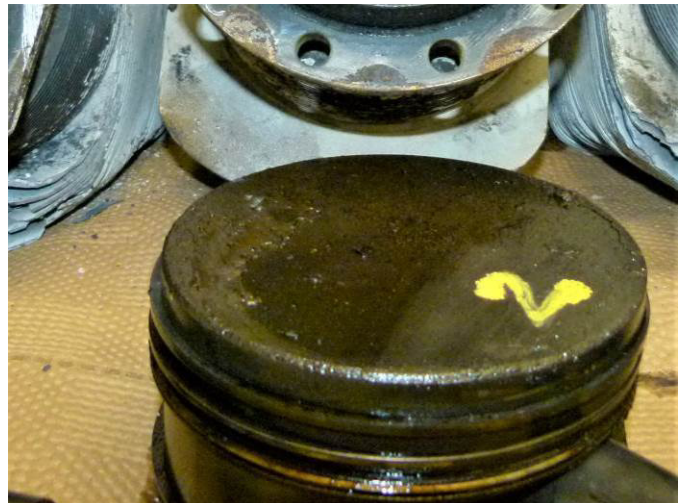
### #2 PISTON, RINGS AND PIN

Normal wear and combustion signatures. The surfaces are oil contaminated due to orientation of the engine after impact.

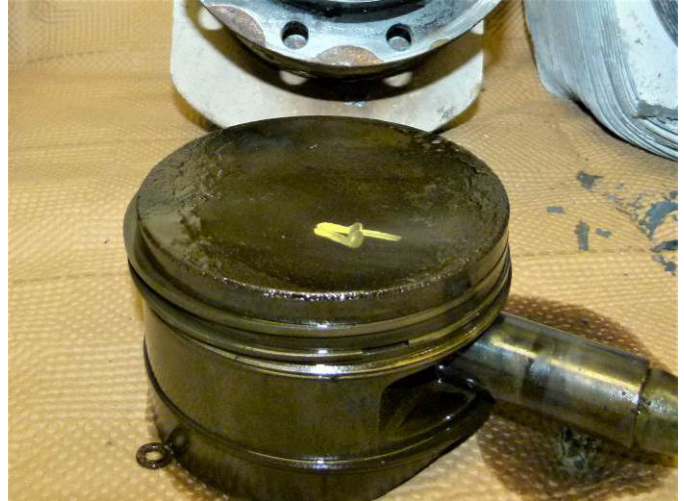
### #4 PISTON, RINGS AND PIN

Normal wear and combustion signatures. The surfaces are oil contaminated due to orientation of the engine after impact.

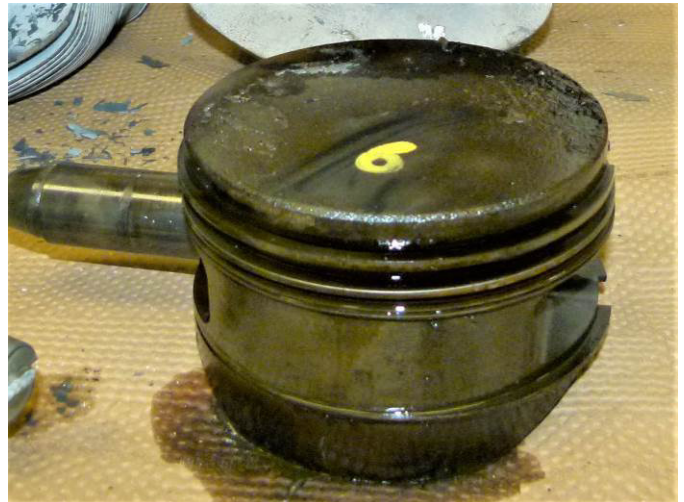
### #6 PISTON, RINGS AND PIN

Normal wear and combustion signatures. The surfaces are oil contaminated due to orientation of the engine after impact.

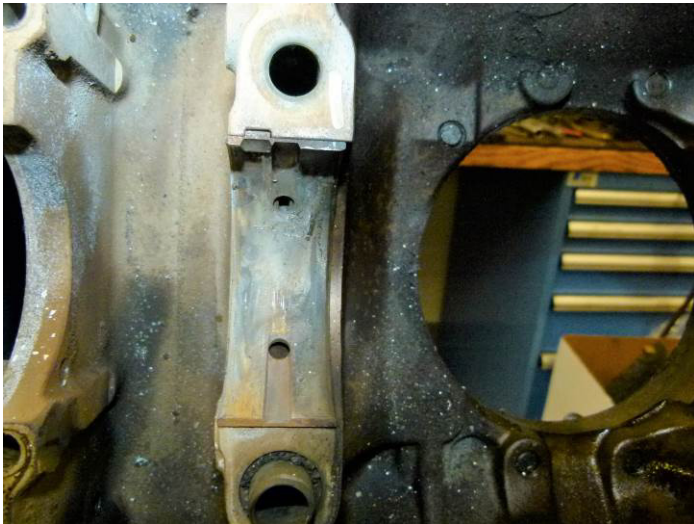
| <b>#1 MAIN BEARINGS</b> | | P/N: 634503 | | Date Code: 06-14 | |

| Condition: | The crankcase was intact but exhibited thermal damage to external surfaces and heat signatures on internal surfaces. | | | | |
| Condition: | #1 main bearing exhibited thermal damage to the bearing surface. | | | | |

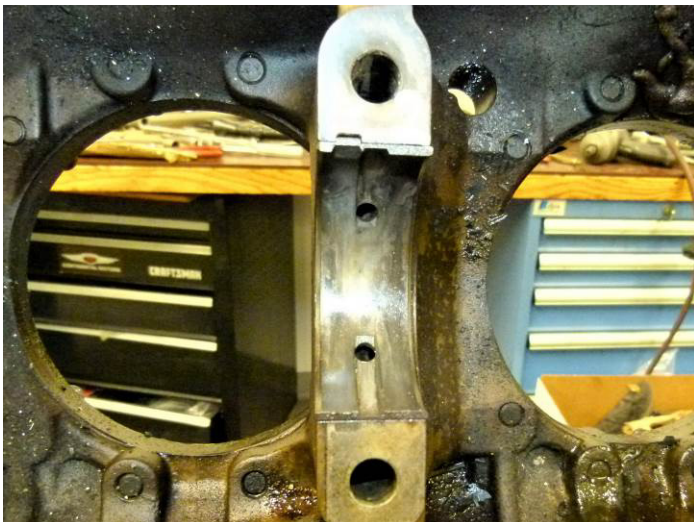
| #2 MAIN BEARINGS | | P/N: 634503 | Date Code: 06-14 |

| Condition: | #2 main bearing exhibited thermal damage to the bearing surface. | | |

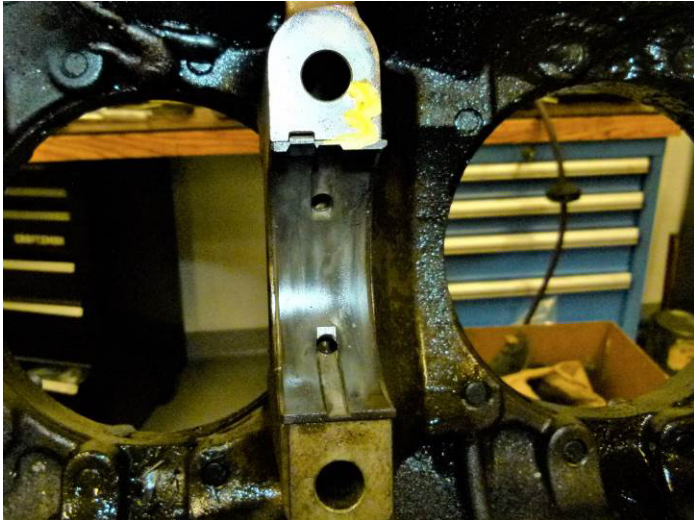
## #3 MAIN BEARINGS

Condition: Normal wear patterns.

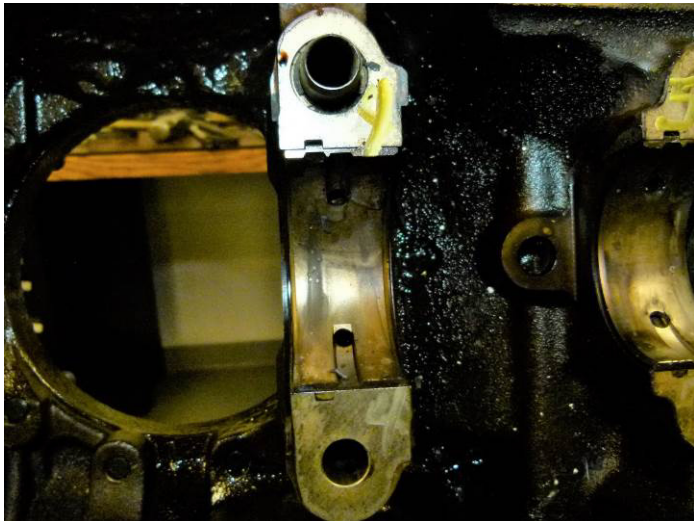
## #4 MAIN BEARINGS

Condition: # 4 main bearings exhibited thermal damage to the bearing surface.

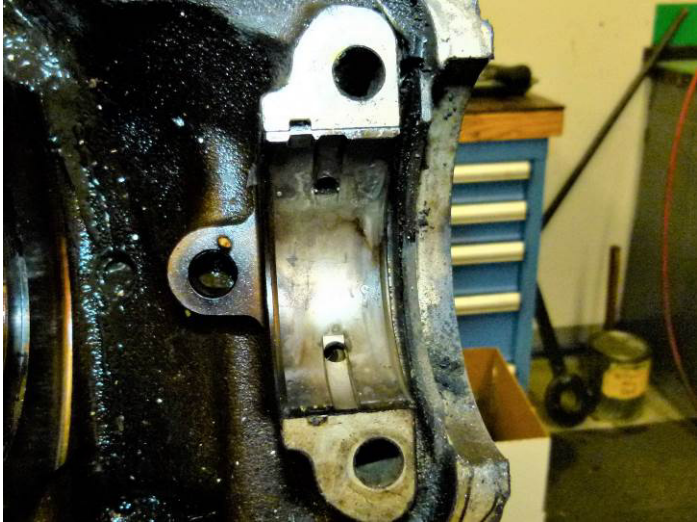
| #5 MAIN BEARINGS | P/N:653547 | Date Code: 08-14 |

| Condition: | # 5 main bearings exhibited thermal damage to the bearing surface. | |

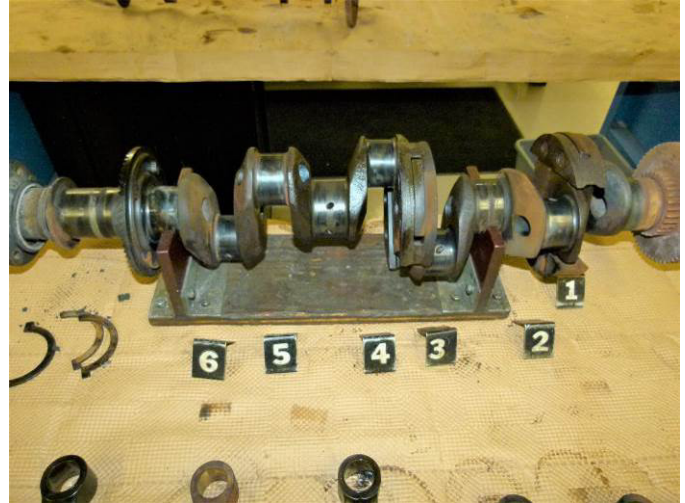
#### CRANKSHAFT

The crankshaft was intact but exhibited thermal damage.

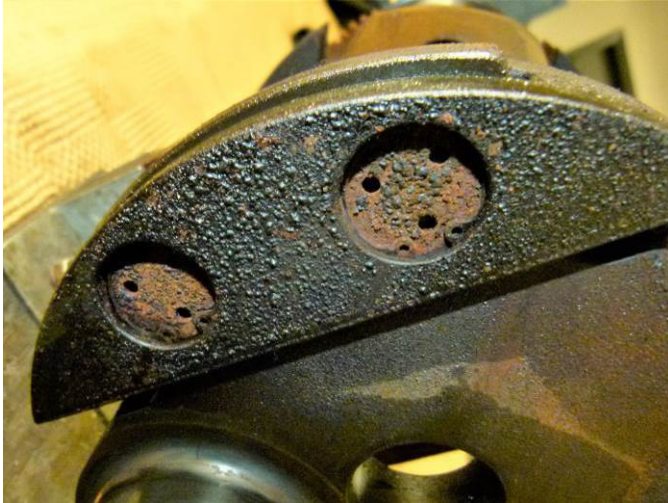
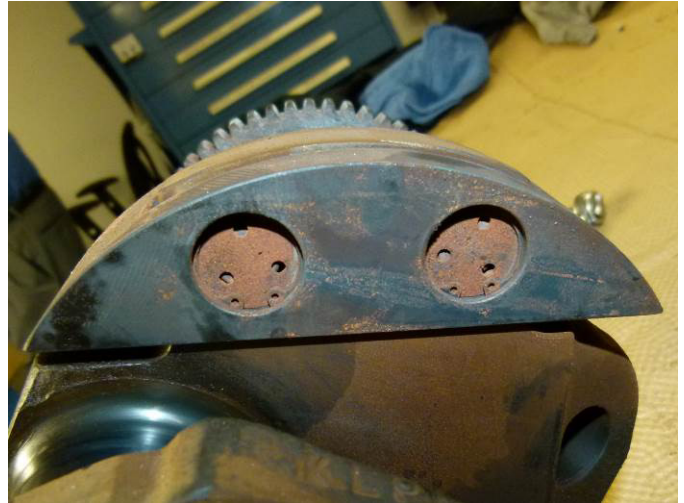
### COUNTER WEIGHTS

The counter weights were free to move on pins. The plates and clips were intact but exhibited thermal damage.

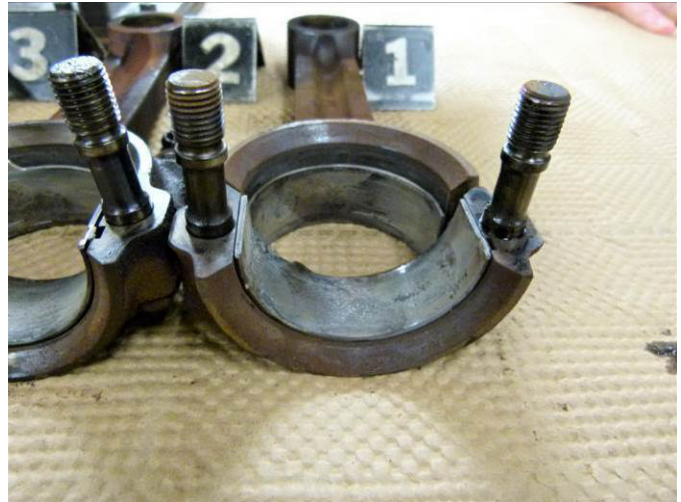
## #1 CONNECTING ROD

Condition: The connecting rod appeared normal except for the thermal damage to the beam surface.

Condition: The rod bearing surfaces were thermally damaged.

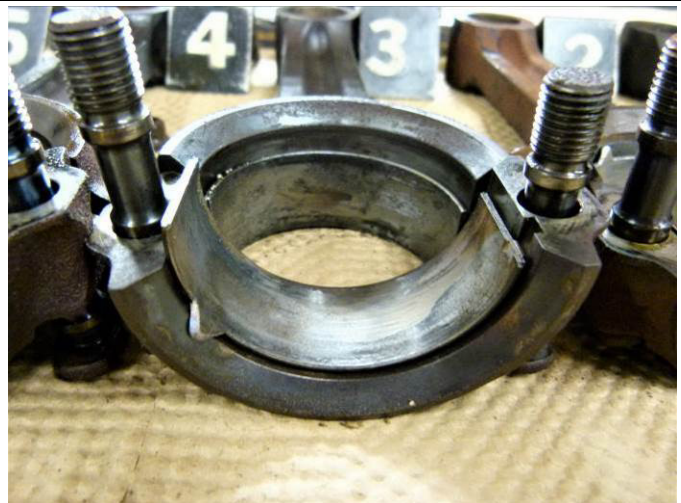
## #3 CONNECTING ROD

Condition: The connecting rod appeared normal.

Condition: The rod bearing surfaces were thermally damaged.

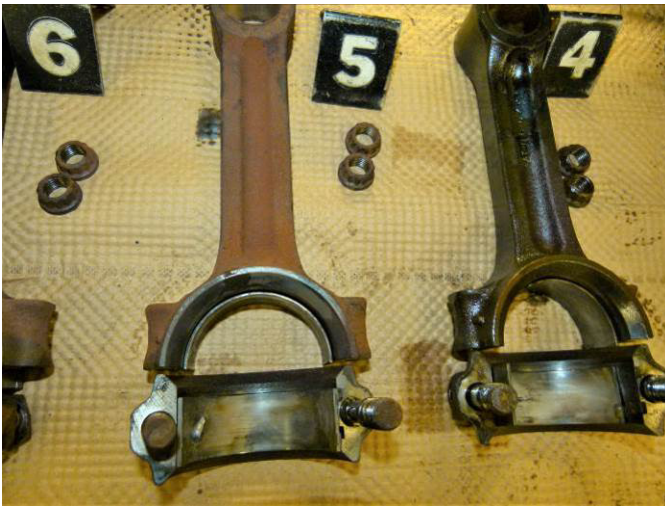
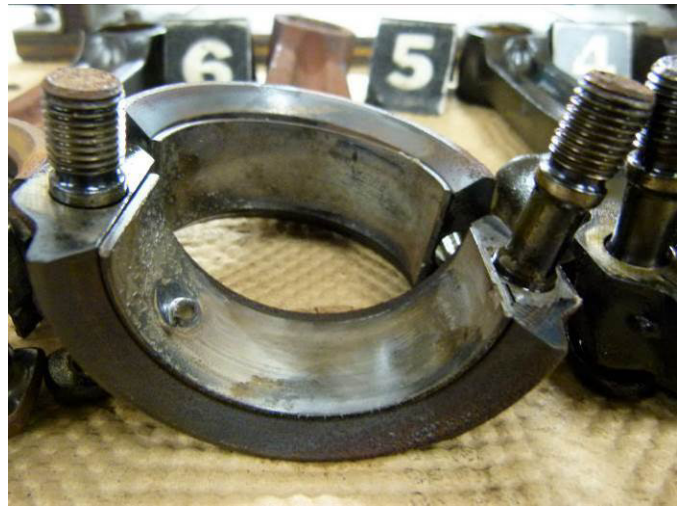
## #5 CONNECTING ROD

Condition: The connecting rod appeared normal except for the thermal damage to the beam surface.

Condition: The rod bearing surfaces were thermally damaged.

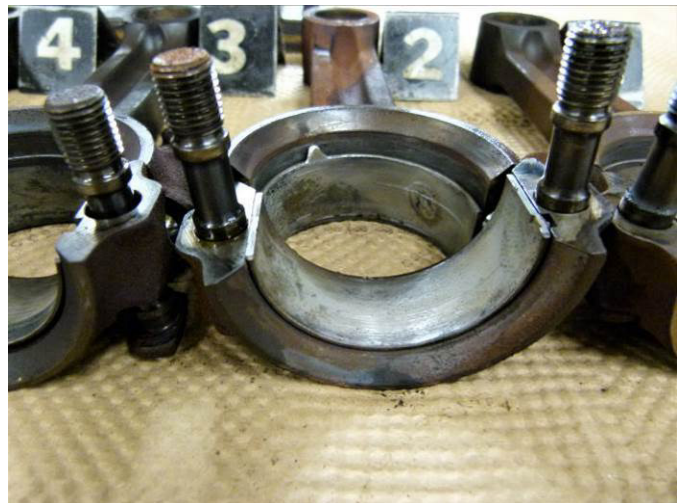
## #2 CONNECTING ROD

Condition: The connecting rod appeared normal except for the thermal damage to the beam surface.

Condition: The rod bearing surfaces were thermally damaged.

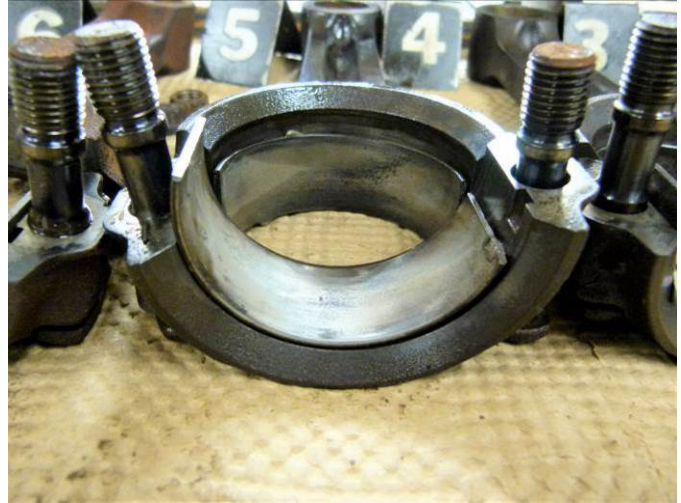
## #4 CONNECTING ROD

Condition: The connecting rod appeared normal.

Condition: The rod bearing surfaces were thermally damaged.
