## ENGINE EXAMINATION REPORT

| ENGINE MODEL | IO550B (6F) |
| AIRCRAFT MAKE & MODEL | Beechcraft A36 Bonanza |
| FILE NUMBER | 16-507 |

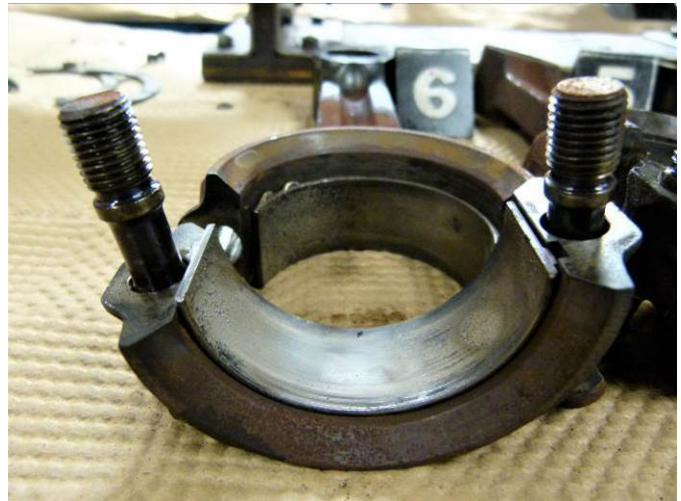
## #6 CONNECTING ROD

Condition: The connecting rod appeared normal except for the thermal damage to the beam surface.

Condition: The rod bearing surfaces were thermally damaged.

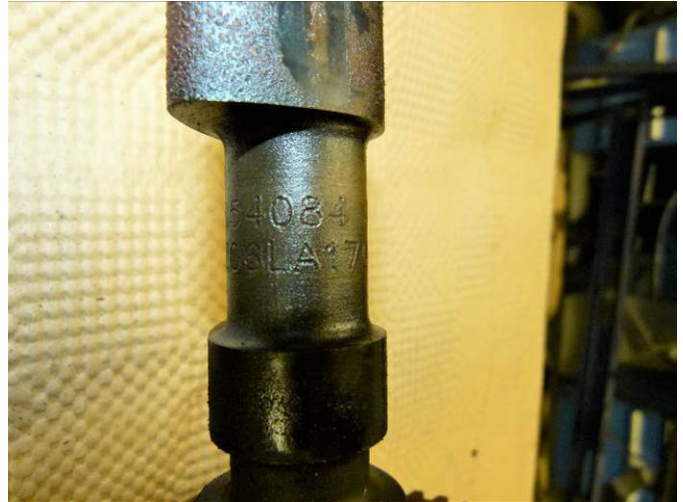
| <b>CAMSHAFT</b> | P/N: 654084-J | S/N: Z06LA170 |

| Condition: | The camshaft exhibited normal wear patterns. | |

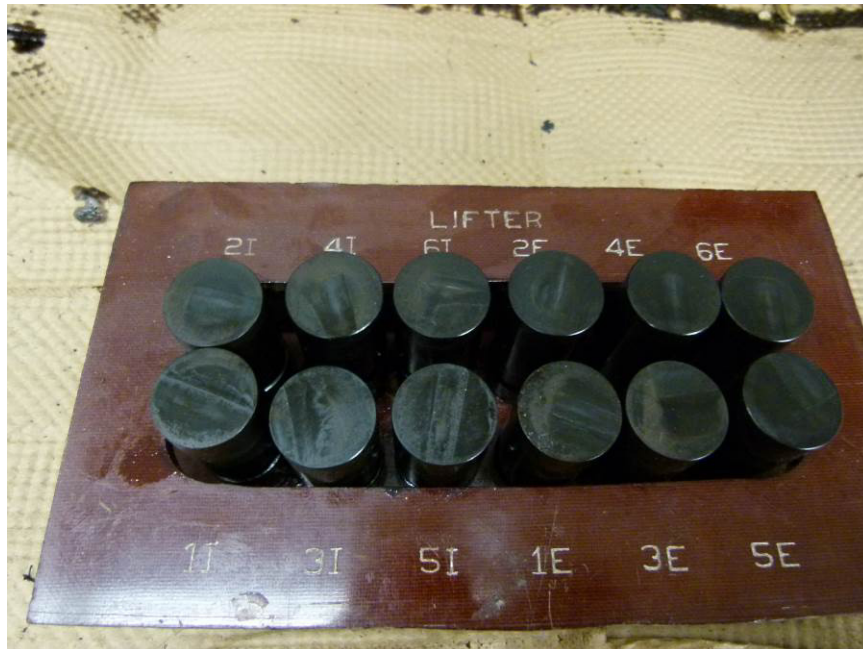
| LIFTERS | #1 | #3 | #5 | #2 | #4 | #6 |

| LIFTERS | #1 | #3 | #5 | #2 | #4 | #6 |
|---|---|---|---|---|---|---|
| Condition: | The lifters exhibited normal wear patterns. | | | | | |

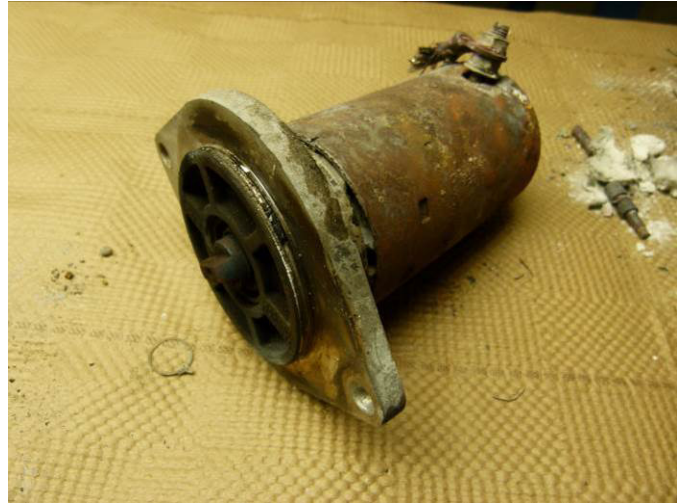
**STARTER**Manufacturer:  
Undetermined

The starter motor was intact but thermally damaged. No data plate was found.

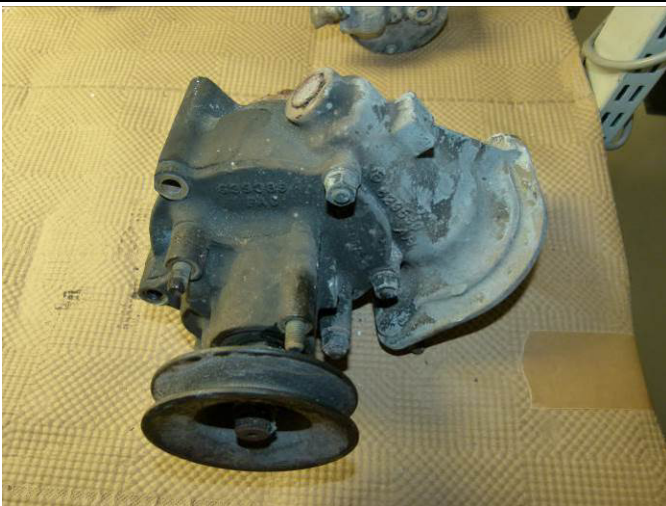
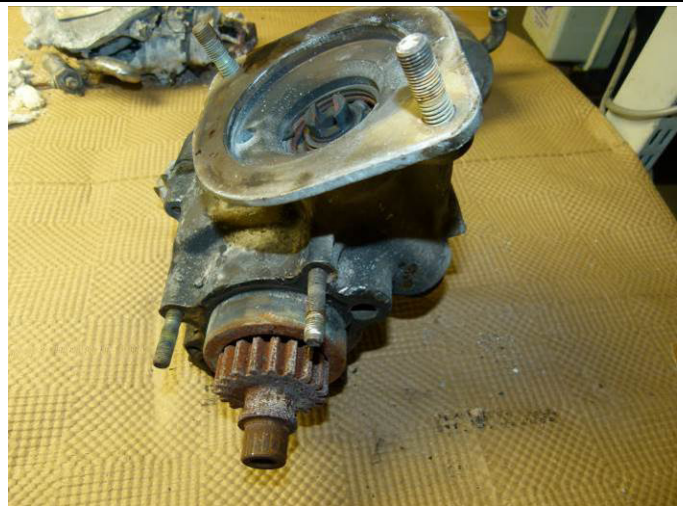
**STARTER  
ADAPTER**

The starter adapter was intact but exhibited thermal damage. The adapter could be rotated manually.

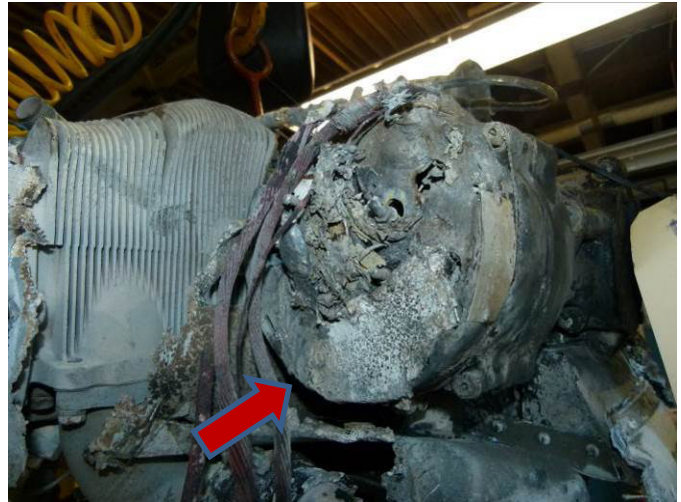
## ALTERNATOR

Condition: Thermally destroyed

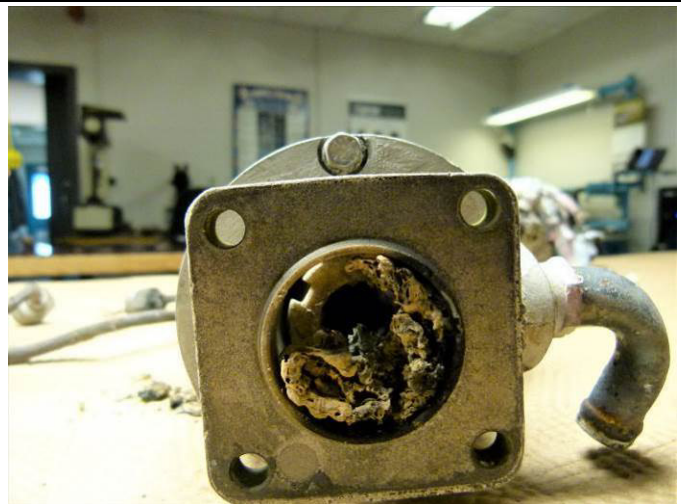
## VACUUM PUMP

Condition: Data tag was thermally destroyed. The plastic drive coupling was thermally destroyed. The pump was disassembled. The carbon rotor and vanes were intact.

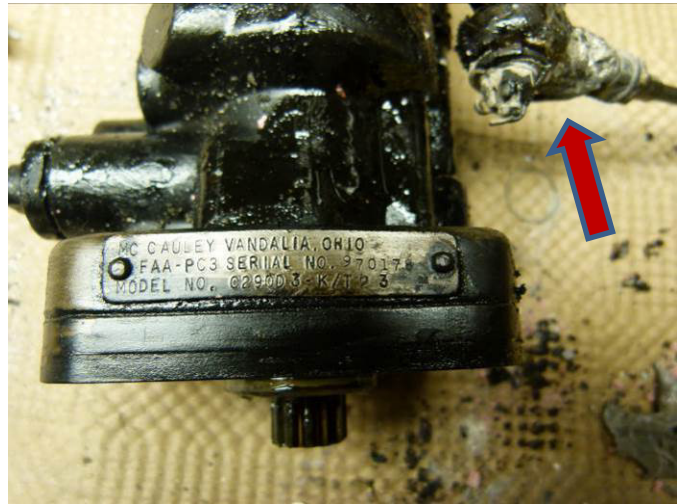
## PROPELLER GOVERNOR

Condition: The governor rotates freely when the drive gear is rotated manually. The governor control cable had been cut but the control arm remained attached and secured properly.
