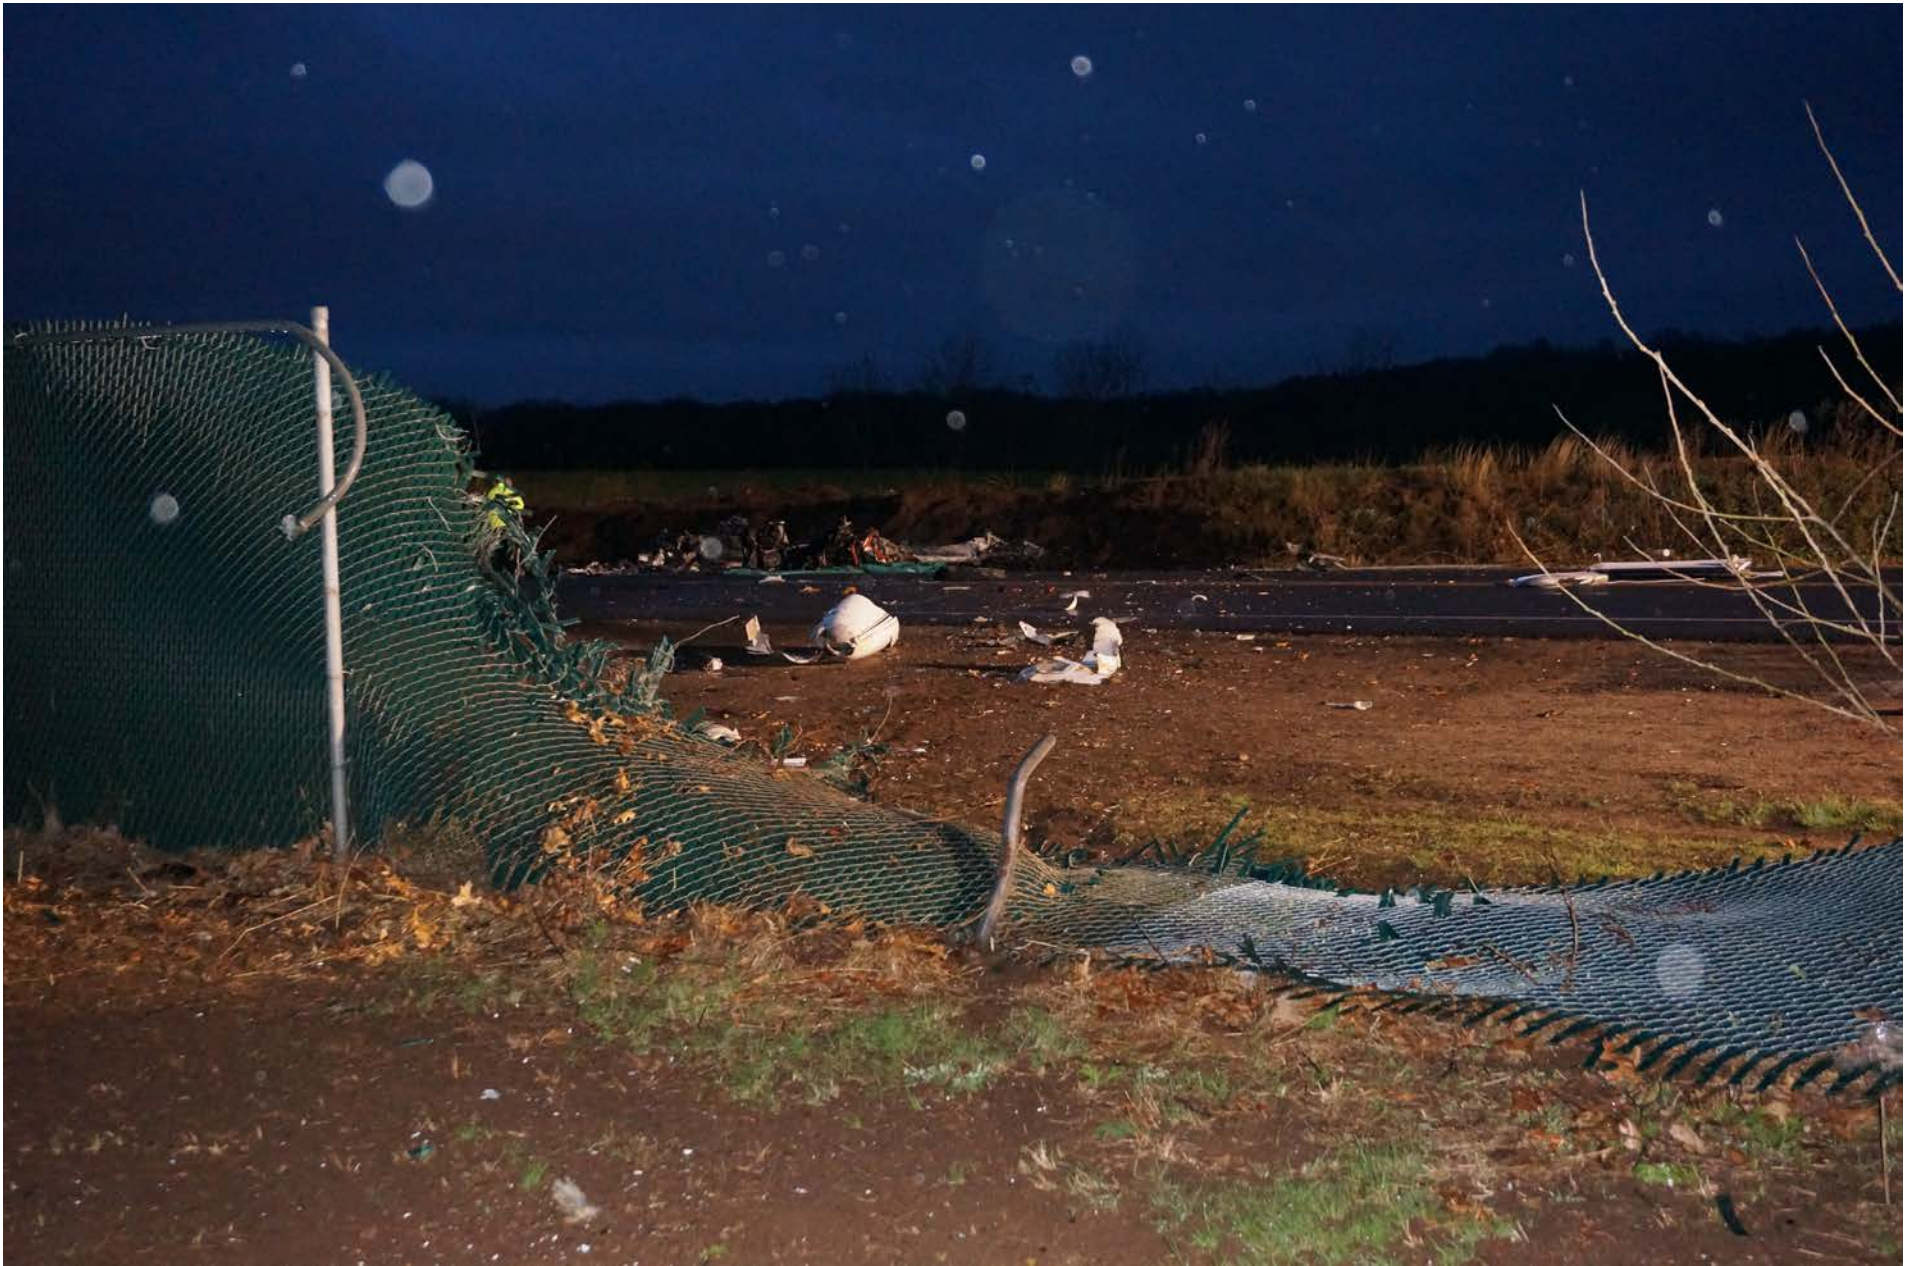
**Photo 1 –Breach in Airport Security Fence**

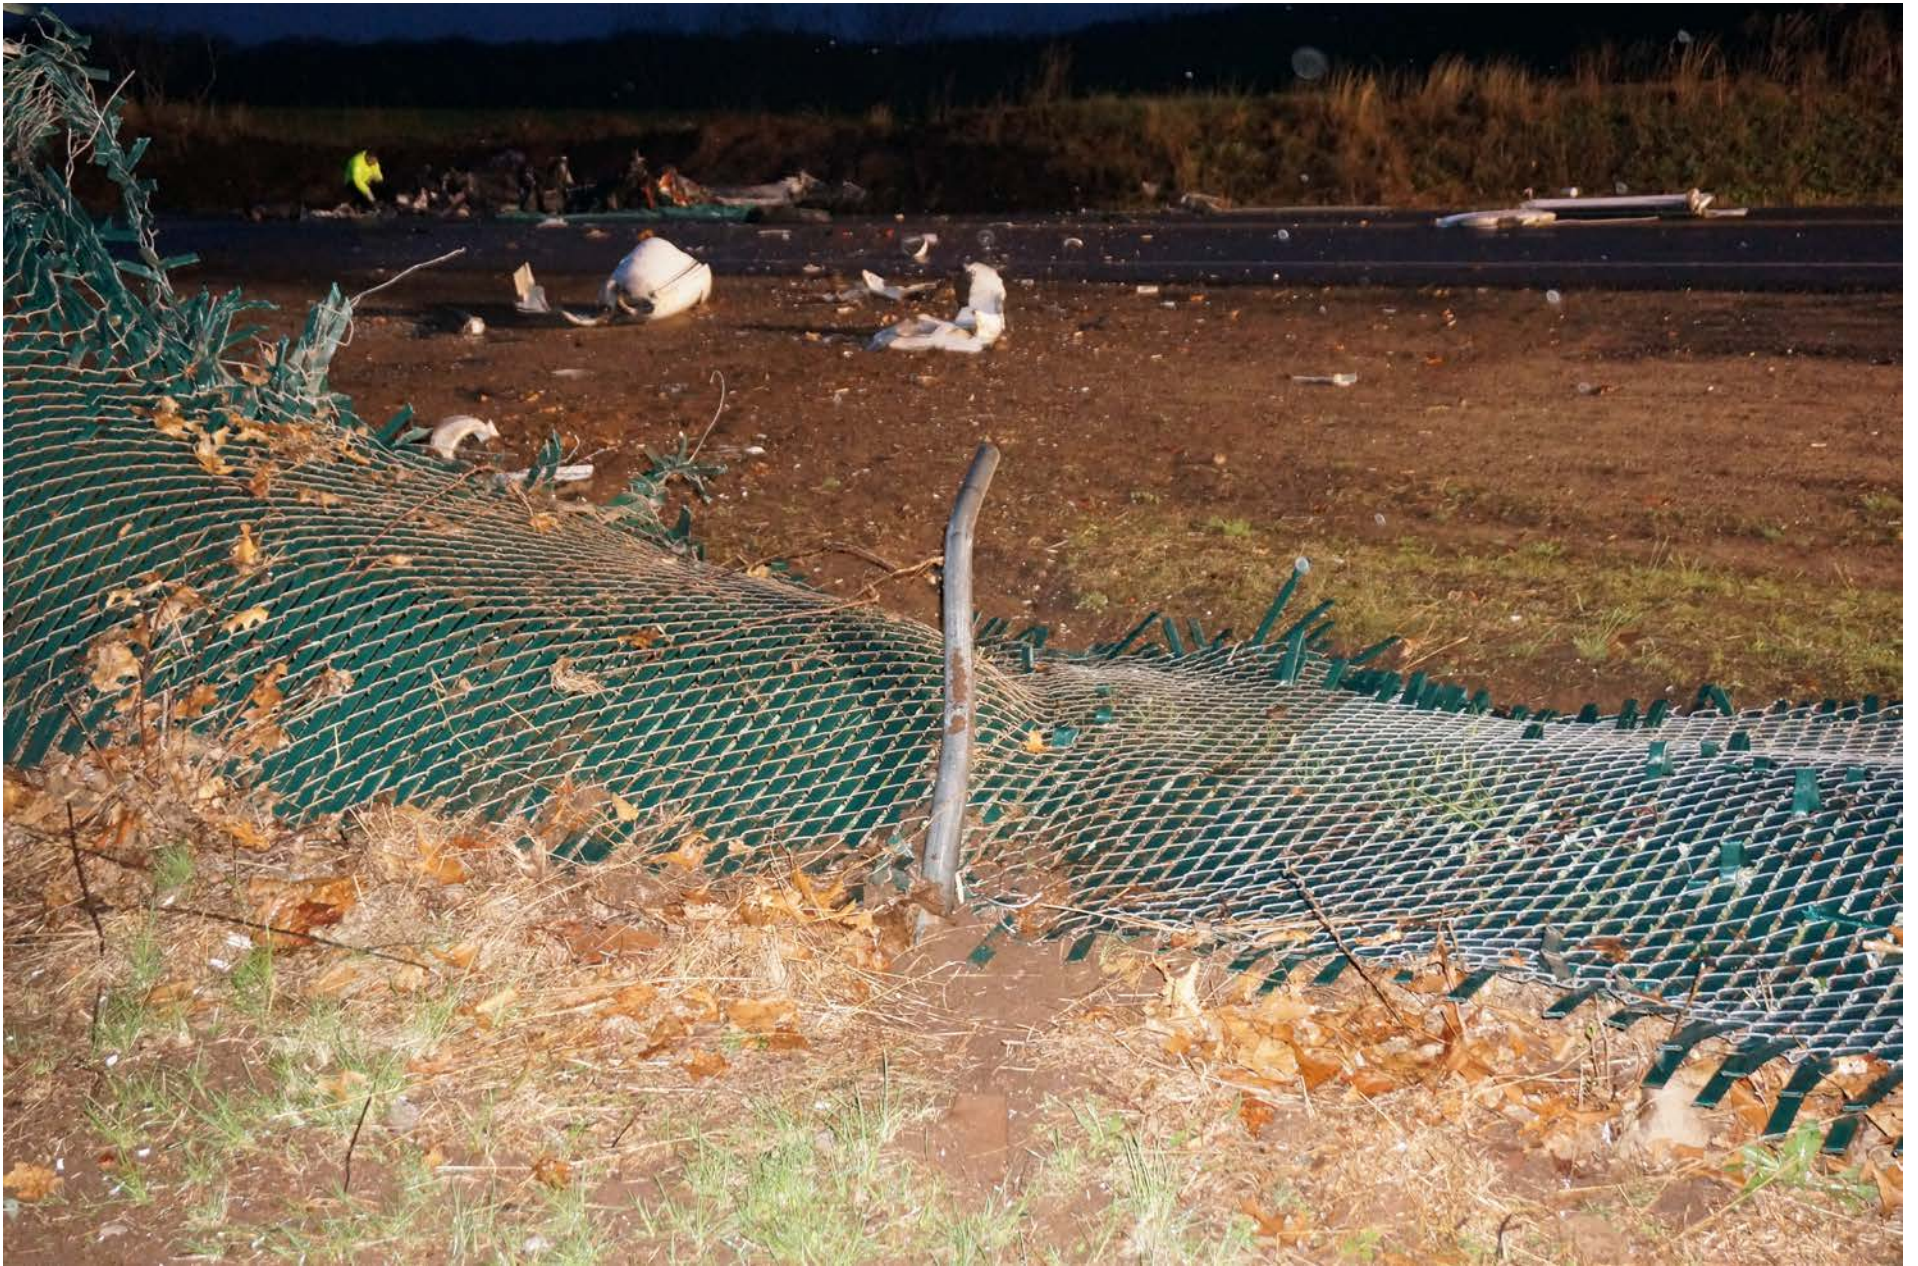
**Photo 2 – Close Up Photograph of Breach**

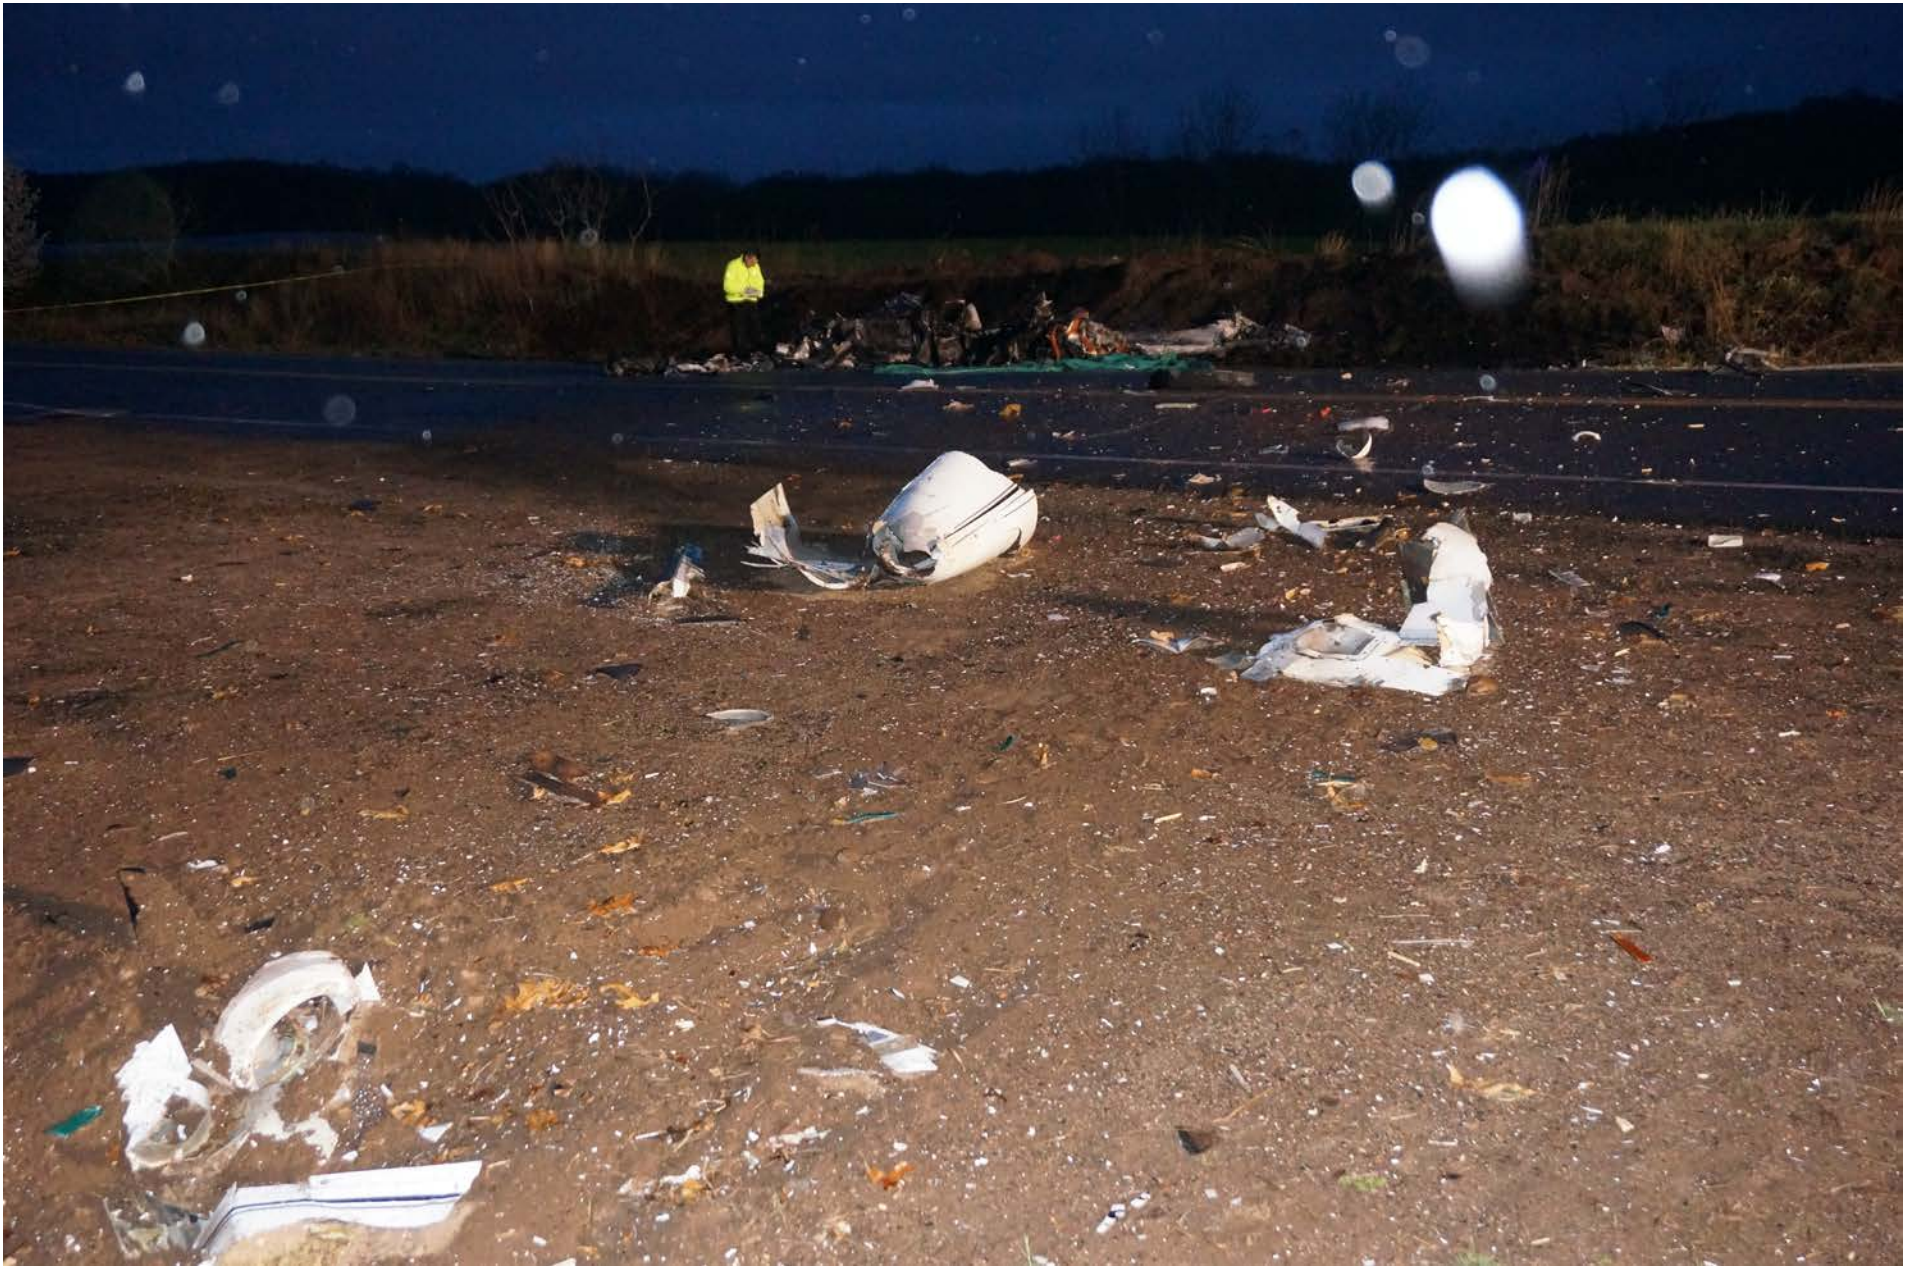
**Photo 3 – Debris Field**

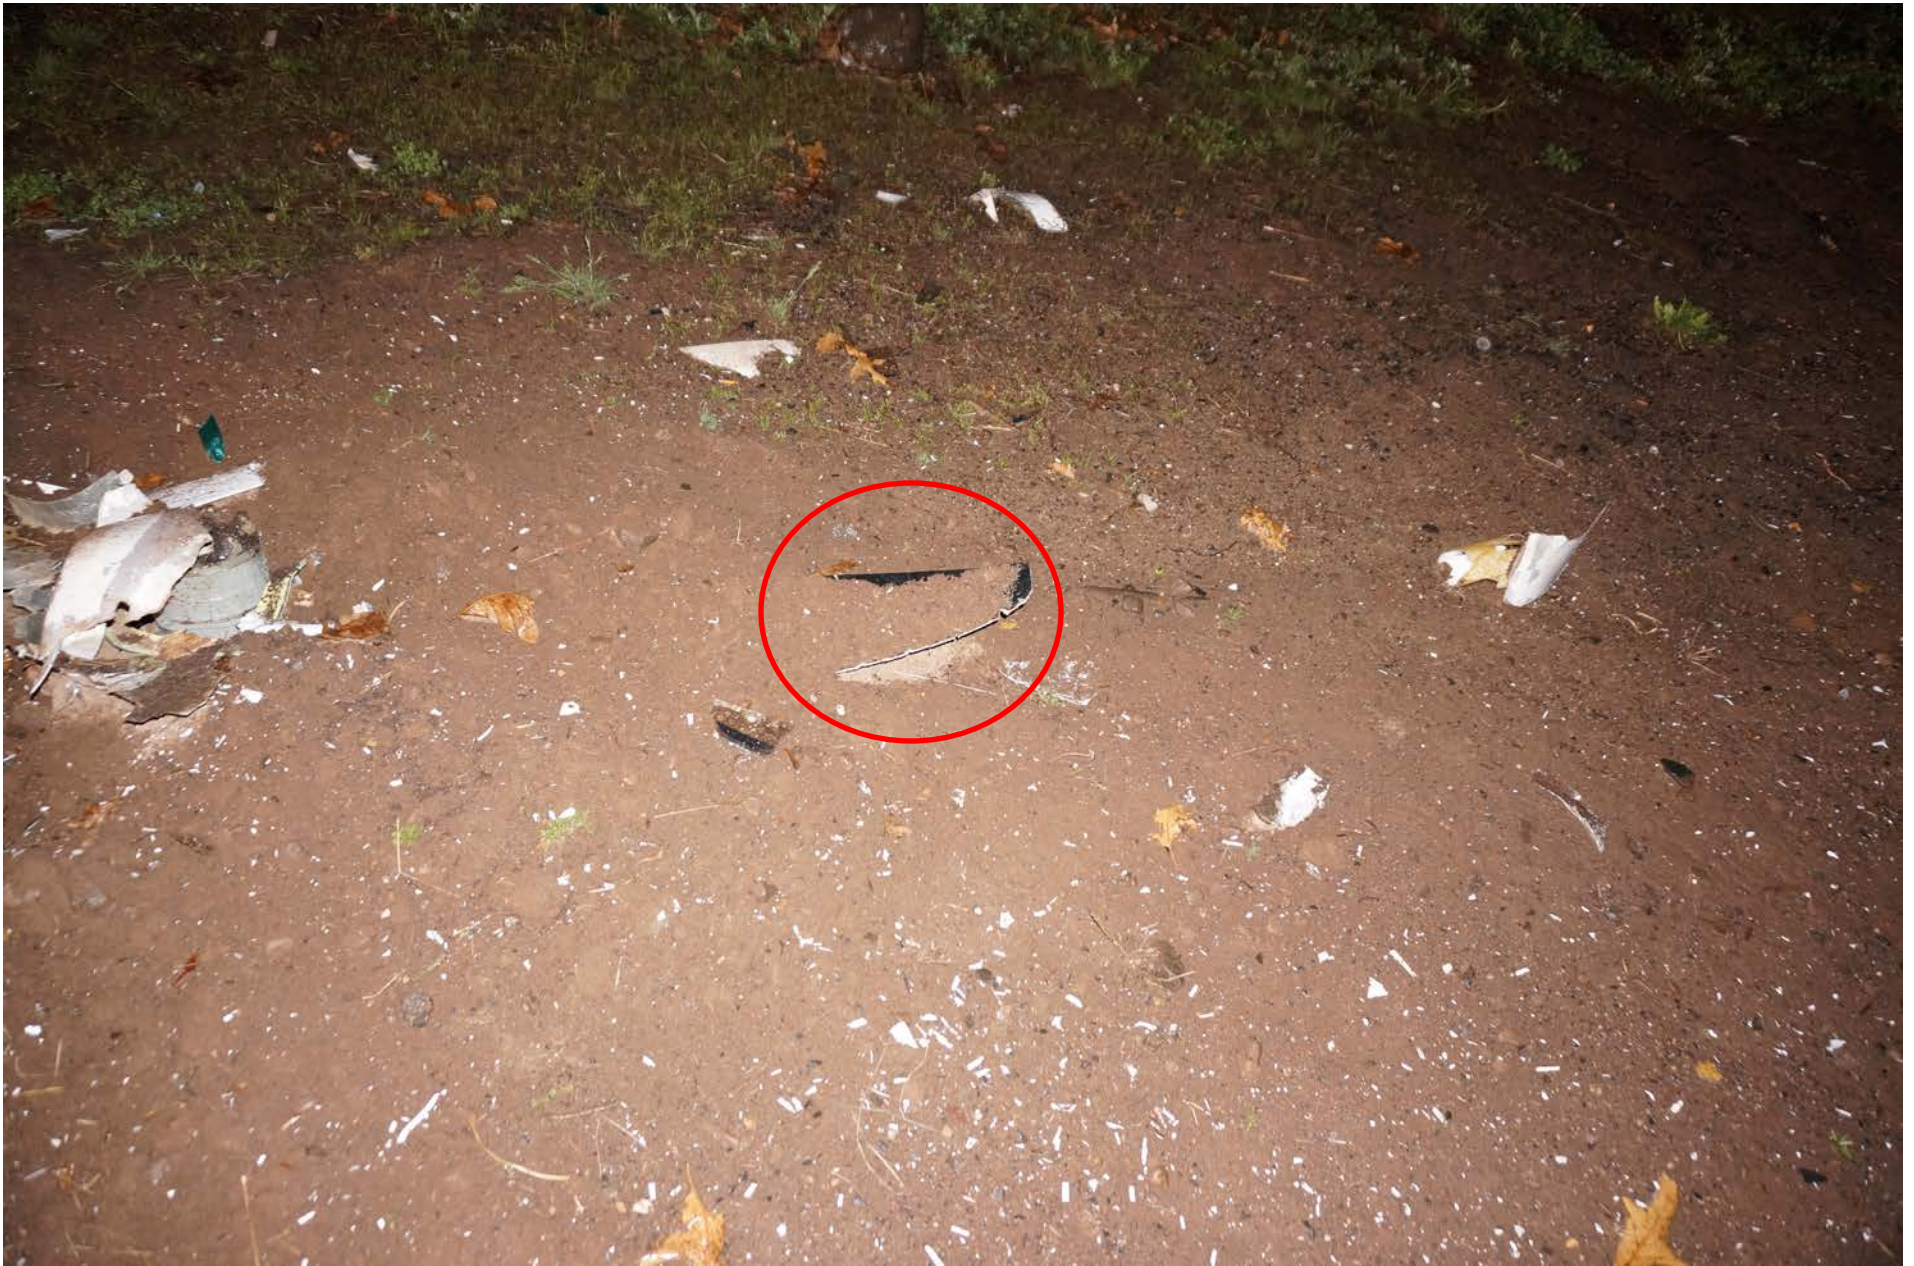
**Photo 4 – Propeller Prior to Removal from the Ground**

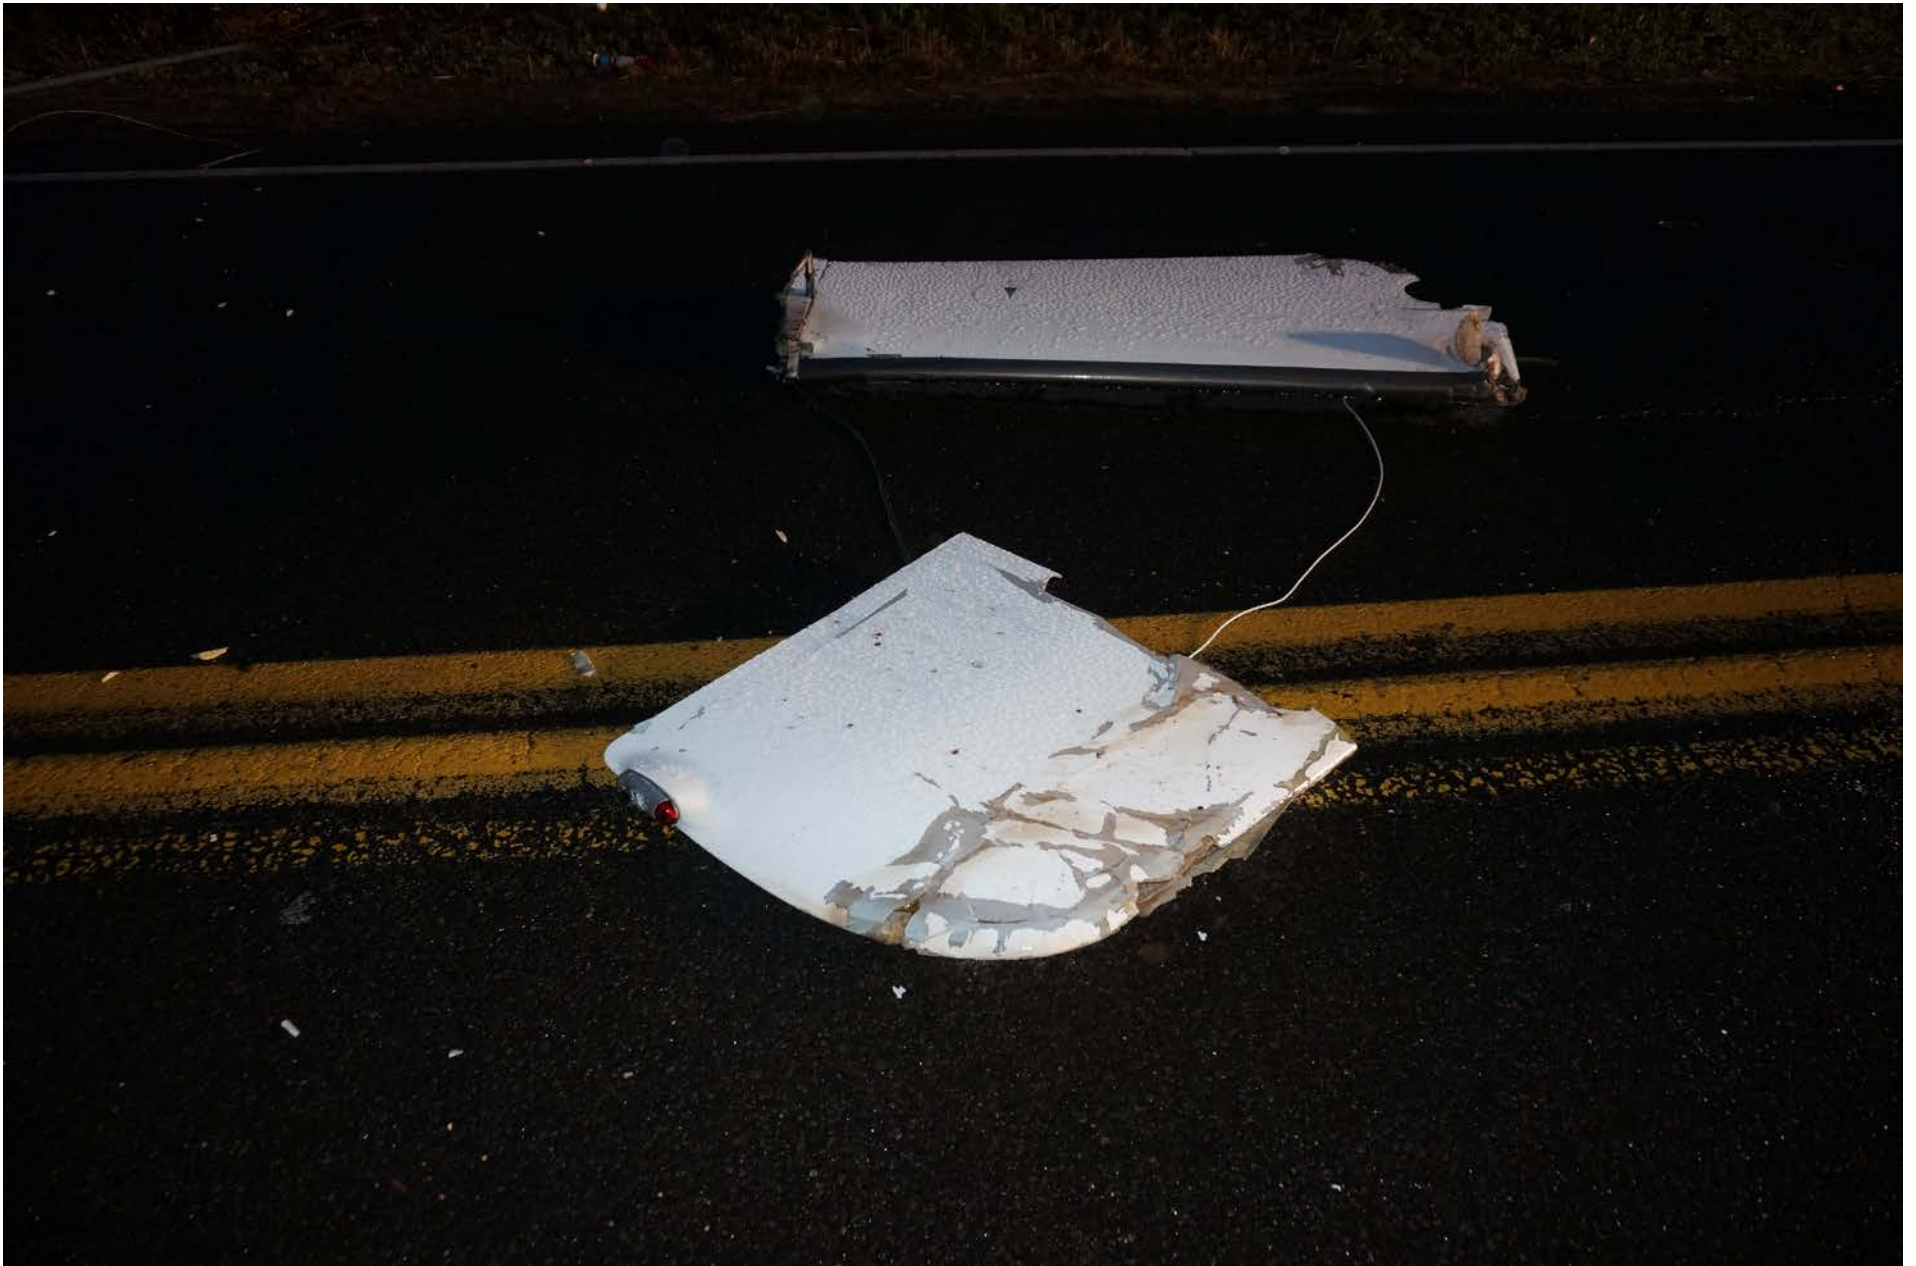
**Photo 5 – Left Wing and Wing Tip**

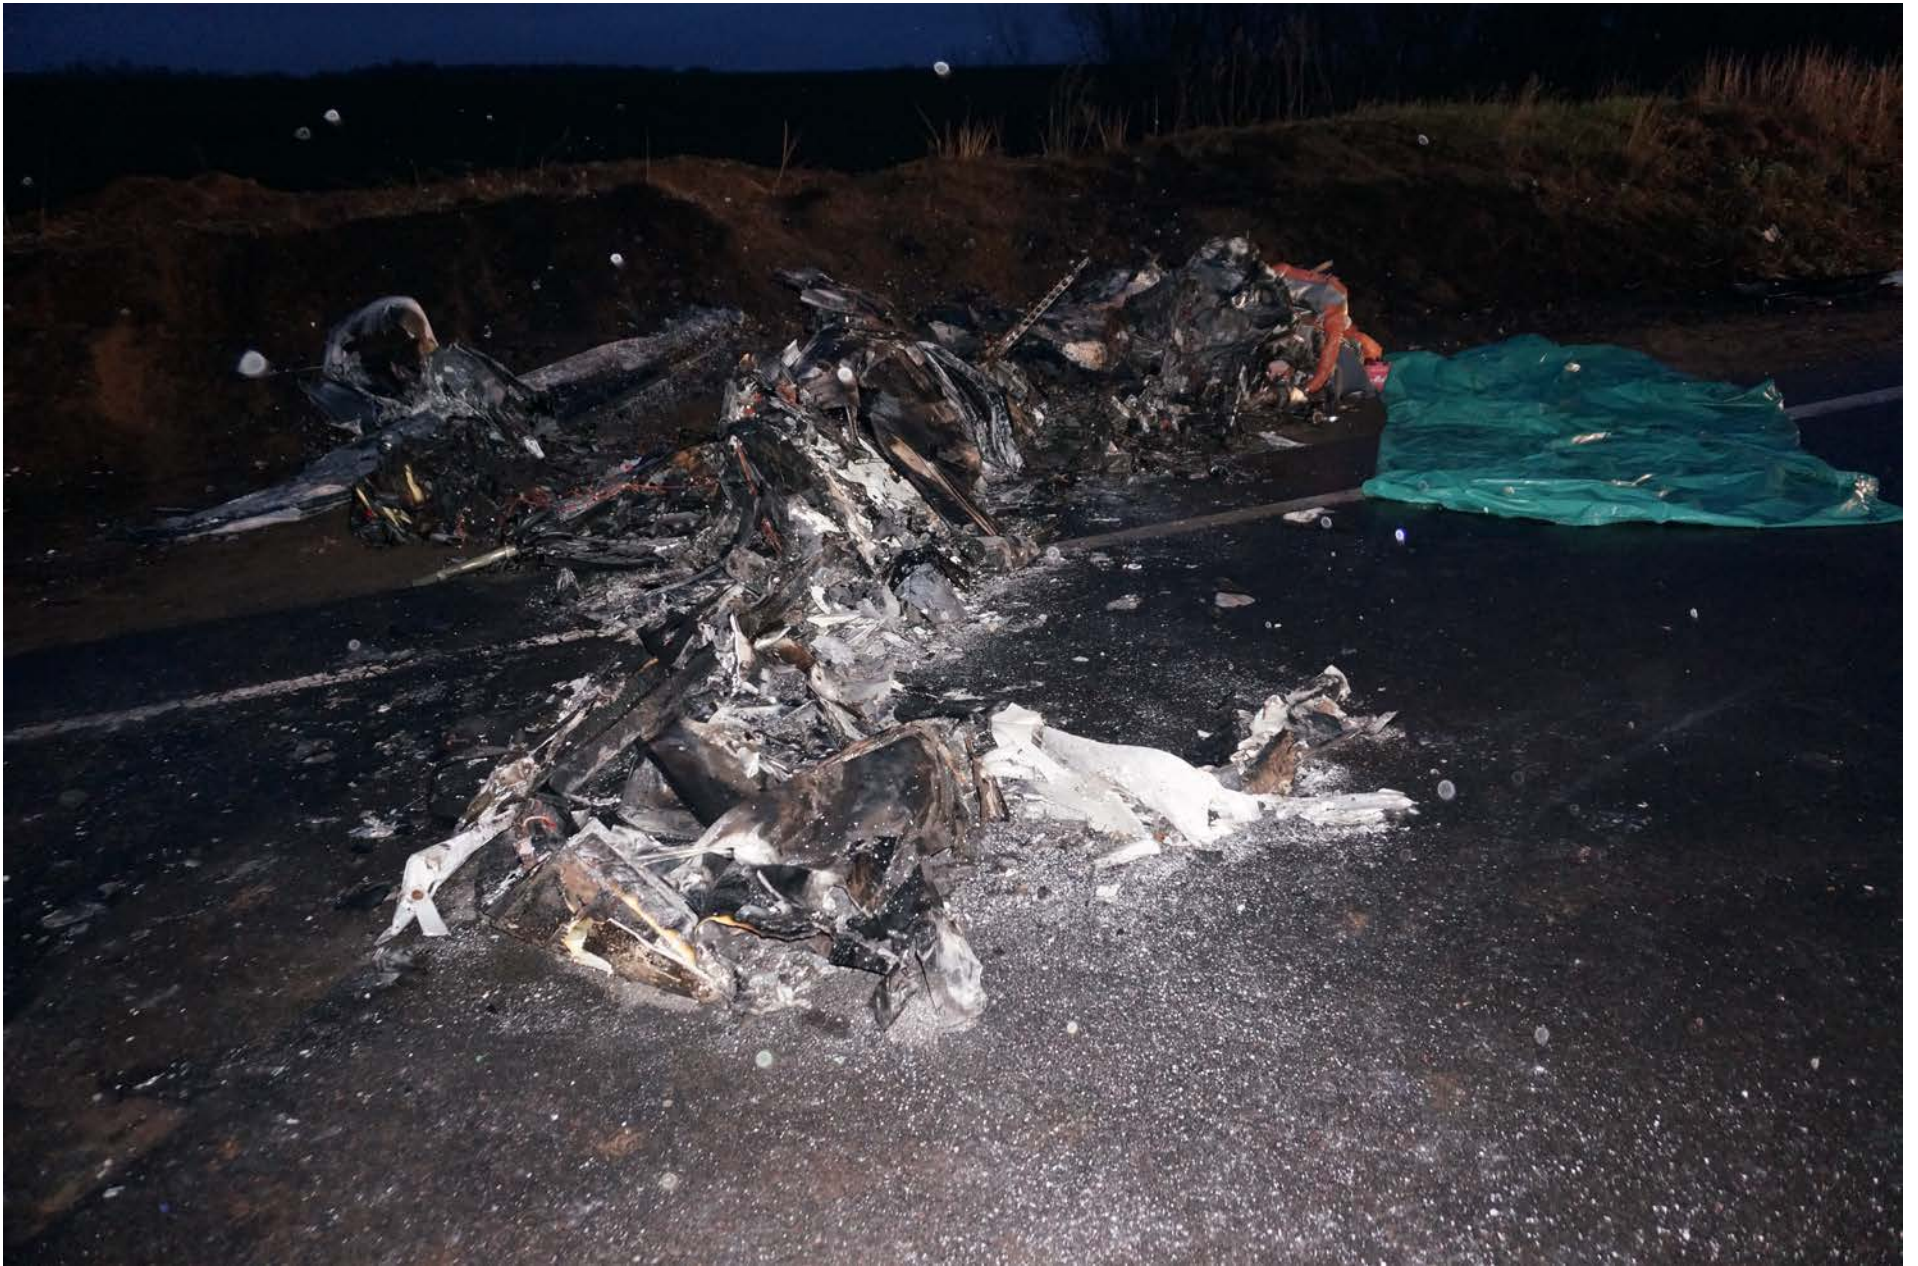
**Photo 6 – Main Wreckage**

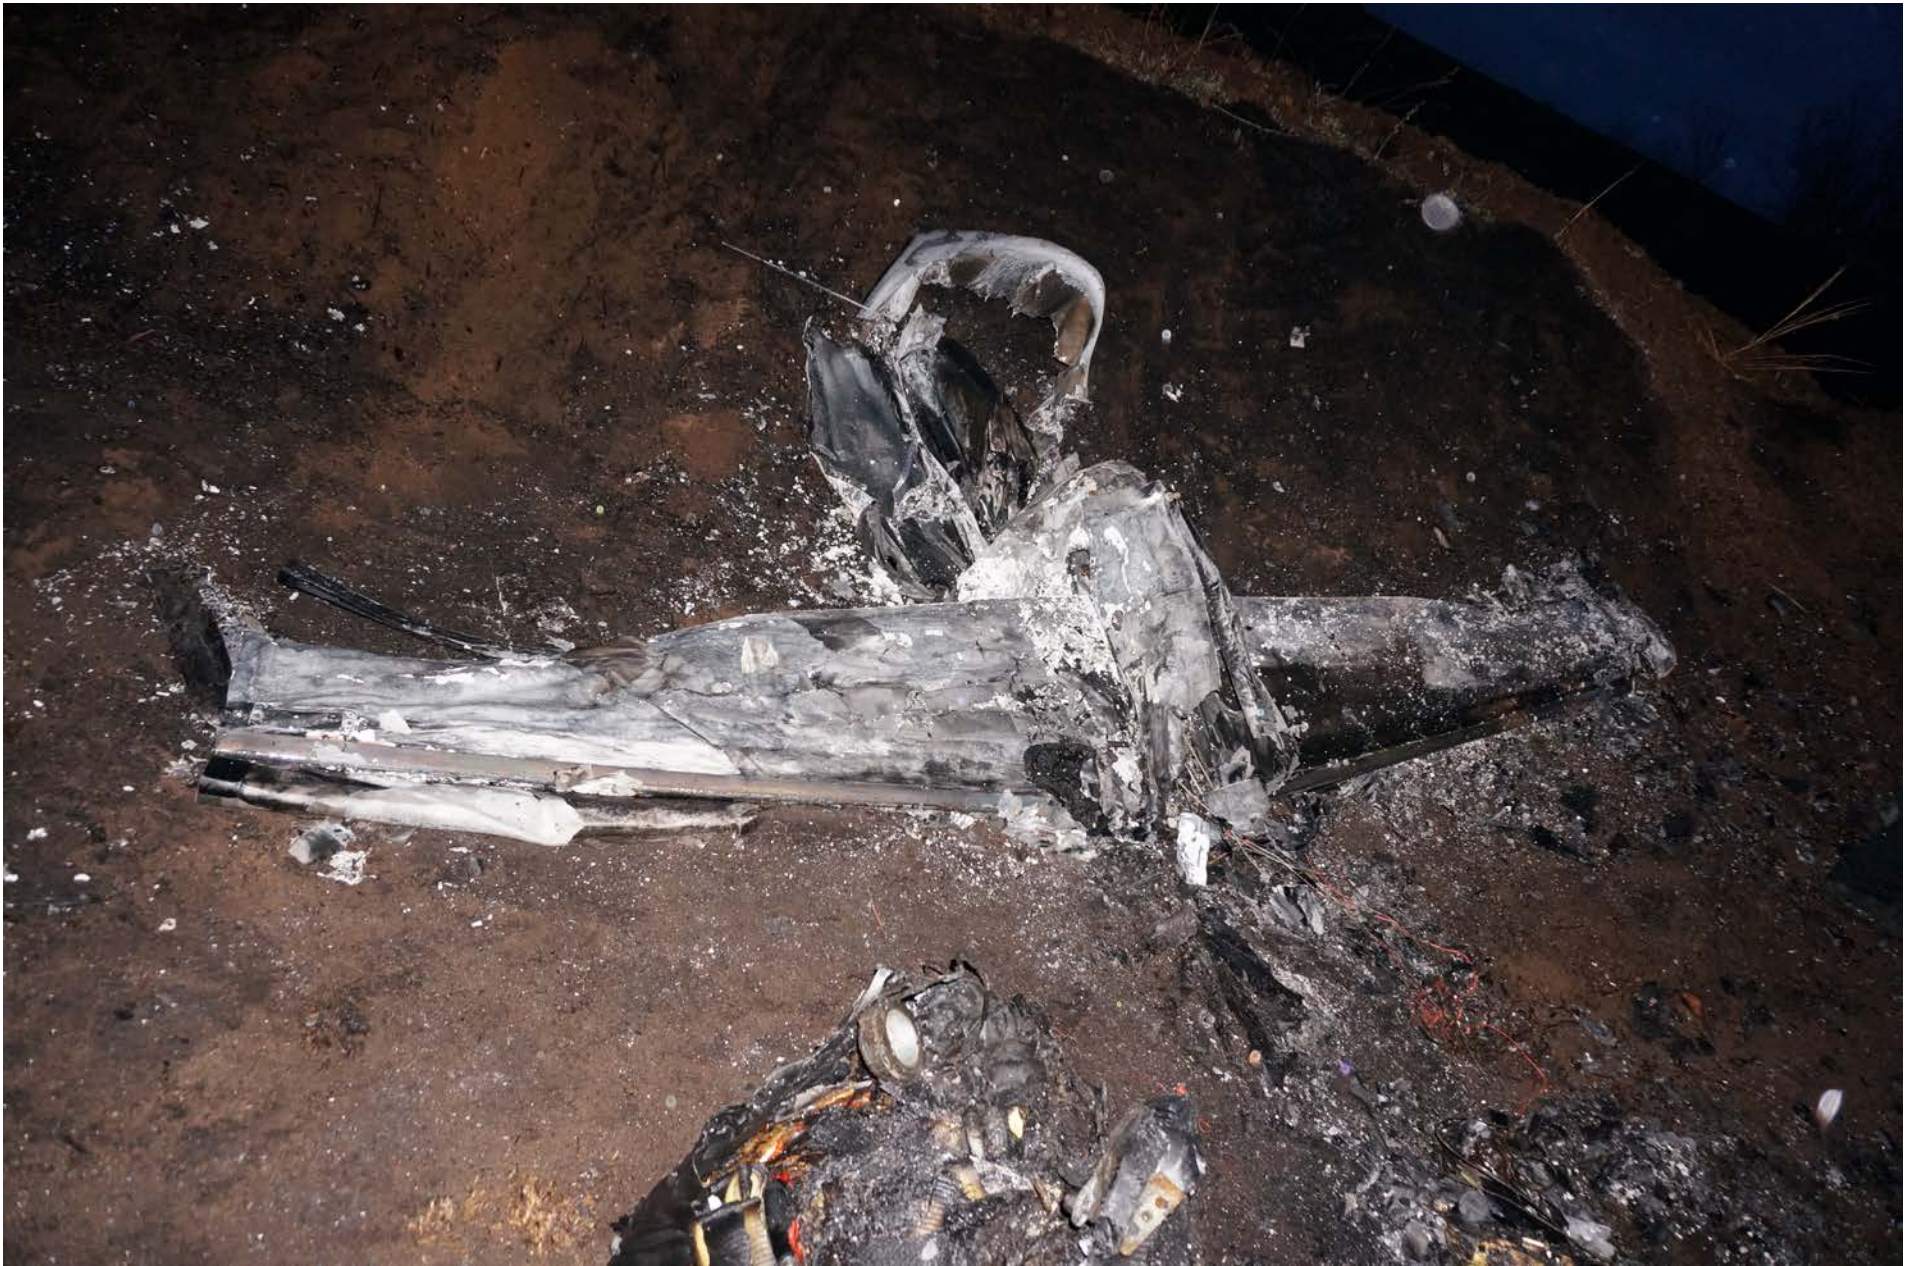
**Photo 7 - Empennage**

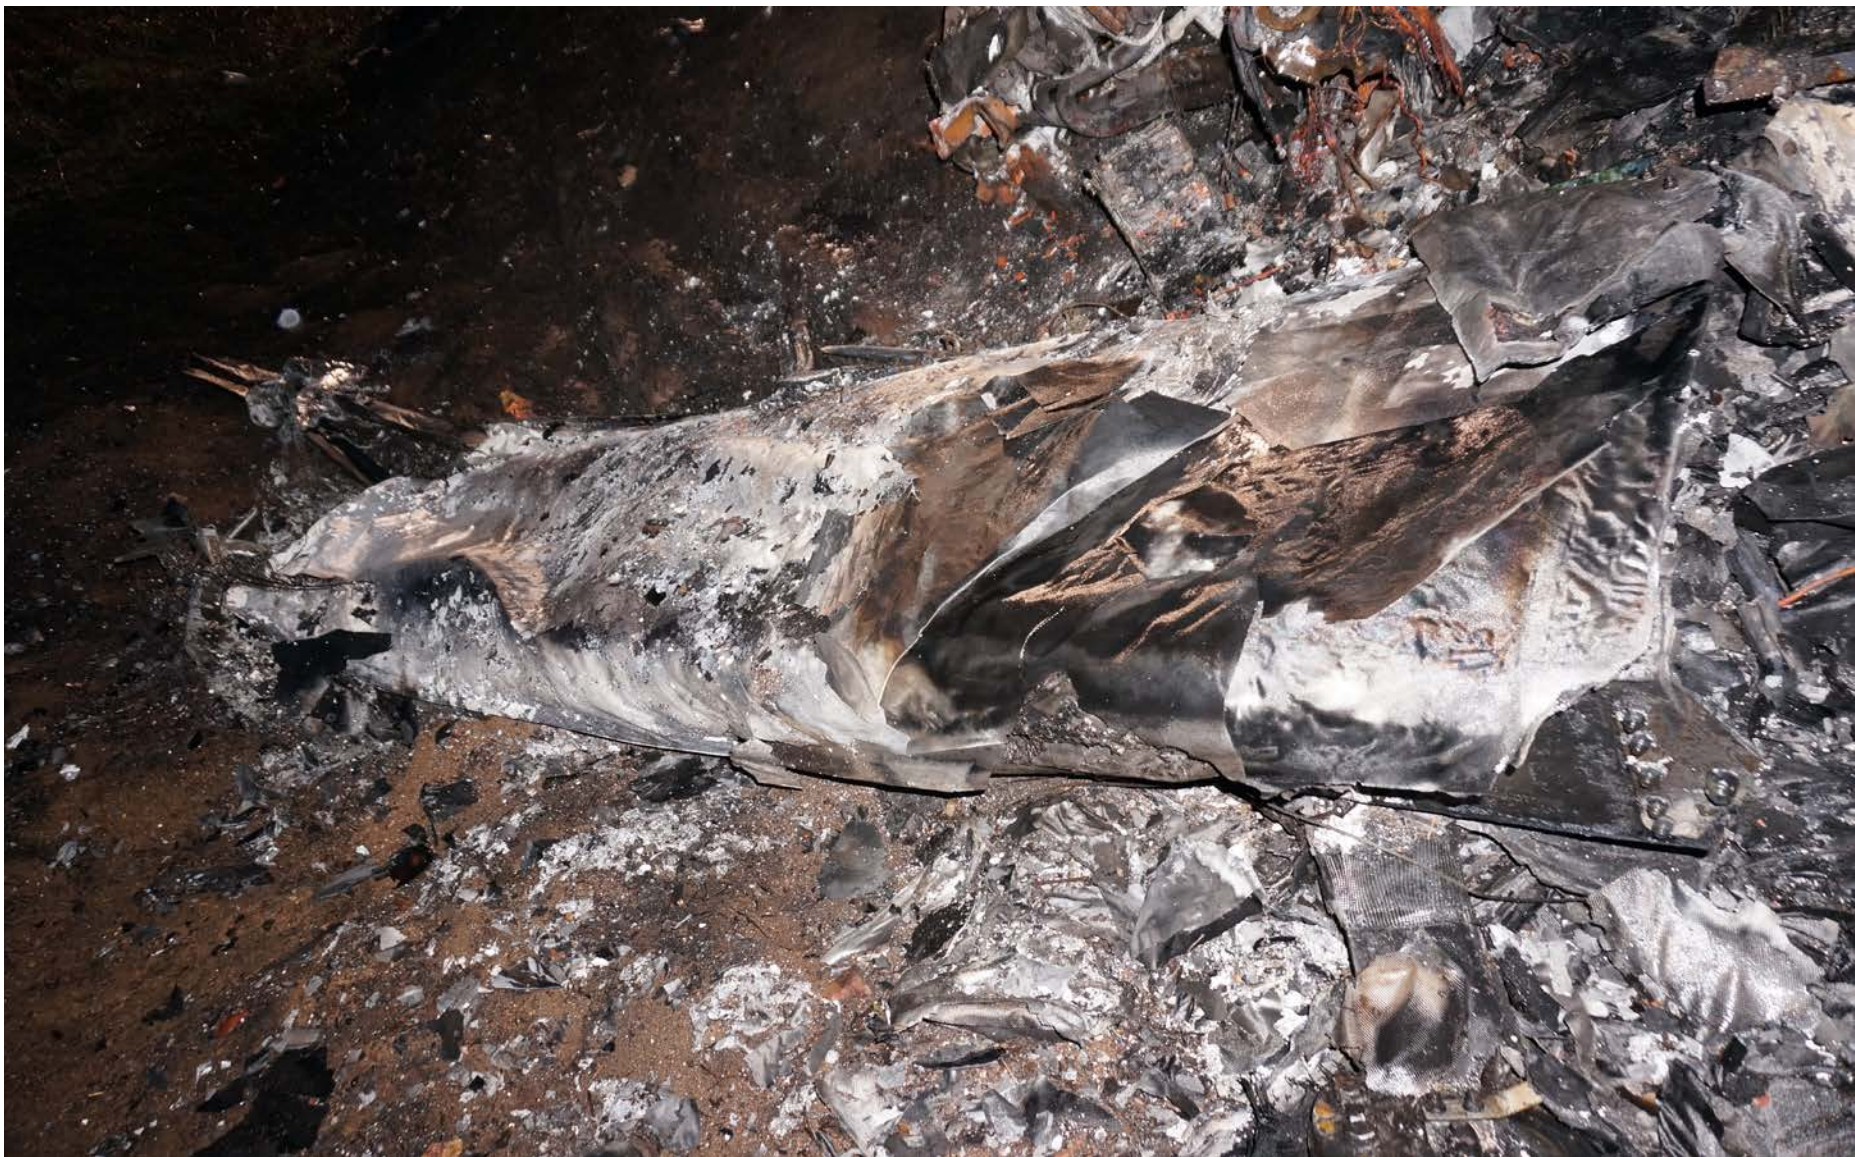
**Photo 8 – Right Wing**

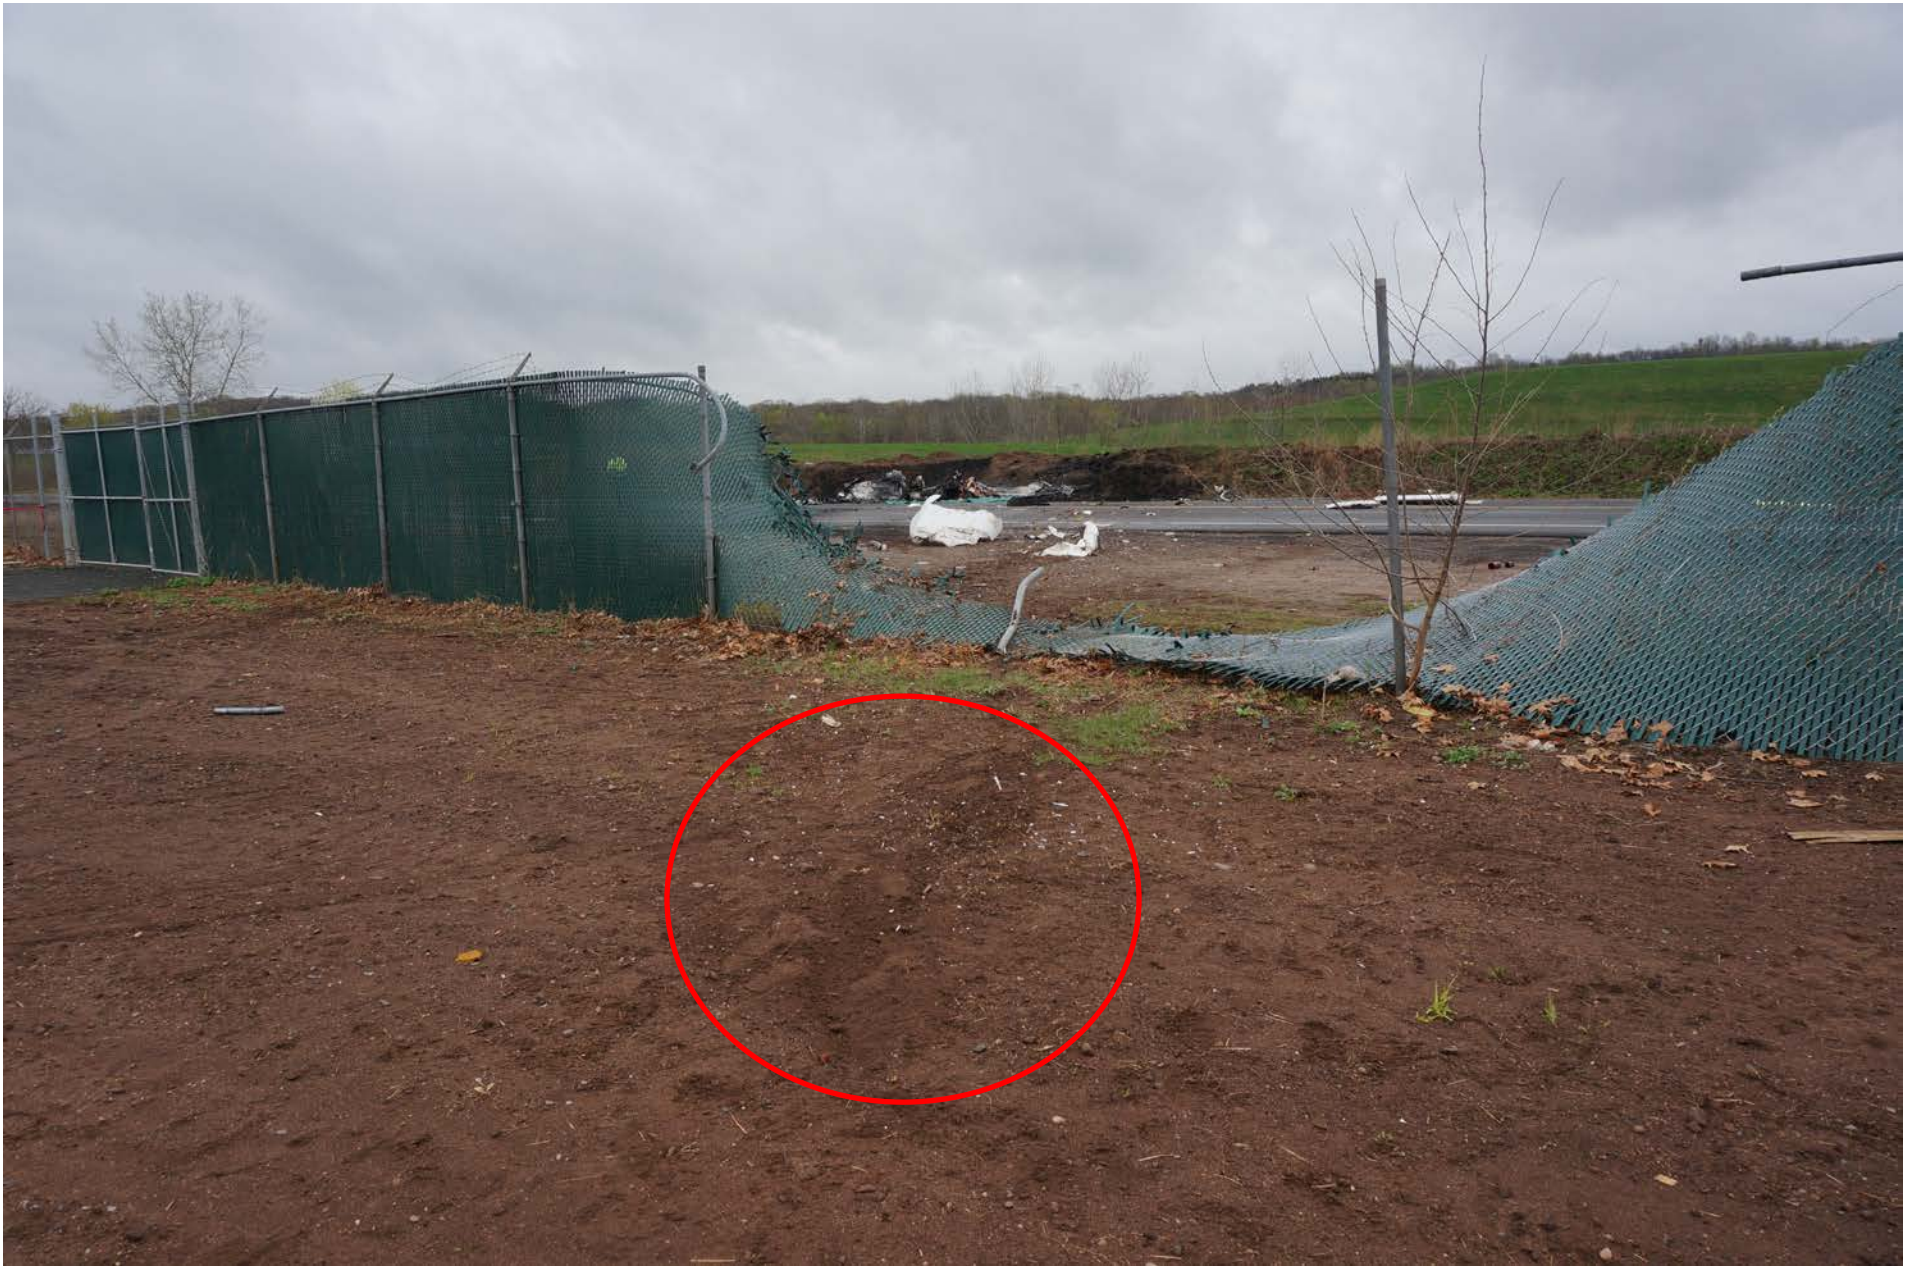
**Photo 9 -Left Wing Tip Drag Mark**
