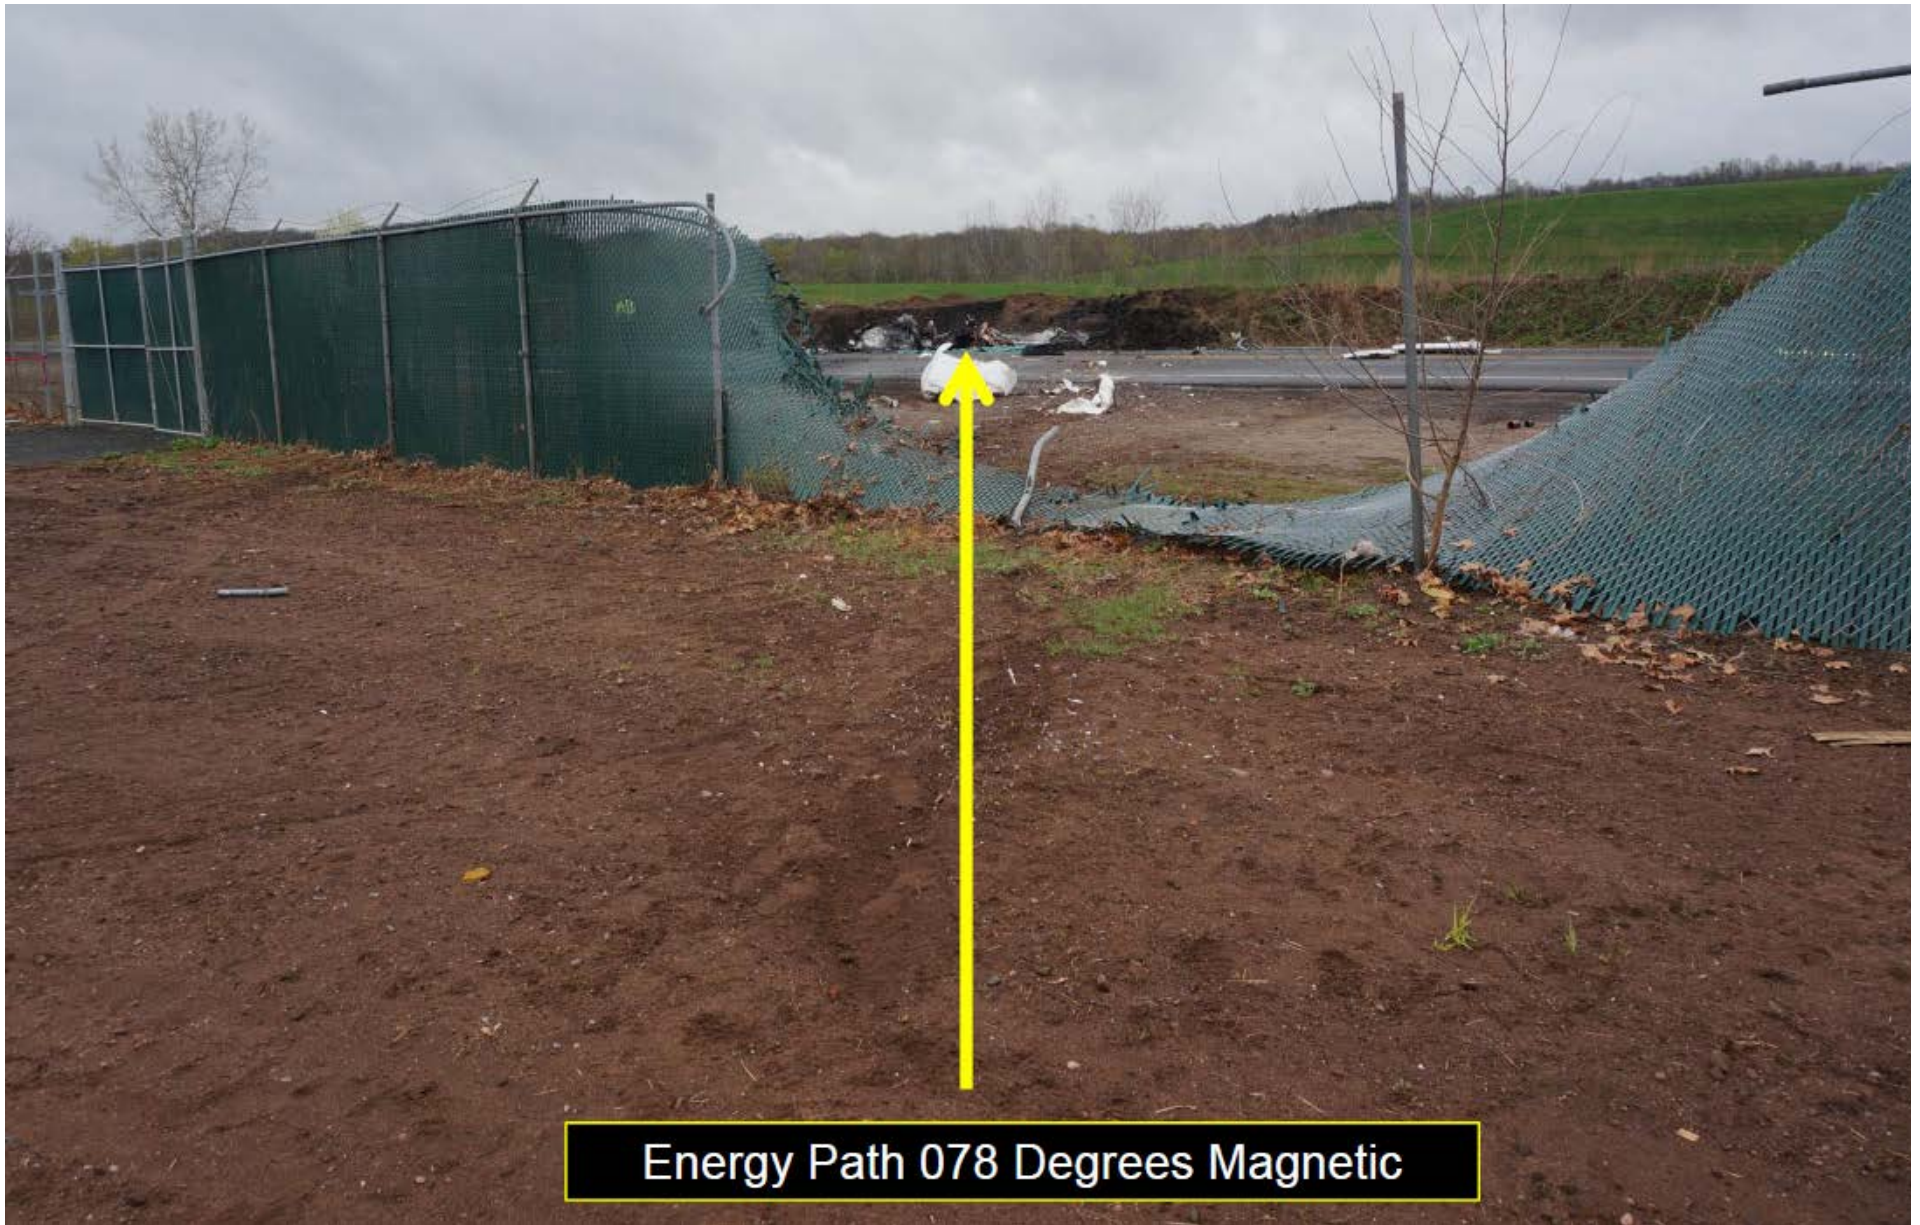
**Photo 10 – Energy Path – Courtesy of Cirrus Aircraft**

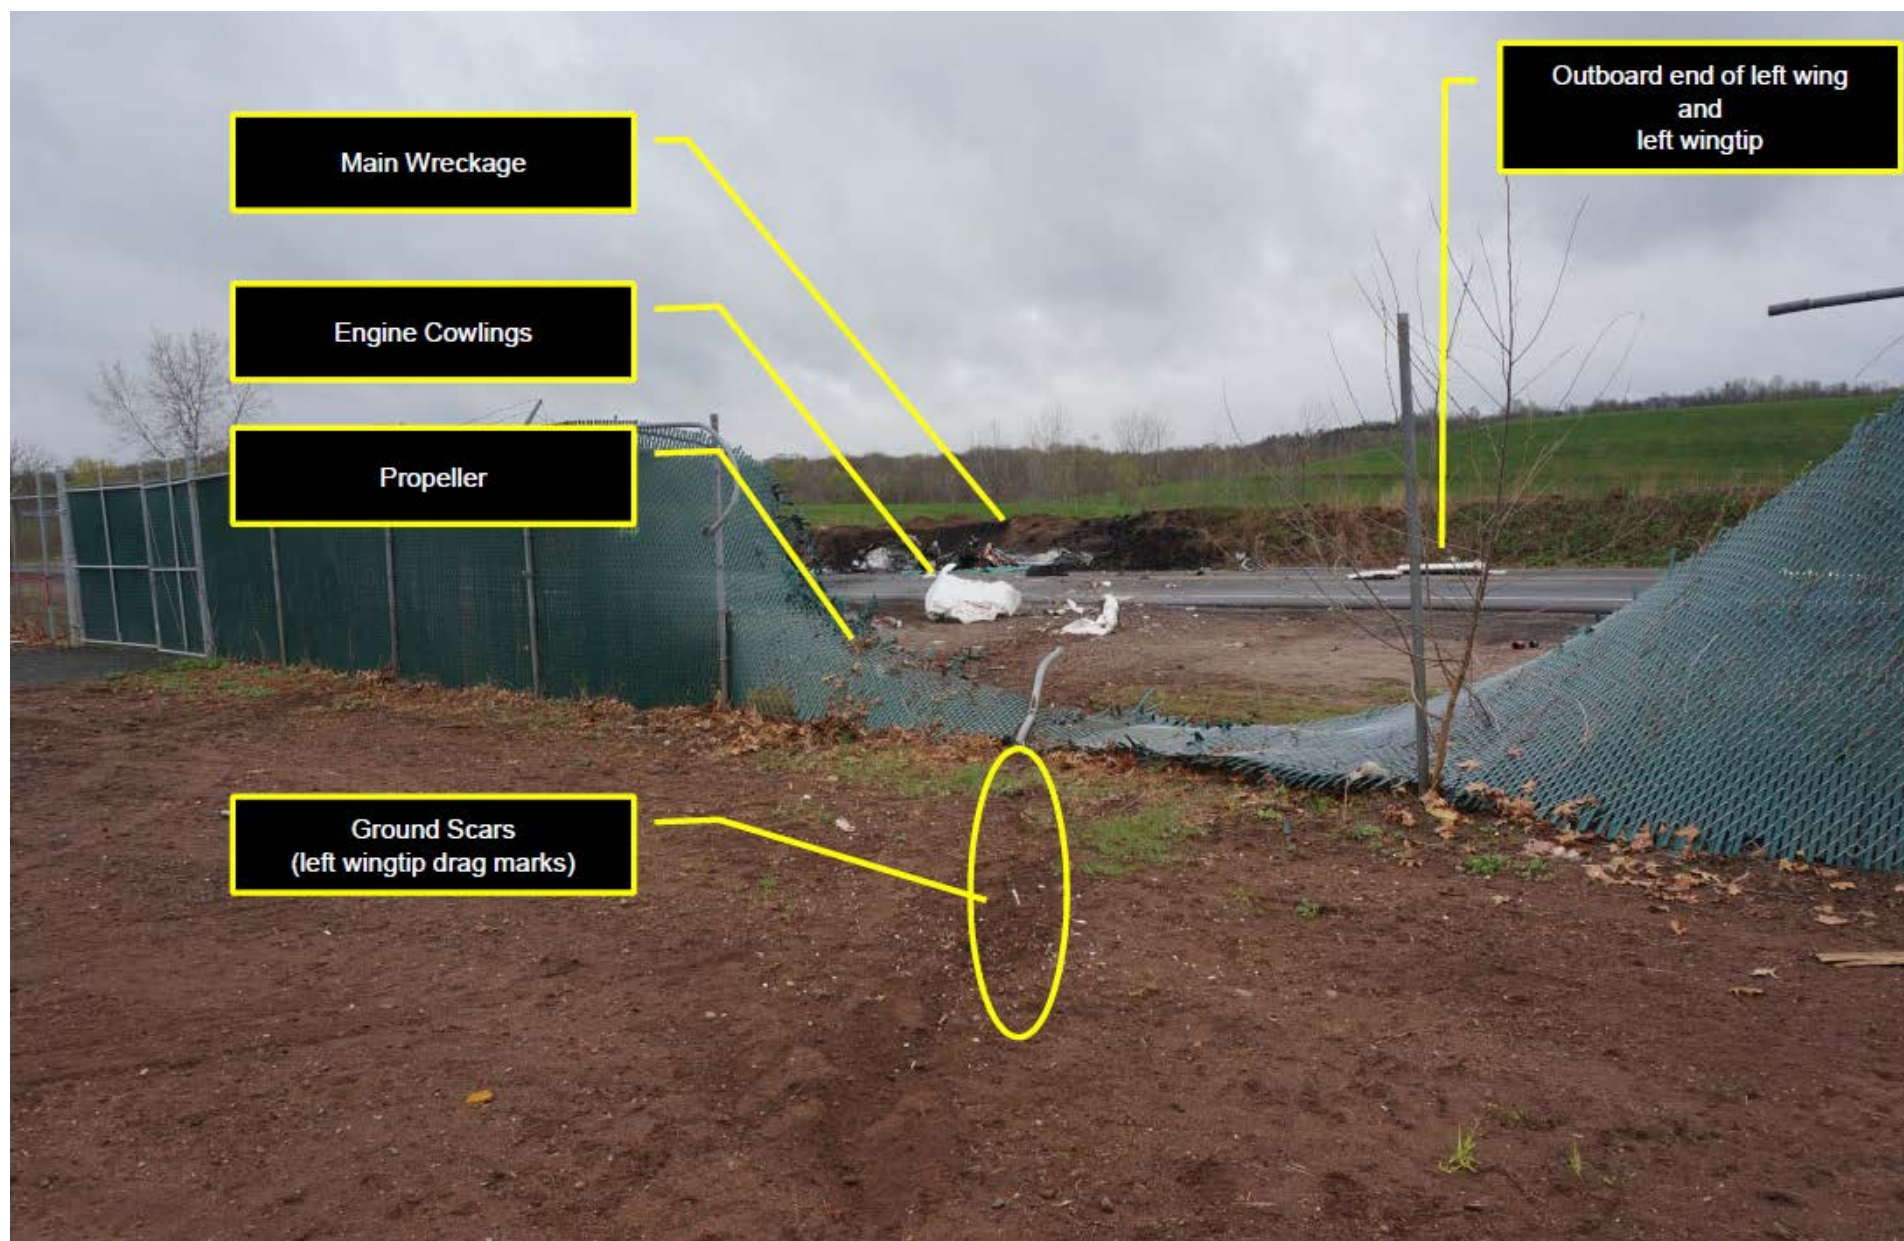
**Photo 11 – Relationship of Ground Scars to the Debris Field – Courtesy of Cirrus Aircraft**

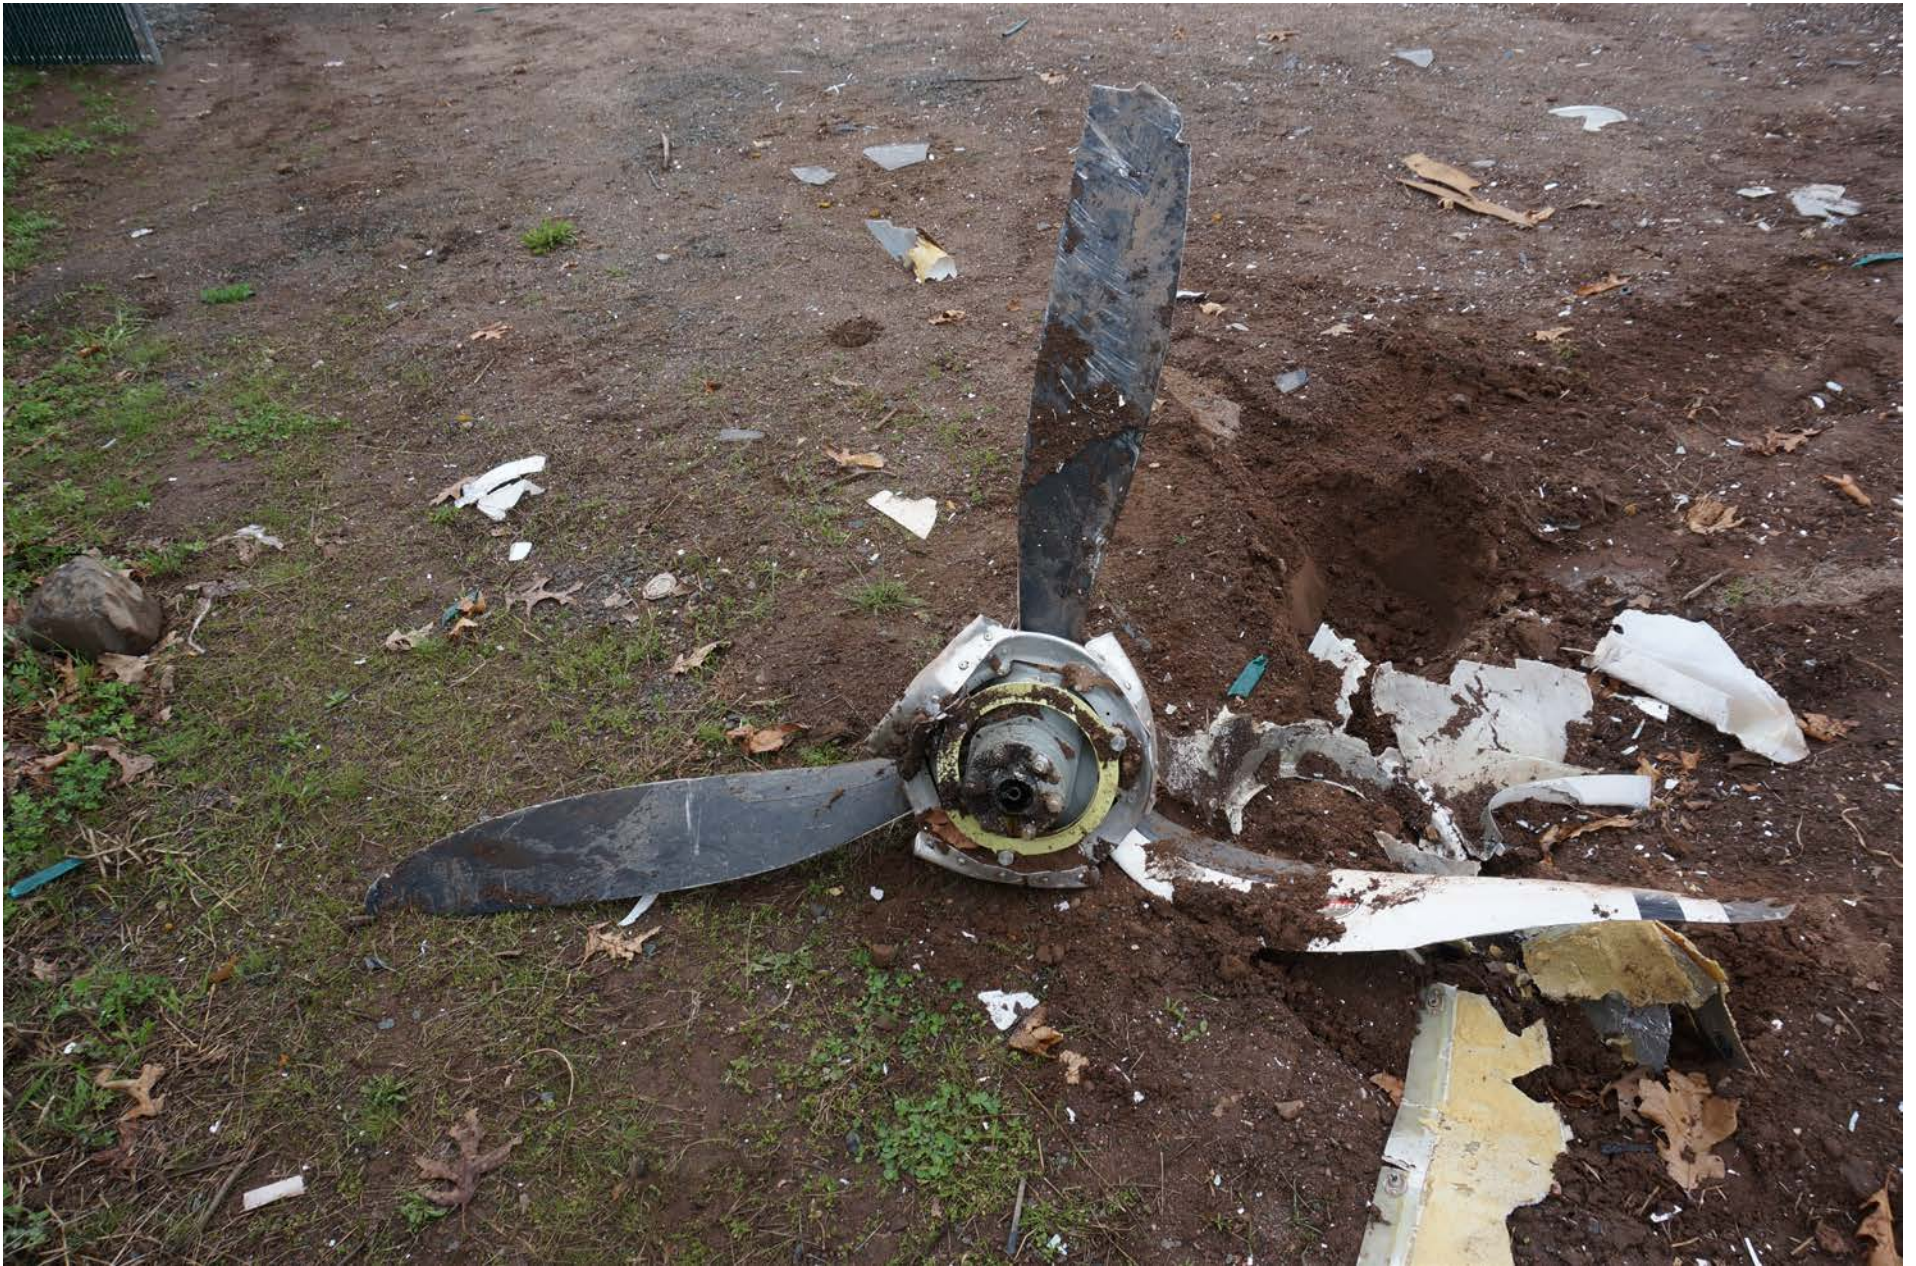
**Photo 12 – Propeller After Removal from Ground**

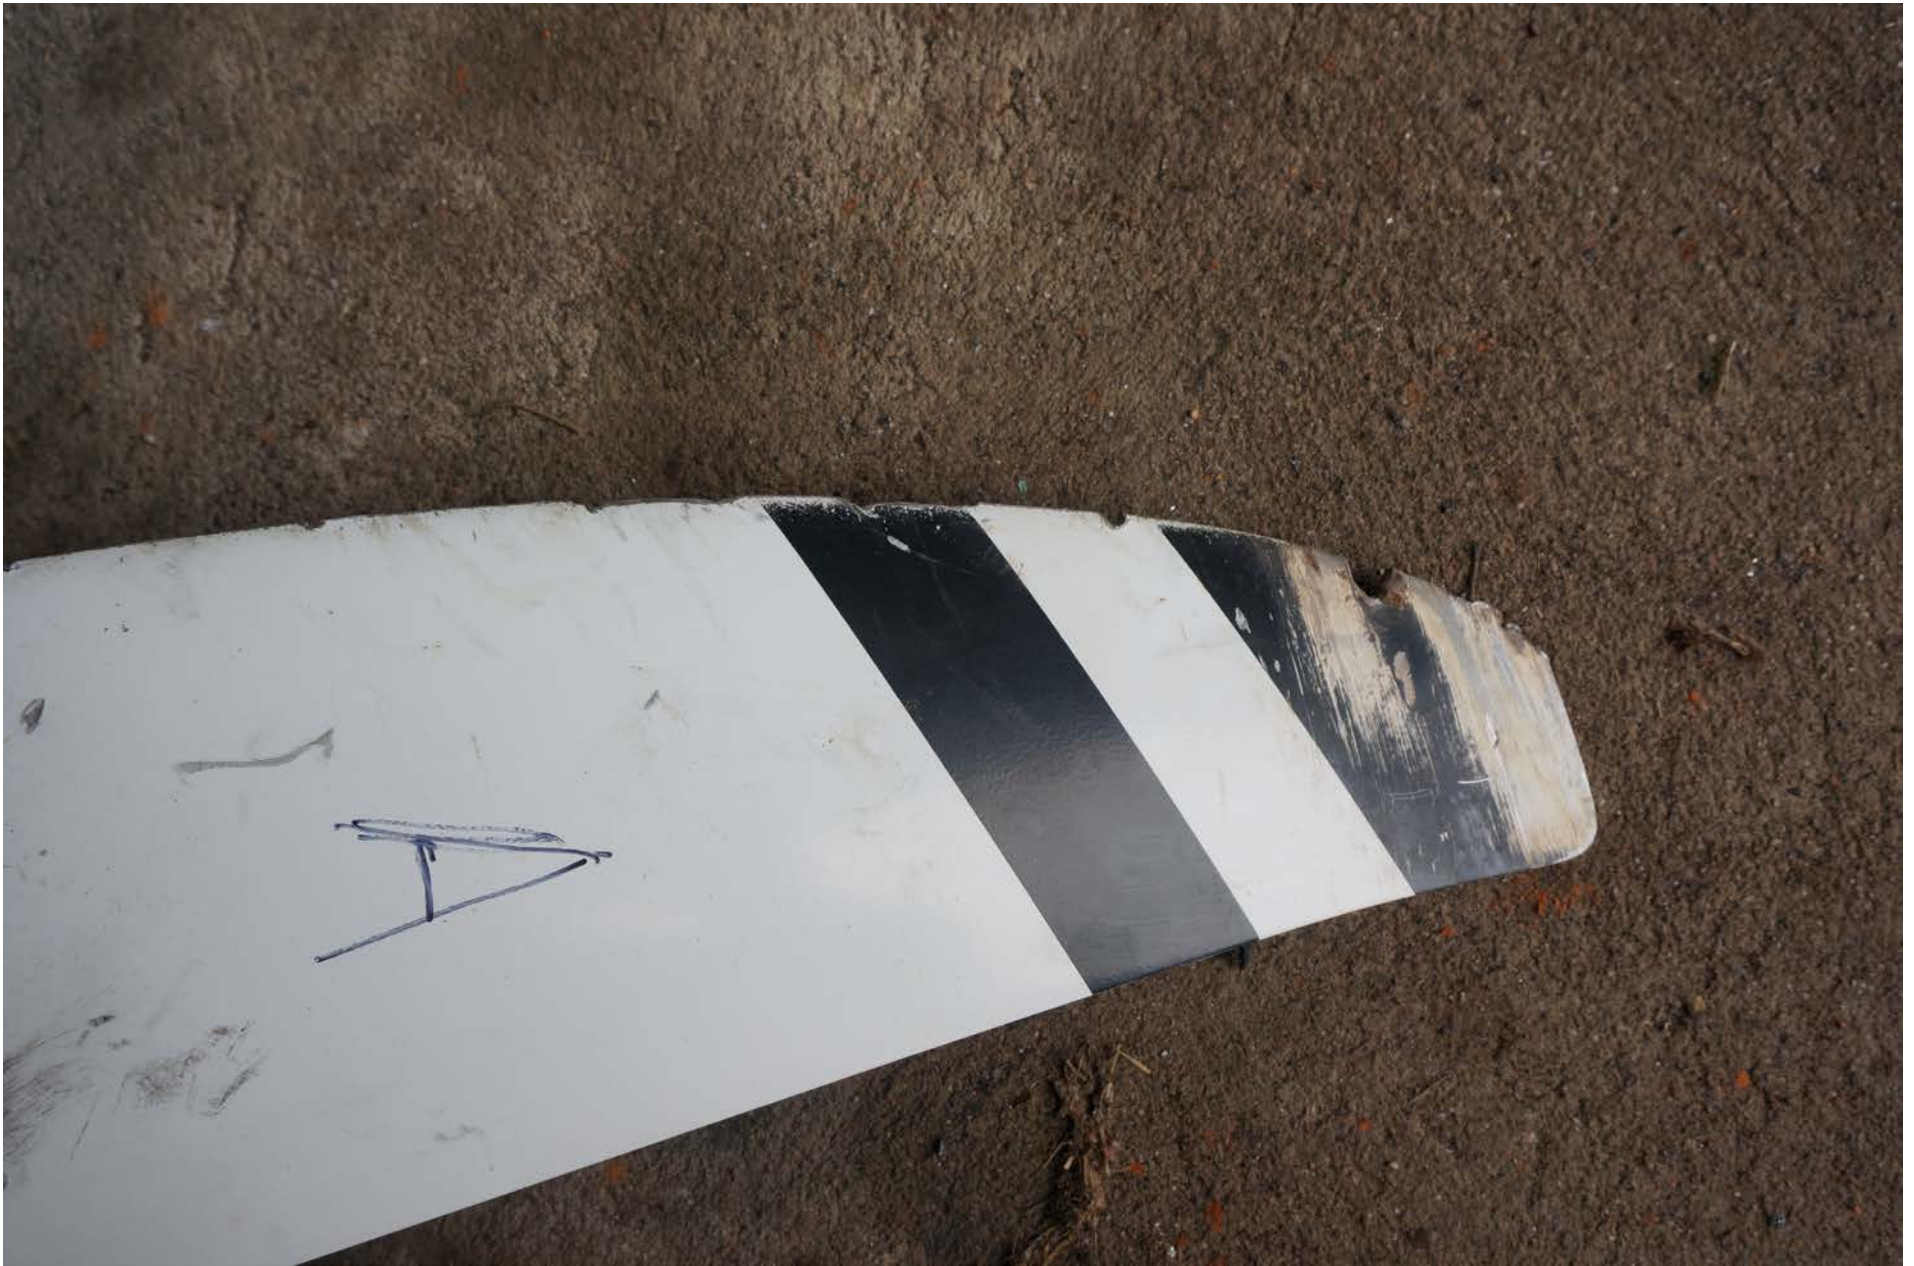
**Photo 13 – Leading Edge Gouging on Propeller Blade**

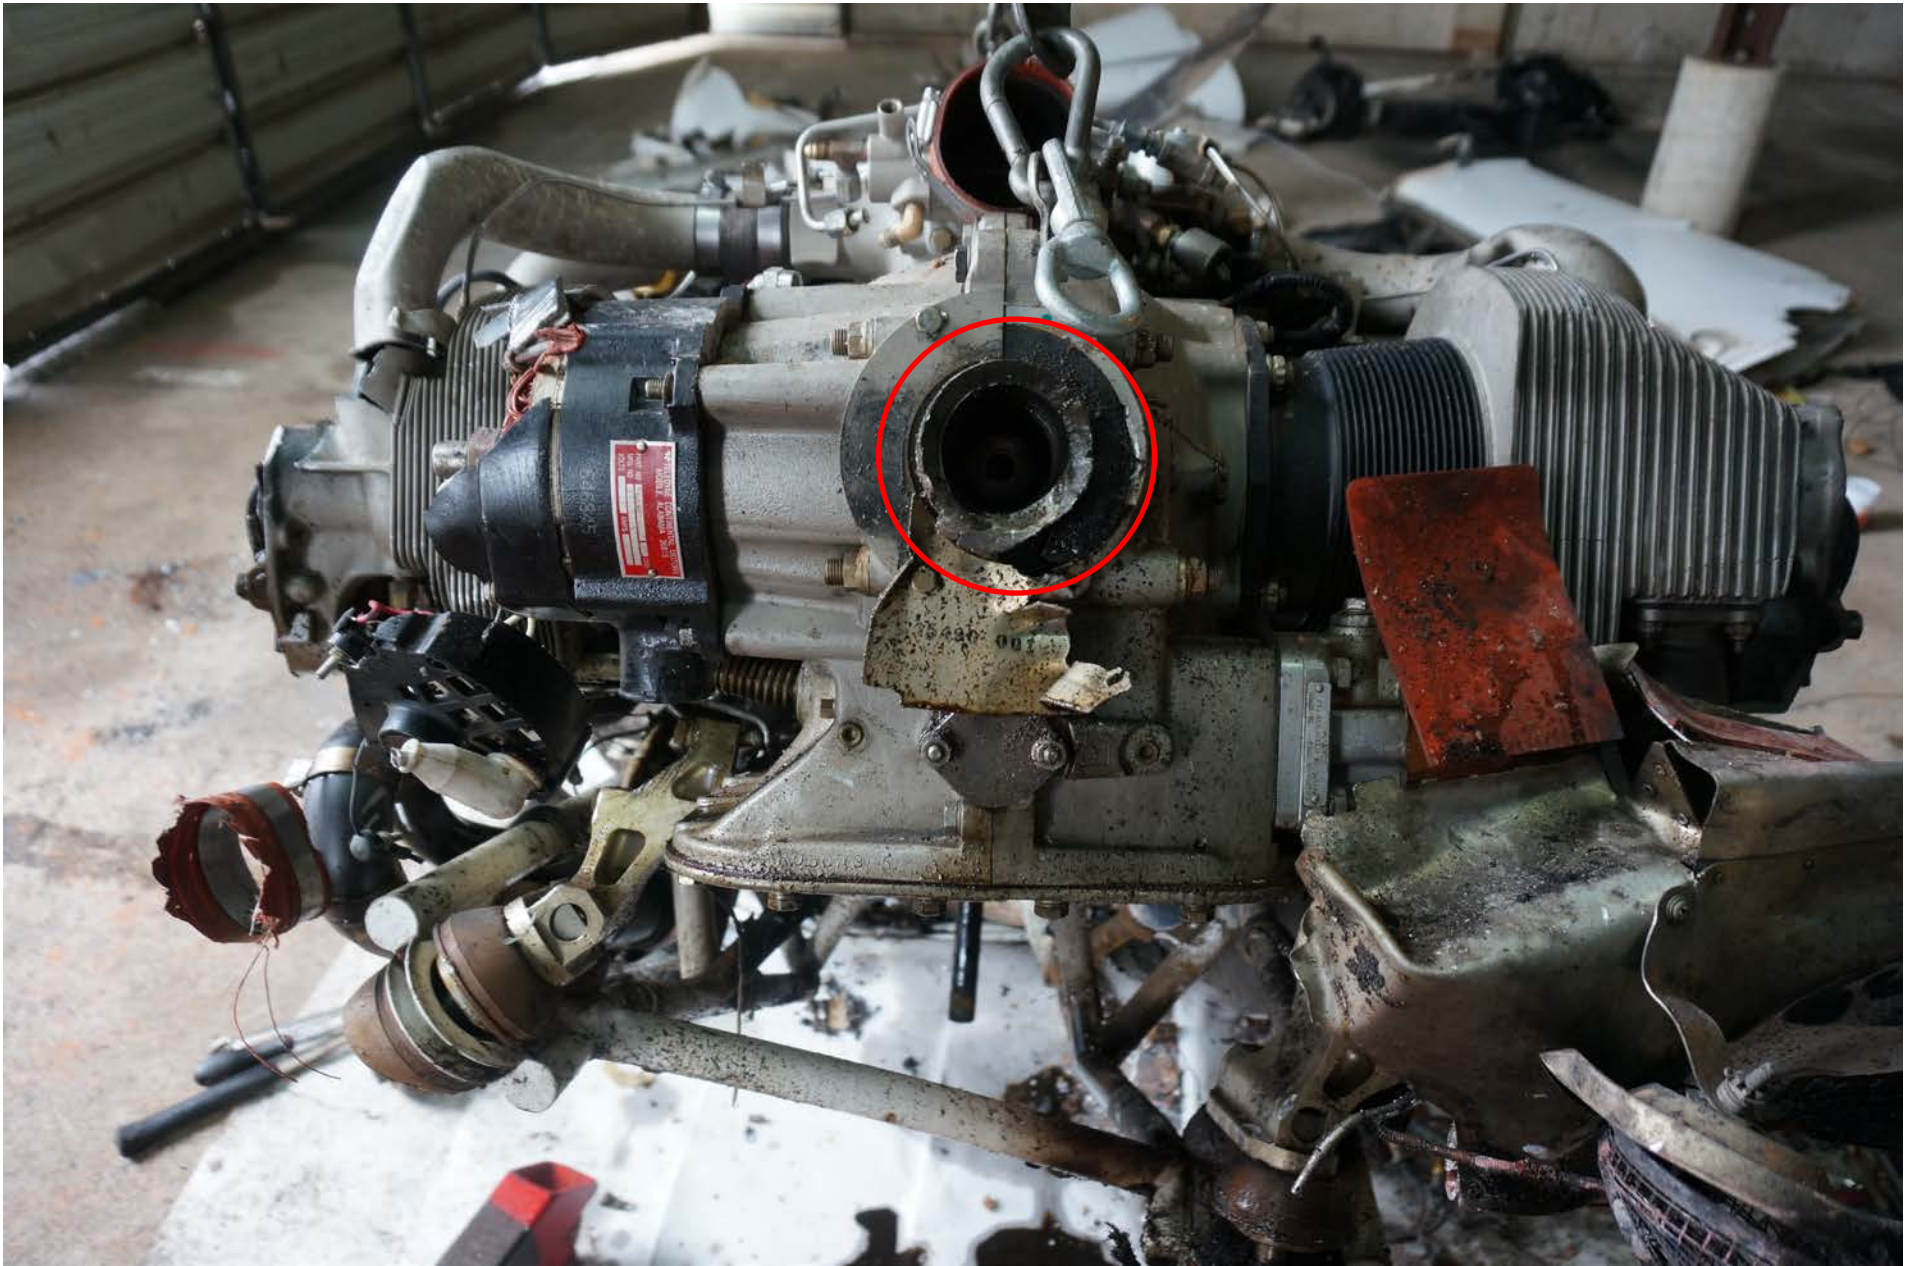
**Photo 14 – Fractured Crankshaft**

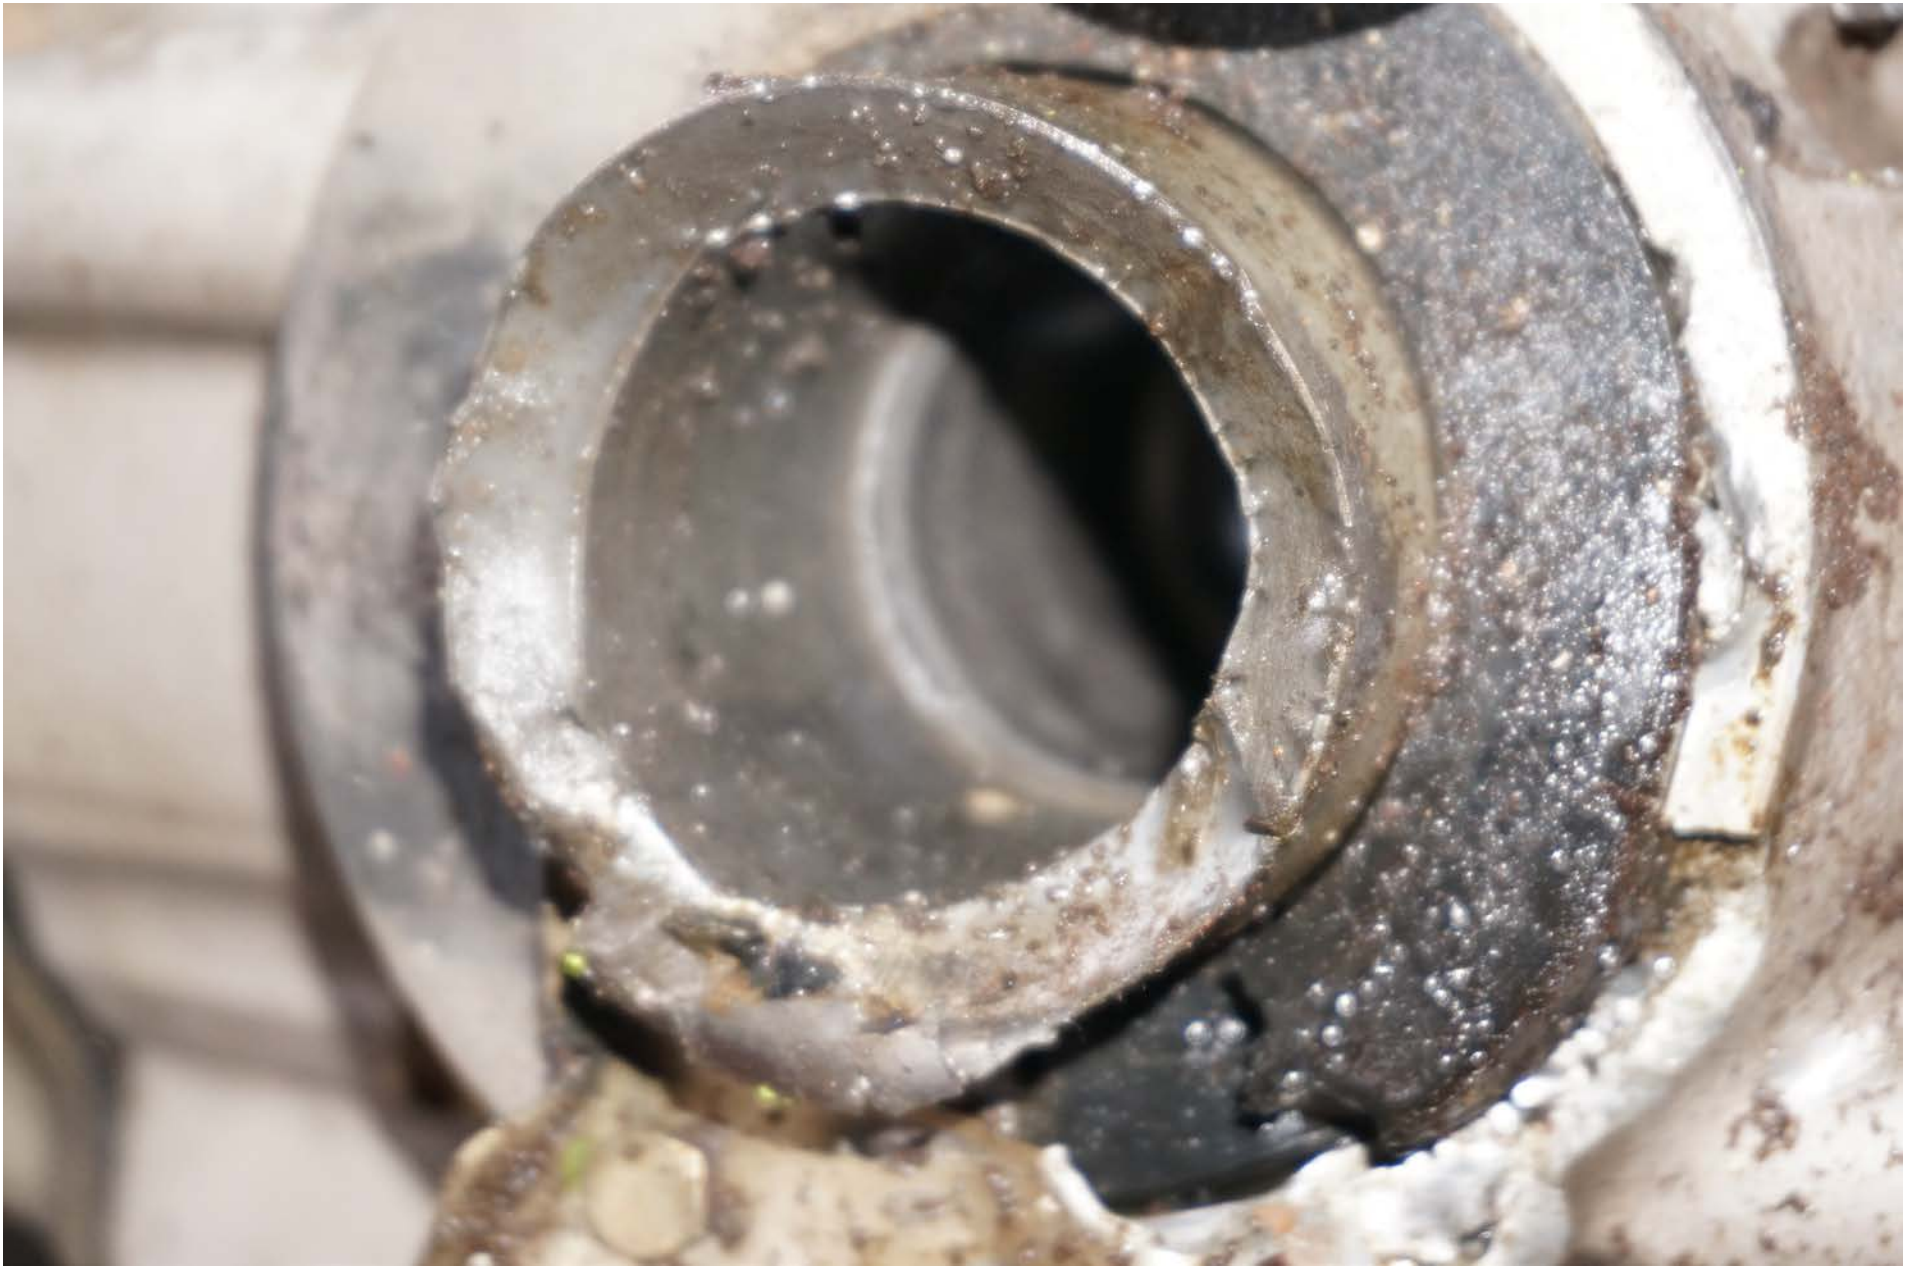
**Photo 15 – Close Up Photograph of Fractured Crankshaft**

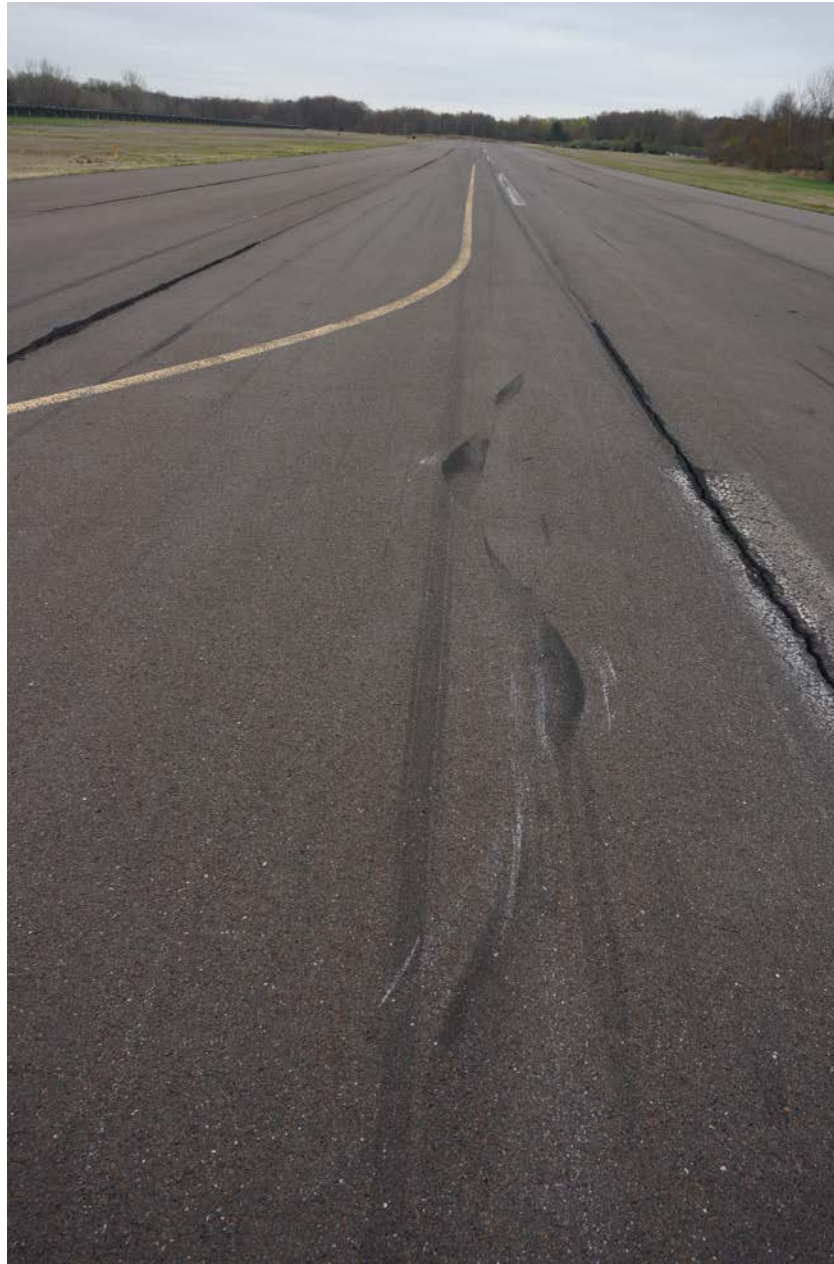
**Photo 16 – First Set of Nose Wheel Tire Marks and Wheel Pant Paint Transfers**

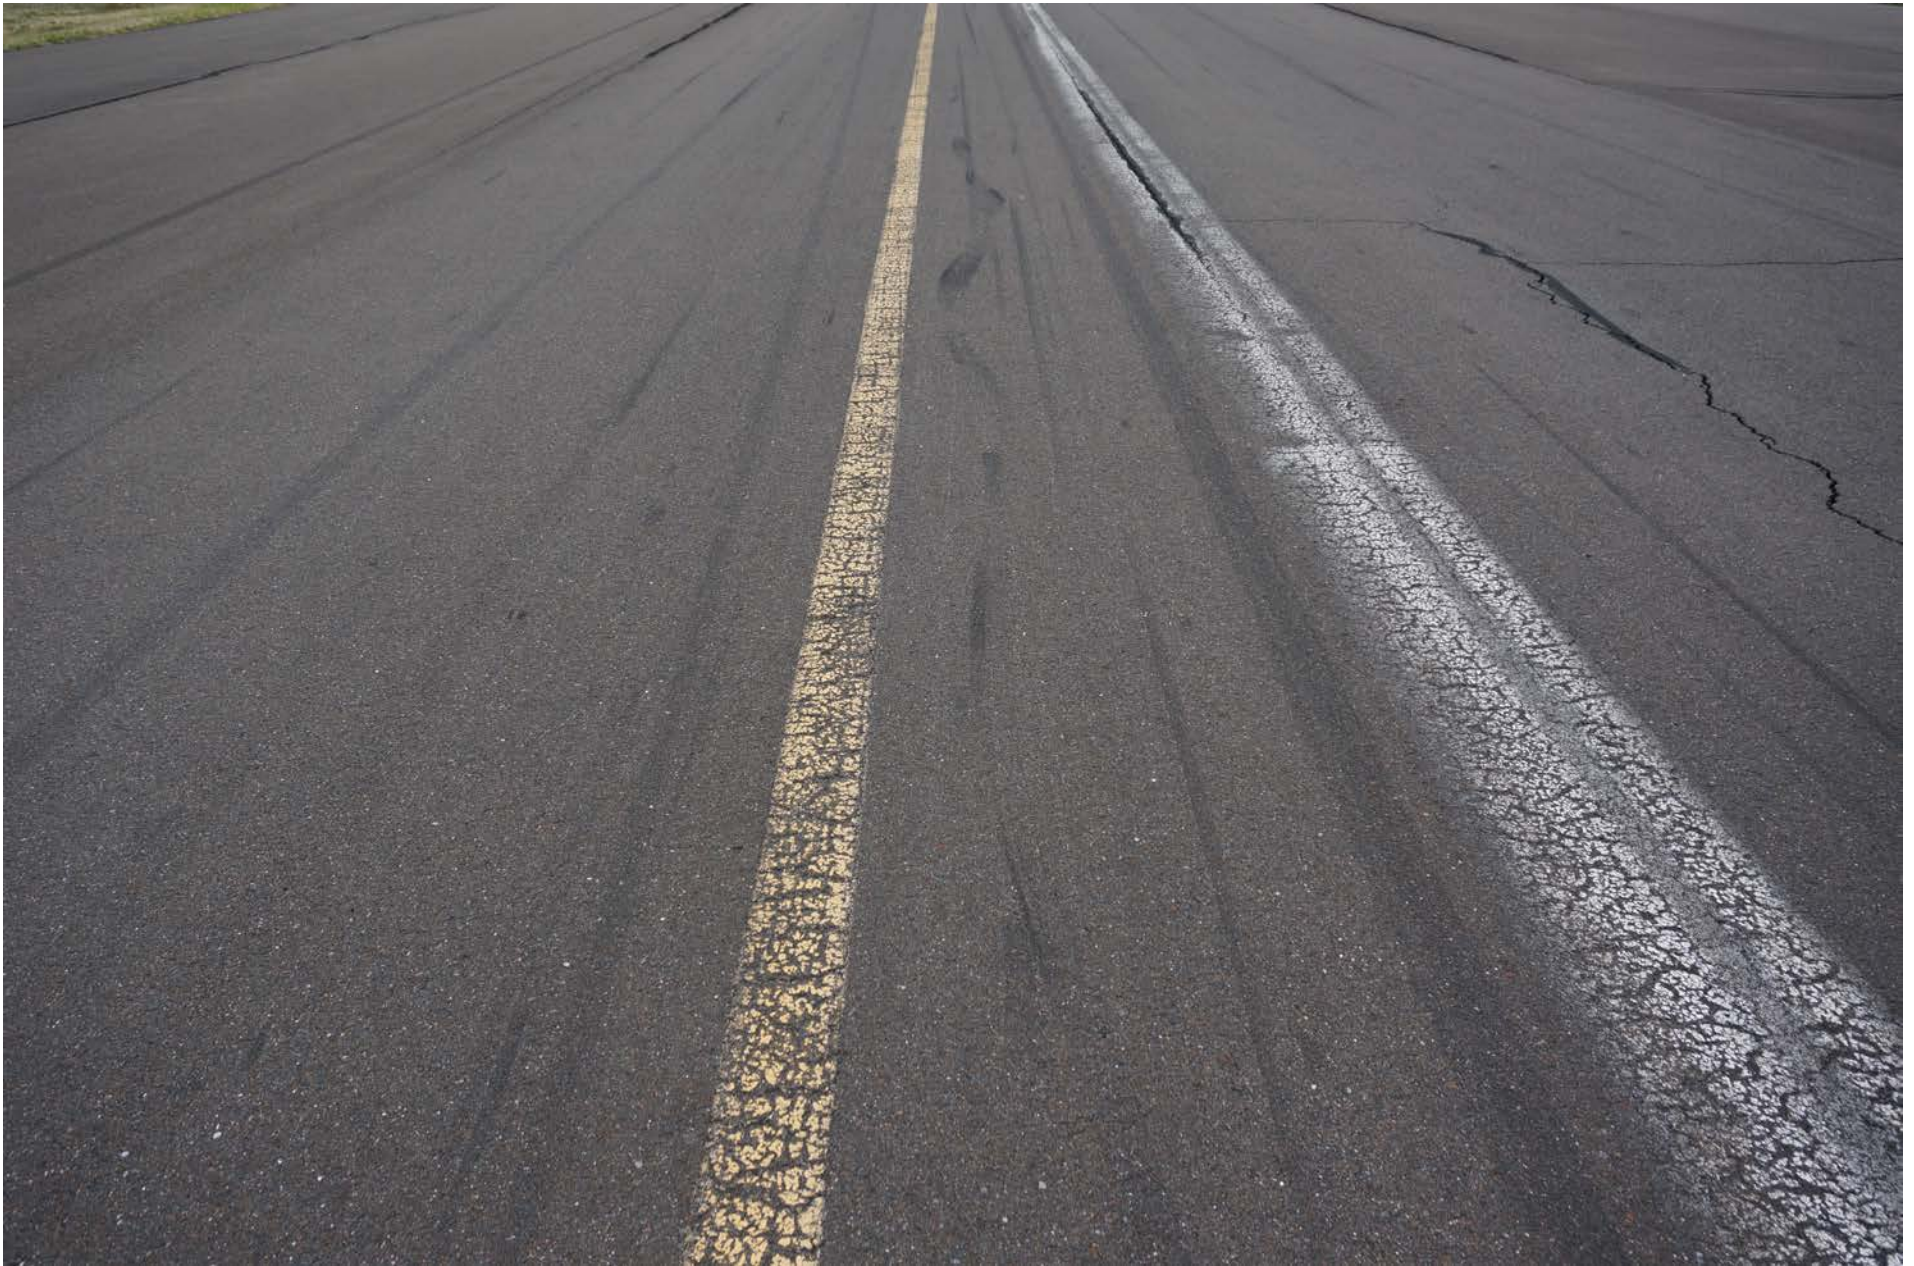
**Photo 17 - Second Set of Nose Wheel Tire Marks and Nose Wheel Pant Paint Transfers**
